Study of the Ponta Negra Beach Surface in Manaus / AM: Evidence and Causes of Mass Movement of the Artificial Beach Landfill

Keyword: Rio Negro; artificial beach landfill; movement of sandy mass; erosion.

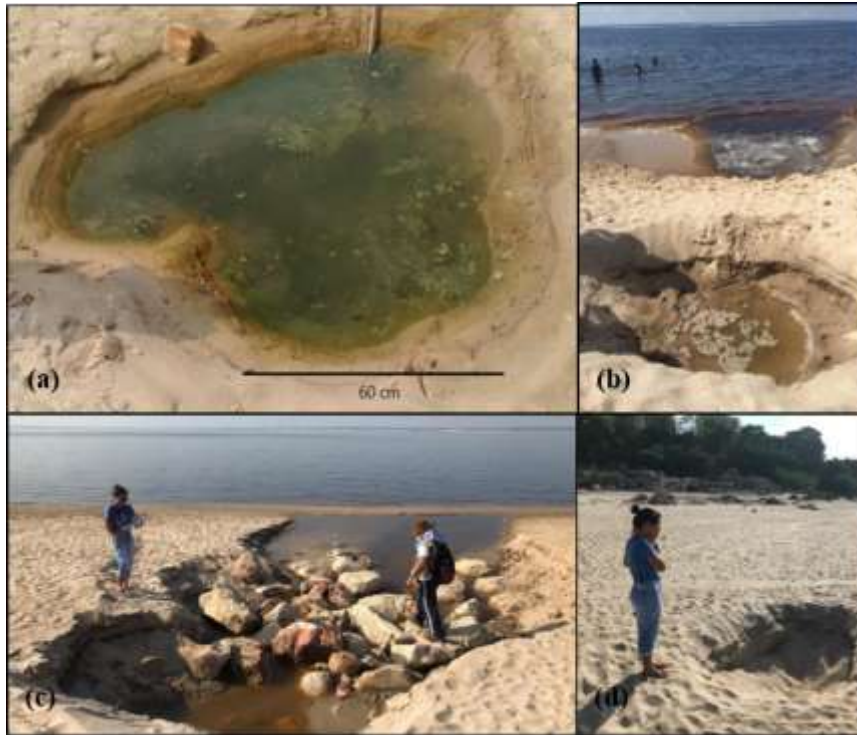
Figure 3: a) Abrupt depression / internal erosion feature in 2017 at the landfill; b) Erosion with the formation of pots on the artificial beach in 2018. c) Erosion on the natural beach, close to the beach line, of almost 6m in length in 2018. d) Cavities about 1 m in diameter in the embankment in 2018.

Both the natural beach and the artificial beach showed erosion in the area, mainly close to the beach line, during the entire research period. These features come in different sizes, ranging from approximately 10 to 50 cm in depth, and from 1 to 6 m in length, and are caused by processes of ravination and internal erosions due to a greater influence of the river on these banks. (Figures 3.4 and 5).

Due to the finer material used in the landfill, it is also easier to remove these sediments by draining surface water from the rains, being responsible for the large presence of pipes exposed on the beach and the transport of sediments from the landfill and its deposition in the river. In addition, the construction and transport of water on the surface also affects the adjacent natural beach, where you can see the presence of large cavities close to the beach line (Figure 3c).

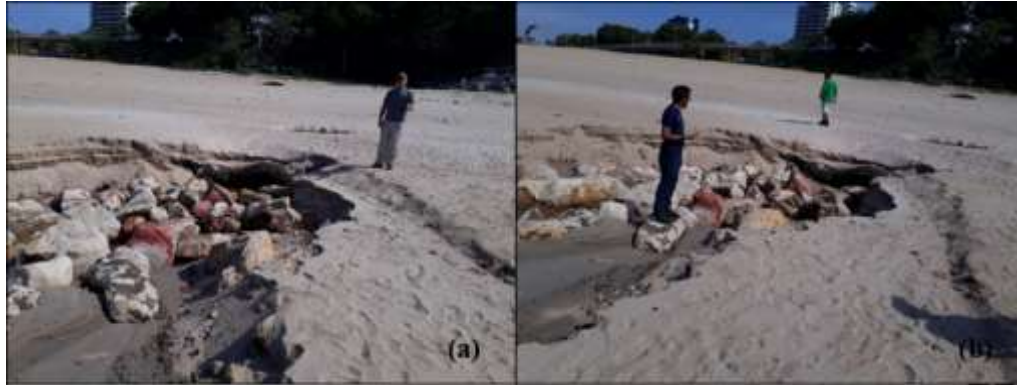
Figure 4: Features found on the transition surface of the embankment and natural beach, during the drought periods, in 2018 - a and b) Erosions with the appearance of the substrate rocks, approximately 2 meters wide, and 40 cm deep.

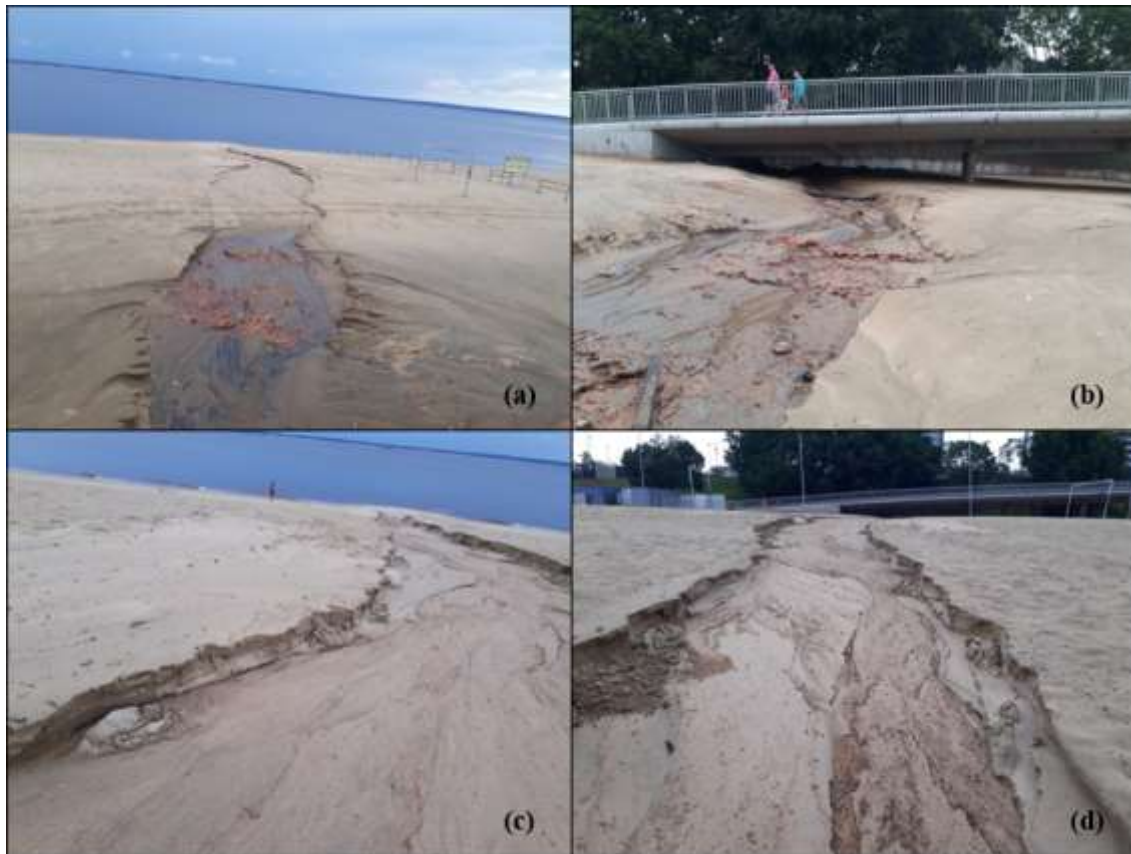
Figure 8: Features found on the landfill surface during low water periods, in 2018 - Features of sandy movement due to rain. Photos a and c) show the sediments towards the river, and photos b and d) show the sediments coming from the beach.

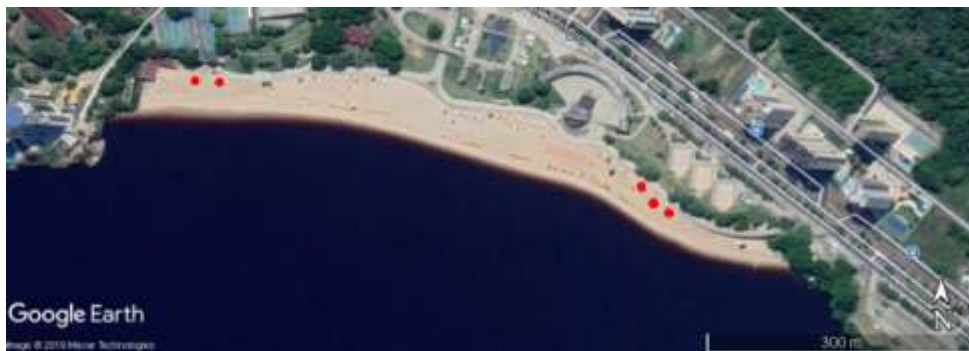
Figure 10: Places where the movements of sandy masses in figures 7, 8 and 9 occur, and water accumulation in figure 7a, caused by the presence of pipes and stairs that channel rainwater more intensely.

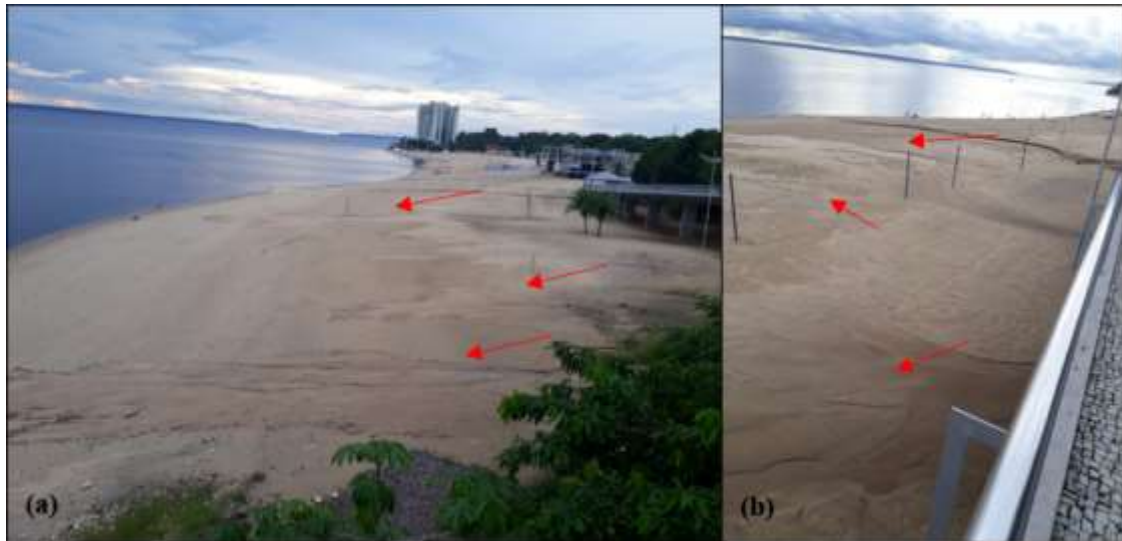
Figure 11: Features found on the landfill surface during low water periods, in 2019 - a) and b) Beach surface presenting, in general, the sandy mass movement features.

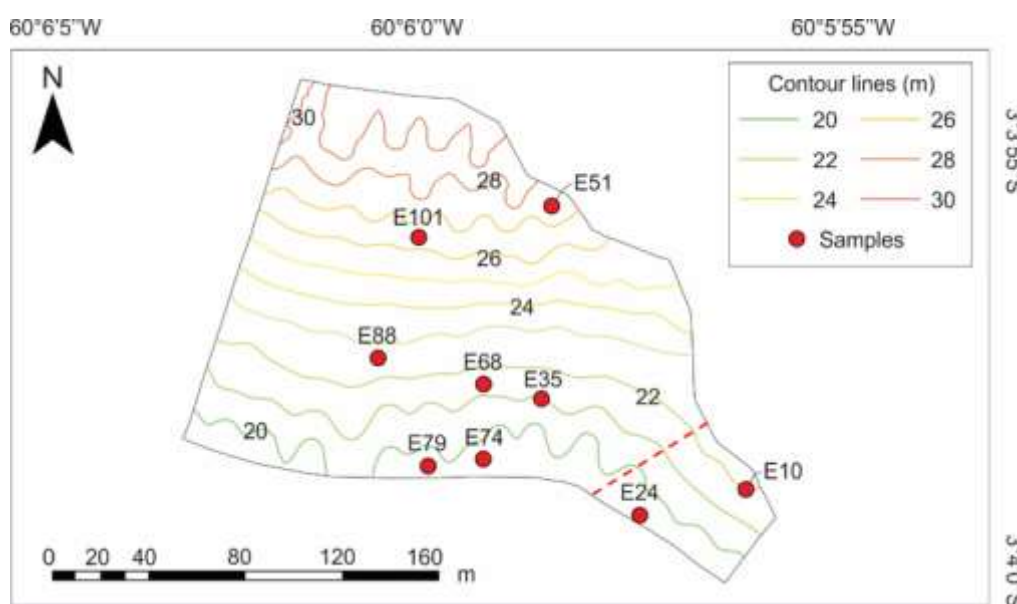
During the topographic survey in 2017, sediment samples were collected at 9 points and taken for analysis in the laboratory (Figure 14). As a result of the analyzes, characteristics of moderately selected sediments, from rounded to angular, were revealed, with the predominant granulometry of medium sand (0.250 to 0.50 mm), being also possible to verify great variations in the presence of silt and clay size sediments.

Figure 14: Map of the location of samples collected in 2017, indicated by red dots. The red dashed line shows the transition between the artificial beach (to the west) and the natural beach (to the east).

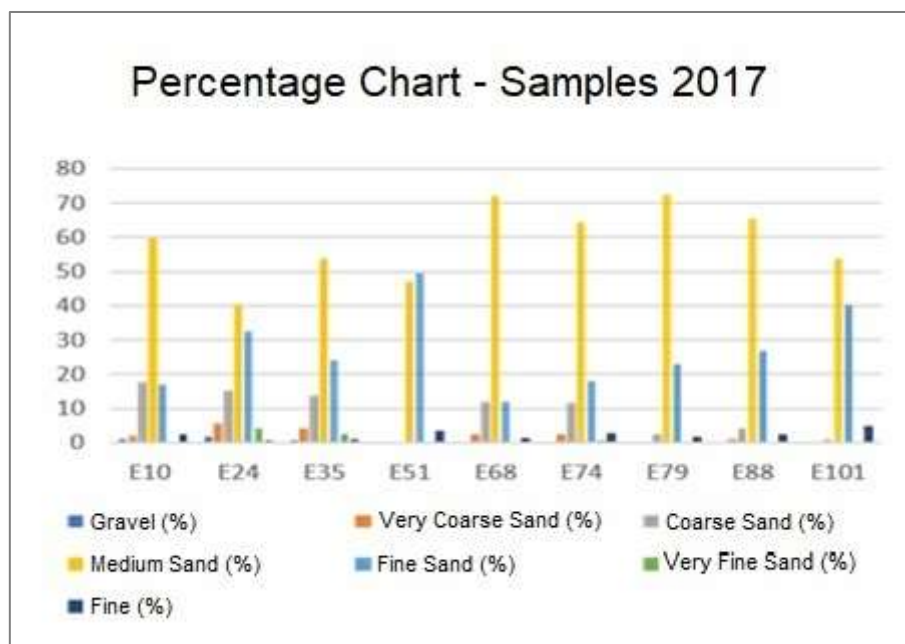
Samples with a higher content of silt and clay granulometry sediments from the artificial beach occur with greater predominance close to the top line of the land, indicating that the greater quantity of fine sediments placed on the beach may have already been remobilized by the action of the river and rains (Figure 15). It is possible to notice that the granulometry of the sediments varies according to the sampled area, proving that the terrain is composed of heterogeneous material (Figure 15).

Figure 15: Percentage graph of the granulometry of the samples. The granulometry of the sediments varies widely, and the predominant type is medium sand.

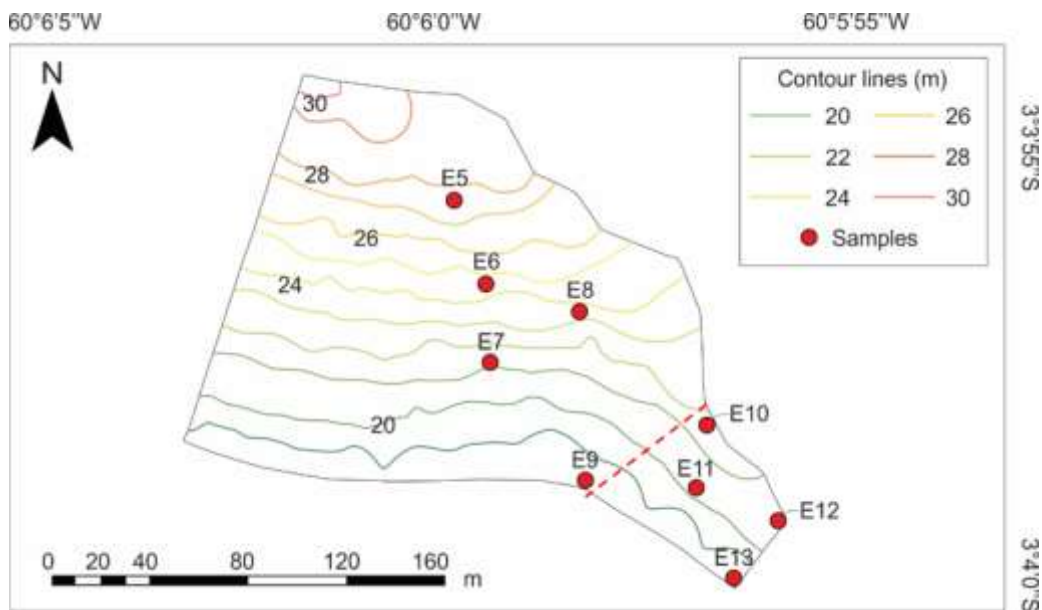
In 2018, sedimentological analyzes of samples collected during this year's topographic survey (Figure 16), revealed that sediments are moderately selected, from rounded to angular, also having predominant grain size of medium sand grains (0.250 to 0.50 mm) in all samples (Figure 17). The sediments still show a great variation according to the collected area, however the fine sediments presented a significant reduction.

Figure 16: Location map of samples collected in 2018, indicated by red dots. The red dashed line shows the transition between the artificial beach (to the west) and the natural beach (to the east).

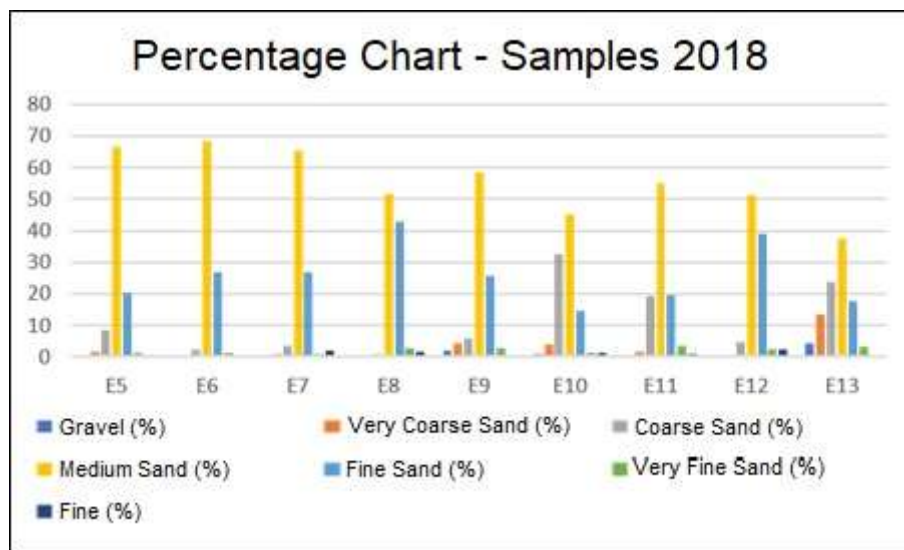
Figure 17: Percentage graph of the granulometry of the samples. The granulometry of the sediments varies widely, and the predominant type is medium sand. There is a reduction in fine sediment (black color) when compared to the 2017 graph (Figure 15).

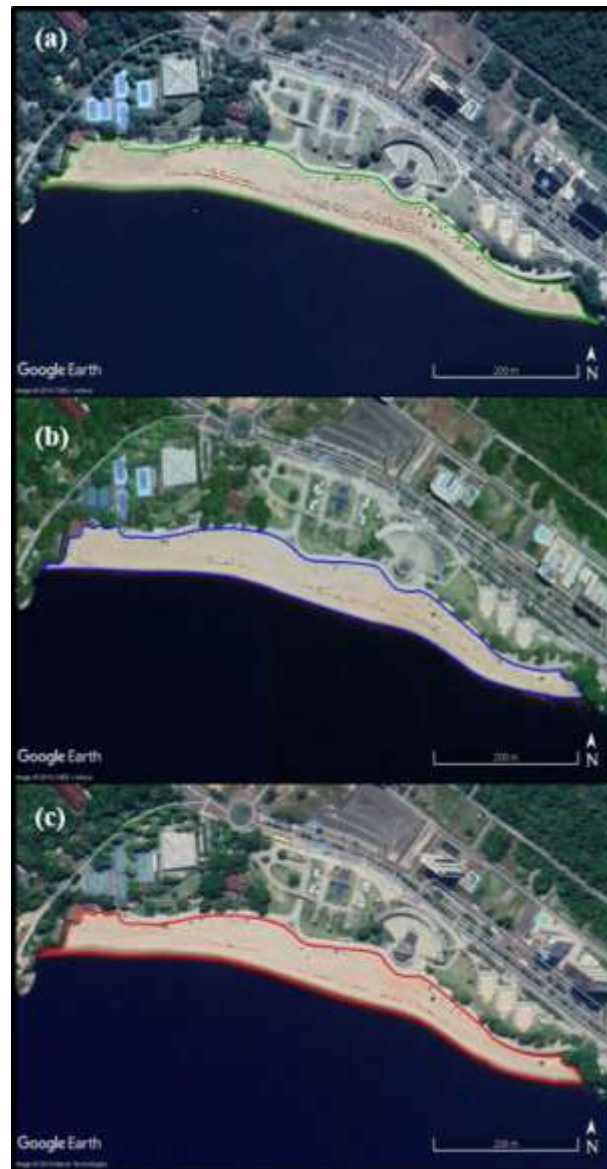
The following images (Figure 18) were used to perform area calculations in times of floods, in order to state that the landfill is being remobilized, and consequently, decreasing over the years.

Figure 18: A) Flood on 7/29/2017, elevation: 27.69 m; B) Flood on 07/20/2018, elevation: 28.15 m; C) Flood on 7/31/2019, elevation: 28.34 m. The polygons in each image were used for area calculations. Source: Images taken in the Google Earth Pro program and elevations data taken from the Porto de Manaus website.

Since the analyzes were carried out on dates close to each year and the elevations values are very similar, the calculation created (Table 9) reveals a significant reduction in the size of the areas over the years, inferring that this reduction was due to action to remobilize the grounded material.
