Installing a prototype wind turbine to produce energy in Antarctica to allow a permanent Colombian scientific base to be established

Citation: Jimenez C L. Installing a prototype wind turbine to produce energy in Antarctica to allow a permanent Colombian scientific base to be established. *Adv Polar Sci*, 2020, 31(4): 258-273, doi: 10.13679/j.advps.2020.0031

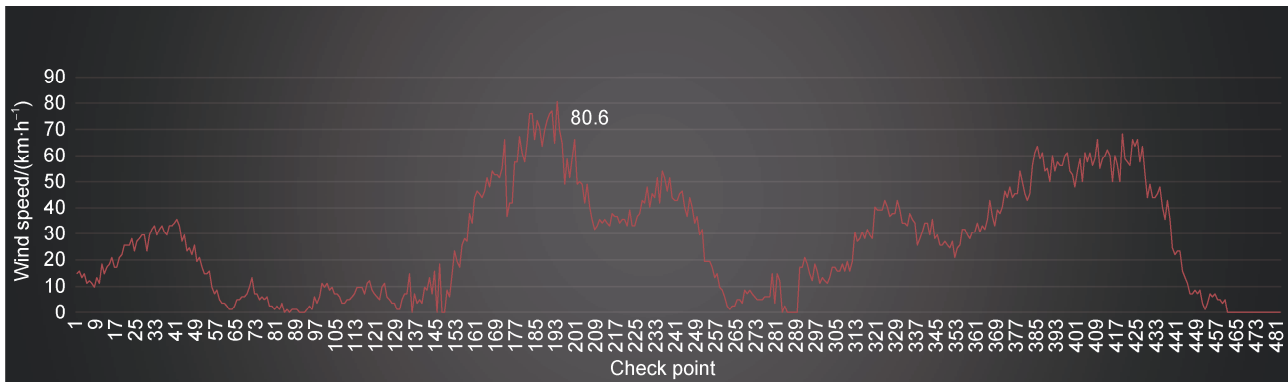
Time series of wind speed and temperature data recorded at the Marambio scientific station during the initial phase in December 2015 of the project are illustrated in Figure 1 (maximum wind speed registered of 80.6 km·h⁻¹ and average of 30 km·h⁻¹) and Figure 2 (maximum temperature registered of −17.6 °C and average of −10 °C, respectively).

Figure 1 Wind speed versus check points at 30-min intervals from 25 February to 7 March, 2018 (Jimenez, 2018).

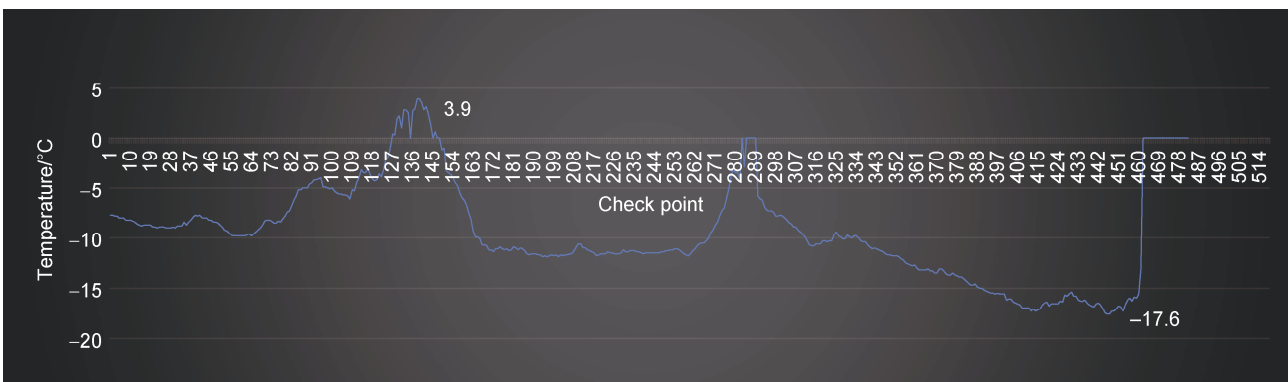
Figure 2 Temperature versus check points at 30-min intervals from 25 February to 7 March, 2020 (Jimenez, 2018).

The meteorological data obtained at the Marambio scientific station indicated that the temperature could fall to $-17\text{ }^{\circ}\text{C}$ (Figure 2), which is another reason supporting the

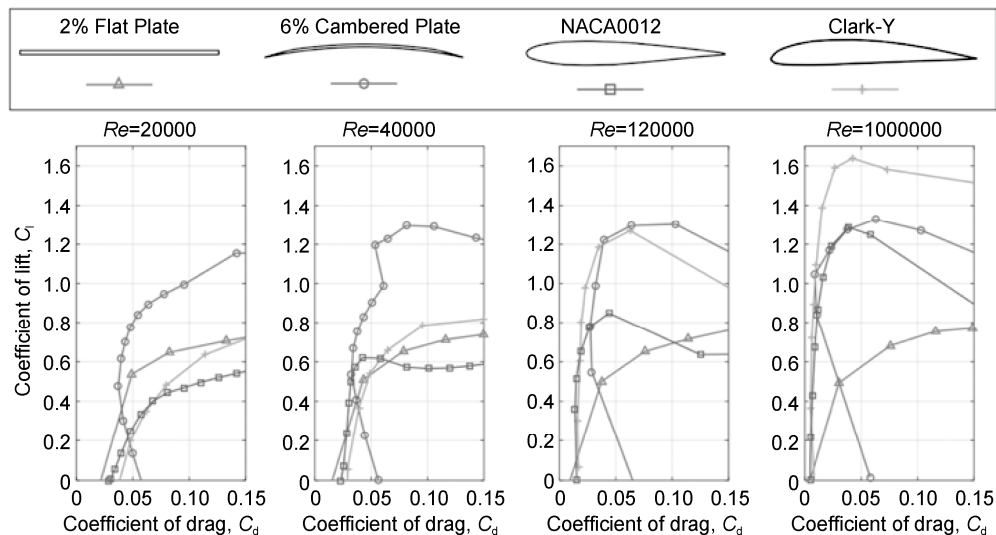
Figure 3 Effect of Reynolds number on multiple airfoils in terms of the drag polar (Winslow et al., 2018).

Generally, blades with a definite twist are more efficient because the lift and drag become closer to optimal levels (Figure 3); however, cost implications mean that most blades cannot be twisted. In areas that require high effectiveness, the offset loss in performance of a flat blade should be considered (Johnson, 1985).

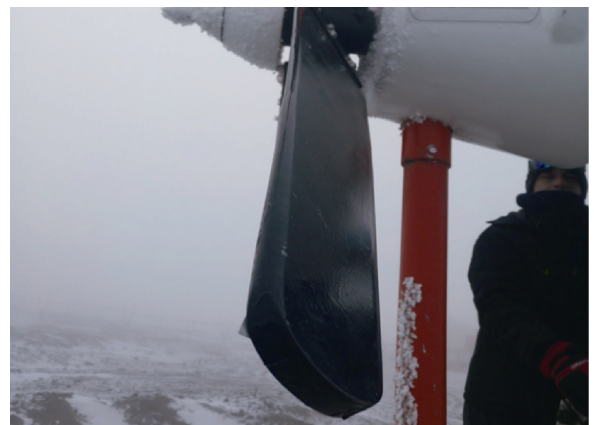
The material selected for fabrication of the propeller was Nylon 6 (Figure 4). It is a common commercially available material that has the following technical features and other characteristics that make it ideal for such purposes:

Figure 4 Flat plate blade made of Nylon 6 with angle of attack of 45° .

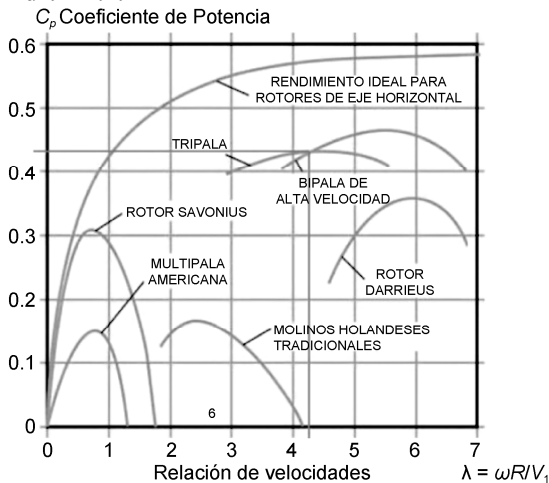
The power coefficient C_p represents the main characteristic of a propeller, in combination with the dimension parameter λ . The latter establishes the relationship between the tangential speed of the blade tip and the actual wind speed (Figure 5):

Figure 5 Performance of windmill and wind turbine propellers (Bastianon, 2008).

It can be determined from Figure 5 that for $\lambda = 4.2$, the corresponding angular velocity ω is $47 \text{ rad}\cdot\text{s}^{-1}$ or

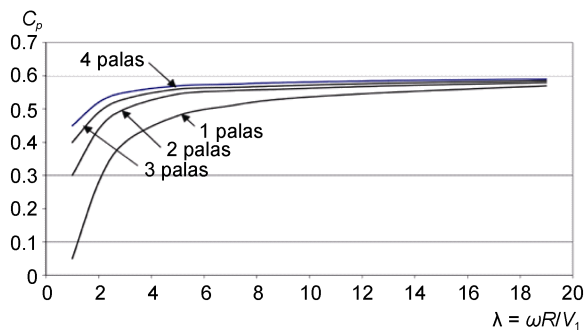
Because λ combines the most important design variables, the behavior of any propeller can be fully defined by representing the power coefficient C_p as a function of the speed ratio λ . Therefore, for the case of our propeller with parameters $R = 2 \text{ m}$ and $V_1 = 80 \text{ km}\cdot\text{h}^{-1}$ ($22.2 \text{ m}\cdot\text{s}^{-1}$) (Figure 6), we find $\lambda = 4.2$.

Figure 6 Aerodynamic performance (C_p) versus λ for propellers with different numbers of blades (Bastianon, 2008).

Similarly, it can be determined from Figure 6 that for a three-bladed propeller, the corresponding power coefficient C_p is approximately 0.55. The maximum C_p values represent the maximum aerodynamic performance of the propeller. The higher the value of λ , the more powerful the performance obtained. This is important when the electricity supply demands a high gearing ratio.

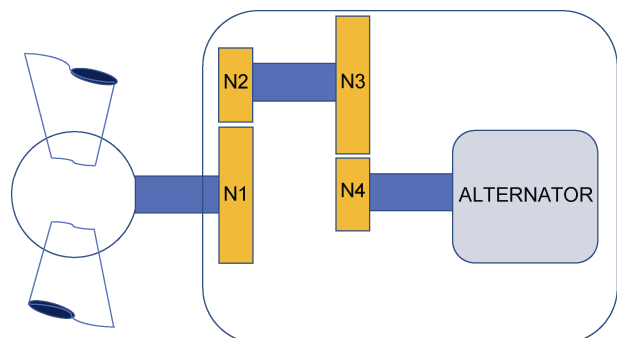
The gearbox comprised a set of four spur gears contained within a speed multiplier gearbox (Figure 7). The design parameters considered a minimum (maximum) input of 1000 (6000) $\text{r}\cdot\text{min}^{-1}$ to the alternator:

Figure 7 Schematic of the gearbox of the wind turbine.

$$\begin{aligned} Z1 \times N1 &= Z2 \times N2 \\ 72 \times 449 &= 21 \times N2 \\ N2 &= \frac{72 \times 449}{21} = 1539 \text{ r}\cdot\text{min}^{-1} \\ Z3 \times N3 &= Z4 \times N4 \\ 72 \times 1539 &= 21 \times N4 \\ N4 &= \frac{72 \times 1539}{21} = 5276 \text{ r}\cdot\text{min}^{-1} \end{aligned}$$

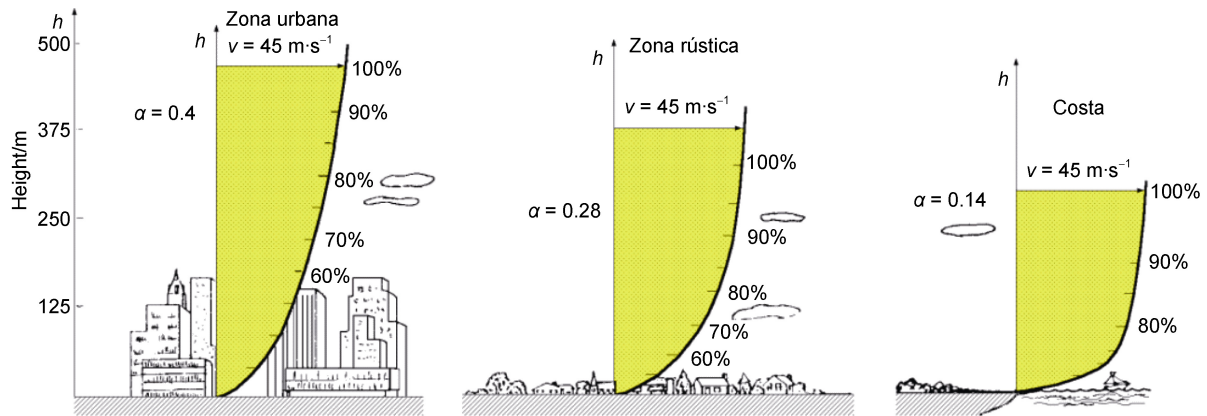
The characteristics of the location of operation are important. For example, the three profiles of wind speed displayed in Figure 8 indicate that a wind turbine is likely to produce more energy in a coastal region owing to the absence of constructions such as the buildings that can affect wind speed over urban areas.

Figure 8 Wind profile characteristics (Armario, 2012).

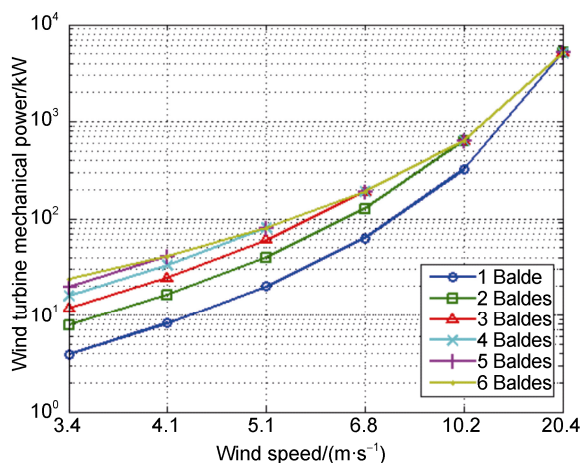
Figure 9 Mechanical power of a wind turbine with different numbers of blades versus wind speed (Tan and Teow, 2016).

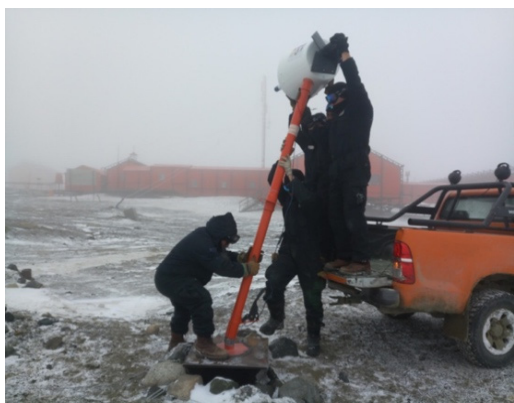
Figure 10 Installation of the wind turbine at Marambio Station in the Antarctic.

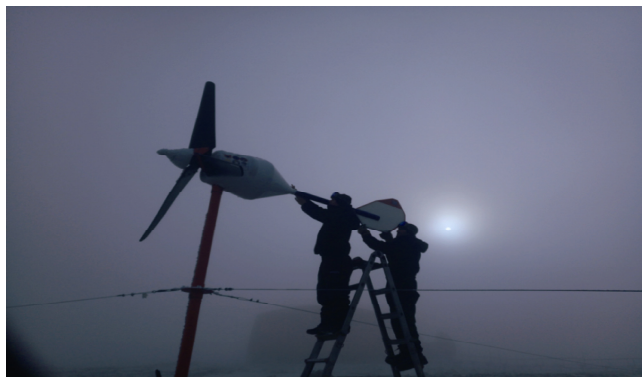
The work in the field was completed under exceptional conditions, i.e., winds of $8\text{--}120\text{ km}\cdot\text{h}^{-1}$ and temperatures as low as $-25\text{ }^{\circ}\text{C}$. Owing to the severity of the Antarctic weather, the working party was split into a group rotation to facilitate completion of the tasks. The need for suitable clothing restricted mobility, which compromised the ability of those involved in manipulating components, tools, and accessories (Figure 11).

Figure 11 Final installation of the prototype Eolic turbine.

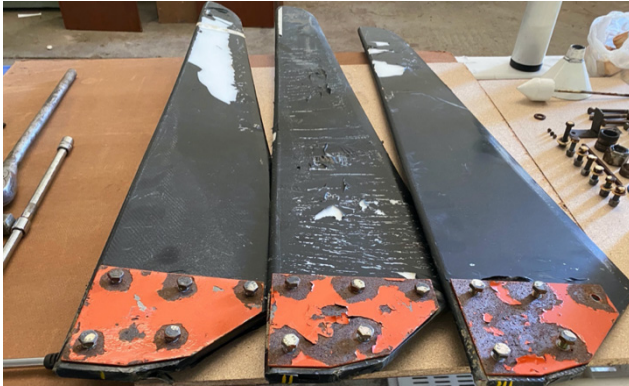
After continuous operation for 2 years in Marambio Station, the performance of the prototype wind turbine was analyzed to provide feedback and knowledge for future developments. Nondestructive tests were performed on the three blades of the propeller after they were uncoupled, as shown in Figure 12. Visual inspection revealed severe granular corrosion on the fastening plates of each blade.

Figure 12 Visual inspection of the propeller blades.

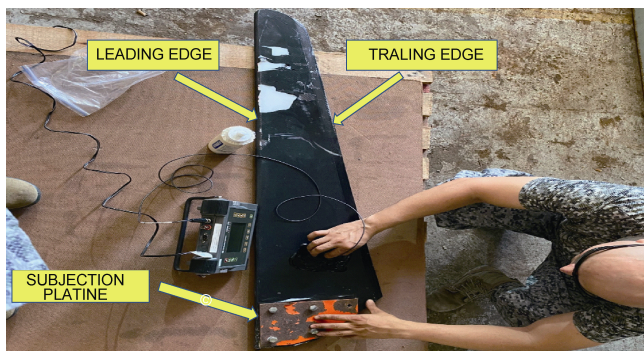
In addition, using the magnetic particle technique, an ultrasound inspection was performed on the blades, with particular attention given to the leading edge, trailing edge, and blade-turbine joint (Figure 13). During the inspection process, no obvious indicators of major problems were found (i.e., cracking, delamination, and loss of material due to erosion). Therefore, the performance of the blades during their 2 years of operation was considered satisfactory.

Figure 13 Ultrasonic inspection of the propeller blades.

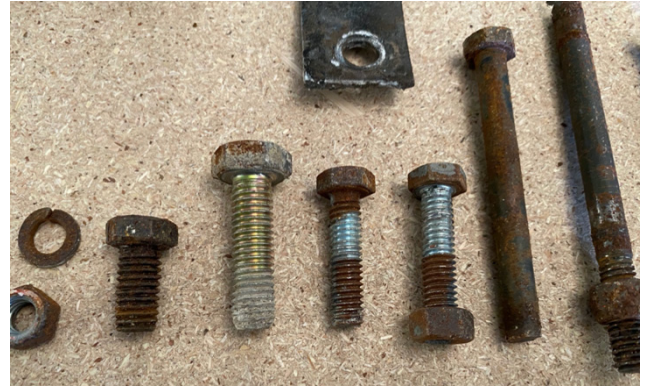
Similarly, ultrasonic inspection was performed on the 18 cast iron screws used to join the internal parts of the wind turbine to the plates of the blades (Figure 14). During the inspection, granular corrosion was evident in the heads

of the screws and in the fastening part of the nut (i.e., those areas exposed to the environment).

Figure 14 Visual inspection of the wind turbine screws.

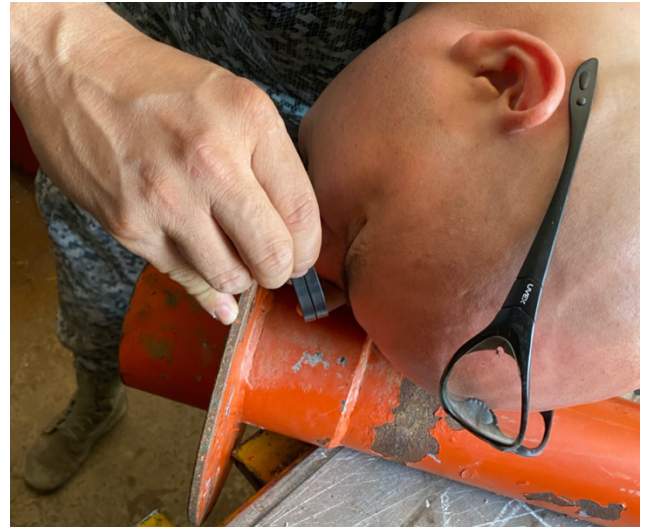
Direct visual inspection using a 10× magnification lens was performed on the entire anchorage structure of the wind turbine after it was cleaned using SKC-S cleaner (Figure 15). During the inspection, granular corrosion was evident in 40% of the structure and loss of the anticorrosive coating (paint) was evident over 40% of the structure; however, no obvious indicators of major problems were found (i.e., cracks, notches, and loss of material due to corrosion).

Figure 15 Visual inspection of the anchorage structure using a 10× magnification lens.

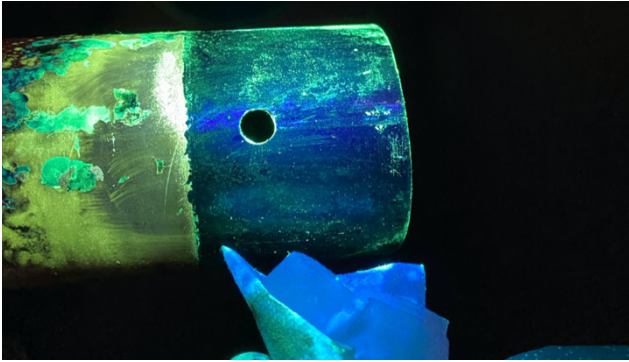
Inspection of the anchoring tube of the wind turbine was performed using the liquid penetration technique (Figure 16). The area to be inspected was first cleaned using SKC-S cleaner. Then, a penetrant (ZL-27A) was applied and allowed to penetrate for 30 min. Finally, a developer (SKD-S2) was applied and allowed a 15-min development time.

Figure 16 Inspection of the anchoring tube using liquid penetration technique.

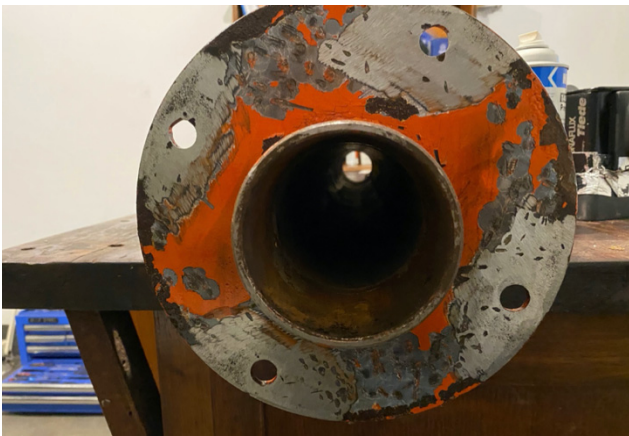
Owing to the high concentration of corrosion due to exfoliation resulting from loss of the anticorrosive coating, the base material had to be exposed by removing as much of the corrosion as possible using a motorized abrasive disc. Once the element to be inspected was prepared (Figure 17),

Figure 17 Support of the wind turbine tensor cable prepared for inspection.

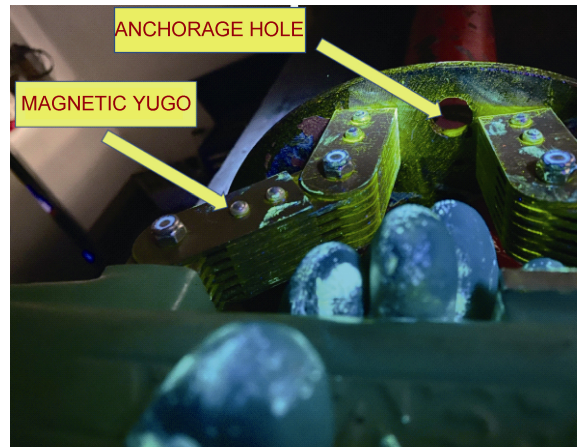
The four clamping holes for the cable attachments at the base of the wind turbine were inspected using the magnetic particle technique, which revealed evident deformation (ovalization) and mechanical notching due to the tension exerted by the strong Antarctic winds (Figure 18).

Figure 18 Magnetic particle technique inspection of prototype. (Lozano, 2015).

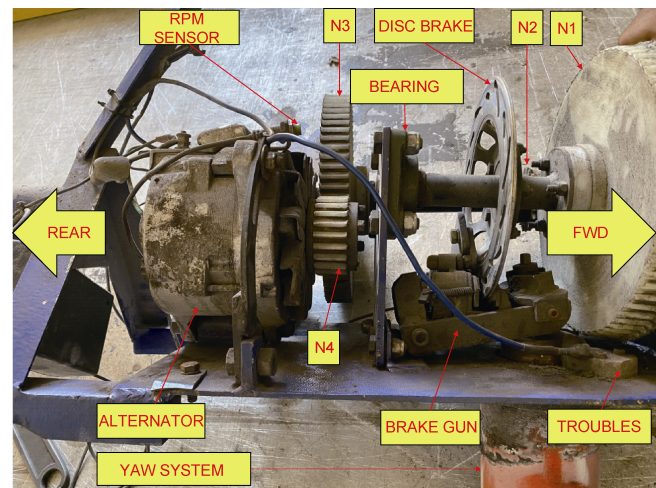
The condition of the mechanical components contained within the nacelle of the wind turbine can be seen in Figure 19 and is discussed as follows.

(1) N3: Main gear with 72 teeth made of Teflon. Damaged during operation of the turbine, with broken teeth with 100% loss of material causing 90% loss of effectiveness;

(2) N4: Secondary gear with 21 teeth made of Teflon. Damaged during operation of the turbine, with broken teeth with 100% loss of material causing 80% loss of effectiveness;

(3) Hand Brake (Brake Gun): Used to arrest movement of the wind turbine, if required. Its performance was 80% effective following excessive wear of one of the two brake pads (inner);

Figure 19 Mechanisms contained in the wind turbine nacelle.

(4) Disc Brake: Used to arrest movement of the wind turbine, if required. Its performance was 100% effective;

(5) Yaw System: Bearing mechanism by which the wind turbine can rotate with the direction of the wind. Its operational effectiveness was 50% owing to the corrosive environment, strong wind loading, and dust. Abrasion resulting from lack of preventive maintenance caused corrosion of the track and bearings, which resulted in loss of its ability to rotate;

(6) N2: Secondary gear with 72 teeth made of Teflon. Damaged during operation of the turbine, with broken teeth with 70% loss of material causing 70% loss of effectiveness;

(7) N1: Secondary gear with 21 teeth made of Teflon. Damaged during operation of the turbine, with broken teeth with 40% loss of material causing 50% loss of effectiveness;

(8) RPM Sensor: Electronic instrument that counts generator revolutions. Its performance was very poor (20% effectiveness) owing to humidity and dust;

(9) Alternator: Transforms mechanical movement into electrical energy. Its performance was reduced by 90%.

Among the conclusions regarding the performance of the turbine, the most obvious improvements could be made in relation to both the ferrous materials and bearings to provide greater capability and sealing to maintain lubrication, and the overspeed system to protect against damage from the excessive wind.

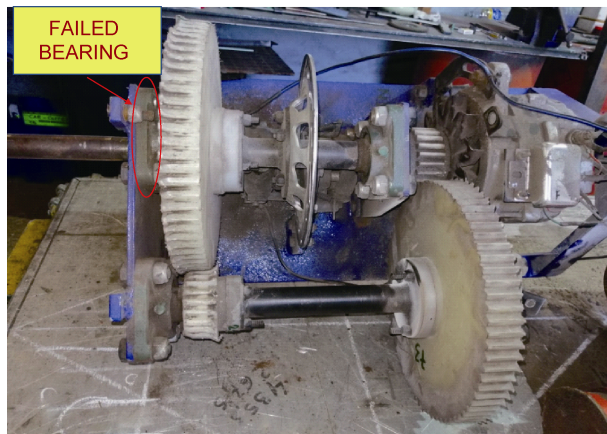
The directional bearing of the yaw system supports the combined weight of the propellers, hub, generator, and nacelle. The conditions of the Antarctic environment (i.e., wind loading, dust, and other factors) contributed to abrasion of the metallic moving parts and corrosion of the track and bearings owing to lack of lubrication (preventive maintenance), which led to 100% reduction of its effectiveness (Figure 20). This damage caused misalignment of the main shaft of the wind turbine that resulted in abnormal wear and reduced power generation to 15% of its potential total capacity.

Figure 20 Wind turbine nacelle.

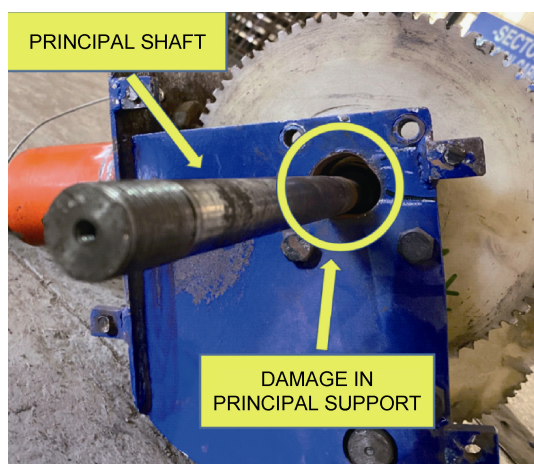
The damage caused by the failure of the bearing generated misalignment in the main axis of the tower, and this off-center movement caused imbalance that resulted in damage to the structure (Figure 21). It can be seen from the figure that the front support suffered loss of material, mechanical notching, and deformation.

Figure 21 Damage caused by failure of bearing.

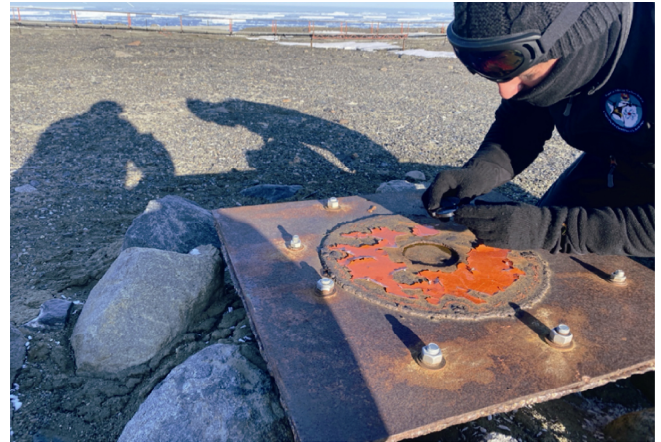
Nondestructive visual inspection revealed three examples of cracking in the area of the foundation of the wind turbine. Furthermore, galvanic corrosion of the foundation screws resulted in loss of approximately 60% of the galvanized coating (Figure 22).

Figure 22 Visual inspection of the turbine base using a 10× magnification lens.

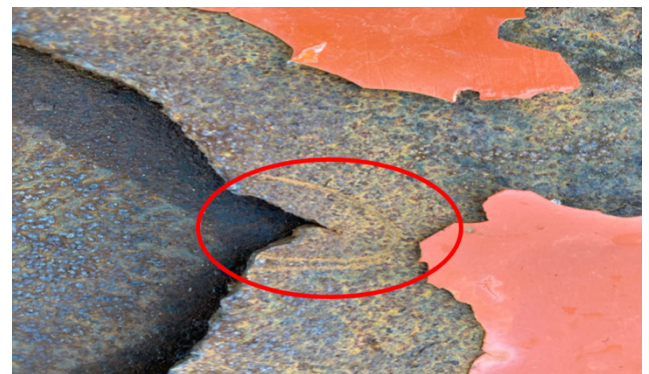
Direct visual inspection also revealed a crack of approximately 30 mm in length and loss of material in the main fastening plate, which was welded to a 5-mm-thick metal plate (Figure 23).

Figure 23 Cracks in the main fastening plate.

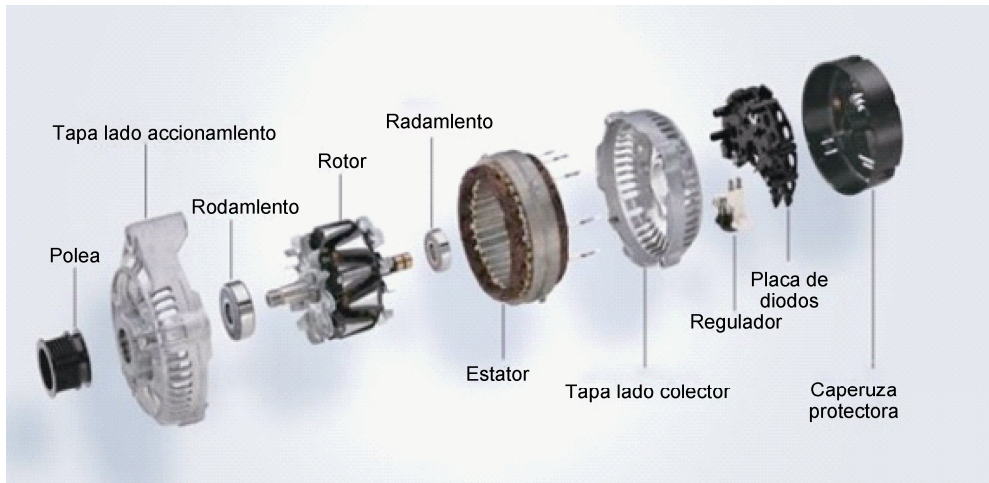
wind turbine. In this case, its simplicity of design, ease of availability on the market, and reasonable cost were the primary considerations regarding selection. The components of the chosen alternator are shown in Figure A3.

Figure A3 Alternator parts (ComoFunciona, 2020).
