IMPACT OF RAPID MASS MOVEMENT AND DRIFTING SNOW ON THE  
INFRASTRUCTURE AND DEVELOPMENT OF LONGYEARBYEN,  
SVALBARD

Erik Hestnes  
Norwegian Geotechnical Institute,  
P.O.Box 3930 Ullevaal Hageby, N-0806 Oslo,  
Norway

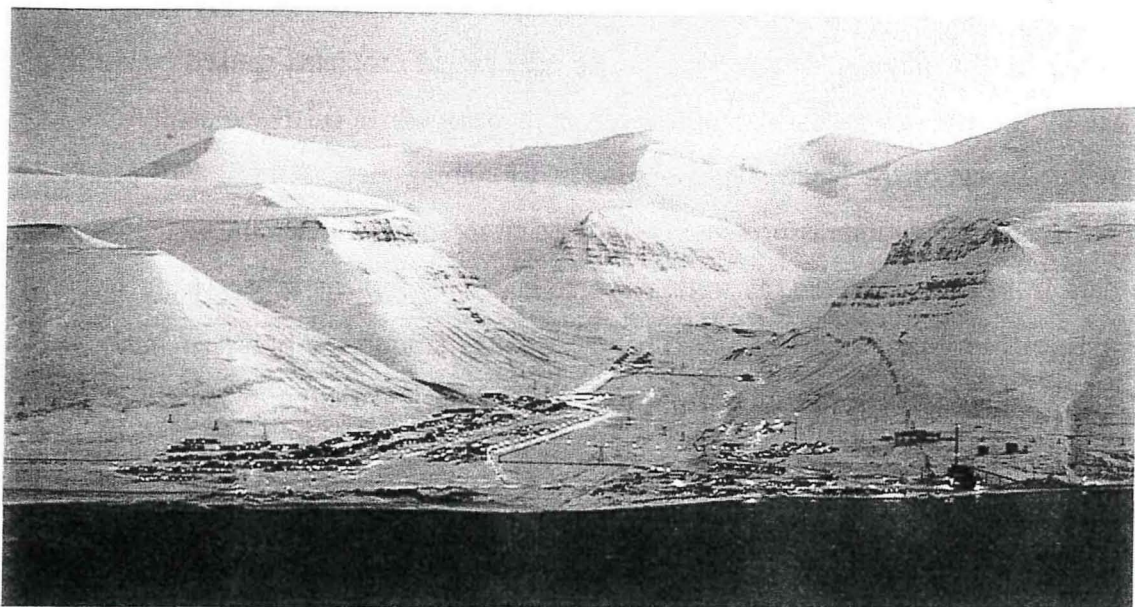
Figure 1: The settlement of Longyearbyen, Svalbard. Adventfjorden in front, Nybyen up-valley on the left hand side. The areas mentioned in the text can be identified on the picture. (Photo T. Kjærnet)

The community centre (Huset), the burial ground, and at least parts of the deserted Sverdrupbyen, as well as the road between these sites, lie in the hazard zone of avalanches, debris flows and rockfalls (Fig. 1-2). Only opinions about the acute avalanche hazard to the road and the community centre, due to current meteorological conditions, have been requested in this area.

Nybyen, today's oldest residential and service area in Longyearbyen, is located on screes and glacial deposits along the foot of Gruvefjellet (Fig. 1-2). Snow avalanches, collapse of cornices, debris flows, rockfall and floods are potential threats to the built up area. Recent incidents have reached the buildings in the northern part. NGI has given advice concerning problems related to cornices and acute avalanche hazard.

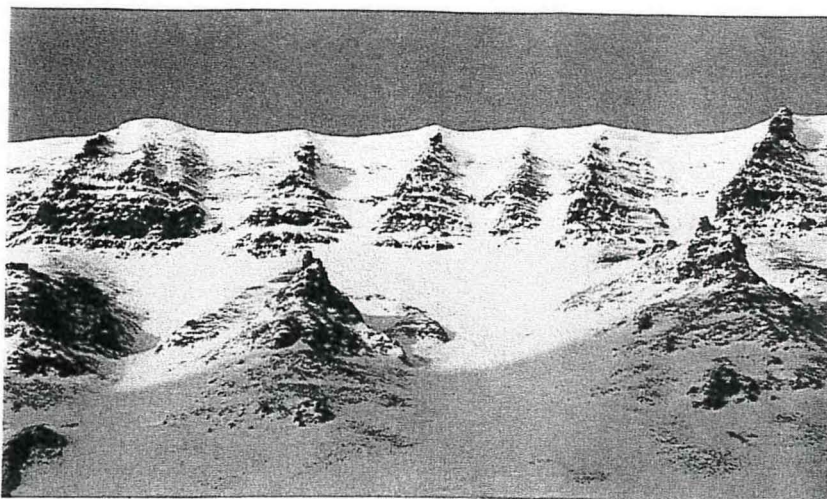
Figure 3: Some of the cornices along the rim of Gruvefjellet. The starting zones of avalanches in the lee-slopes below.

Every winter huge cornices are built-up along the rim of the top plateau, due to the prevailing wind from the southeast (Fig. 3). If parts of these cornices collapse

during winter or spring they may release snow avalanches in the steep lee-slopes below, or come all the way down as big blocks. Either way can be hazardous to

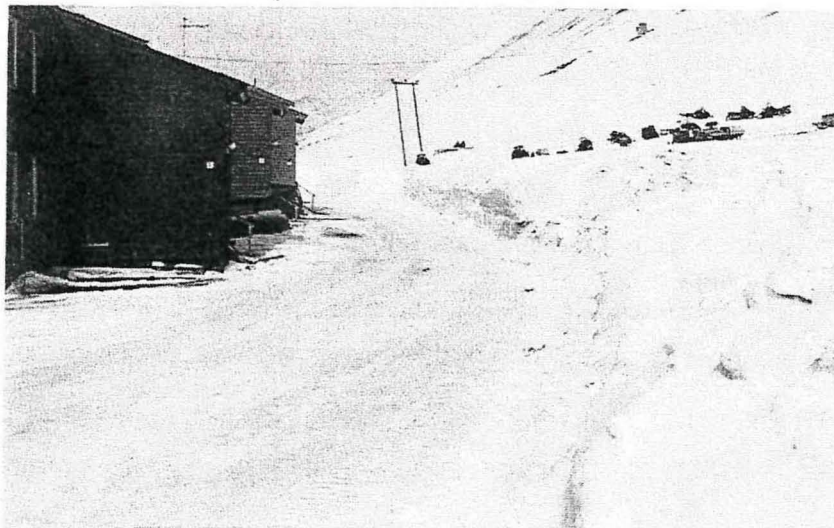
Figure 7: The access to houses along road 222 is frequently blocked by snowdrift.

Mitigation of the snowdrift about the roads 222 and 226 is planned by means of snowfences (Fig. 7). The location and dimensioning of the fences are based on

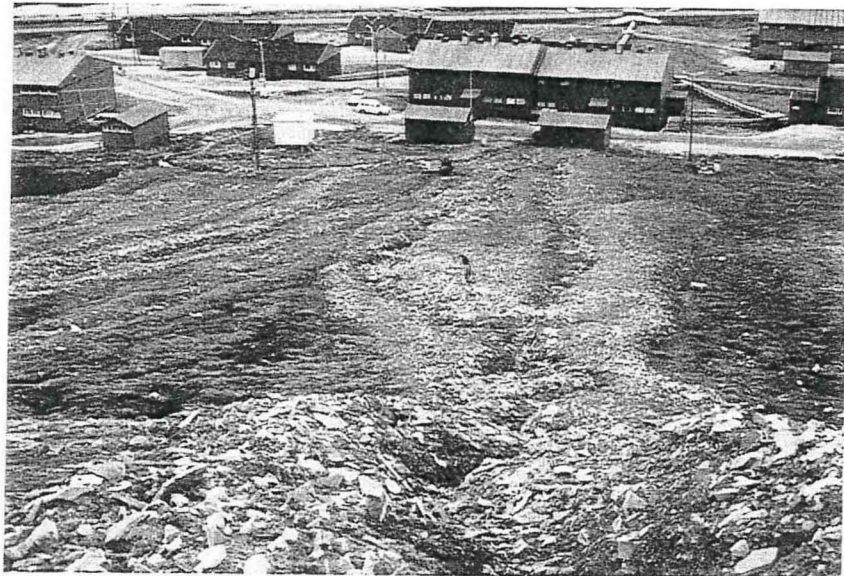
Figure 8: Houses along road 226 are located on debris flow deposits.

The obvious debris flow hazard in the area is notified, but neither routines for acute hazard evaluation nor safety measures have so far been requested (Fig. 8).

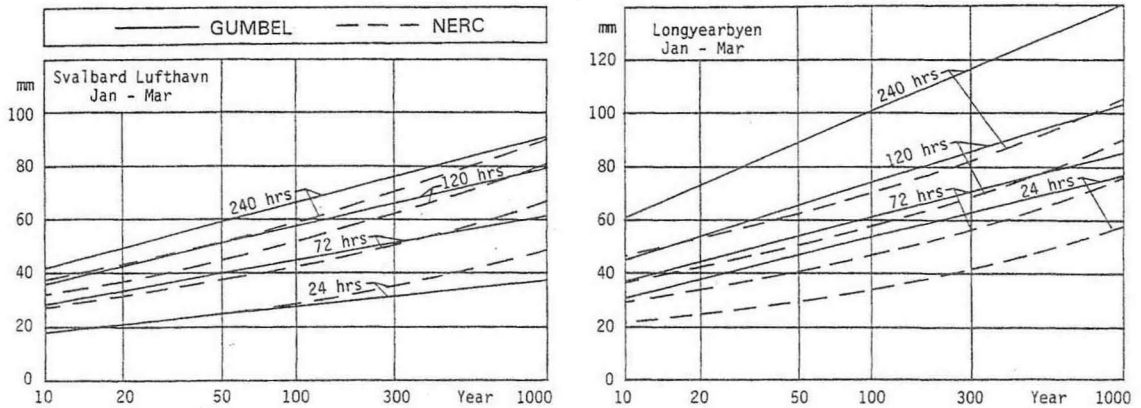
Figure 10: Precipitation prognosis according to Gumbel and NERC.
