# Full scale testing of timber-concrete composite floors in an overhanging configuration

Javier Estévez-Cimadevila<sup>\*</sup>, Félix Suárez-Riestra, Emilio Martín-Gutiérrez, Dolores Otero-Chans

University of A Coruña, Spain

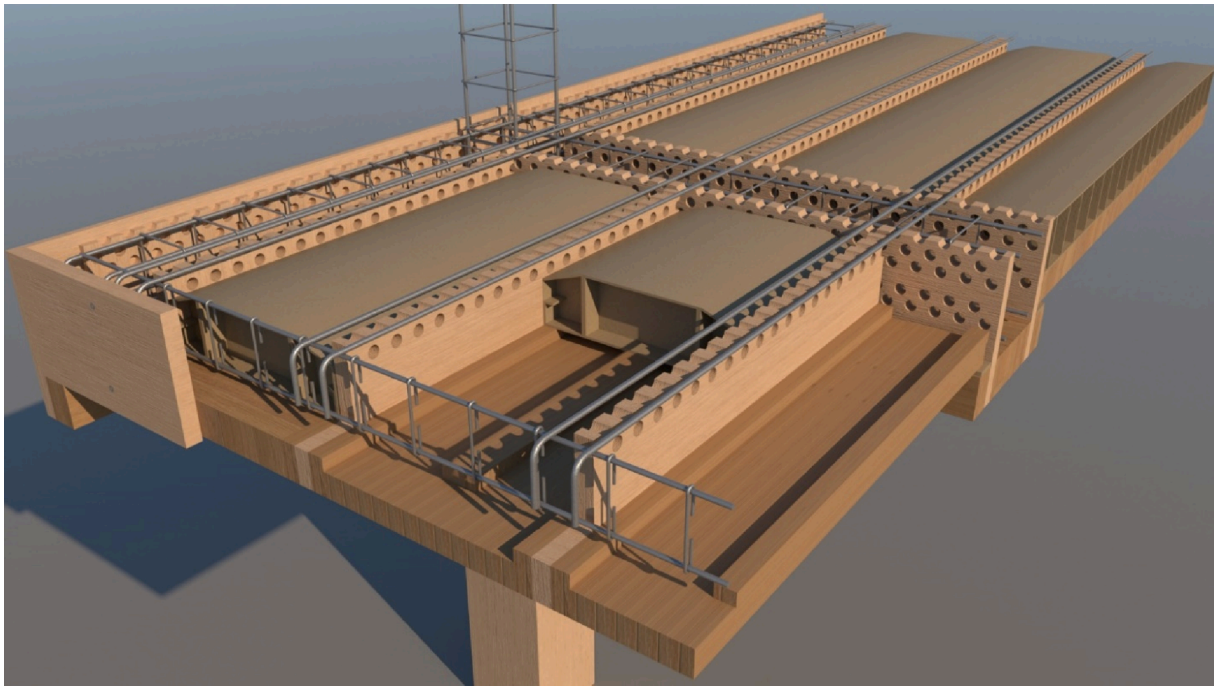
Fig. 1. Three-dimensional model of the flooring system

Our team has patented a comprehensive construction system based on the use of TCC sections in floors, beams, and pillars [12] (Fig. 1). Floors and beams are made up of an inverted T-shape or inverted  $\pi$ -shape prefabricated piece formed with a glulam flange and rib boards made of perforated plywood. This prefabricated piece connects to a poured-in-place concrete top slab through existing holes in the plywood board. The behavior of TCC systems largely depends on the effectiveness of the timber-concrete shear connection, so that in addition to a high strength against shear forces, this is achieved with a reduced slippage of the joint, as this allows a high composite effect. The tests carried out by our team [13] have shown a high efficiency of the solution developed with perforated boards as a means of joining. Likewise, a four-point bending test has been carried out with pieces of 6.0, 7.20 and 8.40 m

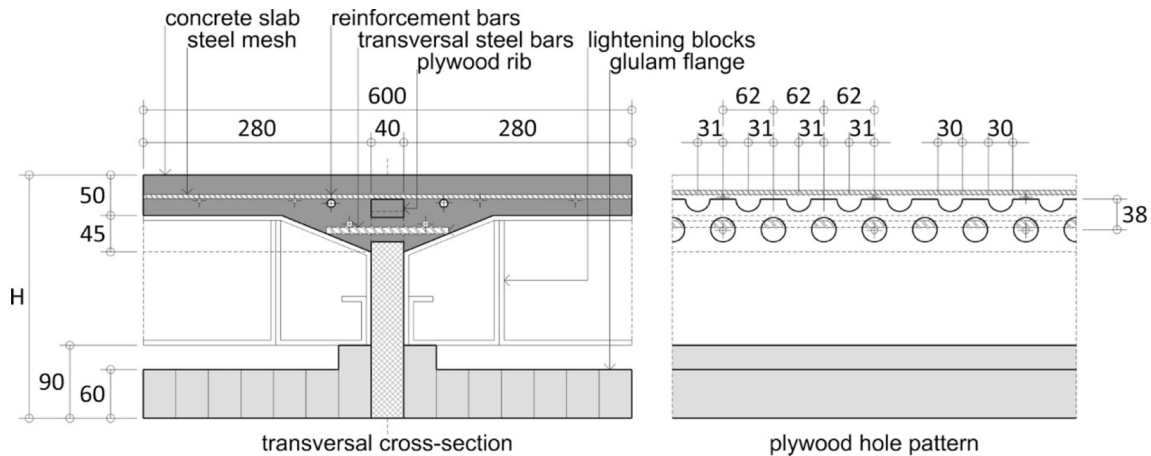
Fig. 2. Specimen geometry. Dimensions in mm.

The overhanging beam configuration tested (Fig. 2) is composed of a prefabricated T-inverted shaped piece formed of a glued laminated timber (GLT) flange glued to a rib made of plywood. The GLT flange is 600 mm wide and 60 mm thick which increases to 90 mm in the rib contact area to reduce glue line stresses. The rib has a thickness of 40 mm and was transversally perforated in its upper part with circular hollows of 30 mm in diameter to connect with a concrete layer poured over the light cardboard blocks. The concrete slab has a thickness of 50 mm, increasing to 95 mm in the connection area with the rib. A 200x200 mm steel mesh with 6 mm diameter corrugated bars has been placed on the concrete slab. Likewise, reinforcement bars 120 mm long and 10 mm diameter have been placed that go through one of every three rib perforations to provide ductility to the wood-concrete connection. Finally, since these are pieces intended for negative bending moment tests, 2 reinforcement bars of 10 mm have been placed, one on each side of the rib. The aforementioned reinforcement bars together with the 3φ6 of the

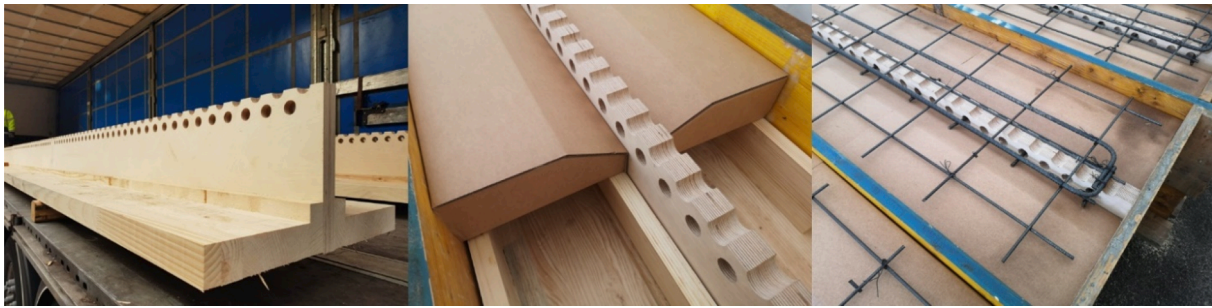
Fig. 3. Specimens manufacture

steel mesh parallel to the guideline of the piece gives rise to a total geometric amount of reinforcement for negative bending of  $7.10^{-3} \text{ mm}^2/\text{mm}^2$ . Fig. 3 shows different stages of the manufacturing process of the specimens.

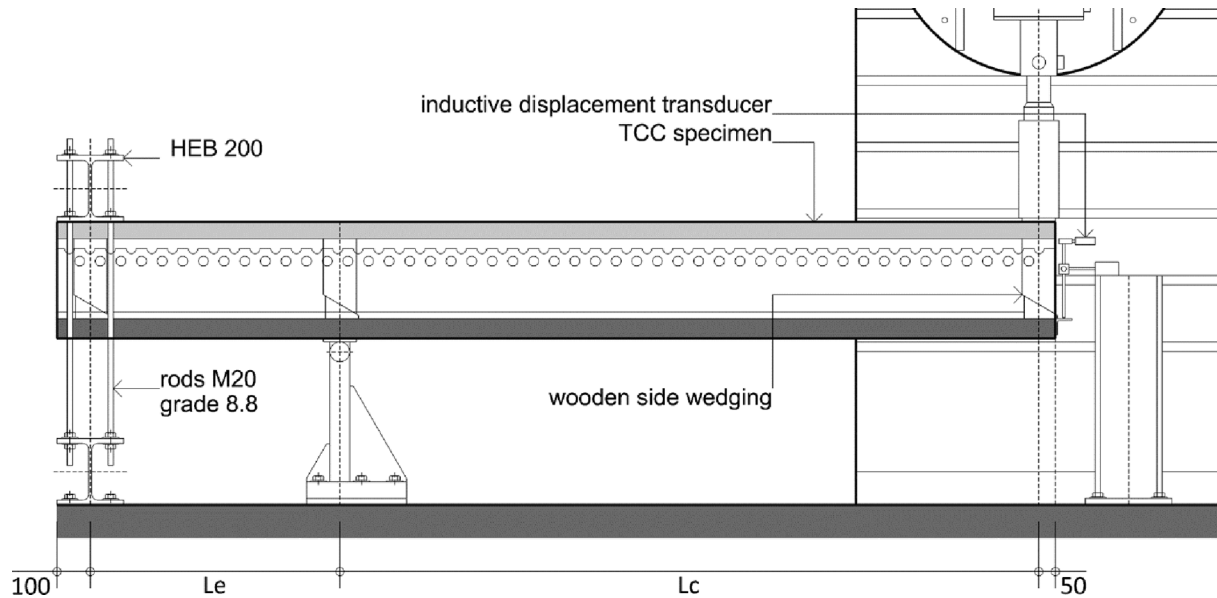
Fig. 4. Bending test

Three-point bending tests were performed with a PB2-F/600 Microtest hydraulic machine (Fig. 4). Vertical displacement was measured at the end of the overhanging beam using a Schreiber SM160.100.2.ST inductive displacement transducer. In addition, an Aramis 3D sensor was used to apply Digital Image Correlation (DIC) to

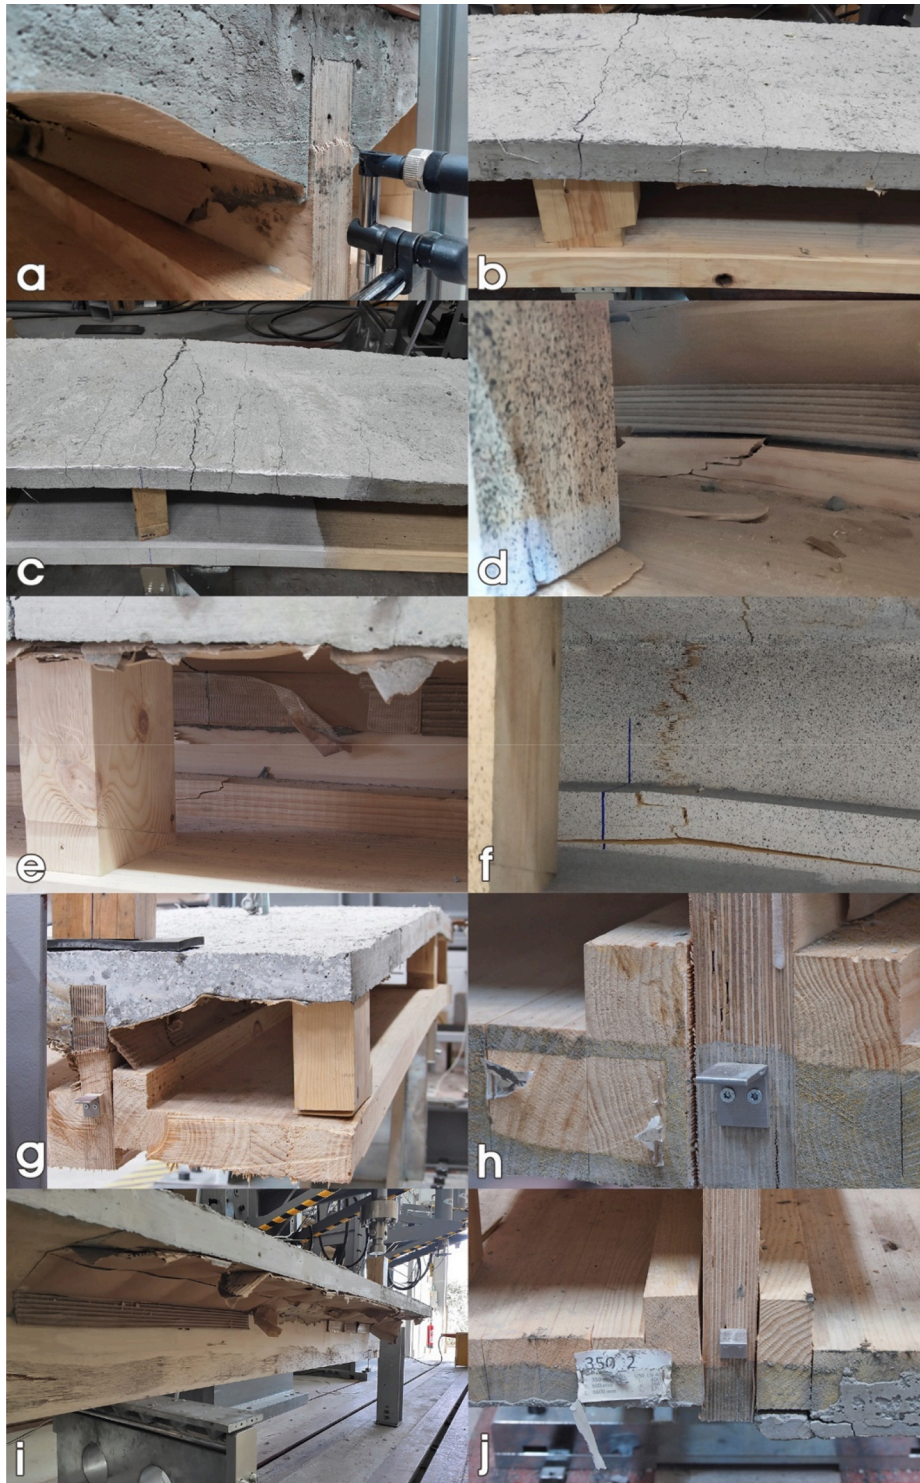
Fig. 6. Failure modes. Samples: 250.1-X (a, b, d); 250.2-X(h); 250.1-Y(g); 300.1-X(i); 300.2-X(e); 300.2-Y(b, f); 350.2-X(j). Note: images e, g, i show the remains of cardboard corresponding to the vaults used as lightening elements and that were partially removed to observe the damage to the wood

As stated above, the specimens 250.1 exhibited significant slab slippage at both ends. Despite the magnitude of the slip (Fig. 6-a), no meaningful variations were observed in specimens 250.1-X and Y in terms of ultimate load and only a clear reduction in stiffness should be appreciated for values higher than the service load (Fig. 5 and Table 2).

Attending to the failure mode, in all cases it has been observed that when approaching the ultimate value, a marked cracking process begins in the concrete with cracks of increasing opening as the load increases and the support is approached, with a transverse path to the longitudinal axis of the piece (Fig. 6-b, c). The failure is reached abruptly and suddenly, observing two types of failure. In three of the specimens, the failure was caused by tension that affected the plywood rib (Fig. 6-d, e, f). In the remaining five, shear failure occurred at the connection of the glulam flange with the plywood rib (Fig. 6-g, h, i, j).

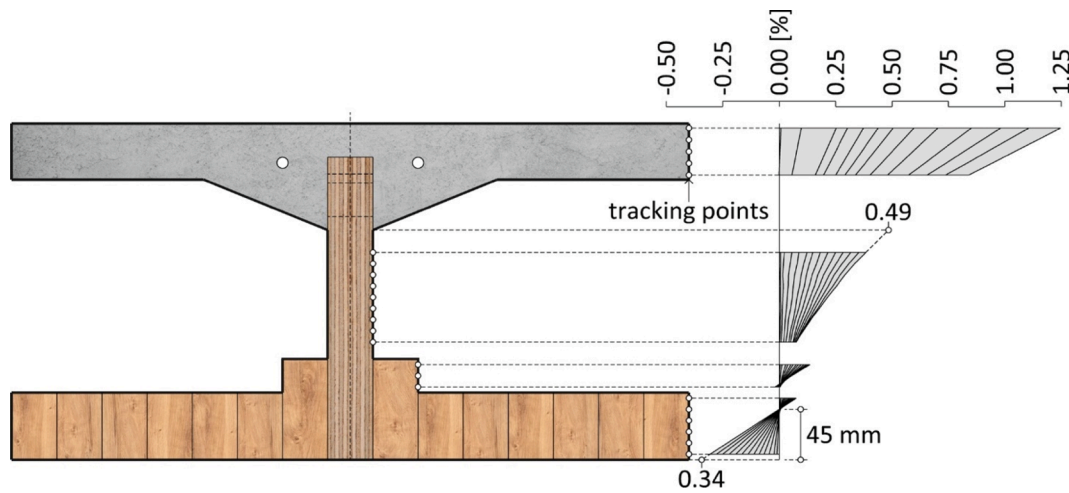
Fig. 8. Strain distributions of the support section of specimen 300.2-Y obtained by DIC for different load values

Fig. 8 shows the strain distribution in the analysed points of the section for different load values. It can be seen that the resulting position of the neutral axis is located  $45 \text{ mm}$  from the lower edge of the piece, which means that practically the entire GLT flange is under compression stresses with normal strain values far shorter than the failure values. In an opposite way, the plywood rib in the area where it meets the concrete has reached a normal strain of  $0.49\%$  with a tensile stress of  $45.09 \text{ N/mm}^2$  obtained considering the global MOE of the board of  $9296 \text{ N/mm}^2$ . These values fully justify the experimental reality observed with a breakage of the piece initiated in the upper part of the rib. On the other hand, the elongation experienced in the fibre corresponding to the position of the negative reinforcement bars has been  $1\%$ , which indicates that the bars are completely in the elastic phase.

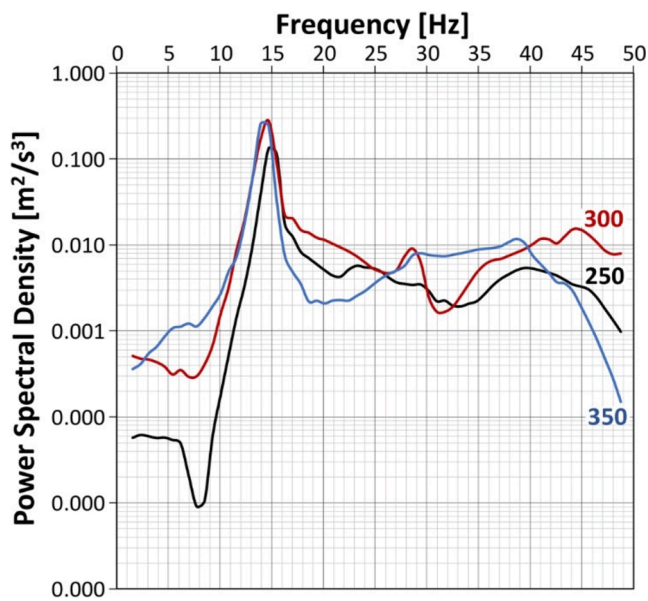
Fig. 9. Curves PSD-Frequency

In order to complete the analysis of the behavior in service of the cantilever floors, it has been considered essential to know the dynamic response of the pieces. To this end, an experimental analysis of the behavior against the limit state of vibrations has been carried out. The experimental analysis has been carried out on a specimen of each of the lengths used. Specimens 250.2-X, 300.2-Y and 350.2-Y have been analysed. The procedure consisted of exciting the system by an impulse reached by hitting with an instrumented hammer and measuring the response with a Bosch Sensortec BMI160 inertial measurement unit. The results obtained considering only the self-weight of the pieces, were natural vibration frequencies of  $15.0$ ,  $14.6$  and  $14.0 \text{ Hz}$  for the spans of  $1.5$ ,  $1.8$  and  $2.1 \text{ m}$ , respectively (Fig. 9).

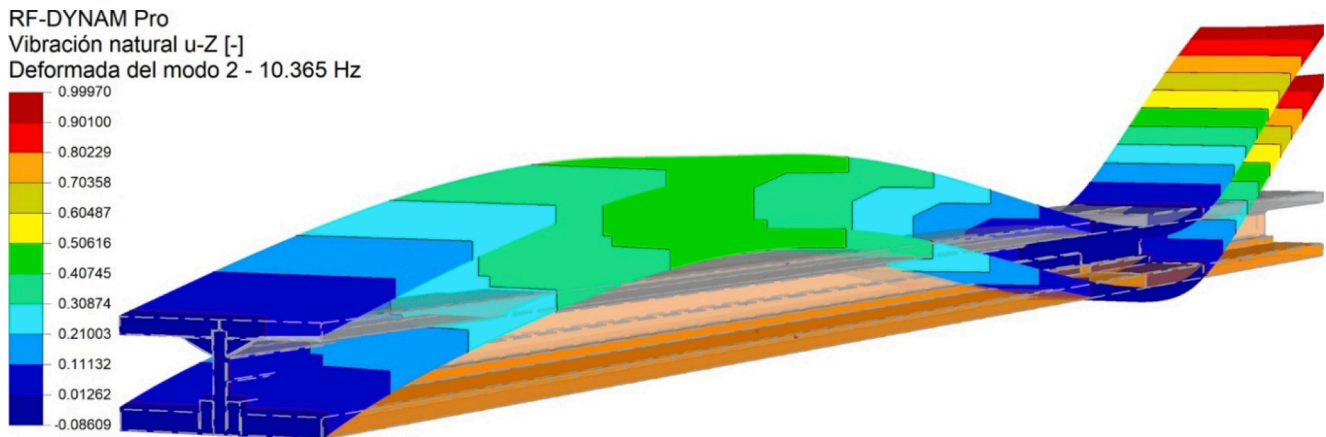
Fig. 11. FEM analysis of specimen type 300. Thickness 300 mm.  $L_c=1.80$  m.  $L_e=4L_c$ . Frequency for  $9.0 \text{ kN/m}^2$  and  $2.50 \text{ kN}$  at the free end of the overhanging beam.
