## Portland's Keystone Crustacean: Signal Crayfish Behavior, Health, & Habitat in the Tryon Creek Watershed

Schmitt, Kyla Marie (2022) "Portland's Keystone Crustacean: Signal Crayfish Behavior, Health, & Habitat in the Tryon Creek Watershed," *International Journal of Undergraduate Research and Creative Activities*: Vol. 14: Iss. 1, Article 5.

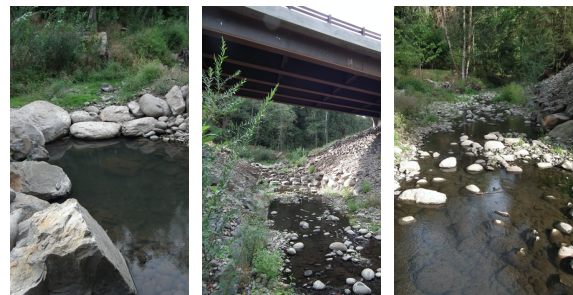
Figures 4A, 4B and 4C. Three different vantage points of Site I.

Site I — the Southwest Boones Ferry Bridge site ( $45^{\circ}26'49.0''N$ ,  $122^{\circ}41'14.3''W$ ) — was one of two research sites intersected by a well-trafficked road (Fig. 4A). Site I was recently subject to a year-long construction

project in which the City of Portland replaced a section of Southwest Boones Ferry Road (which, at the time, rested atop a culvert) with a new, 38-meter bridge. The project concluded in April 2021 (City of Portland, 2021) and included the removal of the road foundation and the reconstruction of a riparian habitat, which entailed placing boulders, engineering pools, replanting native vegetation, and installing large woody debris (Fig. 4B, Fig. 4C).

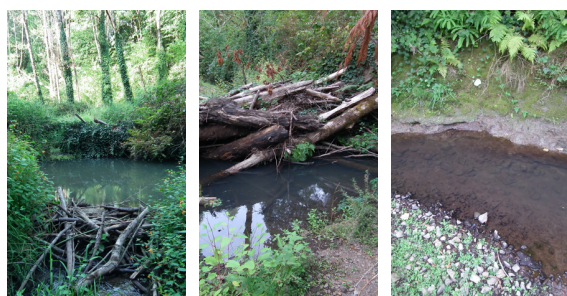
*Figures 5A, 5B, and 5C. Three different vantage points of Site II.*

Site II — the North Creek Beaver Dam site ( $45^{\circ}26'40.8''\text{N}$ ,  $122^{\circ}41'01.5''\text{W}$ ) — was the only site not in close proximity to a pedestrian bridge, road bridge, or culvert. It was primarily characterized by the presence of two beaver dams (Fig. 5A, Fig. 5B), which caused significant pooling in multiple spots along the narrow run (Fig. 5C).

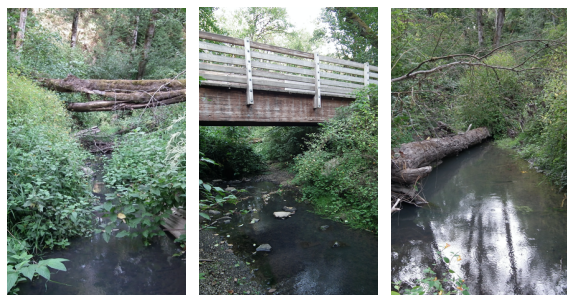
*Figures 6A, 6B, and 6C. Three different vantage points of Site III.*

Site III — the High Bridge site ( $45^{\circ}26'29.9''\text{N}$ ,  $122^{\circ}40'50.4''\text{W}$ ) — was distinguished by its abundance of log jams (Fig. 6C) and thickets of vegetation that jutted out

over the streambank (Fig. 6A). Site III was home to the natural area's most-traversed pedestrian bridge (Fig. 6B).

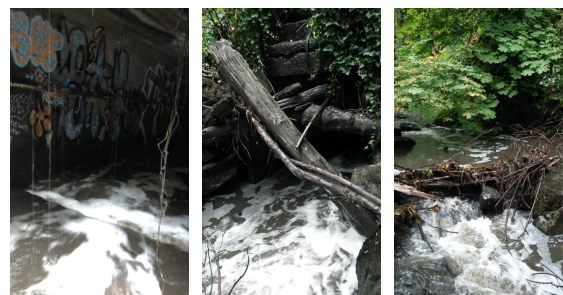
*Figures 7A, 7B, and 7C. Three different vantage points of Site IV.*

Site IV — the Highway 43 Culvert site ( $45^{\circ}25'26.5''\text{N}$ ,  $122^{\circ}39'39.0''\text{W}$ ) — consisted of the culvert running beneath Highway 43 (Fig. 7A, Fig. 7B) and the habitat directly upstream of the culvert (Fig. 7C). The site was located near sewage infrastructure, the odor of which was evident. The culvert contained recently-retrofitted baffles installed to assist with fish passage (City of Portland Bureau of Environmental Services, 2022).

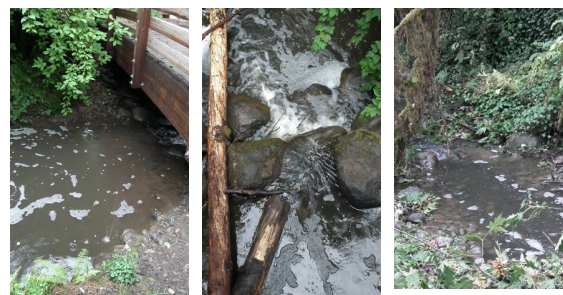
*Figures 8A, 8B, and 8C. Three different vantage points of Site V.*

Site V — the Nettle Creek Bridge site ( $45^{\circ}25'41.1''\text{N}$ ,  $122^{\circ}40'44.4''\text{W}$ ) — was home to the natural area's southernmost pedestrian bridge (Fig. 8A). Site V was also the only site located along Nettle Creek, one of Tryon Creek's tributaries. This section of Nettle Creek was characterized by a slight dropoff just downstream of the bridge (Fig. 8B) and dense English ivy (*Hedera helix*) (Fig. 8C).

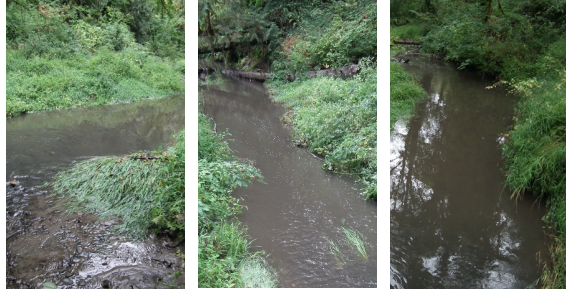
Figures 9A, 9B, and 9C. Three different vantage points of Site VI.

Site VI — the Iron Mountain Bridge site ( $45^{\circ}25'53.0''\text{N}$ ,  $122^{\circ}40'21.5''\text{W}$ ) — was located just upstream of the confluence of Tryon Creek and Nettle Creek. Site VI contained the natural area's easternmost pedestrian bridge and an abundance of grasses and low-lying vegetation (Fig. 9B, Fig. 9C). The run was particularly wide and fairly shallow throughout (Fig. 9A).

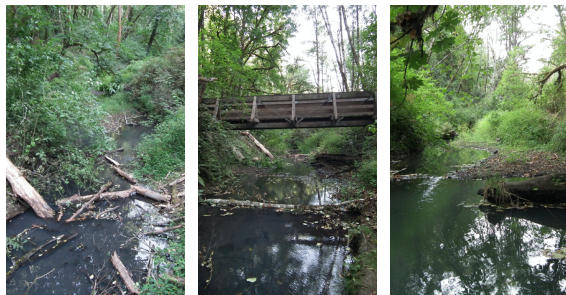
Figures 10A, 10B, and 10C. Three different vantage points of Site VII.

Site VII — the Beaver Bridge site ( $45^{\circ}26'20.5''\text{N}$ ,  $122^{\circ}40'47.5''\text{W}$ ) — was unique in the amount of plant matter debris that pervaded its section of the creek (Fig. 10C). Branches, leaves, and logs cluttered the water and shoreline (Fig. 10A). Site VII was intersected by one of the natural area's central-most footbridges (Fig. 10B).

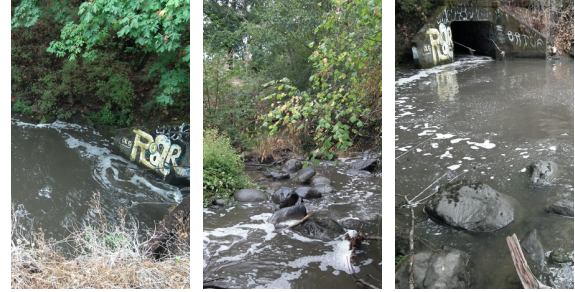
Figures 11A, 11B, and 11C. Three different vantage points of Site VIII.

Site VIII — the Tryon Cove site ( $45^{\circ}25'26.2''\text{N}$ ,  $122^{\circ}39'39.0''\text{W}$ ) — was located immediately beneath the Highway 43 culvert (Fig. 11C). At the end of the culvert, the creek spilled into a deep, still pool (Fig. 11A), which then ran downstream through a field of boulders to reach the Willamette River (Fig. 11B).

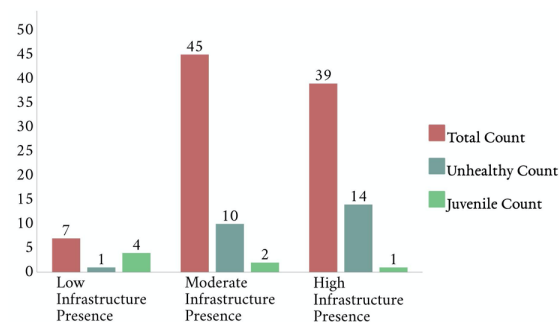
Figure 14. Effect of infrastructure presence on overall crayfish observations, unhealthy crayfish observations, and juvenile crayfish observations.

Disproportionately fewer juvenile crayfish observations were recorded in areas with high to moderate infrastructure presence, and more were recorded in areas with low infrastructure presence ( $\chi^2 = 0.9997$ ,  $df = 2$ ,  $p = 0.0005$ ). However, disproportionately more overall crayfish observations were recorded in areas with high infrastructure presence, and less were recorded in areas with moderate to low infrastructure presence ( $\chi^2 = 0.9970$ ,  $df = 2$ ,  $p = 0.0061$ ). Observations of unhealthy crayfish were not significantly disproportionate by infrastructure presence level. These distributions are reflected in Fig. 14.

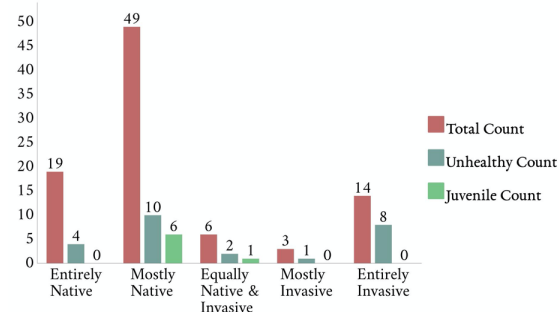
Figure 15. Effect of vegetation nativity on overall crayfish observations, unhealthy crayfish observations, and juvenile crayfish observations.

Overall, unhealthy, and juvenile crayfish observations were not significantly disproportionate among levels of vegetation nativity. These distributions are reflected in Fig. 15.

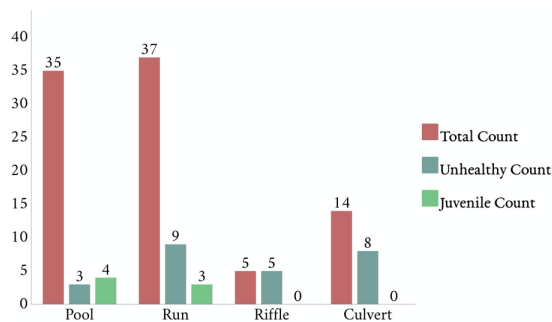
Figure 17. Effect of habitat type on overall crayfish observations, unhealthy crayfish observations, and juvenile crayfish observations.

Disproportionately more unhealthy crayfish observations were recorded in culvert and riffle habitats, and fewer were recorded in pool and run habitats ( $\chi^2 > 0.9999$ ,  $df = 3$ ,  $p = 0.0003$ ). Further, disproportionately more overall crayfish observations were recorded in culvert, pool, and run habitats, and fewer were recorded in riffle habitats ( $\chi^2 > 0.9999$ ,  $df = 3$ ,  $p < 0.0001$ ). Juvenile crayfish observations were not significantly disproportionate across habitat types. These distributions are reflected in Fig. 17.

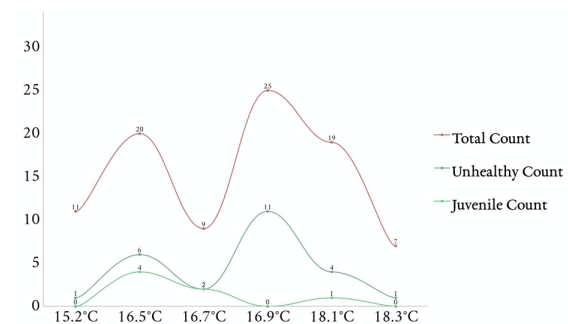
Figure 19. Effect of water temperature on overall crayfish observations, unhealthy crayfish observations, and juvenile crayfish observations.

Overall, unhealthy, and juvenile crayfish observations were not correlated with water temperature. These distributions are reflected in Fig. 19.

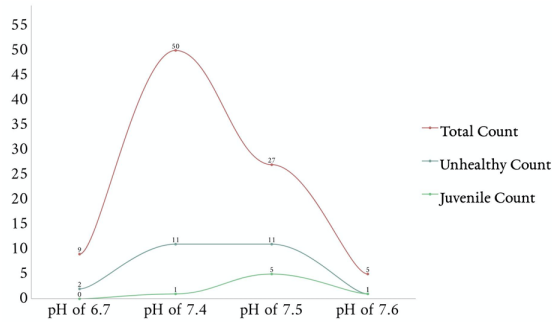
Figure 20. Effect of water pH level on overall crayfish observations, unhealthy crayfish observations, and juvenile crayfish observations.

Overall, unhealthy, and juvenile crayfish observations were not correlated with water pH level. These distributions are reflected in Fig. 20.

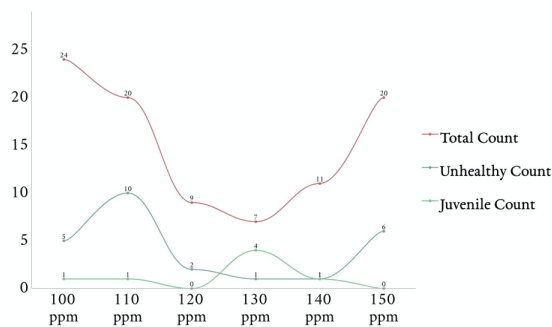
Figure 21. Effect of water alkalinity level on overall crayfish observations, unhealthy crayfish observations, and juvenile crayfish observations.

Overall, unhealthy, and juvenile crayfish observations were not correlated with water alkalinity level. These distributions are reflected in Fig. 21.
