Assessment of Tornado Alerting Performance for Canada

Assessment of wind speeds along the damage path of the Alonsa, Manitoba EF4 tornado on 3 August 2018

Sarah A. Stevenson^a, Connell S. Miller^a, David M.L. Sills^a, Gregory A. Kopp^{a,*},
Daniel M. Rhee^b, Franklin T. Lombardo^b

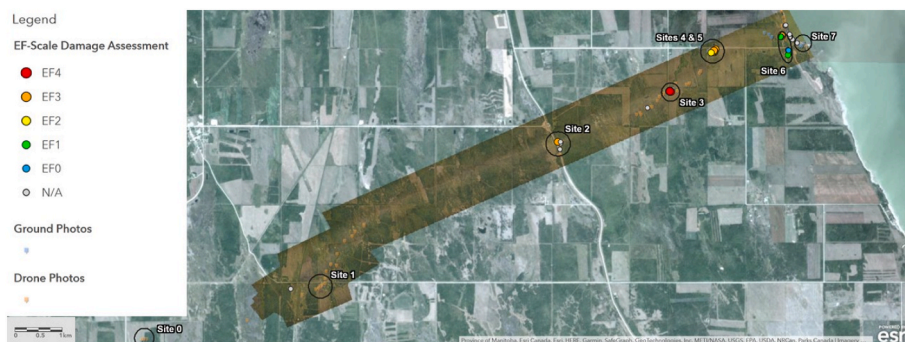
Fig. 1. Overview of Alonsa tornado path as viewed with satellite imagery, with ground survey sites with EF-Scale assessments of structural damage labelled.

The tornado resulted in a damage path 15.7 km in length and with a maximum width of 1600 m. Fig. 1 shows an overview of the damage track with ground survey sites labelled for reference in the following discussion. Sites numbered 1 through 7 have been labelled on the map to indicate areas of structural damage noted on the ground survey. In between these areas, the majority of the damage was to low-lying vegetation and trees. It is estimated that roughly \$2 M in damage resulted from the tornado, mostly to the small farm buildings, single-family homes, recreational trailers, farm equipment and vehicles (Sills et al., 2020).

The ground-based damage surveys conducted by the NTP team covered the sites shown in Fig. 1, with drone surveys used to capture detailed aerial footage of each site, and to fill in sections of the path between residential sites. Drones were also used to capture additional details related to vegetation damage and to provide an additional point of comparison between the ground, aerial, and satellite observations. Significant structural damage was observed at Sites 2 through 7, with the EF4-rated damage (FR12, DOD9) occurring at Site 3. The various survey results are discussed further below.

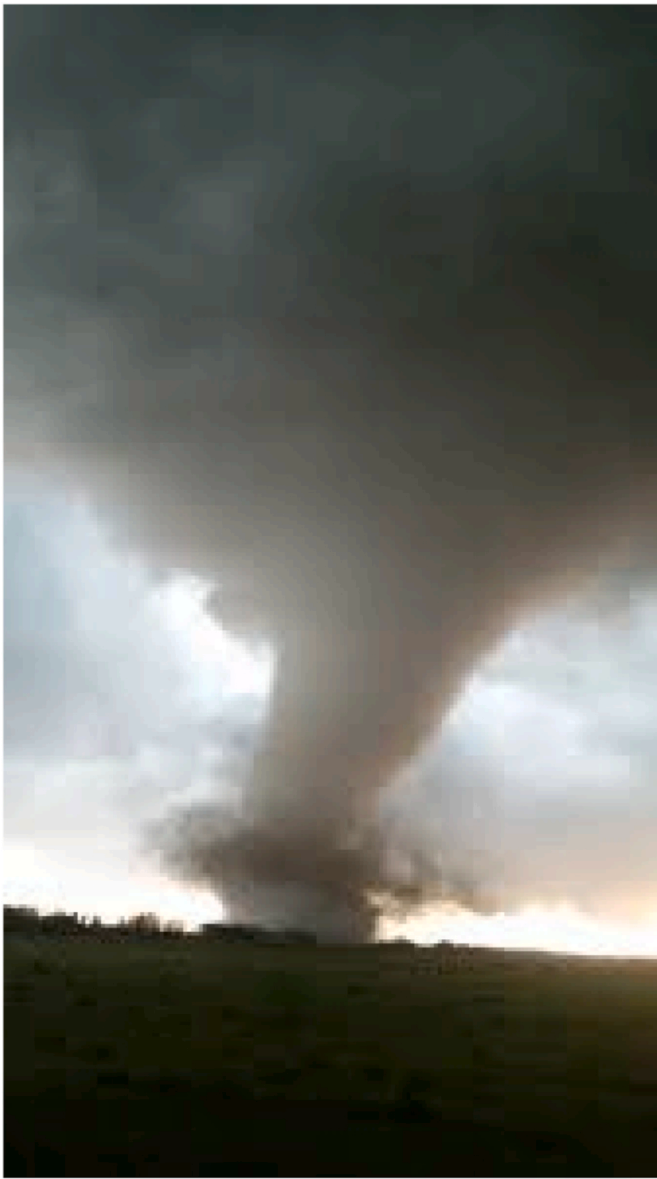
Fig. 3. Screen capture from video by Shawn Cabak showing the Alonsa, MB, tornado at its most intense. Used with permission.

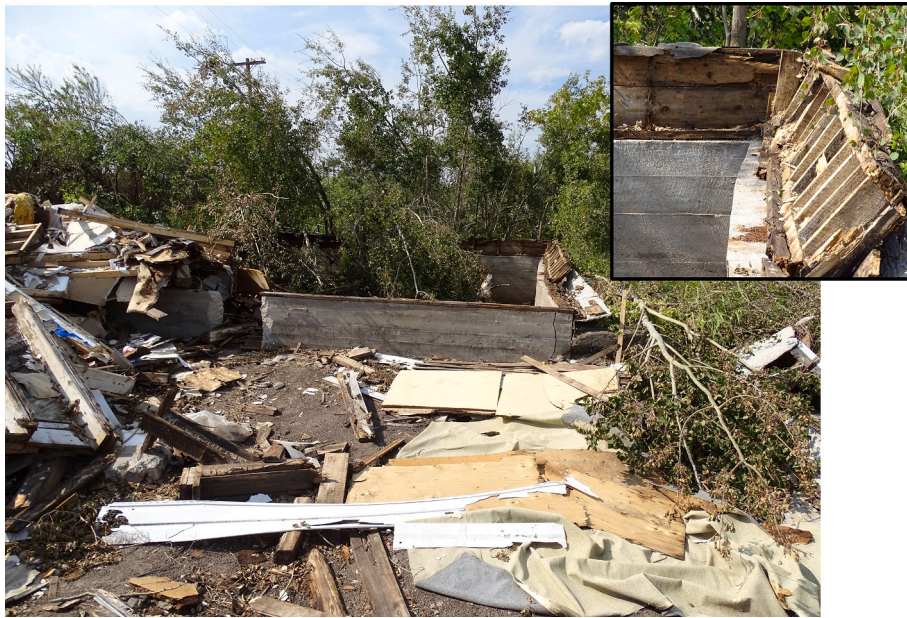
Fig. 4. Damage to abandoned residential structure at Site 2, assessed as DOD9 of FR12. Inset shows closer view of remaining knee wall.

A residential structure with DOD9 (FR12, Lower Bound Wind Speed 230 km/h or EF2) damage was observed at Site 2. Local residents reported that the house at this property had been abandoned prior to the storm, and that some windows may have been missing. The house appeared to be of older construction. The roof and most exterior walls were removed from atop basement walls, as shown in Fig. 4. Upon closer inspection, the sheathing material and wall baseplates appeared to be rotten. This structure was rated as DOD9 because all walls had effectively collapsed, other than short wooden knee walls on top of the basement concrete walls. Drone surveys located a refrigerator, believed to have come from the house or an outbuilding on the same property, about 80 m to the east.

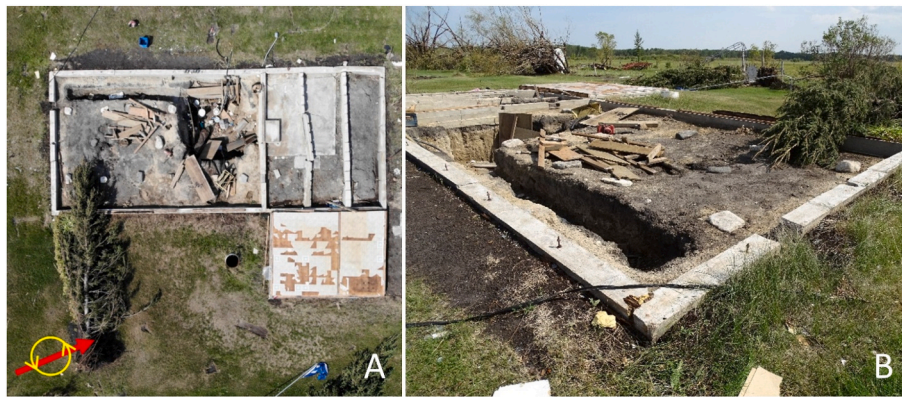
Fig. 5. Drone and ground photos of damage to house at Site 3, assessed as DOD9 of FR12. Red arrow indicates direction of travel of the tornado, and the yellow arrows indicate the direction of rotation.

found 200 m away. The house at Site 3 was swept from the foundation, as shown in Fig. 5. The original house was constructed in the 1950’s and appeared to be firmly anchored to the foundation. However, two additions were observed to have poor connections between the walls and the foundation. Due to the direction of travel of the tornado and orientation of the structure, it is expected that the failure of this house may have initiated in the southern addition, where the walls were removed from atop the plywood subfloor. Cascading failure of the remaining structure is assumed to have occurred. Some of the wooden baseplates of the original structure were still in place with appropriate anchor bolts. Considering that the entire house was not considered to be “well-constructed”, DOD10 for FR12 was deemed inapplicable and the structure was assessed at DOD9 (FR12 – EXP wind speed 275 km/h or EF4). A number of barns and outbuildings on the property were also swept away completely. DOD8 is the highest degree of damage applicable to the SBO DI, described as “total destruction of building.” Given the buildings were swept away, SBO DOD8 UB was assigned giving a wind speed of 210 km/h. It is noted that the wind speed estimates associated with some DIs, such as SBO, are of limited use for assessing strong events because some structure types are only strong enough to resist a relatively low level of wind loading.

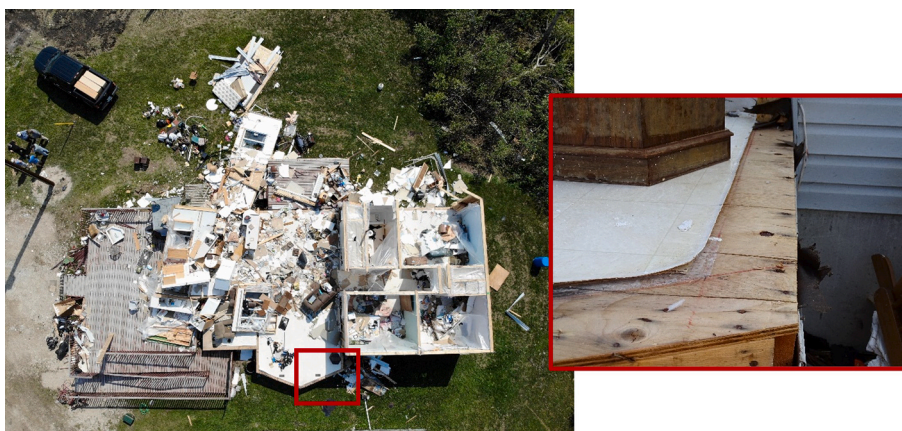
Fig. 6. Drone image of DOD8 damage at Site 5. Inset shows edge of floor structure; exposed plywood indicates location where walls used to sit.

At Site 5, a house built in 1993 lost its roof and three exterior walls (FR12, DOD8 - EXP wind speed 245 km/h or EF3). Inspection of a portion of the roof found on the property indicated that the roof-to-wall connections were toe-nailed, and the roof was of stick-frame

construction. The homeowners, who hid beneath a dining table during the storm, reported that they saw the roof lift off from above them before the walls collapsed. The failed exterior walls enclosed a large open living space, while closely spaced walls enclosing small rooms remained standing. One potential weakness in the failed exterior walls was the nailed connection from the bottom plate of the wall, through the plywood subfloor into the floor framing. This detail is shown in the inlay of Fig. 6. On the same property, several farm structures and a log cabin outbuilding were removed from their foundations (SBO, DOD8 – EXP wind speed 180 km/h or EF2) but were not observed to have been well-anchored.

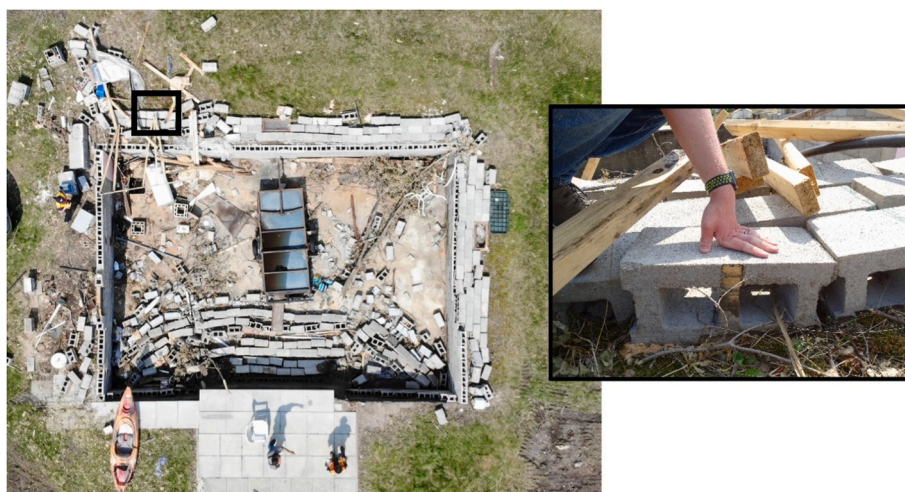
Fig. 7. Drone image showing collapsed basement walls from cottage at Site 6. Inset shows location where floor joists from cottage sat atop of the concrete block basement walls.

The Site 6 property was the last residential property and farmstead impacted by the tornado before it reached and eventually dissipated over Lake Manitoba. This property includes a residential yard on the north side of the road, and farm structures and cattle fences across the road to the south. The homestead included a newer residential structure with no visible damage. Further north along the driveway a cottage in the same yard was completely removed from its foundation (FR12, DOD9 – Lower Bound Wind Speed 230 km/h or EF3). Based on its usage

and size, the FR12 DI was chosen because it was the most fitting DI available, but the LB wind speed was assumed due to the lack of anchorage. Fig. 7 shows the remaining basement and collapsed concrete block basement walls. Discussions with the resident revealed that the cottage was built in 1963, but the basement was constructed later and the building was then lifted and moved atop the basement walls. There were no fasteners between the wood structure and the top of the concrete block walls. Debarked trees were also noted at this property.

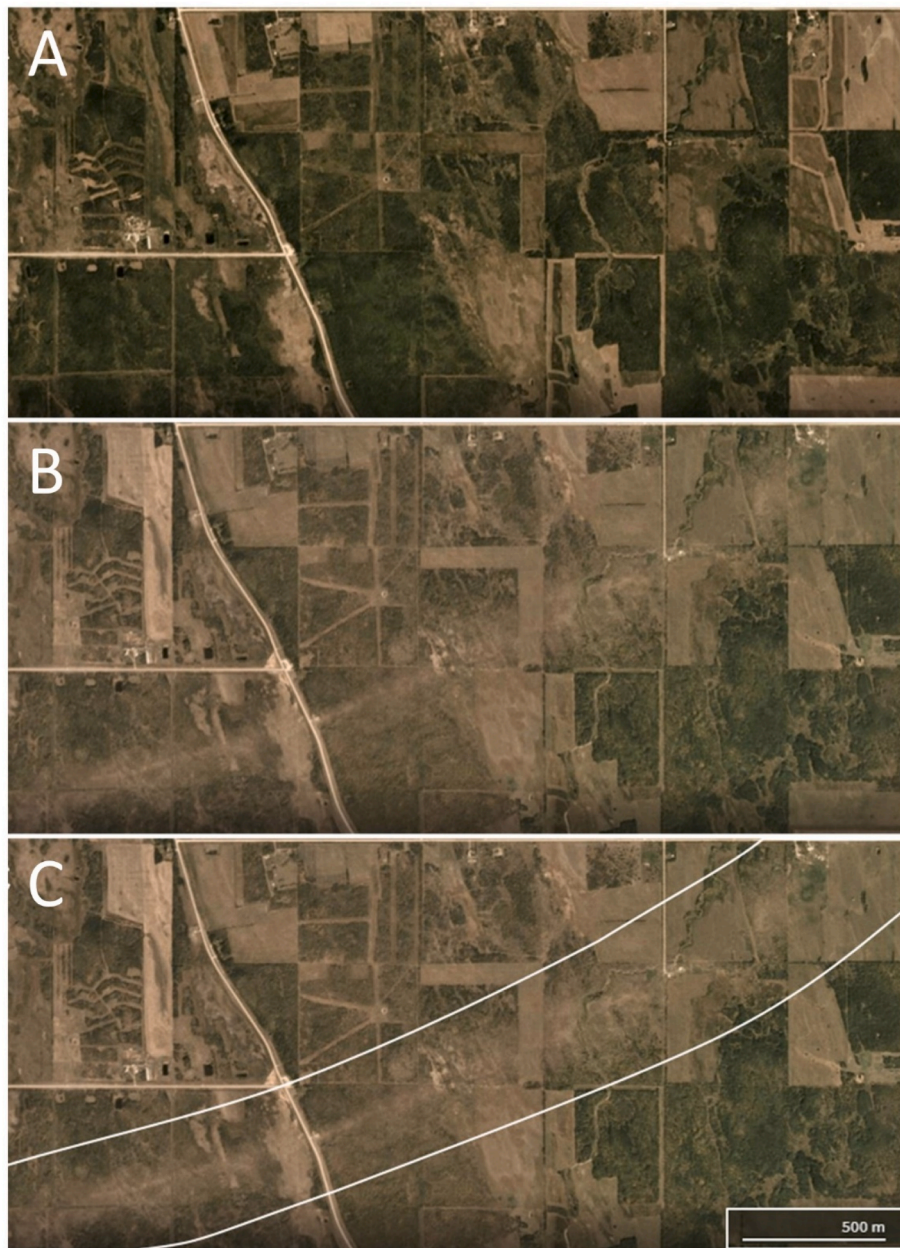
Fig. 8. Satellite imagery review of the Alonsa area showing difference in land cover appearance before and after the tornado. (A) was captured on July 17, 2018, and (B) & (C) are from September 3, 2018. (C) Shows the analyzed extent of the damage path with a white outline.

Early review of satellite imagery did not reveal the start of the path due to poor visibility, so the start of the path was not identified until after the aerial survey was flown. The full survey dataset is available on the NTP ‘open data’ website for public access and use in further research (Northern Tornadoes Project, 2020).

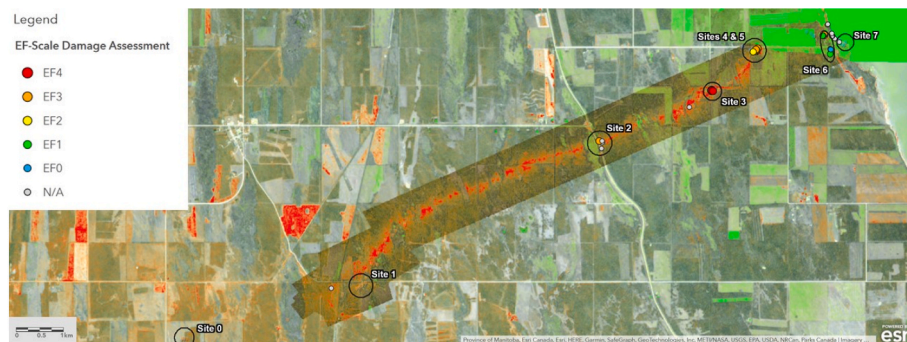
Fig. 9. Overview of the Alonsa tornado damage track including labelled ground survey sites. Satellite imagery of the path is overlaid with NDVI, which indicates the areas of damage to vegetation.

Fig. 9 shows the NDVI visualization of the Alonsa tornado overlain on the satellite imagery of the path. Red values indicate a decrease in vegetation health, green values indicate an increase in vegetation health, whereas transparent values indicate no change to vegetation health. The intensity of this NDVI change is not expressed in the Figure due to complexities in changing crop types across the damaged area, as well as the fact that the NDVI is also picking up color changes from fallen trees in the area. Future work should be done to account for variation in land cover, and its effect on the intensity of change in NDVI values. Debris removal and events such as crop harvesting occurring after the event can alter the NDVI in ways that are unrelated to tornadic damage (Molthan et al., 2014). Typically, large fields that are completely labelled in red have had their vegetation health decreased due to harvesting activities, and fields that are completely labelled in green have had their vegetation health increased due to planting activities, or in the case of water and wetlands, due to algae bloom. In addition, regular seasonal changes in vegetation can also affect the NDVI difference depending on the length between useable satellite imagery (Kingfield and deBeurs, 2017); this can be seen in the southwestern portion of the image. Finally, the area between Site 0 and Site 1 shows little damage to vegetation.

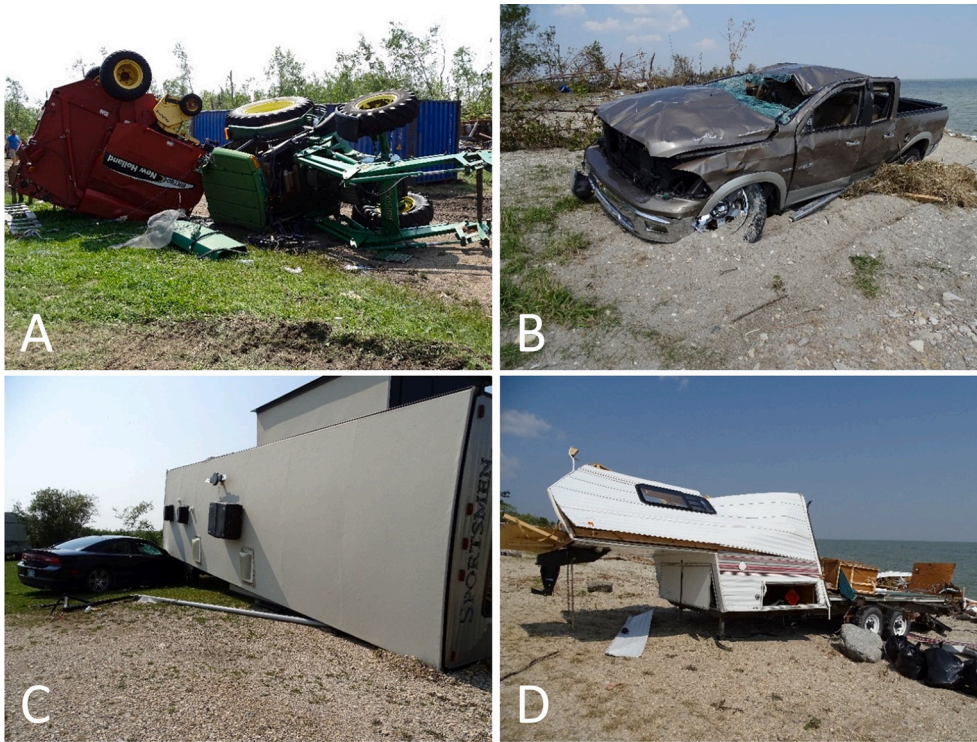
Fig. 10. Ground survey photos showing farm vehicles, passenger trucks, and camper trailers that were lofted by the tornado.

Some of the significant debris items observed in this tornado were large vehicles, including tractors, farm equipment, trucks, RVs, and campers. Fig. 10 shows photographs from the ground survey showing displaced vehicles. The majority of these vehicles originated (recounted by the vehicle owners during the ground survey) from locations near the homes on the edge of Lake Manitoba to the northwest of Site 7. Ground survey observations (from homeowner recollection, as well as examining debris patterns in the sand) showed that the majority of these vehicles were lofted rather than rolled or tumbled to their end points. This was especially clear with passenger vehicles and trailers that landed in the lake; some were located by drone imagery, dozens of meters from the shore while others were found along the beach. Haan et al. (2017) performed wind tunnel and tornado simulator studies on model vehicles to determine their debris threshold wind speeds. The data from their

study predicts that the onset of lofting of vehicles tends to occur in the high-end EF3 to EF4 range.

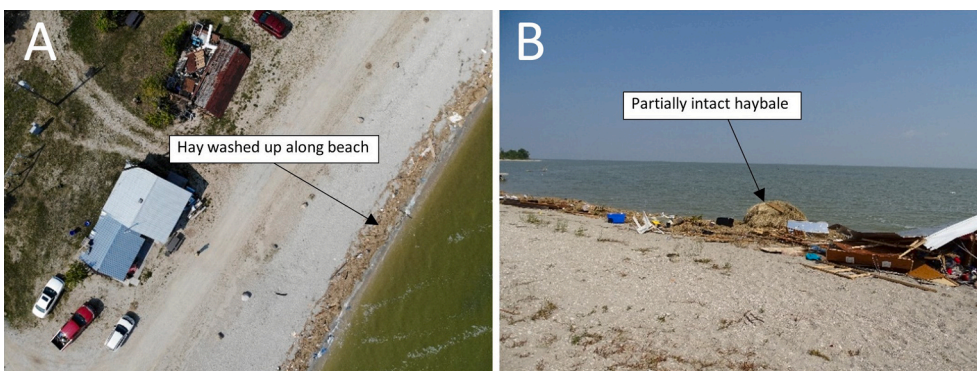
Fig. 11. Drone photograph and ground photograph of hay bale debris that were lofted into Lake Manitoba by the tornado.

Another common debris type observed in the damage survey was the cylindrical hay bale. Over 100 of these were removed from fields between Site 4/5 and Site 6, with some landing among the downed trees to the east and many others apparently landing in Lake Manitoba before being broken down and pushed back to the shore. Several partially intact hay bales were found washed up on the beach at Site 7 (see Fig. 11). Due to their uniform cylindrical shape and having uniform density, these hay bales are an ideal subject for debris flight analysis. Although it is impossible to determine their exact start points, Fig. 12 shows the locations of the fields from which they originated. The hay bales would have had to travel at least 500 m, and up to a maximum of 2000 m, to reach the Lake. Wills et al. (2002) states that loose-laid objects tend to roll or tumble along the ground rather than be lofted. However, there were few signs of hay debris in the fields and the hay bales would have to travel over wooded areas and structures to reach the Lake. Therefore, it appears that the hay bales were, in fact, lofted and a wind field with a strong vertical wind component is assumed to have been present.

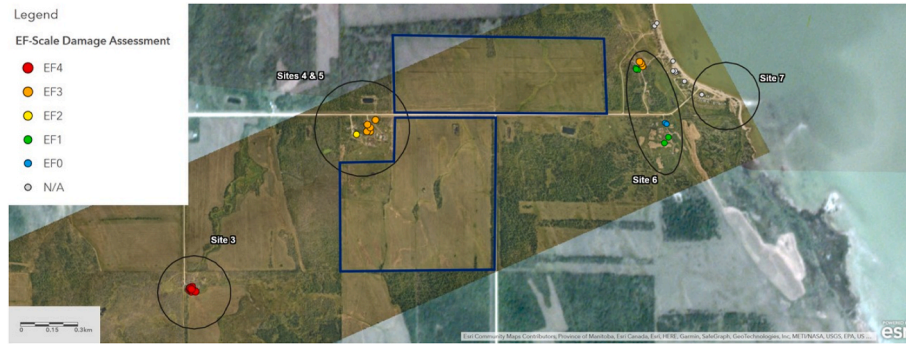
Fig. 12. Estimated originating locations of hay bales that were carried to the lake (right side of image). Fields outlined with blue contained bales prior to the tornado.

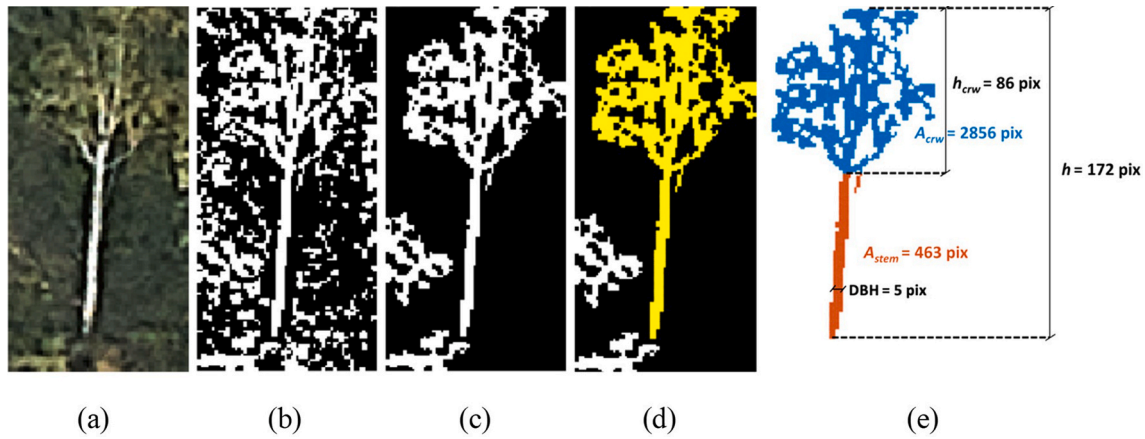
Fig. 13. Tree dimension extraction process from an aerial photograph; (a) sample tree image cropped from satellite imagery, (b) pixels extracted by RGB color filter, (c) filtered image with “small objects” removed, (d) highlighted pixels deemed to belong to the tree by the object detection algorithm, (e) dimensioned image differentiating between tree crown and stem.

of damaged trees (e.g., projected area) can be often challenging from a ground-based damage survey. Using photogrammetry and similar image processing techniques described in Rhee et al. (2021), not only the treefall pattern can be acquired, but the tree dimensions necessary for calculating V_c can also be extracted remotely. An example demonstrating the extraction process using a sample tree from the Alonsa tornado aerial imagery is provided in Fig. 13. In Fig. 13(a), the sample image is first cropped from the aerial imagery. An RGB color filter that filters specific colors from an image is then applied to extract pixels associated with the damaged tree as shown in Fig. 13(b), followed by a noise filter that removes “small objects” in Fig. 13(c). Although the noise filter removes the background noise, large noise (non-tree) objects that have similar color to trees (e.g., roads, hay bales) are still present. Using an object detection algorithm, the binary image is separated into different objects such that only the pixels belonging to the tree can be selected as shown in Fig. 13(d). For detailed procedure and algorithm for extracting tree-pixels should be referred to Rhee et al. (2021). Finally, the crown and stem of the tree are differentiated manually and the number of pixels is counted for all desired dimensions as shown in Fig. 13(e). With the aerial imagery resolution being 5 cm, the tree dimensions (diameter at breast height, DBH; overall height, h ; height of the crown, h_{crown} ; stem area A_{stem} ; area of the crown, A_{crown}) can be scaled into actual heights and areas, with results provided in Table 6. The geometric dimensions of trees estimated from aerial imagery show comparable results to direct measurements from Peltola et al. (1997). Note that the tree dimensions extracted using image processing are dependent on the number of pixels and thus highly sensitive to the digital number (DN) range used in the RGB filter.

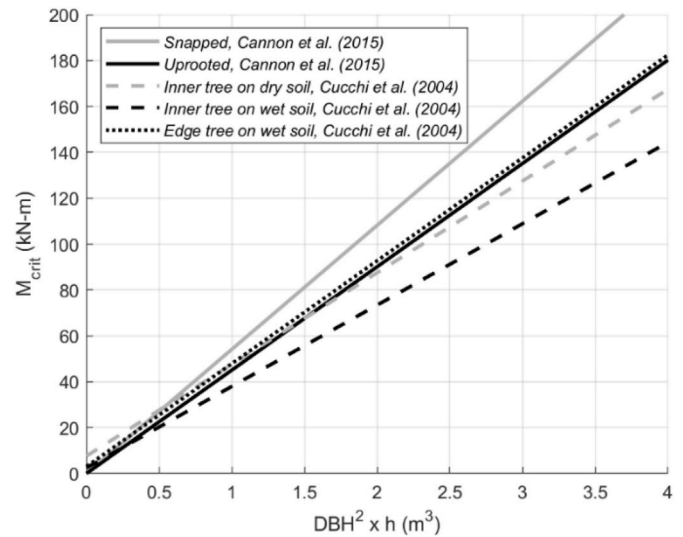
Fig. 14. Regression lines of the critical overturning moment of trees under various conditions.

The wind speed at height, z , is obtained using the Power Law with a 3-sec gust exponent $\alpha = 1/7$ for Exposure B (American Society of Civil Engineers, 2016). A tree typically fails in two failure modes: (1) stem breakage or (2) uprooting, which occurs when the maximum rupture strength or the root-plate soil plate is exceeded, respectively. However, due to the difficulty of acquiring the soil condition, root mass, and the rupture strength of the trees from aerial imagery, linear regression models of the critical overturning moment of trees, measured from experimental winching tests (Cucchi et al., 2004; Cannon et al., 2015), are used instead to estimate the resistance of the tree (Fig. 14).

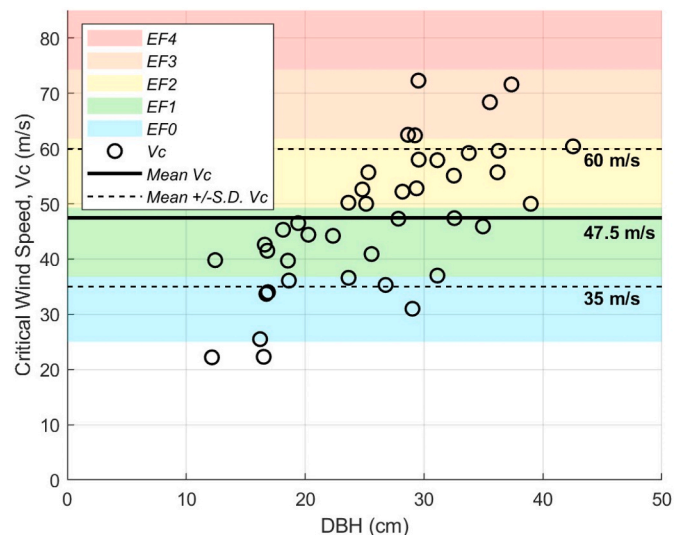
Fig. 15. Critical wind speeds from the treefall analysis for the Alonsa tornado.

A total of 41 trees are sampled, 4 of which are found to have failed by uprooting and the rest by stem breakage. It is important to note that a complete-random sampling is not feasible; only isolated trees are selected due to the difficulty of identifying a single tree among many overlapping fallen trees. This may affect V_c estimation as isolated trees are known to have stronger root systems and larger surface areas (Cucchi et al., 2004). Fig. 15 shows the distribution of estimated V_c of the 41 sample trees plotted against the DBH. The distribution shows an increasing trend as the DBH gets larger with a mean value of 47.5 m/s and a standard deviation of 12.5 m/s. The maximum V_c is estimated at

73 m/s. This verifies that, based on the condition of the trees observed in the Alonsa tornado path, the tree damage observed there warrants a rating at least as high as EF3. The average V_c result from the Alonsa tornado is higher than those obtained from the Joplin, Missouri (40 m/s) and Naplate, Illinois (34 m/s) tornadoes using a different method (Lombardo et al., 2015; Rhee and Lombardo, 2018). A higher V_c is perhaps expected for the Alonsa tornado because most trees in the region (Trembling Aspen and Balsam Poplar) were tall and slender trees with smaller projected frontal areas (Wang et al., 1998), and they failed by stem breakage, which generally requires greater overturning moment than failure by uprooting (Cannon et al., 2015).

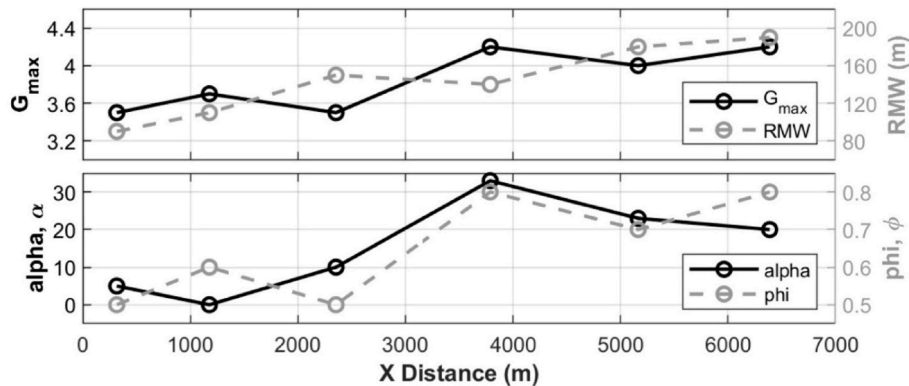
Fig. 17. Change in best-matched parameters along the damage track of the Alonsa tornado. Each plotted circle represents the location of a transect.

the \hat{U}_{max} is at its maximum. Overall, the best-matched RV parameters match the expectations from the preliminary result from Rhee et al. (2021). Using the estimated parameters at each location, the near-surface wind field of the Alonsa tornado is recreated as shown in Fig. 16. Unfortunately, the damaged area near the end of the track (Sites 7 and 8) did not have enough trees (see Fig. 9) to perform the treefall analysis.
