James Madison University

JMU Scholarly Commons

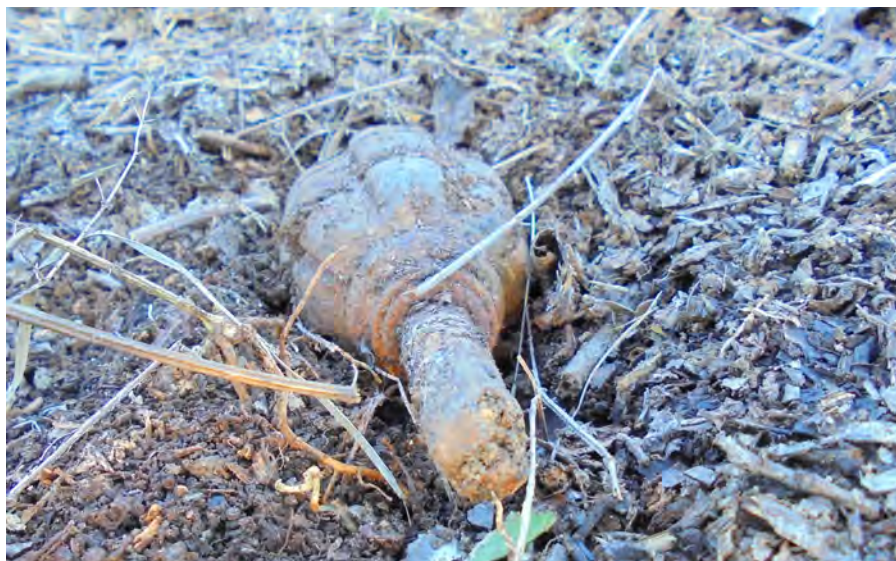
GUIDE TO THE AGEING OF EXPLOSIVE ORDNANCE IN THE ENVIRONMENT

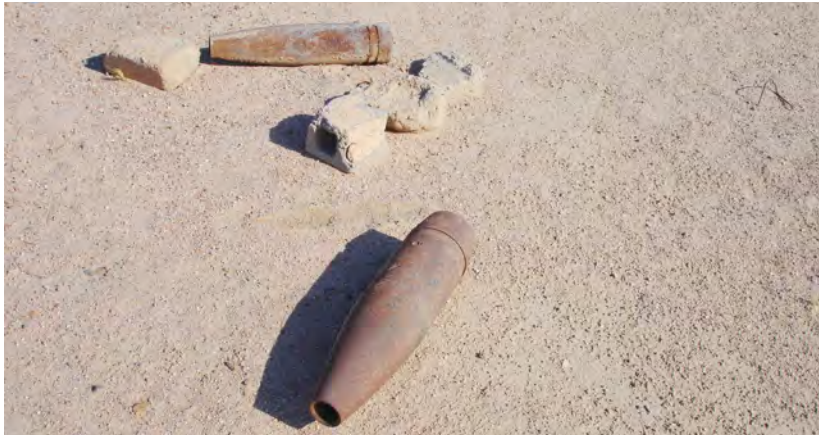
Abandoned explosive ordnance (AXO), Iraq. These unfuzed 130mm artillery projectiles have had their copper driving bands removed. Image: Roly Evans.

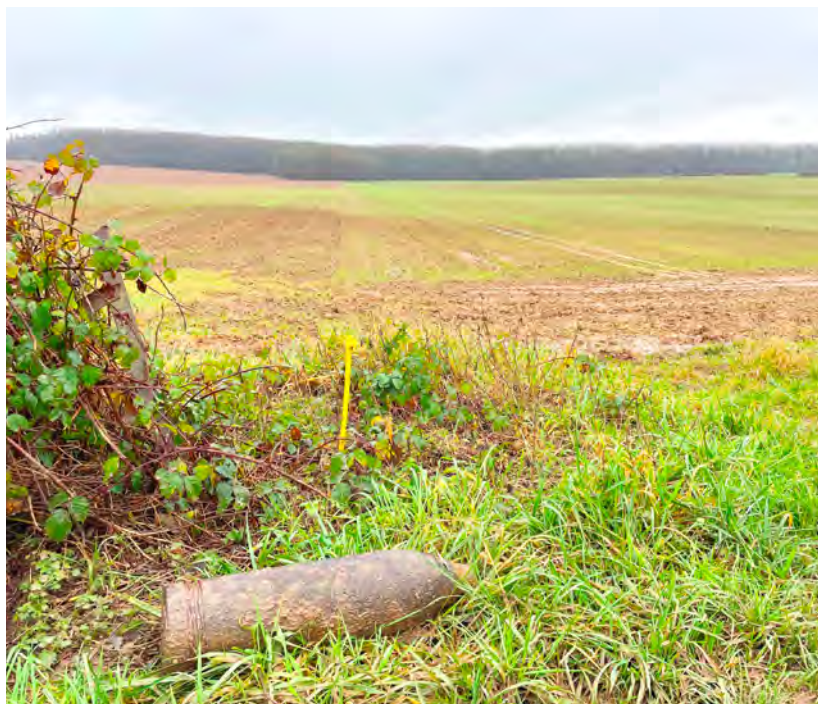
A British 6-inch artillery projectile with the copper driving band removed found close to the old German front line of August 1916, near Guillemont, Somme, France in December 2021. Note that the projectile is in remarkably good condition. Explosive ordnance that is made to withstand extreme forces on firing, and whose casing is designed to produce fragmentation, are resilient, especially in clay soils with higher pH values, and pose a long term hazard. Image: Quentin Naylor.

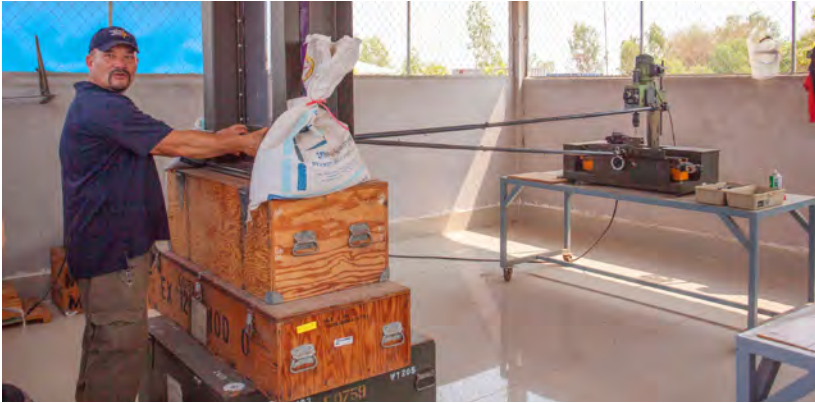
A Mechanical Remote Fuze Disassembly Kit (MRFDK) used for removing small energetic components such as primers in fuze rotors, Golden West Humanitarian Foundation GWHF Cambodia 2014. Specialist explosive processing facilities, whether permanent or mobile, may be needed to fully ascertain the effects of ageing on explosive ordnance. Image: GICHD.

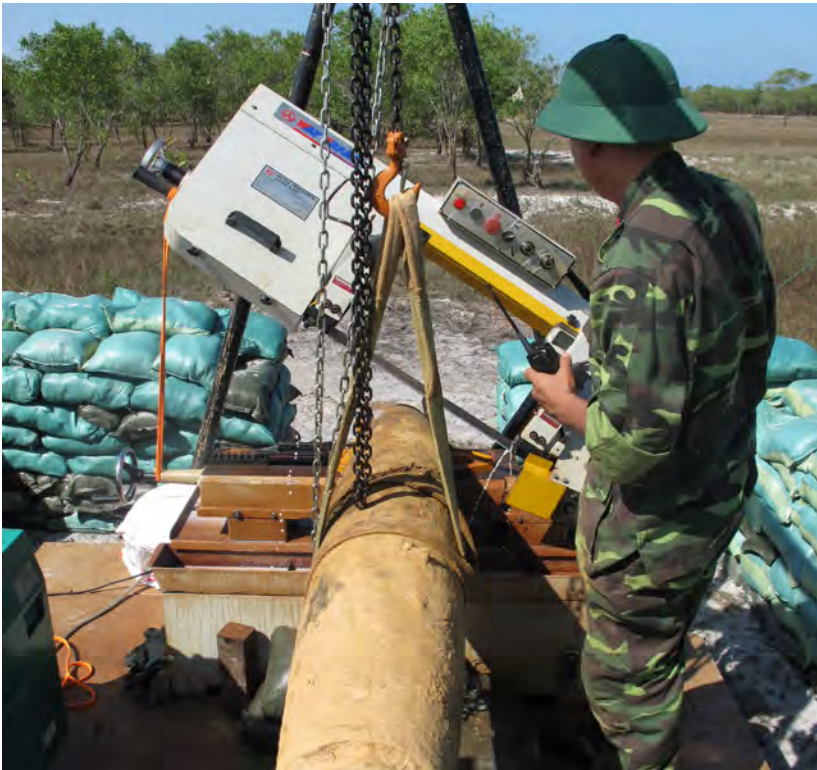
A portable cutting deck, operated by the Golden West Humanitarian Foundation in Vietnam. Access into thick-cased munitions, such as mortar bombs, projectiles and air-dropped bombs, can be achieved using commercial bandsaws, which are adapted for remote operation and observation. This is a specialist task but, performed properly, allows even the largest ordnance to be sectioned and examined internally. In this instance a Vietnamese soldier from Technology Centre for Bomb and Mine Disposal Engineering Command (BOMICEN) sets up a cut on a Mk-82 General Purpose Bomb. Image: Fenix insight Ltd.

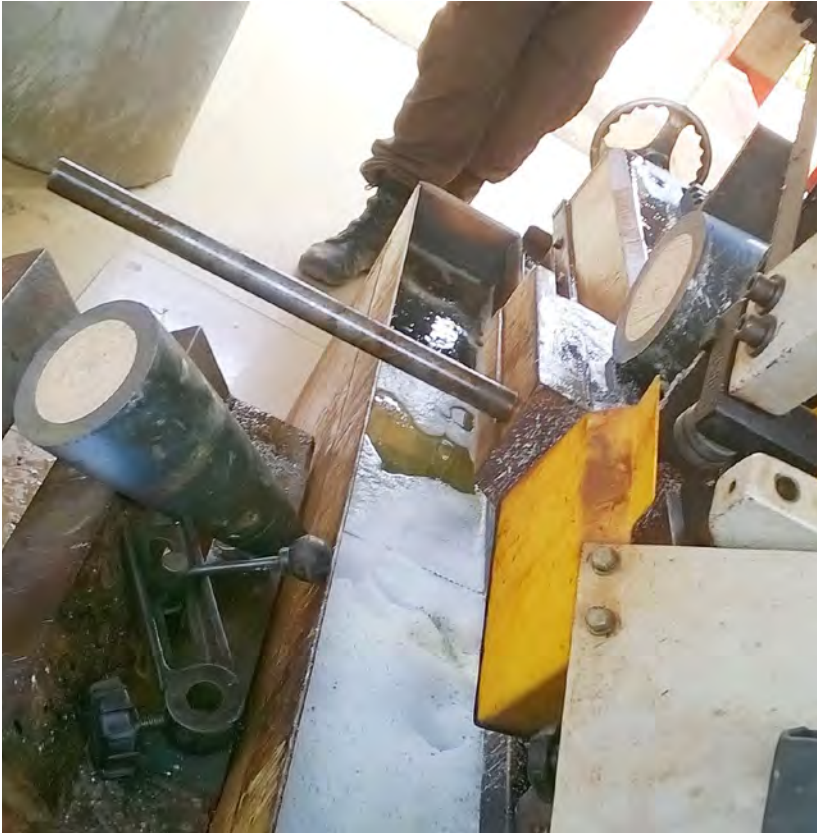
A cut on a Russian 152mm OF-540 high explosive artillery projectile at the Golden West Humanitarian Foundation (GWHF) specialist processing facility in Cambodia. The projectile casing and pressed TNT fill are in good condition and have not been subject to significant ageing in the environment. Image: Roly Evans.

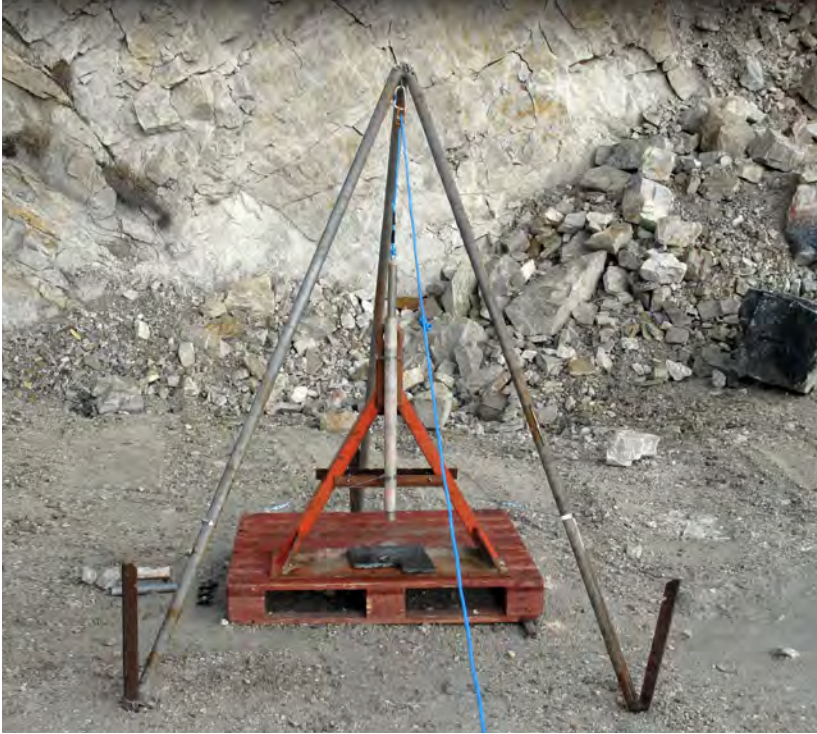
An improvised explosive test rig in the Falkland Islands/Malvinas. During this operation, landmine fuzes were first separated from their main charges, substantially reducing the explosive hazard, and therefore the safety distance. Using remote operation and observation, a weight was dropped onto the fuze to see if it would function. The rig was sufficiently strong to withstand the detonation of the small amounts of explosive within the fuze. Image: Fenix Insight Ltd.

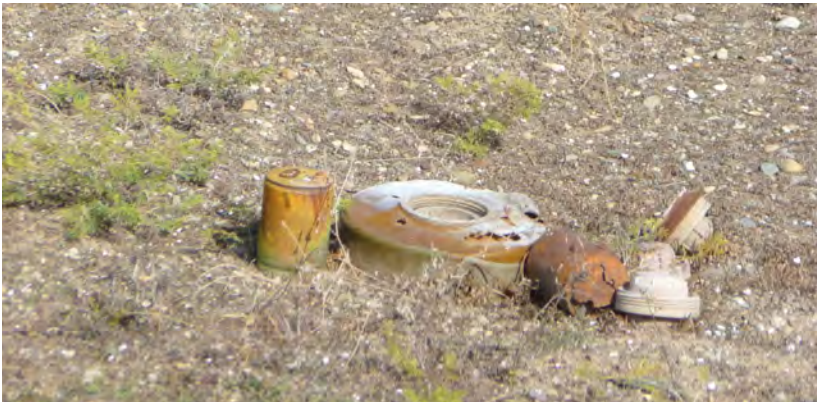
Various mines in the same environment show different ageing characteristics. The relatively thin plastic cased TM-62P3 anti-vehicle mine shows rupture of the casing, possibly accentuated by the effect of prolonged exposure to ultraviolet (UV) sunlight. The thicker cased MVP and MVCH mine fuzes seen on the right are more resilient, albeit their colour has bleached in the sun. The OZM-72 bounding fragmentation mine on the left shows discolouration of the protective paint but has broadly withstood the ageing process well. Image: Roly Evans.

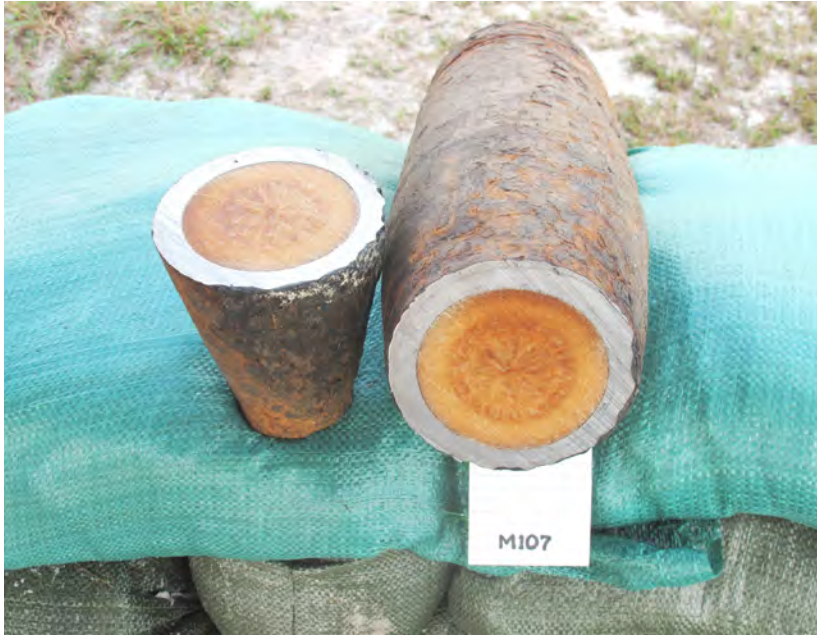
A Vietnam-era 155mm United States M107 projectile, recovered in Quang Tri province and cut open for analysis in 2018. The Composition B filling, which is a mixture of RDX and TNT, shows virtually no sign of deterioration over the 50 years or so since it was manufactured. Most of the military high explosives used in main ammunition fillings are extremely stable and resilient even when the casing has deteriorated. In this case the casing has protected the main explosive fill remarkably well.

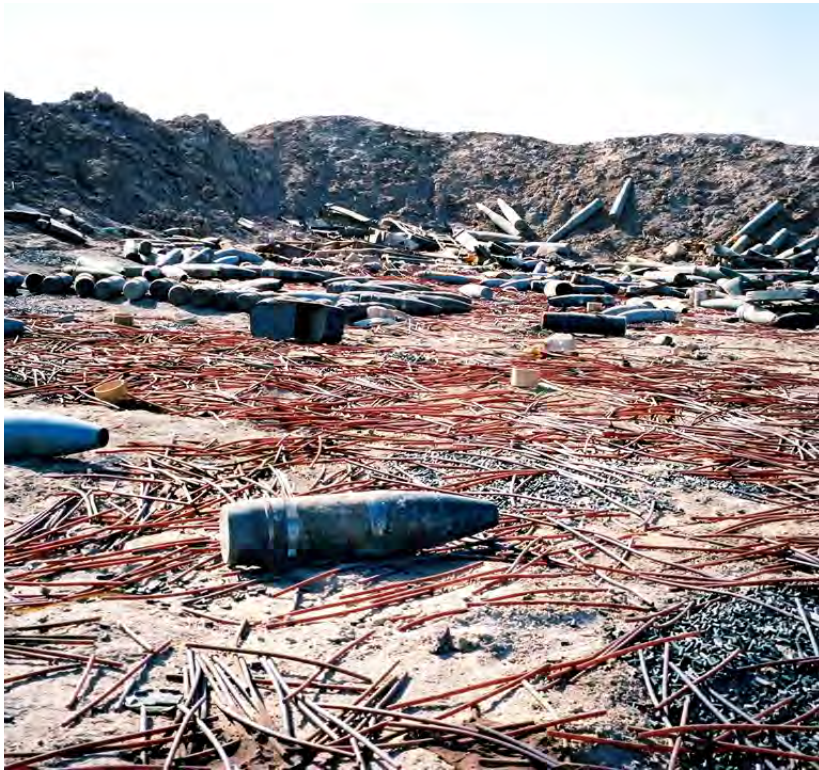
An ammunition depot in Iraq, 2003. Looters seeking brass cartridge cases have tipped unwanted double-based propellant out onto the ground, where it becomes dry and brittle in the hot sun. In this state, propellant is highly vulnerable to ignition by heat and friction. Image: Fenix Insight Ltd.

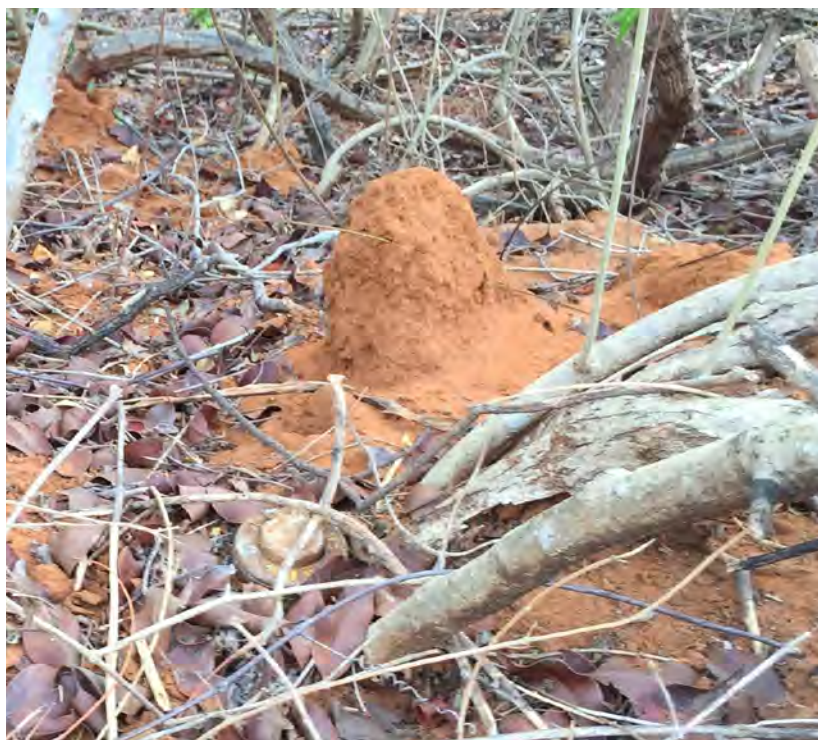
A P4Mk2 anti-personnel mine on the jungle floor in Sri-Lanka. The plastic casing is relatively resilient. The sandy soil drains quickly. Many mines found here were still viable.
Image: Roly Evans.

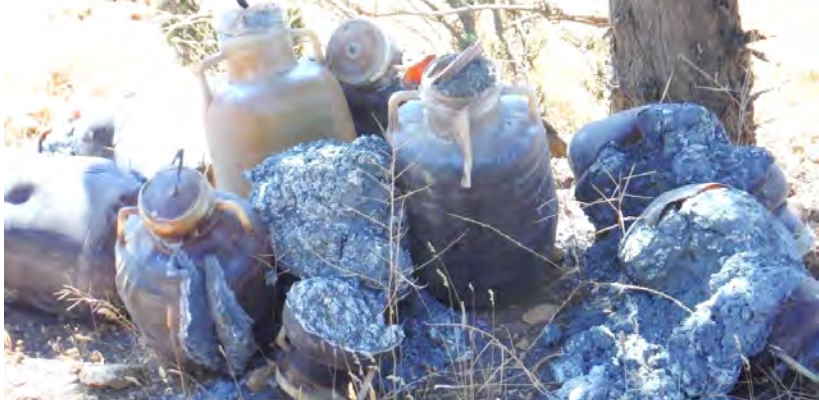
Thin plastic containers used to contain aluminized ammonium nitrate have split easily after less than a year, Kobane August 2015. Thin cased plastic containers will invariably rupture if they contain an explosive mixture such as aluminized ammonium nitrate due to the changes to crystal structure caused by temperature cycling. Plastic of any thickness is especially vulnerable to damage from UV light over time. Image: John Montgomery.

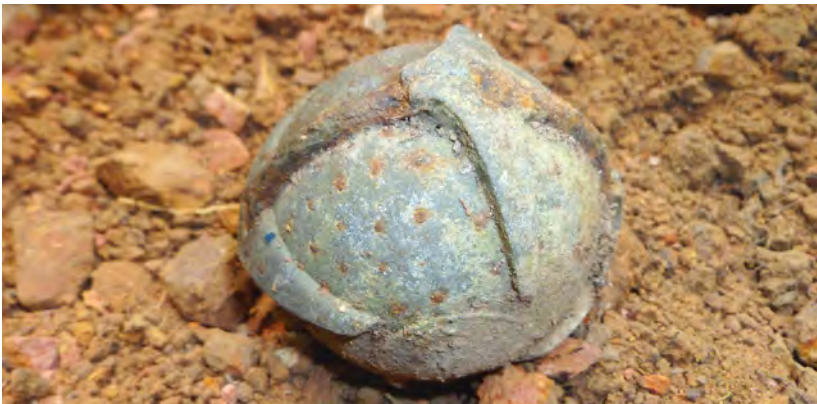
A BLU-26 explosive submunition found in Lao PDR. The steel alloy components can be seen by the difference in corrosion around the clamp ring join of the submunition and the ball bearing fragmentation beneath the main aluminium outer casing. The outer casing has an aluminium oxide layer that corrodes slower than steel alloy. This item has been on the floor of a primary jungle for over four decades, albeit on high ground with good drainage. While it is certainly weathered, the resilience of the casing is nevertheless evident. Image: Roly Evans.

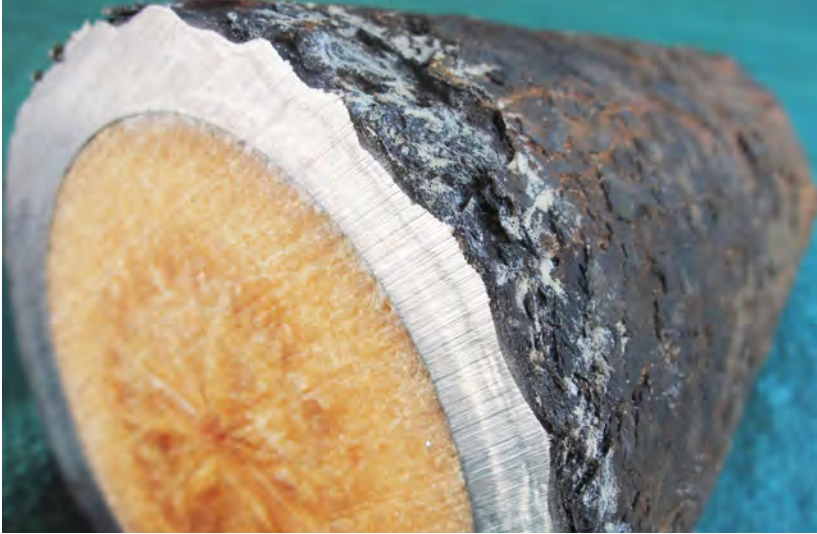
The casing of an unexploded M107 projectile, recovered around 50 years after it was used in Vietnam. A section through the projectile shows the surface is heavily corroded, although the steel beneath is in remarkably good condition. Under some circumstances, a superficial iron oxide rust layer may provide protection that slows down the corrosion process. Image: Fenix Insight Ltd.

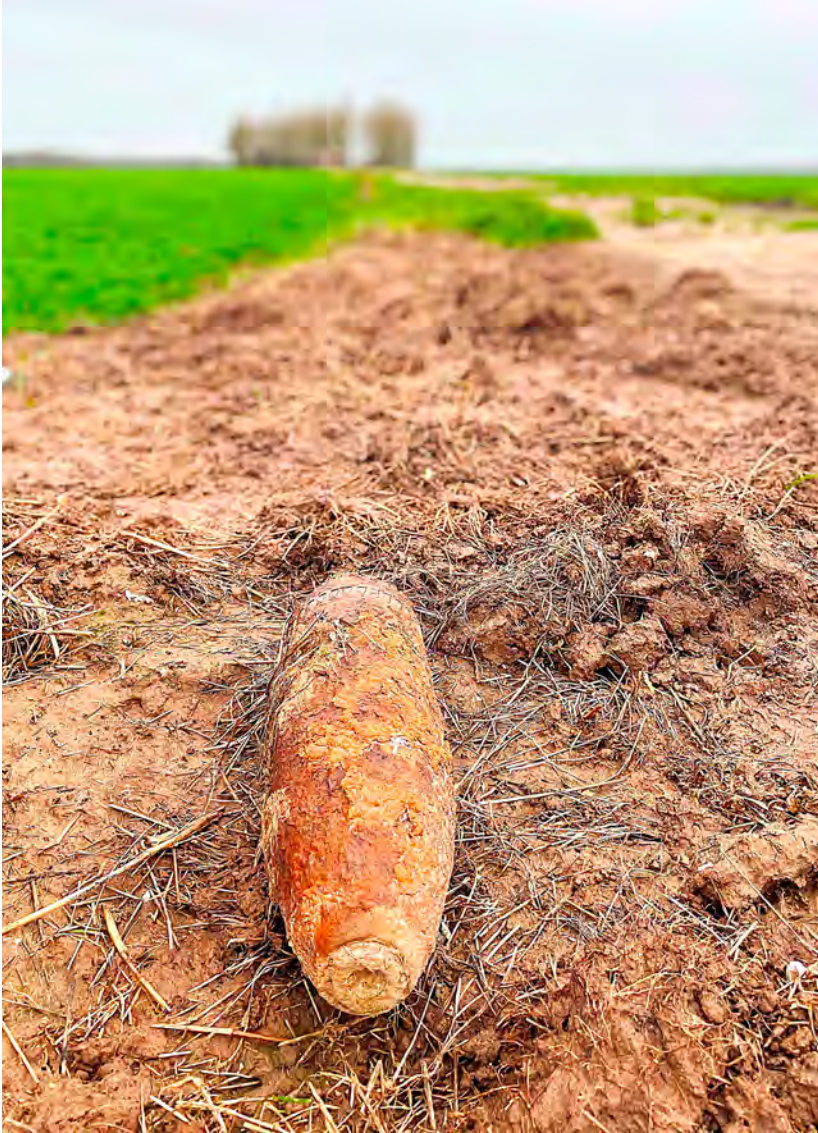
A British 4.5 inch artillery projectile near Thiepval, Somme France, January 2023. The rotating band and copper fuze adaptor for the Fuze No. 44 show how resilient copper and copper alloys can be despite prolonged exposure in the environment for over 100 years. The layer of clay soil has very likely also helped to preserve the projectile.
Image: Quentin Naylor.

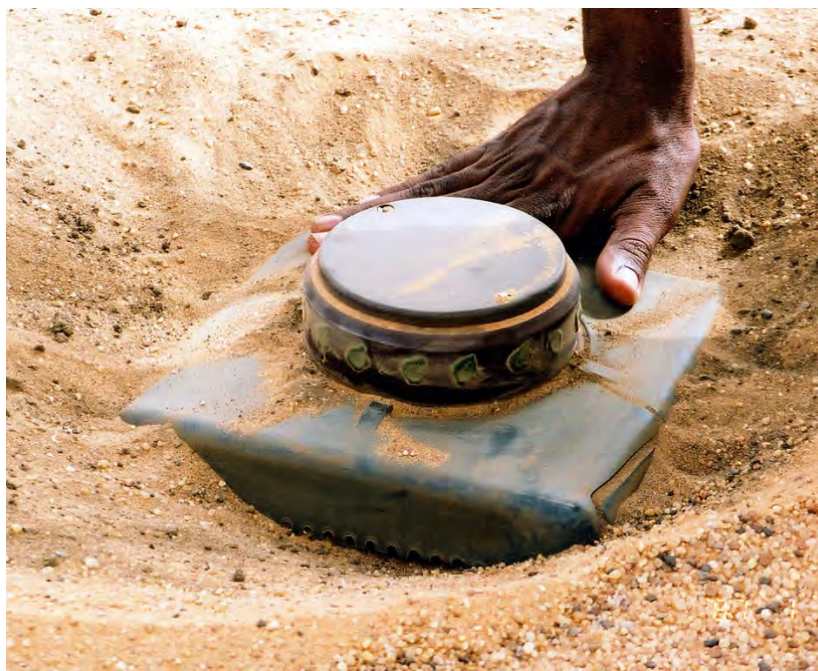
A PRB M3 mine in northern Chad. The mine was buried and had thus been largely protected from UV light. In this instance the high temperature has caused a split in the polythene mine casing. The bakelite fuze assembly has on the other hand remained intact. Different plastic materials age at different rates even in the same conditions. Bakelite is a remarkably resilient material that is even difficult to penetrate with thermite torches. Image: Fenix Insight Ltd.

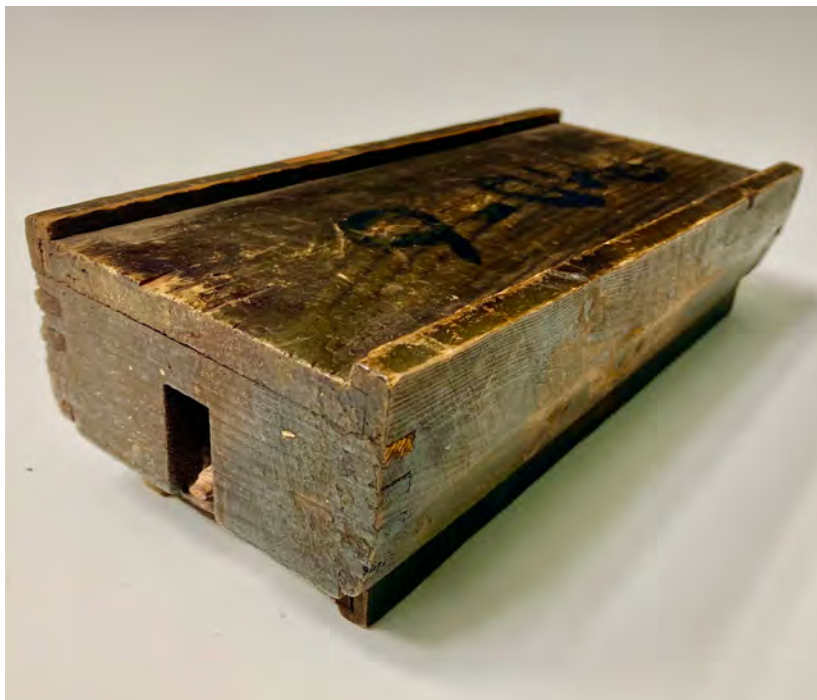
The Russian PMD-6 box mine, as it appears intact. The PMD-6 has a wooden case that was judged to be adequate for its expected short service life. It was never intended or expected to remain functional for years. Image: GICHD.

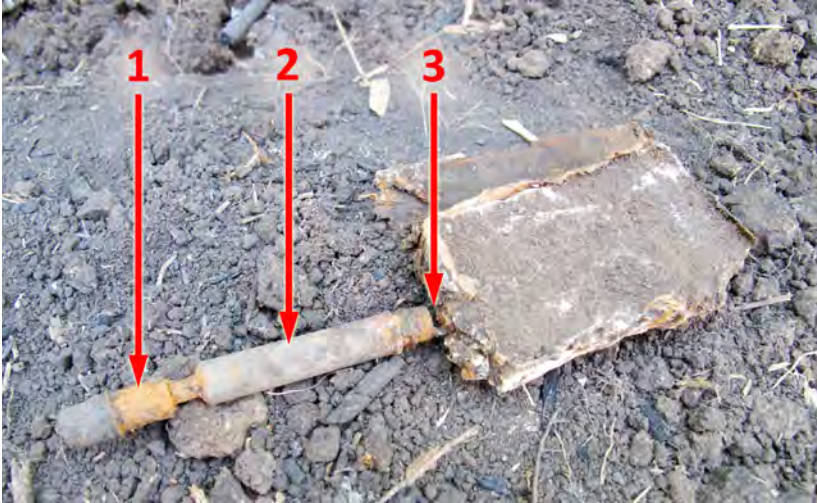
The effects of ageing on the materials of a Russian MUV-2 fuze, used in a PMD-6 anti-personnel mine, buried more than 30 years ago in Cambodia. The wooden casing of the PMD-6 has long since rotted. Image: Fenix Insight Ltd.

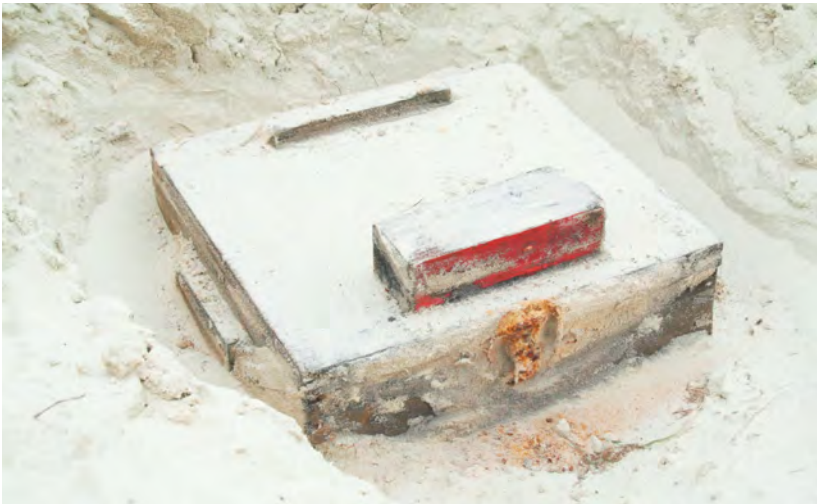
A wooden-cased Holzmine laid during World War II that survived intact in the sand dunes of Skallingen, Denmark. Mines above the water table could remain intact if sufficiently enclosed with sand. Image: Martin Jebens, Danish Coastal Authority.

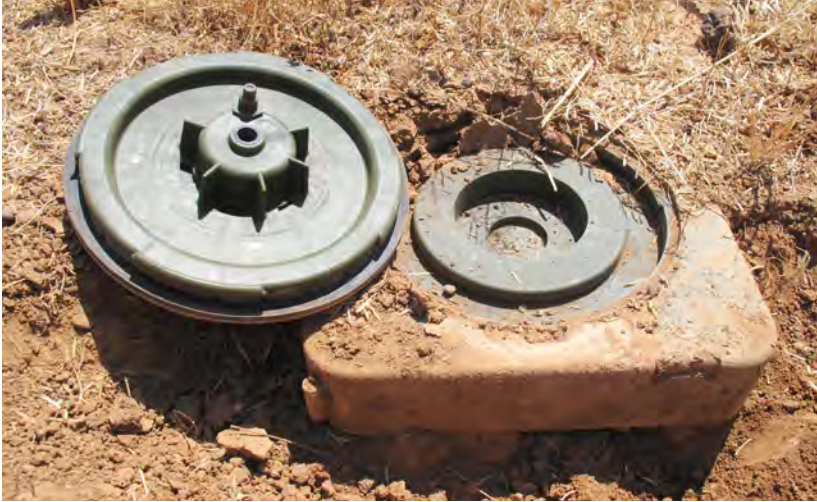
A United States M19 anti-tank mine in Jordan. The mine is fully functional and shows few signs of deterioration, despite having been buried for around 40 years. The relatively thick plastic and rubber seals around the threads protect the internal components of the mine. Many M19s cleared in Afghanistan have also been found in good condition. While more susceptible to UV damage if exposed to prolonged sunlight, buried mines with thick plastic casings can be very resilient, possibly as resilient as steel cased ERW in certain circumstances. Image: Fenix Insight Ltd.

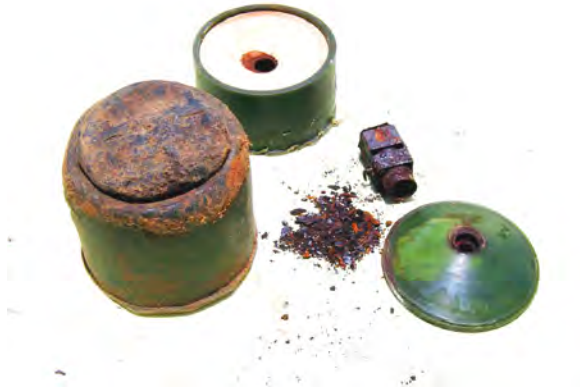
Poor design and production, can make a munition more vulnerable to ageing. The Vietnamese MD-82B has a thermoplastic body, sealed at the top with a rubber O-ring and by melting the side wall to the base. Neither seal is effective, and water frequently enters the casing. The corrosion is partly a result of poor design, failure to understand the operational environment and inadequate quality management.

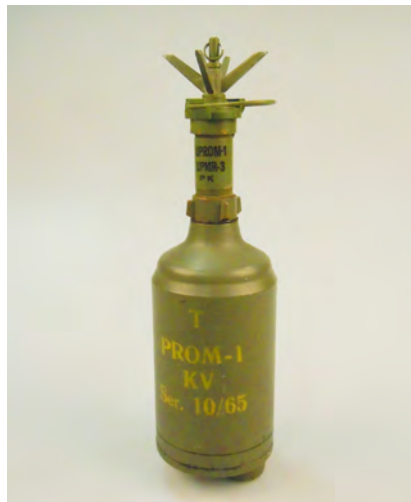
Good design and production, can make a munition more resilient. The PROM-1 has a sheet steel casing, but this is well protected and the few joints have robust hermetic seals. This is a product of experienced designers with a good understanding of the operational environment, and carefully controlled production. In Bosnia, the PROM-1 has proved the most resilient of the mines laid during the 1990s conflict, and the mine that poses the greatest ongoing hazard. Image: Dutch Defence Expertise Center EOD.

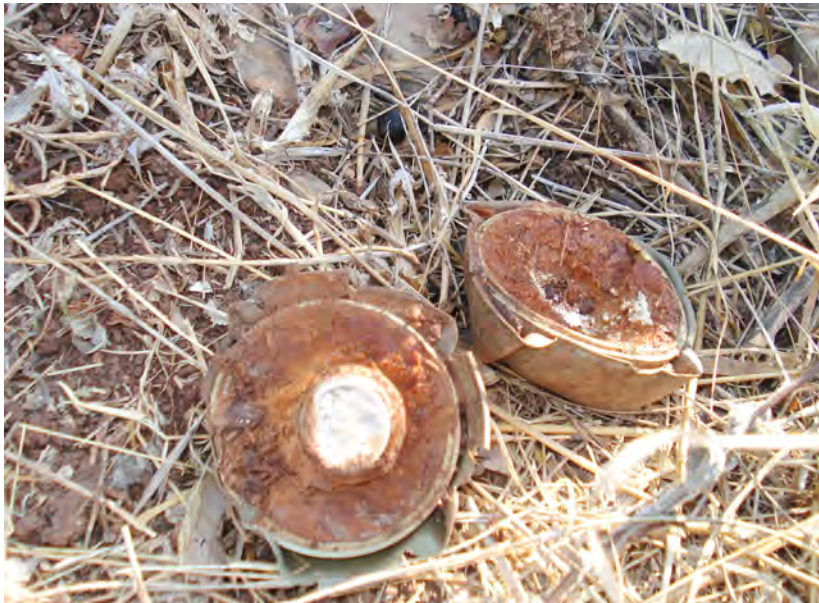
A BLU-63 submunition that has split apart on impact, exposing the cyclotol explosive fill and aluminium encased M219E1 fuze to the elements. This item will age far quicker than one that was undamaged on impact. Image: Roly Evans

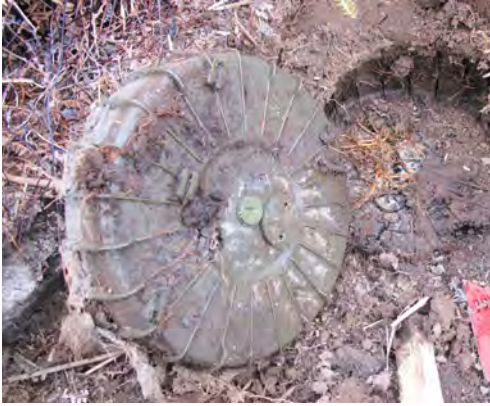
An SB-81 anti-tank mine recovered during clearance operations in the Falkland Islands/Malvinas.

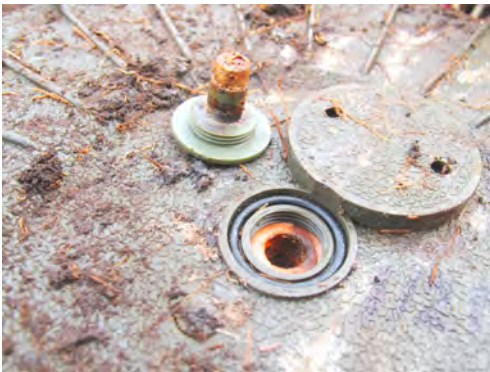
Examination shows that the loose plug allowed water to enter the casing, saturating the detonator over time.

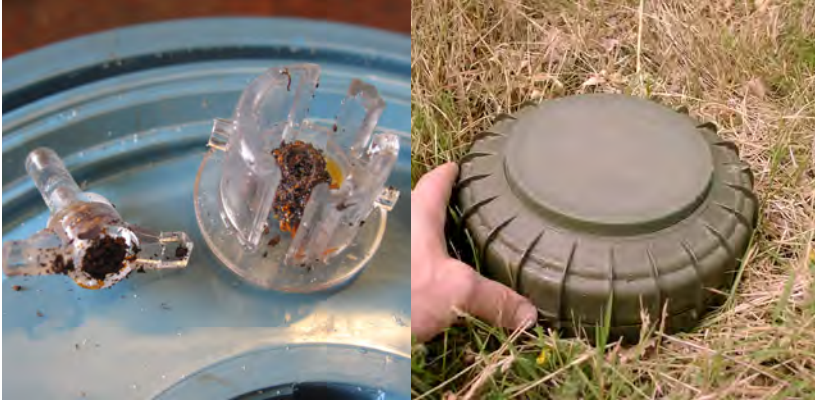
Externally, SB-81 anti-tank mines recovered from coastal areas of the Falkland Islands/Malvinas in 2019 looked similar to those used inland, since there was very little deterioration of the casing. Usually an intact glass reinforced polycarbonate casing would imply functioning internal components. However in this instance some water ingress into the casing has taken place. The presence of salt water in mines from coastal areas has had a significant corrosive effect on the metallic fuze components. The polycarbonate plastic fuze components have proved more resilient. Images: Fenix Insight Ltd.

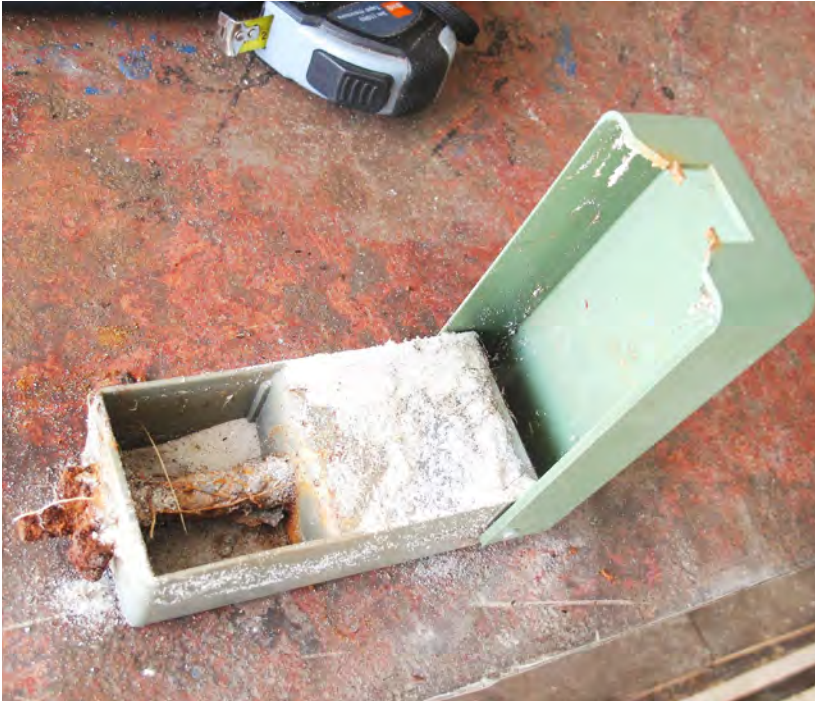
An Israeli No 4 anti-personnel mine in the Falkland Islands/Malvinas, recovered from a coastal minefield near Port Stanley in 2019. Water often carries fine particles, such as sand, which have an abrasive effect and can fill voids within the fuze mechanism, blocking its action. The No.9 fuze igniter seen here is heavily corroded and no longer functional although it still presents an explosive hazard. Image: Fenix Insight Ltd.

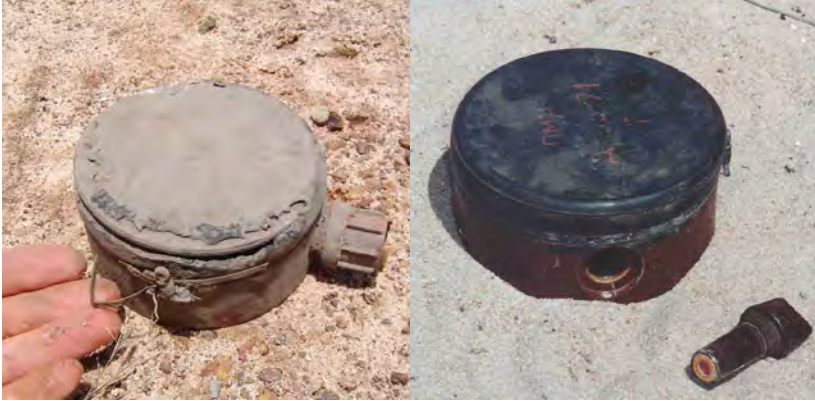
Left: A PMN mine recovered in Cambodia. The hot wet climate has caused the rubber cover to perish and the securing band to rust through. Right: A PMN of a similar age in Afghanistan has been well-preserved, with little deterioration of the rubber cover or securing band. Images: Fenix Insight Ltd.

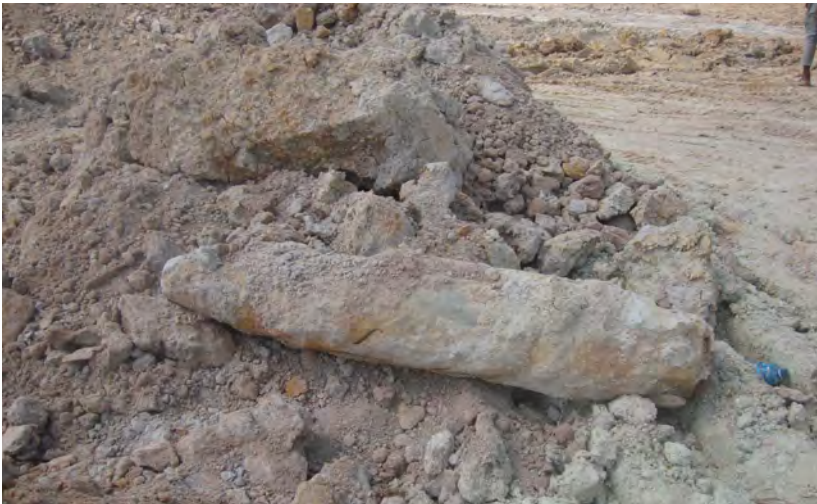
Heavy clay may exclude oxygen and thereby almost prevent the corrosion of ferrous metals. This Mk82 aerial bomb was found in clay soils in Phnom Penh in 2015.

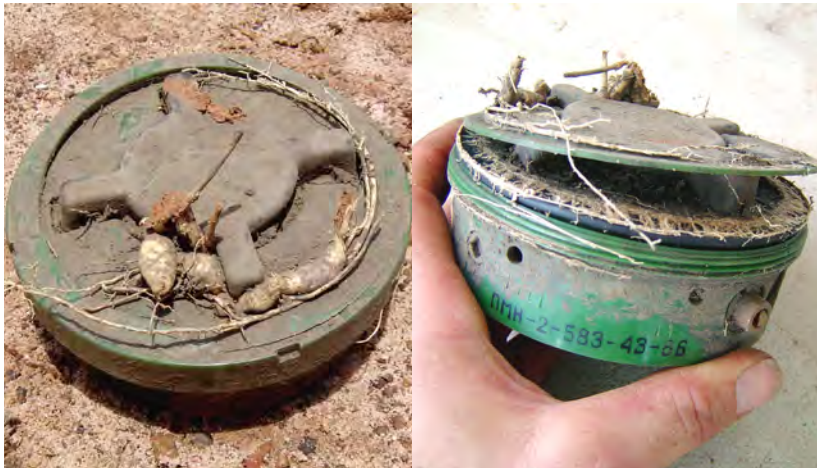
A Russian PMN-2 anti-personnel mine recovered from northern Cambodia in 2009. Small roots have spread into the small gaps and joins around the pressure plate. Disassembly of the PMN-2 mine shows that the root structure has penetrated the mine casing, levering components apart and allowing water to enter.
Images: Fenix Insight Ltd.

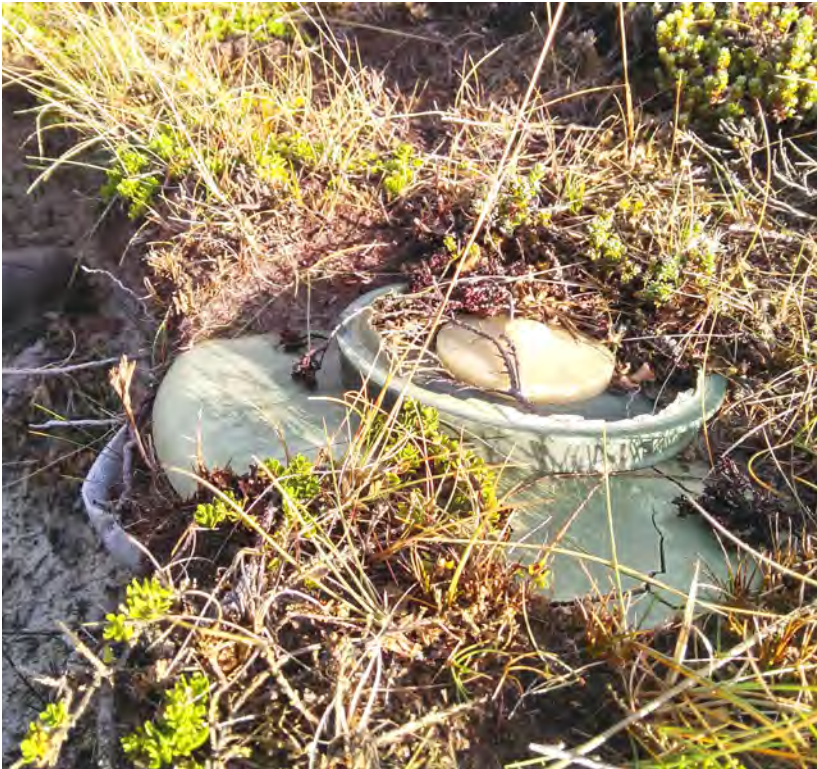
A C-3-B anti-vehicle mine found in the Falkland Islands/Malvinas in May 2018. The mine has been on or near the surface for approximately 36 years and shows case cracks consistent with damage from UV light. Image: Guy Marot.

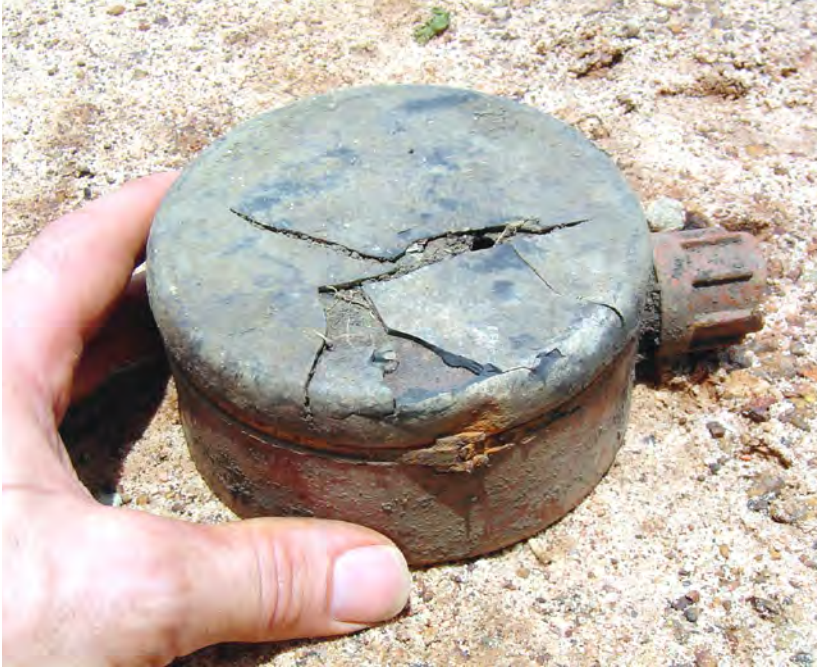
A Russian PMN anti-personnel mine recovered in Afghanistan in 2010. This mine was left on the surface and suffered prolonged exposure to sunlight. The rubber has lost its flexibility and become extremely brittle, resulting in the formation of cracks and loss of some sections. This has breached the integrity of the casing and allowed water to enter the mine, causing corrosion damage to the internal mechanical mechanism, particularly the spring that supports the last holding device in the mine but also the coiled spring that is part of the striker assembly. The bakelite body of the mine is remarkably resilient however. Image: Fenix Insight Ltd.

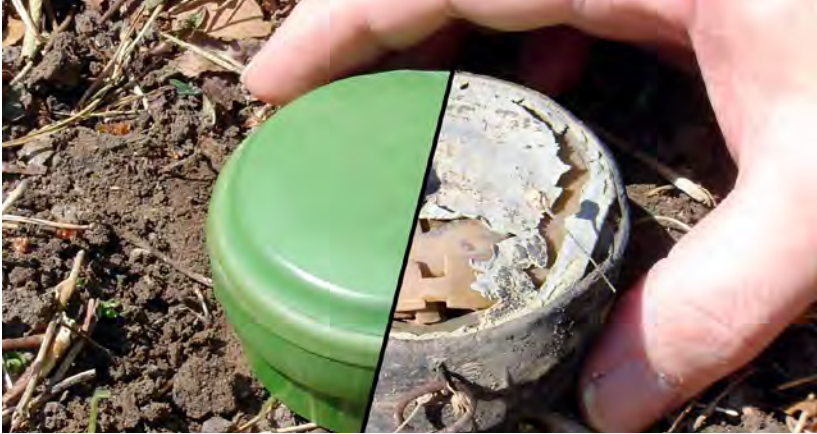
A composite image contrasting the appearance of a new Chinese Type 72 anti-personnel mine (to the left) with its appearance after years of exposure to sunlight in Cambodia. The green cover is made from thin rubber, which becomes grey and perishes, exposing the buff-coloured pressure plate beneath. The result is that the aged mine looks nothing like it did when new, making it difficult to recognise.

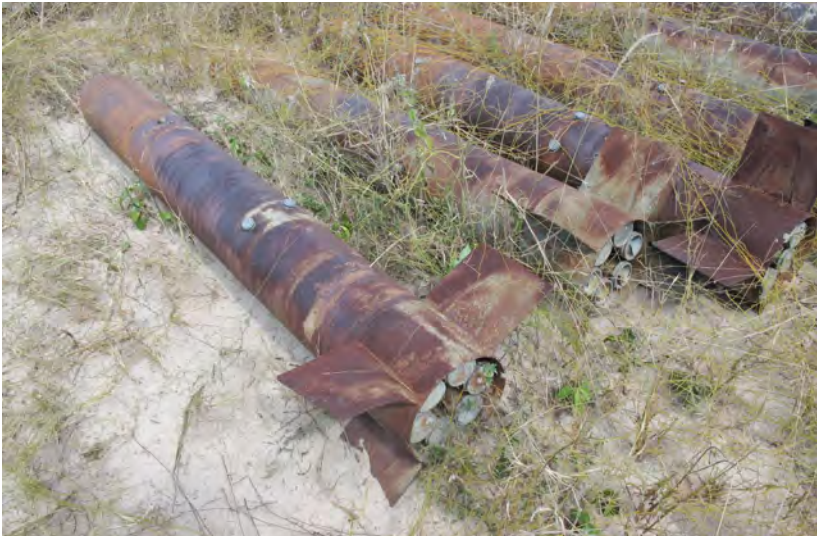
Russian S-24B rockets in a depot in Mozambique in 2014. At some point, fire has swept through the vegetation, burning the paint from the upper surfaces but failing to initiate the motors, also leaving the paint on the underside relatively unscathed.

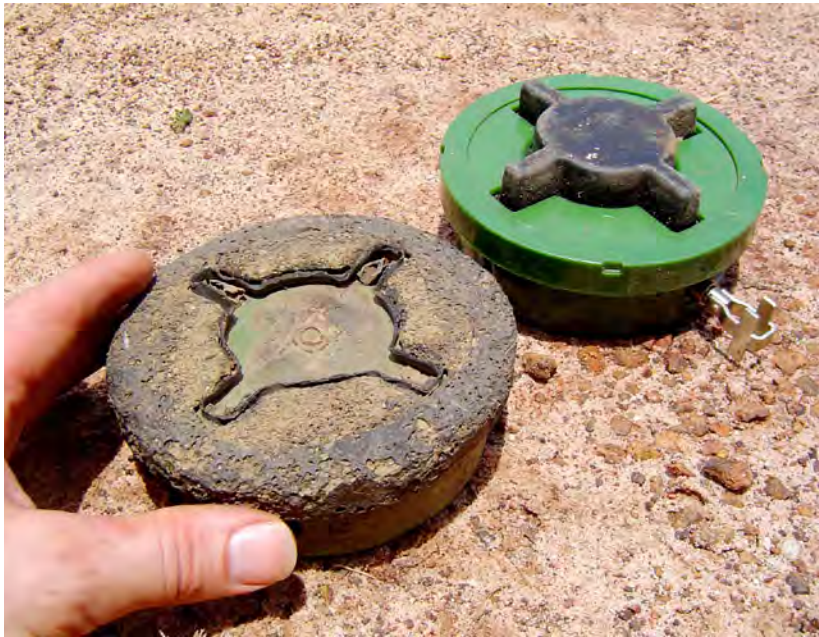
Russian PMN-2 anti-personnel mines recovered from different minefields in northern Cambodia in 2009. The mine in the foreground has been severely damaged by fire, which has burned away the cruciform pressure plate and allowed water to enter the mine. The explosive components are undamaged but, ironically, the loss of the pressure plate means that this mine could no longer function as designed.
Image: Fenix Insight Ltd.

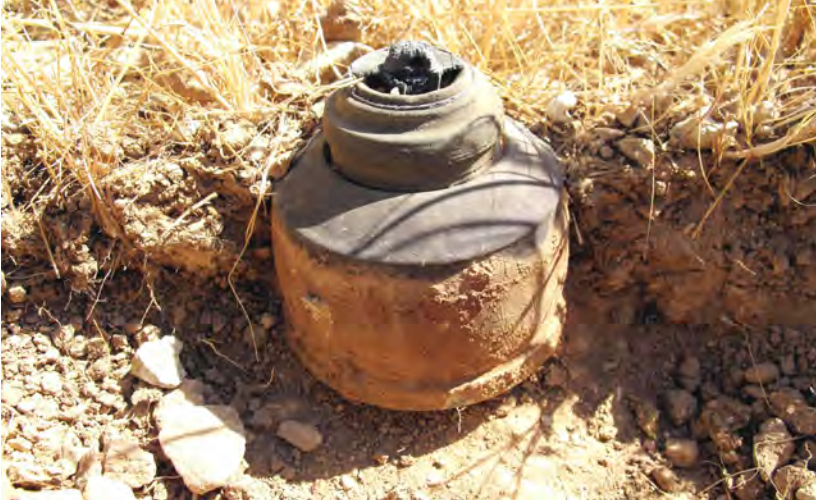
A Belgian M35 anti-personnel mine in Jordan, 2010, where a brush fire has swept through the minefield. The majority of the mine was buried, so reasonably well protected, but the fuze was burned and is no longer waterproof. The TNT explosive filling in the lower body of the mine has swelled, bulging the normally flat top surface and discolouring the plastic. As the body cooled, it remained in this position, so that the new shape and colour make the mine difficult to recognise.

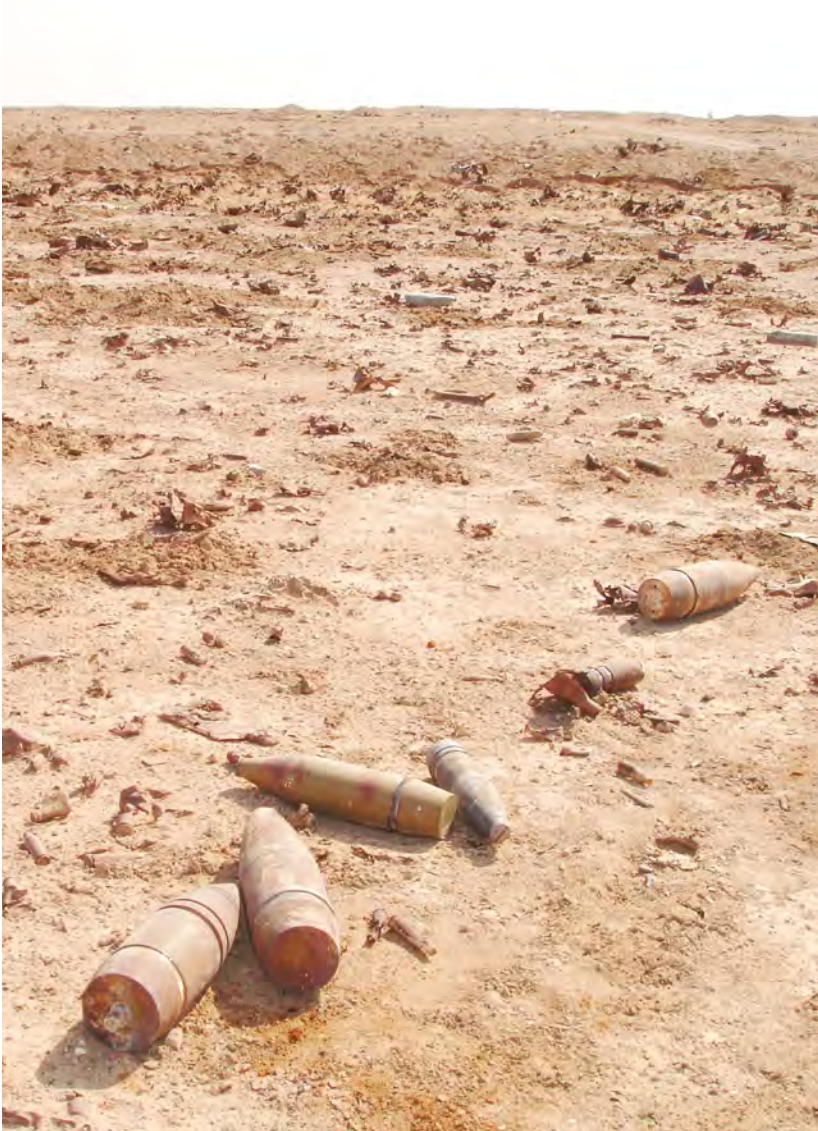
Abandoned projectiles in Iraq. Whether ERW is fuzed or armed, it remains an explosive hazard. Image: Roly Evans.

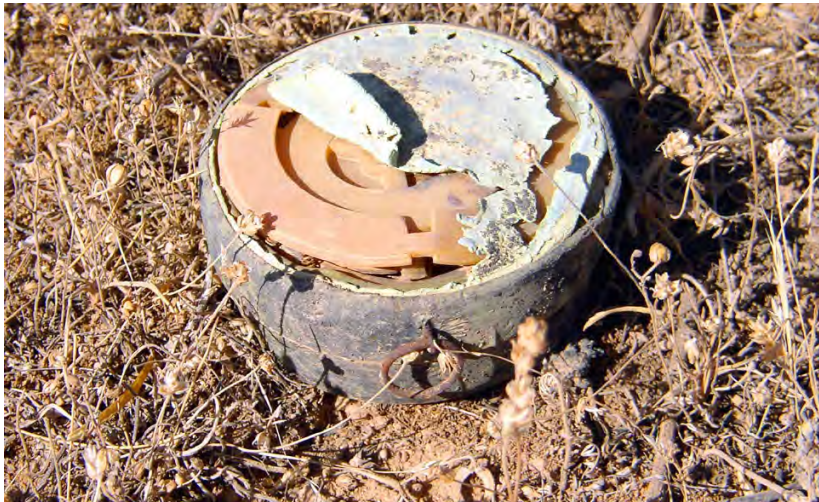
Thin rubber is certain to perish after decades of exposure to an outdoor environment.

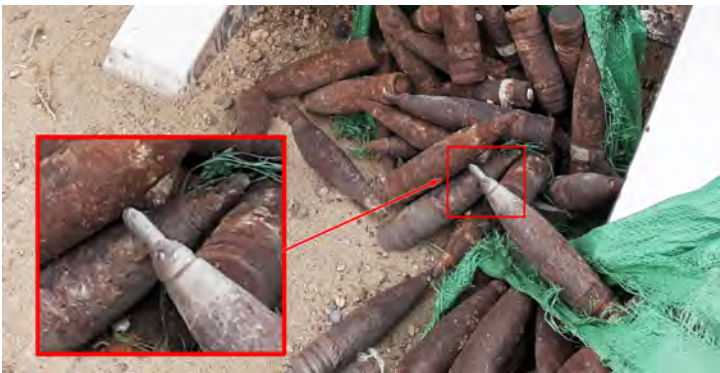
Russian 30mm cannon ammunition in Afghanistan, 2020. Some of the A-670M fuzes have lost their windshields, allowing water to penetrate the fuze body. Image: The HALO Trust.

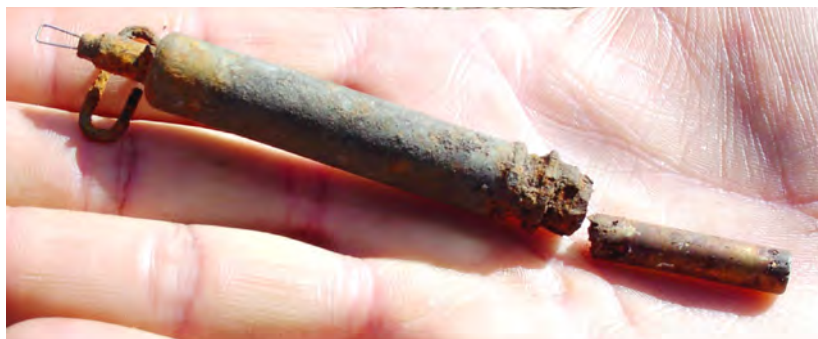
A Russian MUV-2 fuze from a PMD-6 anti-personnel mine recovered in Cambodia, 2010. The upper hollow section of the aluminium detonator capsule has corroded away, separating the explosive from the fuze. Since the mine was buried, this gap was then filled with earth and probably would have prevented the fuze from functioning. Image: Fenix Insight Ltd.

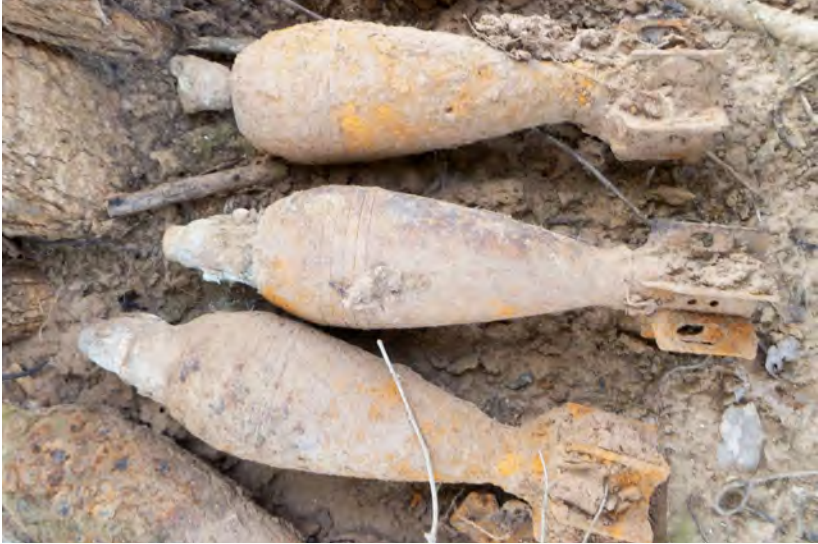
Weathered AXO gathered by local farmers. Note that corrosion of the fuzes is more advanced than on the mortar bodies. Image: Roly Evans.
