James Madison University

JMU Scholarly Commons

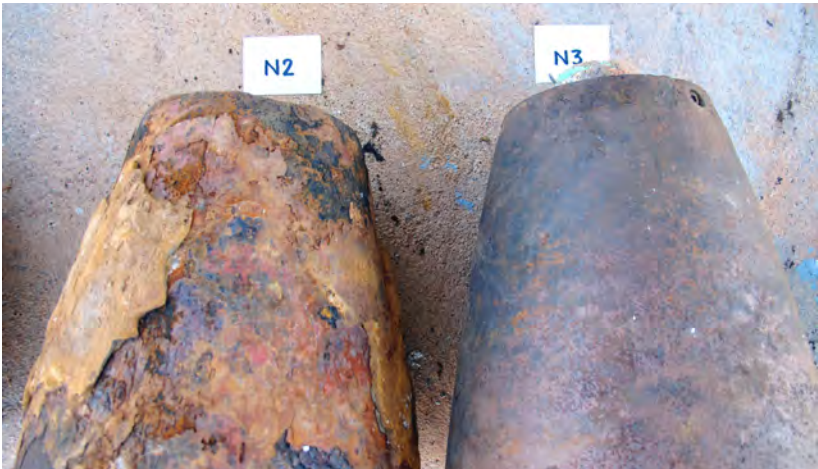
Nose sections of United States Mk 82 bombs dropped during the Indochina Wars and recovered, unexploded, in the early 2000s. These heavy steel casings were virtually unaffected by impact, other than the loss of paint coatings. Both have been exposed to water for nearly 50 years, but have corroded differently, possibly because of the soil conditions in which they were buried. The nose fuzes were heavily damaged on impact, but even the heaviest corrosion would still take several more decades to penetrate the steel casing. Image: Fenix Insight Ltd.

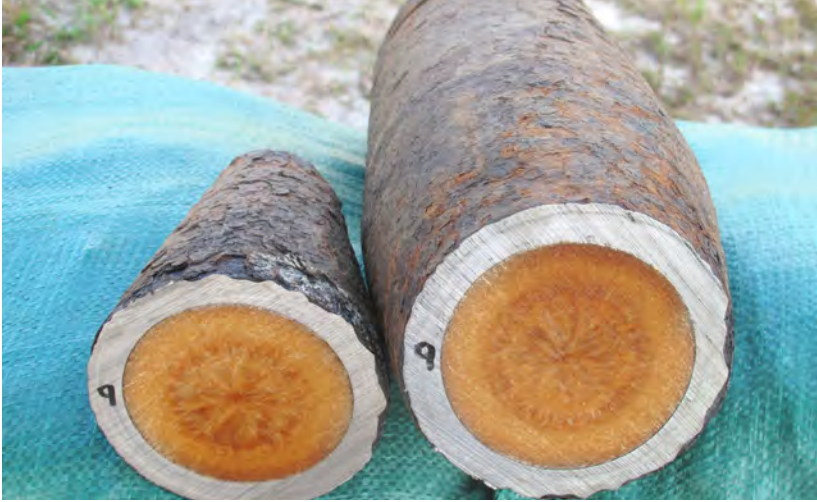
Externally, this Vietnam-era US M107 155mm HE projectile, recovered in 2018, appears heavily rusted. However, once cut open to reveal the HE filling, the thickness of unaffected steel becomes apparent. This is typical of many steel-cased munitions, such as mortar rounds, projectiles and air-dropped bombs.

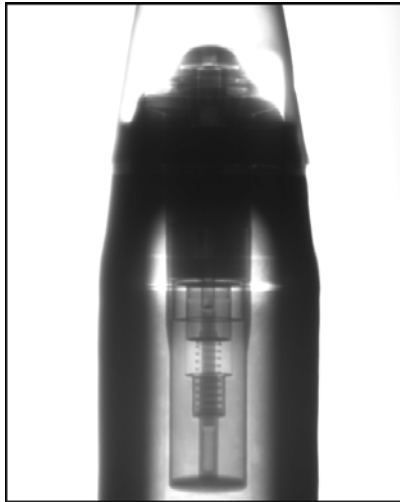
An x-ray image of a German GrZ04 fuze in a remarkable condition, with springs still intact. Many World War I artillery projectiles had fuzes that were largely internal to the fuze pocket and have therefore been protected by the thick steel casing. What is not visible is any ageing of the pyrotechnic holding devices within the fuze that often degrade due to humidity. Image: Belgian EOD Group (DOVO-SEDEE).

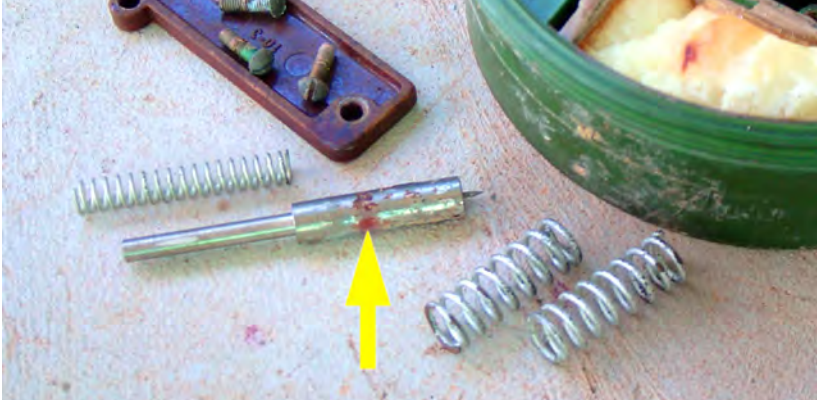
The springs in this Russian PMN-2, also recovered from Cambodia in 2014, are in good condition; however, the plating on the striker has been lifted and bulged by corrosion (yellow arrow). Because of the fine tolerances in the fuze, this small dimensional change is sufficient to seize the striker into place and prevent the mine from operating. Image: Fenix Insight Ltd.

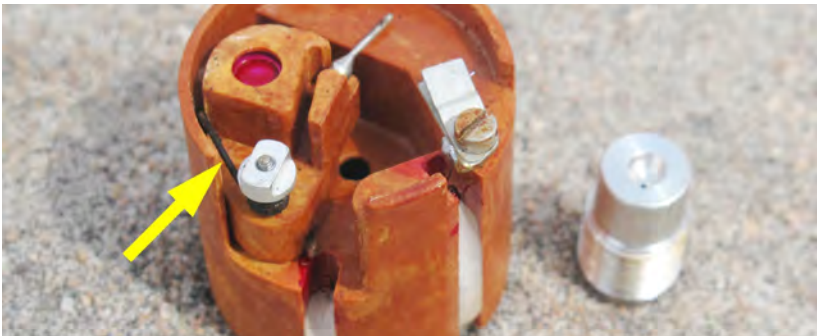
This fuze is from the Russian PTAB-2.5M submunition, which is found within the stockpiles of many countries. In this example, the small spring (yellow arrow) that turns the detonator rotor has failed due to corrosion. This spring is responsible for bringing the detonator into line with a booster and making an electrical connection. This tiny component is the only point of failure in the whole munition, but it is enough to prevent it from operating. Image: Fenix Insight Ltd.

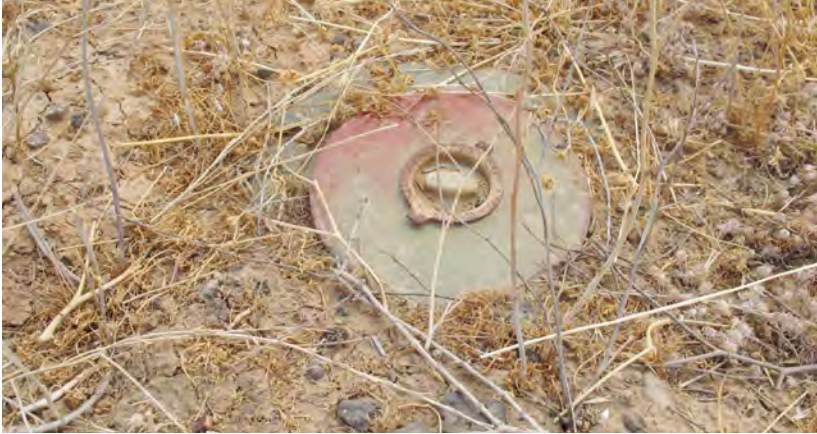
A United States M15 anti-tank mine, encountered in 2010 in a minefield on the Jordanian border with Syria. Disarming this mine should be a simple matter of unscrewing the central plug and removing the fuze; however, the plug is firmly rusted into place. This is an example of ageing preventing a render-safe procedure, leaving demolition as the only practical disposal option. Image: Fenix Insight Ltd.

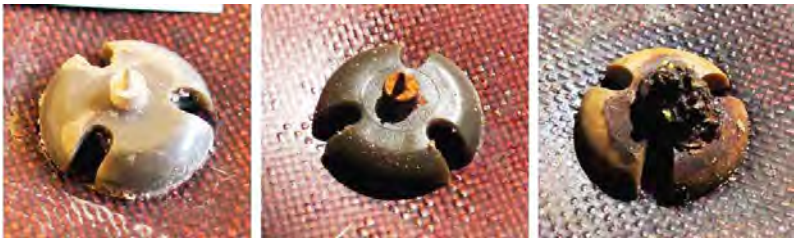
Firing pins recovered from United States M14 anti-personnel mines in Jordan during the early 2000s. The pin on the left is virtually as-new, but the pins in the centre and right have become shorter and blunter. These are unlikely to initiate the mine's stab-sensitive detonator. Corroded firing pins will also make the mine even harder to detect.

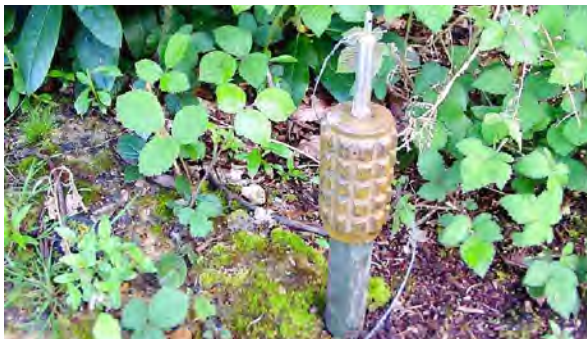
Contrary to popular belief, most tripwires are made from iron or steel, with little or no protection. Tripwires used with mines like this Chinese Type 59, laid in Cambodia more than 40 years ago, rusted away many years ago. Image: Fenix Insight Ltd.

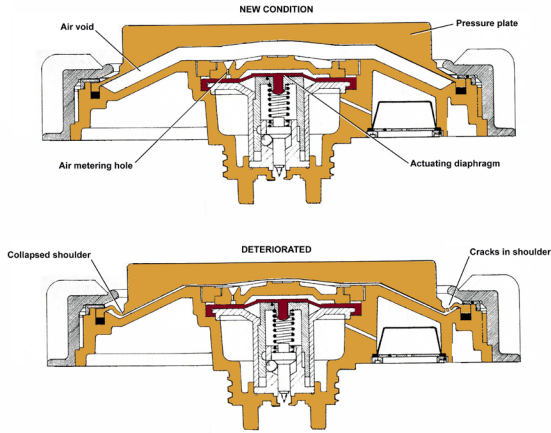
Top: The air-filled cavity beneath the pressure plate prior to the application of pressure functioning the mine. When pressure is applied, this air is used to distort a diaphragm and actuate the fuzing mechanism.

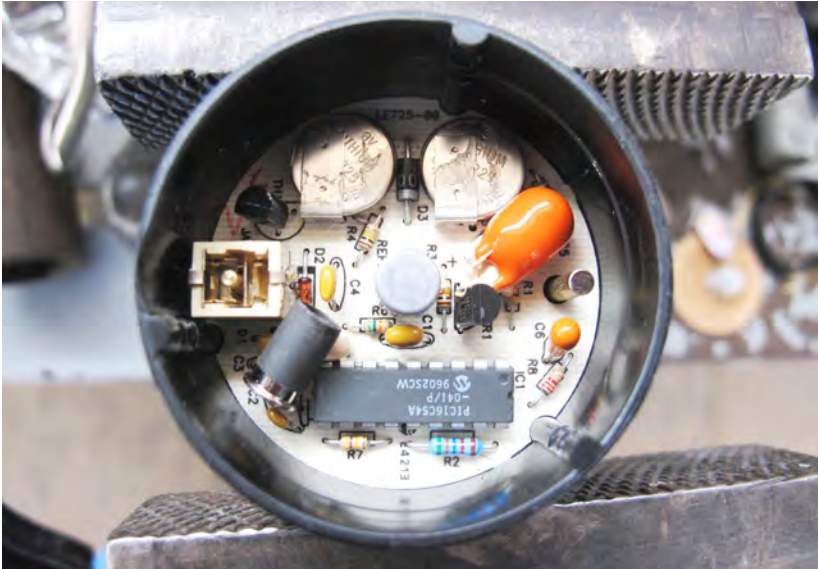
The electronic fuze of a Spanish SNA submunition is powered by two lithium batteries. These batteries are isolated from the circuit until the weapon is deployed.
Image: Fenix Insight Ltd.

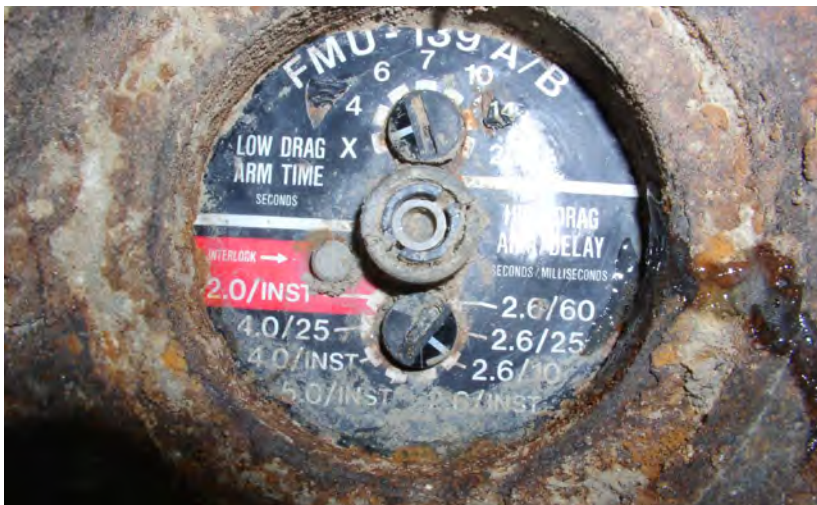
An FMU 139 A/B electro-mechanical fuze in the tail of a MK-83 aircraft bomb in Iraq. The fuze contains capacitors charged from the employing aircraft prior to being dropped. The charge has long since dissipated. Image: Roly Evans.

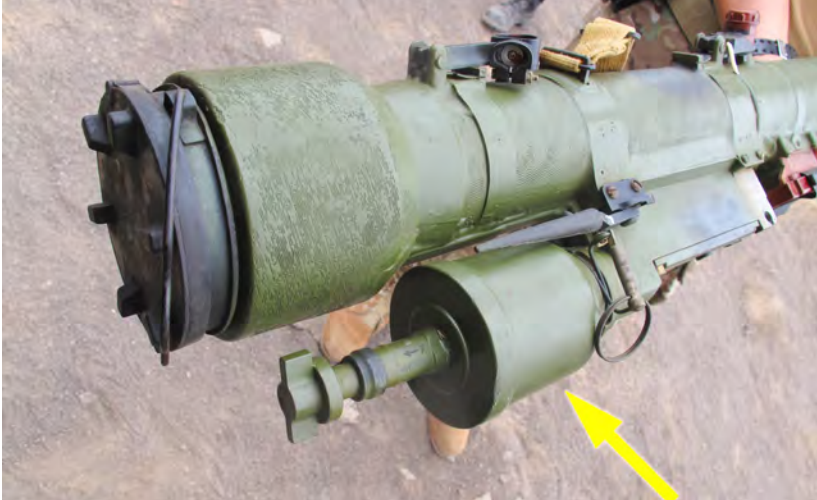
Shoulder fired air-defence systems such as the Russian SA-7, SA-14, SA-16 and SA-18 missiles use thermal batteries. These are fitted to the launcher and activated by twisting a key at the end of the battery assembly. Once heated up, the battery provides power for a few minutes before it cools and expires permanently. Image: Fenix Insight Ltd.

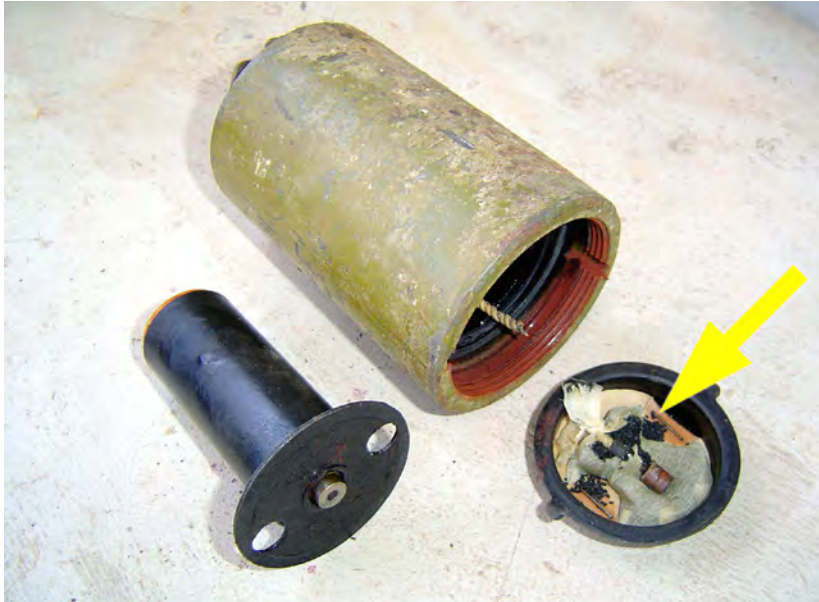
A Russian OZM-4 bounding mine, recovered from storage in Cambodia. The black powder and igniter (arrow) are still in good condition after 50 years. However, both are vulnerable to water and will fail to function if they are damp. In such a case, the initiation train will be broken and the mine will fail to operate.

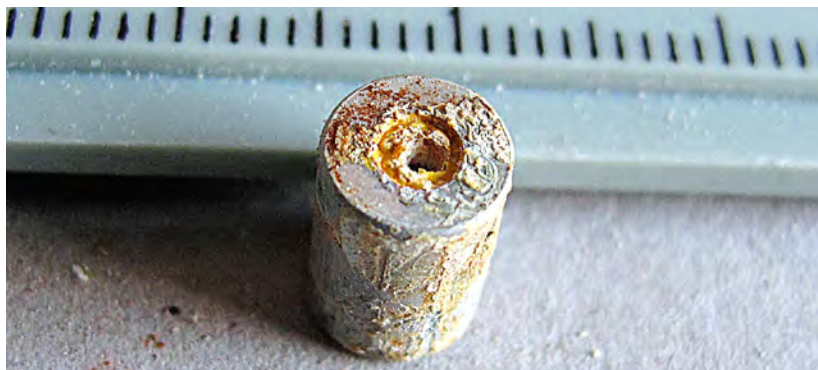
A detonator assembly from an Italian SB-33 mine, laid in the Falkland Islands/Malvinas in 1982 and recovered 35 years later. The hole in the top shows that, at some point, the mine had been actuated and the mechanical components of the fuze mechanism have functioned correctly, driving the firing pin into the stab receptor. But the detonator failed to function and the mine remained unexploded. It is probable that prolonged saturation or damp has caused this failure. Image: Fenix Insight Ltd.

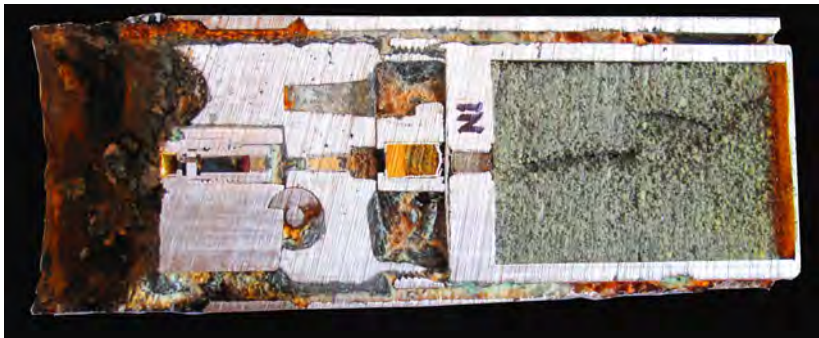
The sectioned body of a Vietnam-era US M904 bomb fuze, recovered in Cambodia. The components of the explosive train are clearly visible running horizontally through the centre of the fuze. Their alignment shows that this section of the fuze was correctly armed. For some reason the striker has not initiated the in line explosive train. The primary explosive may still be viable, as it is well protected by the fuze casing, but the pyrotechnic elements of the explosive train are no longer functional. Note also the zinc and aluminium oxides that have filled the gaps between the steel casings. Image: Fenix Insight Ltd.

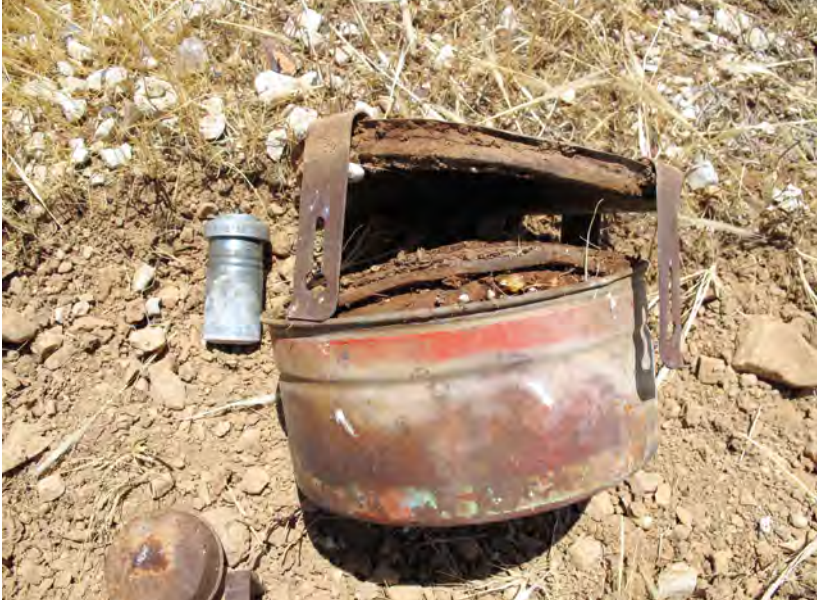
A British Mk 5 anti-tank mine in Jordan, with TNT being forced out of the casing by internal corrosion. This is an extremely rare instance where the fuze (to the left of the mine) may still be viable, but the loose structure of the main charge may be unable to sustain detonation. Usually, by this stage the fuze would have suffered numerous points of failure due to ageing. Image: Fenix Insight Ltd.

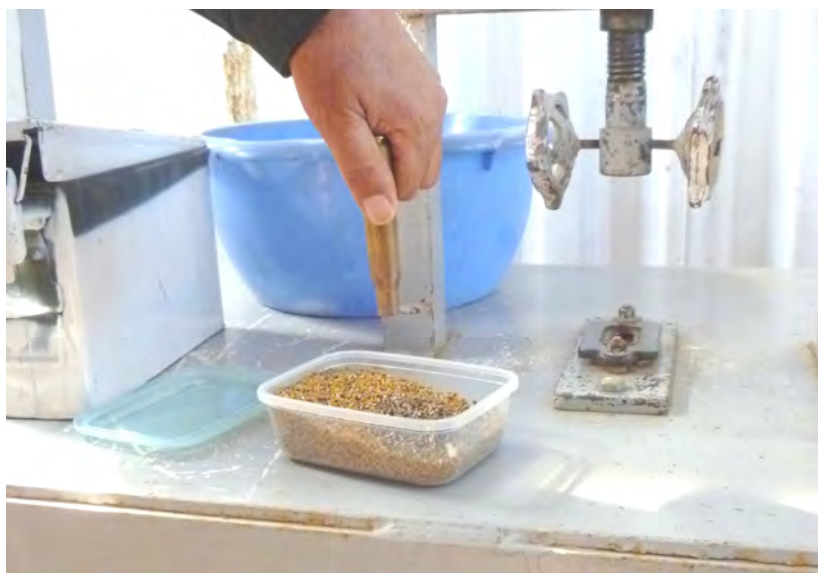
Double based propellant removed from debulleted 12.7 x 107mm ammunition. The propellant contains stabilizers to absorb the nitrogen oxides emitted by the degradation of nitrocellulose. Such stabilizers are used up over time and ammunition containing propellant can become a fire hazard. This risk increases in hot environments. It is for this reason that AXO found in the field containing propellant should not normally be stored in an ASAs or explosive stores. Image: Roly Evans.

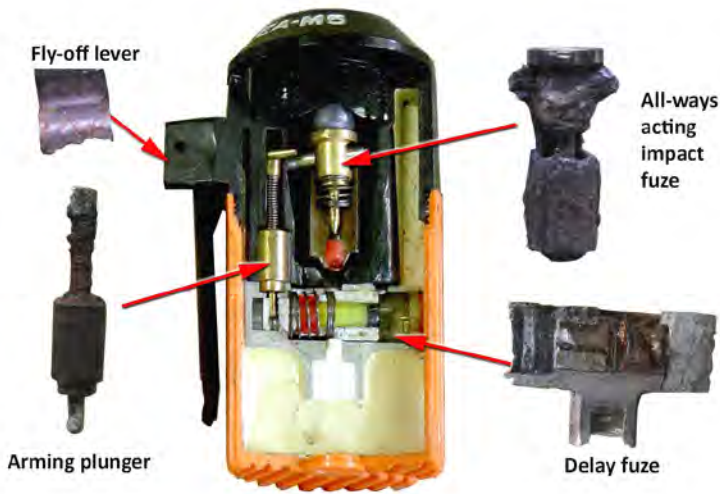
The Spanish M-5 is a complex hand grenade incorporating both delay and impact fuzes. This image shows a section through a new grenade, along with aged components from an example recovered in the Falkland Islands/Malvinas in 2015, 33 years after the war. The multiple points of failure among both mechanical and energetic components meant that the risk from the aged grenade was minimal. Image: Fenix Insight Ltd.

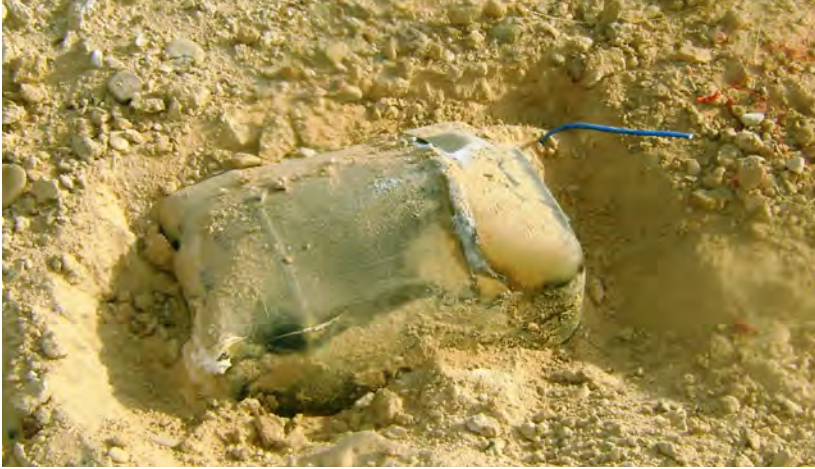
An expanded aluminized ammonium nitrate charge in a 20 litre plastic container, Jalawla, Kurdistan Region of Iraq, August 2016. Expanded charges would routinely split plastic casings. Image: Bob Gravett.

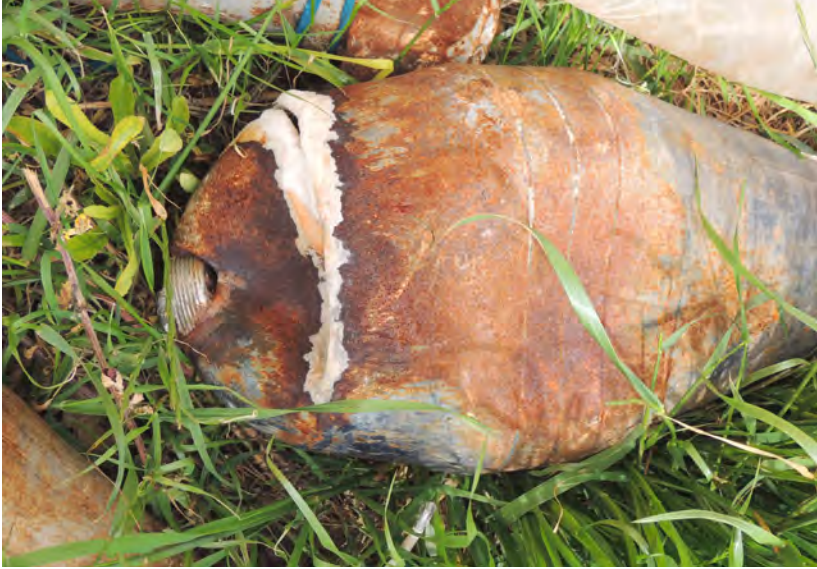
Ammonium nitrate HME exudation from a 220mm improvised mortar, April 2015, Kobane, Syria. The mortar contained knotted detonation cord to act as a booster. Detonation cord is susceptible to hygroscopic action. Image: Bob Gravett.

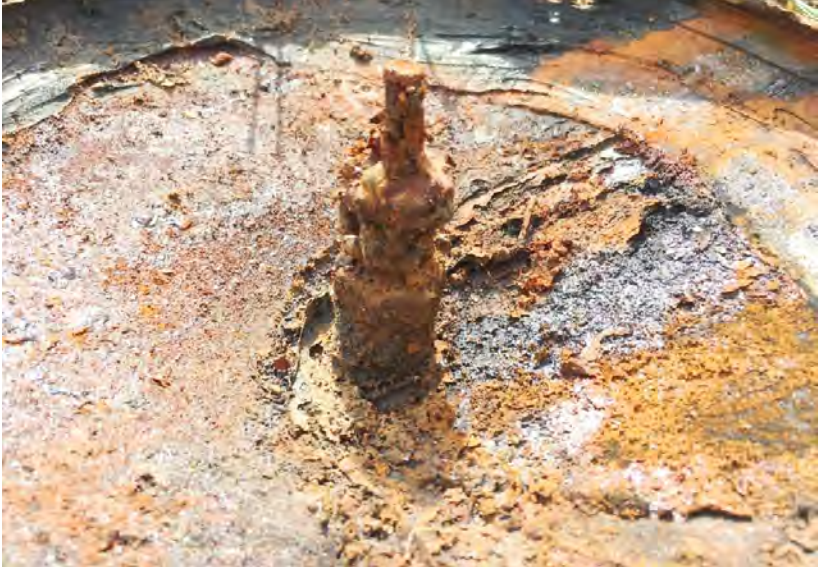
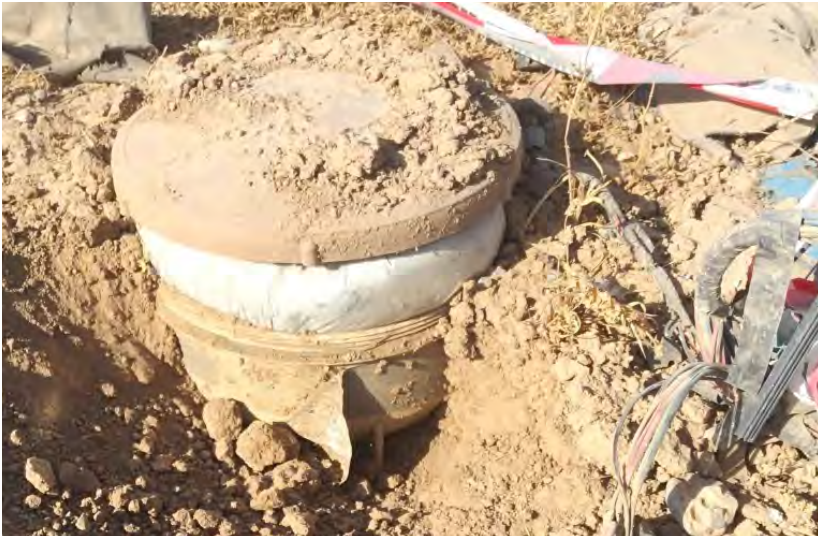
Image top shows a heavily corroded improvised mechanical fuze used in the mechanical version of the VS-500. Image bottom shows expansion of the aluminized ammonium nitrate main charge in an electrically initiated VS-500. Both images: FSD.

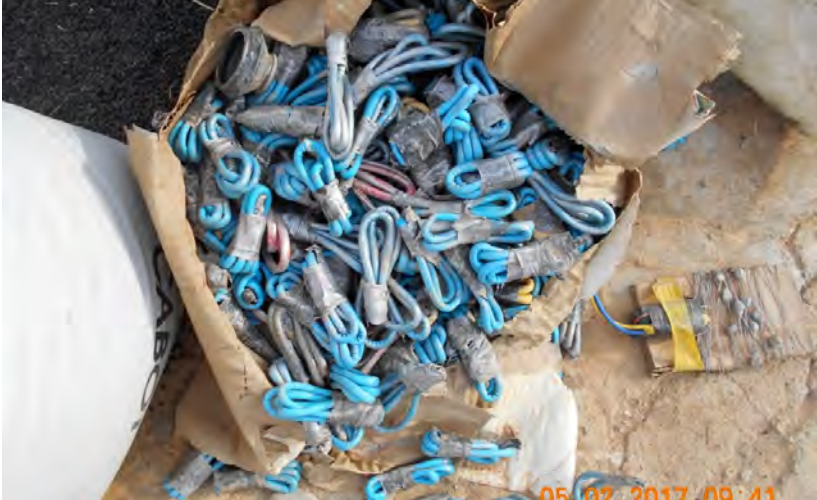
Detonation cord knotted to make improvised boosters. Detonation cord, whether military or commercial, is susceptible to hydroscopic action and potential failure in the presence of moisture. Also note the 9v battery linked to the crush wire on the right hand side of the image. Image: FSD.

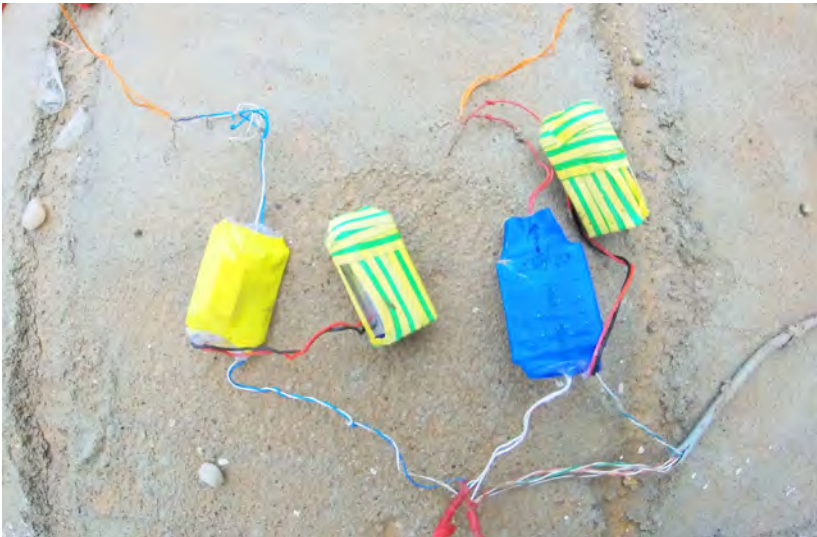
9v batteries recovered from victim operated IEDs, Iraq, December 2016. How long a 9v battery retains its potential is a key consideration in how long the device remains viable. Image: Bob Gravett.

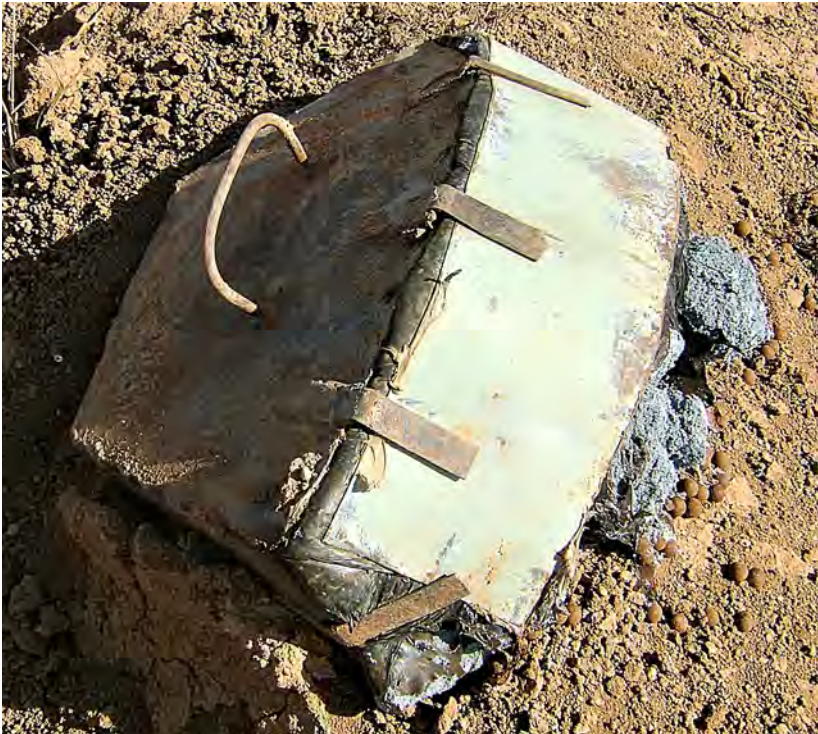
Improvised explosives such as ammonium nitrate and aluminium mixtures, pictured here in an IED found in Iraq, are far more vulnerable to deterioration than military high explosive. Unlike factory-made munitions, IEDs frequently fail because of the degradation of their main charges. Image: Bob Gravett.

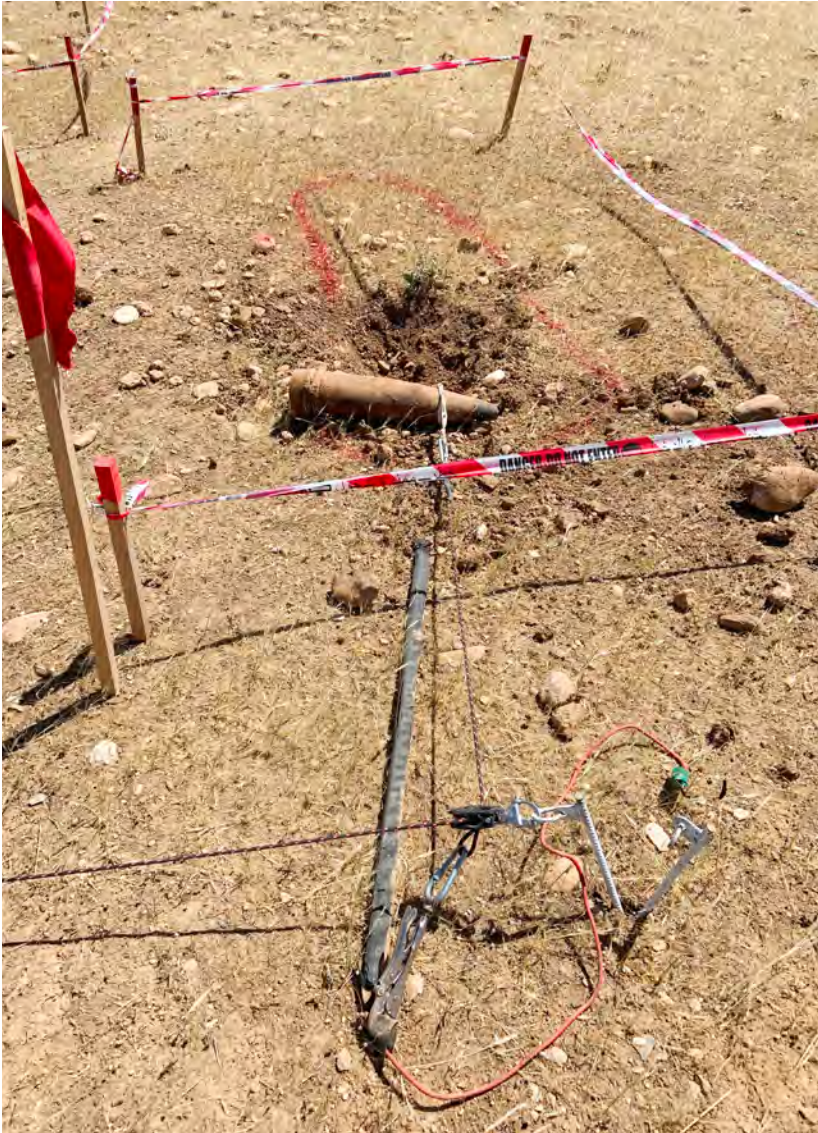
A semi-remote pull on a high explosive 130mm artillery projectile employed as a main charge in an IED, Tel Kaif district, Mosul, May 2022. Use of ERW typically results in IEDs with a far more resilient main charge than those employing improvised explosive mixtures. Image: Daniel Davids.

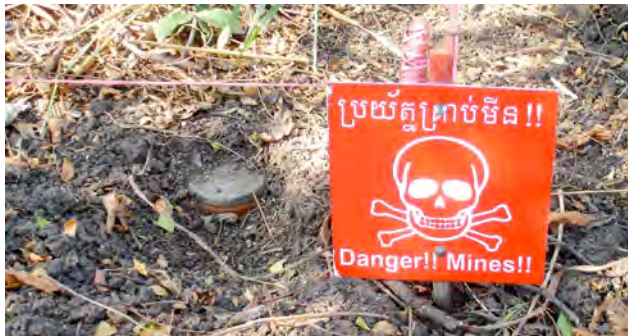
A PMN mine found in Cambodia, December 2006. The PMN has a cocked striker with a plastic holding device held in position by a vertical spring. As this vertical spring degrades the mine can become even more sensitive to movement. Eventually the striker assembly of the mine will also corrode diminishing the risk of the mine initiating if moved. As the PMN ages the risk it presents changes over time. Image: Sean Moorhouse.

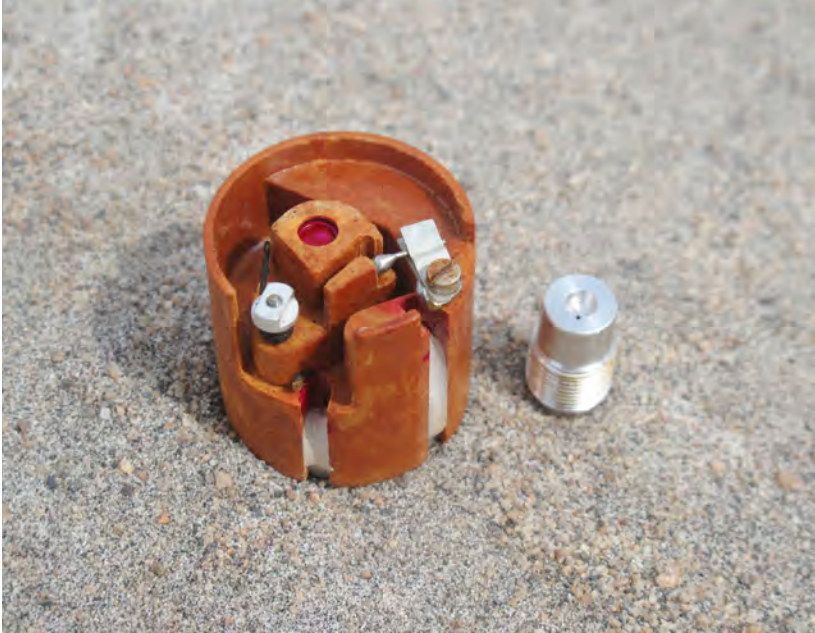
A corroded and broken detonator rotor spring in the fuze of a PTAB-2.5M submunition. Here, the fuze is seen armed, with the rotor central. However, the absence of the spring means that the rotor can now move by gravity or turning moment. Once the arming action has freed the rotor, it is a question of chance whether it remains out of line or falls into line. The orientation of the fuze is not visible from the outside, nor is it possible to see the position of the rotor. This means that it may alternate between being armed and unarmed as it is moved. Corrosion of the rotor spring has made this item more dangerous. Image: Fenix Insight Ltd.

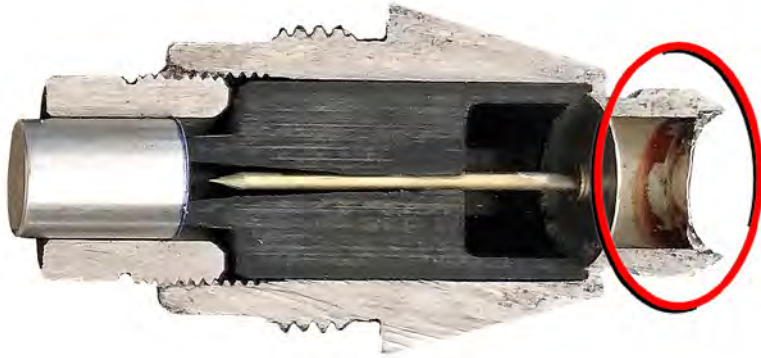
The Russian AM-A fuze is extremely simple, with a firing pin positioned in line with a detonator and with no safety or arming mechanism, just a block as a holding device that is crushed on impact. The front of the fuze casing (circled in red) is designed to protect the firing pin, but also has the thinnest section of steel (where it is designed to collapse or shear). If this section of the casing were to disintegrate, the firing pin would be more vulnerable to impact, and the fuze would become more sensitive. AO-1SCh submunitions using AM-A fuzes were known to have high failure rates when employed in Syria. Image: Fenix Insight Ltd.

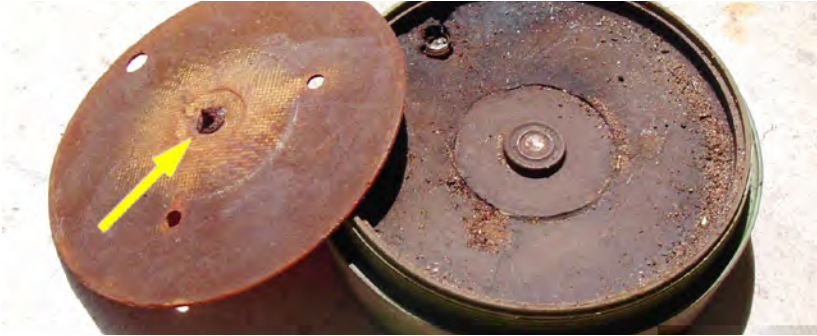
The Chinese Type 72 anti-personnel mine has a firing pin (arrow) weighing just 0.12g, which makes it barely detectable. Any significant loss of metallic mass, as the pin rusts, may take it below the detectability threshold, even though the pin may still be long enough to fire the stab-sensitive igniter. This may have been the case with some of the mines examined in Cambodia in 2015. Image: Fenix Insight Ltd.

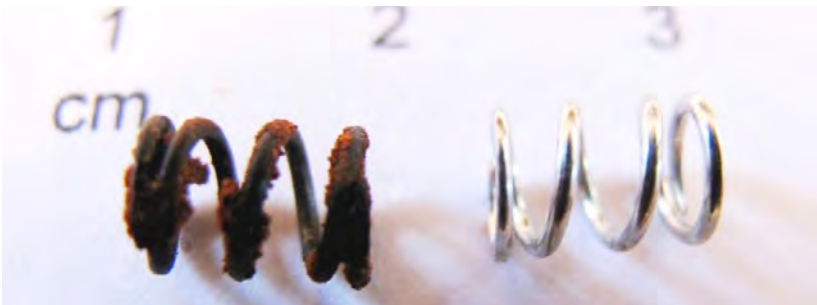
Springs from P4B minimum metal anti-personnel mines, one corroded, another not. The corroded spring's conductivity will reduce making the mine harder to detect. For minimum metal mines, corrosion of the only metallic components makes them even harder to detect. Image: Fenix Insight Ltd.

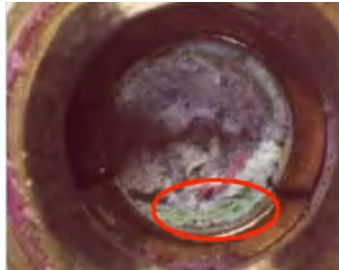
A photo from the Dutch Safety Board accident investigation showing green copper azide crystals (circled) inside the casing of an M-6 mortar bomb fuze. The formation of this sensitive compound is believed to have caused a fatal accident in 2017, and could become a hazard in many types of ammunition as it ages.

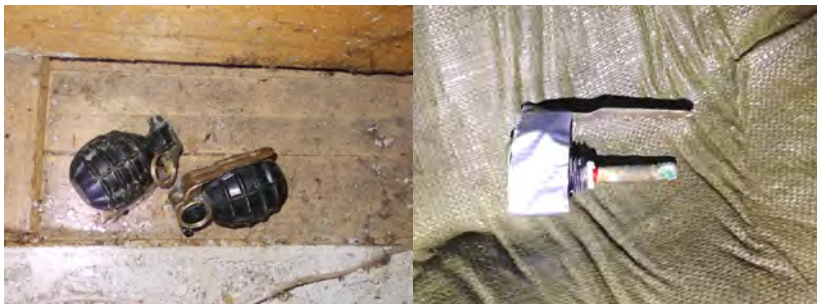
Two M-75 grenades retrieved during an EOD task. While the grenades look to be in reasonable condition, removal of the fuzes revealed corrosion of the detonator casing, probably caused by humidity over time. While not confirmed, it is possible that the blue substance is some form of verdigris. Images: Private.

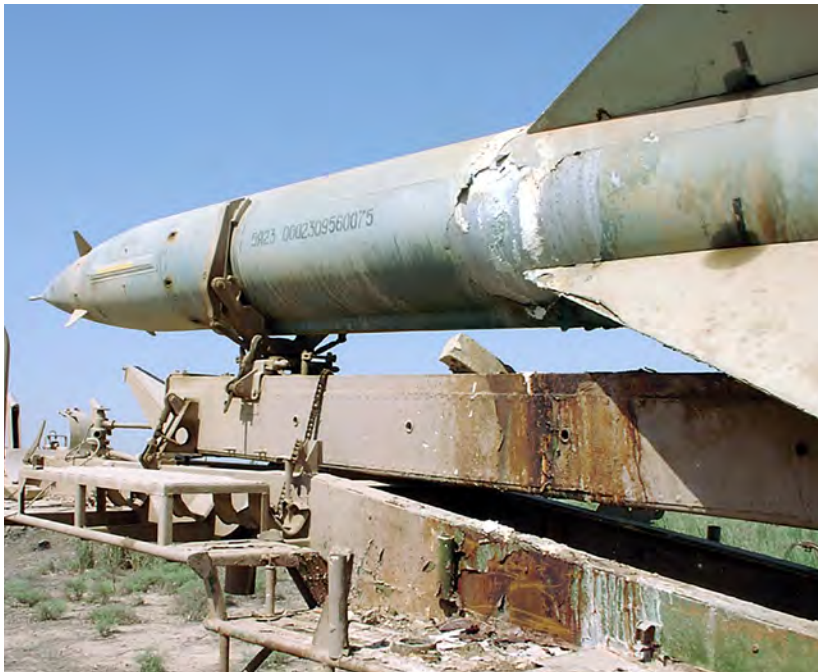
An SA-2 missile in Iraq following the war. Liquid fuel and oxidant from the rocket motor is leaking and contaminating the ground. Image: Fenix Insight Ltd.

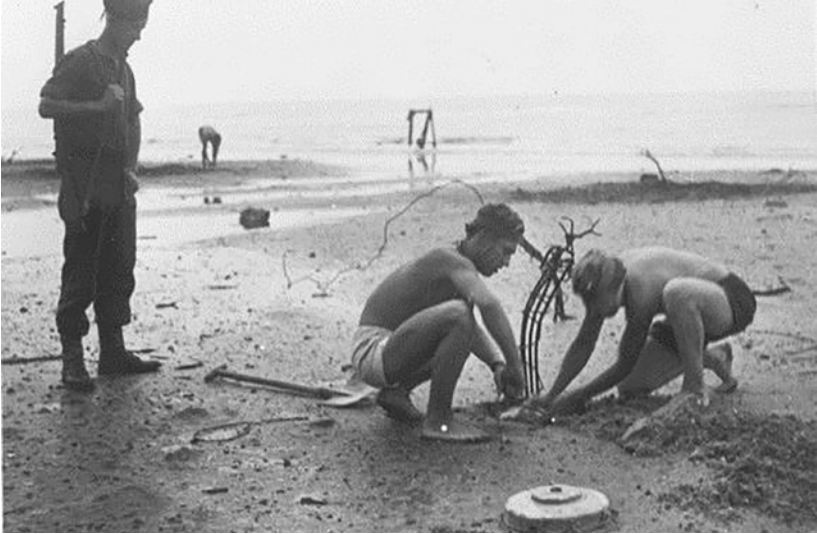
Tellermine-42s being removed from beach obstacles using clearance drills acceptable at the time. Tellermine coated in tar were found to be resilient to seawater for up to six months. Image: NIOD Institute

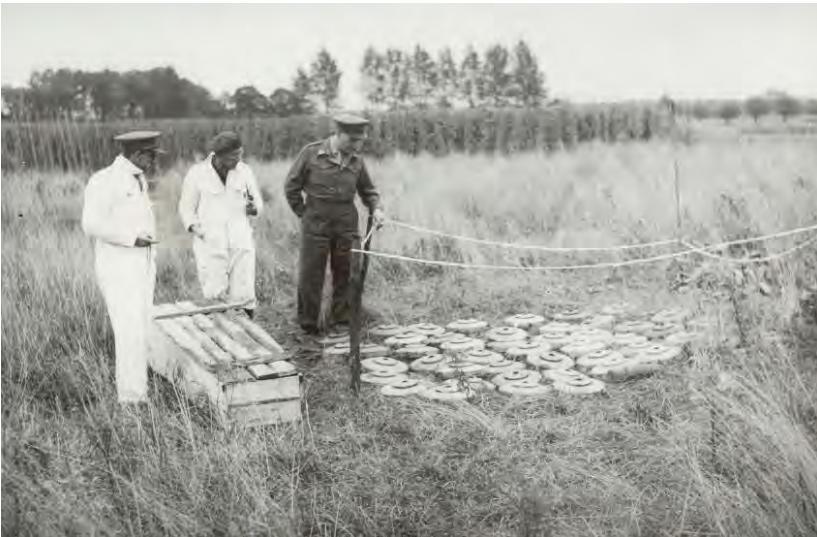
Inspecting Tellermine-42s removed from a "low lying meadow". While rusting was observed in this environment after 12 months, metal cased Tellermine were still deemed 100% effective after 18 months. Image: NIOD Institute

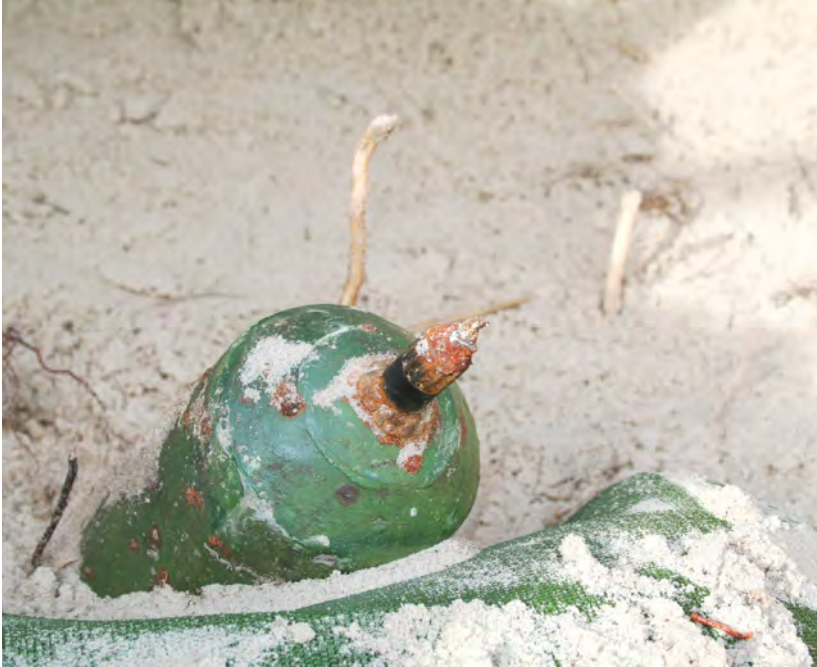
A stockmine with ZZ-42 igniter found buried in the sand dunes at Skallingen, September 2006. While the mine body, consisting of metal fragmentation embedded in concrete, has proved very resilient, with the paint still showing, and the bakelite fuze body is intact, the exposed part of the striker has heavily corroded. The fuze is no longer functional, although it could still pose an explosive hazard.

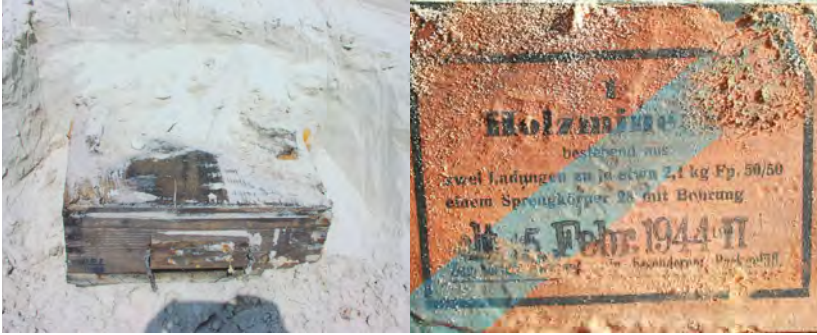
A Holzmine-42 found deeply buried in sand dunes, Skallingen. Such was the lack of corrosion to some wooden mines found in sand dunes that it was not uncommon to even find paper markings still intact, such as this label found in September 2010, showing a date of manufacture of February 1944.
Images: Martin Jebens, Danish Coastal Authority.

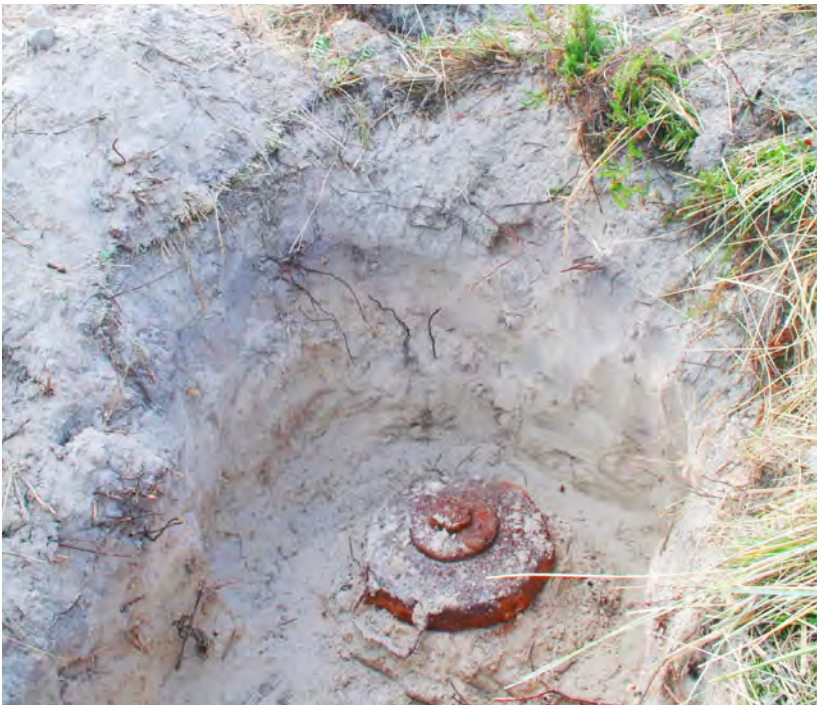
A Tellermine-42 found heavily corroded but intact. Being buried under a meter of sand has largely protected the mine for over seven decades.
Image: Martin Jebens, Danish Coastal Authority.

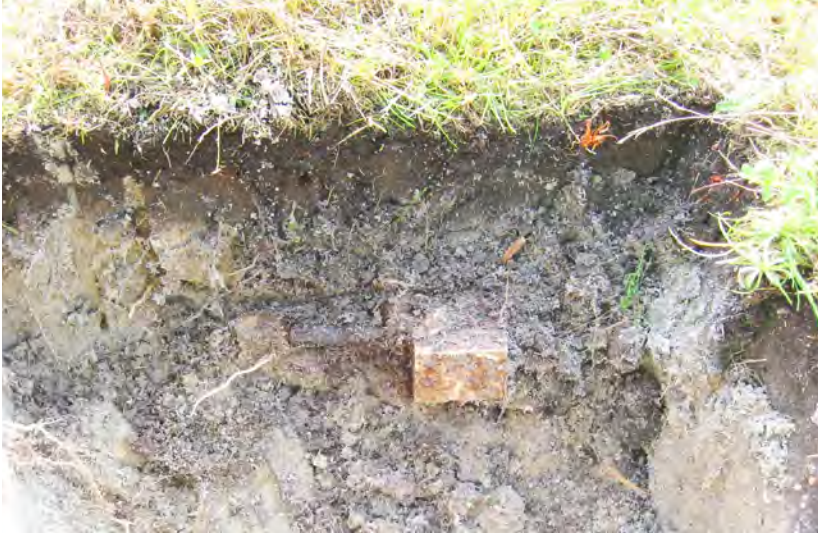
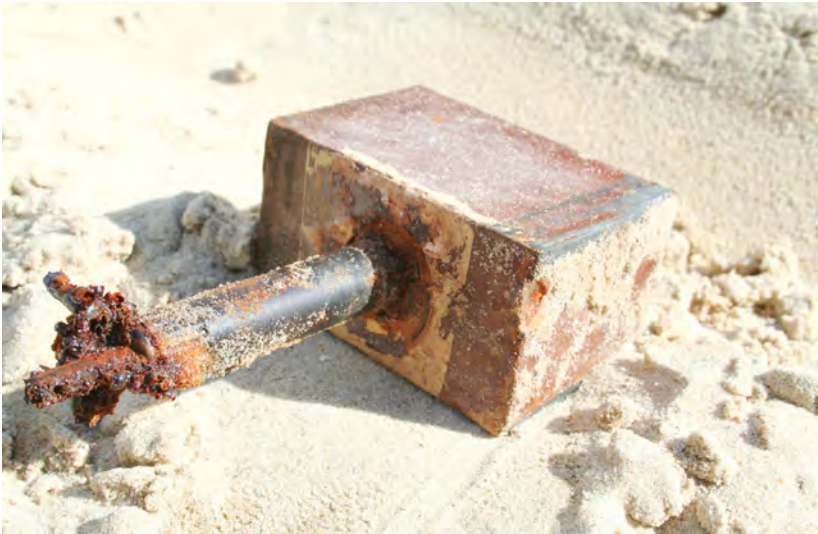
Wooden Schuminen have corroded leaving just the 200g TNT blocks in wax paper and the ZZ-42 fuzes. Note the bakelite fuze body is still in remarkably good condition but the steel striker and retaining pin have corroded. TNT has a relatively low solubility, as shown by the relative resilience of these charges, albeit these have not been subjected to prolonged saturation in salt water. Images: Martin Jebens, Danish Coastal Authority.

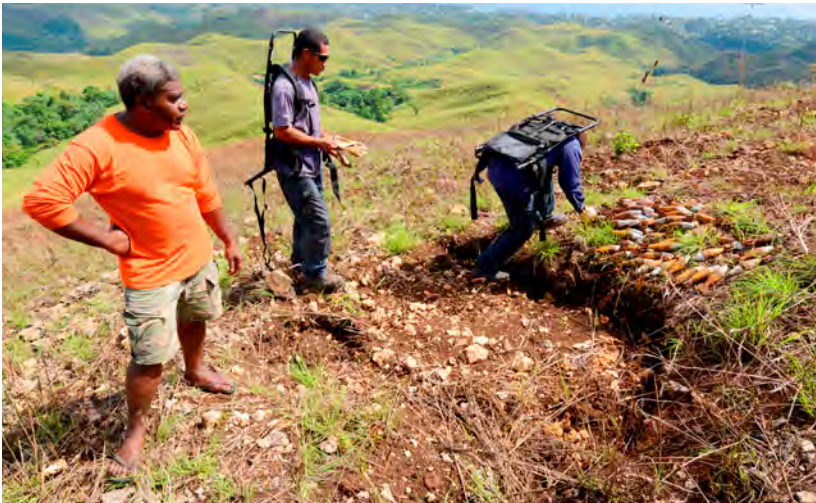
A Royal Solomon Islands Police Force (RSIPF) EOD team and local villager, Willy Basi inspect 69 mortar rounds left by an old mortar position south of Honiara in the Solomon Islands. This AXO has stayed in this position since it was abandoned in 1942. While the fuzing has not been armed the ordnance has noticeably aged and still poses a hazard to the local population. Image: John Rodsted.

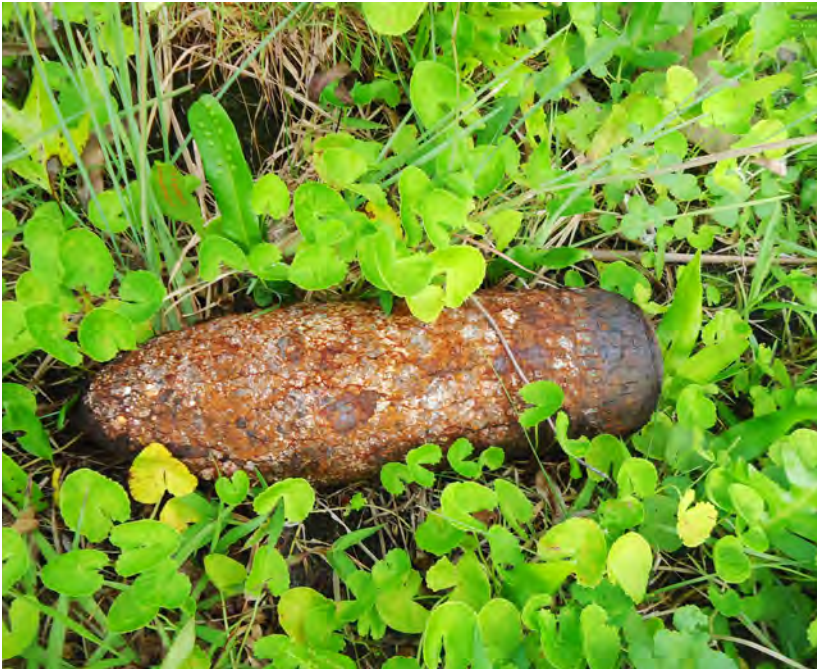
A fired Japanese Type 91 15.5 cm HE projectile, showing heavy external corrosion.

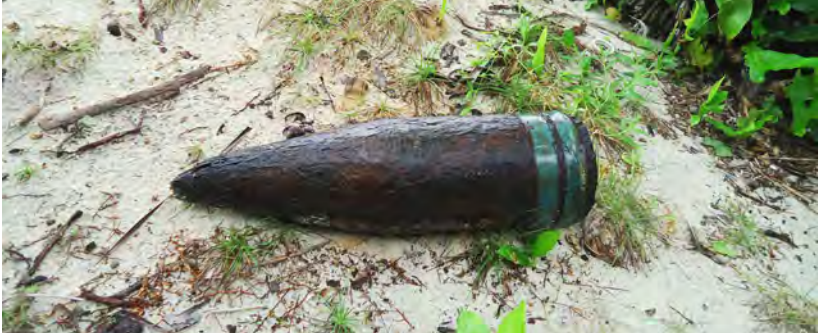
A Japanese 15 cm Type 13 or 88 Common projectile, showing deep corrosion from exposure to seawater. The copper driving bands are now green due to the copper salts produced by chemical reaction with the local environment. The smooth driving bands indicate that this projectile has never been fired. This classifies it as abandoned (AXO) rather than unexploded (UXO) explosive ordnance. While its fuze may be considered not armed, AXO still poses a significant explosive hazard. It can be misused by fishermen. In other countries AXO has frequently been employed as a main charge in IEDs. Image: Len Austin.

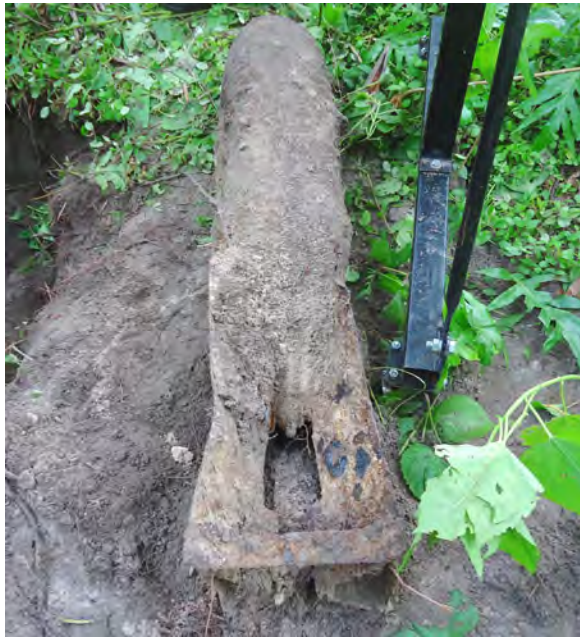
A shallow-buried Japanese Type3 No25 Mk8 Bomb Mod1 – 4, recovered in relatively good condition with the tail fins still intact. Between the fins, at the rear of the bomb casing, is the remains of the tail fuze, no longer functional. Image: Len Austin.

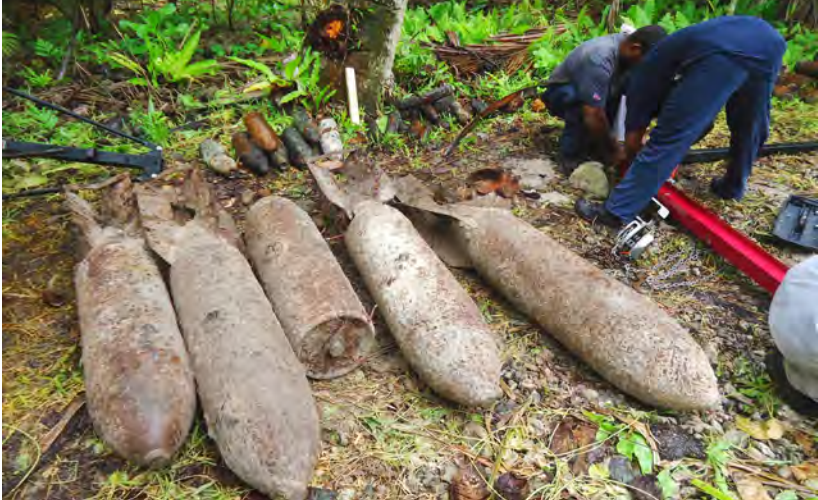
Recovery of Japanese bombs from a buried stockpile. These Type 3 No25 Mk8 Mod1 – 7 bombs are unfuzed, with just a blanking plug fitted into the fuze wells. The absence of a fuze and primary explosive reduces the risk significantly. While a degree of corrosion can be seen, the resilience of the thick cased munitions is evident.

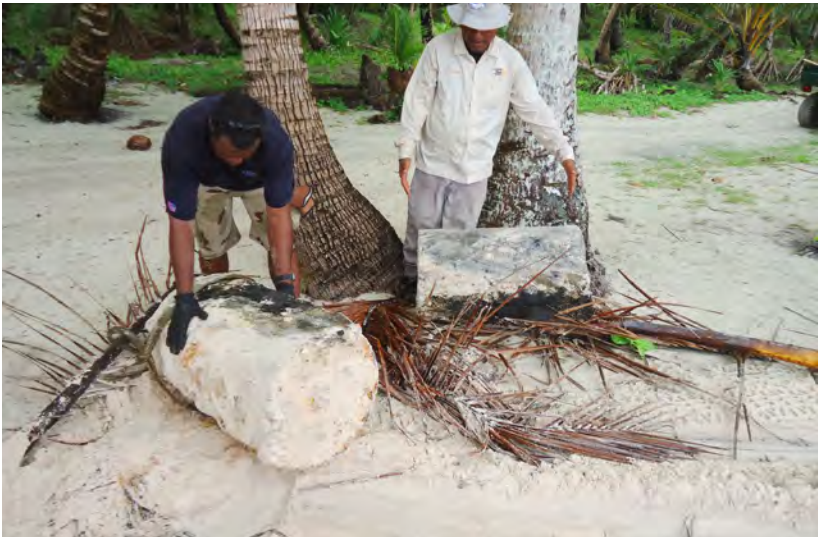
A Japanese Type 3 Sea Mine, presumed to have been washed up on the shore and subsequently buried in sand. Image: Len Austin.
