James Madison University

JMU Scholarly Commons

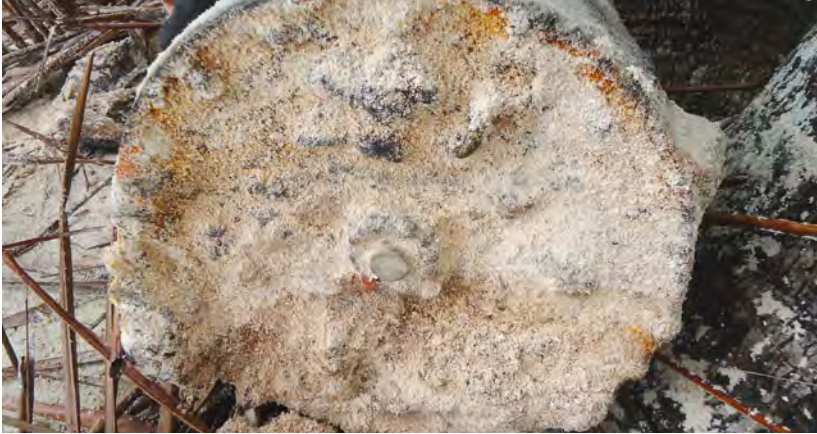
The combination of abrasive sand and salt water has accelerated the corrosion of the casing, which has partly disintegrated, leaving the explosive filling exposed.
Image: Len Austin.

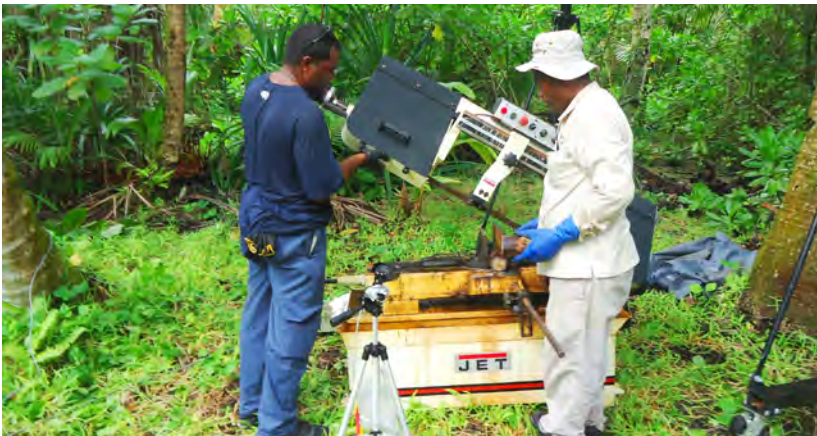
A portable cutting deck, based on a commercial bandsaw, conducting exploitation of Japanese 75mm Type 94 HE projectiles. While not a conventional ammunition process facility, mobile cutting stations can still conduct exploitation safely by effectively controlling the surrounding area as a range. All cuts are conducted remotely. The TNT fill is ultimately disposed of by open burning. Image: Len Austin.

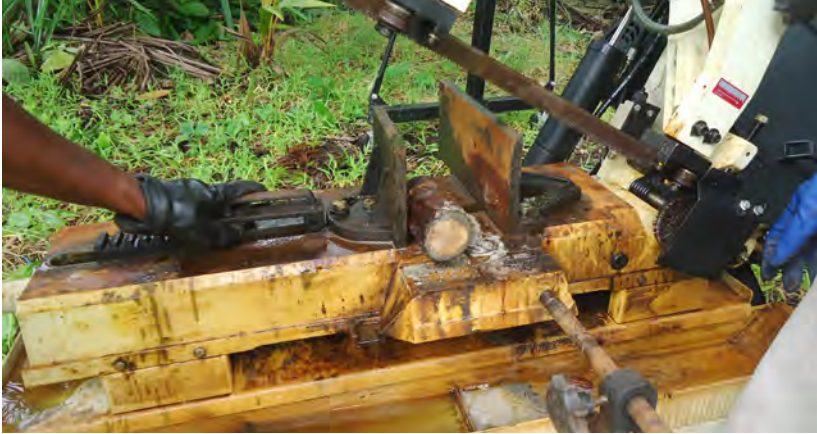
The team inspects a cut made on a 75mm Type 94 HE projectile. Where possible, the cut avoids sensitive components and exposes the maximum diameter of filling. Cutting also allows the internal condition of the munition to be assessed. On this item the uneven corrosion of the steel casing can be seen. Image: Len Austin.

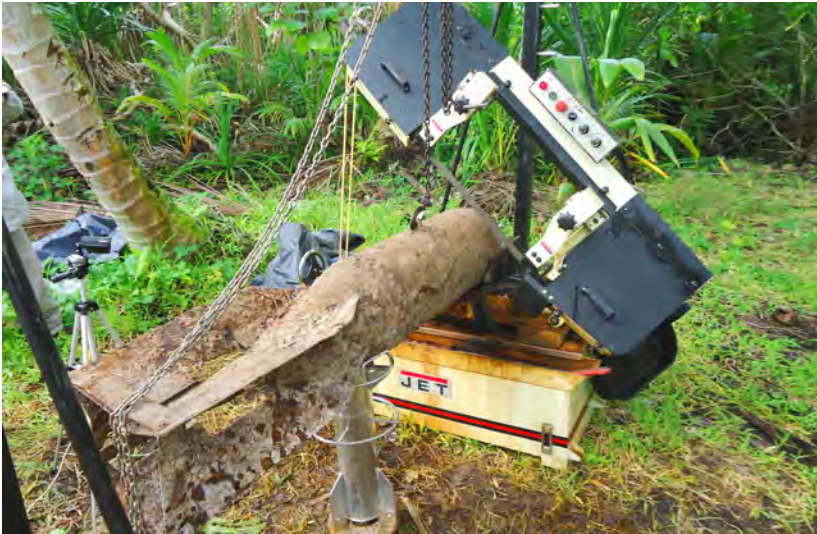
Even large bombs, such as this Japanese Type3 No25 Mk8 Mod1, can be remotely cut using the adapted bandsaw rig, if the state of the fuze enables the bomb to be moved. This allows the high-risk fuze components to be separated from the main charge, while giving access to the explosive so that it can be burned out. The fuze section can be left nearby, so that the heat also destroys the primary explosive, which detonates harmlessly. Image: Len Austin.

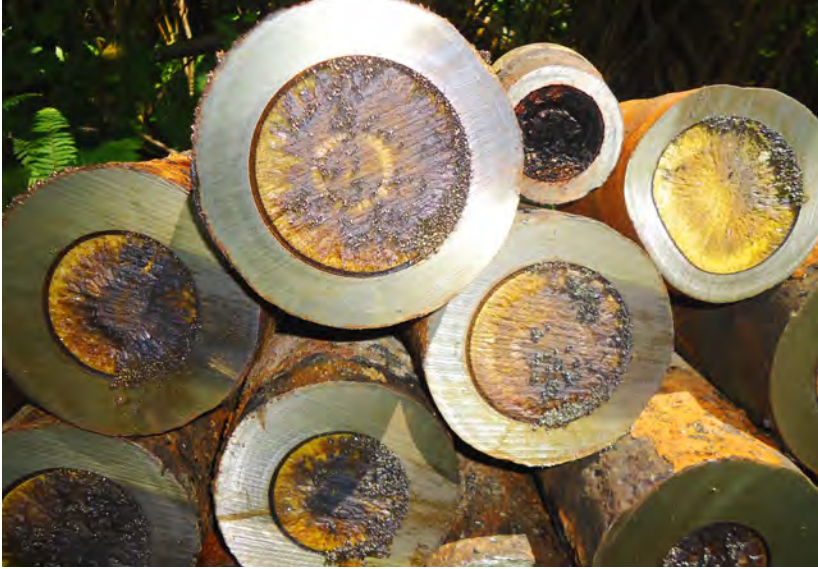
Cuts through 75mm and 15cm projectiles show that, despite the external corrosion, there is still plenty of unaffected steel. The yellow explosive filling is based on TNT, which darkens to a brown colour when it is exposed to light. Image: Len Austin.

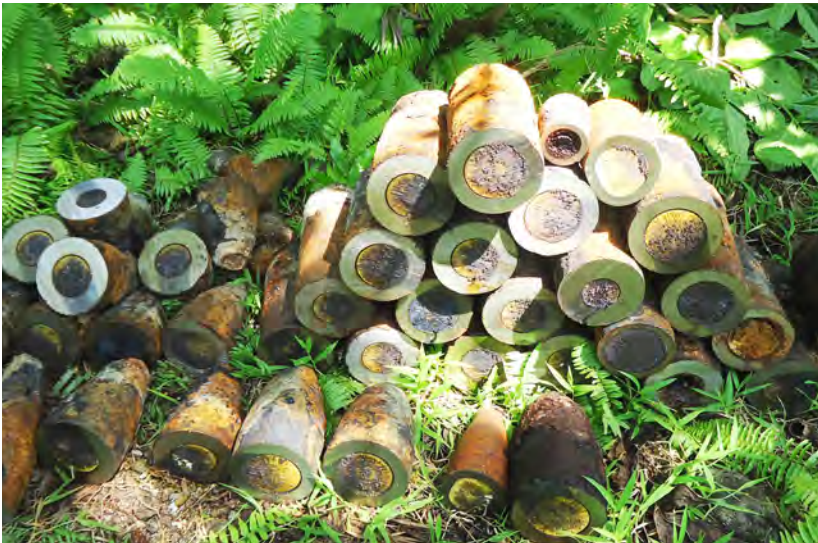
Projectiles that have been cut and inspected await final disposal. Image: Len Austin.

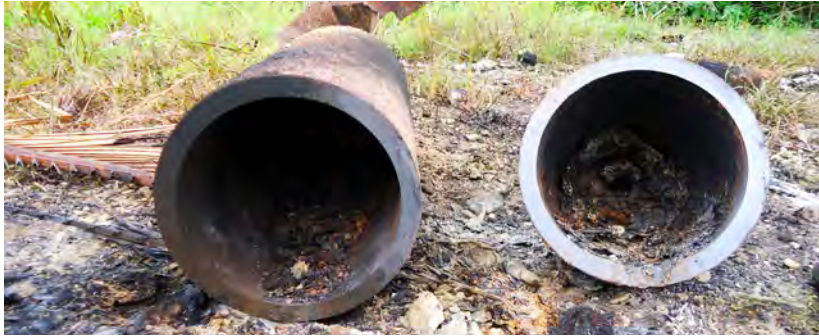
A Japanese Type3 No25 Mk8 Mod1 bomb, which has been cut in half. The explosive has then been burned out from both halves to leave the empty steel casings. Once checked to ensure that no hazardous material remains, the scrap steel from these operations can be recycled. In some regions, this process helps to pay for the clearance work. Image: Len Austin.

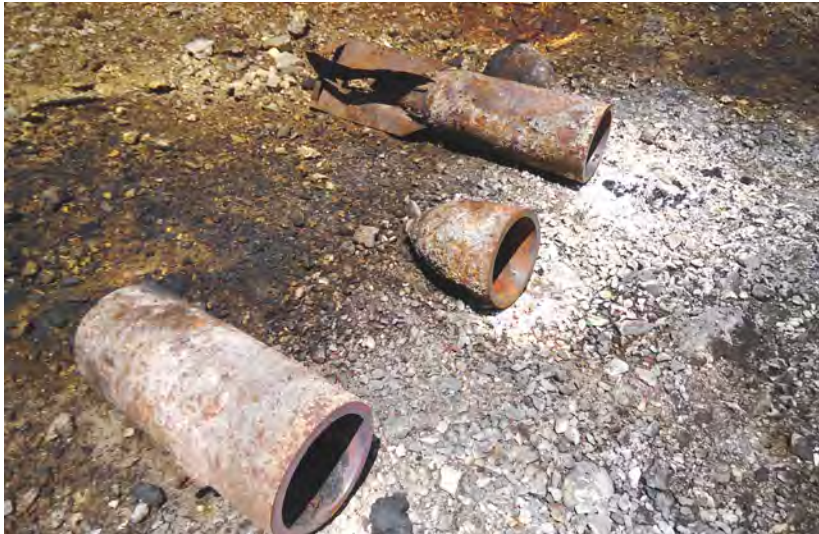
Another view of the burned-out Japanese Type3 No25 Mk8 Mod1 bomb. In the centre is the nose cone, which contains the fuze. This has been cut off separately to ensure that explosion of the fuze cannot detonate the main charge in the larger sections.

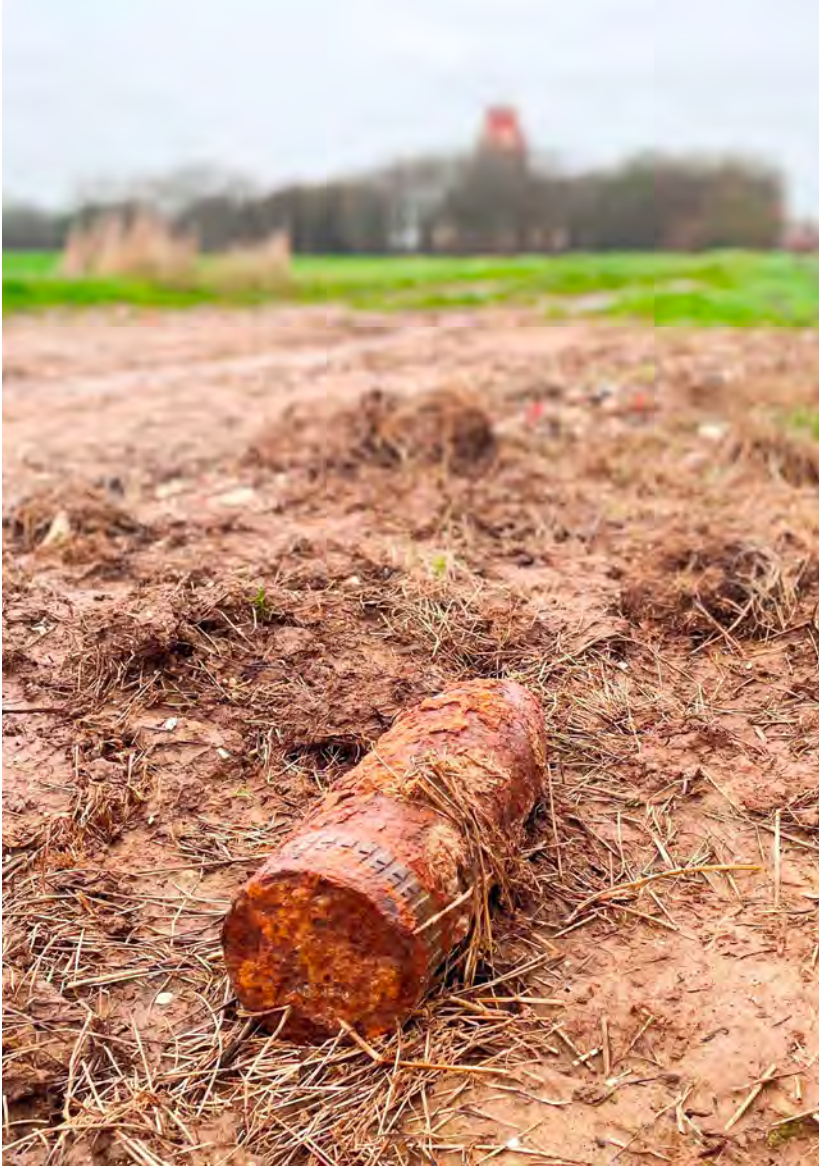
A British 4.5inch artillery projectile found in a field close to the Thiepval Memorial, Somme, France, January 2023. Despite being in the ground for over 100 years the projectile is in remarkable condition. Note the relative ageing of the driving band compared to the casing. Image: Quentin Naylor.

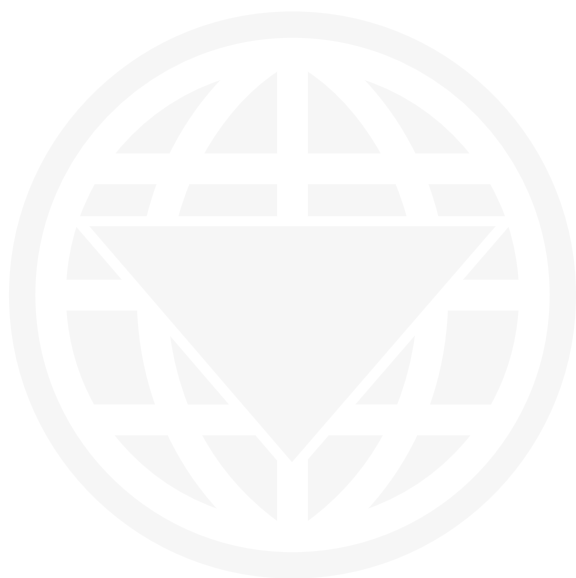
Geneva International Centre for Humanitarian Demining (GICHD)
