## RESEARCH ON SOIL DEGRADATION RESULTING FROM SHEET AND GULLY EROSION PROCESSES. CASE STUDY – THE RAUL ALB HYDROGRAPHIC BASIN, DAMBOVITA COUNTY, UP TO THE POINT IT MEETS BARBULETU STREAM

The research works focused on the upper hydrographic basin of the Raul Alb creek up to the point it meets Barbuletu stream, covering an area of 4 034 ha and aimed at establishing the degree of soil degradation as a result of the complex action of sheet and gully erosion. Following the pedological study, seven soil types have been identified, each with several subtypes, which fall into five large soil classes. Regosols account for 51.00% of the catchment area, followed by eutric cambisols, 18.70%, rendzic leptosols 11.55% and phaeozems 11.00%. The fluvisol, anthrosol and luvisol total 7.75% of the entire basin. The class of Entisols is present in 56.10% of the area, followed by Mollisols 22.55% and Inceptisols 18.70% of the analysed area. The Entisol class (eroded phases) is to be found in 2.26% of the area, whereas the Alfisols account only for 0.39% of the hydrographic basin. In terms of sheet erosion, slightly eroded lands represent 48.26% of the total of 4 034 ha investigated, followed by the

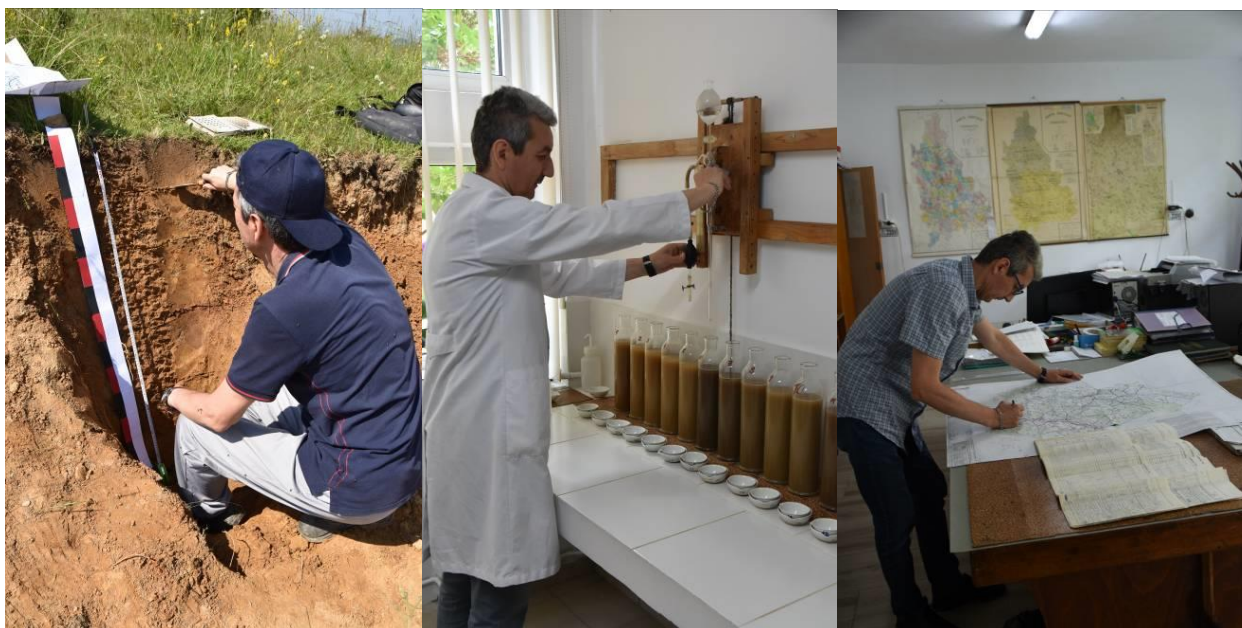
Figure 3 The execution phases of the pedologic study: field phase, laboratory phase and office phase (original photos)

The pedological study conducted in the upper part of the Raul Alb watershed in 2019-2021 required prior stages of documentation and creation of the topographic base, followed by three technical phases of execution: the field phase, the laboratory phase, in 2019-2020, and the office phase in 2020-2022 (*figure 3*).

The field phase consisted in the execution of 46 soil profiles in representative areas, in which 224 pedological samples were collected from diagnostic horizons; these samples were analysed in the laboratory of the Office of Pedology and Agrochemical Studies (OSPA) Dambovita, according to the *Methodology for the Development of Pedological Studies, Parts I, II, III, 1987*.
