EXPLOSION FREE IN FIRE SELF-VENTING (TPRD-LESS) COMPOSITE TANKS: PERFORMANCE UNDER FIRE INTERVENTION CONDITIONS

Molkov V, Kashkarov S, Makarov D

Ulster University, Hydrogen Safety Engineering and Research Centre (HySAFER), Shore Road,
Newtownabbey, BT37 0QB, Northern Ireland, UK

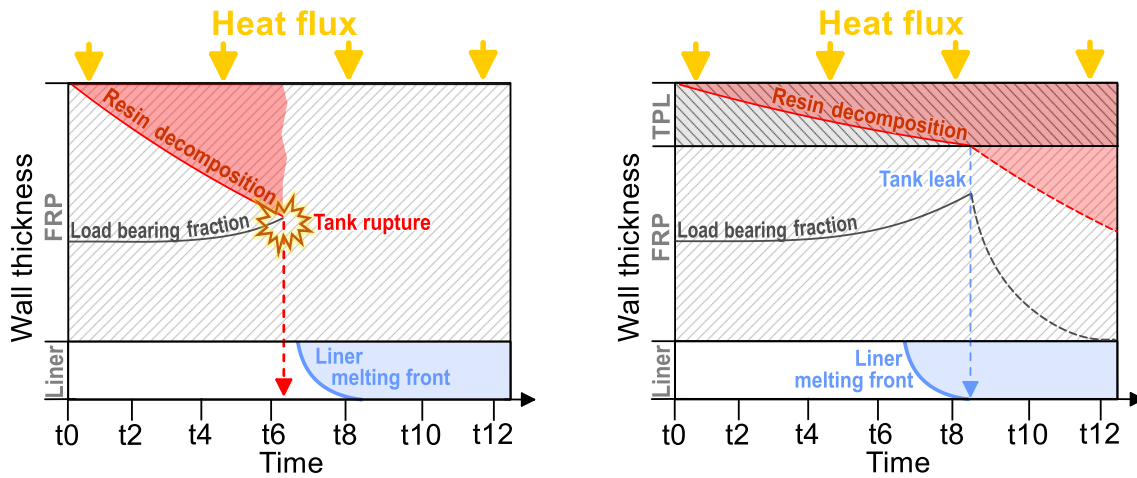
Figure 3. Schematic explanation of μ LNB safety technology [2] for Type IV tanks: original (left) and μ LNB (right) tank performance in a fire

Figure 3 schematically explains the performance of a standard (left) and a μLNB tank (right) in a fire. The standard tank has a liner and a fibre-reinforced polymer (FRP). The μLNB tank has an additional thermal protection layer (TPL) that can be load-bearing as well. Heat flux from a fire is applied to the external tank surface. The common features for both types of tanks include heat propagation into the wall and degradation of the composite resin (“Resin decomposition” line) and the moving outwards load-bearing wall thickness fraction (“Load bearing fraction” line). In the case of the standard tank, when two fronts, i.e., resin decomposition front and load-bearing wall thickness fraction location, meet each other the tank is not anymore able to bear the load of increasing hydrogen pressure and, thus, ruptures. This happens for the standard tank if the hydrogen-tight liner in the tank is intact, i.e., did not melt. The μLNB tank has two composites of different thermal conductivity, the heat of decomposition, etc. The self-venting performance of the tank is provided by a proper design using the intellectual property (IP) of Ulster University [1,2] and HySAFER in-house proprietary models and tools accounting for thermophysical and geometrical parameters of the liner, two composite layers, safety factor, etc [24,25]. The design of μLNB tank provides melting of the liner before the tank loses its load-bearing ability. The melting of the liner initiates microleaks of hydrogen through the structure of FRP and TPL layers. Despite further propagation of the decomposition front into the tank wall (see Figure 3, right),

the load bearing wall thickness fraction reduces drastically due to the tank depressurisation. This eliminates conditions for tank rupture in a fire.

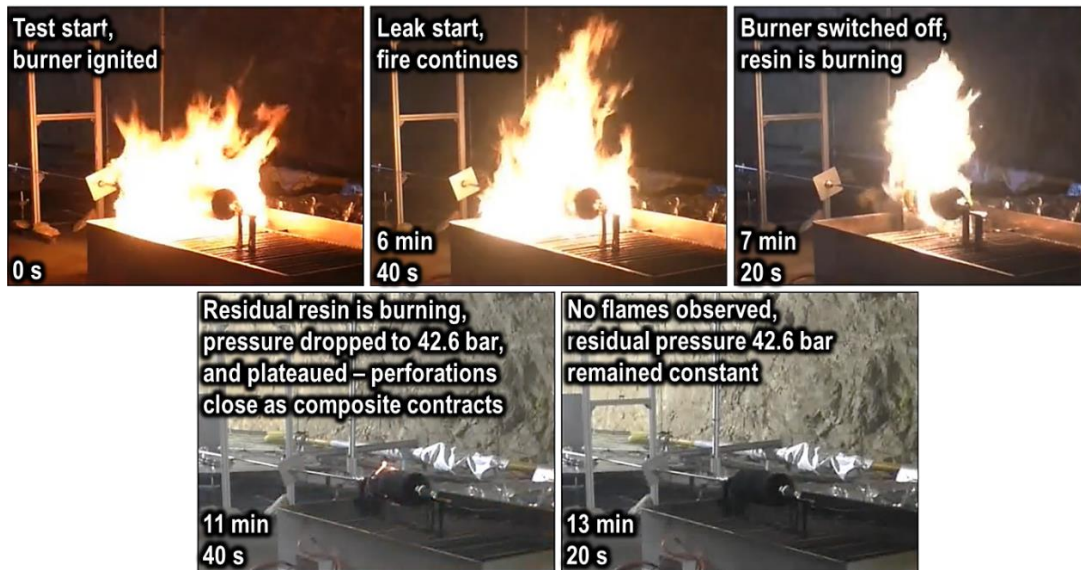
Figure 1. Snapshots of the μ LNB tank fire test with COPV#CB-1

Figure 5 shows a series of snapshots of fire test with COPV#CB-1. The test starts when the burner is ignited (snapshot "0 s"). Microleaks are started after the liner melts at 6 min 40 s (snapshot "6 min 40 s"). The flame size around the tank is practically the same with an insignificant increase at the moment of leak start. Snapshot "7 min 20 s" shows combustion around the tank when the burner flame is switched off. What is seen in this snapshot is the combustion of composite resin assisted by hydrogen released through the microchannels in the wall. Few residual flames are seen in snapshot "11 min 40 s" which corresponds to the time when the pressure decrease stops due to the contraction of the composite wall at significantly decreased pressure and formation of the pressure plateau at a level of 4.3 MPa. No

flame was observed in the snapshot “13 min 20 s”.

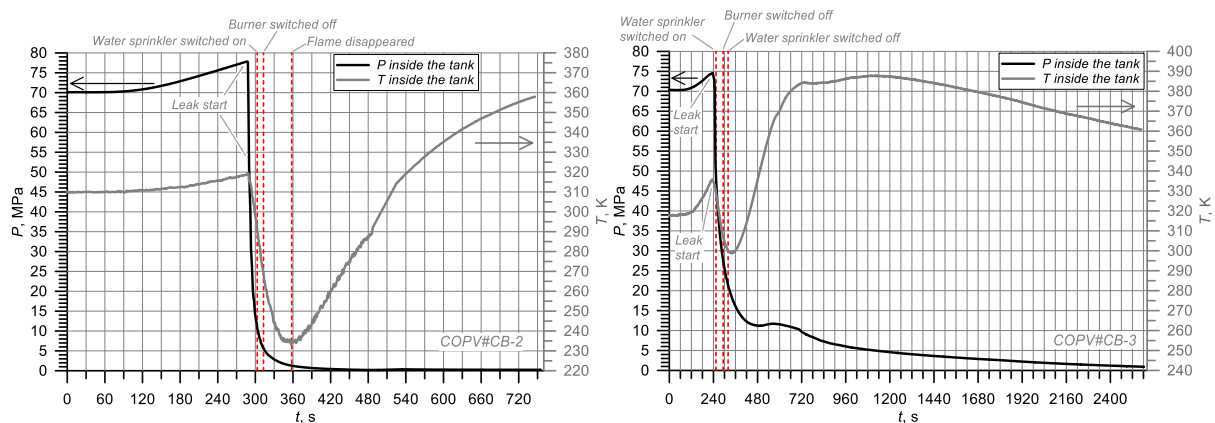
Figure 2. Pressure and temperature transients measured inside μ LNB tank prototypes during the fire tests: COPV#CB-2 with liner L2 (left), COPV#CB-3 with liner L1 (right)

Figure 6 shows the comparison of pressure and temperature dynamics for tank COPV#CB-2 (left) and tank COPV#CB-3 (right). The only difference in tanks' design is the grade of liner. The order of actions in the tests was as follows. The burner was ignited when the pressure in tanks was practically equal to NWP=70 MPa. Tank COPV#CB-2 started to leak after melting of liner L2 after 4 min 45 s when pressure increased to 78 MPa, while liner L1 melted somewhat faster at 3 min 50 s when pressure raised to only 74.5 MPa. The rate of pressure growth was the same in both tanks but in test COPV#CB-3 liner L1 melted earlier. The drop of pressure in the test with tank COPV#CB-2 is responsible for the decrease of hydrogen temperature from 45°C down to -38°C (decrease by 83 degree), while the smaller rate of pressure decrease in tank COPV#CB-3 resulted in temperature decrease from 58°C (indicating that liner L1 could have higher thermal conductivity) to the minimum of 25°C (decrease by 33 degrees only).

In about 10 s after the start of microleaks, the sprinkler was switched on and water sprays were applied to the top to the burning tank surface. Then in 10-20 s the burner was switched off. Then the tests proceeded differently. While in the test with tank COPV#CB-2 the water supply continued to the end of

test, in test with tank COPV#CB-3 water was switched off in 20 s after the burner was switched off. This is thought to be a reason of larger temperature drop in test with COPV#CB-2.
