Romankiewicz, T 2023, 'The building blocks of circular economies: Rethinking prehistoric turf architecture through archaeological and architectural analysis', *Open Archaeology*, vol. 9, no. 1, pp. 1-24.
<https://doi.org/10.1515/opar-2022-0331>

The Building Blocks of Circular Economies: Rethinking Prehistoric Turf Architecture Through Archaeological and Architectural Analysis

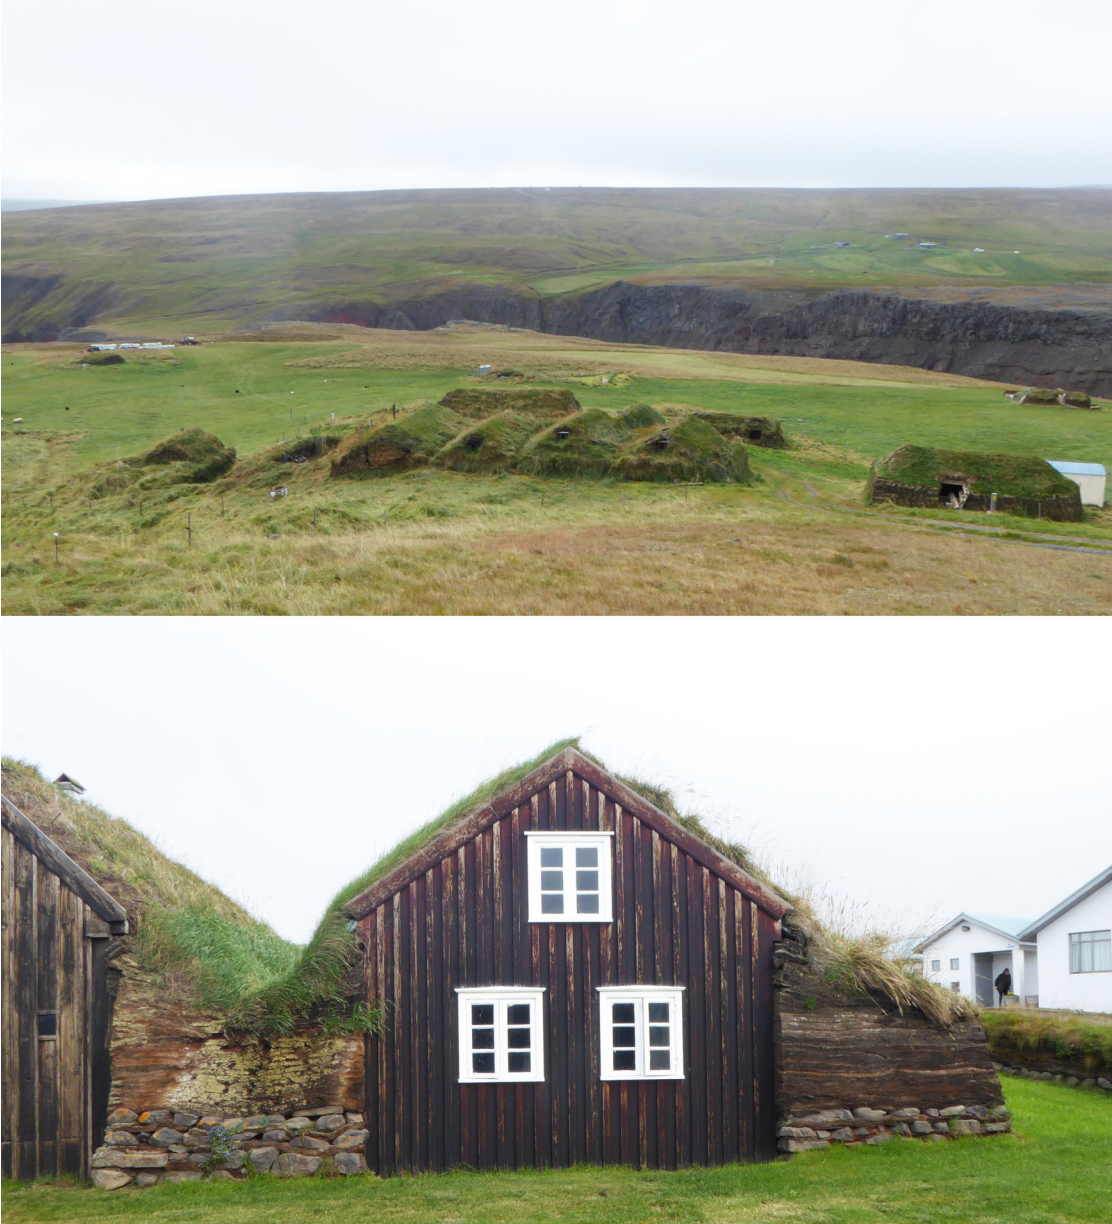
Figure 1: Turf houses surviving in the landscape, September 2022, Skagafjörður municipality, northwest Iceland. Top: Tyrfingsstaðir; bottom: Storu-Akrar. Photographs: Tanja Romankiewicz.

One exception to this, and the often-cited example for well-preserved upstanding turf houses, is the Icelandic tradition. The last surviving upstanding structures generally date to the eighteenth and nineteenth century, such as at Hólar and Glaumbær in the northwest. Only a few original houses are still upstanding without significant rebuilding (Figure 1). While most of these houses are preserved as living museums, only parts of their walls still contain the 200–300 years old original turf blocks. Many wall elements have seen repeated repair, especially in those parts which are most exposed to rainwater draining off the roofs or which are threatened by wind-drying and erosion. Freshly cut turf “bricks” were used to replace the original bricks or blocks (Figure 2; Stefánsson, 2019b, pp. 14–15). The flexibility and malleability of turf walls, and of the individual turf blocks, allowed such ad hoc, *in situ* repairs without compromising the building’s overall structural integrity. Older turf buildings, like Viking longhouses or the medieval and post-medieval turf houses from Scotland survive only as low banks, in areas where they have escaped the plough (e.g. James, 2009; Strachan, Sneddon, & Tipping, 2019). The upstanding structures that we associate with them today are full-scale reconstructions (e.g. Scotland: Newtonmore Highland Folk Museum, Noble, 1983; Iceland: Þjóðveldisbærinn Viking Farm Stöng or Bergþórshvoll reconstruction at Eiríksstaðir).

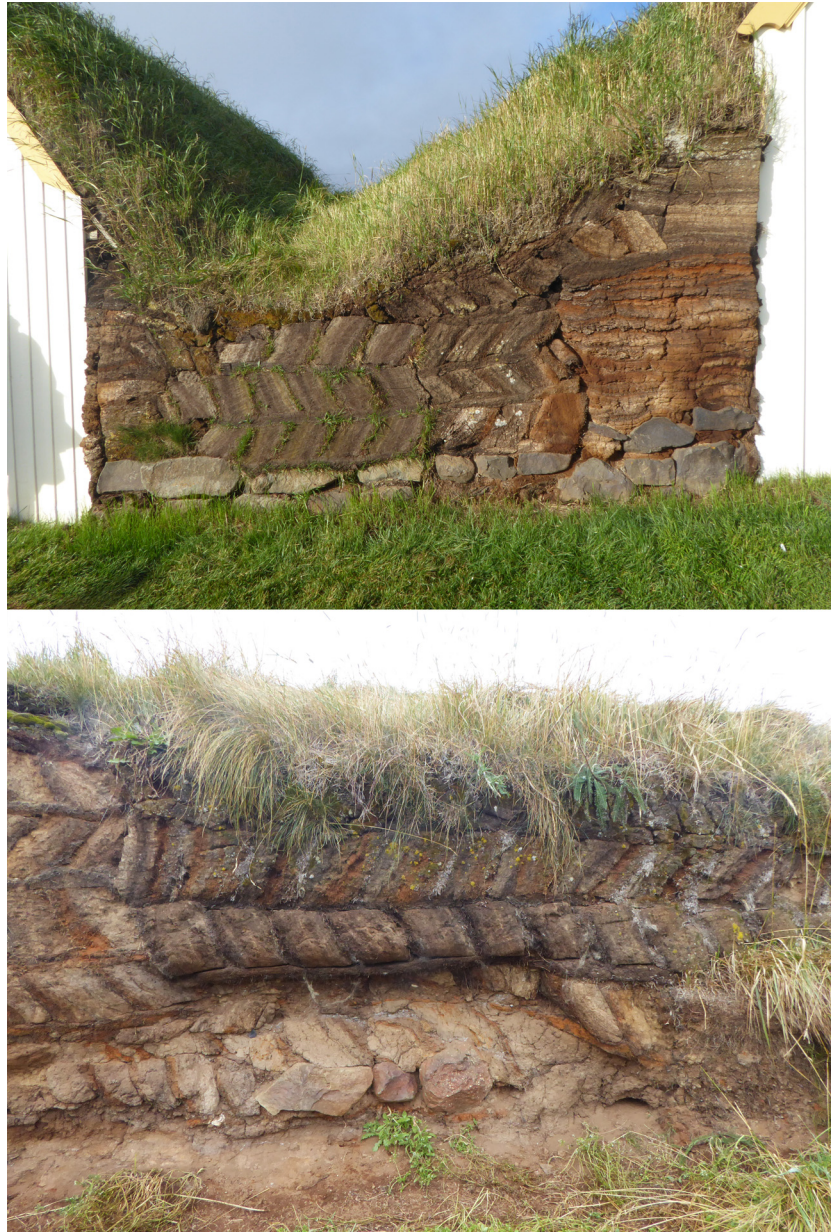
Figure 2: Replacement of individual turf blocks as ad hoc, *in situ* replacements, Skagafjörður area, Iceland. Top: main farm buildings at Glaumbær Museum; bottom: multi-phased wall repairs of an outbuilding at Tyrfyngsstaðir. Photographs: Tanja Romankiewicz.

Identifying the dynamics in turf house architecture starts with the repeated, ad hoc, *in situ* repairs introduced above for the Icelandic building tradition. The replacement of individual turf blocks means houses can rarely be pinpointed to a specific construction date as individual parts have been rebuilt over time.

Within this process over time, a turf house therefore turns into a palimpsest of materials from different events of building and rebuilding (Figure 2; compare Lucas, 2021, pp. 91–93). In the same way as earlier material contained within a freshly cut turf block complicates absolute dating methods, the replacement of individual blocks with younger ones or the reuse of older blocks complicates the relative phasing of when a building's shape and layout was first constructed (compare Evans, 2013 on complicated “narratives” beyond individual buildings). The genotype of a turf house as it was first conceived may be of very different date to how its phenotype presents in the present (compare Romankiewicz, 2011, pp. 24–25 for similar discussion of drystone architecture). Since building methods did not see substantial changes over time, traditional methods from buildings archaeology also have only limited success in disentangling individual phases (Stefánsson, 2019b, p. 14).

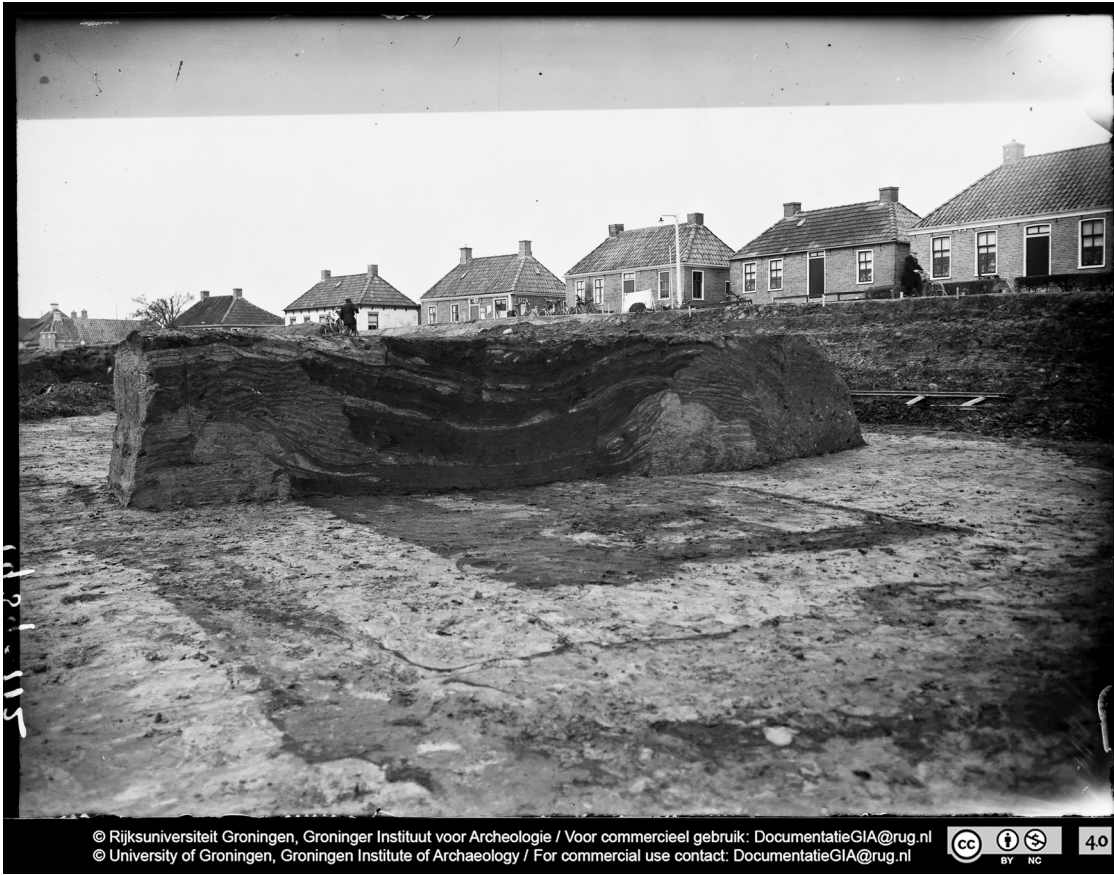
Figure 3: Section through the terp at Tuinsterwierde, near Leens, northern Netherlands, excavated by Albert Egges van Giffen 1939. © Rijksuniversiteit Groningen, Groninger Instituut voor Archeologie/© University of Groningen, Groningen Institute of Archaeology. CC-BY-NC 4.0.

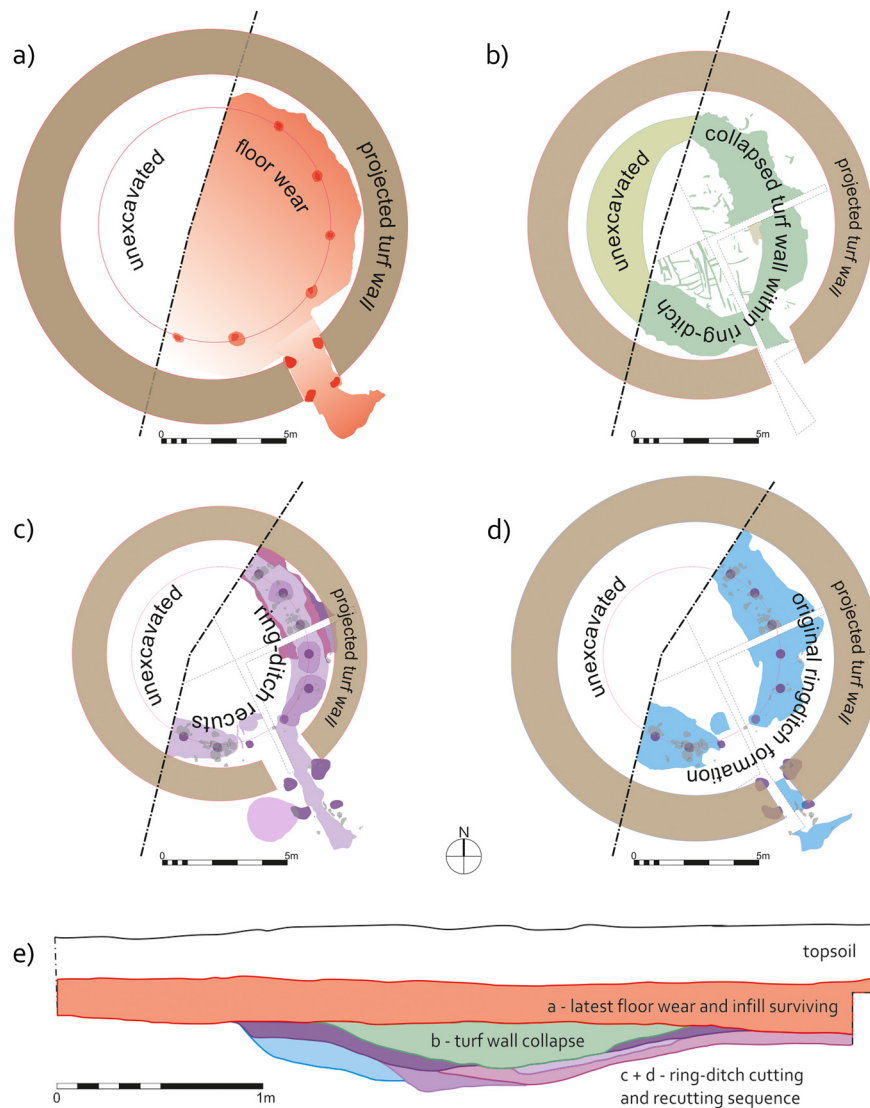
Figure 6: (a–e) Ground plan series of Structure 3, Deer's Den, Aberdeenshire, Northeast Scotland, starting with the final phase surviving (a, in red), collapsed turf wall surviving in ring-ditch hollow underneath (b, in green), preceded by a series of ring-ditch uses (c and d, purple and blue as the earliest). (e) Section showing ring-ditch cutting sequence and infills (Drawings: Tanja Romankiewicz after Alexander, 2002, Illus 8 and Illus 9, as well as a series of field drawings).

The final use of Structure 3 as preserved shows a shallow depression over its entire footprint, ca. 12 m in diameter, offering about 450 m² of floor area (Figure 6a, in red). The evidence suggests a light wear within a large house with no substantial clearing out activities, perhaps only light brushing consistent with human dwelling rather than for stalling animals. This last surviving footprint on this stance is minimally offset from an earlier structure and was built with a larger postring (c. 9.25 m diameter, compared to c. 7.25 m). Enough of the earlier structure must have remained in the landscape for the later house to return and reoccupy this spot. The new house was built over the homogenous silty infill of the earlier ring-ditch, which represents the earlier, collapsed turf wall as discussed above.

The earlier roundhouse consisted of several phases of use, indicated by the depths of the ring-ditch and the multitude of clearing-out events already discussed (Figure 6b–e). A series of intercutting pits and elongated

In fact, the final footprint of the ring-ditch area at Structure 3 Deer's Den (Figure 6b, in green) suggests that this hollow had encroached not only into the turf wall, but also into the central area, typically interpreted as the living space of a byre-house. In the ring-ditch phase marked here in green, this internal "dwelling" space became reduced to an oval of about 4.2–6.5 m across, totalling an area under 30 m². This is only about a tenth of what was available to the inhabitants of the first 8–11 m roundhouse footprints prior to the developing ring-ditch (Figure 6d), who would have had between 200–300 m² at their disposal, and even less compared with the 450 m² offered inside the latest house (in red, Figure 6a). In light of these dimensions, it seems unlikely that humans and animals shared the same space when the ring-ditch was at its fullest extent, especially if allowing for some truncation of upper fills. The central area most likely served only as access to distribute water and fodder and provide day-to-day animal care. The cattle farmers who kept their animals in this structure must have lived elsewhere on site. In fact, the fills of the latest ring-ditch, before the collapse of the turf wall on top of these, contain discrete lenses of hearth waste and other domestic refuse (Alexander, 2002, p. 21). After the farmers took out their animals for one last time, they may have filled the ring-ditch with the waste from the building they occupied nearby. The well-recorded tipping lines within these final deposits indicate not only dumping from within but also from the outside edge, which suggests that even parts of the wall had been removed by this stage.

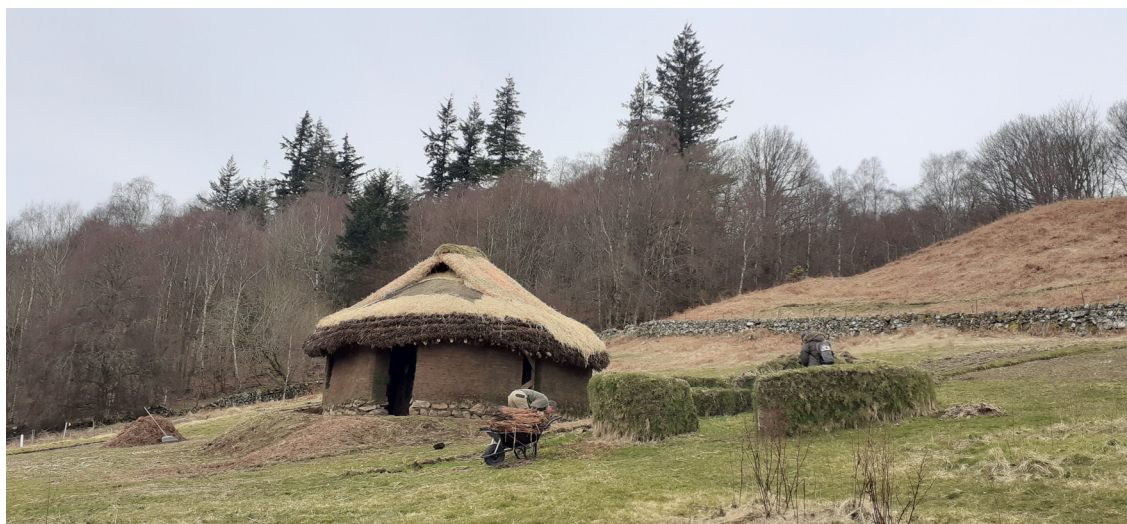
Figure 7: The modern turf structures built at Comrie Croft, Perthshire, central Scotland; left: roundhouse structure with modern windows and stove; right: turf bench. Photographs: Tanja Romankiewicz.
