Structural Engineering and Mechanics Research  
Reports

## Revised Load Rating Procedures for Deteriorated Prestressed Concrete Beams

This report summarizes a 27-month research project investigating the effects of corrosion-induced deterioration on the load-carrying capacity of prestressed concrete beams and any recommendations to the current load rating procedures described in the MassDOT LRFD Bridge Manual (1). The study consisted of reviewing existing literature, reviewing inspection procedures and reports, testing of out-of-service prestressed concrete beams with documentation of current condition, and quantitative analyses to determine the adequacy of current load rating procedures and recommended procedures.

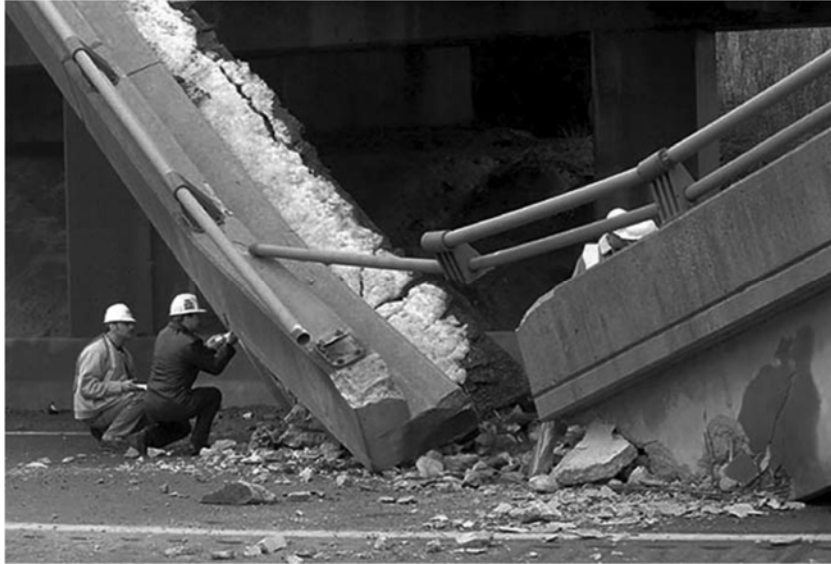
On December 27, 2005, a fascia beam on the Lake View Drive Bridge carrying State Route 1014 over I-70 in Washington, PA failed under service loads without warning of impending failure (2). The failure occurred near the midspan of the bridge (see Figure 2.1). Forensic analysis revealed that 20 of the 60 prestressed strands in the fascia beam were severed and 39 of 60 had some level of corrosion. Beams from that bridge were sent to Lehigh University to be studied to improve load rating procedures. The beam flexural capacities were tested to correlate observed damage and remaining capacity. The investigation attributed failure of the beam to several factors. Improper fabrication of the shear keys between adjacent PC box beams allowed chlorides to leak through in between the beams and penetrate the concrete. These chlorides accelerated corrosion of the strands and stirrups, compromising the flexural strength and shear strength of the beam and the ability for load to be distributed to adjacent members by corroding post-tensioning strands. The cardboard void forms, much like cardboard used in household boxes, used during fabrication of the box beams shifted during construction, allowing for the dimensions of the void and dimensions of the beam to change, and causing a reduction in the thickness of the flanges and webs. Too many vent holes allowed the chloride-laden water to penetrate the concrete more easily.

**Figure 2.1: Lake View Bridge collapse**

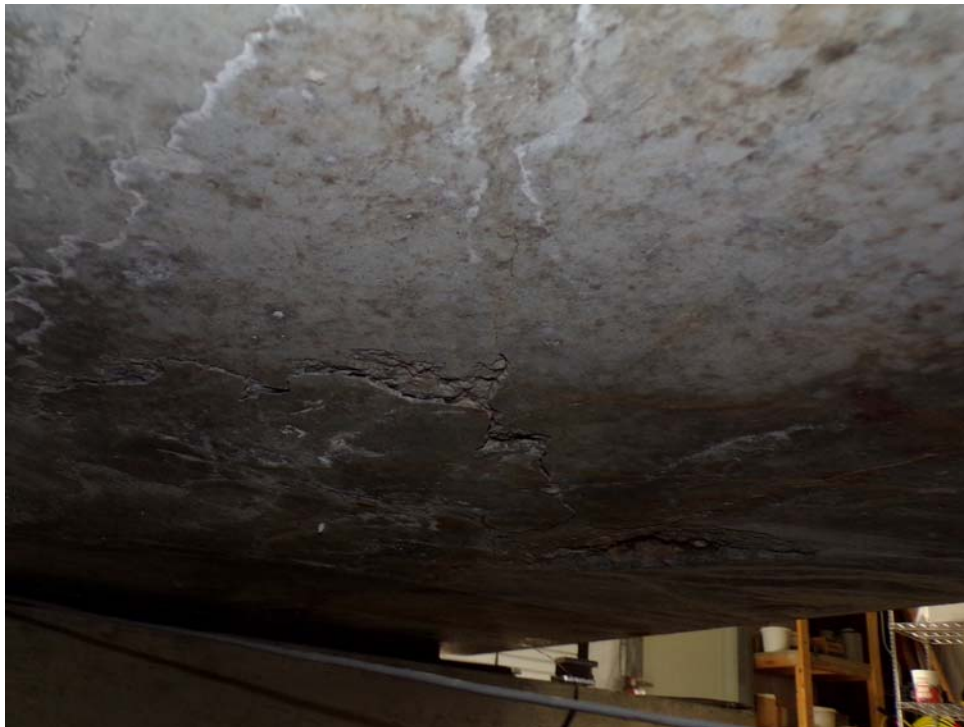
**Figure 4.15: Bottom Surface Deterioration (Specimen E4)**

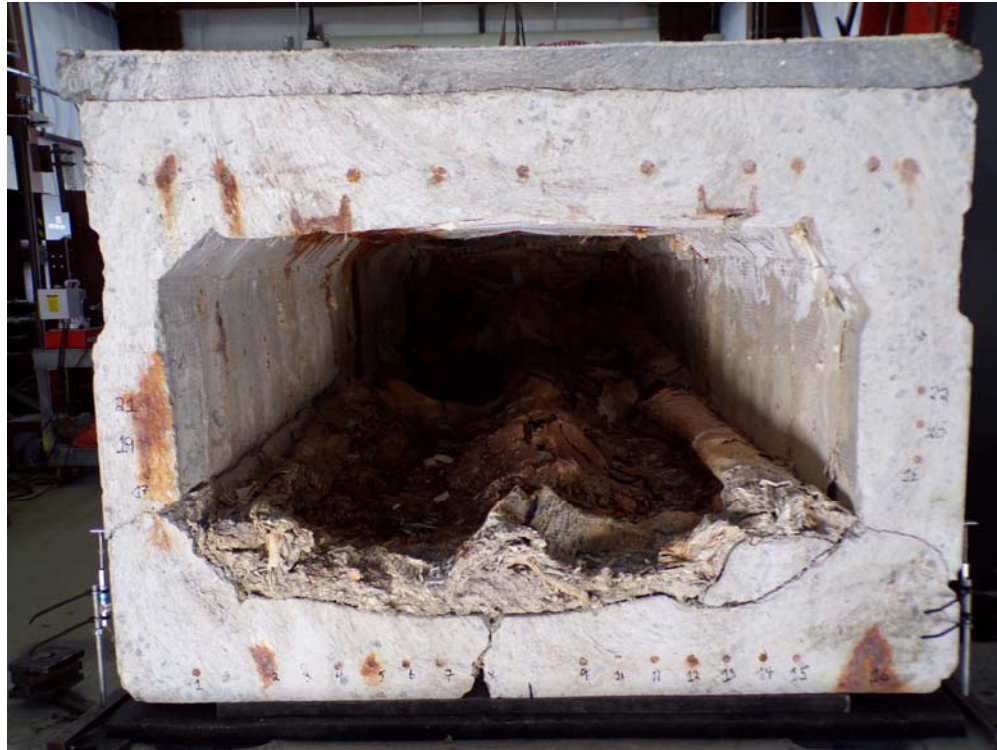
**Figure 4.16: Effect of form void shifting in web thickness (Specimen E4)**

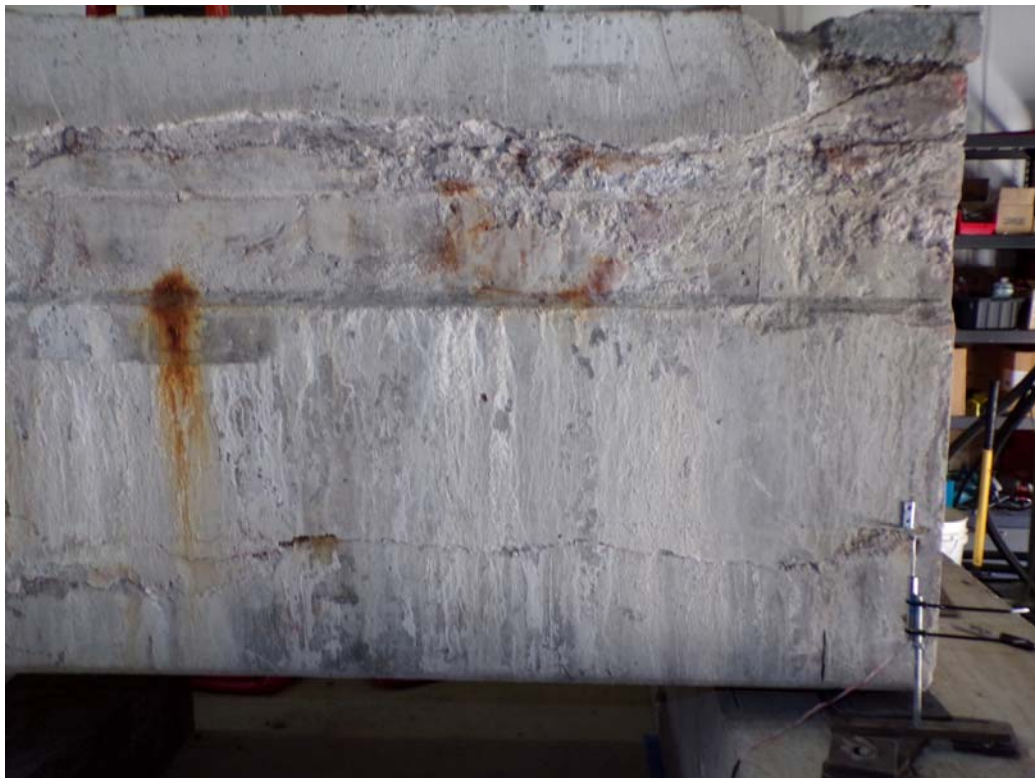
**Figure 4.17: Longitudinal cracking at south end of Specimen E4**

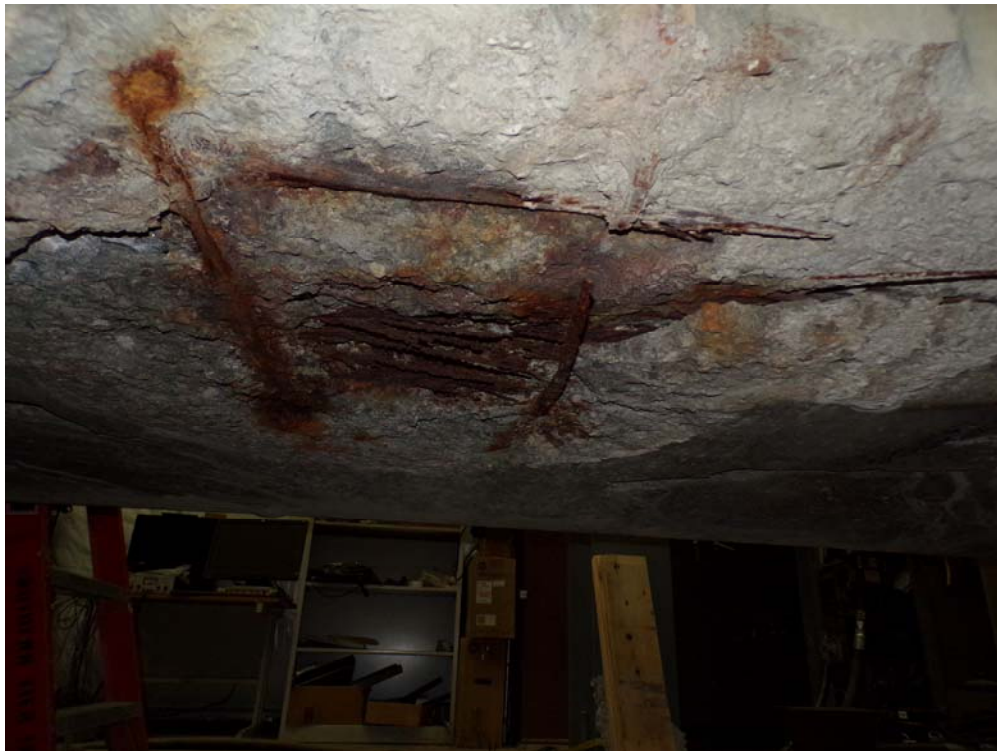
**Figure 4.19: Exposed and corroded strand in bottom of Specimen E3**

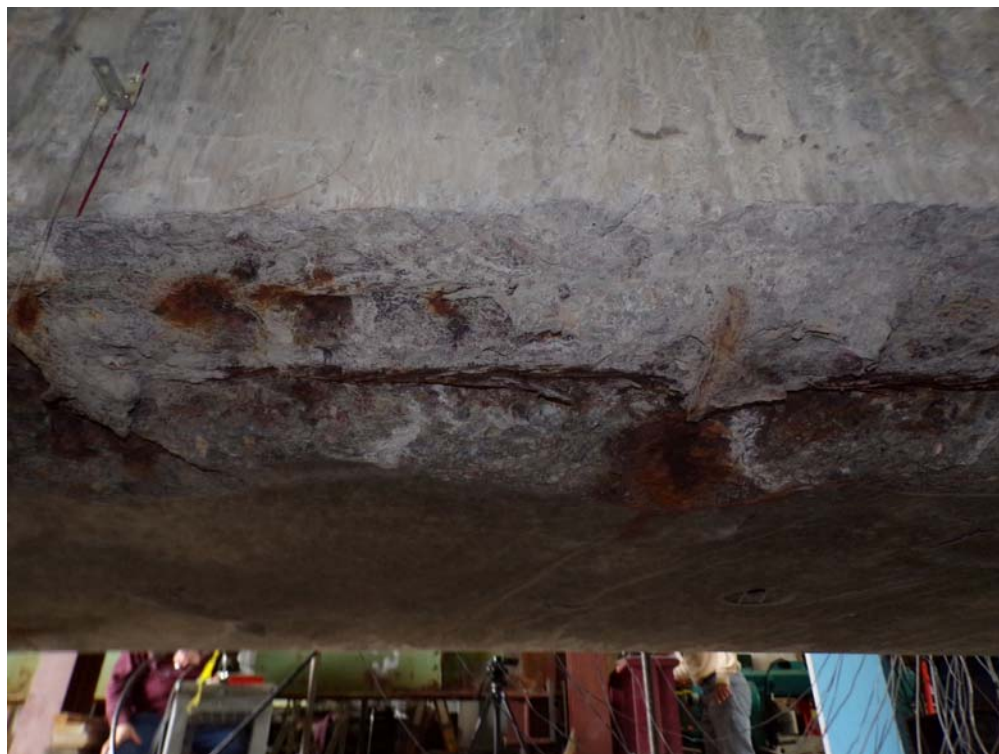
**Figure 4.23: Spalled concrete corner in Specimen E9 exposing fractured strand**

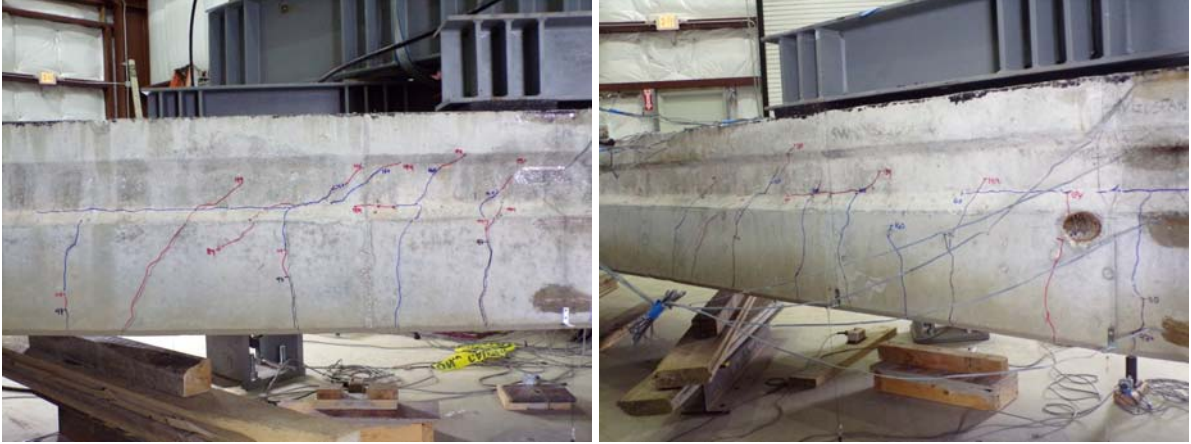
Cracks tended to follow similar patterns on the two faces of the beams. Sections under the northwest and southeast load points experienced similar crack patterns, as did the southwest and northeast load points, as shown in Figure 5.9. The northeast and southwest load points first experienced flexural cracks and, as loading increased, experienced flexure-shear cracks extending further out towards the beam ends. The northeast and southwest corners primarily experienced flexural cracks.

**Figure 5.9: Cracking of Specimen R2 (northeast and southwest load points, 184 kip)**

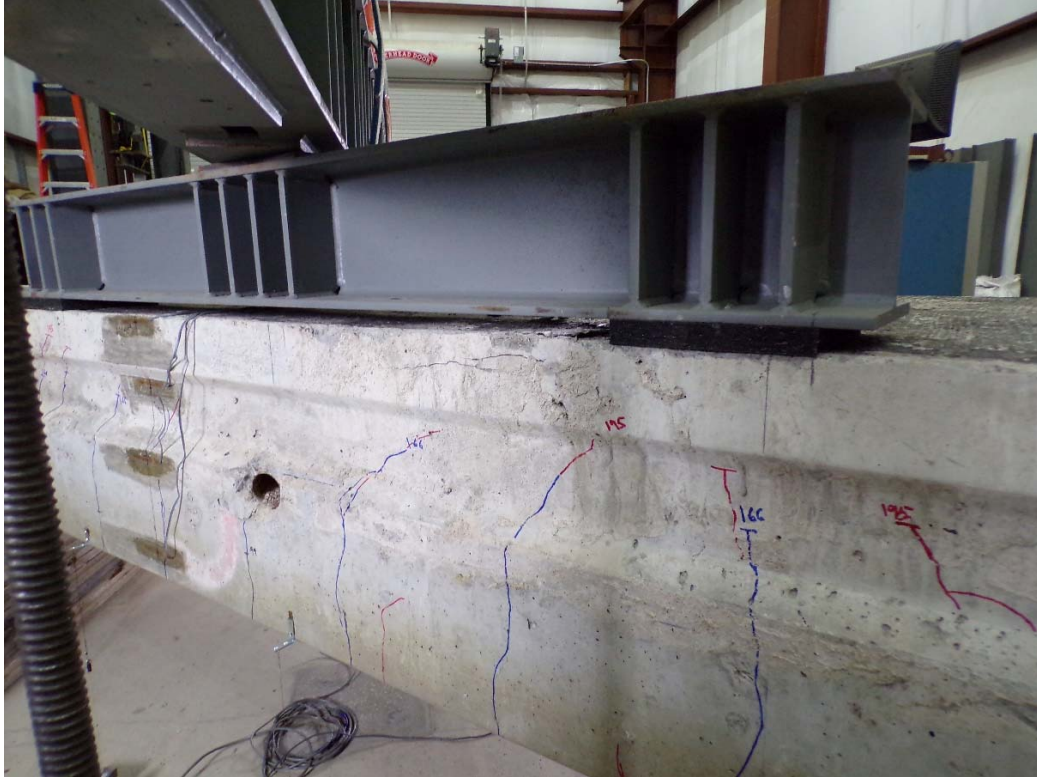
**Figure 5.12: Cracking of Specimen R3 at concrete crushing (northwest load point)**

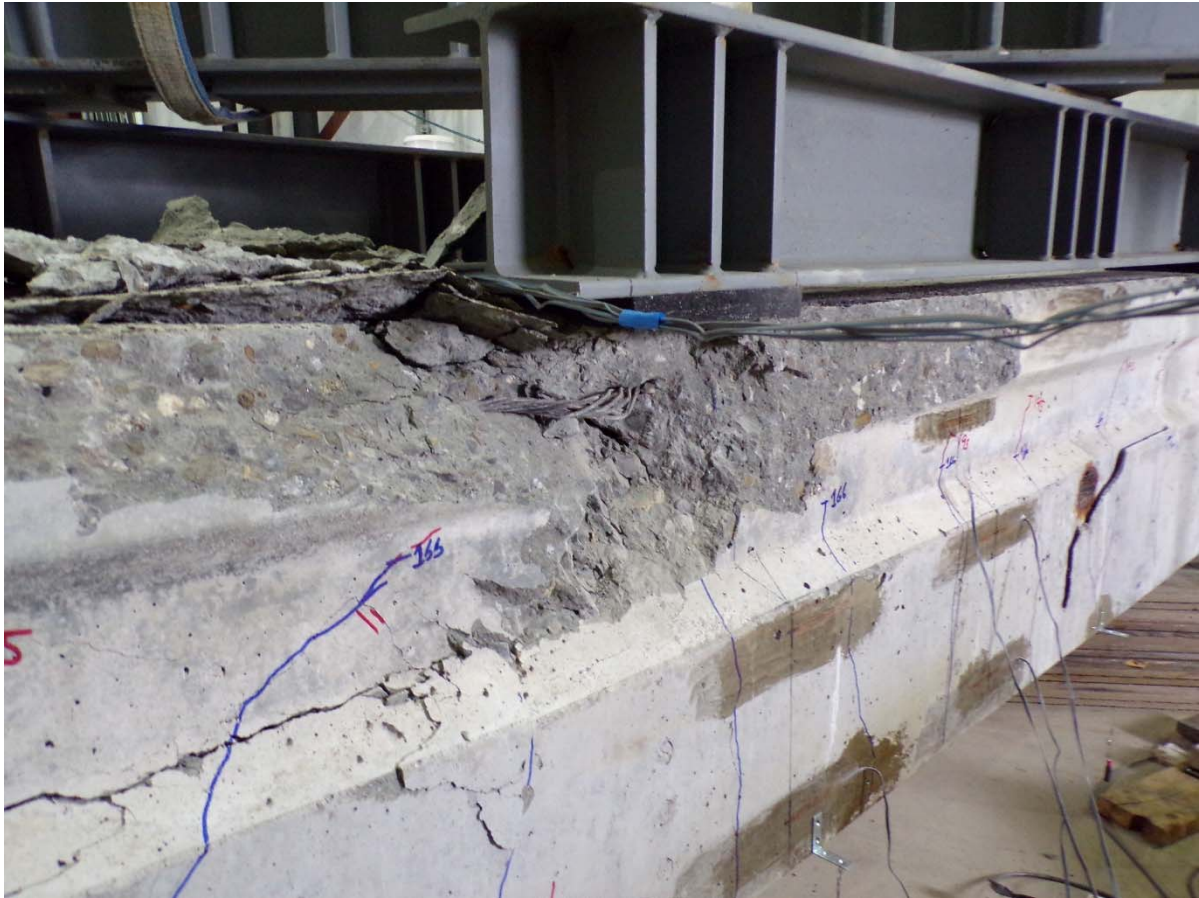
**Figure 5.13: Concrete crushing at failure of Specimen R3**

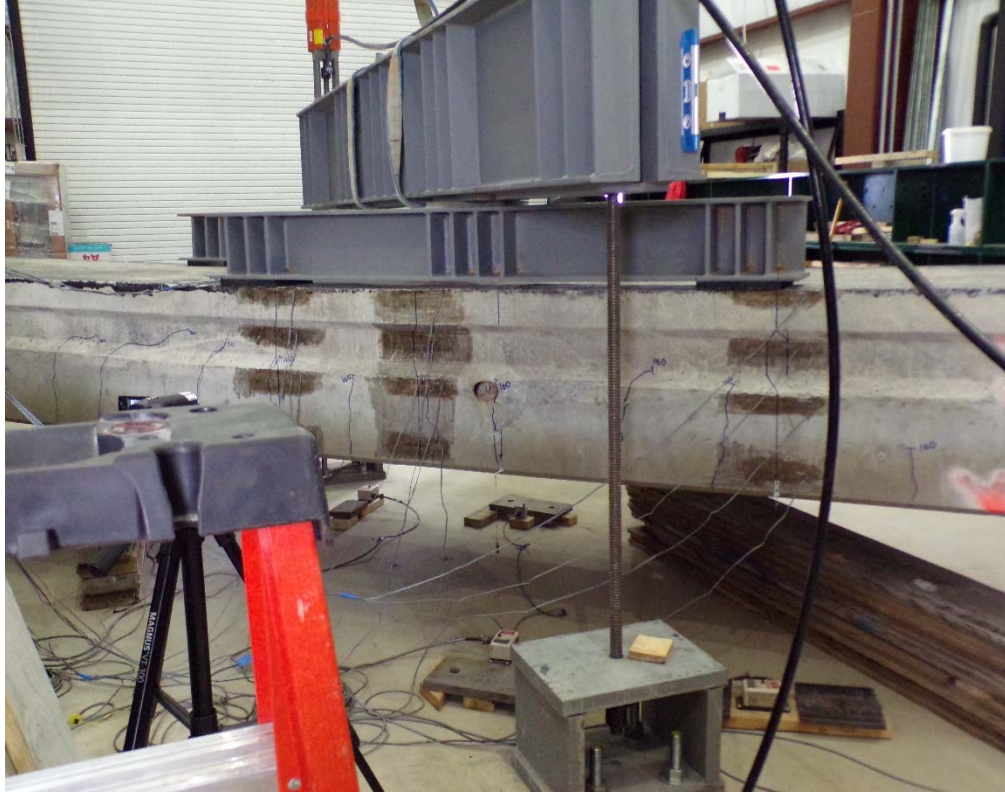
**Figure 5.16: Cracking in Specimen R4 at 160 kip**

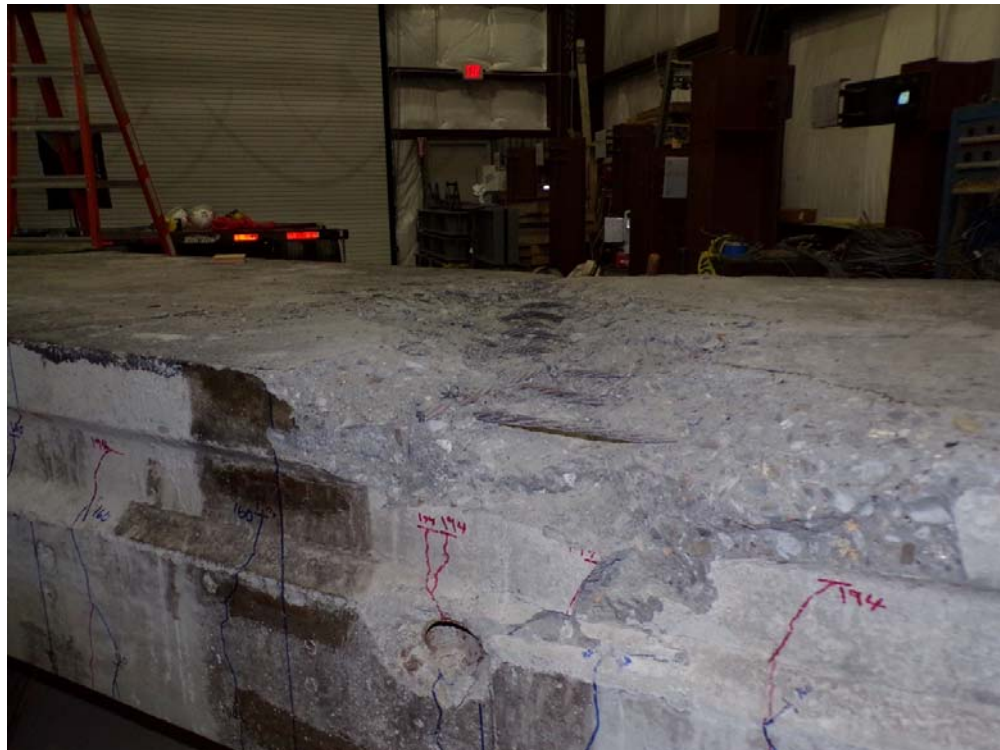
**Figure 5.17: Concrete crushing after failure of Specimen R4**

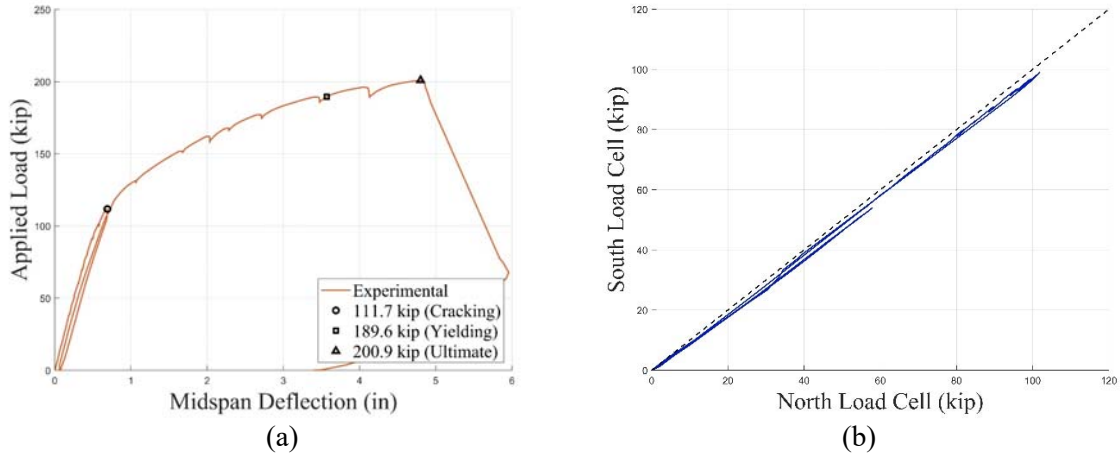
Figure 5.18 shows the load-displacement curve of Specimen R4 and a comparison of the load cell readings. The load cell reading comparison indicated less deviation than that recorded for Specimen R3. The north load cell registered slightly higher loads in comparison with the south load cell; the maximum difference was approximately 10%.

**Figure 5.18: Specimen R4: (a) Load-deflection response; (b) comparison of north and south load cells**

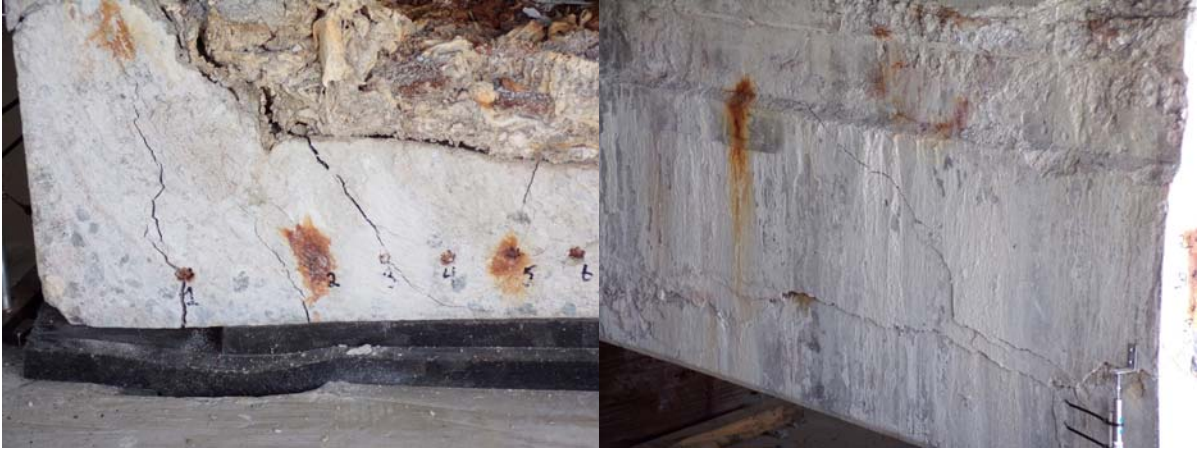
**Figure 5.21: Cracking of Specimen E4 at south end triggering strand slip**

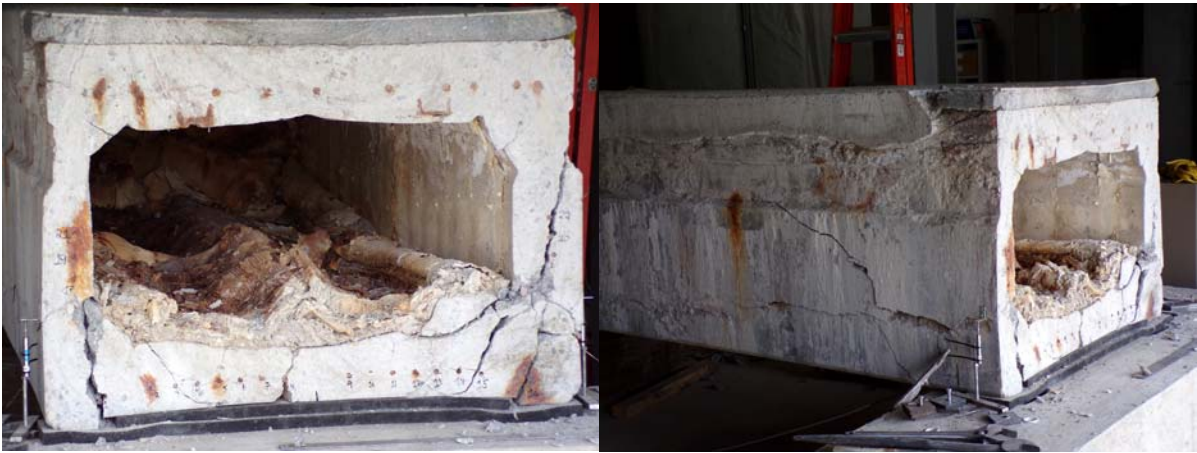
**Figure 5.22: South end failure of Specimen E4**

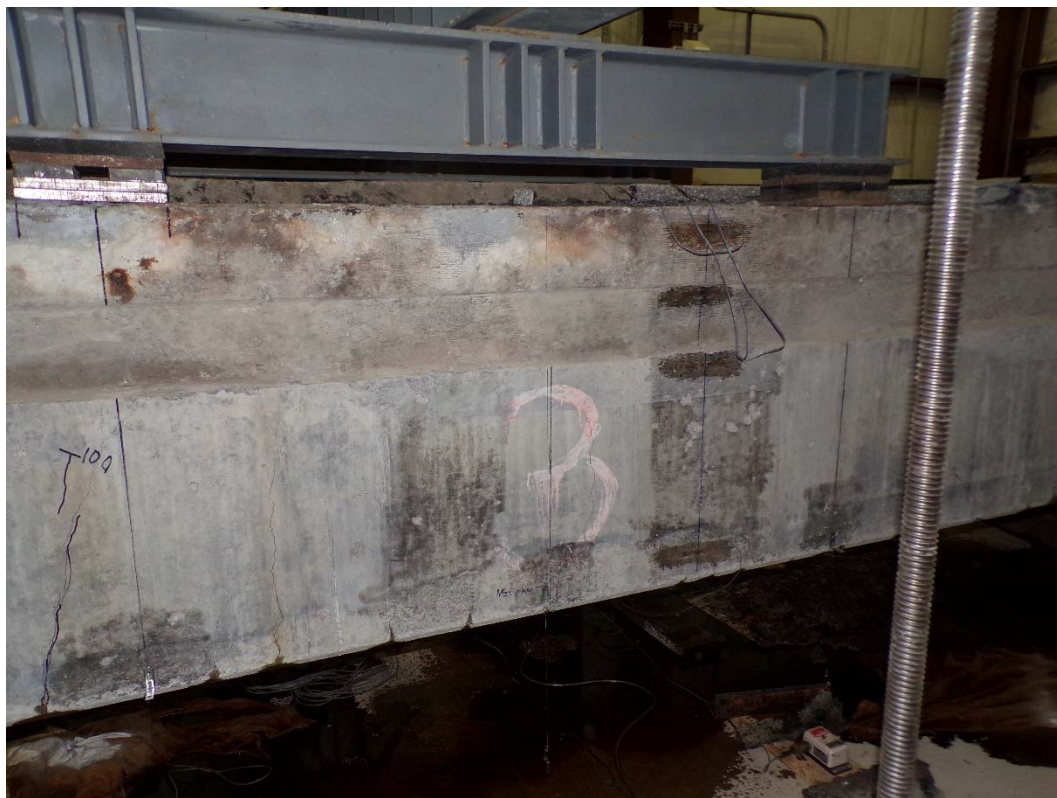
**Figure 5.25: Flexural cracking of Specimen E3 and water leakage**

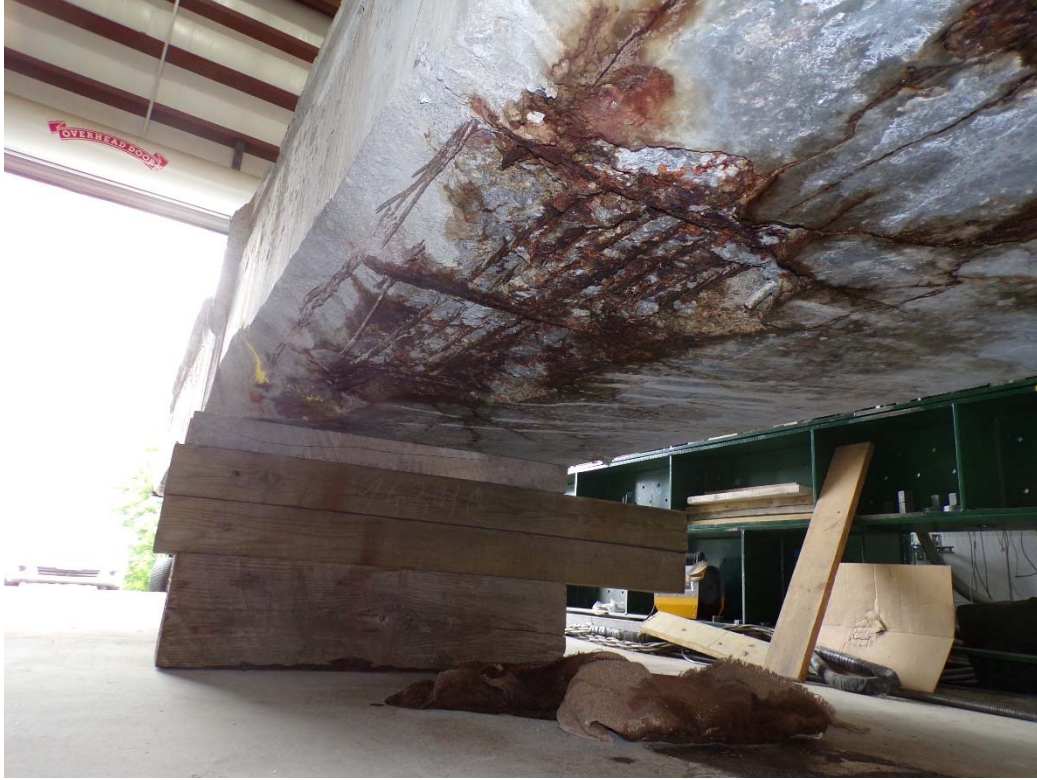
After the test, the bottom surface of the beam was examined to determine the number of strands that had become visible due to the loss of cover, as seen in Figure 5.26. Nine strands were exposed after concrete spalling; multiple sections exhibited strand exposure.

**Figure 5.26: Severely corroded strand exposed in Specimen E3 after concrete spalling**

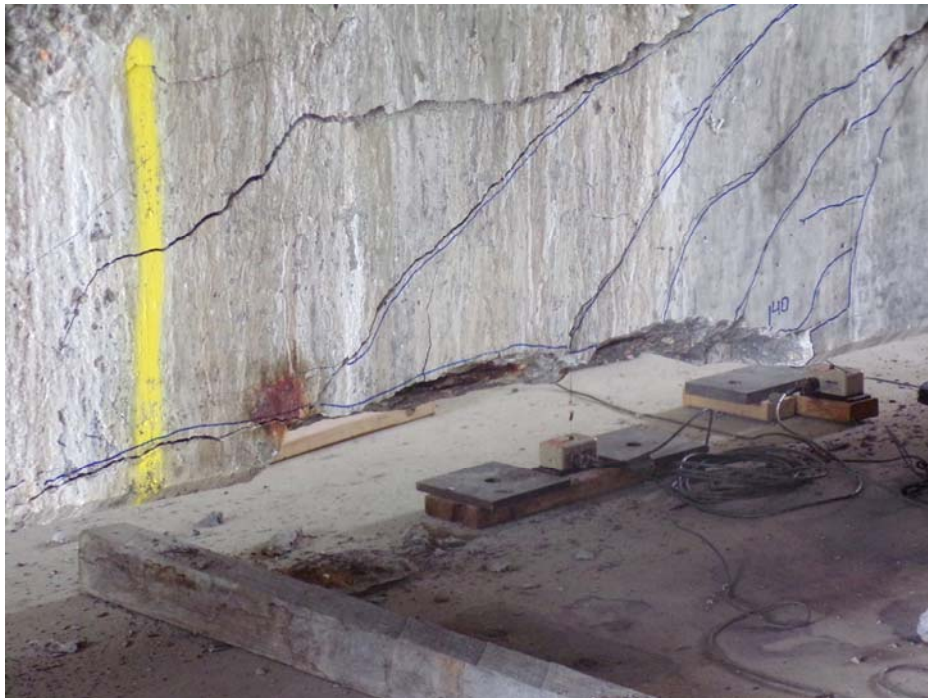
**Figure 5.29: Flexure-shear cracking of Specimen E9 near peak load**

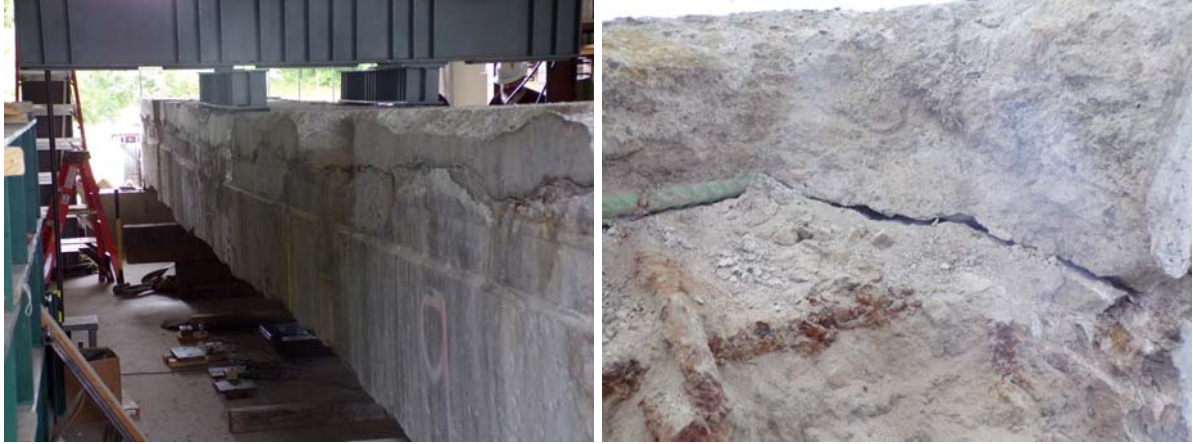
**Figure 5.30: Debonding of concrete overlay in Specimen E9 (north shear span)**

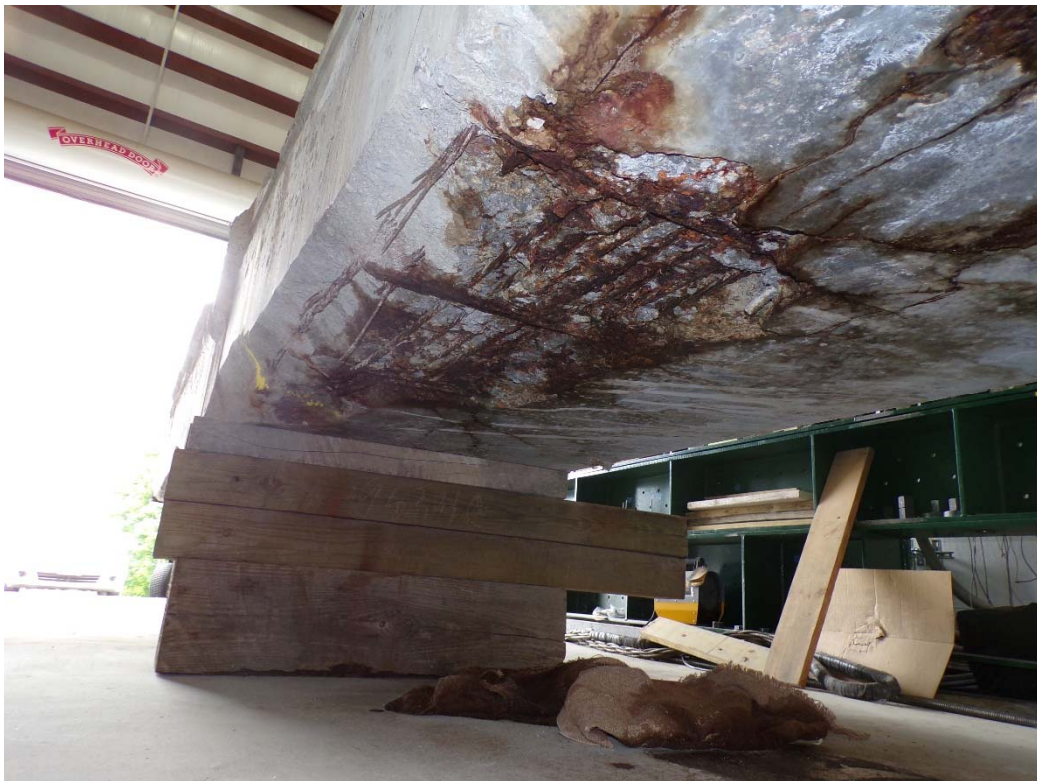
After the test, the beam was examined to determine whether strands had ruptured to estimate their contribution to moment capacity of the beam. During the test, some of the strands were exposed due to spalling of concrete cover (see Figure 6.12). These strands were considered to be ineffective for moment capacity of the beam. Nine visible strands were exposed after the loss of concrete cover, many of which exhibited corrosion, including pitting or fractured wires.

**Figure 6.12: Specimen E3 showing visible deterioration of strands after spalling of concrete cover**

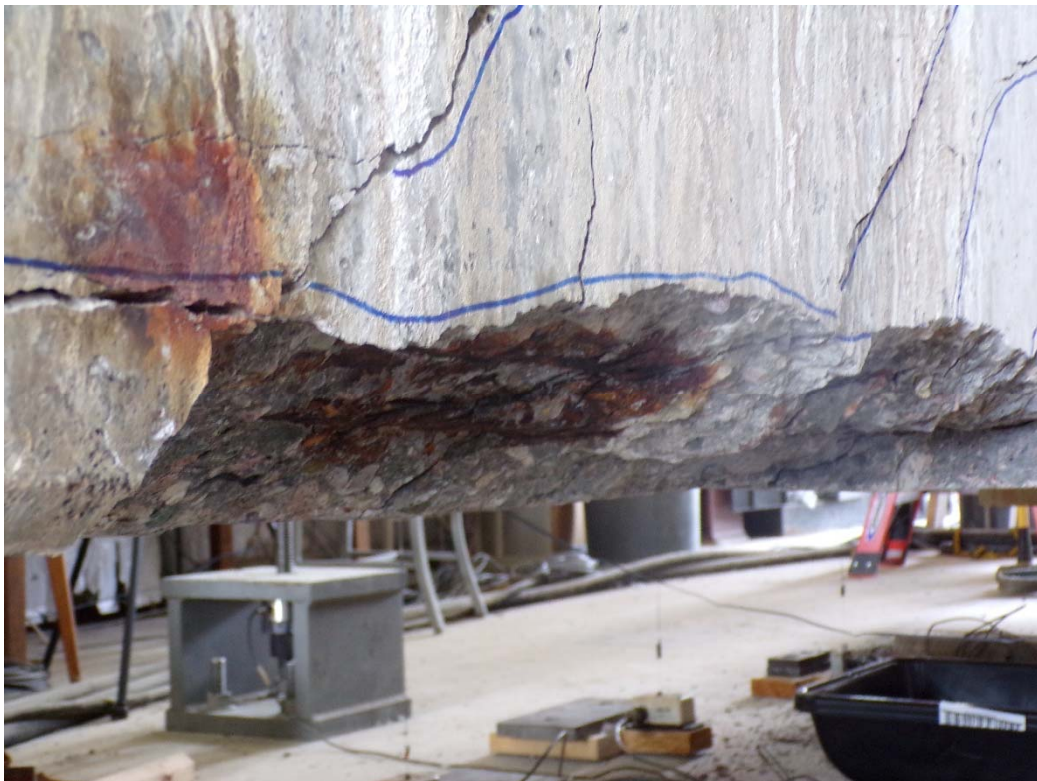
**Figure 6.15: Visible strand corrosion and section loss in Specimen E9 after spalling of concrete**

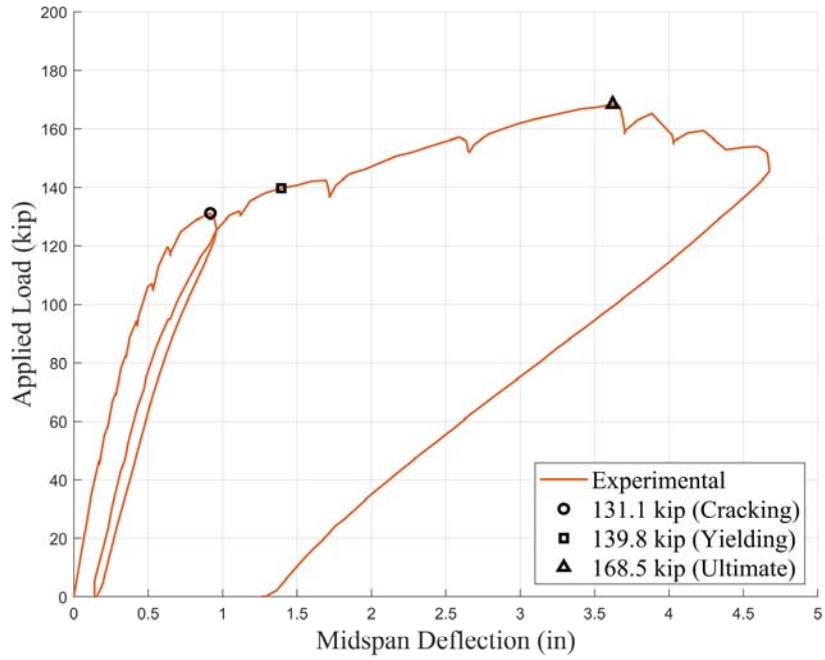
**Figure 6.16: Specimen E9 applied load-deflection curve with critical points**

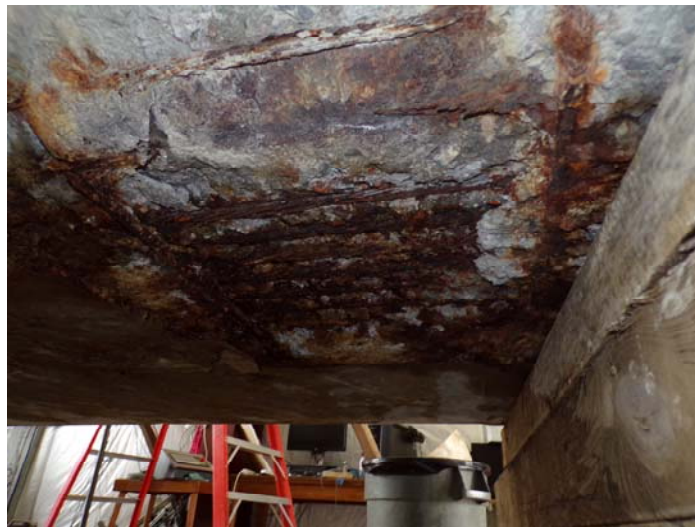
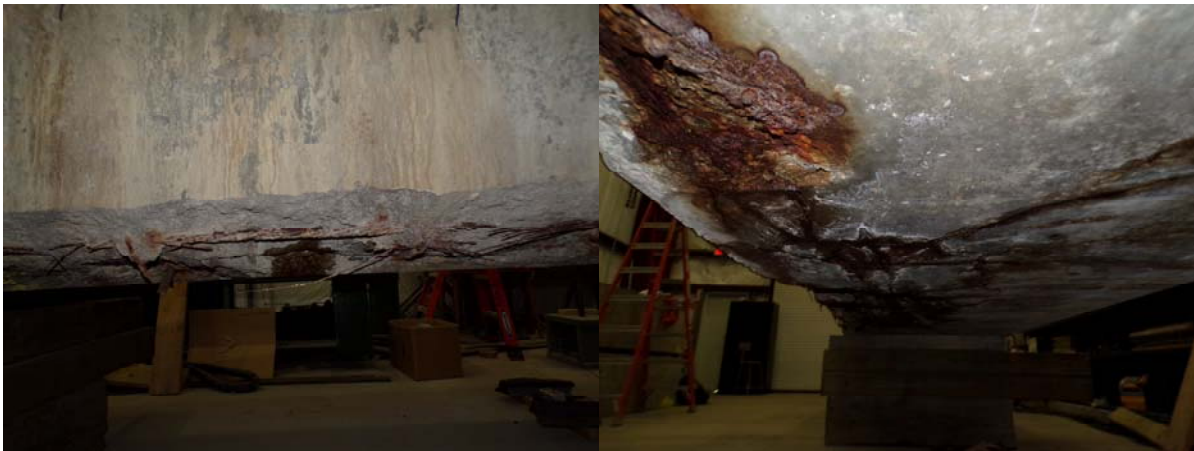
(a) Deterioration mapping on bottom surface (hatched area spalled after test)

(b) View of Section 3 after the test

(c) View of Section 4 before and after test  
**Figure 7.5: Deterioration of Specimen E3**
