## The Garisenda Tower in Bologna: Effects of degradation of selenite basement on its static behaviour.

**ABSTRACT:** The Garisenda tower in Bologna, a 48 m tall structure with a square base of 7.45 meters per side, is characterized by an overall out of plumb of 3.32 m in the South-East direction. Its construction dates back to the XI century and, due to its impressive leaning, in 1350–1353 the original height of 60 m was reduced to the 48 m of the present day (Cavani 1903; Giordano 2000). The tower can be seen as partitioned in a lower portion, with walls composed by two external leaves of selenite stones filled with rubble conglomerate, and an upper portion where the external leaves are made of masonry bricks. Recent investigations have proved that selenite blocks of the basement have been altered as a result of (a) exposition to high temperatures during important fires, that took place at the end of XIV and XVII centuries, and possibly because of the presence of forges (that were demolished at the end of the XIX centuries) and (b) high level of humidity in the inner lower part of the tower. This process has produced a gradual local disintegration of the selenite stones, leading

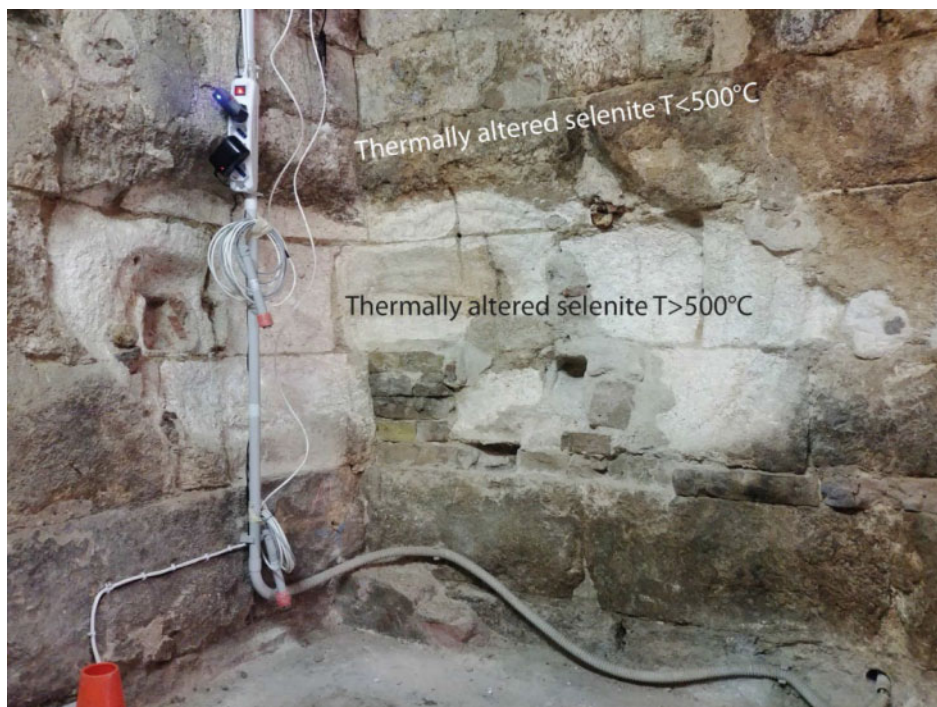
The selenite leaves in the inner part of the tower (which contain the rubble conglomerate) display the typical signature of thermal alteration. The gray and sparkling appearance of the original rocks was turned into white by dehydration of the gypsum crystals, which may start at relatively low temperatures, as low as about 100° C. The whitening of the gypsum crystals is one of the distinctive geological feature for the recognition of ancient fires in historical sites (Lugli 2002), such as the Palace of Knossos in the Minoan Crete (from the middle Bronze Age), Eraclea Minoa in Sicily (6th-1st BCE) and the medieval Abbey church in Nonantola, Modena (Lugli 1995, 2019). The change in colour from gray to white is due the formation of a mosaic of bassanite (emihydrate,  $\text{CaSO}_4 \cdot \frac{1}{2}\text{H}_2\text{O}$ ) and soluble anhydrite ( $\text{CaSO}_4 \cdot \varepsilon\text{H}_2\text{O}$ ) microcrystals. These sulfate crystals are unstable and rapidly rehydrate back to gypsum ( $\text{CaSO}_4 \cdot 2\text{H}_2\text{O}$ ) capturing moisture and capillary water to form an alabastrine rock. These mineral transitions are accompanied by significant volume changes. Although the initial dehydration induces the presence of secondary porosity by volume decrease, the voids are rapidly closed by the growth and volume expansion of the late gypsum crystals. The resulting white rock shows pseudomorphs of the original selenite crystals, but consist of new microcrystalline interlocking gypsum crystals. Because the rehydration phenomena occur soon after the fire, the mechanical properties of the resulting alabastrine rock was actually improved by the textural rock changes connected to the dehydration-rehydration transitions compared to the original rock. A core drilled on the northern wall of the tower showed that the thermal alteration of the selenite rock reached the depth of 15 cm from the slab surface.

At the south-eastern corner of the tower the thermal alteration process was much stronger. Here the rock has been deeply pulverized at the scale of the single micro-crystal components, with loss of material and a regression of the original slab surface of 20 cm (Figure 1). As revealed by SEM-EDS analyses, the disaggregated material consists of anhydrite that was not rehydrated back

Figure 1. Different degrees of thermal alteration of the selenite rock in the southwestern corner of the Garisenda tower entrance room. Note the recession of the slab surface affected by higher temperature.

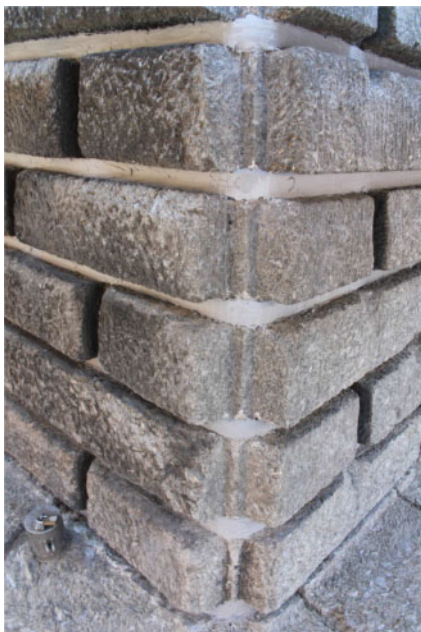
Figure 6. FRCM belting (A).

(a) passive confinement of the tower base obtained through FRCM belting along horizontal joints of stonework, with the voids between the “bugnato” and the selenite leaves filled using ad hoc elements that can be easily removed in the future;

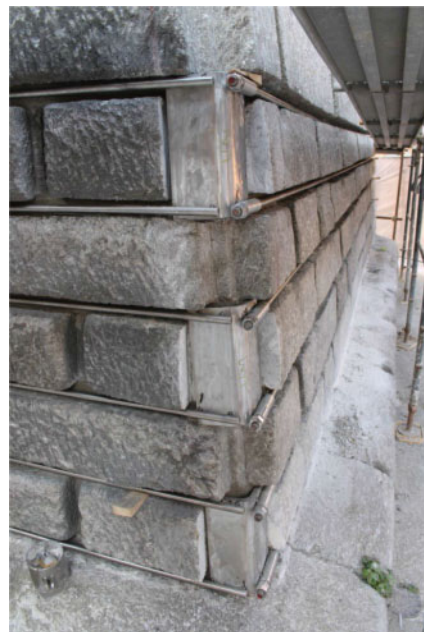
Figure 7. Post tensioned steel bars (B).

(b) active confinement of the tower corner by insertion of post tensioned stainless steel bars 24 mm in diameter (stainless steel AISI 304) and corner stainless-steel plates;

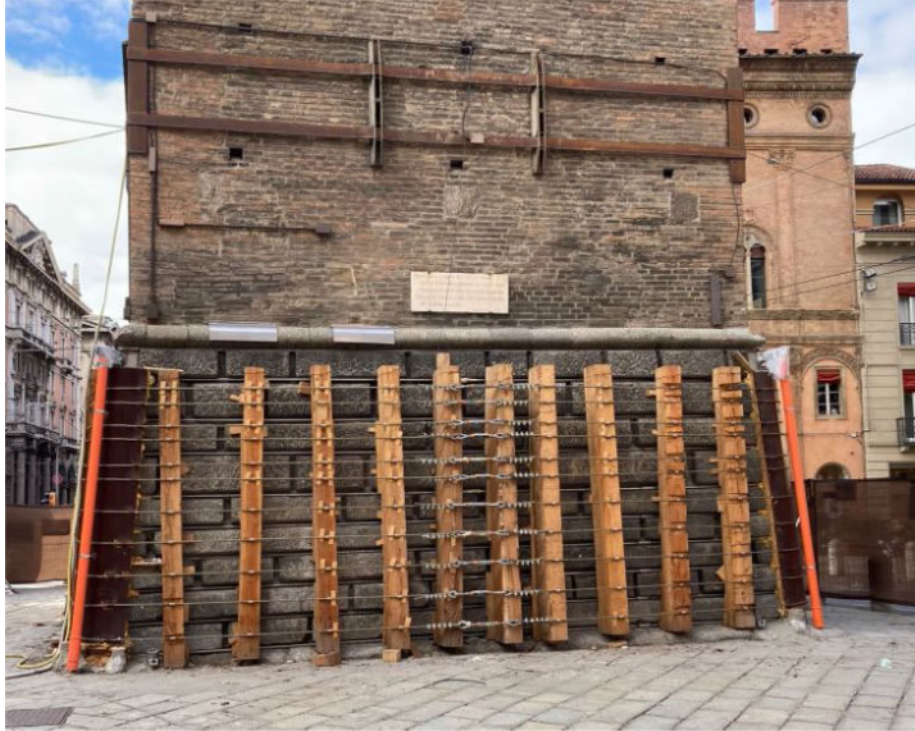
Figure 6. Confinement of the bugnato (C).

(c) active confinement of the “bugnato” through a funicular belting of the tower base. This was obtained by a monitored post tensioning of steel-cables with the insertion of wood blocks (of different thickness) between the “bugnato” and the cables.
