CHALLENGES WITH SAMPLING AND UNDERSTANDING LEAD CORROSION ISSUES IN
PUERTO RICO AFTER HURRICANE MARIA

MELANIE ROSE WARREN

Master of Science

Department of Civil, Environmental, and Architectural Engineering

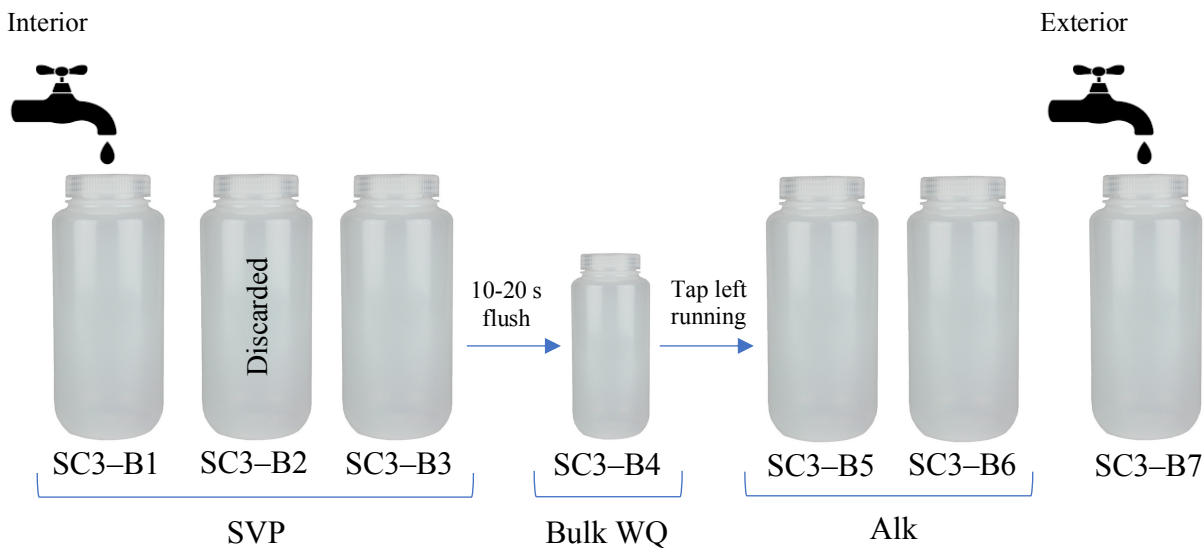
Figure 2. Sampling Campaign 3: Graphic depicting the sampling approach.

A FD 6+HS 1-liter sample was collected in a wide-mouth HDPE bottle for lead, copper, and other trace elements (termed SC3–B1) (Figure 2). Following, two (2) sequential 1-liter samples (termed SC3–B2 and SC3–B3) were also collected, bringing the total of the SVP to three (3) liters. As SC3–B2 was being filled, a 30 mL aliquot was collected from a free-flowing stream, and free chlorine was measured. The tap was left open for 10 to 20 seconds, allowing the water to flush, and one 500 mL sample (termed SC3–B4) was collected in a wide-mouth HDPE bottle for bulk water quality parameters. Flow rate was estimated by determining the amount of time to fill SC3–B4. SC3–B4 was rinsed three times prior to collection and samples were collected avoiding headspace as much as feasible. With the tap still open, two (2) 1-liter bottles were collected headspace free (termed SC3–B5 and SC3–B6). pH, temperature, and total and free chlorine were measured from a free-flowing stream after the SVP samples were collected and value was recorded after readings were stable. Alkalinity was measured on-site from SC3–B5 and SC3–B6, the value was averaged (relative difference 4.5%), and the samples were discarded. Each SVP sample was measured on-site for turbidity and inspected for signs of particulate material or discoloration compared to other samples. SC3–B2 was discarded after turbidity and physical characteristics were recorded. A final, 1-liter sample (SC3–B7) was collected from the exterior hose bib after all interior collections were finished. SC3–B1, SC3–3, SC3–B4, and SC3–B7 were shipped back to Colorado for analysis.

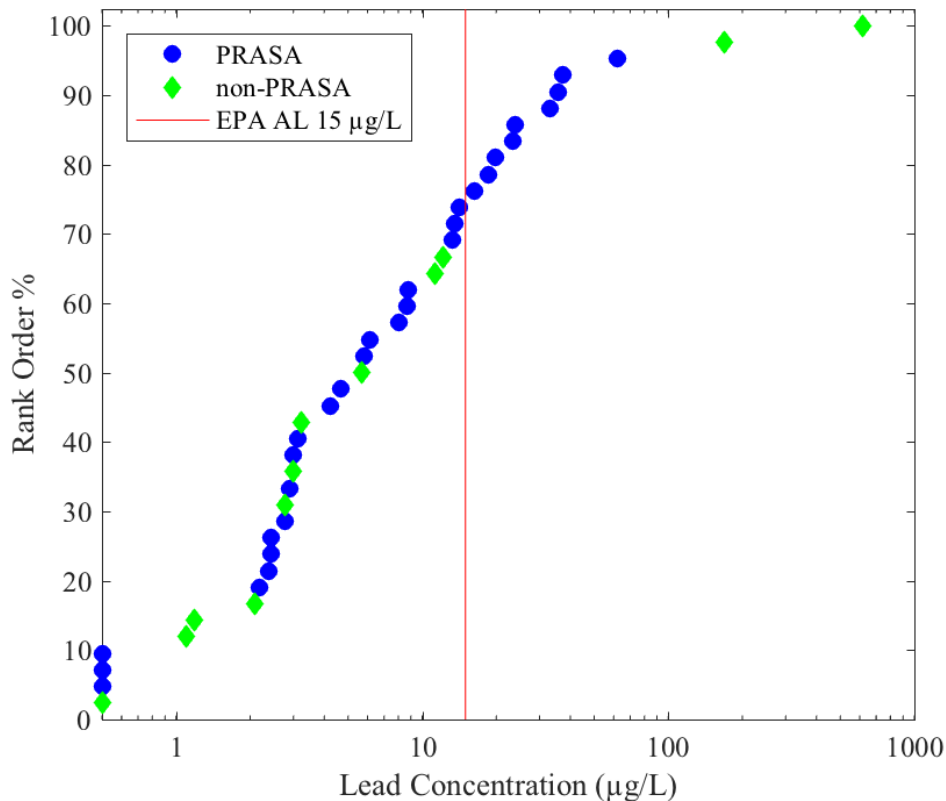
Figure 3. Rank order versus lead concentration of all samples across all locations for PRASA and non-PRASA systems from Sampling Campaign 1 & Sampling Campaign 2. This graph includes data points for the new sampling location in the Patillas-Mulas system, Site 33a, but excludes Sites 33b and 33c.

To assess the overall distribution of lead concentrations, Figure 3 plots the rank order percentile for samples collected from distribution systems in SC 1 and SC 2. As previously mentioned, the locations for SC 1 were randomly selected with no adherence to the U.S. EPA LCR tiering system, and the nine (9) samples for SC 2 were re-sampled sites that had elevated WLLs above the U.S. EPA LCR AL in SC 1. Sample volumes were 125 mL for both SC 1 and SC 2. For both sampling campaigns, the combined the 90th percentile concentration was 35 $\mu\text{g/L}$. While this comparison to the AL is out of context, since the sampling protocol did not adhere to the U.S. EPA LCR requirements, it still raises a concern, since the concentration is more than twice the U.S. EPA AL of 15 $\mu\text{g/L}$.

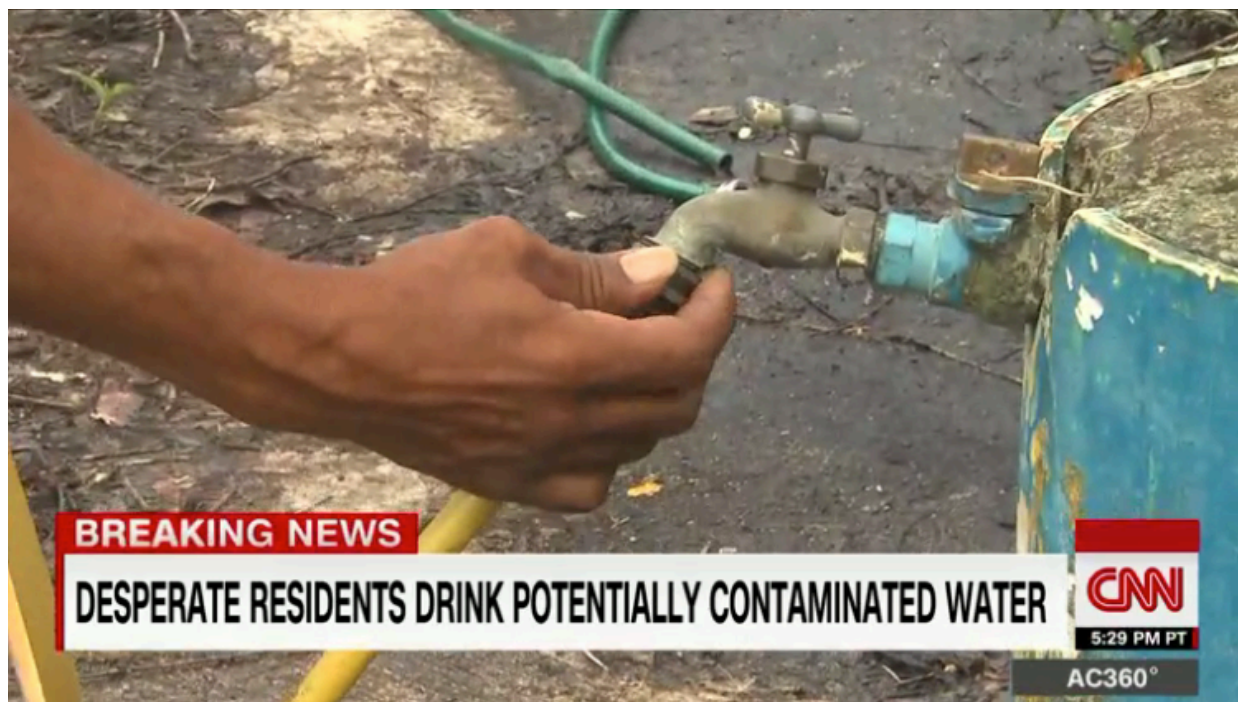
Figure 14. The hose bib tap at a well-head used to collect water from during water scarcity after Hurricane Maria located on the Dorado Groundwater Contamination Site (a superfund site) in Puerto Rico west of San Juan.

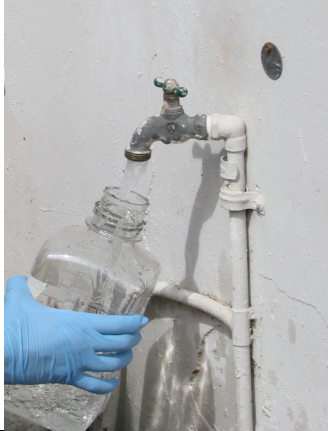
4

<p>Samples were collected from a outdoor tap at Inter American University of Puerto Rico at Arecibo. We got permission to collect water at this site from the Science and Technology Department Head. The faucet had a garden hose connected but was disconnected prior to sample. The faucet was unused that day prior to our arrival. We repeated the sampling at this location on April 19th. Because this second sampling was not done by us but was done by the Department Head after our solicitation, the only sample accompanying our metal sample is pH data.</p>
5

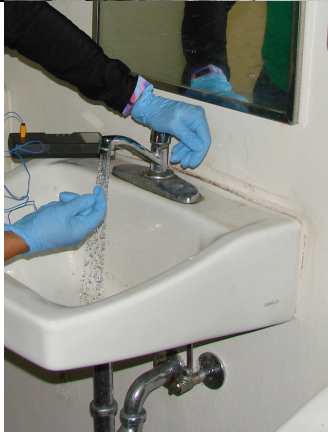
<p>This sample was collected from the female restroom in a high school in the municipality of Utuado. Because of the central location and elevation of this town, it was hit very hard by the hurricane. We had permission from the school's principal to collect this sample and were invited by one of the high school science teachers. However, the faucet that they had dedicated for us to sample was an indoor faucet with the integrated faucet filter. There is no record on how many times was that faucet open prior to us sampling.</p>

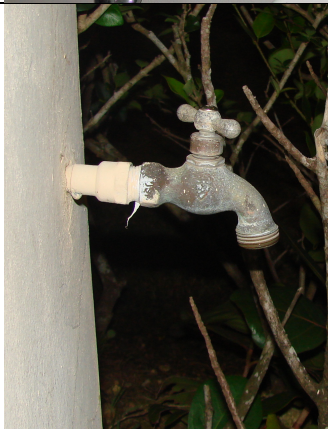
6

<p>Samples were collected from a house that receives water from PRASA in the municipality of Vega Alta, in the proximity of the municipality of Dorado. The faucet was located outside the house in front of the main entrance.</p>

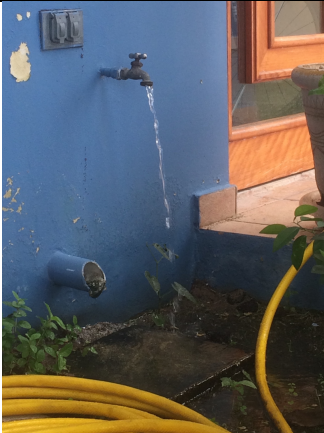
7

<p>Samples were collected from a house that receives water from PRASA in the municipality of Humacao. The faucet was located outside the house in front next to the main entrance.</p>
8

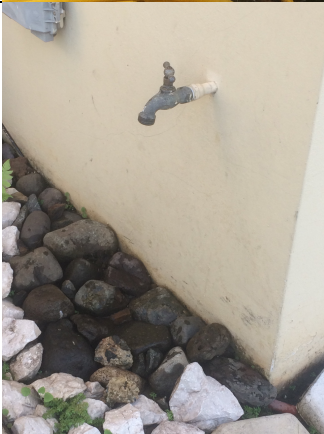
<p>Samples were collected from a house that receives water from PRASA in the municipality of Gurabo. The faucet was located outside the house in front next to the main entrance.</p>
9

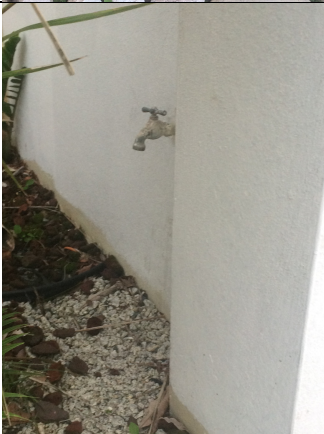
<p>Samples were collected from a house that receives water from PRASA in the municipality of Trujillo Alto. The faucet was located outside the house in front next to the main entrance.</p>

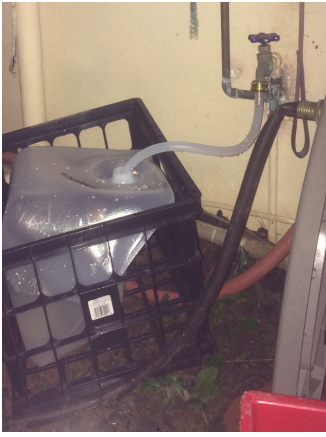
10

<p>Samples were collected from a house that receives water from PRASA in the municipality of San Juan. The faucet was located outside by the back of the house.</p>
		<p>Site was revisited on March 29, 2018, after the initial results indicated high lead levels in the water. Sample for metal analysis was collected from the same faucet that was collected during the first sampling.</p>
11

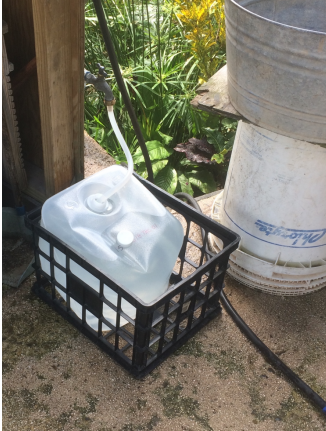
<p>Samples were collected from a house that receives water from PRASA in the municipality of Adjuntas. The faucet was located outside the house. There are about 5 houses in this location, all of them are family houses. The sample was collected from a faucet that is located in front of a garage where they keep their washing machine. The faucet had a garden hose connected, but the hose was disconnected when we collected the samples.</p>
12

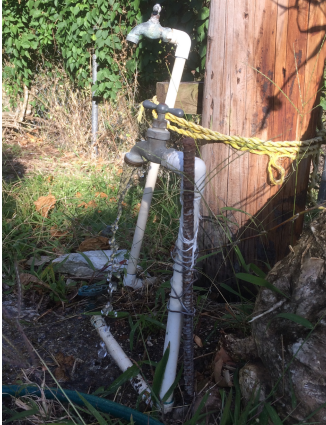
<p>This house receives water from PRASA. Although it is located in the municipality of Coamo, the owners indicate that the water they receive is from the municipality of Barranquitas. The tap was located outside the house and it had a garden hose connected. The hose was disconnected before sampling. At some point, this community was a non-PRASA, that is the second tap that you see in the picture, but no water was flowing out of that tap. We ask around if any of the nearby houses had access to the community water system, but none of them have access.</p>

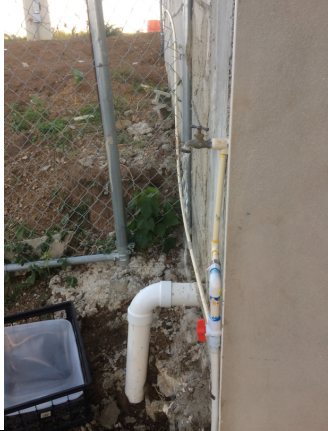
13

<p>Sample was collected from a house that receives their water from PRASA in the municipality of Santa Isabel. This is a recently constructed house (just before the hurricane).</p> <p>The faucet was located outside, by the back of the house. PVC pipe and brass tap.</p>
14

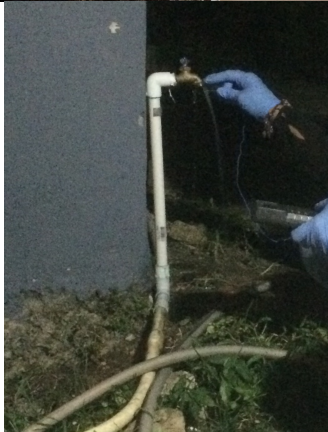
<p>Samples were collected from a house that receives water from PRASA in the municipality of Juana Díaz. The sampling tap was located outside the house by the front. Water comes through a PVC pipe and a brass tap.</p>
15

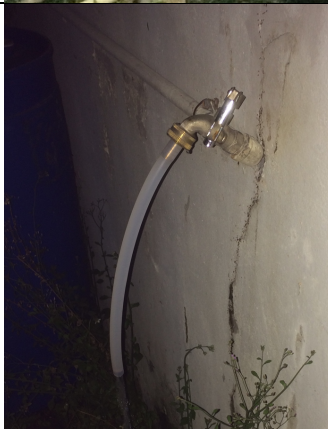
<p>Samples were collected from a house that receives water from PRASA in the Municipality of Yauco. The sampling tap was located outside by the front of the house. The tap had a garden hose connected, but the hose was disconnected prior to sampling.</p>

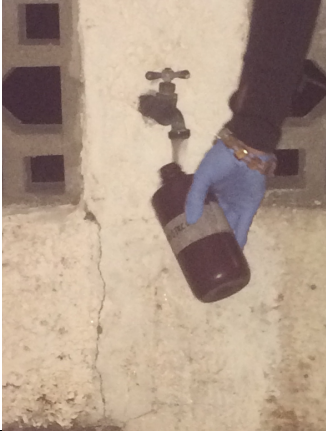
16

<p>Sample was collected from a house that receives water from PRASA in the municipality of San Germán. Sampling port was located outside the house.</p>
		<p>Site was revisited on April 1st, after the initial results indicated high lead levels in the water. Sample for metal analysis was collected from the same faucet that was collected during the first sampling.</p>
17

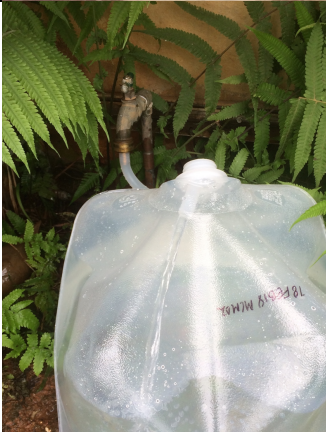
<p>Samples were collected from a house that receives water from PRASA in the mountainous region of the Municipality of Mayagüez. House is located very close to the spring samples that day (18FEB18MCM01). The sampling tap was located outside the house by the front.</p>
18		<p>Samples were collected from a house that receives water from PRASA in town of Aguada, by the beach in a sector called Espinar. This sector was completely flooded the day of Hurricane María fromf the Culebrina River. The sampling tap was located outside the house by the front.</p>

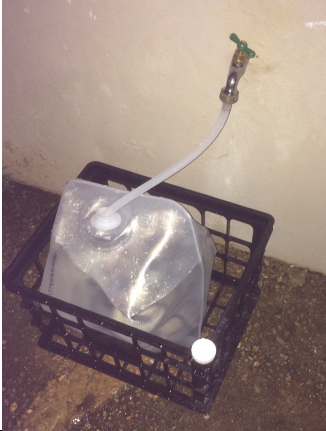
20

<p>Samples were collected from a house that receives water from PRASA in Municipality of Isabela. Sampling port was outside, by the side of the house.</p>
21

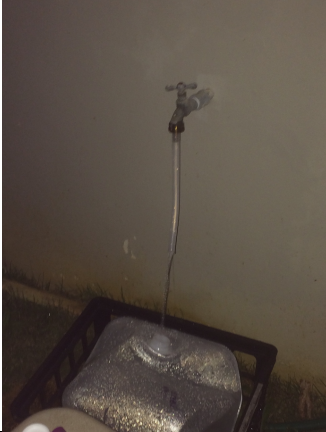
<p>Samples were collected from a house that receives water from PRASA in Municipality of Moca. The tap was located outside, by the back of the house. Sampling port had a garden hose connected but was disconnected prior to sampling.</p> <p>Site was revisited on April 1st, after the initial results indicated high lead levels in the water. Sample for metal analysis was collected from the same faucet that was collected during the first sampling.</p>
22

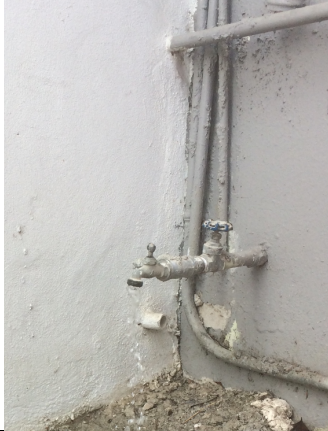
23

<p>Water samples were collected from Inter American University of Puerto Rico, Ponce's Campus. The sampling port was located outside the Student Center.</p>
24

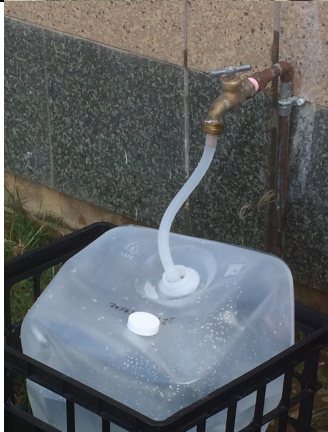
<p>Water samples were collected from Inter American University of Puerto Rico Guayama's Campus. The sampling port was located outside the building where the administrative offices are located.</p> <p>Site was revisited on March 28th, after the initial results indicated high lead levels in the water. Sample for metal analysis was collected from the same faucet that was collected during the first sampling.</p>
25

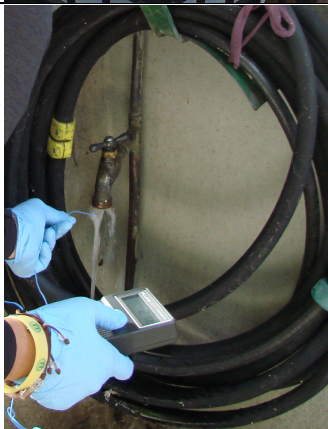
<p>Sample was collected from a house served by a community potable water system in the municipality of San Germán. Sample was collected from a faucet located outside the house. The faucet had a garden hose connected, but the hose was disconnected it prior to sampling.</p>

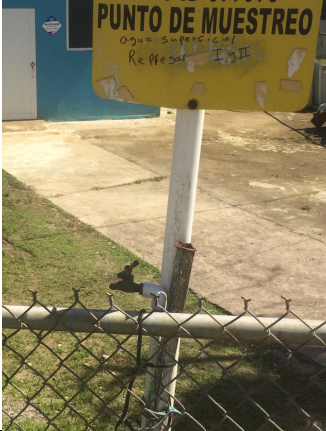
26

<p>Samples were collected at the sampling port of a community water system (non-PRASA) in the municipality of Yabucoa, in the south east of the Island. This town is where Hurricane Maria made landfall, with the strongest winds, which were sustained in approximately 155 mph. This site has a surface water and a well to supply the water to the community, but since this is one of the most devastated town, the lack of electricity and the small capacity of their emergency generator resulted in the use almost exclusively of surface water for consumption.</p>
27

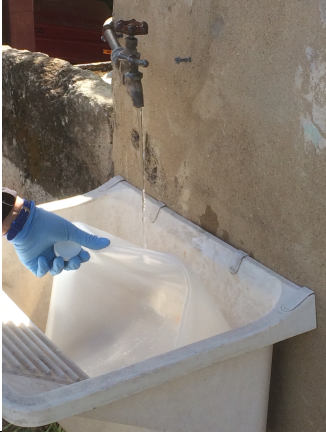
<p>Samples were collected from a non-PRASA system at the community sampling port. The “metal” pipe was being directly hit by the sun and those the relatively elevated temperature of the water.</p>
28

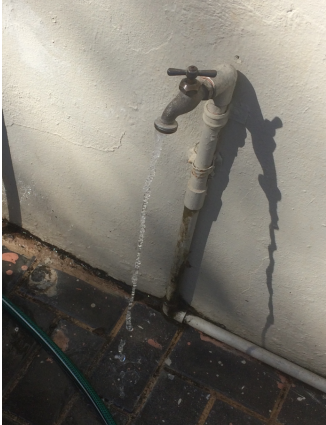
<p>Sample was collected from a house served by a community potable water system in the municipality of Guayama. Sample was collected from a faucet located outside by the front of the house. There was no power in the community when this sample was collected.</p>

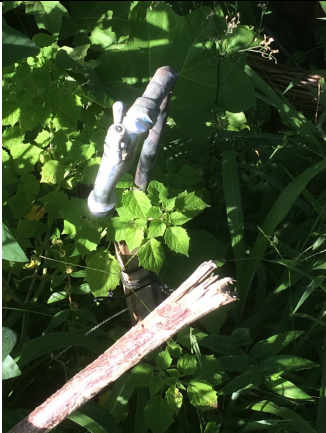
<p>29</p>

<p>Samples were collected from the sampling port of a community potable water system in the municipality of Patillas. There was no power in the community when this sample was collected.</p>
<p>30</p>

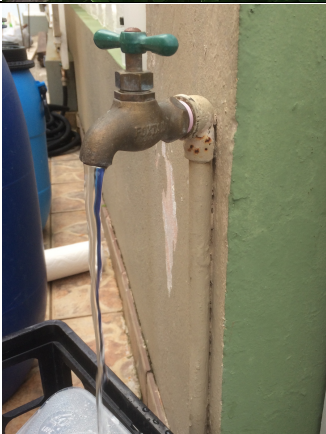
<p>Samples were collected from a house that receives their water from a community water system in the town of Patillas. The samples were collected from outside the house. This is also the sampling port for the community. There was no power in the community when this sample was collected.</p>
<p>31</p>

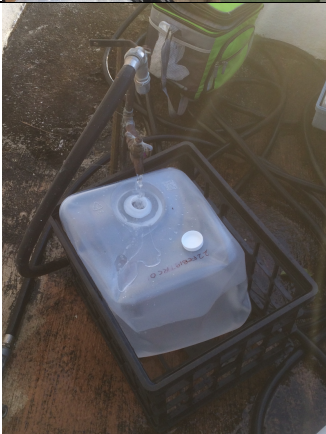
<p>Samples were collected from a house that receives their water from a community water system in the town of Patillas. The samples were collected from outside the house. This is also the sampling port for the community. There was no power in the community when this sample was collected.</p> <hr/> <p>Site was revisited on March 28th, after the initial results indicated high lead levels in the water. Sample for metal analysis was collected from the same faucet that was collected during the first sampling.</p>

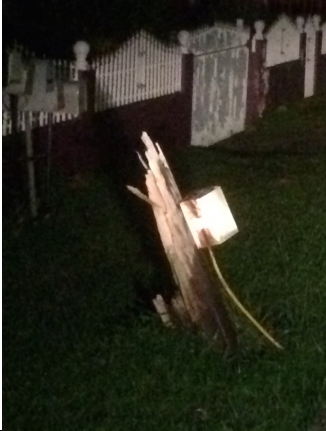
32

<p>Samples were collected from the sampling port of a community water system in the town of Patillas. The sampling port was located at the base of an electricity pole. The pole was broken due to the hurricane, but the sampling faucet was still intact. There was no power in the community when this sample was collected and the sample was collected late at night.</p>
33

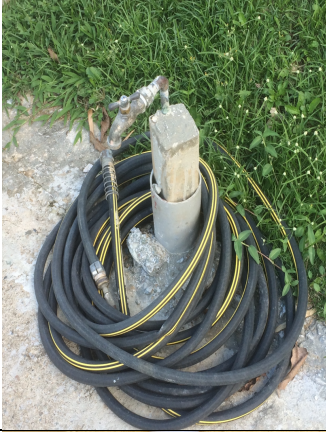
<p>Samples were collected from a house that receives their water from a community water system in the town of Patillas. The samples were collected from outside the house, by the entrance of the house there was a faucet with a garden hose. The garden hose was removed prior to sampling. There was no power in the community when this sample was collected.</p> <p><i>First sample was collected at night, the picture is from the second sampling</i></p> <p>Site was revisited on March 28th, after the initial results indicated high lead levels in the water. Sample for metal analysis was collected from the same faucet that was collected during the first sampling.</p>

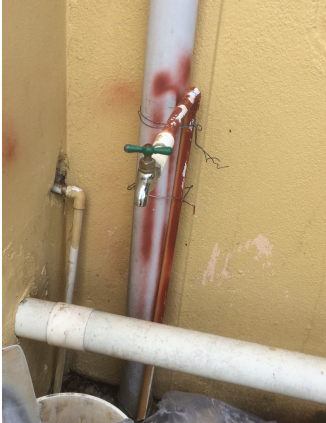
33-DIST

<p>As part of the campaign to revisit site 22FEB18TRC08, and in order to try to investigate a high lead measurement, a sample was collected from the community sampling port.</p>

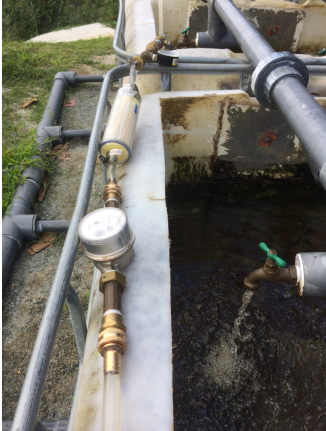
<p>33- RAW</p>

<p>As part of the campaign to revisit site 22FEB18TRC08, and in order to try to investigate a high lead measurement, a raw water sample was collected, water coming directly from the pipe that brings the water to the system</p>
<p>33- RIVER</p>

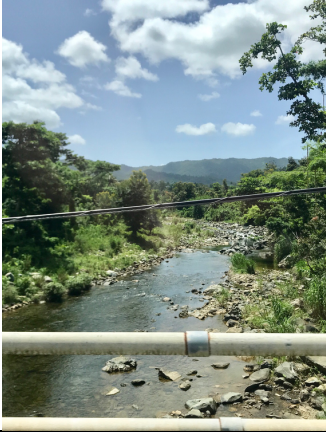
<p>As part of the campaign to revisit site 22FEB18TRC08, and in order to try to investigate a high lead measurement, raw water sample was collected directly from the river. Because of access issues, the sample was collected downstream of the intake of the system.</p>
<p>34</p>

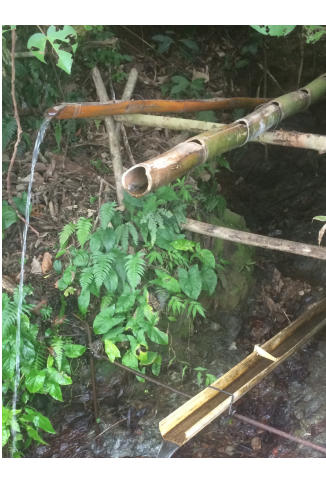
<p>Samples were collected from a natural spring at the side of road PR-120, at the borderline between the municipalities of Maricao and Sabana Grande. Spring water was flowing through an improvised bamboo pipe. At the same site there was a small water accumulation pond with a metal/aluminum pipe to drain the water. Anecdotal information suggests that hundreds of people collected water at that site during the emergency.</p>

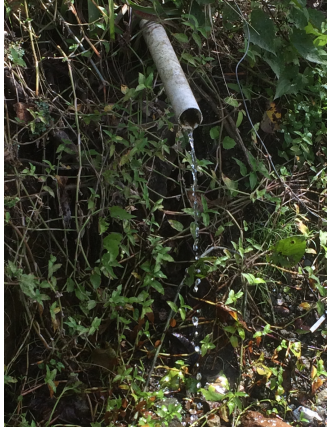
38

<p>Water samples were collected from a natural spring. Water is coming out of metal pipe from a spring located along road PR-5518 in the Municipality of Adjuntas.</p>

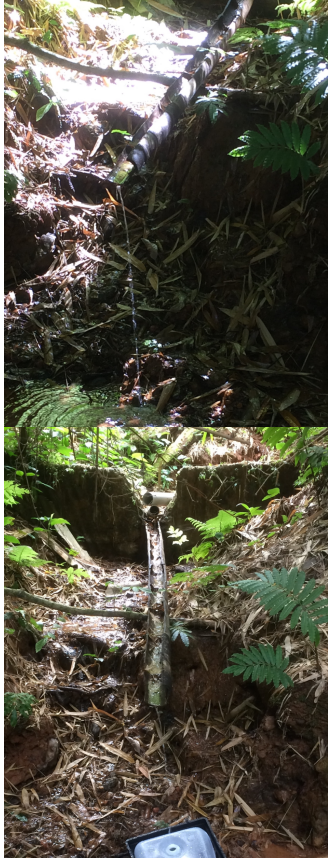
<p>39</p>

<p>Water was coming out from a PVC pipe flowing into a bamboo pipe. Water accumulates in a reservoir, if it rains a lot, the water from the reservoir will also run through the bamboo pipe. On the day of collection, there was little flow. Anecdotal information suggests that, when PRASA turns on their well system, near this site, the flow of the spring slows down.</p>
<p>40</p>

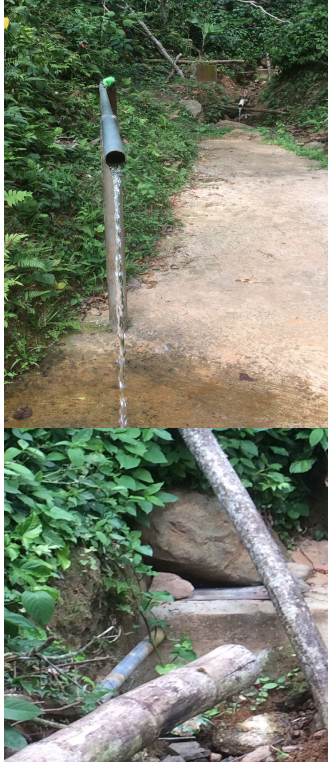
<p>Samples were collected from a spring in the municipality of Mayagüez, on the border with Las Marias. The water was coming out of a metal pipe. The pipe had a green biofilm growing inside. There were two pipes, one small PVC and one metal, delivering water. Samples were collected from the metal one, because it is the more accessible to the public, it is where most people were collecting water and even taking baths at this place during the emergency.</p> <p>The spring water comes out of the rocks, accumulates in a small artificially made pool and flows through the metal pipe (see pictures below). The accumulation pool is covered by rocks.</p>

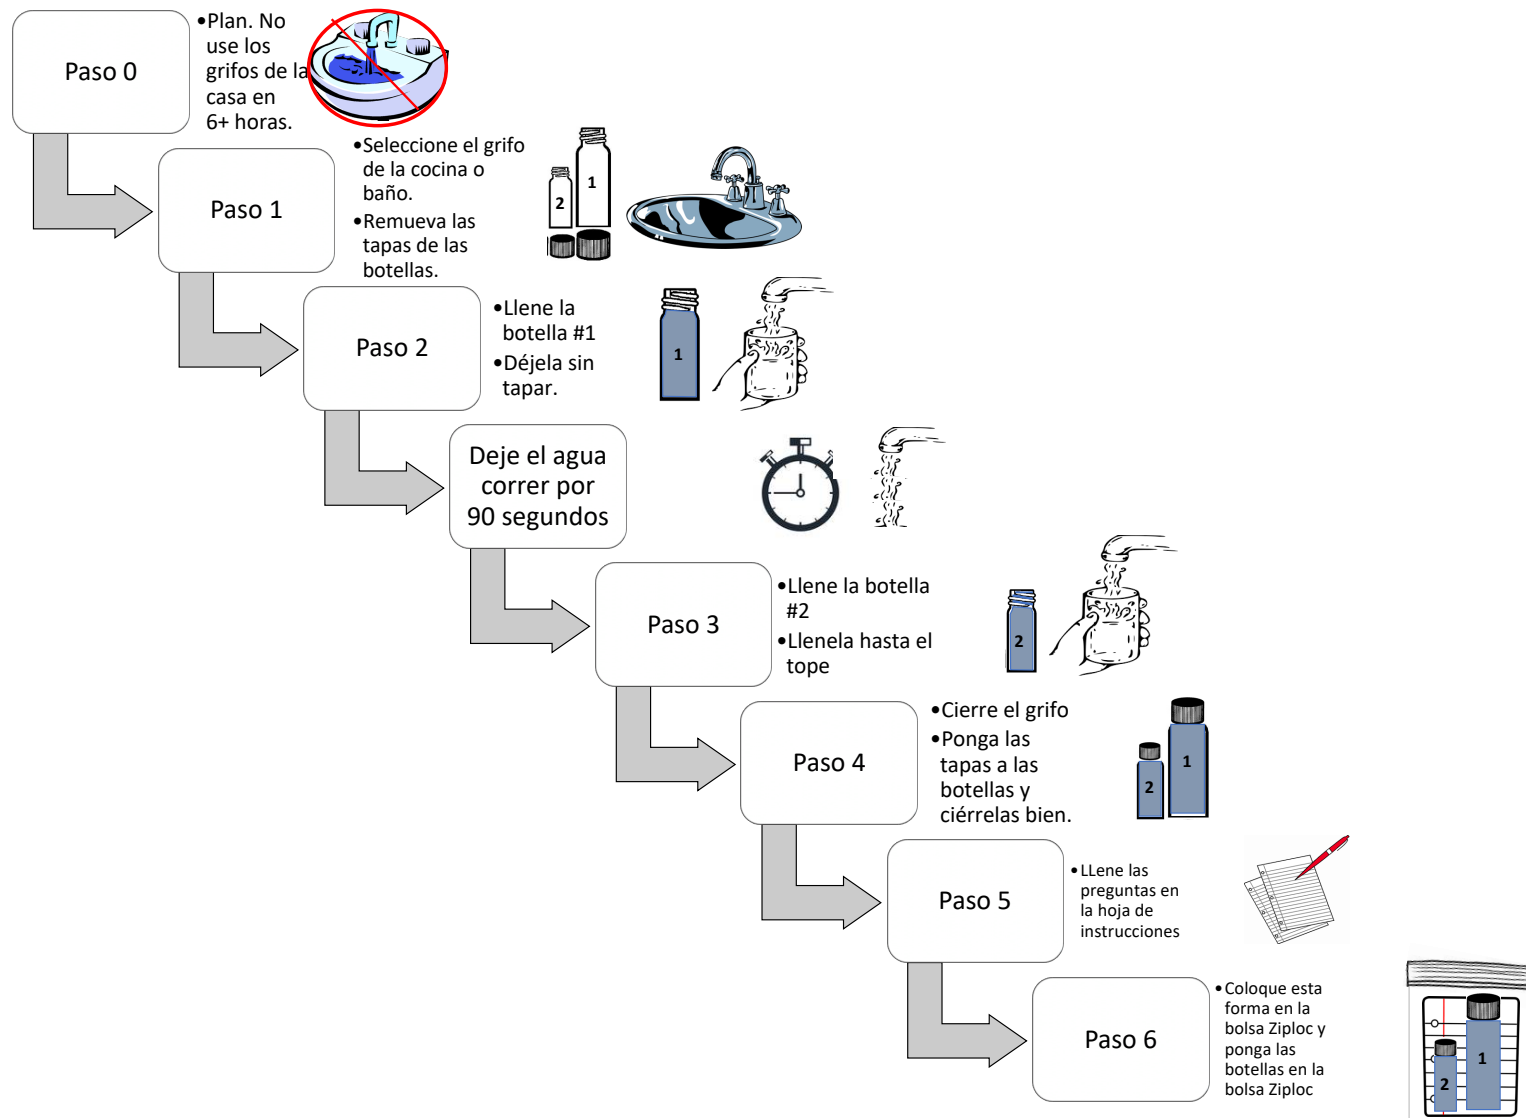
Figure A2. Sampling Campaign 4: Pictogram on the back of the instruction sheet that was included in sampling kits.
