Schuster Slope Landscape Management Plan Revisited

A re-design plan for a steep slope restoration
project in the Pacific Northwest

Submitted in partial fulfillment of the requirement of the

Masters in Natural Resources Degree

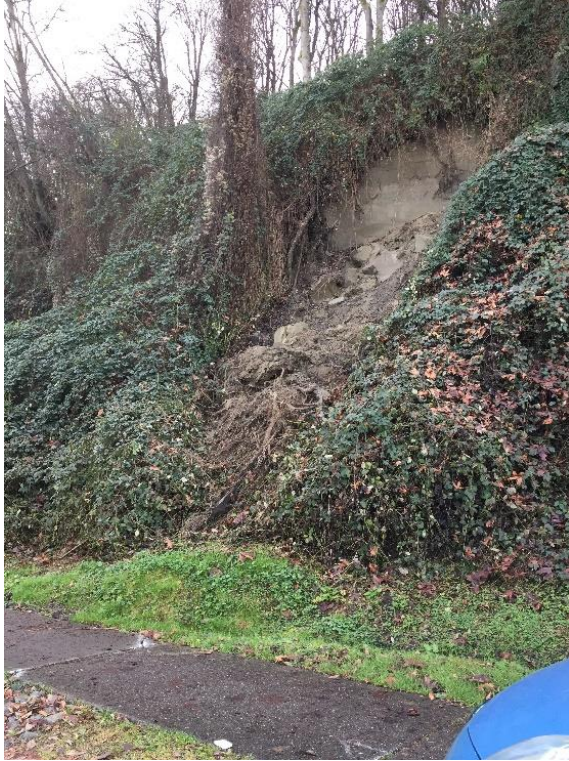
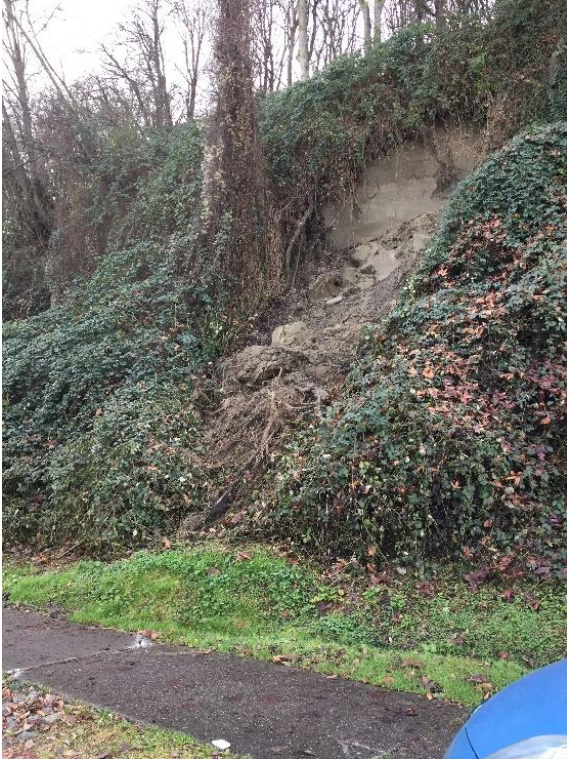
Photo 1. Surficial slide on Schuster Slope near pedestrian walkway, January 2019.

Each management consideration has objectives, standards, and performance measures along with estimates of a timeframe and level of effort necessary to complete. Slope stability and geologic hazard mitigation is achieved through the establishment of a 100% soil-binding root zone specifically of tree roots. Forest health is described as a self-sustaining PNW forest that mimics the Target Ecosystem. Public safety includes the protection of the Schuster Parkway road at the base of the slopes from surface erosion and soil sloughing, however mass slope wasting is not addressed in the LMP. The presumption that most landslides occur during or shortly after rainstorms (Crozier, 2005) is a near certainty on the Schuster Slopes where an average five slides occur each winter (Environmental Services, 2015; Photo 1).

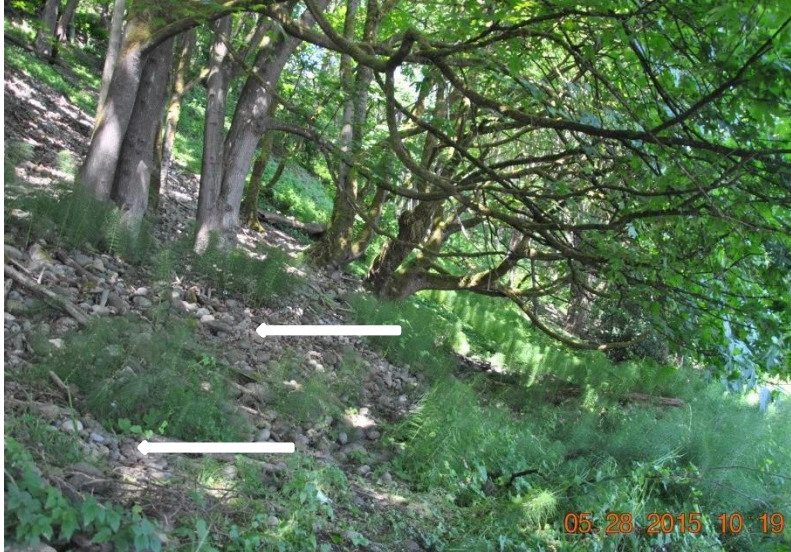
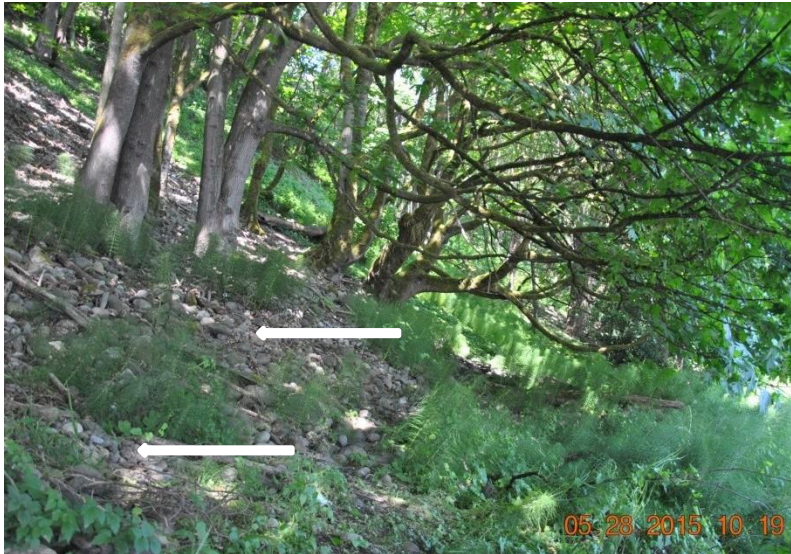
This Restoration Design paper will focus on the most difficult section of Management Unit 1, Treatment Plot 6. The roughly 1-acre area has proven the most difficult area to establish vegetation to date. This area of MU 1 constitutes slopes ranging from 67% to over 100%. The precise soil type is not identified in the work plan but from site observations the entire area appears to be unconsolidated glacial outwash and till with fines and coarse gravel at mid-slope ranging down to large cobble-sized stones at the toe and northern extent of the slope. A wetland buffer extends into a portion of the site (Map 3). A deep summer shade extends over the entire Plot from a mature deciduous forest with minimal shrubs and groundcovers, native or invasive (Photo 3, 4). No conifer trees were growing on site prior to restoration activities commencing in 2015. Maples and cottonwood trees pepper the site at 25-50' spacing. A difficult combination of actively moving slopes, deep shade from mature pioneer tree species, and dry soil conditions during the Pacific Northwest summers all contribute to a sparse understory.

Photo 3. Treatment Plot 6 understory. Note large cobble stone pervasive onsite.

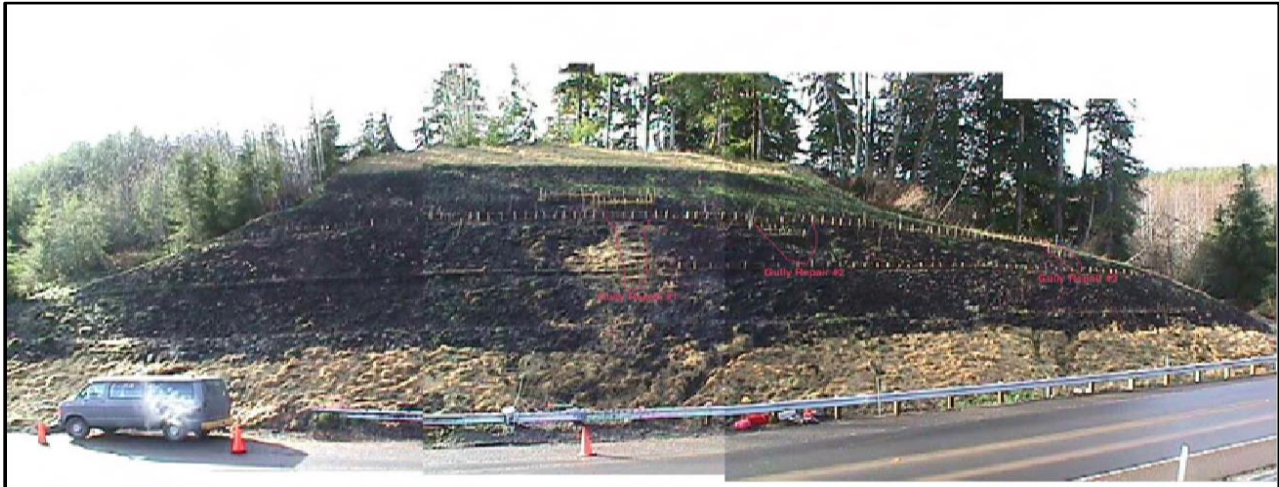
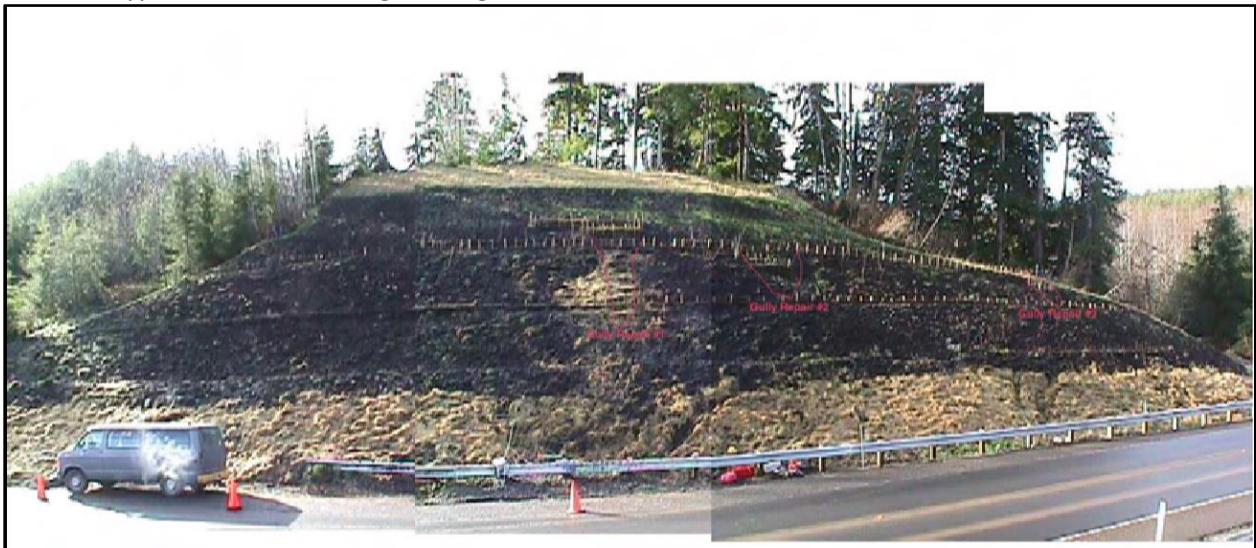
Photo 6. Typical roadside bioengineering work.

While terracing the lower to mid slope portions of the driest cobble and gravel prone areas will be a laborious effort and vegetation succession is expected to stabilize to soil only to maximum root penetration depth, surficial slide processes could still occur as the vegetation terraces decline or fail shortly after installation, especially in the first year following installation (Norris et al., 2008; Lewis et al., 2001). As such, best management operations for this work includes beginning at the toe of the slope and work uphill from there to first stabilize the base of work area and to improve the efficacy of work crews as they move upslope. Contiguous structures will not be possible as is often seen along roadside stabilization sites (Photo 6) due to the intermittent presence of existing trees. Though soil amendments were recommended in the consultant Work Plan, such materials are not being recommended for the cribwall terraces. While Lewis et al., (2001) found these additions aided in early plant establishment in a drier climate bioengineering project, their addition had no correlated effect in the previous planting efforts on the site. In addition, access and labor constraints at this project site make such additions difficult and time consuming.

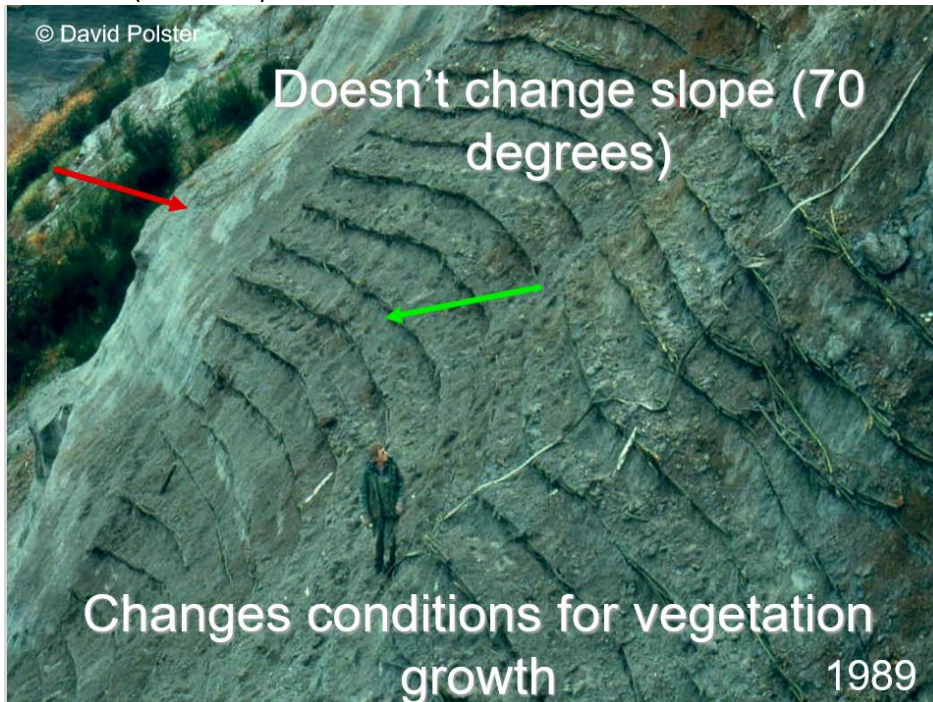
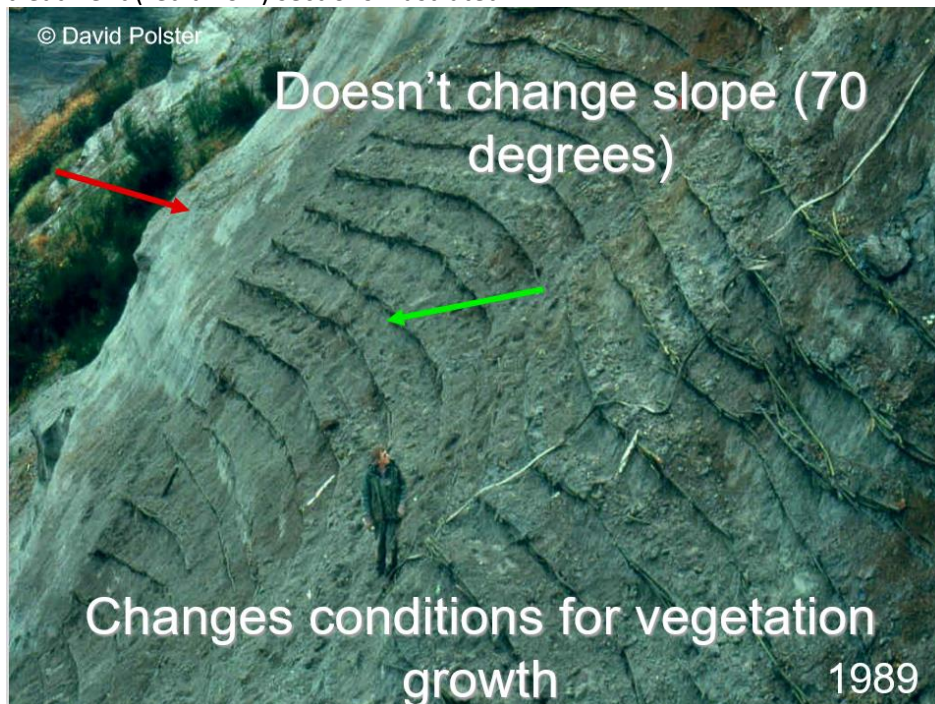
Photo 8. University of British Columbia slope stabilization work. Treatment (green arrow) and non-treatment (red arrow) sections illustrated.

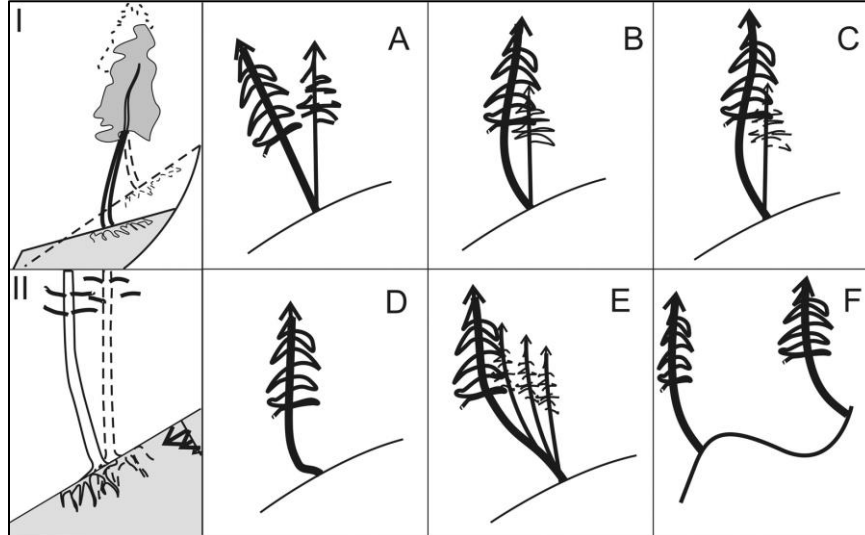
Figure 2. Tree growth response to moving soil.

Slopes with simplified vegetation communities such as solitary trees do not provide adequate stabilization. In shallow soils, tall trees may be more susceptible to falling during wind storms, and thus may not be ideal as the sole vegetation type. While tree roots do provide increased soil cohesion strength, this may only have positive benefits on surficial soil creep (Cammeraat et al., 2007) and have limited benefits for deep soil movements. Specifically, persistent and/or intense rainfall impact can destabilize large (sand and gravel) and small (fine silt) particles at the forest floor surface, creating rivulets then rills and gullies (Styczen and Morgan, 1995). Similar to root structures adapting to wind forces, trees and woody shrub plants can form reaction wood as slopes shift that leads to corrective growth (Stokes et al., 1995; Stokes et al., 1997). Reaction wood is anatomically different than normal stem or branch wood due to mechanical stressors, such as strong wind, weighted loading, or soil movement (Scurfield, 1973). Figure 2 demonstrates differing tree growth responses to moving slopes based on species and the timeframe of the soil movement. Apart from this growth pattern being a natural growth reaction, it is also a salient indicator of slopes that have moved downward in the past.

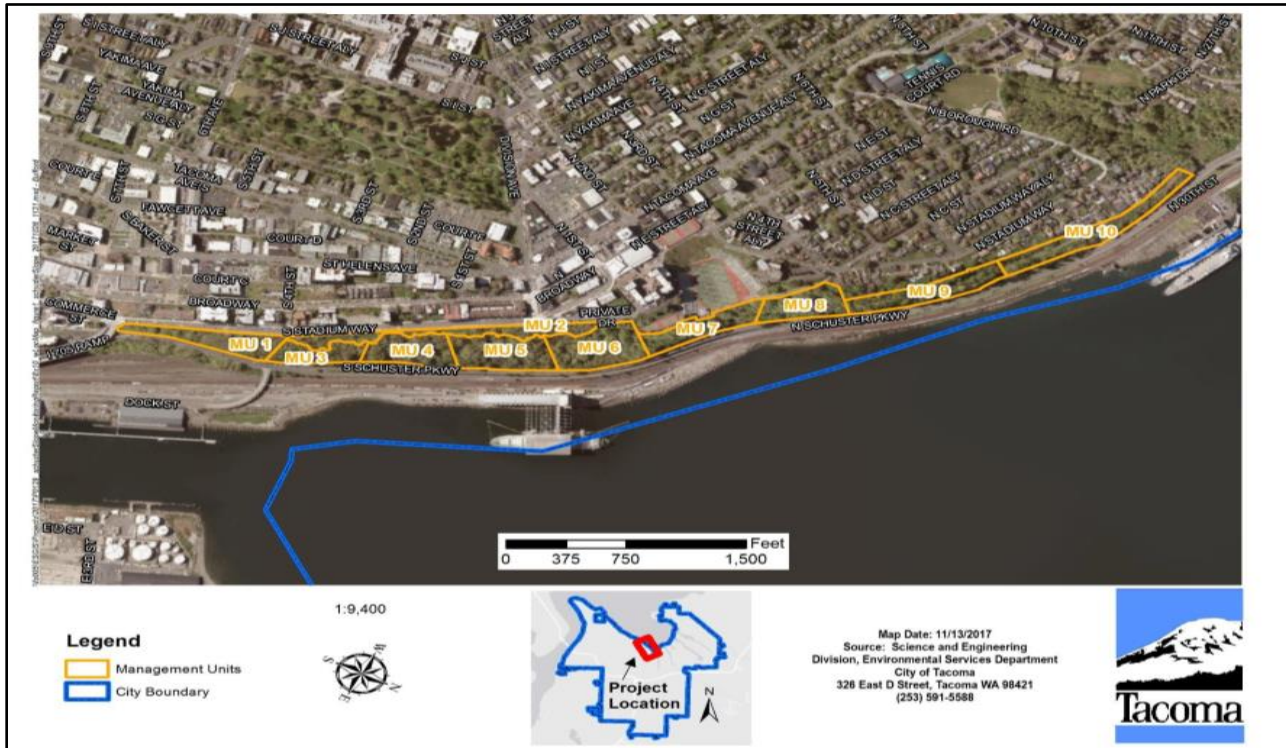
Map 2. Schuster Slope project area with Management Units identified.

The Schuster Slopes project area was divided into 10 Management Units (MUs), each approximately 3 acres in size (Map 2). The division was made to identify areas of similar topography and vegetation composition that would be a manageable work size during the fall/winter planting seasons.

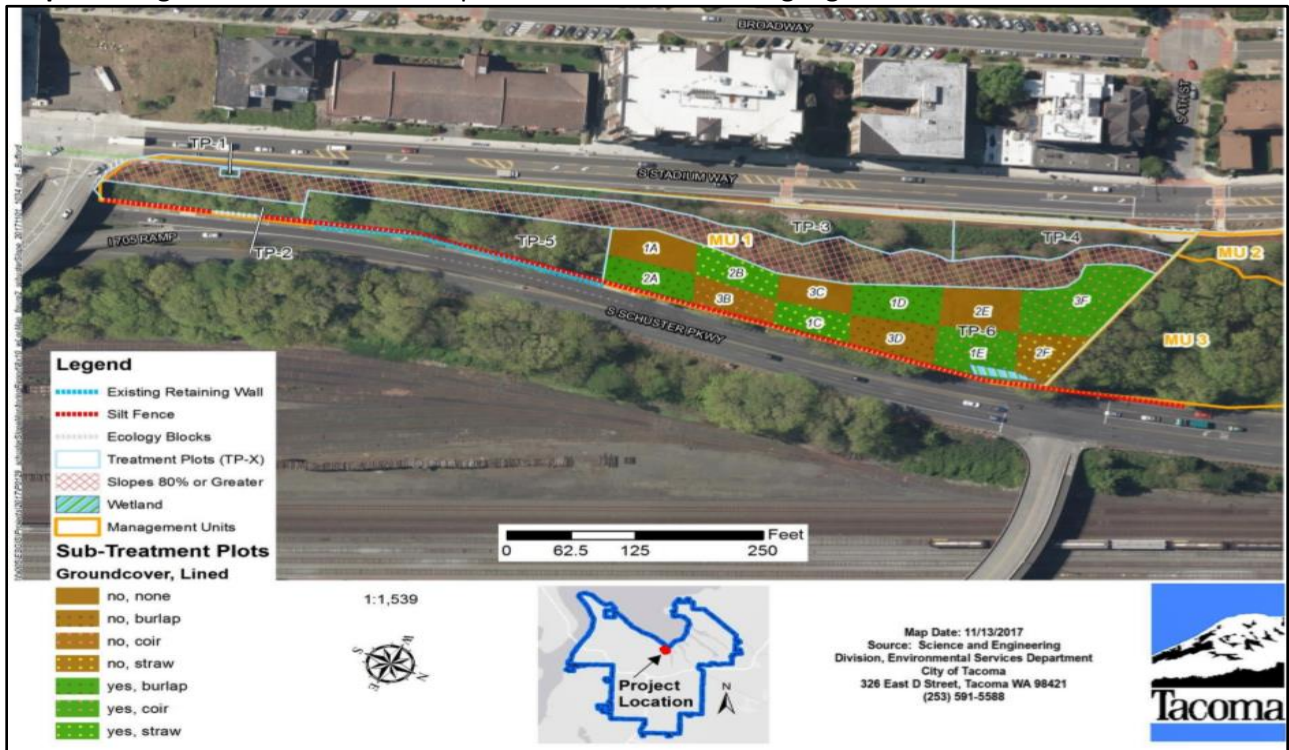
Map 4. Management Unit 1 with sub-plots of Treatment Plot highlighted

installation on Treatment Plot 6 was resumed in summer 2016 in anticipation of planting during the fall and winter of 2016.

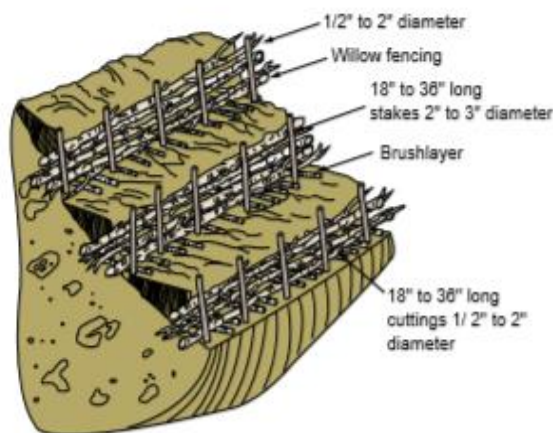
Brushlayering

- Begin project at base of treatment area. Excavate 16 to 20 inch deep trenches along slope contour and for full width of treatment area. Spacing of trenches averages between 5 to 8 feet full measurement depending on site conditions. This technique can cause additional erosion during installation, therefore, it is important to construct project in phases and to avoid excavating more area than is necessary to install plant materials (figure 11).
