AN ABSTRACT OF THE THESIS OF

Title: Evaluation of a Pedestrian Call Extension and Cancellation System at a Midblock Trail Crossing

A THESIS

Oregon State University

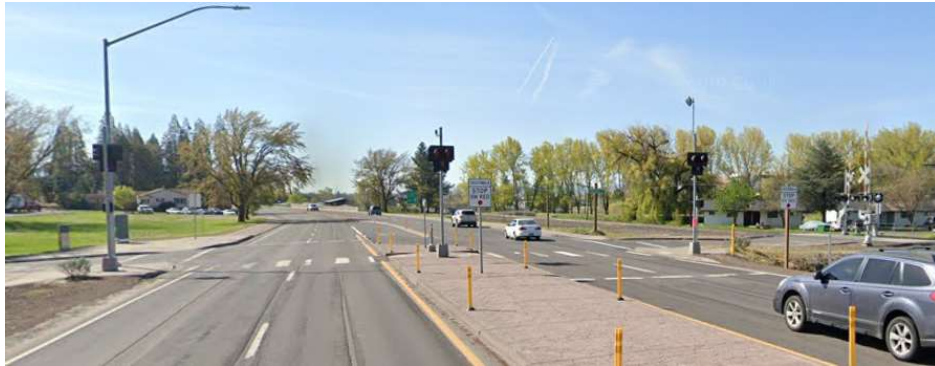
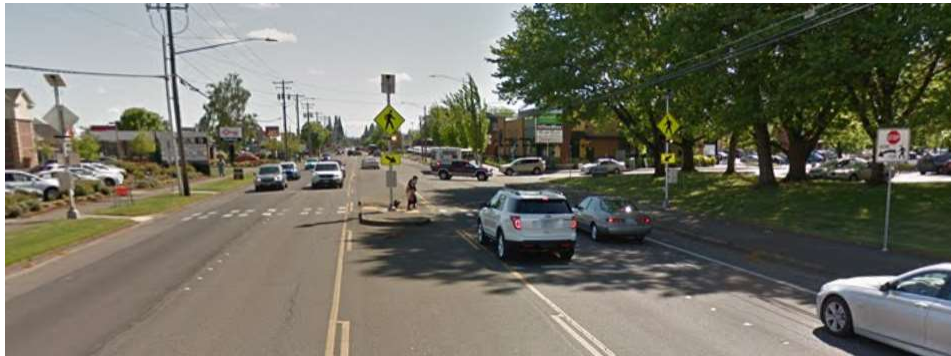
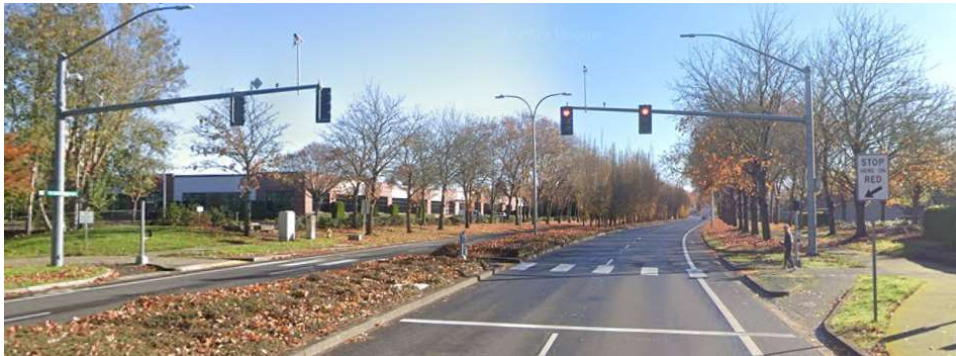
Figure 3- Examples of (a) PHB, (b) RRFB, (c) Signalized Midblock Crossing in Oregon

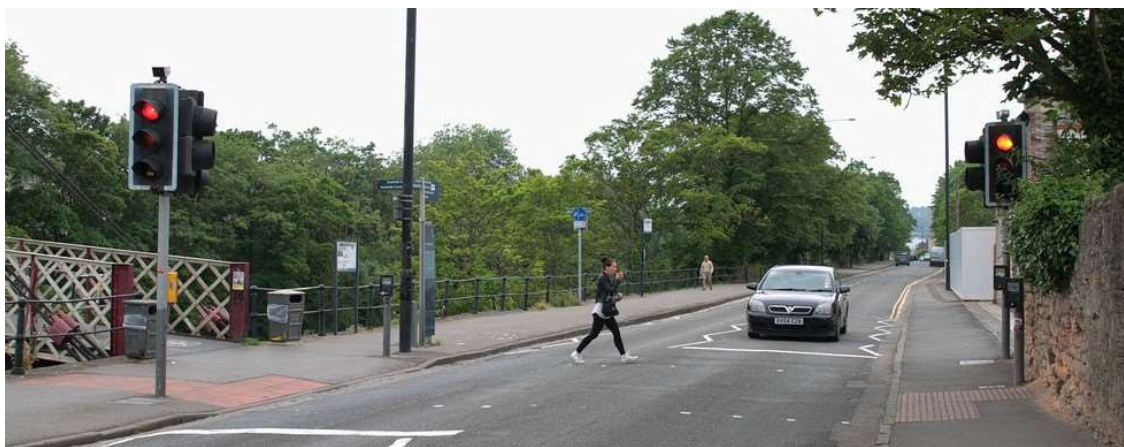
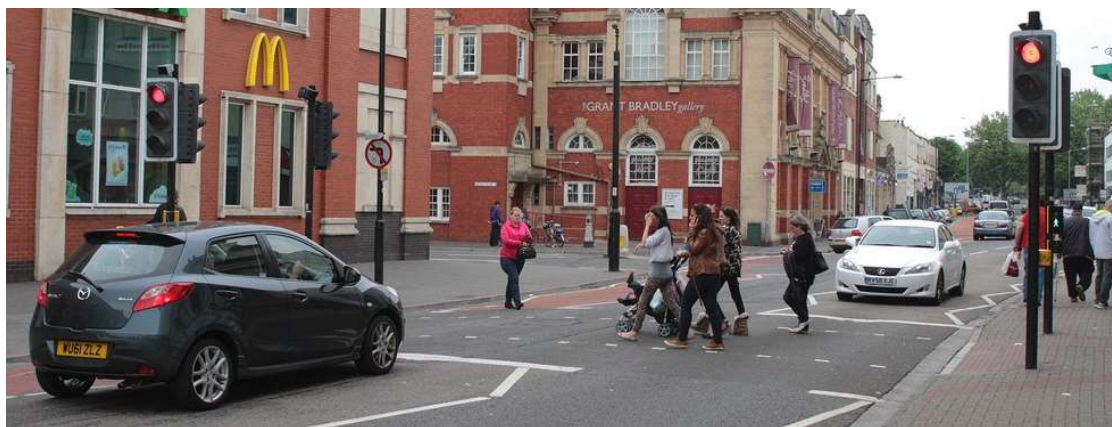
Figure 4-Examples of (a) Pelican and (b) Puffin Crossings in the UK (City of Bristol 2014)

The Puffin was designed to reduce vehicular delay while increasing safety for pedestrians (Hassan et al. 2013, 2014; Walker et al. 2005). The Puffin crossing detects pedestrians throughout the crossing maneuver using pressure sensitive mats and radar sensors and varies the vehicular phase accordingly. The Puffin also has the ability to cancel the pedestrian phase if the pedestrian jaywalks or walks away from the crossing. This ability reduces the number of unnecessary pedestrian phases, and therefore reduces vehicular delay (Hassan et al. 2014; Walker et al. 2005). If no pedestrians are detected in the curb-side detector when the pedestrian interval is appropriate, the traffic signals remain green (Hassan et al. 2014). To that end, the Puffin crossing does not inform pedestrians of a cancelation.

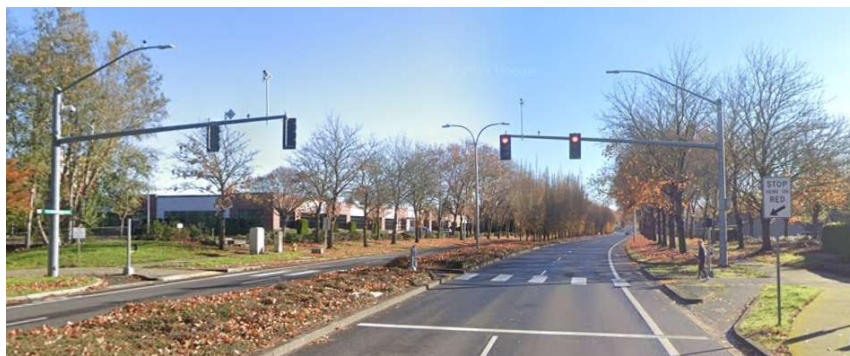
Figure 5- The Rock Creek Trail Crossing on Evergreen Parkway

The pilot site identified to implement the passive pedestrian cancellation and extension system is located at a signalized mid-block crossing Evergreen Parkway and Rock Creek Trail in Hillsboro. Evergreen Parkway is classified as a collector with a speed limit of 45 mph and an ADT of approximately 16,800 vehicles per day. The Rock Creek Trail serves the community by providing connectivity in Northeast Hillsboro. The trail has high pedestrian and bicycle volumes, most of which are recreational trips, likely contributing to a high frequency of jaywalking. The crosswalk consists of two 27-ft crossings and a 16-ft wide median. The crosswalk, sidewalk, and trail are 10 ft, 6 ft, and 12 ft, respectively. Additionally, the crosswalk includes a raised median and refuge island, a coordinated signal, and nighttime illumination. The crossing is shown in **Figure 5**.

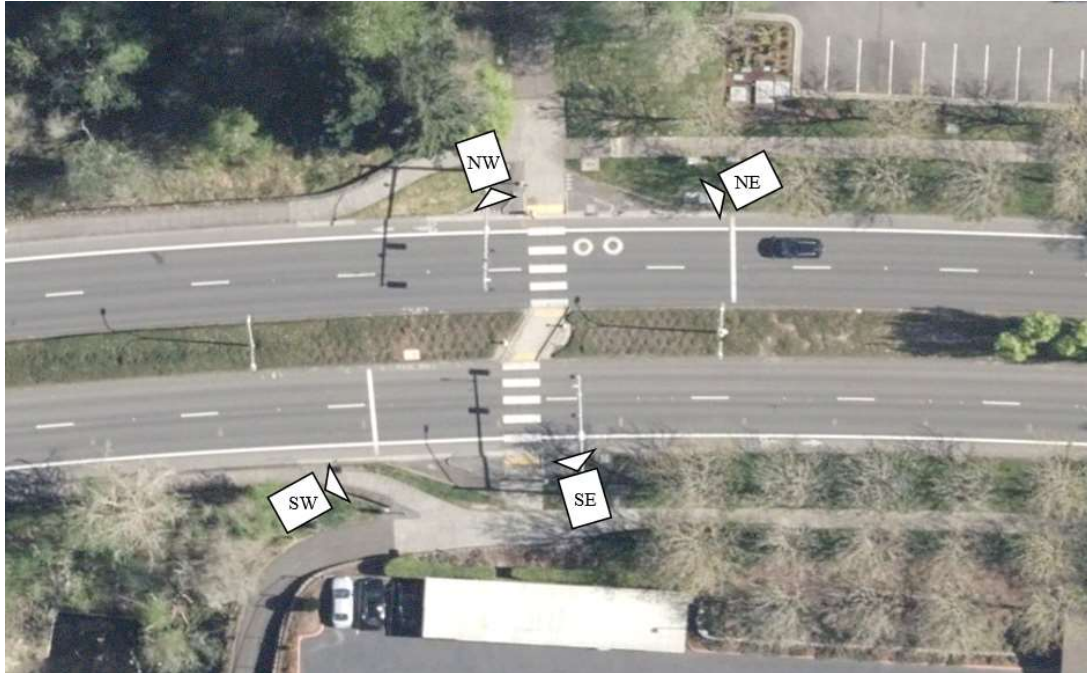
Figure 7- Approximate Camera Locations at the Study Site for Observation

In each phase, temporary optical cameras were installed to record pedestrian movements in 12-hour intervals for one week (seven days). Four cameras were positioned around the pilot location to capture the entire crosswalk, pedestrian indication, and vehicular traffic, as shown in **Figure 7**. The NW and SE cameras view the crosswalk. Both were high-definition cameras that allowed researchers to observe pedestrians pressing the push button and view of the pedestrian indication. The NE and SW cameras showed eastbound and westbound traffic, stop lines, and vehicular indications. **Figure 8** displays the four camera views used for data collection. Thermal detection sensors are located on the same poles as the NW and SE cameras. Combined with outputs from the controller log, researchers evaluated the crossing and waiting behaviors of pedestrians.

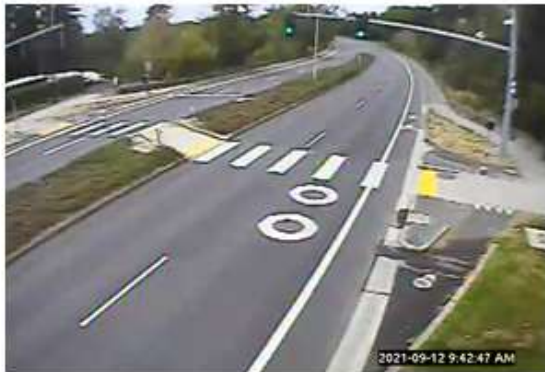
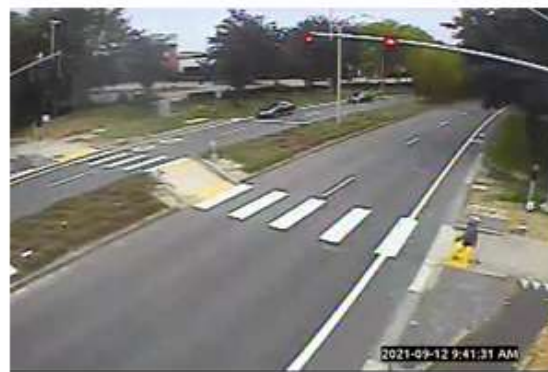
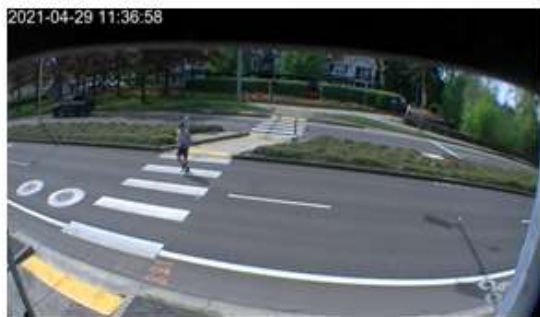
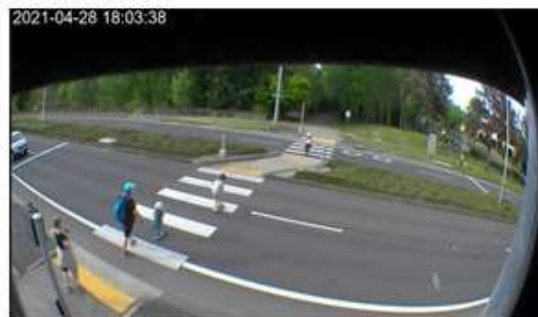
Figure 8- Camera Views (a) NE Camera, (b) SW Camera, (c) NW Camera, (d) SE Camera

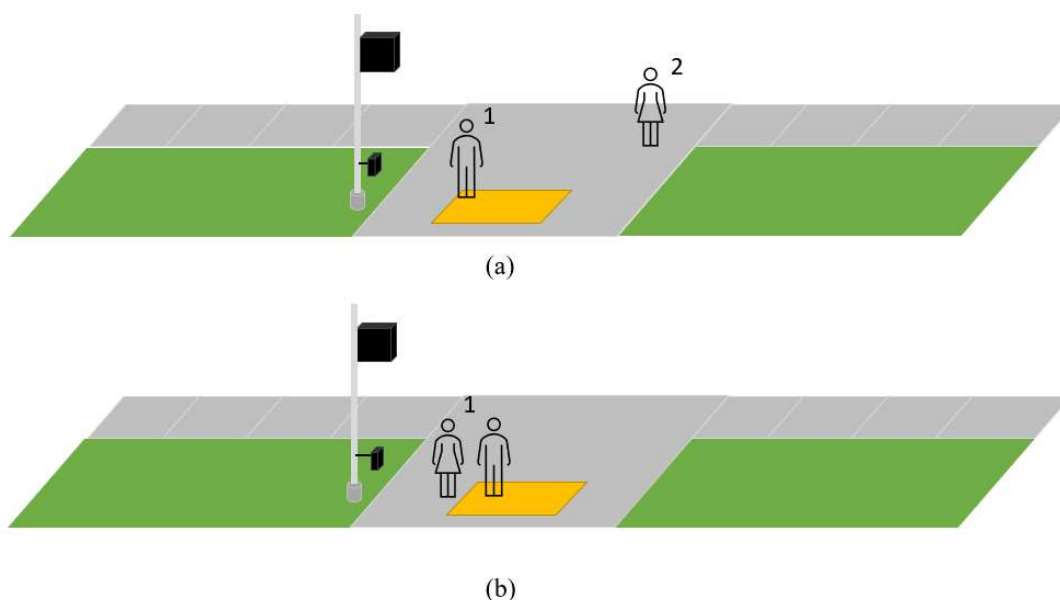
Figure 10- Example of (a) Two Individual Observations and (b) One Observation

One observation is defined by a pedestrian/pedestrians or bicyclist/bicyclists that cross the street at or near the defined crosswalk. Users may or may not enter the curbside waiting zone or use the entire crosswalk (e.g., a bicyclist entering the crosswalk at the median from the traffic lane). A group was determined to be together if they entered a waiting zone at the same time and appeared to have common origins and destinations. If a trail user entered the wait zone after another and waited several feet behind the lead pedestrian, these were considered two separate observations, as shown in **Figure 8**. Pedestrians or bicyclists waiting at opposite curbside zones at the same time were recorded as two observations. The pre-installation observation period yielded 1649 unique observations. The two post-installation observation periods yielded 1772 and 1230 observations, respectively. Due to the second after condition occurring in early Fall with colder, wetter weather, fewer observations were collected. Each data collection period

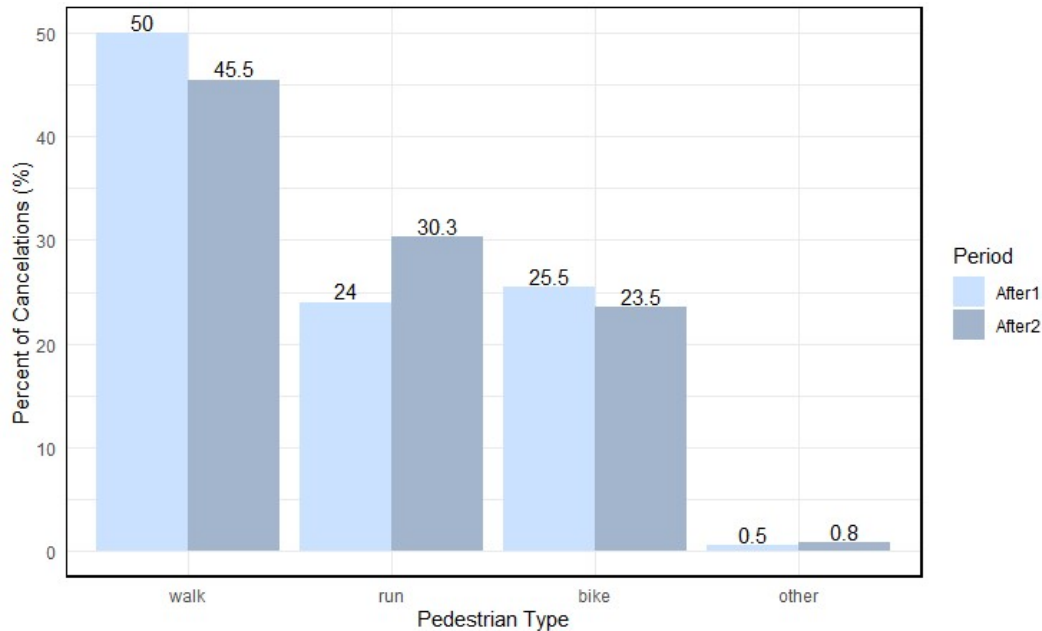
Figure 11- Cancellations by User Type Distribution

The Pedestrian Call Extension and Cancellation System aims to reduce vehicular delay by canceling calls for service after a pedestrian jaywalks, decides not to cross, or otherwise leaves the waiting zone. During After 1, 204 cancelations (12.3% of observations) occurred throughout the observation period. During After 2, 133 cancelations (10.8% of observations) occurred throughout the observation period. Results are presented in **Table 3**. As shown in **Figure 11**, 50.0% and 45.5% of these cancelations were caused by walkers during After 1 and After 2, respectively. Runners caused 24.0% of cancelations in After 1 and 30.3% of cancelations in After 2.

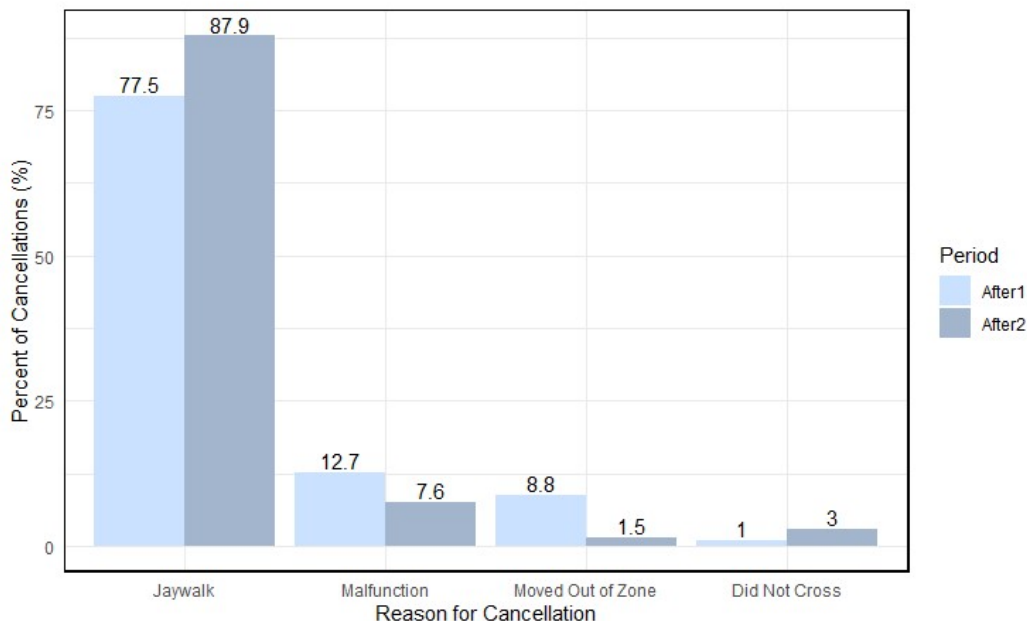
Figure 12- Cancellation Cause Distribution

Four (4) scenarios for a cancellation exist: the user jaywalks, the user leaves the waiting zone, the user walks away and does not cross, or a malfunction occurs. Jaywalkers caused the majority of cancellations with 77.5% and 87.9% in After 1 and After 2, respectively. Malfunctions, however, accounted for 12.7% and 7.6% of cancellations in After 1 and After 2, respectively. Results are shown in **Figure 12**. Between After 1 and After 2, a total of 36 malfunction-caused cancellations occurred. Of these malfunctions, 24 (66.7%) occurred at the southside wait zone, and 32 (88.9%) pressed the pushbutton after the call was canceled. Each malfunction is described in detail in Appendix B- Edge Cases.

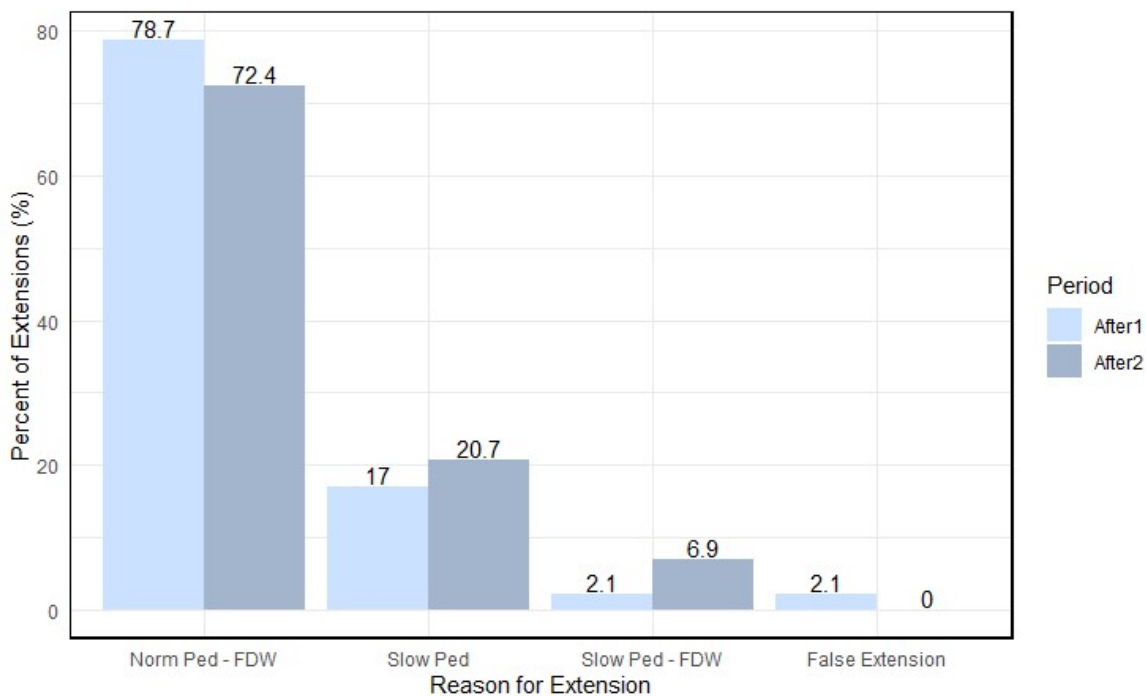
Figure 13- Distribution of Extension Causes

which the system is designed for, only account for 17.0% and 20.7% in After 1 and After 2, respectively. One false extension occurred when a pedestrian pressed the median pushbutton while crossing. Although no one was present in the crosswalk when the pedestrian phase was served, the call was recorded as a one-second extension.

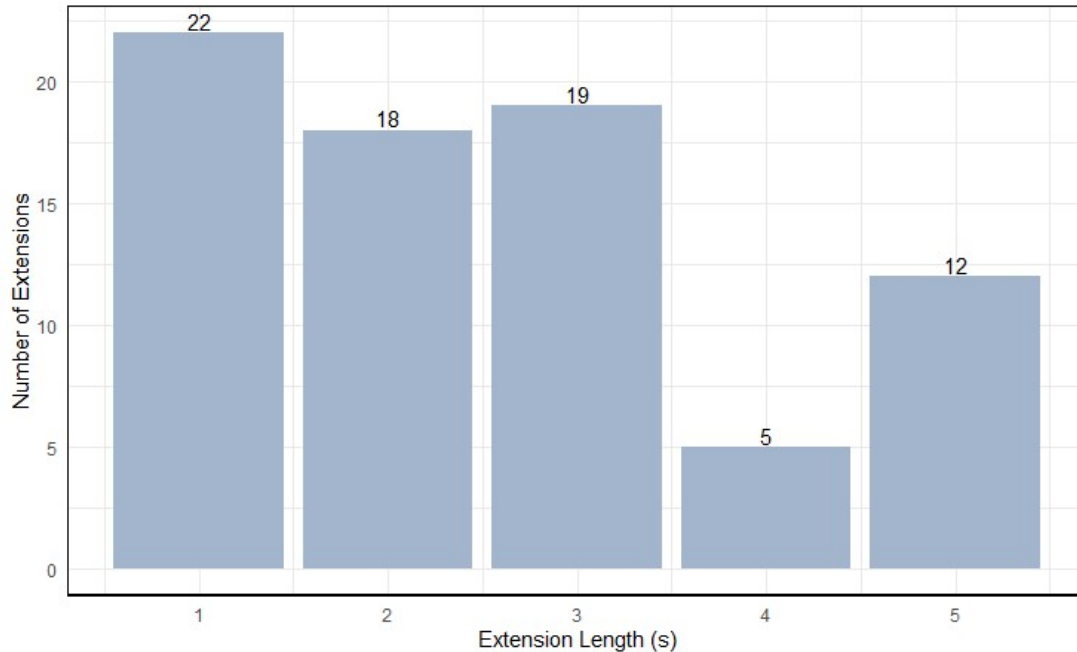
Figure 14- Frequency Distribution of Extension Durations

Calls are extended between one and 10 seconds, depending on a pedestrian's location within the crosswalk and speed. The average extension length in After 1 was 2.4 seconds with a standard deviation of 1.4 seconds. The average extension length in After 2 was 2.8 seconds with a standard deviation of 1.4 seconds. Generally, pedestrians only need a couple of seconds to complete a crossing maneuver, even if entering during the FDW phase. All extensions were between one and five seconds. A distribution of extension duration is shown in **Figure 14**.

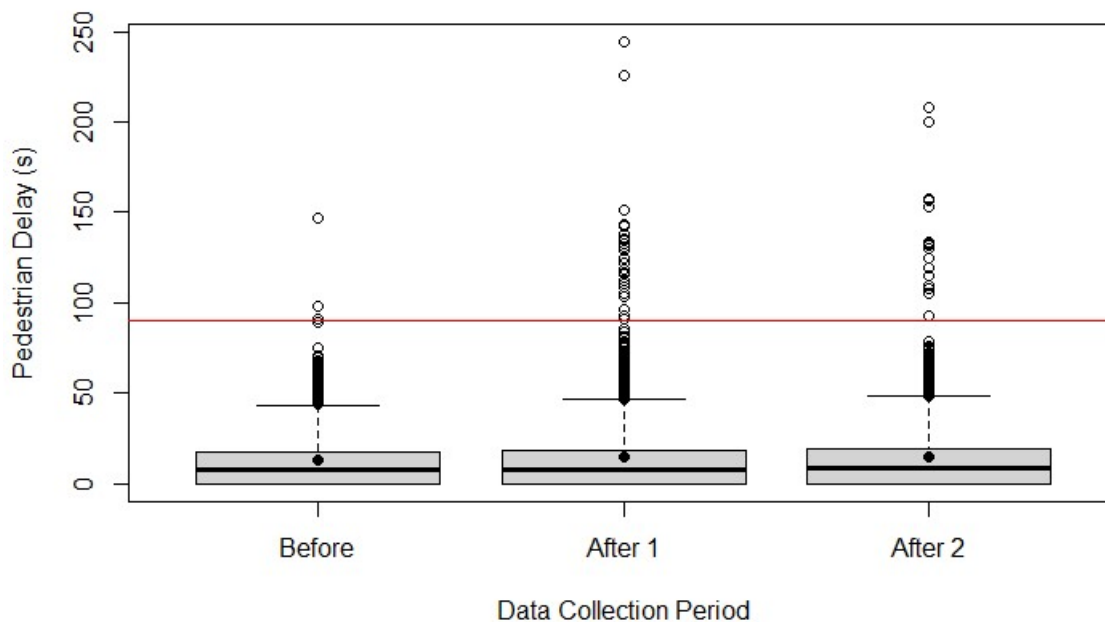
Figure 15- Boxplot of Pedestrian Delay with Outlier Reference

Pedestrian waiting time, which equates to the amount of time a pedestrian waited before beginning to cross, was recorded for each observation. Delay was recorded from the time the pedestrian pressed the pushbutton or arrived at the waiting zone area adjacent to the button if the pushbutton was not activated (National Academies of Sciences Engineering and Medicine 2022). Average pedestrian delay in the Before, After 1, and After 2 periods were 12.7, 14.9, and 15.1 seconds, respectively. The boxplot in **Figure 15** shows the distribution of pedestrian delay across observation periods.

As shown in **Figure 15**, all three observation periods include several data points with pedestrian delay beyond the maximum value determined by Interquartile Range (IQR). According to the Interquartile Range Rule, outliers are defined by one and a half times the third quartile of the IQR. However, this method results in different outlier thresholds for each observation periods and eliminated 286 (83 from Before, 126 from After 1, 77 from After 2) observations that potentially represent valuable insights into system operations under high volume periods. To better fit the data and crosswalk signal timing, outliers are defined as observations with pedestrian delay above 90 seconds. This corresponds with the location at which IQR-defined outliers begin to visually begin to separate from each other, as seen in **Figure 15**. It also corresponds with the signal's cycle length during peak hours.

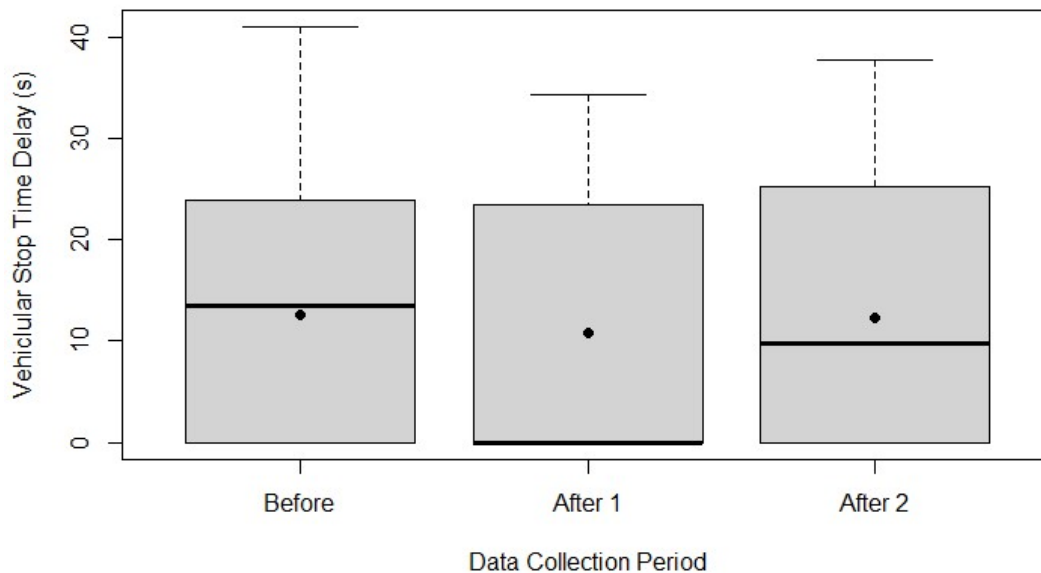
Figure 16- Boxplot of Vehicular Stop Time Delay

Unlike pedestrian delay, the vehicular delay data do not indicate any outliers when considering the Interquartile Range Rule. As a result, no outliers were removed from the dataset to analyze stop time delay.

As shown in **Figure 16** average vehicular delay initially decreases after the Pedestrian Call Extension and Cancellation System installation and increases again by the second after observation period. One-sided t-tests were conducted to compare mean vehicular stop time delay between After 1 & After 2 and Before and the three After conditions (After 1, After 2, and Overall After). Doing so shows there is convincing evidence that the mean vehicular delay between After 1 & After 2, Before & After 1, and Before & Overall After are significantly different. There is no evidence that there is a difference in the mean stop time delay between Before & After 2. This may be due to the higher percentage of cancellations observed in After 1 than in After 2. Overall, it can be concluded that vehicular stop time delay decreased after installation. Results are displayed in **Table 9**.

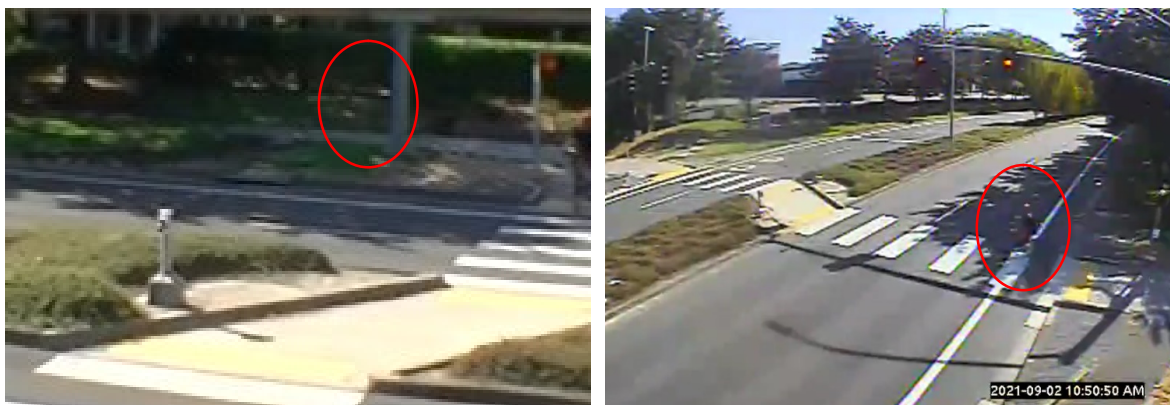
- 30. * September 2, 10:50:** Call was recorded as canceled, but pedestrian interval was served. Noted that waiting zone was in shadow. Pedestrian began crossing during yellow change interval. No FLIR available for southside wait zone for this observation period.

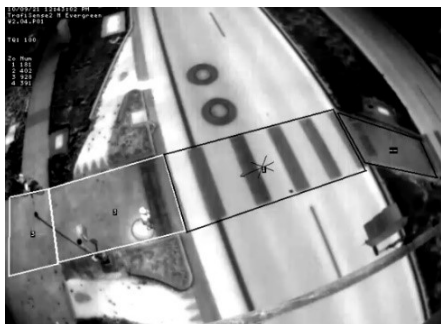
57. ** **October 9, 12:10:** Pedestrian jaywalked, and the call appears canceled, but is not recorded in the call logs as a cancelation.
58. **October 9, 12:43:** Two pedestrian arrived at same time, on opposite sides of street. Both pressed pushbutton, NB pressed multiple times. The pedestrian who had previously crossed stopped at the edge of the northside wait zone, and the FLIR eventually dropped occupancy for this section (see below). Call canceled with 132 second ped delay.

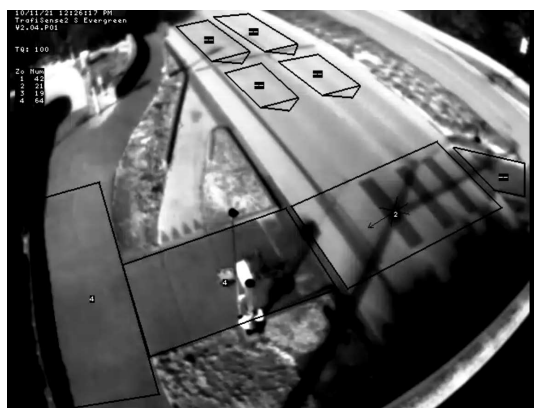
- 67. *** October 11, 12:31:** NB Pedestrian pressed pushbutton upon arriving to wait zone and behind the pedestrian signal head. FLIR occupancy turned on and off. Call canceled and the pedestrian pushed the button again and crossed on the Walk symbol. Sunny conditions, no shadows. Screenshot of FLIR below.

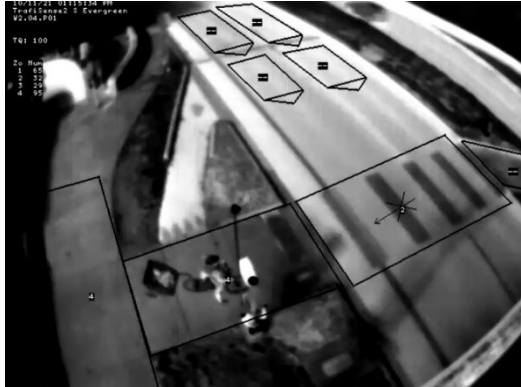
- 68. * October 11, 12:39:** Call was recorded as canceled, but pedestrian interval was served. Pedestrian began crossing during yellow change interval.
- 69. *** October 11, 13:** NB bicycle pressed pushbutton upon arrival to wait zone. FLIR dropped occupancy after pedestrian stood still for a few seconds. Call canceled, and the pedestrian pushed the button again and crossed on the Walk symbol. Cloudy conditions, no shadows. Screenshot of FLIR below.

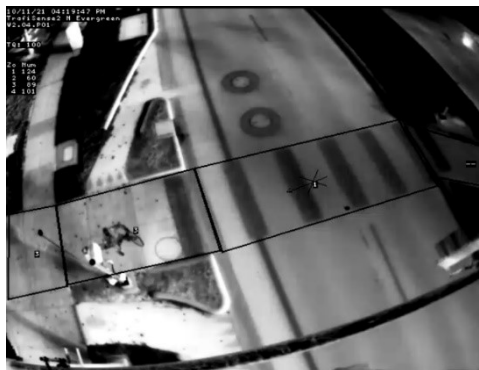
70. *** **October 11, 16:23**: SB bicyclist pressed pushbutton. Another pedestrian approached and stood in line with the pedestrian signal head. The two appear to talk for several seconds, after a while the FLIR occupancy drops, and the call cancels. The second pedestrian walked away, and the original pedestrian pushed the button again and crossed on the Walk symbol. Wait zone never regained occupancy after the second pedestrian walked away.
