**Hatfield Marine Science Center  
Dynamic Revetment Project  
DSL permit # 45455-FP**

**Monitoring Report  
February, 2014**

February 25, 2014

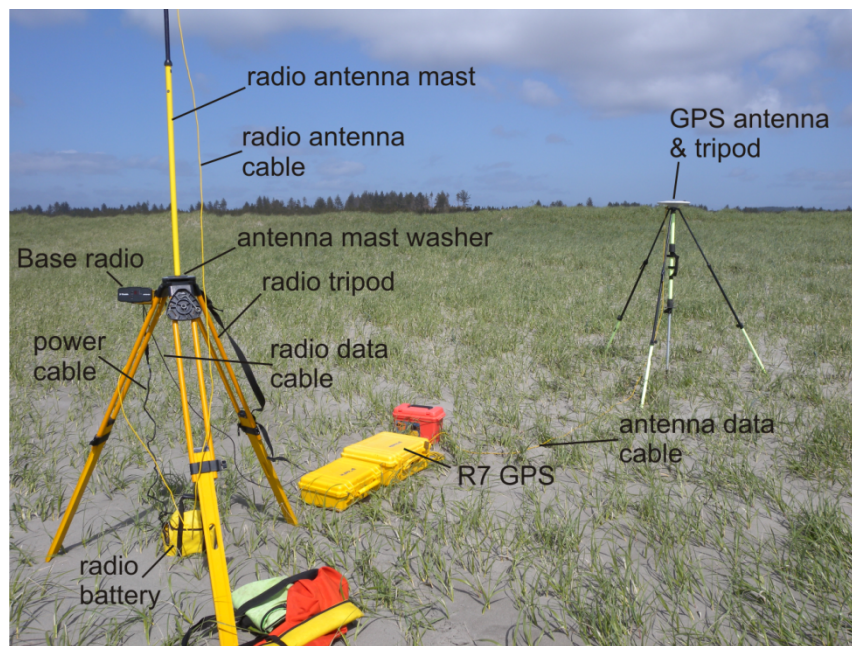
Figure 2.1. The Trimble R7 base station antenna in operation on the Clatsop Plains. Corrected GPS position and elevation information is transmitted by an HPB450 Pacific Crest radio to the R8 GPS rover unit.

station (R7), Zephyr Geodetic antenna (model 2), HPB450 radio modem, and R8 “rover” GPS (Figure 2.1). Trimble reports that both the R7/R8 and 5700/5800 GPS systems have horizontal errors of approximately  $\pm 1\text{-cm} + 1\text{ppm}$  (parts per million \* the baseline length) and  $\pm 2\text{-cm}$  in the vertical (Trimble, 2011).

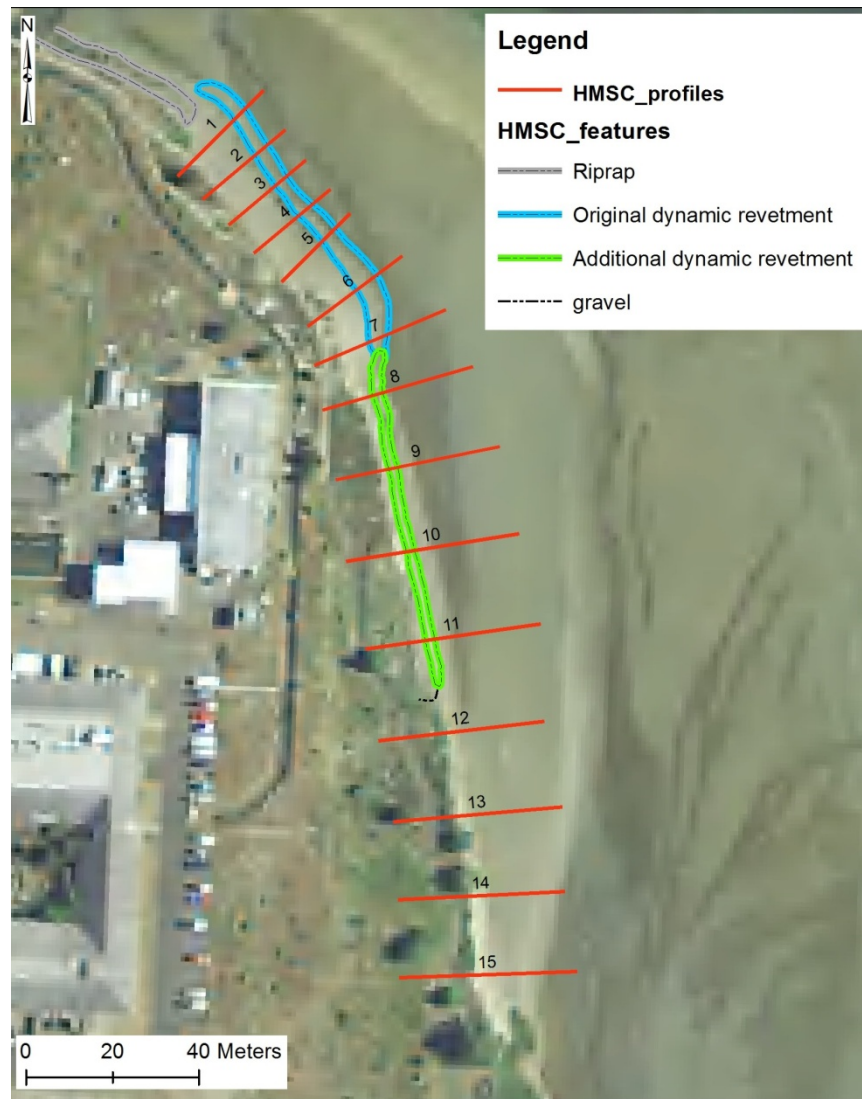
Figure 2.2: Location map showing the HMSC beach and shoreline monitoring network. Blue shaded dashed line denotes the cobble ‘lag’ toe of the original dynamic revetment, green shaded dashed line denotes the cobble ‘lag’ toe for the expanded section and grey shaded dashed line denotes the location of rip rap rock.

For the purposes of this study, we established 15 beach profile transect lines along the estuary trail (Figure 2.2), which extends from the HMSC wharf in the northwest, southward approximately 290 m (~950 ft). Of these, 5 of the lines were originally established in May 2006 (1-5) to document changes on the original gravel beach constructed there in late 2006, while the remaining 10 lines were established in July 2011. GPS Surveys were undertaken on the original profile 1-5 lines in May 2006, March 2007 and in September 2007 (Table 2.1). These data have been supplemented with high resolution terrain elevations extracted from a LIDAR dataset (8 points per m<sup>2</sup>) collected by DOGAMI for the Northern Oregon coast in July 2009. Table 1 presents the times when all surveys of the beach were carried out. As described in our previous report, subsequent future surveys will be confined to mid-late winter (~February/March timeframe) and in late summer (~September).

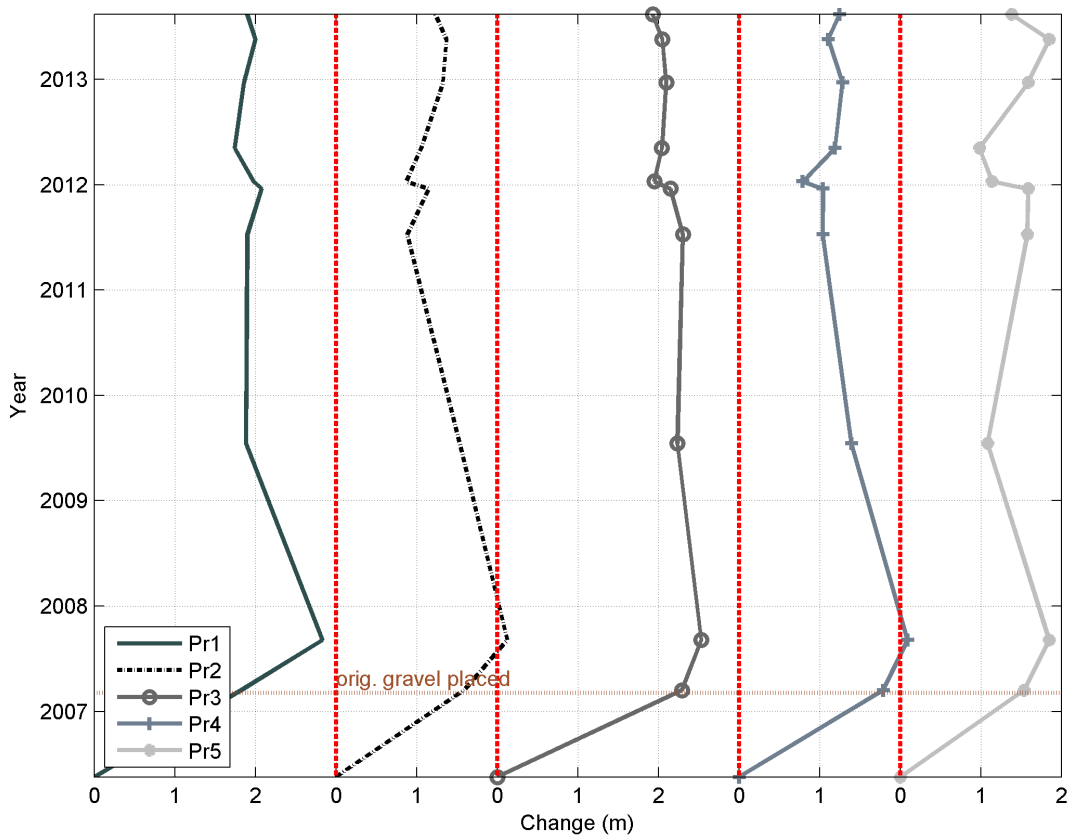
Figure 2.1: Transects 1 to 5 span the region where the original dynamic revetment/gravel beach was constructed. The zero line reflects the initial survey prior to construction of the gravel beach.

Figures 2.3, 2.4 and 2.5 present the change over time as measured at the 2.4 m elevation contour for all the transect sites, with the study area having been divided into three study reaches: original dynamic revetment (Figure 2.3), expanded dynamic revetment (Figure 2.4), and control area (Figure 2.5). Individual profile responses and time stacks (EDA plots) of changes taking place at selected contour elevations can be accessed online using the NANOOS Beaches portal: <http://nvs.nanoos.org/BeachMapping>. To view these data, select “Newport” in the regions section of the web portal. From there it is possible to zoom in to obtain a close-up view of the HMSC campus and access the individual data plots.

Figure 2.3, which depicts the measured changes in the original gravel beach area, indicates that the initial dynamic revetment design (blue dashed line in Figure 2.2), which included placement of gravel on the beach face and a lower cobble “lag” berm located at the juncture between the sandy beach and the inter-tidal mudflats, has been successful in stabilizing further retreat of the beach. This is characterized by the fact that there have been negligible changes to the gravel beach morphology over time.

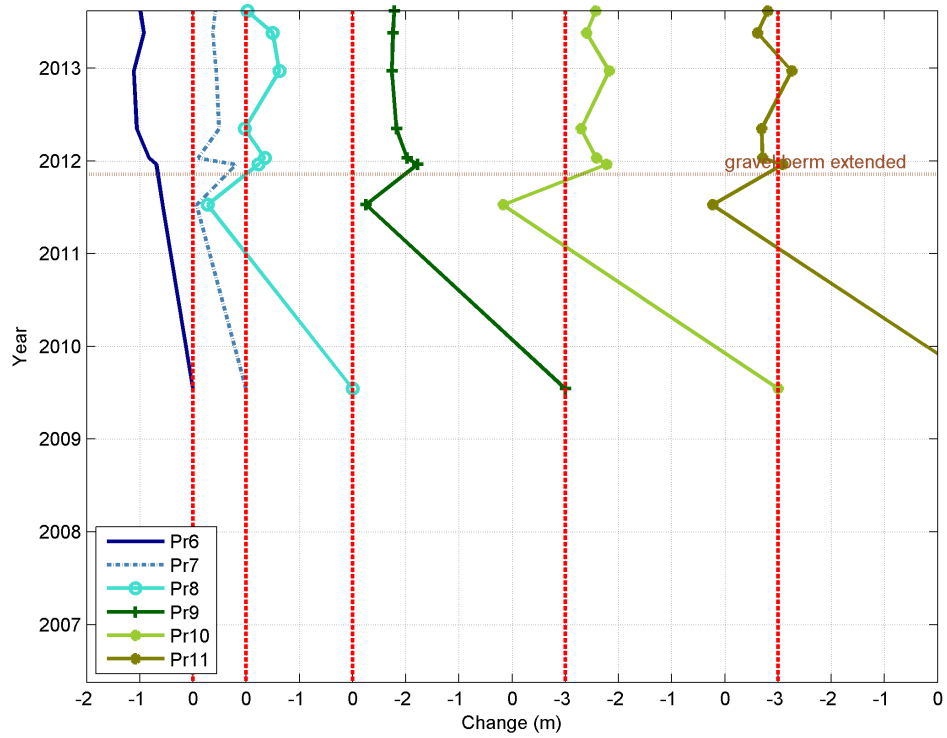
Figure 2.2: Transects 6 to 11 span the region where the expanded dynamic revetment/gravel beach was constructed. The zero line reflects the initial survey prior to construction of the gravel beach.

Further south, between Transects 6-11 (Figure 2.4), the beach survey data indicate that the expanded gravel beach section is also stable, such that erosion of the beach and backshore has essentially ceased. In Figures 2.4 and 2.5, the baseline for our current monitoring efforts is the 2009 LIDAR. Some sediment loss appears to be occurring in the vicinity of Transect 6 (Figure 2.4), although the amount of gravel loss is negligible. As noted in our previous report, we recommend that HMSC consider adding some additional gravel to this portion of the existing dynamic revetment in order to safe guard its volume.

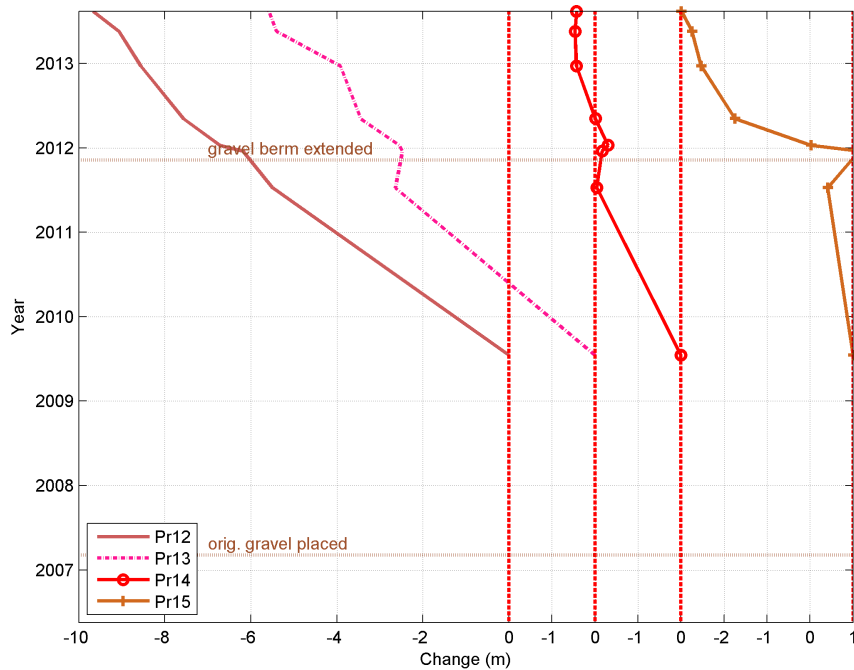
Figure 2.5: Transects 12 to 15 span the unprotected (control) region. The zero line reflects the initial survey prior to construction of the expanded gravel beach.

In contrast, the southern “control” area continues to experience significant erosion (Figure 2.5), with some areas having eroded by 7.5 to 9.6 m (respectively HMSC 13 and 12), decreasing to -2.4 m at Transect 14 and -4 m at Transect 15. In the case of the two former transects, the current rate of erosion is unchanged from the period prior to gravel beach construction, which indicates that the erosion is independent of the recently constructed gravel beach. As noted in our earlier report, these changes reflect a complete landward translation of the entire beach profile. Hence, based on current patterns, we fully expect the erosion to continue to occur in the south.

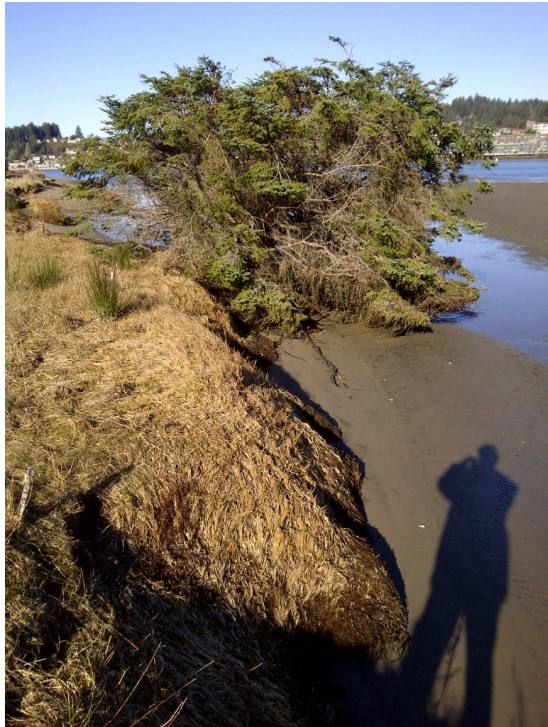
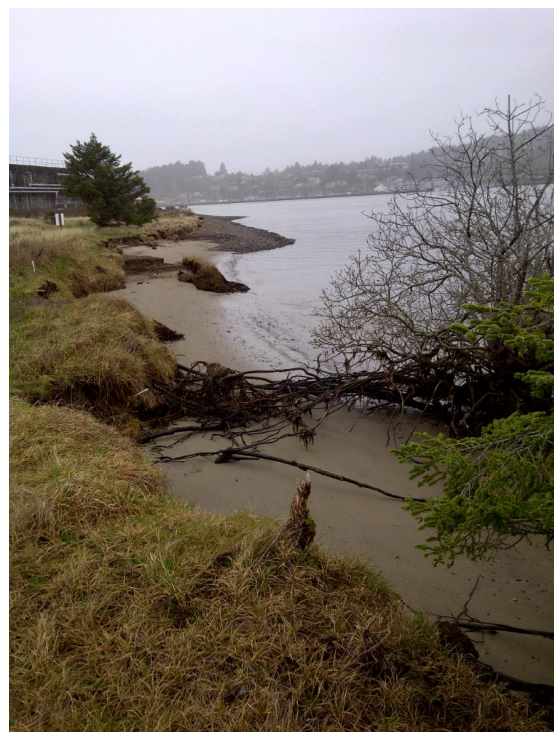
Figure 3.6: A. Trees near Reference site 4 for fish trawls showing intertidal structure added by collapsed trees, January 2013. B. View of eroded roots from second tree, February 2014.

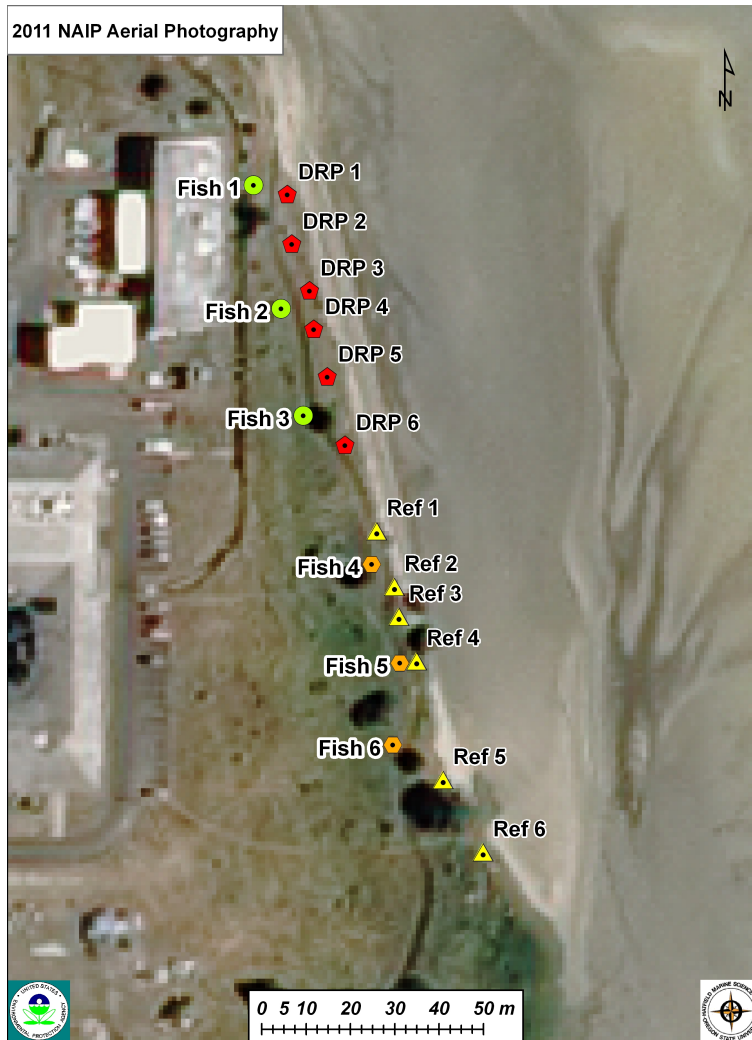
Figure 3.6: Vegetation plots in DRP (red symbols, DRP 1-6) and Reference (yellow symbols, Ref 1-6) survey areas. Locations of fish sampling transects are shown as green (DRP, Fish 1-3) and orange (Reference, Fish 4-6) symbols.

To assess possible changes in shoreline vegetation following DRP installation, sampling was focused on the approximately 1 to 10 m wide strip of land between the paved HMSC estuary trail and the shoreline (Figure 3.6). This area contains mixed vegetation community types including high marsh, dune and terrestrial plants and shrubs. Six 1-m<sup>2</sup> quadrats were established within the DRP and Reference areas in October 2011 (Figure 3.6) and a labeled PVC stake was placed to mark the quadrat center. A Trimble R8 GNSS unit was used to establish horizontal and vertical positions of the center of each plot by performing an RTK survey with the ORGN network. Quadrat Reference 1 was lost to erosion prior to sampling. The remaining 11 quadrats were resampled on September 6-7, 2012. During 2013, Reference Quadrats 2 and 3 were lost to erosion. Quadrats 4 and 5 are now also threatened by erosion and may disappear within the next year. Therefore, new quadrats were established inland of the original plots as substitutes, and are designated as quadrats 1A, 2A, and 3A.

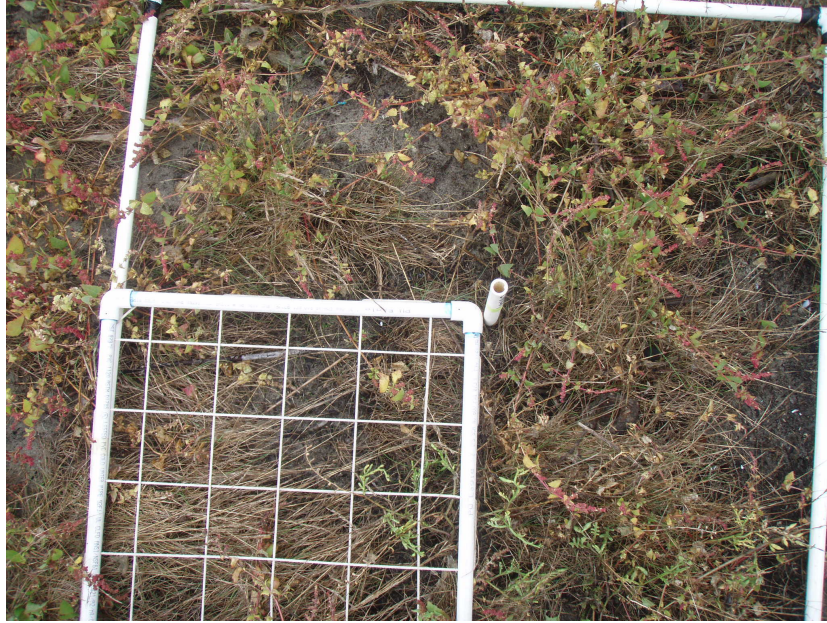
Figure 3.7: Close up of 1-m<sup>2</sup> quadrat used to determine plant presence-absence with the 0.25-m<sup>2</sup> quadrat used to determine percentage cover of vegetation.

Vascular plant presence or absence (usually at the species level) was visually assessed by scanning one 0.25 -m<sup>2</sup> quadrat within each 1-m<sup>2</sup> quadrat (Figure 3.7). Plant percent cover was assessed by visually evaluating the percentage that each plant species contributed to the overall plant community present within the 1-m<sup>2</sup> quadrat. Percent cover estimates also considered non-

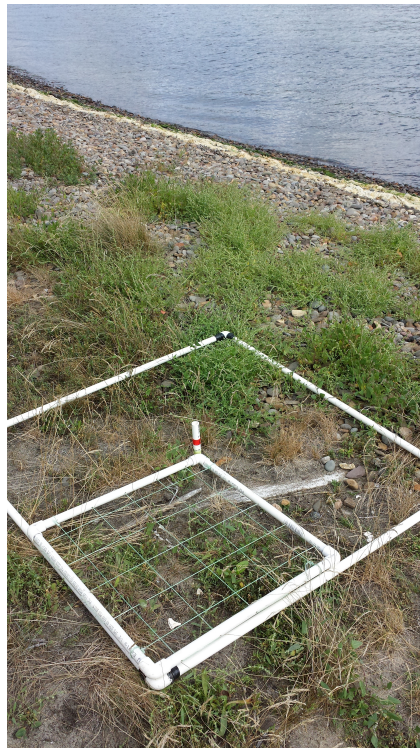
Figure 3.8: Vegetation monitoring Quadrat DRP 1, September 2013. Note presence of some gravel moved from top of berm landward into the quadrat, and the presence of vegetation on the upper beach face growing up through the gravel. View to northeast.

The lower average vegetation cover at the DRP sites has been a consistent result during the monitoring and was present in the pre-project samples. DRP quadrats 1-3 occur at lower elevation than most other sample locations, and as described in the 2012 report, there is also a topographic low spot in the shoreline near beach profile 9 (Figure 2.1), which allows the back shore area to be more frequently flooded by fall and winter king tides. The patchy nature of vegetation at DRP 1 is shown in Figure 3.8, which also shows gravel that has moved into the quadrat from the adjacent beach by overwash. Note also in Figure 3.8 that vegetation is growing up through the gravel on the upper beach face.

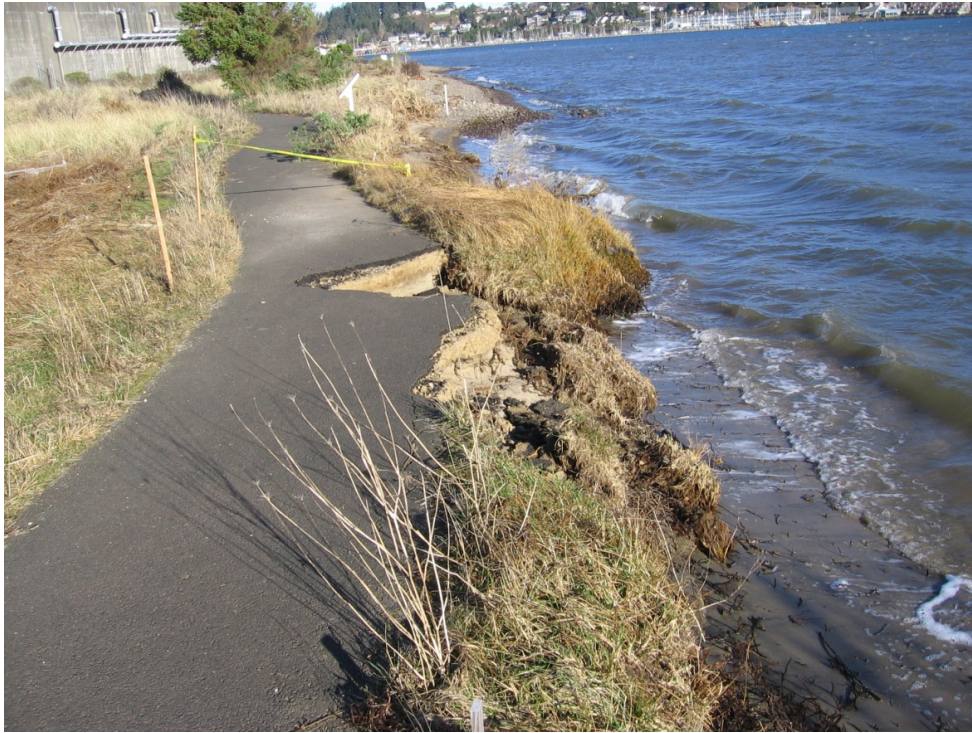
Figure 4.1: View of collapsed section of HMSC nature trail, February 3, 2012.

As described in Section 2.2, as of February, 2014, both the 2007 and 2011 DRP shoreline sections appear mostly stable, while erosion has continued to occur in the Reference area immediately to the south of the DRP. “King” tides occurring from November – February have continued to roll back the shoreline vegetation, and steep vertical scarps at the vegetation edge are the norm along this shore section. Erosion in the unprotected Reference area in the period 2009-2013 has been as great as 9.6 m (31.5 ft). The effect of erosion during 2013 can be seen in comparison of Figures 4.1, 4.2 and 4.3, taken from a similar spot on the HMSC Nature Trail. Erosion in 2013 has continued to create vertical banks of collapsed sod, with salt marsh vegetation collapsing and being eroded away (Figure 4.4). Erosion has continued along the entire length of the Reference area, and has begun to erode low salt marsh habitat which has not been exposed to erosion before. Following King tides and high winds, large chunks of marsh sod had been uprooted from this area and transported hundreds of meters southward onto the sand flat opposite the HMSC picnic shelter. The erosion has also begun to curve in behind the southern end of the DRP and may threaten the stability of the DRP project in this area in the longer term (Figure 4.5).

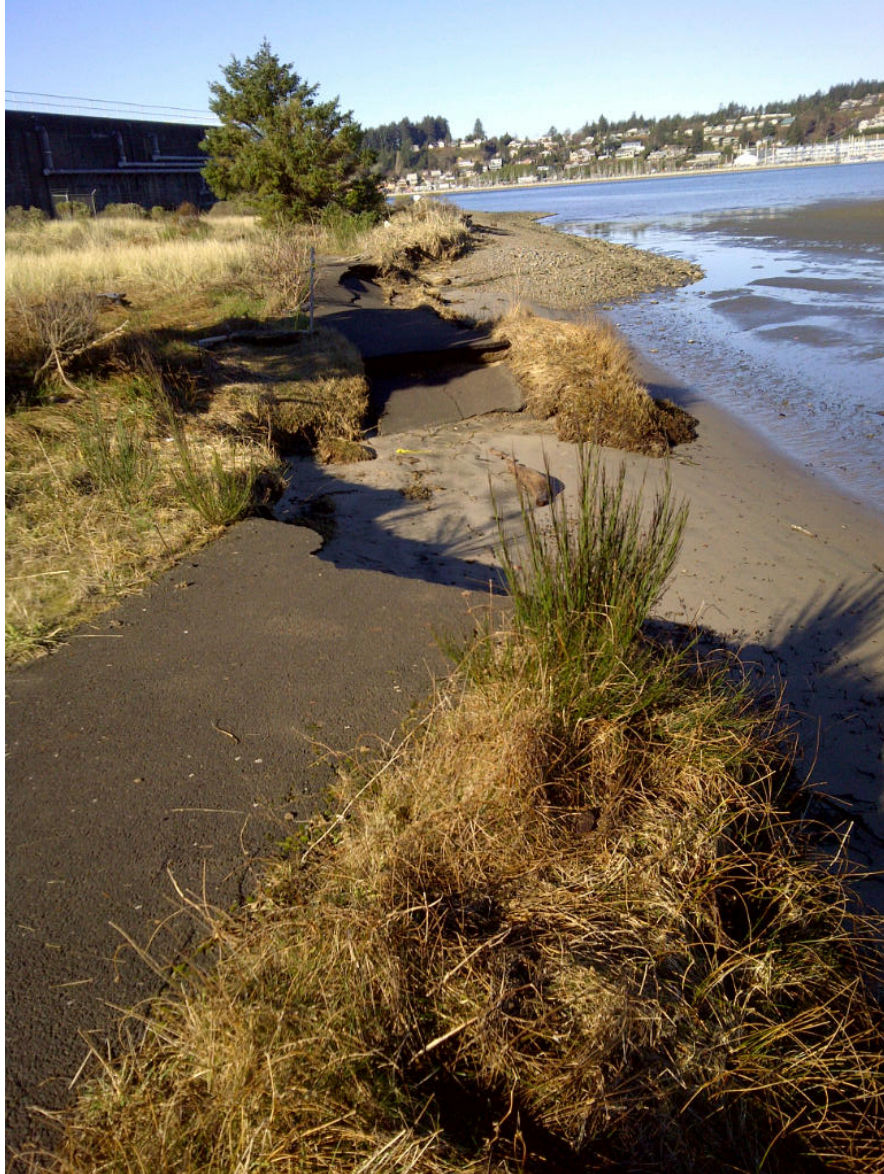
Figure 4.2: View of collapsed section of HMSC nature trail, January 16, 2013. The trail has been completely washed out in the foreground. The trail information sign seen at the top of Figure 4.1 has been removed after erosion undermined the posts supporting it. An additional 60 feet of trail in the middle distance has been undermined and the asphalt has collapsed on the shore.

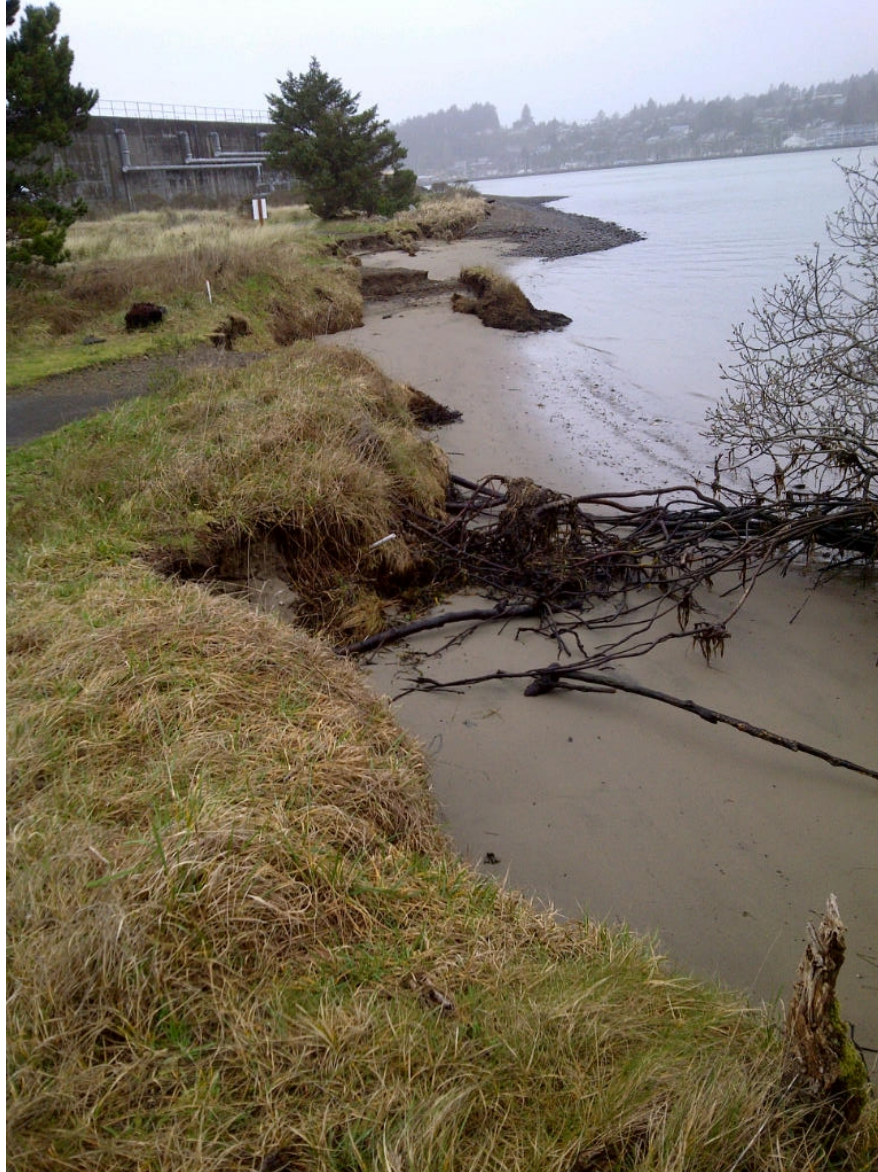
Figure 4.3: View of eroded section of HMSC nature trail, February 14, 2014. The trail has been completely washed out in the section shown in Figure 4.2, and collapsed asphalt has been removed. Another of the Reference area monitoring quadrats for the vegetation studies (PVC stake in center of picture) has been lost to erosion.

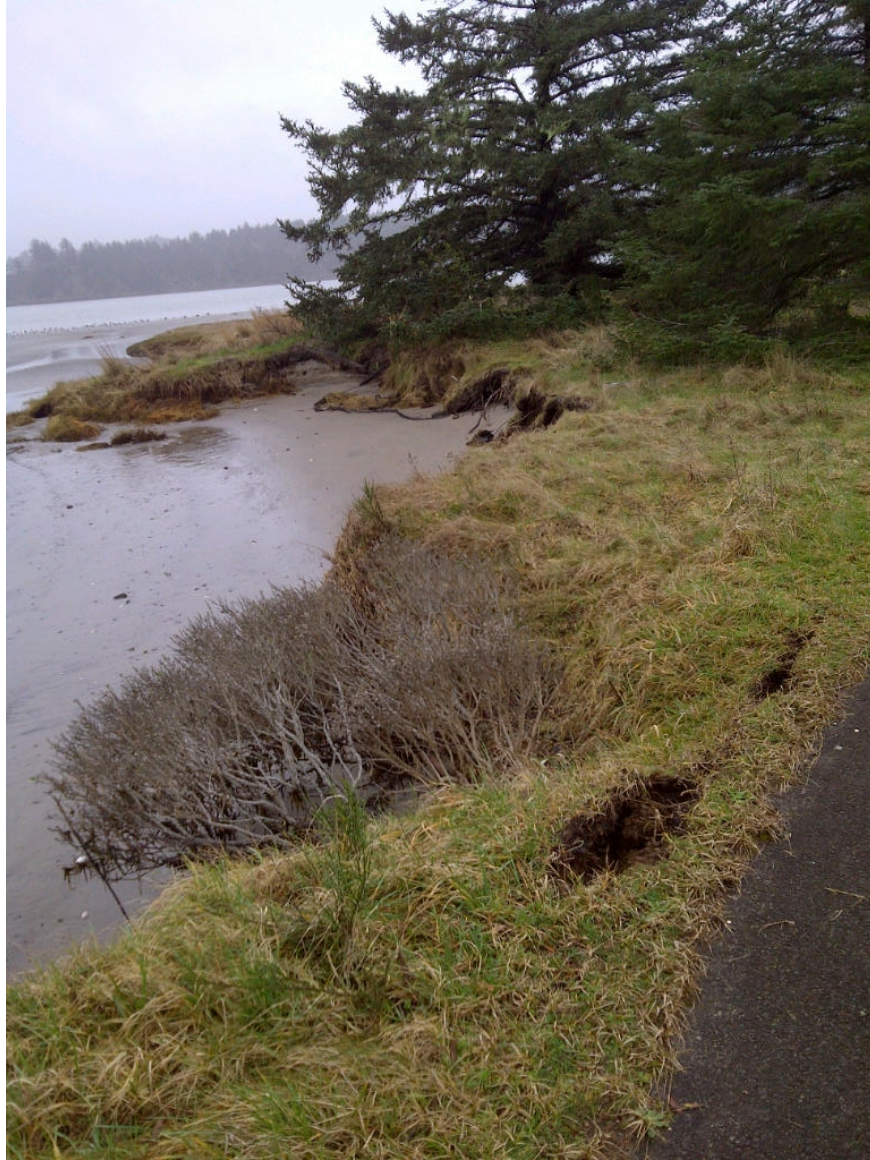
Figure 4.4: View to the south of the 2011 DRP in the Reference area (February 14, 2013), showing collapsed banks with 4 foot vertical scarps. In the upper left, erosion is now starting to attach low salt marsh habitat on the point and beyond which has not previously been exposed to erosion.

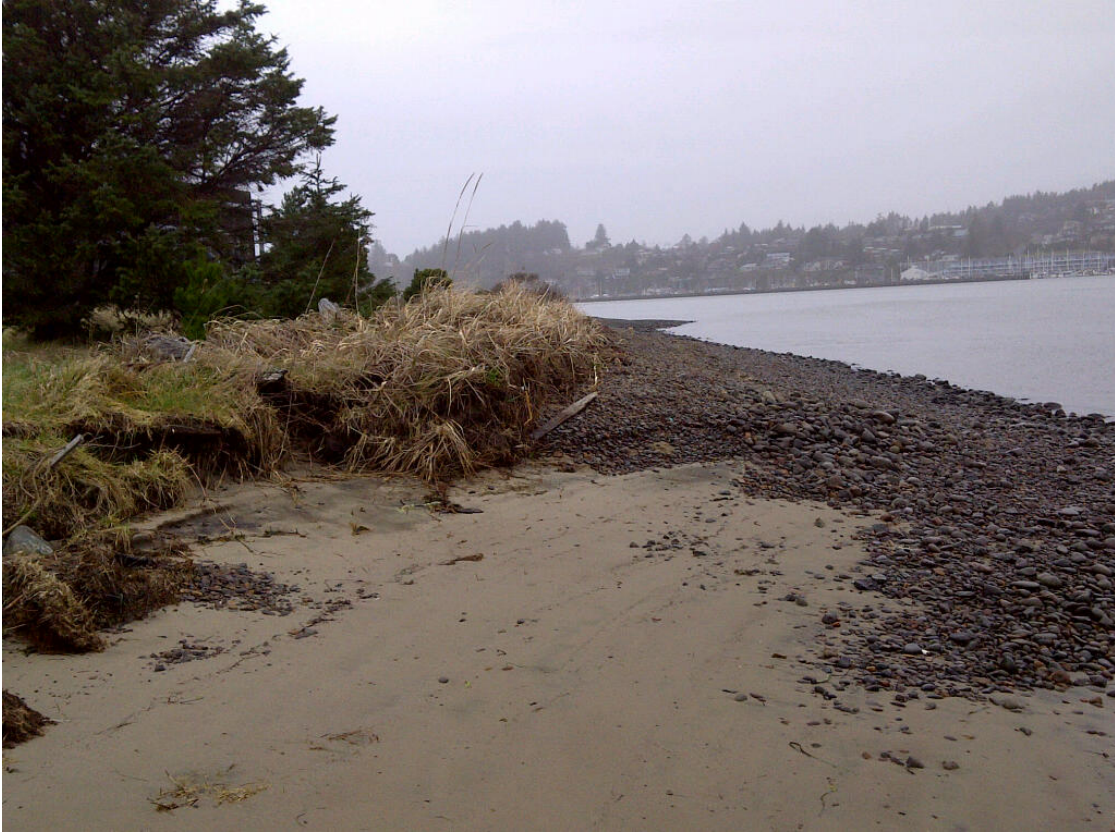
Figure 4.5: View of the southern end of the 2011 DRP (February 14, 2014). Erosion has removed high salt marsh vegetation and is beginning to erode shoreline protected by the DRP.
