# Liquefaction at Strong Motion Stations and in Urayasu City during the 2011 Tohoku-Oki Earthquake

The 2011  $M_w = 9.0$  Tohoku-oki earthquake generated a large number of unique soil liquefaction case histories, including cases with strong ground motion recordings on liquefiable or potentially liquefiable soils. We have compiled a list of 22 strong motion stations (SMS) where surface evidence of liquefaction was observed and 16 SMS underlain by geologically recent sediments or fills where surface evidence of liquefaction was not observed. Pre-earthquake standard penetration test data and borehole shear wave velocity ( $V_s$ ) profiles are available for some stations, but critical information, such as grain size distribution and fines plasticity, are often lacking. In the heavily damaged city of Urayasu, we performed post-earthquake cone penetration testing at seven SMS and  $V_s$  profiles, using surface wave methods at 28 additional locations to supplement existing geotechnical data. We describe the liquefaction effects in Urayasu, the available site characterization data, and our initial data interpretations. [DOI: 10.1193/1.4000110]

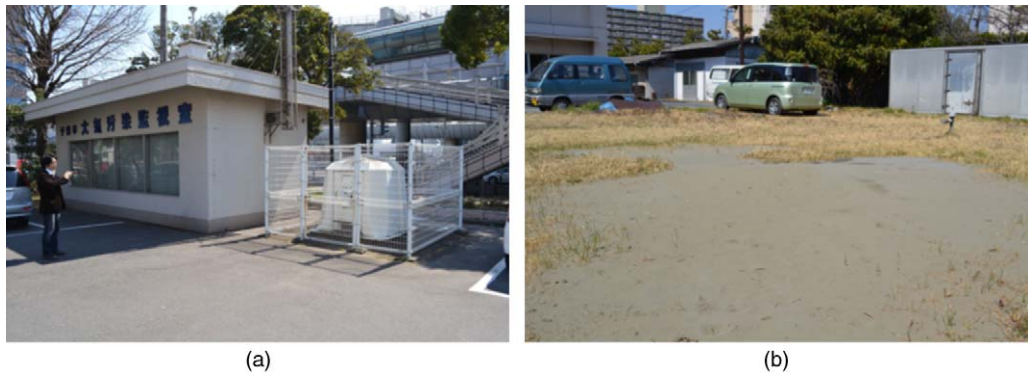
**Figure 2.** Two recording stations in Chiba: (a) station CH009 without ground failure, and (b) station CHB024 with extensive sand boils and moderate ground deformations.

KNET station CHB009 (Figure 1a and Table 2) is an example of a station where no surface evidence of liquefaction was noted despite the presence of saturated sands in the subsurface and a PGA value of 0.183 g. The ground surface around the recording station showed no signs of deformation or soil ejecta in the vicinity, as illustrated by the post-earthquake photograph in Figure 2a. The acceleration time series recorded at the station (NIED 2011), as shown in Figure 3, exhibit no evident change in site response characteristics

KNET station CHB024 (Figure 1a and Table 1), just a short distance away from CHB009, is an example of a liquefaction site, as evidenced by the extensive surface ejecta and ground cracking shown in the post-earthquake photograph in Figure 2b. The acceleration time series recorded at the station (NIED 2011), as shown in Figure 3, exhibit a clear change in site response characteristics (e.g., deamplification and period elongation) at about 130 s, which is attributed to the triggering of liquefaction. The PGA at the site was 0.237 g. The soil profile consists of about 1.5 m of fill, overlying a thick sand layer (Figure 4b). The water table is estimated to be at a depth of about 3 m. The SPT blow counts, which are assumed to correspond to a typical energy ratio of 75%, are generally less than 20, as indicated in Figure 4b. Excluding a dense layer between approximately 4–7 m, the CRRs are all lower than the earthquake-induced CSRs computed using the procedures from Idriss and Boulanger (2008). The fines content of the sand is not available, so it was assumed to be 5% based on its visual description. The analysis results are reasonably consistent with the observed field behavior in that the  $FS_{liq} = CRR/CSR$  was well below unity for most of the sand stratum. The predicted free-field surface settlement, again using the procedures from Idriss and Boulanger (2008), is about 50 cm, which is greater than generally observed at the site (near adjacent buildings on pile foundations). The overestimation of surface settlements could be attributed to the expectation that liquefaction may initiate in certain depth intervals and not progress throughout the entire stratum due to the reduction in dynamic stresses following liquefaction triggering. Additional information regarding post-liquefaction settlement analyses is provided below. More detailed analysis of site response effects will require additional site characterization data that is not currently available.

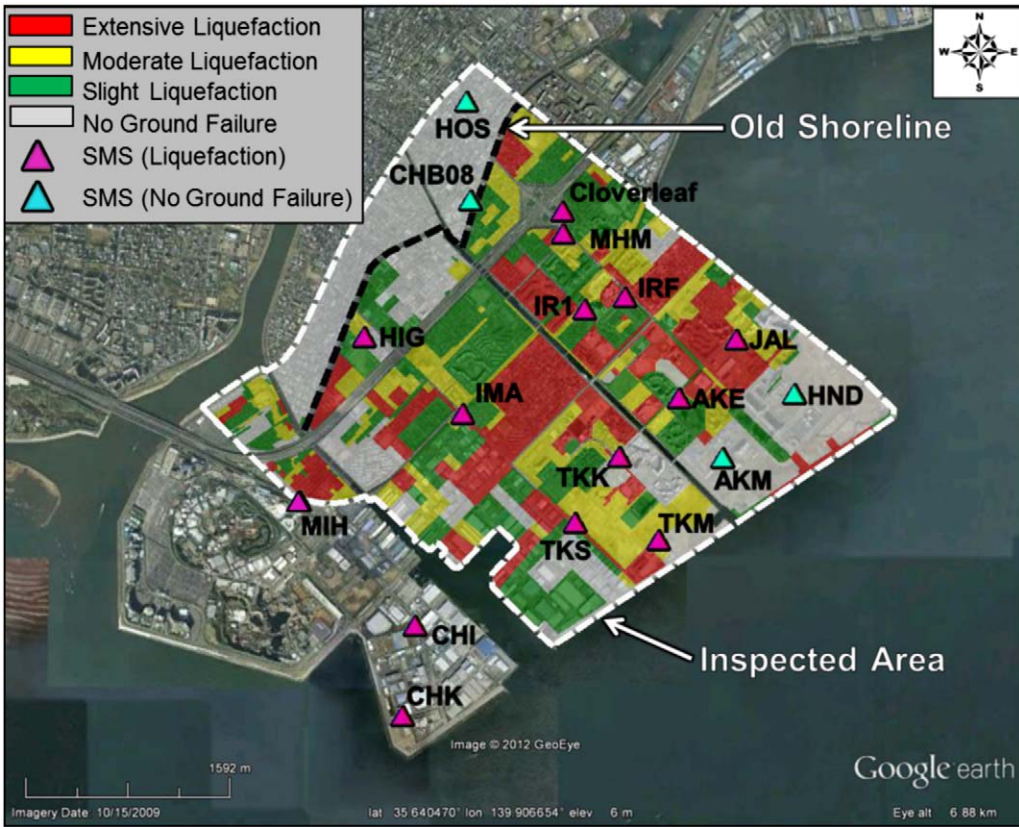
**Figure 7.** Liquefaction severity map of Urayasu City with the locations of strong ground motion stations (liquefaction severity after Tokimatsu and Katsumata 2012).

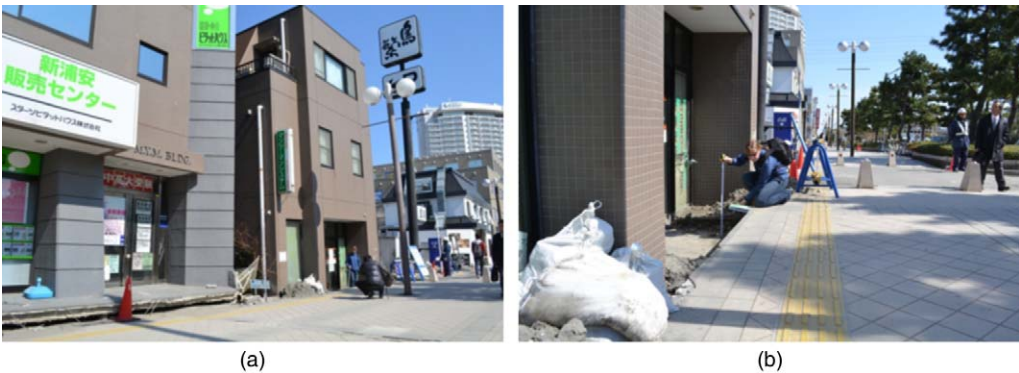
**Figure 8.** Differential settlements between a gray building on piles, a brown building on a shallow foundation (brown building on the right), and the ground surface in Urayasu (GEER 2011).

Ground surface settlements relative to buildings supported on pile foundations varied significantly across the city. The photographs in Figure 8 illustrate a particularly interesting case where the ground settled about 30 cm relative to a building on piles (gray building in left photo), while an adjacent three-story building on a mat foundation tilted and settled an additional 40 cm relative to the ground surface (i.e., approximately 70 cm of total settlement). This case clearly illustrates potential problems with the common practice of assuming shallow foundation settlements can be predicted by computing free-field (i.e., volumetric strain) ground surface settlements alone, without including the effects of soil-structure interaction beneath the shallow foundation.

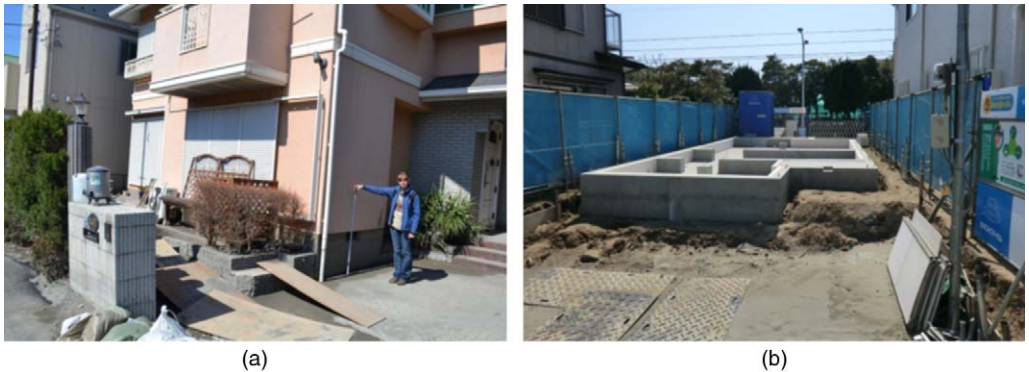
**Figure 9.** (a) Tilt and settlement of a residential home in Urayasu, and (b) foundation for a residential home in construction (GEER 2011).

Large numbers of residential buildings exhibited tilts in addition to settlements, as illustrated by the photograph in Figure 9 (left). Tilts of up to 1 to 3 degrees were observed in many cases for residential homes. The structures generally appeared to be free from structural damage, which is attributed to the common foundation design illustrated by the photograph in Figure 9 (right). This foundation was comprised of a 20-cm thick reinforced concrete mat with stiff reinforced concrete perimeter and tie beams. Foundations like these tend to be stiff and strong enough to withstand substantial settlements and tilting while minimizing

distortion of the superstructure. Many of these structures can be re-leveled without the need to rebuild the superstructure.

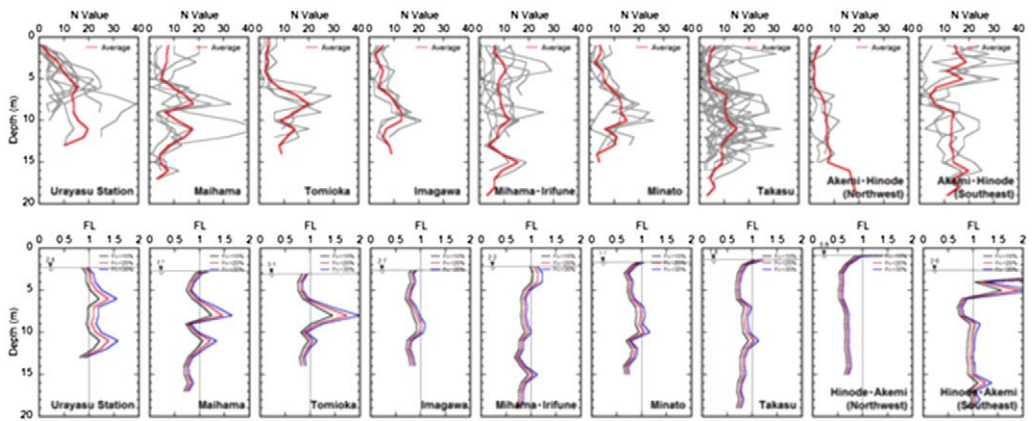
**Figure 10.** Subsurface profiles of SPT blow count (top) and estimated mean factor of safety against liquefaction (bottom) for various parts of Urayasu City (Tokimatsu et al. 2012).

Tokimatsu et al. (2012) presented liquefaction triggering analyses for many SPT boring logs from across Urayasu City, as shown in Figure 10. The information is organized left to right by districts (refer to Figure 5) generally progressing from Moto-Machi (native soils) to Shin-Machi (fills). The raw SPT blow counts ( $N$ -values) are provided in the top plots, while the liquefaction triggering analyses using the mean SPT  $N$ -values within each district are provided in the bottom plots. Notice that the triggering analysis for the mean profile in the district of Urayasu Station generally indicates factors of safety greater than 1.0, consistent with observations of no ground failure in the native soil deposits. However, some of the individual SPT profiles in the native soils appear to be susceptible to liquefaction based on penetration resistance and general soil type.

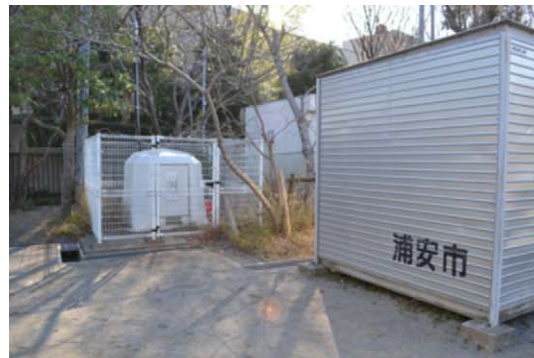
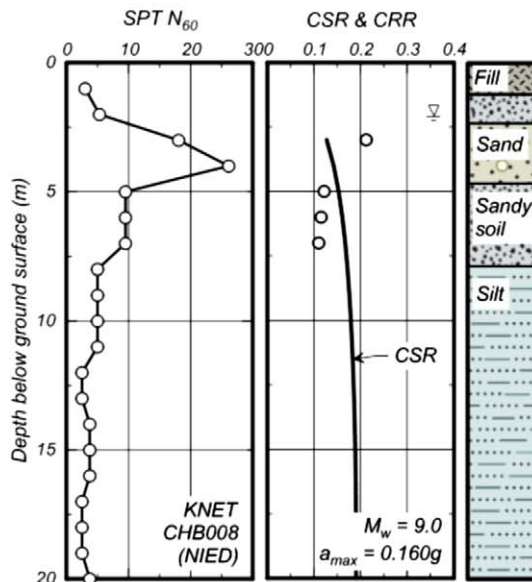
**Figure 11.** KNET Station CHB008: (a) Photograph showing no surface evidence of liquefaction, (b) horizontal acceleration recordings, and (c) liquefaction analysis of SPT data (motions and profile KNET, [NIED 2011](#)).

Consider, for example, the soil profile beneath strong motion station KNET CHB008, which is located just inside the old shoreline in the native soil deposits of Moto-Machi (location shown in Figure 7). There was no surficial evidence of ground failure at this SMS, as shown by the post-earthquake photograph in Figure 11a, and the recorded accelerations also contained no evident effects of liquefaction (Figure 11b). The soil profile consists of 1.0 m of fill, overlying 1.25 m of sandy soil, overlying 2.25 m of sand, overlying 3.5 m of sandy soil on top of a thick silt layer (Figure 11c). The water table is estimated to be at a depth of about 2 m. The SPT  $N_{60}$  values, based on an assumed typical energy ratio of 75%, were 18–26 in the 2.25-m thick sand layer, about 10 in the underlying 3.5-m thick sandy soil layer, and about 5 or less in the underlying silt layer. To perform a liquefaction evaluation, the fines content of the sand was assumed to be 5% and the fines content of the underlying sandy soil was assumed to be 25%. The plasticity of the silt strata is not available, so two scenarios were considered: (1) the silt is nonplastic such that it should be analyzed using liquefaction correlations, or (2) the silt is sufficiently plastic that it should instead

be analyzed using cyclic softening procedures. For the first scenario, a liquefaction analysis using the procedures from Idriss and Boulanger (2008) indicates that the silt layer would be expected to have liquefied throughout its full depth (factors of safety against liquefaction,  $FS_{liq}$ , ranging from 0.33 to 0.49), and the expected surface settlement would have been about 61 cm. For the second scenario, cyclic softening analyses using the procedures from Idriss and Boulanger (2008) indicate that the silt layer would be expected to be safe against cyclic softening (i.e., peak shear strains less than 3%) and would develop relatively small reconsolidation settlements provided its OCR was greater than about 1.2. This second scenario is clearly in better agreement with the absence of observable ground deformations at the site, similar to what was found for the CHB009 site presented in Figure 4. The liquefaction analysis results shown in Figure 11c are based on this second scenario, such that the potential role of the overlying sand and sandy soil layers can now be examined independently of the silt. The CRR and CSR values computed for the sand and sandy soil layers using the procedures from Idriss and Boulanger (2008) are compared in Figure 11c; the  $FS_{liq} = CRR/CSR$  values were significantly greater than 1.0 in the sand layer, but only about 0.65–0.80 in the 3.5-m thick sandy soil layer. The predicted surface settlement, using the procedures from Idriss and Boulanger (2008), is about 8 cm. These computed  $FS_{liq}$  and settlement values are not consistent with the lack of liquefaction evidence at this SMS, which may simply reflect limitations in the assumptions that were required to perform the analyses. These results again illustrate how the reliable interpretation and analysis of these SMS sites will require additional site characterization data, including fines content and plasticity information for the different strata, an improved understanding of magnitude scaling (duration) factors for silty sands, and improved estimates of the earthquake-induced CSR values.

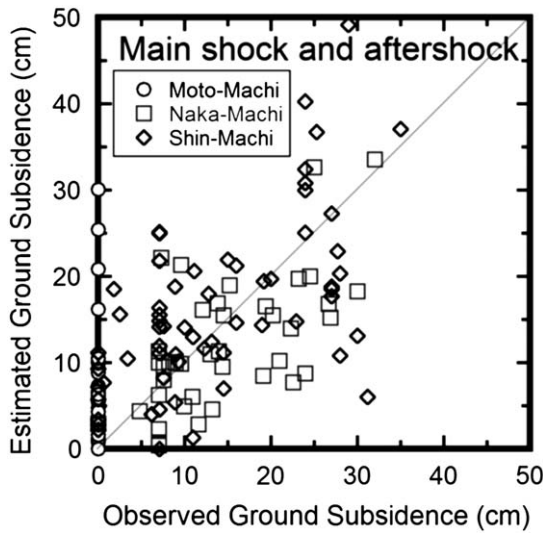
**Figure 12.** Comparison of observed and estimated ground surface settlements using AIJ procedures and including the effects of the  $M_w = 7.7$  aftershock (Katsumata and Tokimatsu 2012).

derived from terrain models made before and after the earthquake using airborne LiDAR surveys. These comparisons are provided in Figure 12. The estimated settlements primarily ranged from 0 cm to about 35 cm, and the observed free field settlements also ranged from about 0 cm to 35 cm. However, the data points are quite dispersive without a strong correlation or bias between estimated and observed settlement. Of particular interest are the many “false-positive” estimates of liquefaction-induced settlements in the native soils of Moto-Machi, where settlements up to 30 cm were estimated from some SPT data while observed settlements were essentially zero (small). These differences between computed and observed settlements warrant further study and may in part reflect local variations in soil consistency, fines plasticity, age, ground shaking intensity, measurement uncertainties, and other factors that are not fully characterized at this time. For individual sites, differences could also result from dispersion in the settlements inferred from the LiDAR data, which have been shown to have standard deviations in the range of 6–20 cm under “best case” conditions involving minimal vegetative cover (Stewart et al. 2009).

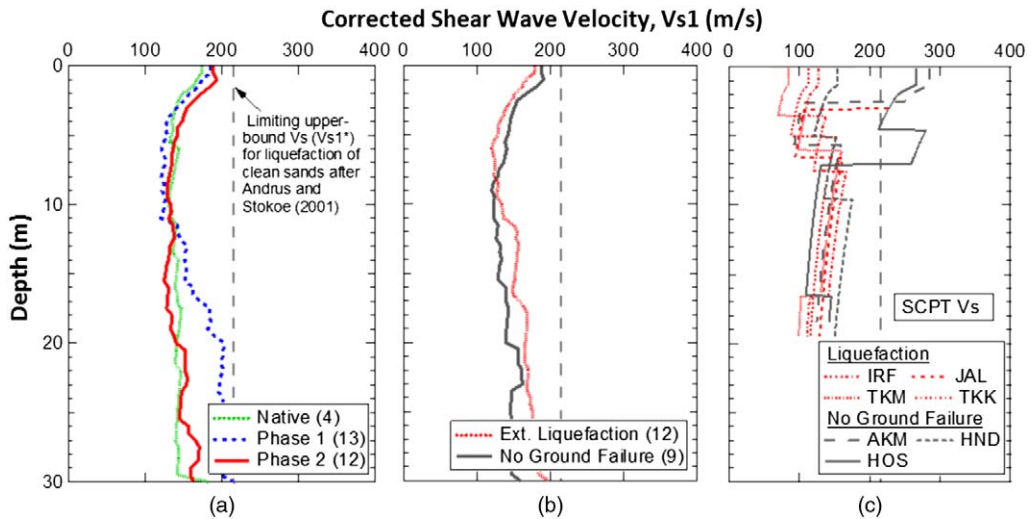
**Figure 14.** Comparisons of overburden-corrected shear wave velocity ( $V_{s1}$ ) profiles from Urayasu: (a) Median  $V_{s1}$  profiles from surface wave data collected on native soils, phase 1 fills (1964-1975), and phase 2 fills (1976–1980), (b) median  $V_{s1}$  profiles from surface wave data collected in locations of extensive liquefaction and locations with no surface evidence of liquefaction or ground failure, and (c) seismic CPT  $V_{s1}$  profiles at four SMS that liquefied and three that had no surface evidence of liquefaction or ground failure.

The median, overburden-corrected shear wave velocity ( $V_{s1}$ ) profiles for the native Phase I and Phase II soil zones are compared in [Figure 14a](#). The number of profiles used to compute the median  $V_{s1}$  values are provided inside parentheses in the legend. The median  $V_{s1}$  profiles for all three soil zones are almost identical down to about 12 m. In addition, the  $V_{s1}$  profiles are well below the recommended upper-bound corrected shear wave velocity for liquefaction (i.e.,  $V_{s1}^* = 215$  m/s; [Andrus and Stokoe 2000](#)). These data indicate that significant small-strain aging effects, which might lead to increased liquefaction resistance, cannot be discerned in the median  $V_{s1}$  profiles, as all of the soils appear to be loose enough to liquefy down to significant depths based on available  $V_s$ -based liquefaction correlations (e.g., [Andrus and Stokoe 2000](#), [Kayen et al. 2012a](#)). Interestingly, the Phase I soils appear on average to be relatively stiffer at depth than the native and Phase II soils (yet still very soft).

The median  $V_{s1}$  profiles for the areas with extensive liquefaction and with no ground failure are shown in [Figure 14b](#). While the  $V_s$  profiles collected in areas with extensive liquefaction are slightly softer on average near the ground surface, the median  $V_{s1}$  profiles for both extensive liquefaction damage and no ground failure are almost identical down to about 12 m depth and are well below  $V_{s1}^* = 215$  m/s. These data indicate that significant differences in small-strain shear stiffness do not exist between zones of extensive liquefaction and no liquefaction.

Profiles of  $V_{s1}$  obtained from seismic CPT (SCPT) testing at seven SMS, four with evidence of liquefaction and three without evidence of liquefaction or ground failure, are compared in [Figure 14c](#). These data also fail to show a significant difference in shear stiffness between sites with evidence of liquefaction (stations IRF, JAL, TKM, and TKK in [Figure 7](#)) and sites without surface evidence of liquefaction or ground failure (stations AKM, HND, and HOS in [Figure 7](#)). The one exception is the SCPT  $V_{s1}$  profile at station HOS, which is located on native soil deposits well away from the reclaimed land. This  $V_{s1}$  profile is significantly stiffer than the others over the top seven meters with velocities greater than  $V_{s1}^* = 215$  m/s.

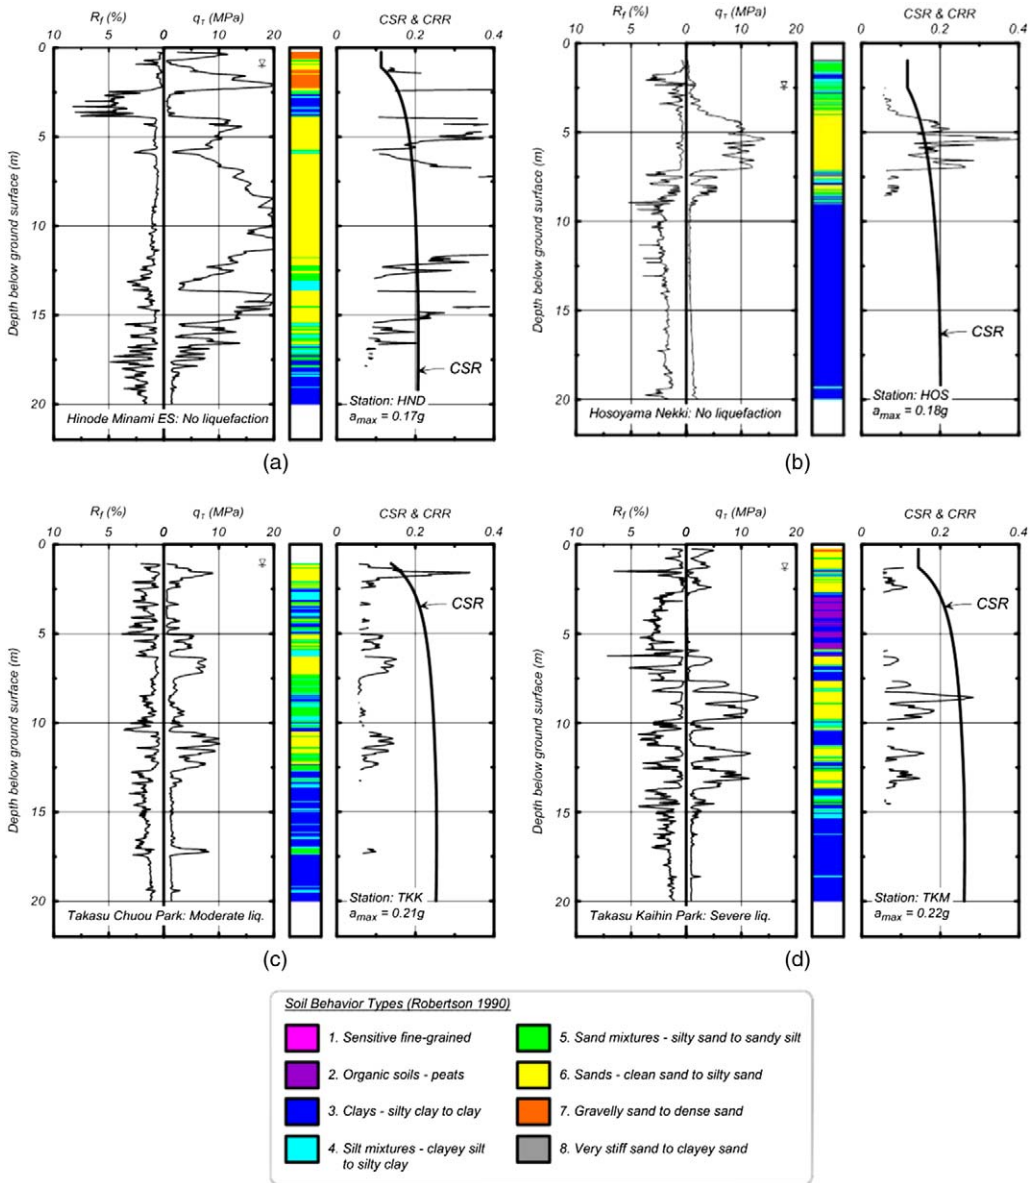
**Figure 15.** Cone penetration test profiles and liquefaction analyses at four strong ground motion recording stations in Urayasu with (a) no surface evidence of liquefaction or ground failure, (b) no surface evidence of liquefaction or ground failure, (c) moderate liquefaction, and (d) severe liquefaction.

The CPT liquefaction analyses for the HND (Figure 15a) and HOS (Figure 15b) stations are generally consistent with the observed absence of ground failure, although they both illustrate some of the common difficulties in analyzing CPT data near interfaces and interlayers. Clay soil types, corresponding to soil behavior type indices ( $I_c$ ) greater than about 2.6, were identified at depths of 2.5–3.9 m ( $I_c \approx 2.9$ ), 13.1–13.6 m ( $I_c \approx 2.6$ ) and below 17.5 m ( $I_c \approx 3.1$ ) at the HND station and at depths of 1.0–2.4 m ( $I_c \approx 2.8$ ) below 8.6 m ( $I_c \approx 3.3$ ) at the HOS station. For the sand layers, fines contents were estimated by correlation to the  $I_c$  value (Idriss and Boulanger 2008) with an Urayasu-specific adjustment upward from the general correlation to give  $FC \approx 20\%$ , on average. The sand layers at both stations are sufficiently dense that liquefaction triggering would not be expected (i.e.,  $CRR > CSR$ ) at points more than about 30 cm from an interface with a clay soil type. The liquefaction analyses for both stations do, however, show that the computed CRR values are less than the CSR values near clay interlayers (e.g., 5.9 m at HND) and in intervals that appear to have finely interlayered sands and clays (e.g., 15.5–17.5 m at HND and 7.2–8.6 m at HOS). The low CRR values in these intervals can represent artifacts that stem from the known limitations in CPT data near such interfaces. The potential settlements due to one-dimensional reconsolidation were computed to be 8 cm and 11 cm at HND and HOS, respectively, based on these point-by-point analysis results. The amount of liquefaction triggering and computed settlements can be reduced to the range of a couple of centimeters if the effects of the clay-sand interfaces are accounted for, such that the computed and observed responses are reasonably consistent when these types of details are appropriately considered.

The CPT liquefaction analyses for the TKK (Figure 15c) and TKM (Figure 15d) stations are also generally consistent with the observations of moderate to severe liquefaction effects. Clay soil types are encountered in numerous layers at these stations, with  $I_c$  values being similar to those for the clay soil types at similar depths at stations HND and HOS. Sand layers at the TKK and TKM stations have generally smaller overburden-corrected tip penetration resistances, such that they give generally smaller CRR values than obtained at the HND and HOS stations. The CSR values are also greater at the TKK and TKM stations because the measured peak ground surface accelerations (0.21 g and 0.22 g) are greater than measured at the HND and HOS stations (0.17 g and 0.18 g). The combined effect is that liquefaction would have been expected at the TKK and TKM stations for the observed shaking levels, although these analysis results also have the previously discussed problem of likely overpredicting the extent of liquefaction near clay-sand interfaces. The potential settlements due to one-dimensional reconsolidation were computed to be 29 cm and 20 cm at TKK and TKM, respectively, based on the point-by-point analyses. These values can similarly be reduced significantly by accounting for interface effects, but the remaining settlements would still be consistent with the observation of surface effects.
