Geomorphic and Ecological Disturbance and Recovery from Two Small Dams and Their Removal

Desirée D. Tullos^{1*}, Debra S. Finn², Cara Walter¹

1 Water Resources Engineering, Oregon State University, Corvallis, Oregon, United States of America, **2** Department of Integrative Biology, Oregon State University, Corvallis, Oregon, United States of America

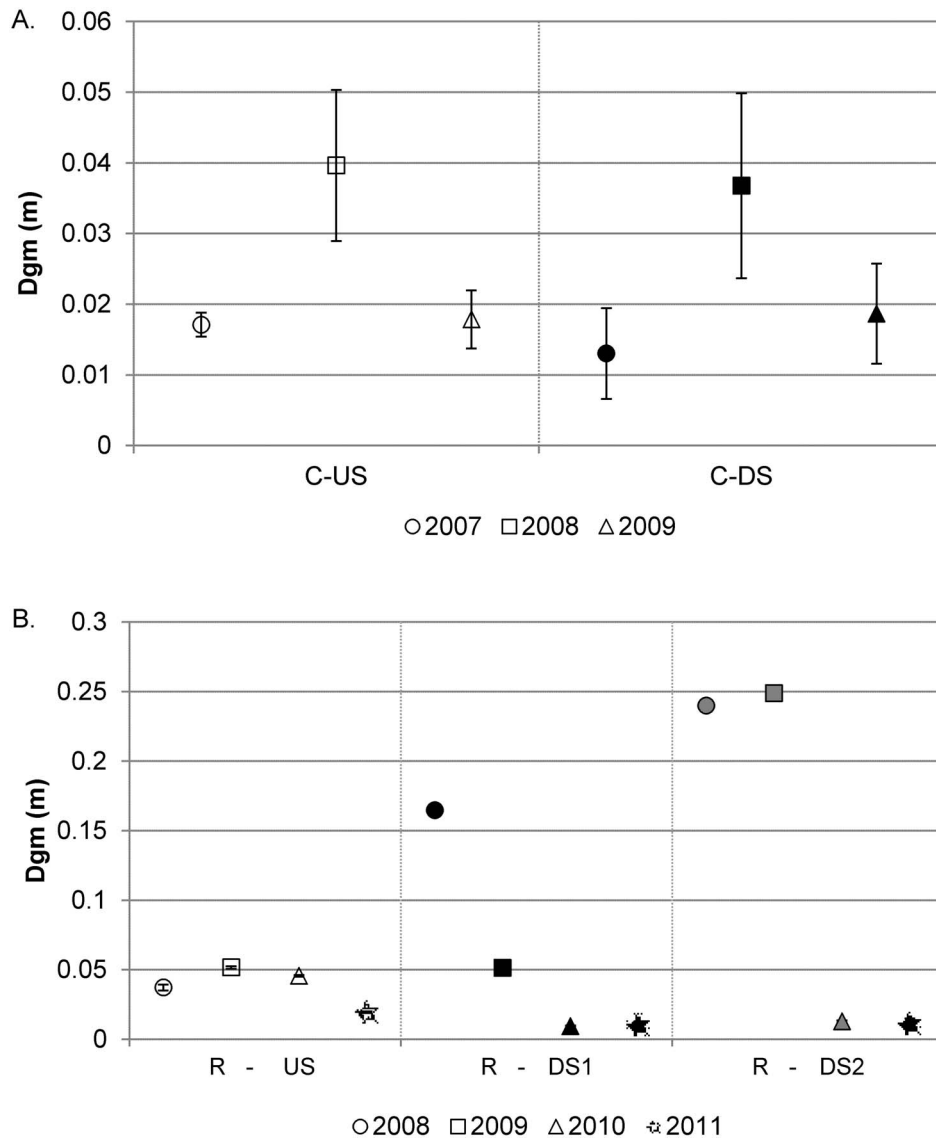
Figure 4. Plot of geometric mean grain size by reach over time at a) Calapooia River and b) Rogue River. Symbols represent the mean value, and lines represent two standard errors from the mean. doi:10.1371/journal.pone.0108091.g004

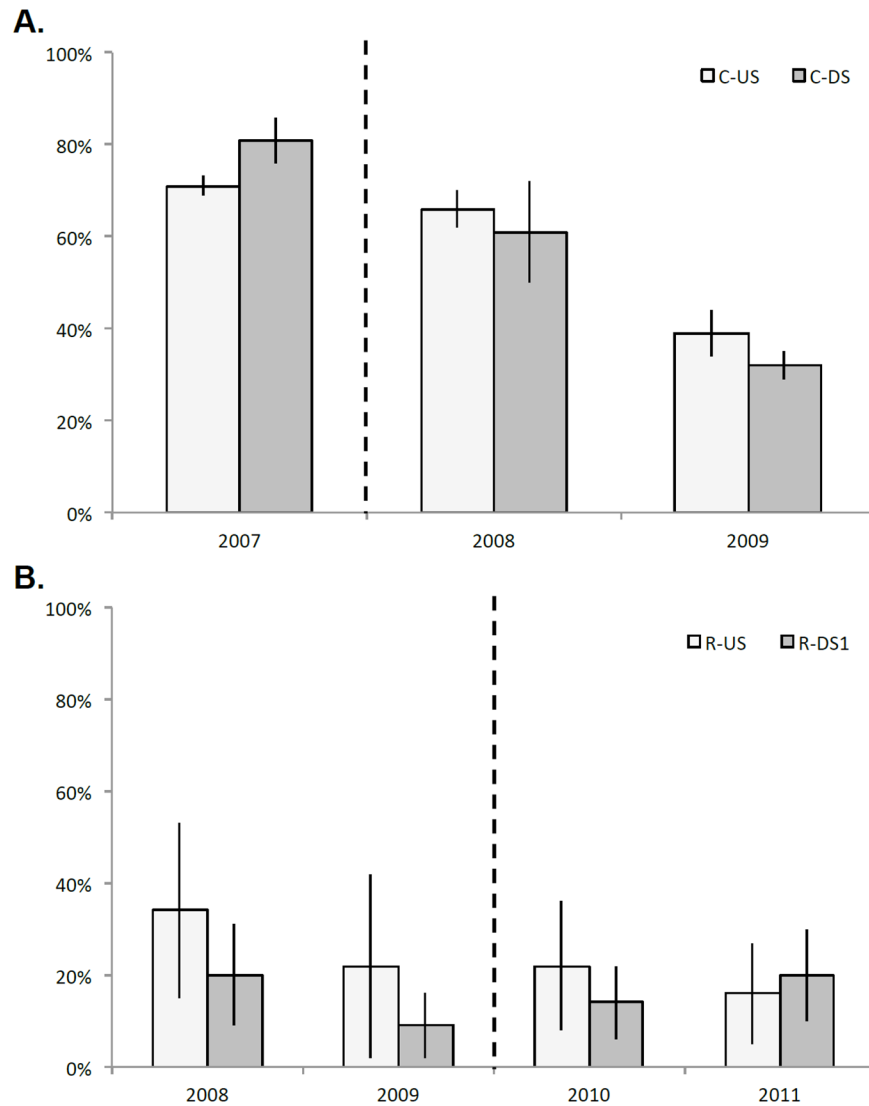
Figure 8. Mean %EPT (expressed as a proportion, ± 2 standard errors) per reach across A) riffle sample units on the Calapooia, and B) transects sampled on the Rogue. In both panels, year is on the x-axis, and lighter-colored bars represent the upstream reaches. Vertical dashed line shows timing of dam removal. Note that the second downstream reach is not plotted for the Rogue River due to the lack of change over time.

The univariate indicators %clingers (Figure 7) and %EPT (Figure 8) illustrate upstream-downstream trends across years, particularly in the Calapooia River, although only one of the within-year *t*-tests produced significant differences. With no statistical difference in % EPT across the years on the Calapooia River (Figure 8A), the only statistically significant difference on the Calapooia River was greater %clingers in C-DS than C-US in 2007, the year prior to dam removal (Figure 7A). In the two years following dam removal, the two reaches on the Calapooia River became statistically indistinguishable for %clingers. Values of %EPT were greater, though nonsignificant (*p* = 0.11), in C-US relative to C-DS for the Calapooia River prior to dam removal,

followed by convergence of these reaches in the two years following dam removal. Year-to-year trends were difficult to assess and were nonsignificant on the Rogue River due to high reach-scale variability for both %EPT and %clingers (Figures 7B, 8B).
