**OBSTRUCTING PUBLIC ACCESS TO
THE BACKWATERS OF THE WILLAMETTE RIVER:
A CASE STUDY OF "BERMS" NEAR PEORIA, OREGON**

A RESEARCH PAPER

**MASTER OF SCIENCE
GEOGRAPHY PROGRAM**

JANUARY 1992

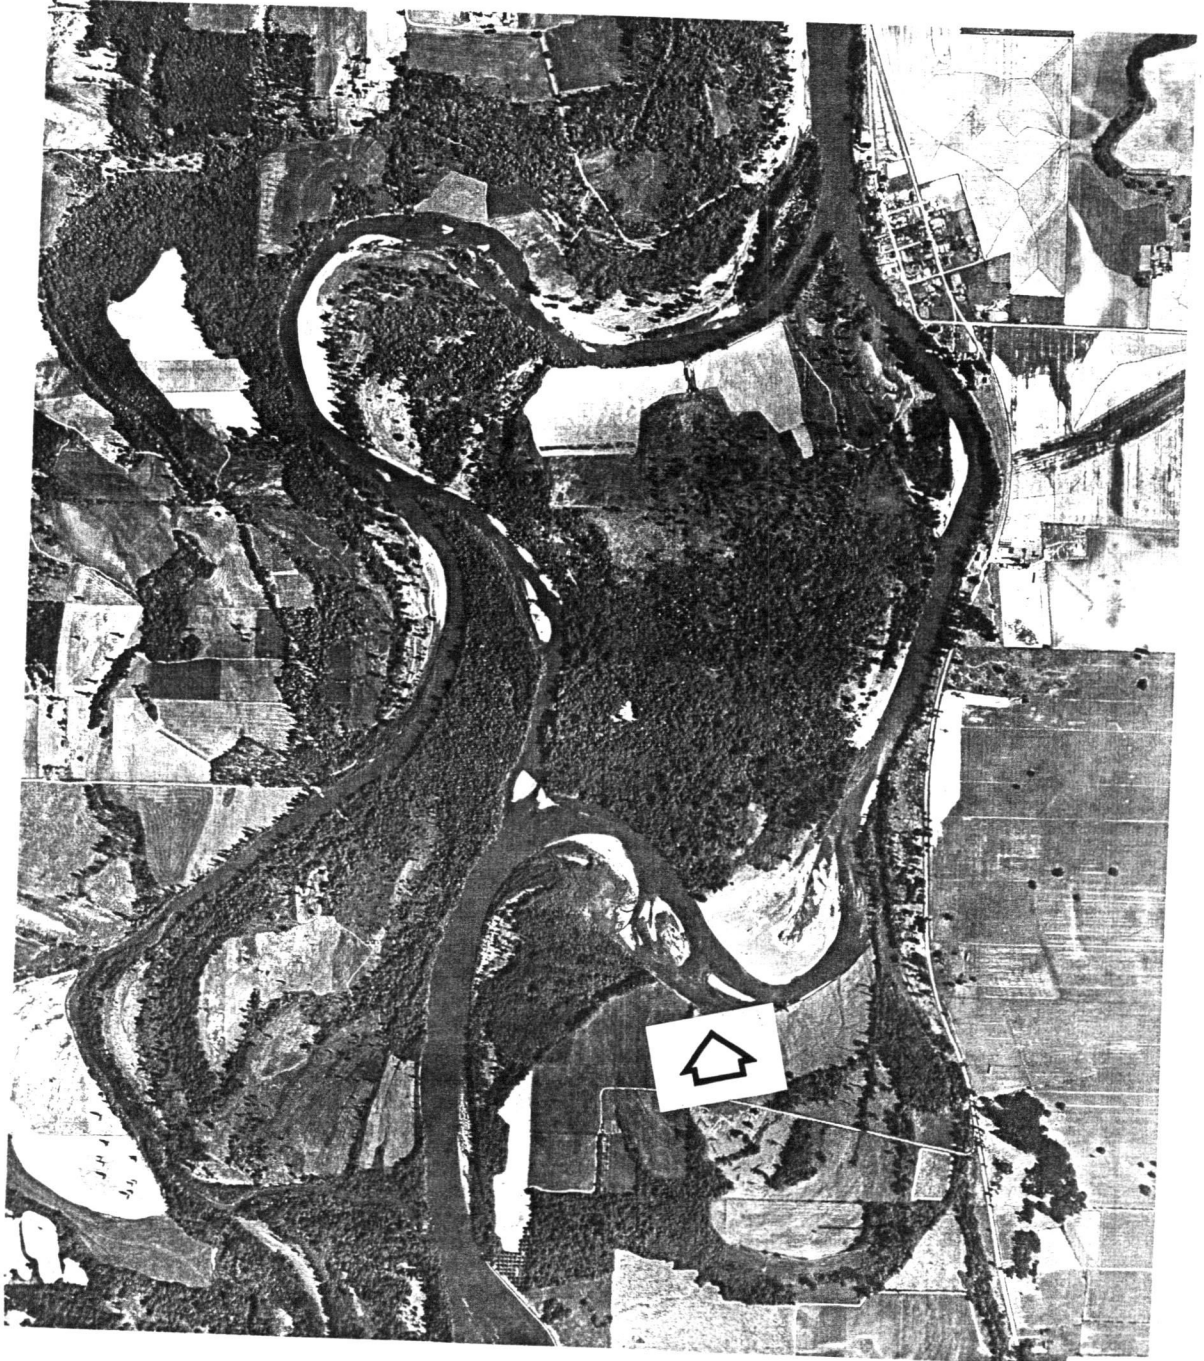
Figure 3
Aerial photograph of the study area from 1948.

A comparison of individual aerial photographs of earlier (Figure 3-5) and more recent years (Figure 6-7) provides detailed information about channel shifting and landform and vegetation changes in the study area. The 1948 aerial photograph (Figure 3) indicates the study area as a major channel of the Willamette River. Agricultural activity seems limited due to the extensive forest cover evident on the south, southeast, and east side of the study area. The 1956 aerial photo (Figure 4) shows a limited physical feature change from 1948. However, the 1961 aerial photograph (Figure 5) shows inconsistency in the flow of the river and reveals the branching of the main channel with the formation of an island due to the flooding that occurred during the early 60'S. An examination of the 1970 aerial photograph indicates a new phenomenon in the area. It shows a diversion structure running across the river from the southwest in a northeast direction (Figure 6). Inquiries about the structure at the Corps office in Portland revealed that a 1200 feet long dike was constructed and completed by the Corps in 1964 for flood protection purposes in the area. A further examination of

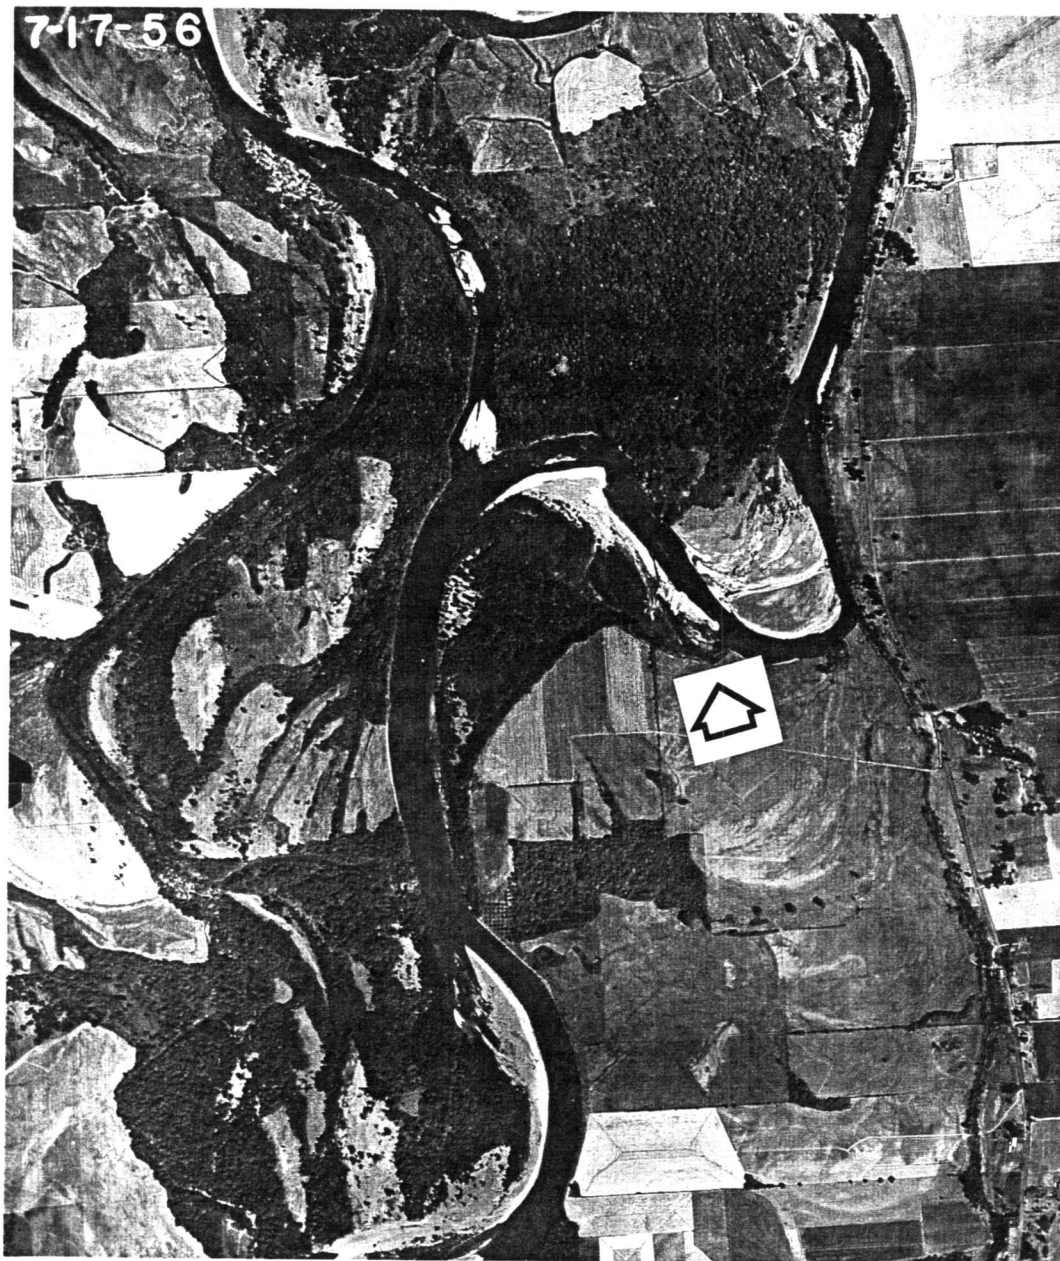
Figure 4
Aerial photograph of the study area from 1956.

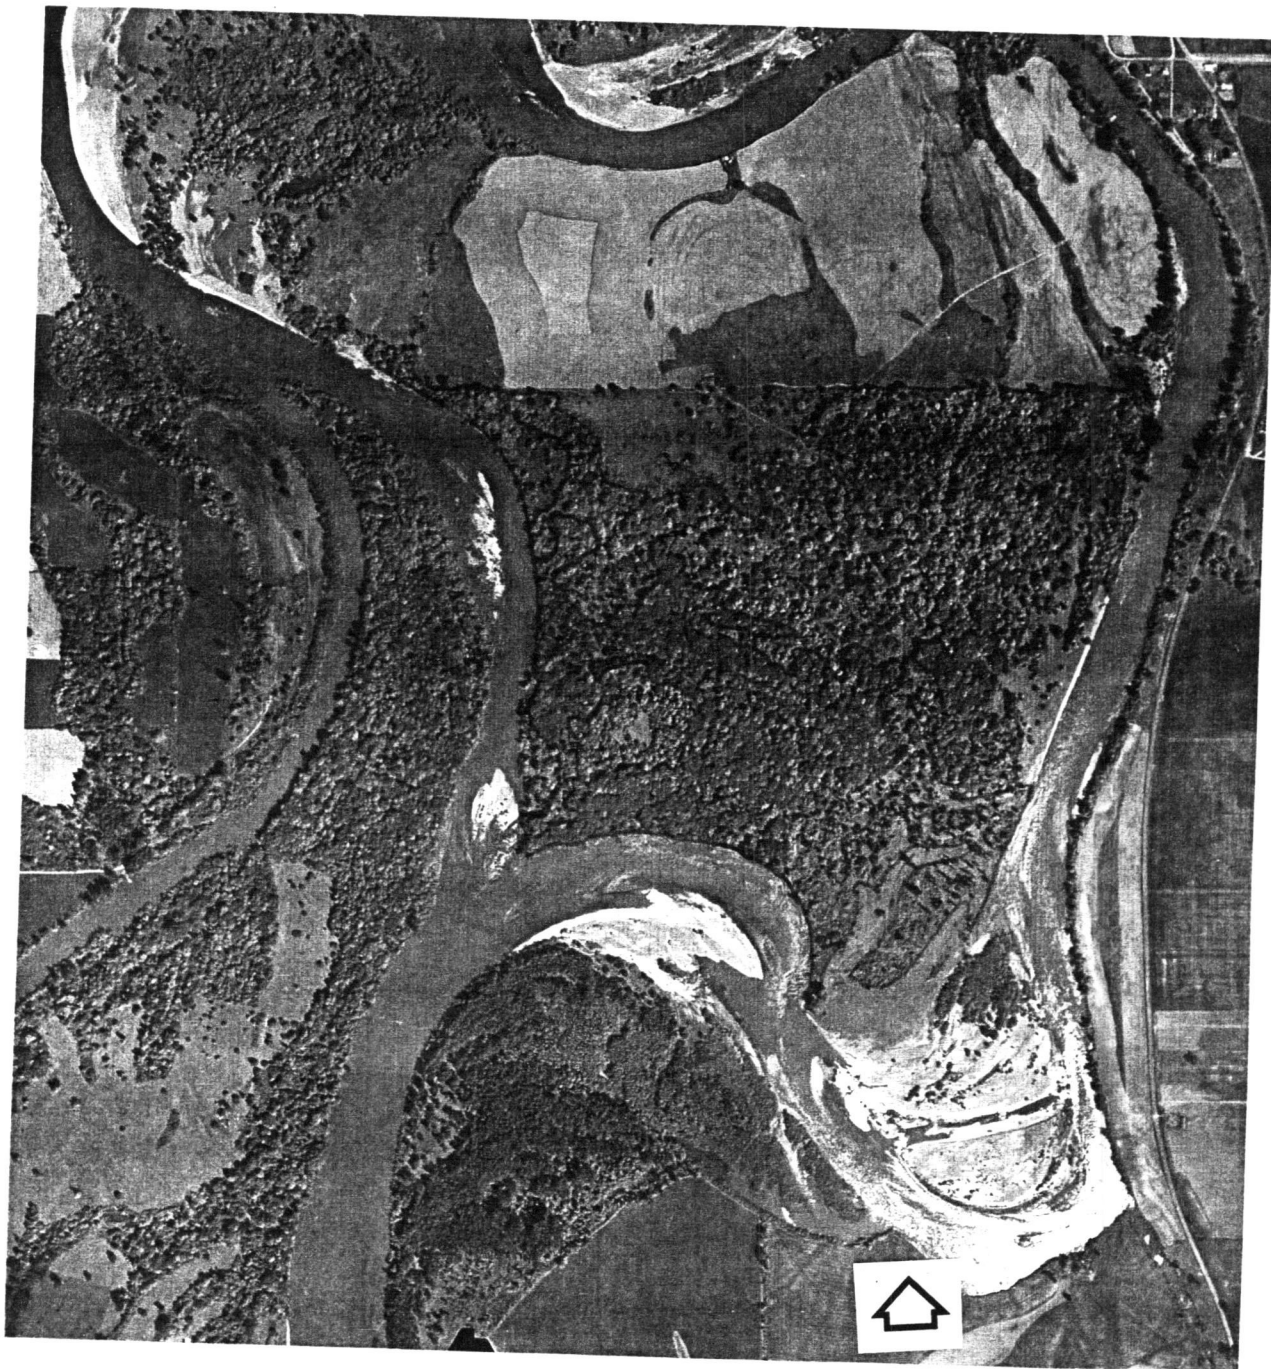
Figure 5
Air photo of the study area from 1961.

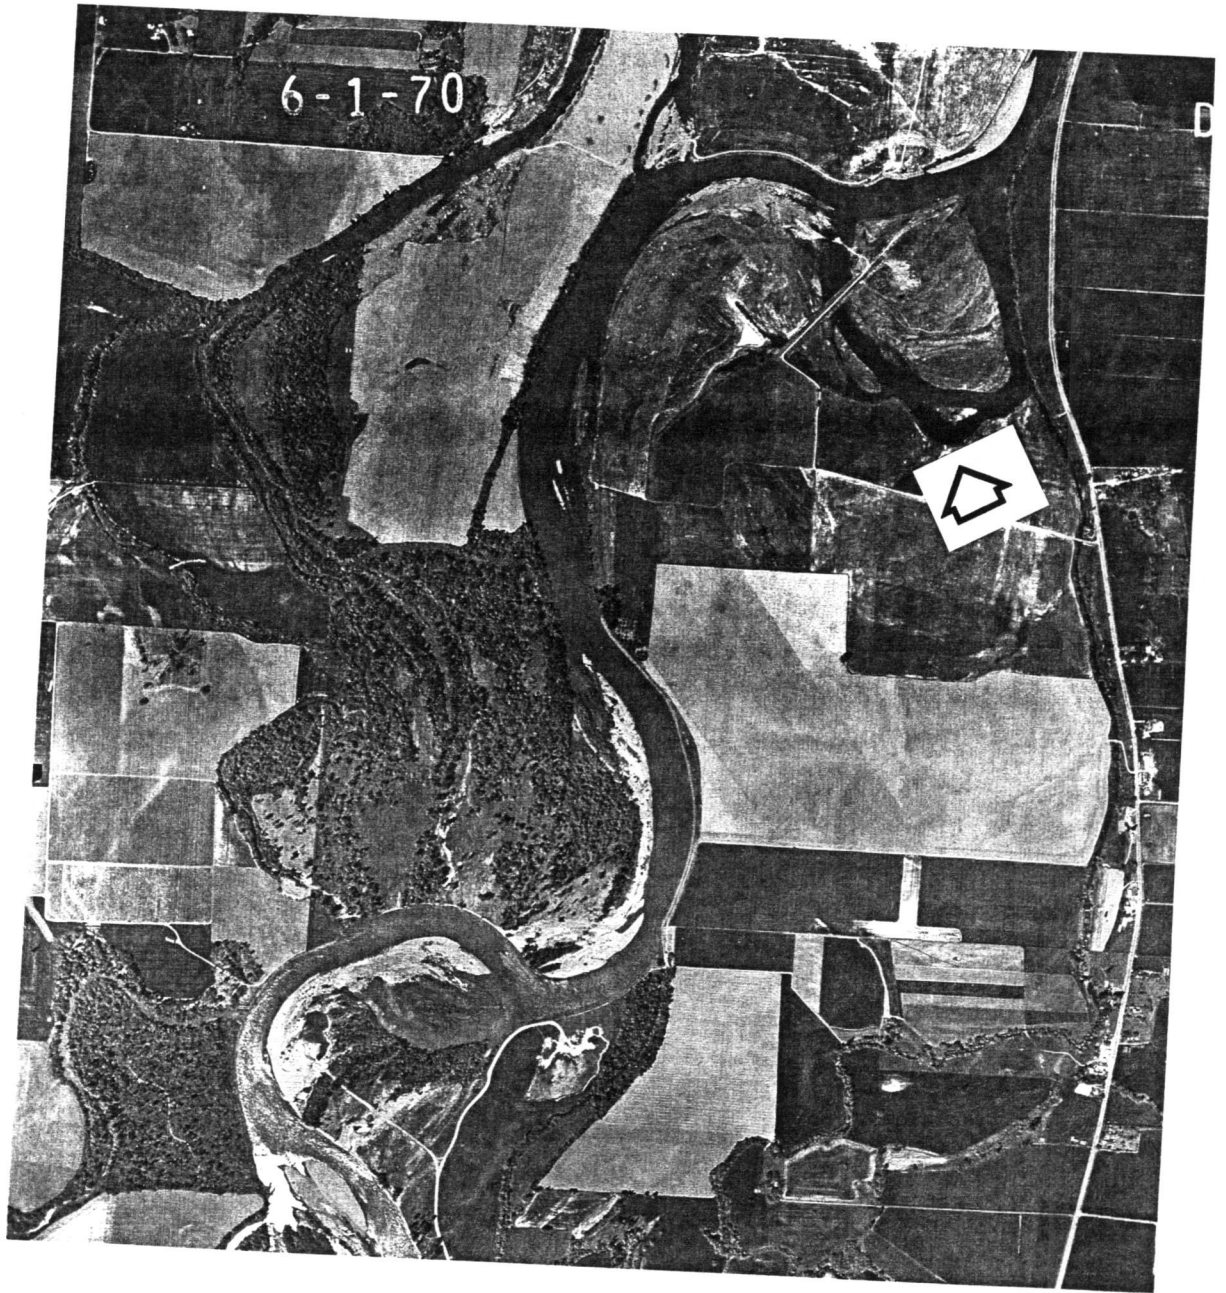
Figure 6
Aerial photograph of the study site from 1970.

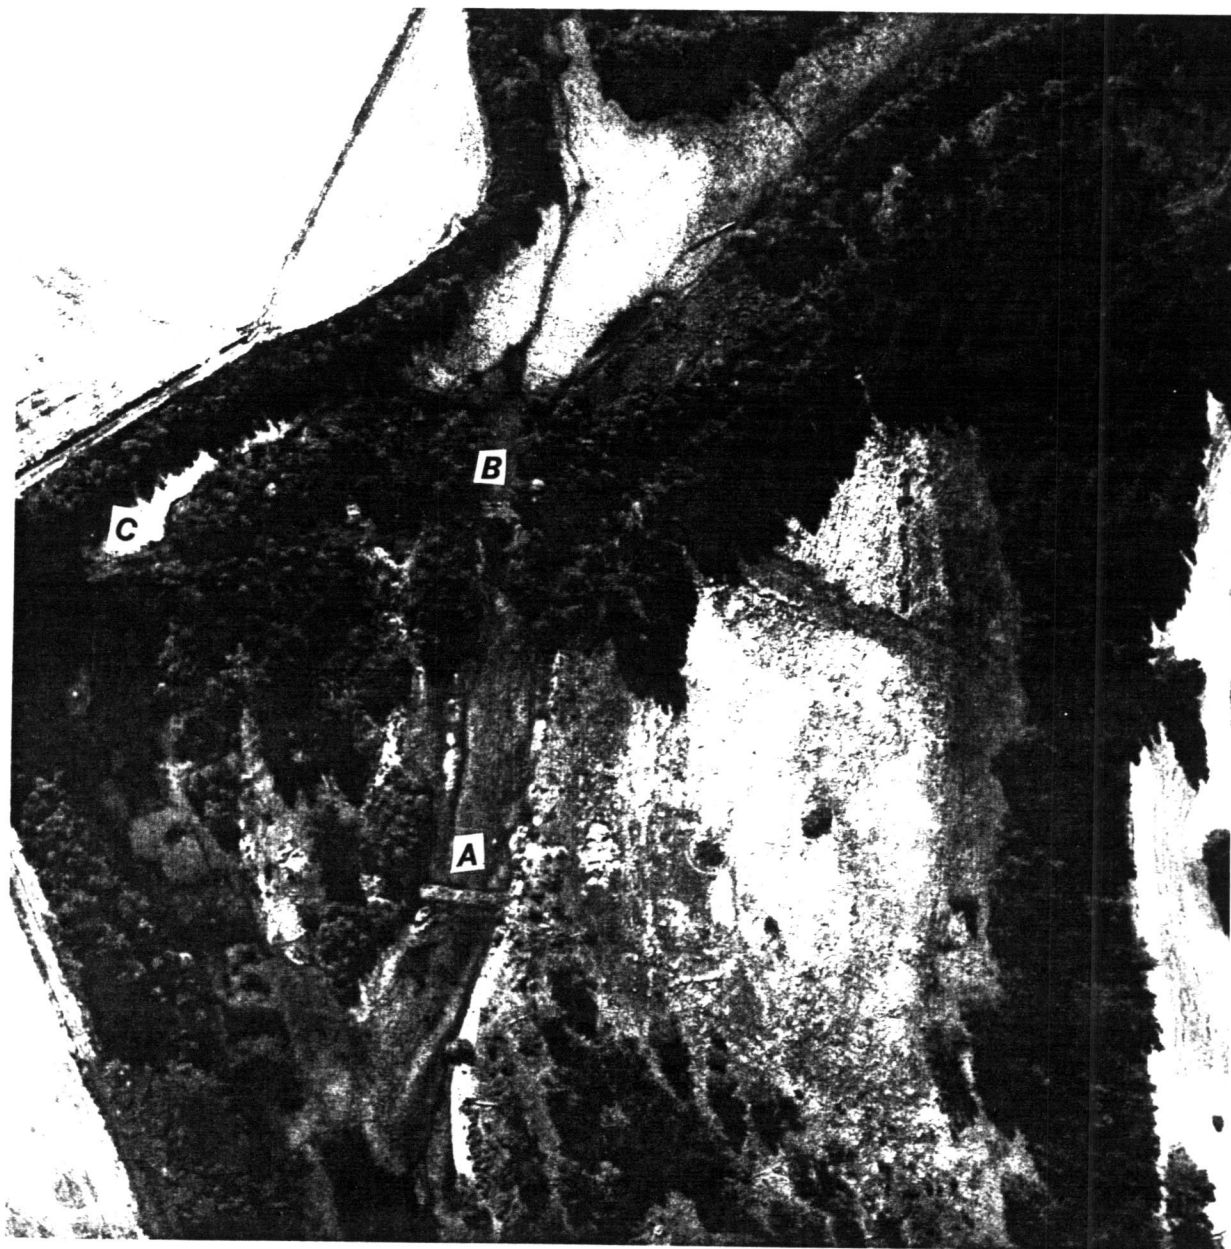
Figure 7
A 1991 Aerial photograph of the study area.

recent aerial photographs (1976, 1980 and 1985) at the US Corps of Engineers and Linn County Planning offices is consistent with river course and other landform changes in the backwaters of the Willamette River in the study area. An aerial photograph taken in 1991 (Figure 7) shows additional manmade landform changes present in the study area. These manmade structures marked A,B,and C in the air photo and the corresponding map (Figure 8) are the focus of this study. A cross section of these manmade obstructions is represented in (Figure 9, A,B,C).

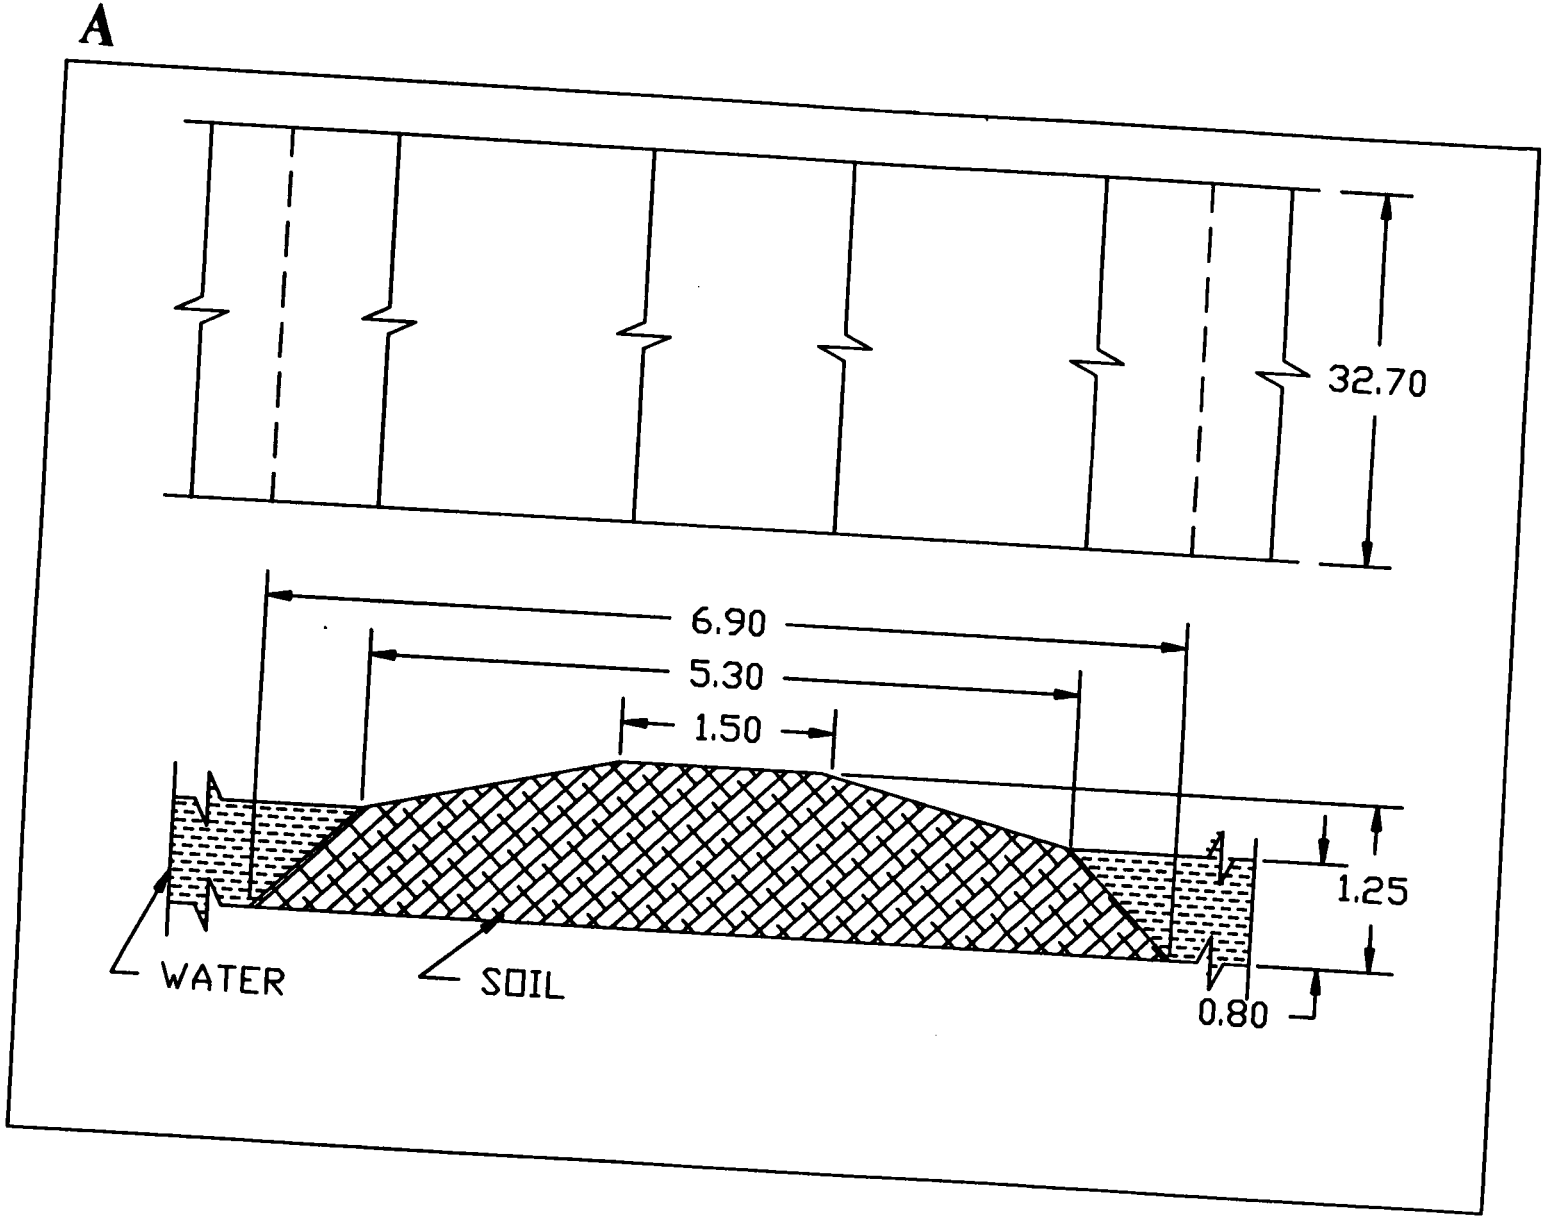
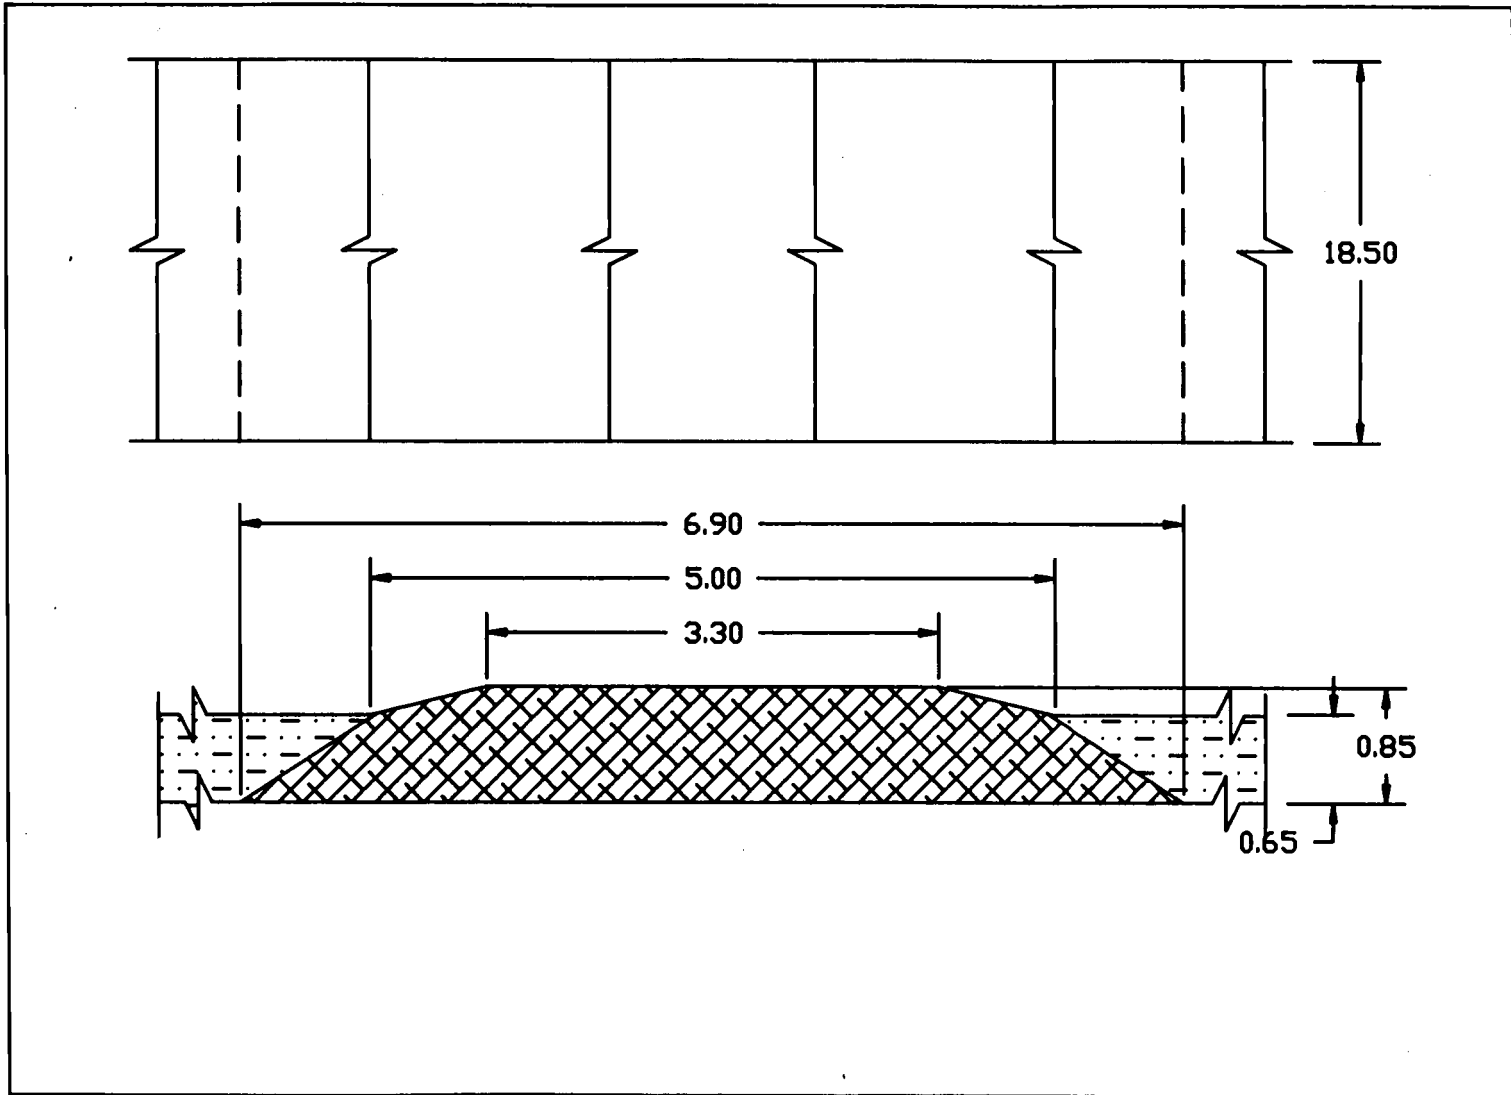
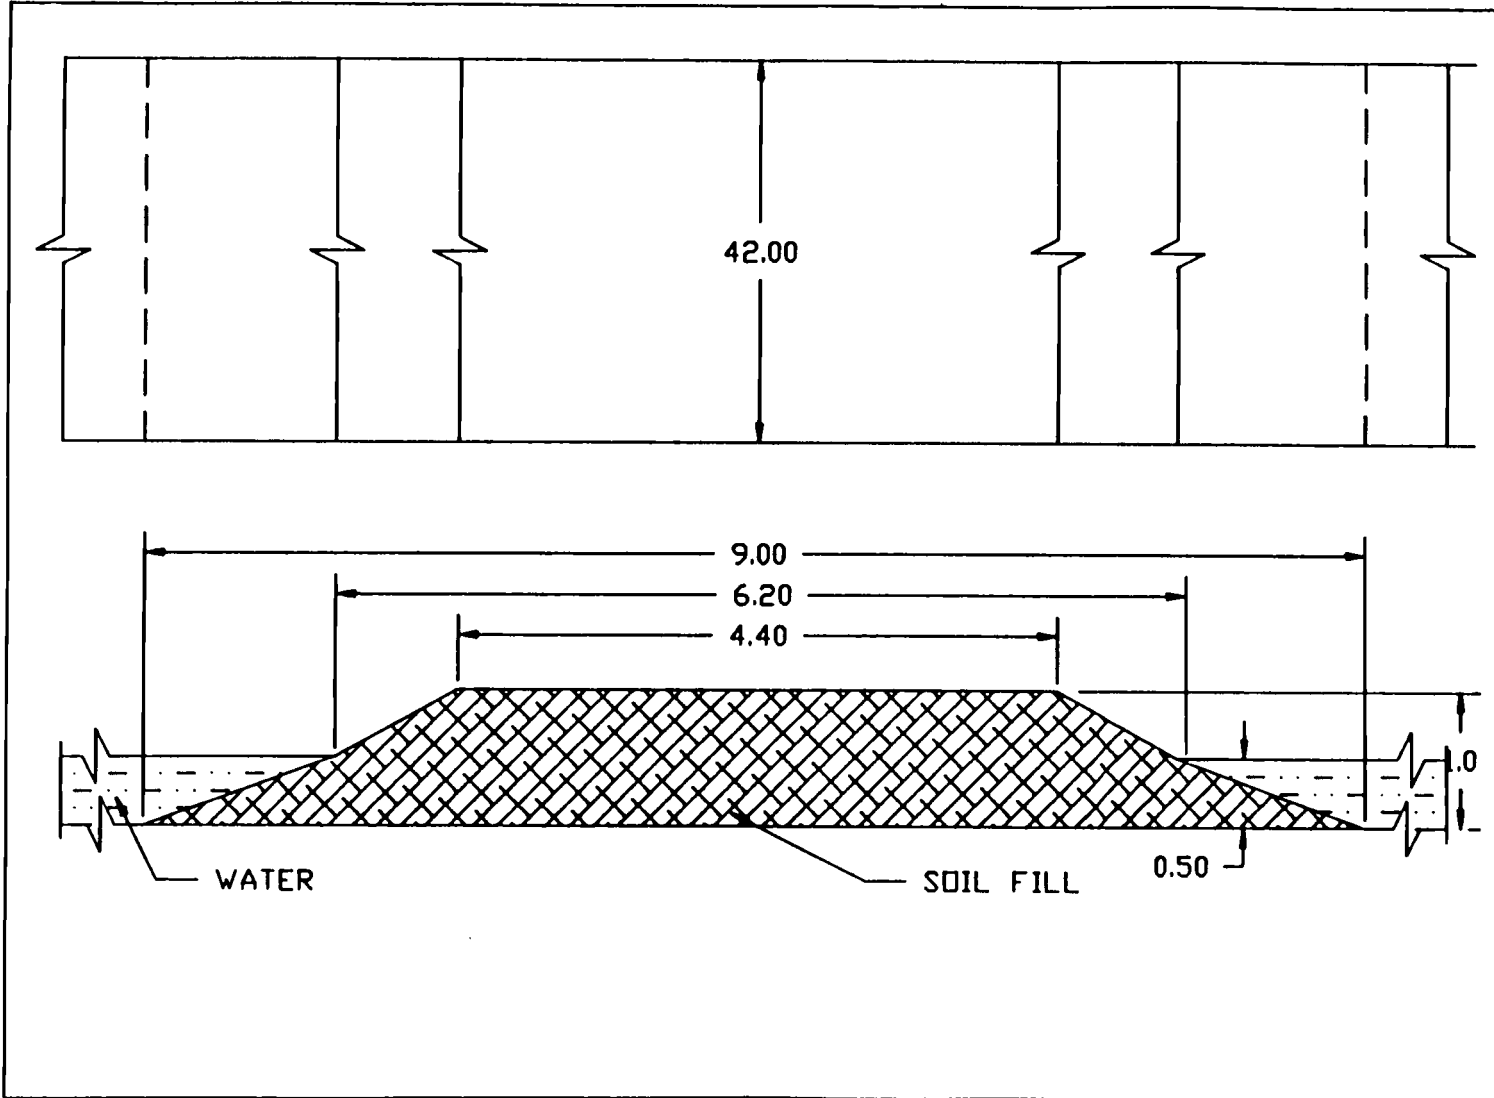
Figure 9
(A,B,C) A cross section of the berm constructions in the study area.

inquiries were made at offices of The Division of State Lands in Salem, the US Corps of Engineers in Portland, and Linn County Planning Department in Albany. Staff in the first two offices referred to Oregon Water Laws rules ORS 541-685 (renumbered to 196-900), "the removal of material filling," which indicates that a permit is required for filling more than 50 cubic yards of material from the bed or bank of a navigable river. Their files showed that no request for a permit was filed at either office to construct the berms under investigation, which required approximately 725.27 cubic yards of fill. This is more than 14 times the maximum amount which requires a permit!

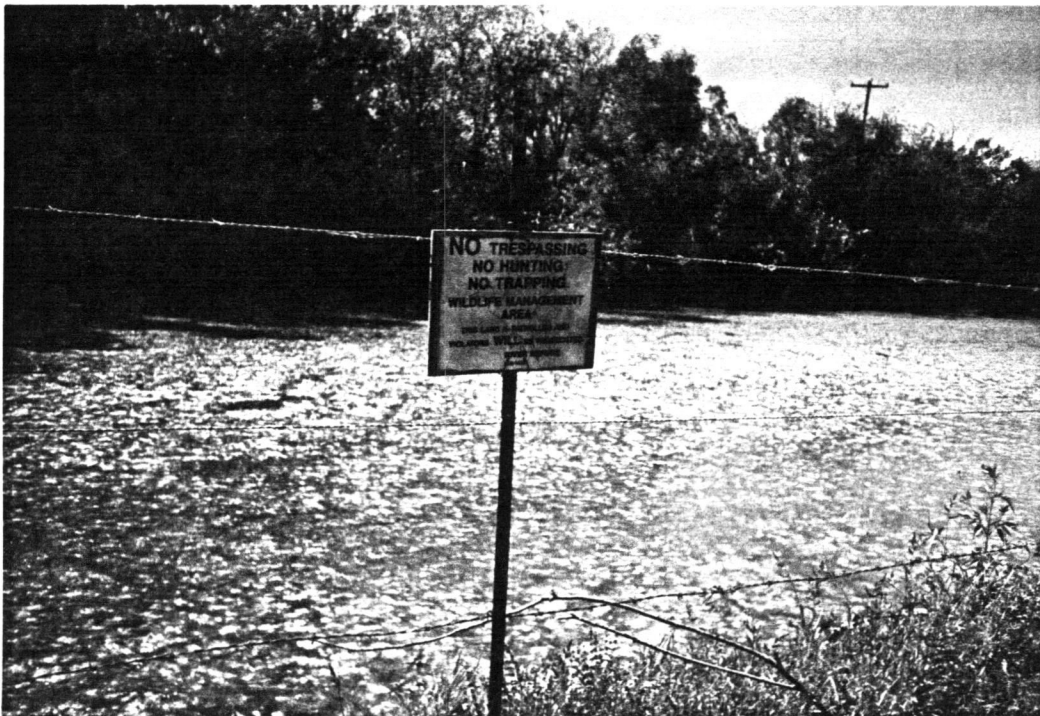
Figure 12
Illegal wire fencing with "no trespassing" signs on the berm structures in the study area.

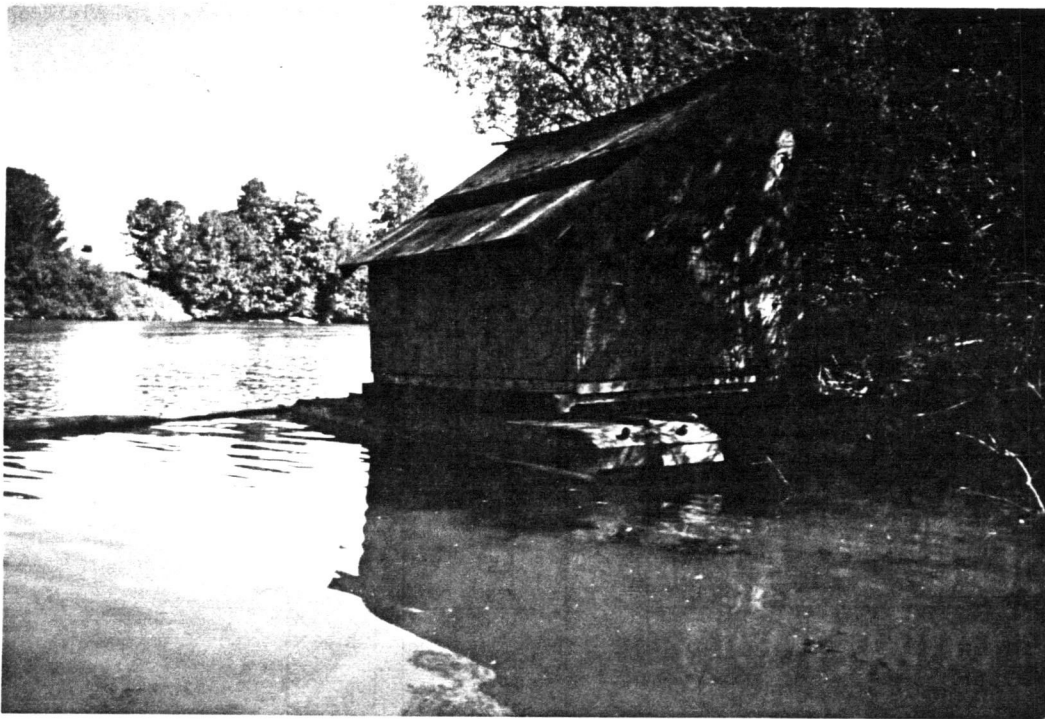
Figure 13
A water fowl hunting blind in the vicinity of the site.

Further study of the area also indicates the purpose of the berm structures. Hunting blinds and nesting boxes on the river banks confirm water fowl hunting activities in the closed "management area" and vicinity as a whole. It seems that the berm structures are being used to impound water and attract water fowl for hunting (Figure 13). The Water Laws of Oregon, ORS 274.430, (1988, 10) defines state ownership of meandered lakes and navigable waters and declares that they are public waters. The intention of the land owners, i.e., appropriating a public resource for private recreational purposes is not compatible with the Water Laws of Oregon.
