Timothy L. Deboodt for the degree Doctor of Philosophy in Rangeland Ecology and Management presented on May 8, 2008.

Title: Watershed Response to Western Juniper Control

A DISSERTATION

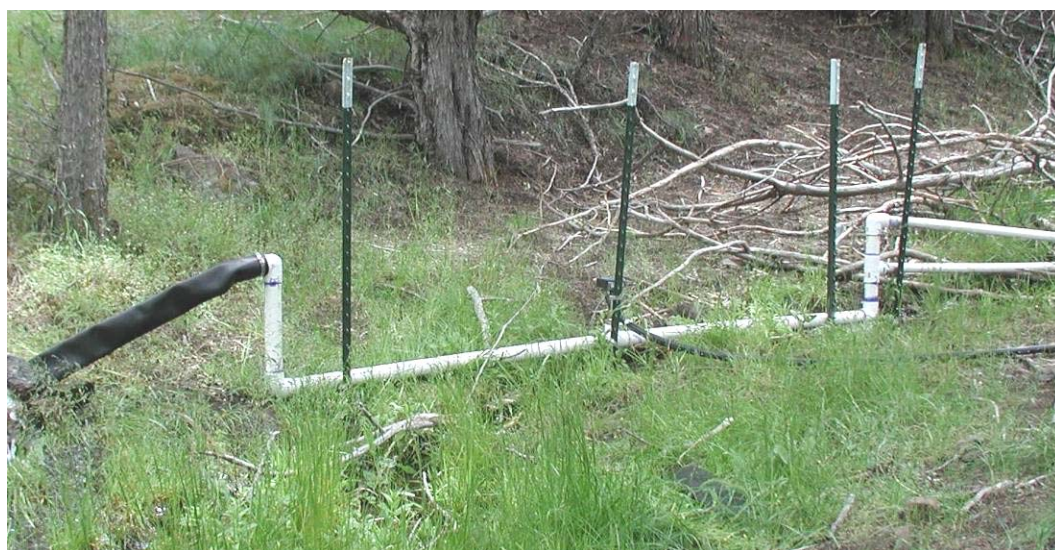
To allow for remote access of each spring, a VORTFLOW/FLOW COMP© sensor was installed at the end of each outflow pipe (Figure 7). The sensor was calibrated to read flows from 3 – 100 gpm. When flows dropped below 3 gpm, flow was not detectable by the sensor.

Figure 7. Spring flow monitoring site, Mays with VORTFLOW/FLOW COMP©

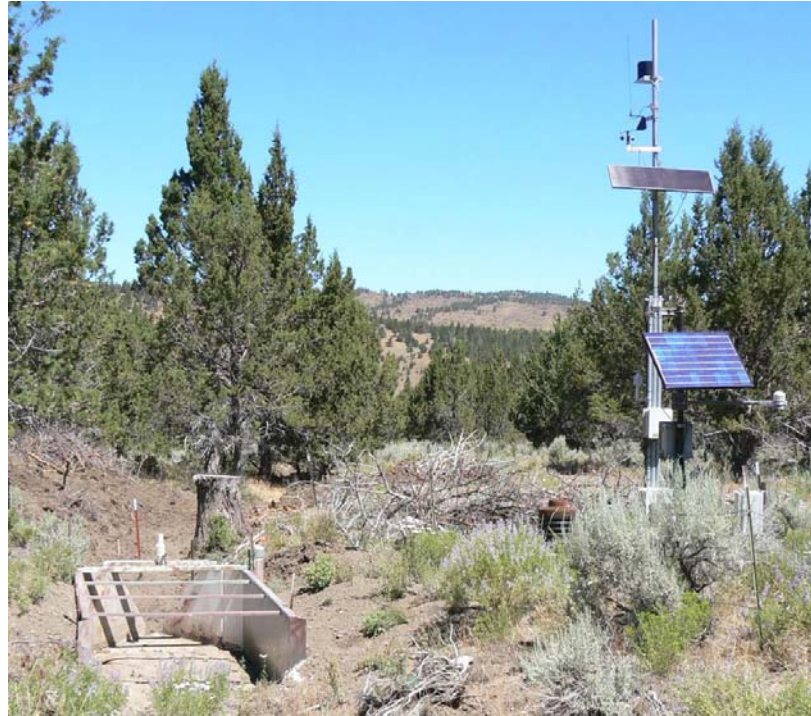
Sensors were supplied by Automata Inc., Nevada City, California. Installation was done by Wy-East RC&D technicians from The Dalles, Oregon. Sensors were mounted on a 50 mm diameter pole. The pole was 4.5 m tall and was built to pivot in the middle to allow access to sensors for maintenance and calibration. Solar panels were used to keep a 12 volt deep cycle battery charged and functioning (Figure 8). The Belfort Instruments Universal Range Gauges continued to be used and maintained as a redundant, back-up system (Fisher 2004).

Figure 8. Jensen weather station and flume

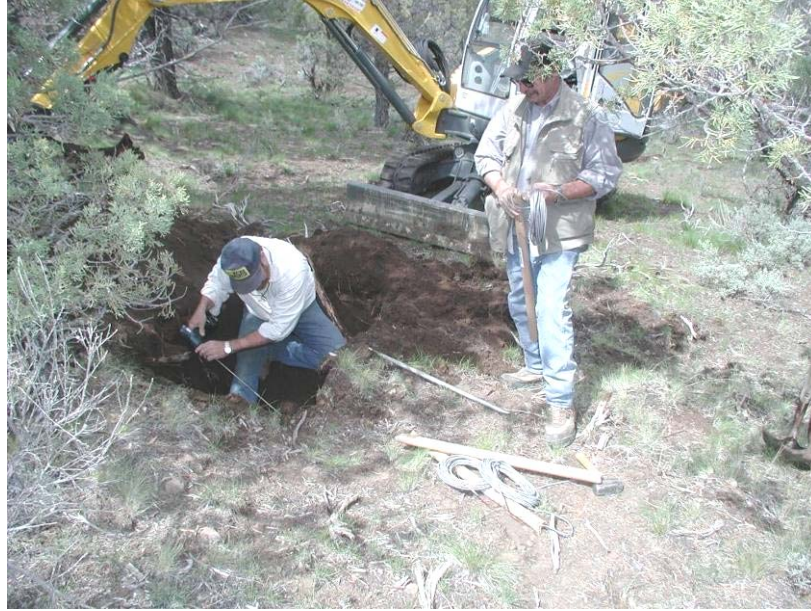
In semi-arid watersheds, soil moisture may be the only measurable hydrologic response following vegetation conversion (Hibbert 1983; Wilcox 1994). Soil moisture and soil temperature monitoring were added to the monitoring protocol in May, 2005. Soil moisture sites were placed in two locations within each watershed. At each site, 3 soil moisture stations were located and at each station, 3 soil moisture probes were installed. Soil probes were installed at 0.2, 0.45 and 0.76 m of soil depth. At each station, a hole, 1m x 1.5m x 1.2m (width x length x depth) was dug utilizing a mini, track-excavator. Probe holes were then drilled into the wall of the large hole utilizing a 16 mm drill bit (5/8 inch) (Figure 9).

Figure 9. Installation of soil moisture probes

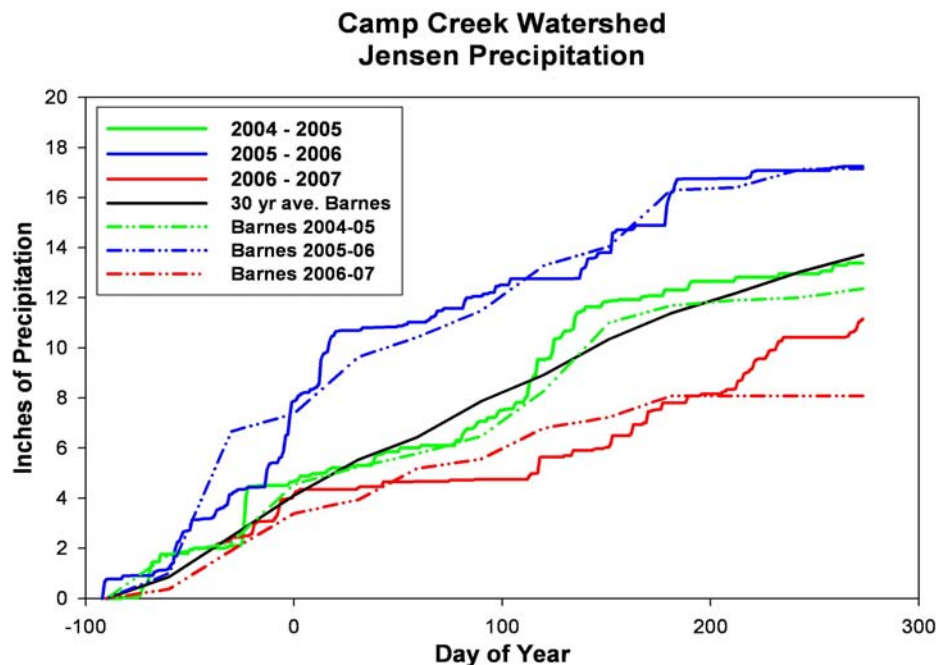
Figure 13. Camp Creek Watershed Jensen precipitation compared to Barnes Station

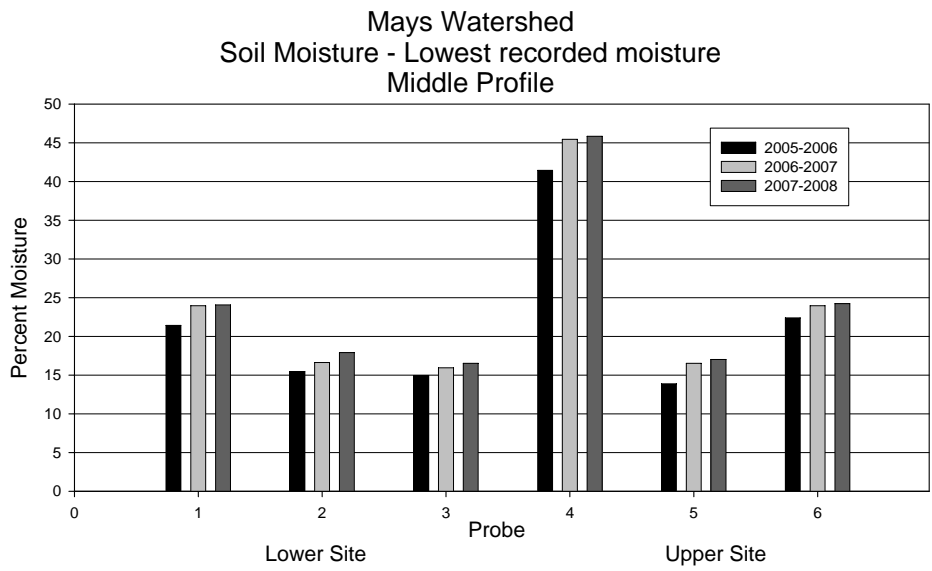
Figure 21. Mays Watershed Soil Moisture, end of season probe readings for middle profile.

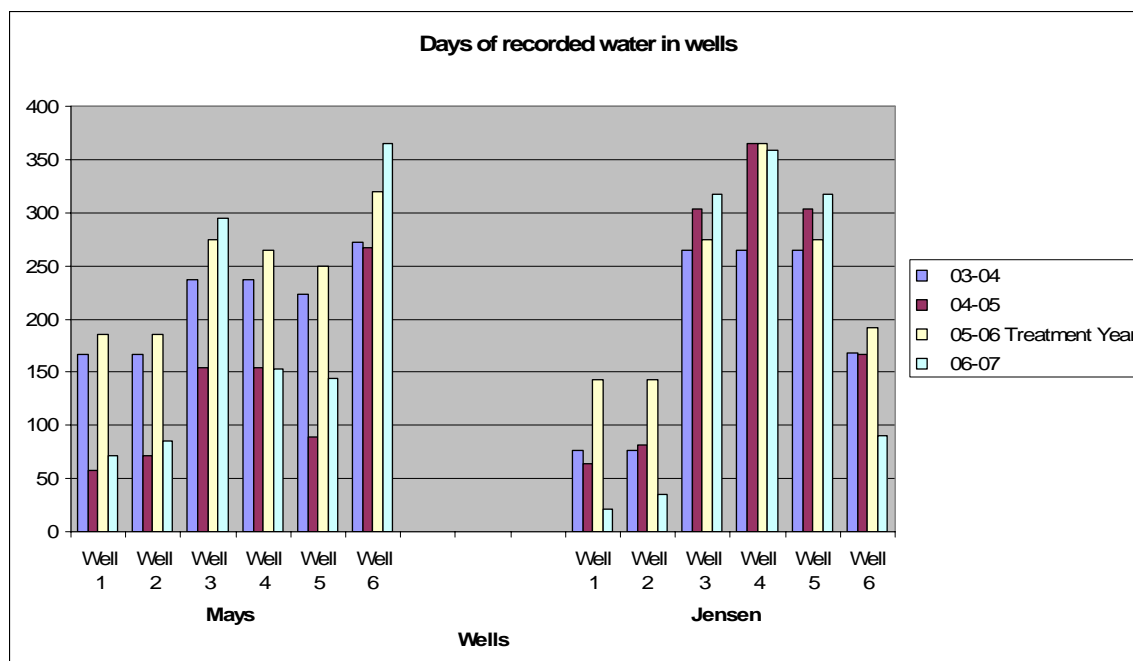
Figure 27. Days of recorded water in wells for the water years 2003-04 through 2006-07.

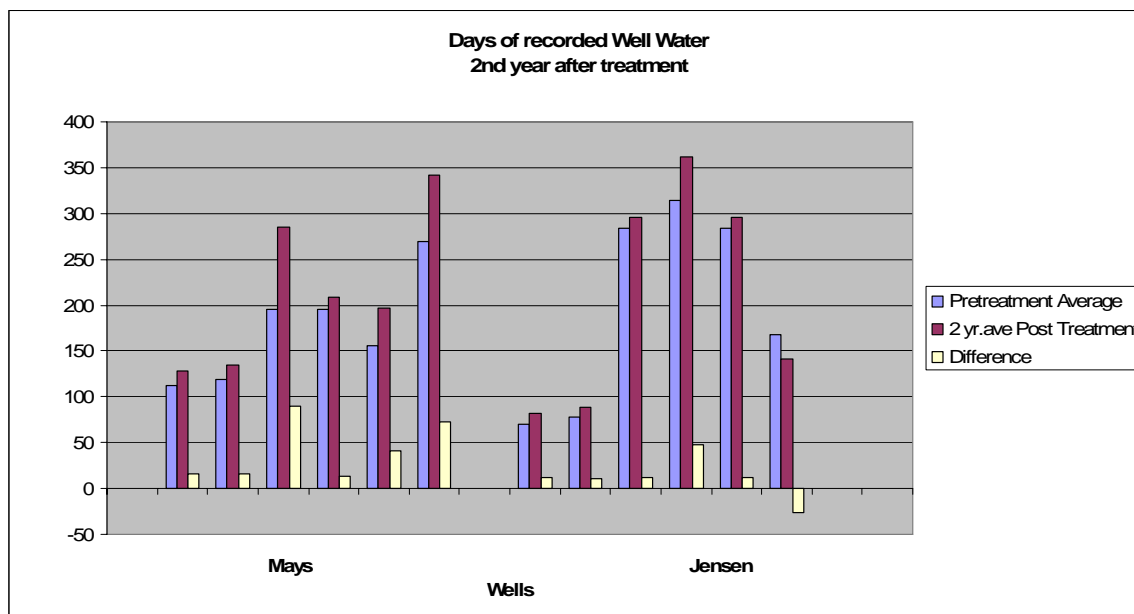
Figure 28 illustrates the average of each of the 2-year periods of pre and post treatment. The difference between the two years is shown as well.

Figure 28. Days of recorded well water pre and post treatment and the associated difference.

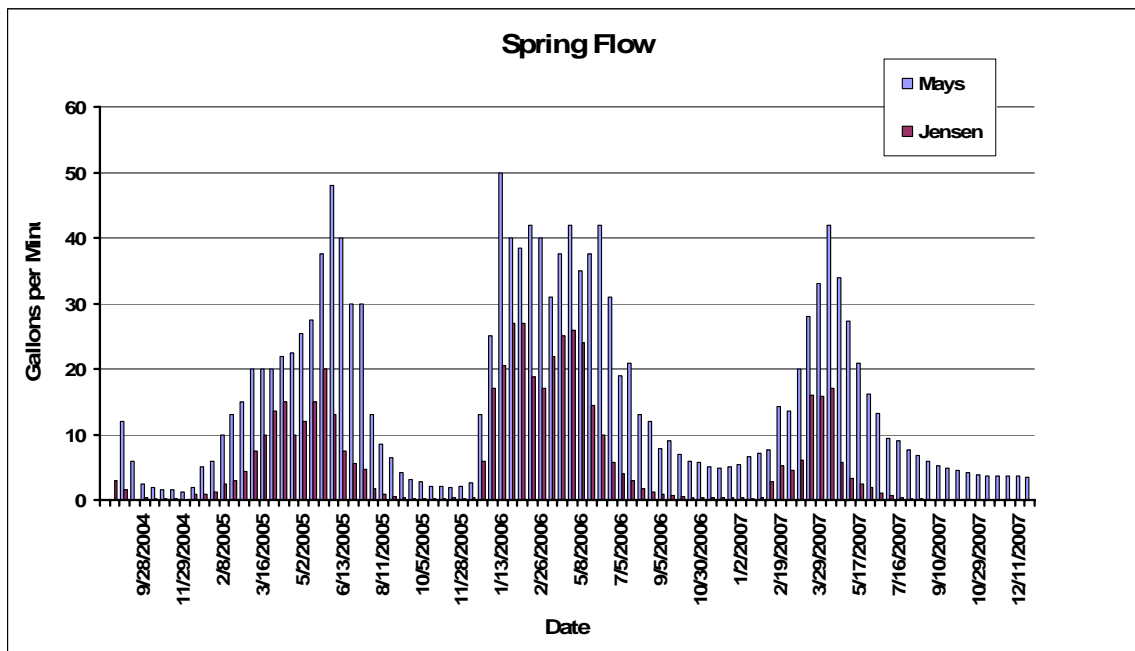
Figure 31 illustrates the differences in output between the two springs and the differences between years. Spring flow was dependent on timing/type and amount of precipitation. Base flow (that flow which is least likely to be influenced by a recent precipitation event or snow melt period) was the late season flow, the period between July and November.

Figure 31. Mays and Jensen spring flow, 2004 – 2007.

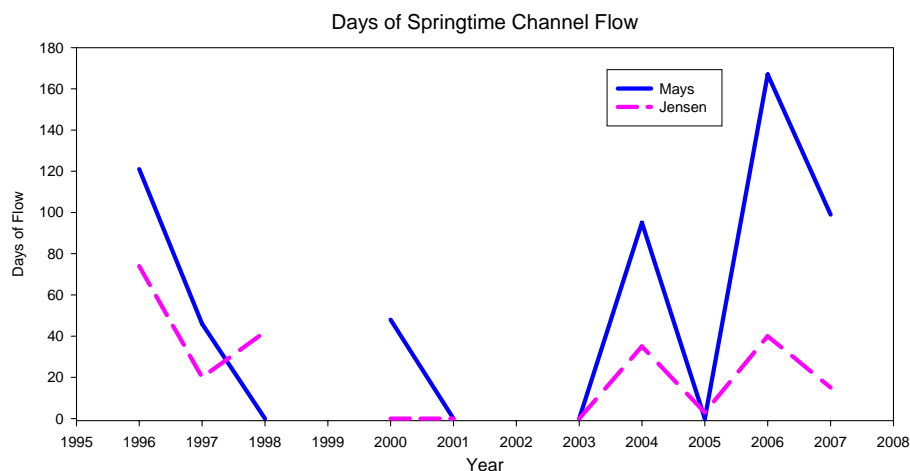
The channel flows of Mays and Jensen were ephemeral in nature, only existing during periods of snow melt or summer thunderstorm activity. In an attempt to look at channel flow as influenced by the treatment, total flow volumes and days of flow were looked at for the entire year and seasonally looking at spring flows (Figure 33). Spring flows were singled out because they were most likely to occur. For the years of data collection in which complete years were recorded (10 out of 13 years) Mays had 6 years of springtime flow data and Jensen had 7 years. Spring flow was defined as any flow occurring from January 1 to June 30 of each year. In all but 1 year (1996) days of channel flow in Mays exceeded Jensen.

Figure 33. Number of days of channel flow from January to June.

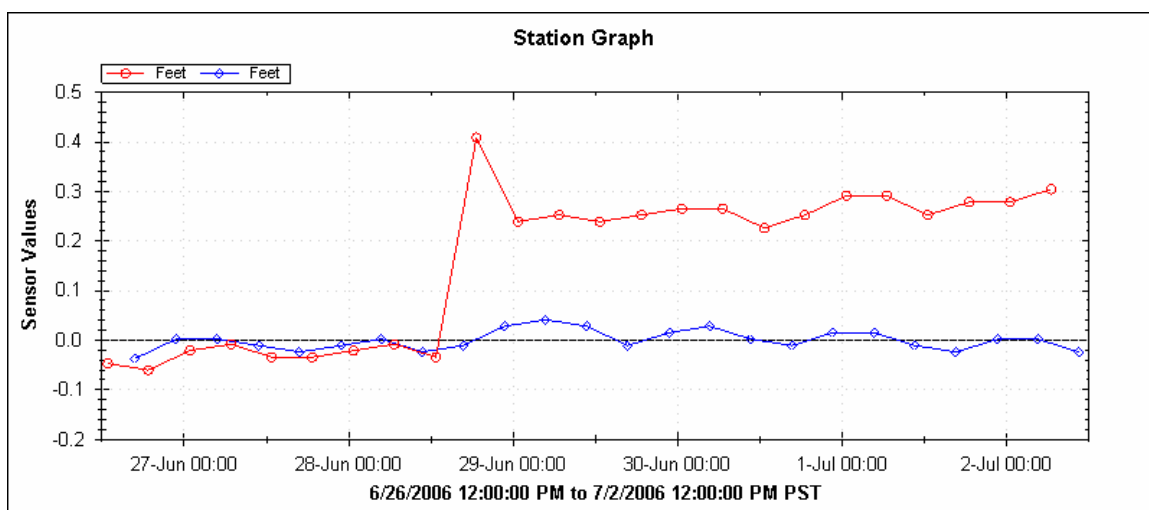
Within 1 hour of the start of the storm, sensors in Jensen flume (red) recorded flow of .4 ft on the staff gauge. Flow in Mays (blue) was not detected. The continuous flow in Jensen after the initiation of the storm reflects sediment deposits in the flume and not actual flow. Flow lasted less than 6 hours.

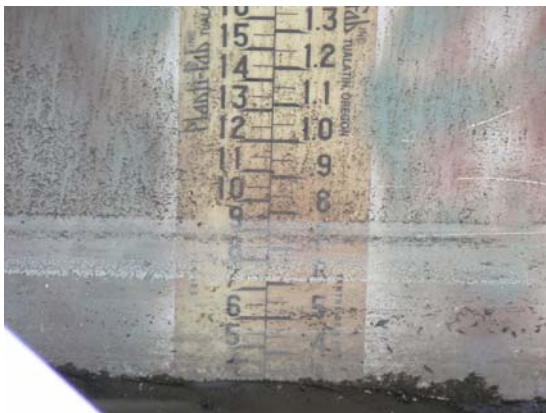
Staff gauge in Jensen flume showed that actual flow may have been as high as 22.86 cm (9 inches). The bottom of the photo shows the height of mud in the flume.

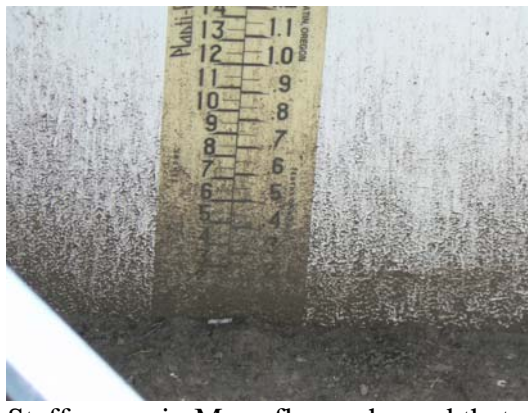
Staff gauge in Mays flume showed that rain drop splatter scattered mud on the walls of the flume but no flow line is visible.

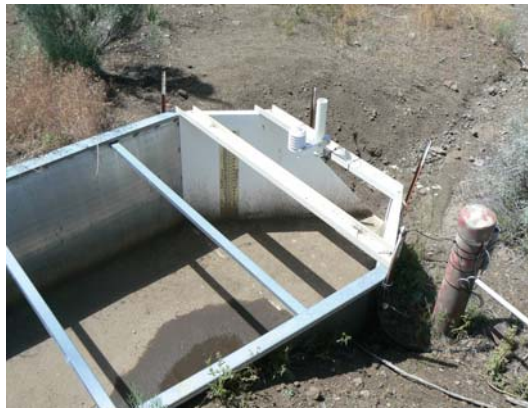
The ultrasonic sensor in Mays recorded no changes in depth of flow. Sediments on the flow of the flume are less than 31 mm (1/8 inch) deep.

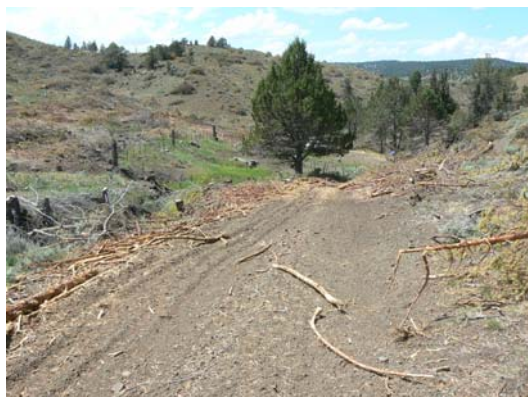
This road was used as a skid trail. Just days before the storm, road condition was soft, with several inches of loose soil on top.

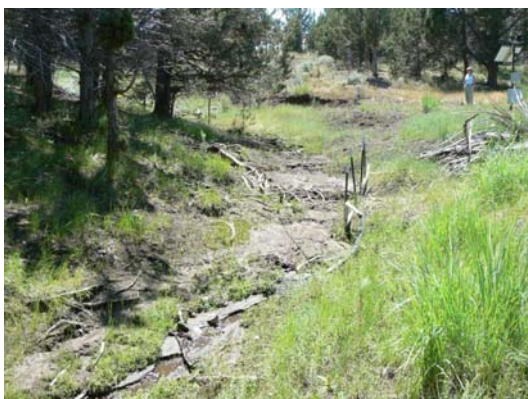
Channel deposits were numerous in Jensen following the storm. These deposits were place near Jensen spring.
