A THESIS

Oregon State University

**Riparian Cover Changes
Associated with Flow Regulation and Bank Stabilization
Along the Upper Willamette River in Oregon between 1939 and 1996**

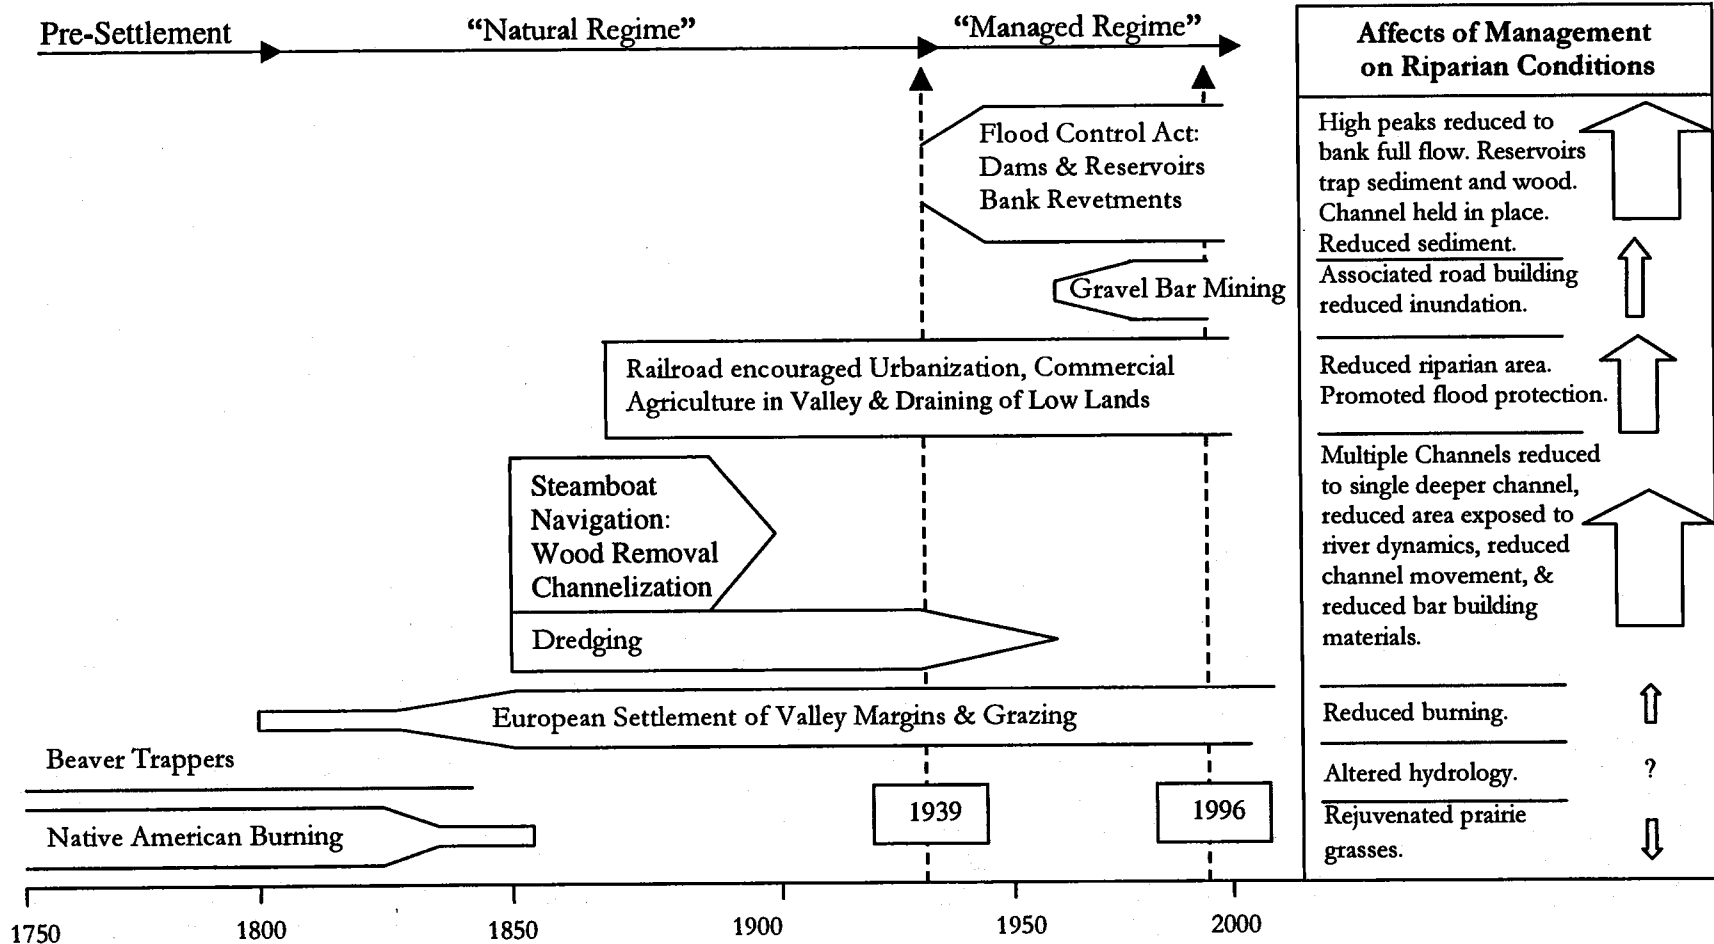
Figure 3. Human Interaction along the Willamette River

↑ Upward arrows mark management which reduced disturbance of cover, encouraging the development of mature vegetation.
 ↓ Downward arrows mark management which increased disturbance of cover, causing a regression of vegetation or maintenance of immature vegetation.
 Arrow width indicates the relative severity of impact on riparian conditions. (Boag 1992, Boyd 1999, USACE 1999, 1979, 1975, Morris Brothers conversation)

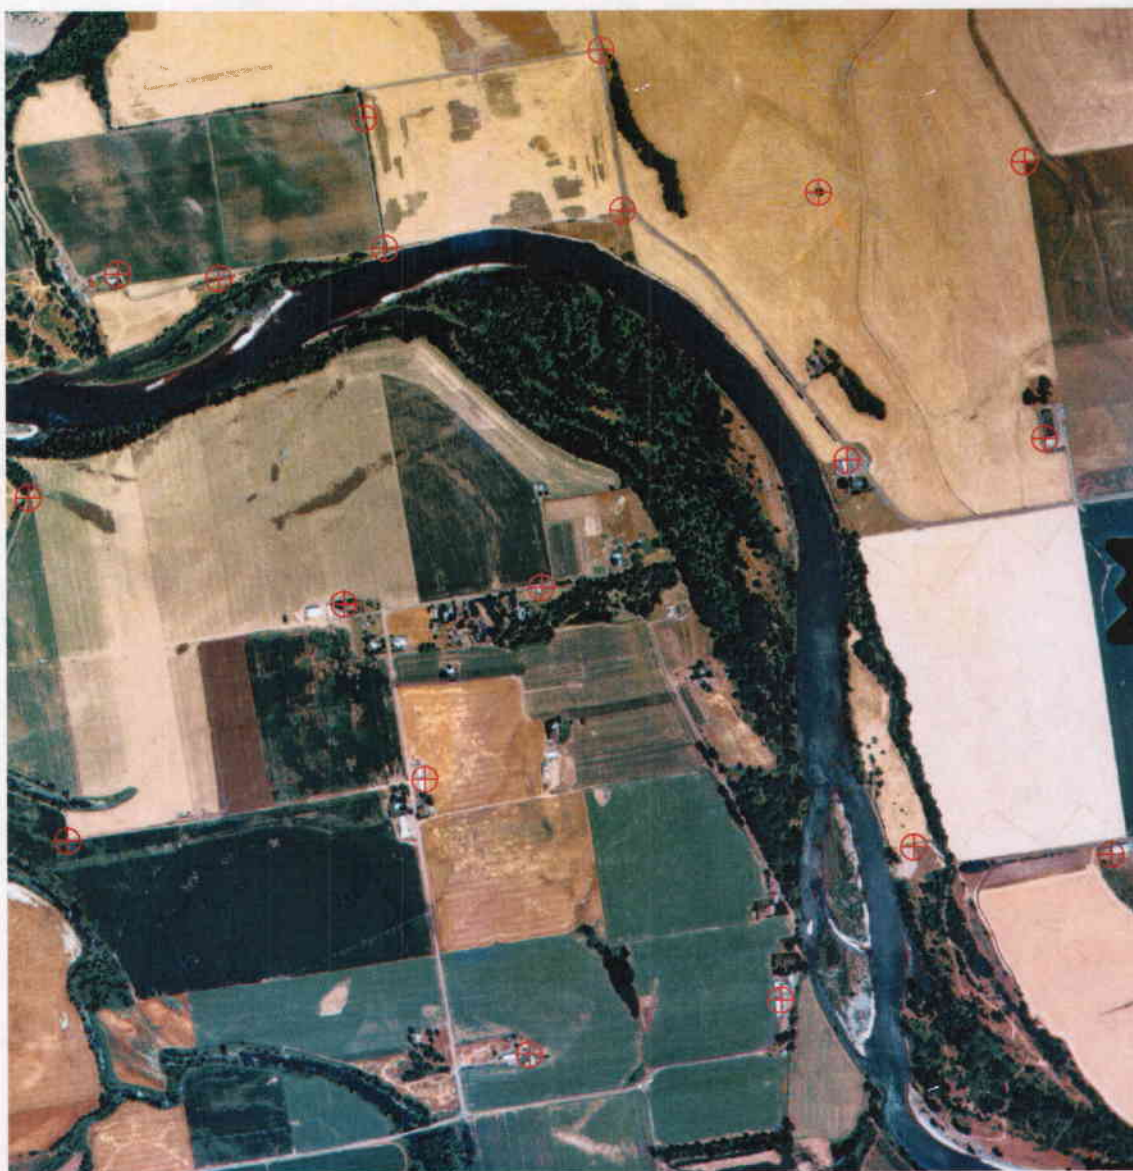
Figure 4. Ground Control Point Example

Features considered for rectification ground control points at southern site on 1996 image.

⊕ mark ground control points.

Once images were aligned, numerous possible ground control points were noted on a print of the orthophoto and printed enlargements of the photo images. The area covered by the 1939 photos was printed at a scale of 1:5,250 (2 X the photo scale). The area covered by the 1996 images was enlarged to a scale of 1:8,000 (3 X the photo scale). The scale for printing the orthophoto images was selected to give the highest resolution possible while leaving sufficient alignment features in the zoom transfer scope frame of view. All possible ground control points were pin-pointed with a dot from a fine point felt tip marker on enlarged paper copies of the images. Written notes detailing the exact location of the points were helpful because the amount of detail seen through the zoom transfer scope and later at the computer terminal was higher than the accuracy of the marker. Specified parts of intersections, building corners and other micro features were utilized as control points (Figure 4). An evenly distributed coverage of >15 accurate points across each photo was sought for rectification (Figure 4).

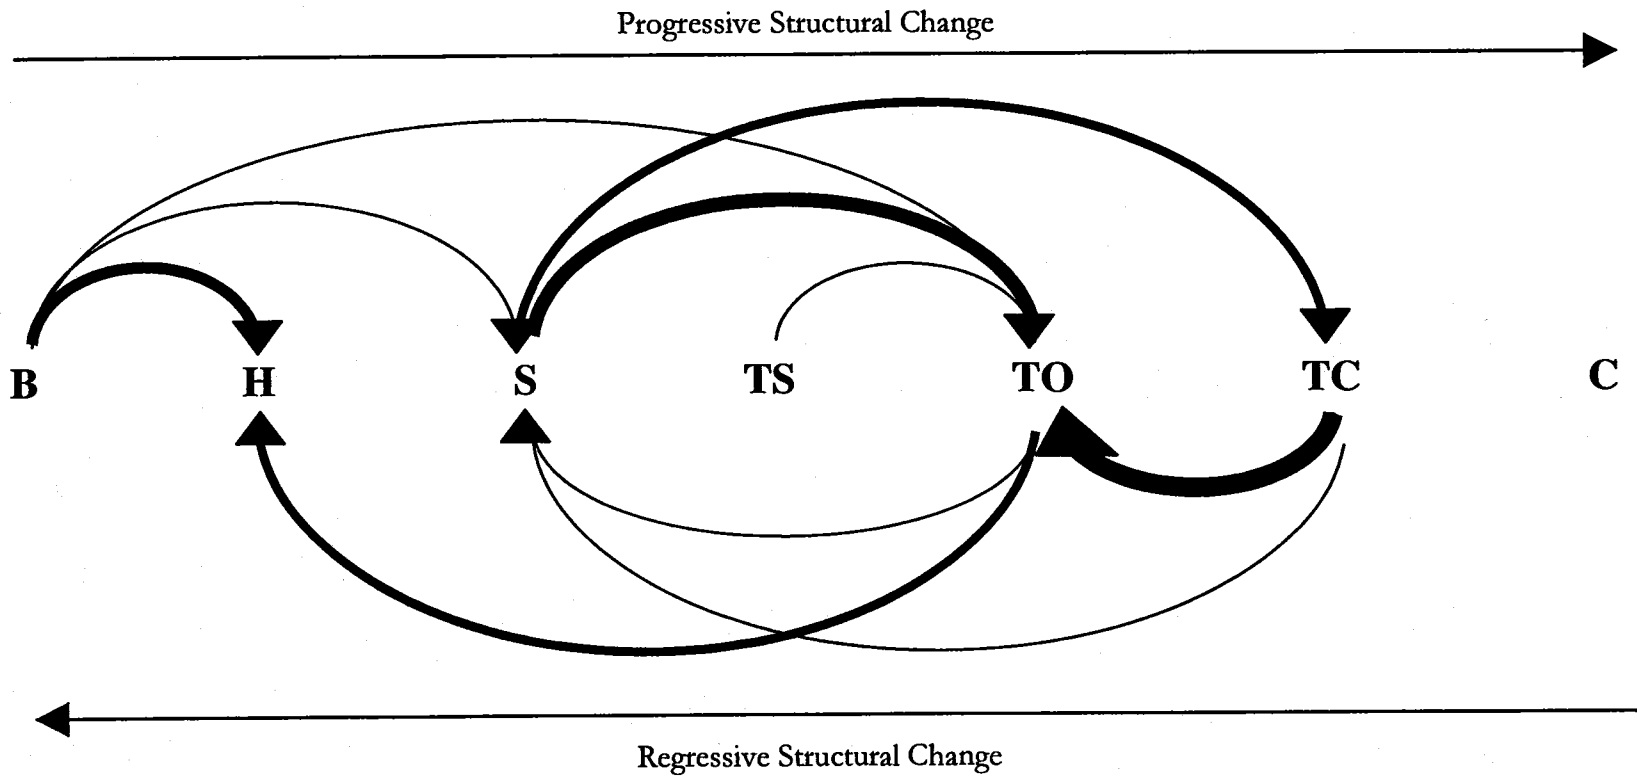
Figure 11. Northern Site Cover Change Diagram (1939-1996)

B = bare, H = herbaceous, S = shrub, TS = small trees, TO = open-canopy trees, TC = closed-canopy trees, and C = cleared
The thickness of the arrow shaft represents the percent of site experiencing that particular change in cover between 1939 and 1996

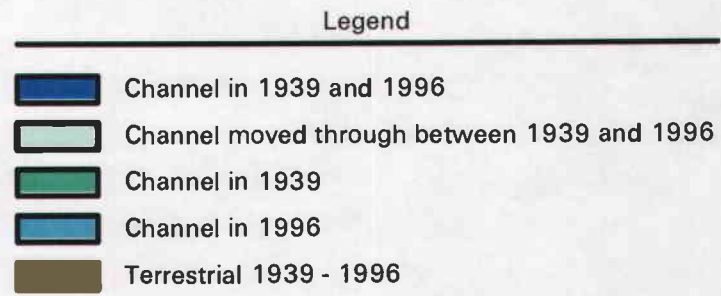
Figure 13. Northern Site Fluvial and Terrestrial Areas

Channel movement at the northern site between 1939 and 1996 included: an eastward shift in the north, a northward shift in the central portion of the site, and a westward shift in the south (Figure 13, blue polygons). By 1944 the bare point bar forming at the apex of the southern point bar in 1939 elongated, and widened into a mid-channel bar located downstream of the 1944 revetment (Figure 14, Lower Bend). Three events occurred by 1956: (1) The area between the mid-channel bar and the point bar to the south filled in with land; (2) The bank downstream of the revetment eroded, and (3) The southern and northern mid-channel bars present in 1996 formed. In 1961, overflow paths ran along the southern border of the abandoned 1939 channel and scour marks were present across the bar deposited since 1939 (Figure 12 & 13). By 1963, extension of the 1944 revetment halted channel widening and forest erosion downstream of the 1944 revetment (Figure 14). After the mid-1970s, the only landform changes were the formation of mid-channel bars.

The area unaffected by channel migration between 1939 and 1996 was located on the inside of river bends (Figure 13, tan polygons). The terrestrial area that underwent progressive structural change experienced a lower degree relative to 1939 fluvial areas because most terrestrial areas already had vegetation (Figure 15, terrestrial area, blue

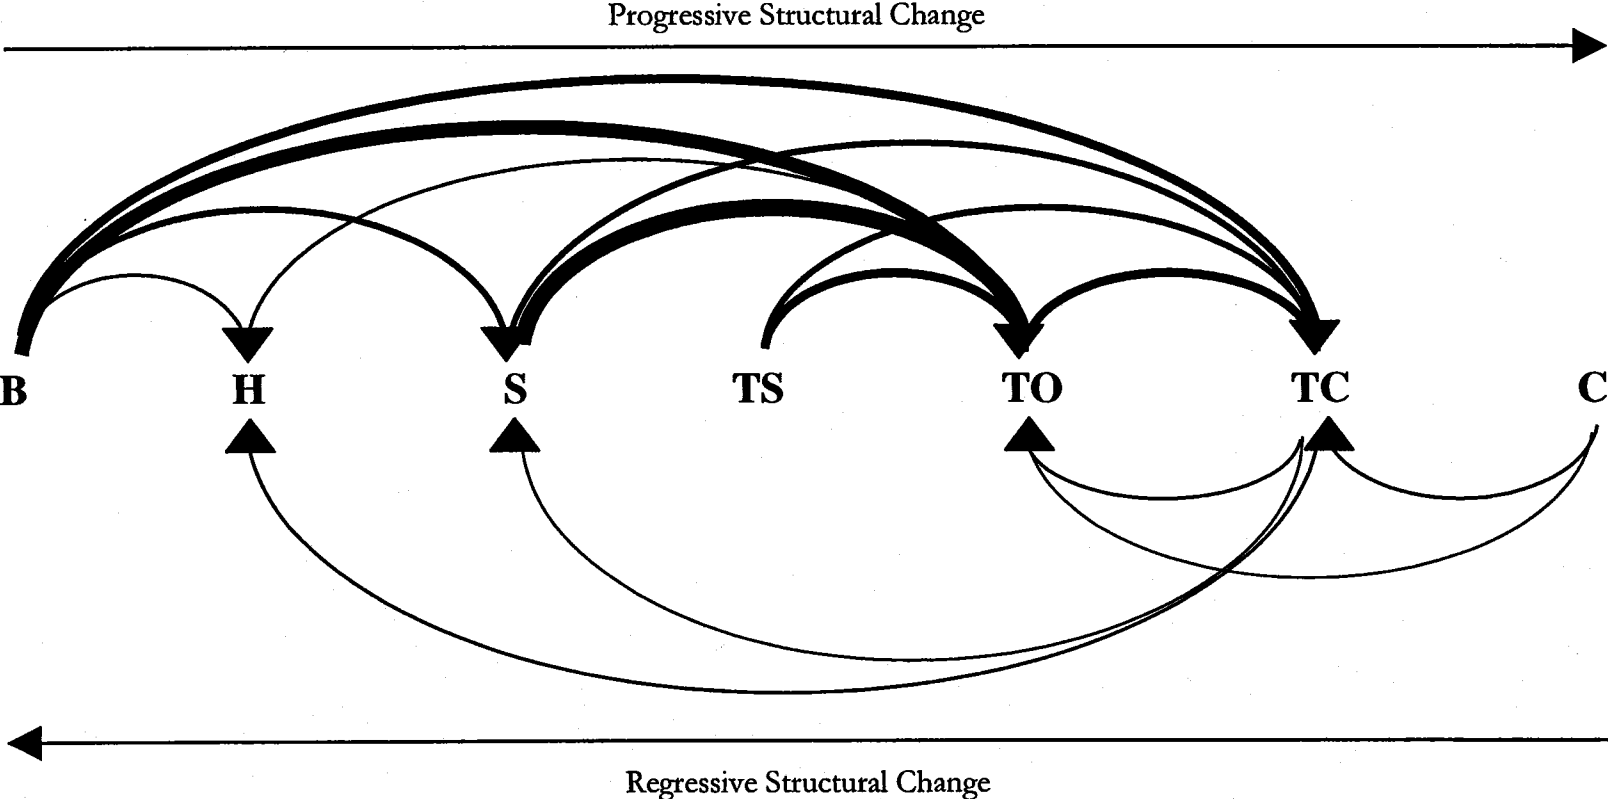
Figure 20. Southern Site Cover Change Diagram (1939-1996)

B = bare, H = herbaceous, S = shrub, TS = small trees, TO = open-canopy trees, TC = closed-canopy trees, and C = cleared
The thickness of the arrow shaft represents the percent of site experiencing that particular change in cover between 1939 and 1996
