Anthony M. Rikli for the degree of Master of Science in Civil Engineering presented on May 25, 2011.

Title: Evaluation of Straw Wattle Placement and Surficial Slope Stability

Oregon State University

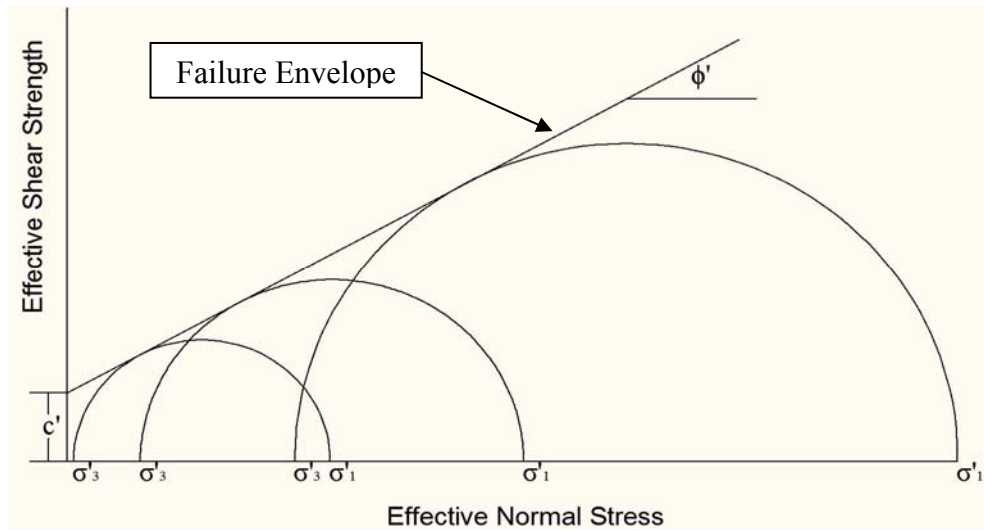
Figure 2. Mohr-Coulomb failure envelope

Slope stability is determined by the ratio of forces driving failure and forces resisting failure. The soil's shear strength is its capacity to resist failure and is described by the friction angle (ϕ') and cohesion (c') of the soil in Mohr-Coulomb Theory. These parameters are shown in a Mohr-Coulomb diagram shown in Figure 2. The force driving failure is the weight of the soil mass and the load applied to it. Theoretically, the points on the circles (Figure 2) that are tangent to the Mohr-Coulomb failure envelope represent the stress conditions at which the driving forces have become greater than the resisting forces. This is considered a strength failure in the soil. Notice that this failure envelope assumes a soil's strength fails linearly with increasing stress with a cohesion intercept (c') at zero effective normal stress. In reality, however, this cohesion is not fully mobilized at low stresses. Therefore a lower intercept is produced, creating a curved, rather than linear, strength failure envelope (Holtz, Kovacs, and Sheahan, 2010).

The Mohr-Coulomb failure envelope (Figure 2) yields a simplified relationship between the stress and shear strength of a soil at failure using a best fit line tangent to each Mohr circle developed. A soil at failure is defined here as the largest ratio of the stress applied by the load cell (σ_1) to the stress applied by the surrounding water (σ_3). In other words, the ratio of these two stresses is greatest when the soil fails. This Mohr-Coulomb failure envelope also gives a limit at which failures can occur within a soil. For example, a Mohr's circle below the line represents a stable condition where no failure will occur within the soil. Above the line, no shear strength failure can occur with a corresponding principle stress. The Mohr-Coulomb failure envelope is simplified to be linear, however, as discussed earlier, in reality; this criterion is represented with a curve.

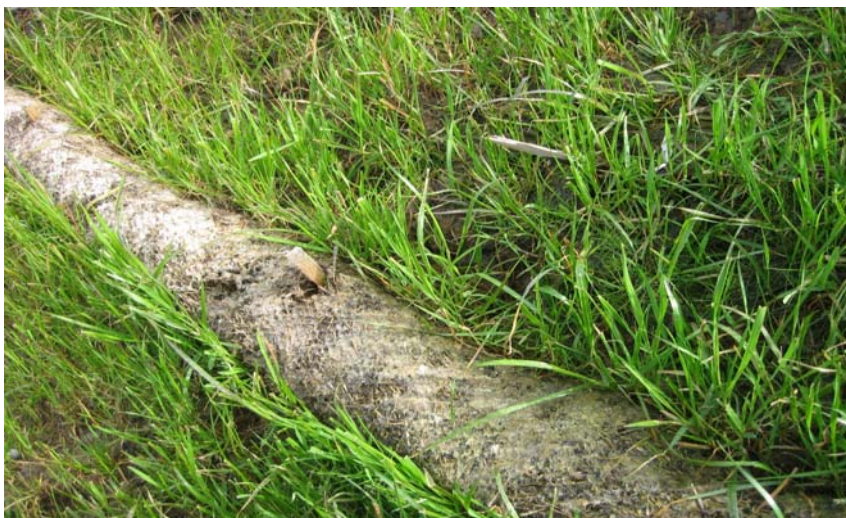
Figure 6. Example of straw wattle placement on-site

Straw wattles were installed according to specifications given by Granite Construction (Granite). Figure 6 shows an example of the straw wattles on-site. Originally, straw wattles, at lengths of 10 feet (3 m), were spaced at 25 feet (7.6 m) from the top to bottom of the slope and no vegetation was placed. With the increasing amount of wattle-bracketed surficial slope failures observed, the spacing was changed to 75 feet and grass seed was installed into the embankment slopes.

According to Granite, the wattles were placed level with slope contours and the spacing between, as discussed previously, was 75 feet (23 m). A sight level and string line were used to paint the wattle line. A 6-inch-wide trench was then dug using shovels along the contour line approximately 3 to 5 inches deep to avoid gouging into the slope too much (Gehling, 2010). At the connection of straw wattles, one foot of the connecting wattle was overlapped onto the new wattle. Once the wattle was set, a stake was inserted every 5 feet (1.5 m) of wattle.

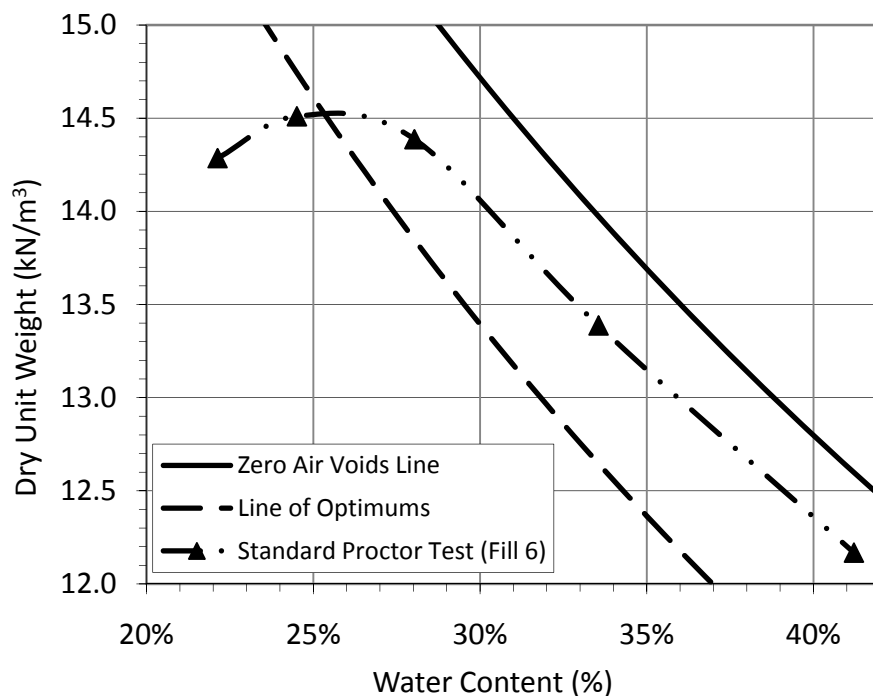
Figure 13. Example of standard compaction test results

An example of standard compaction test results is seen in Figure 13. Notice that the data plotted is compared with a line of optimums and zero air voids curve. The line of optimums is a curve fitting all optimum moisture contents and maximum dry densities of a soil using different compactive effort. The zero air voids curve is a theoretical curve where the soil is 100% saturated leaving no air pockets or voids within the compacted specimen. Although possible, this line is not physically achievable through compaction alone.

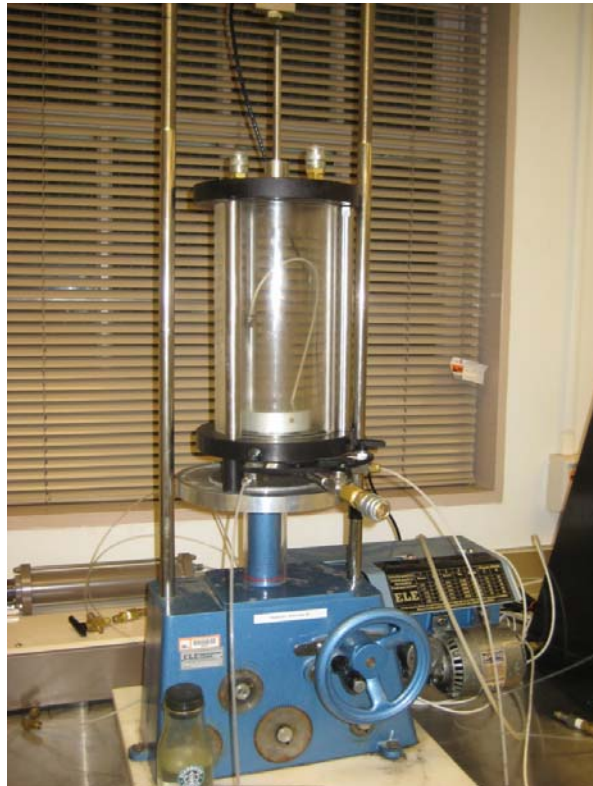
Figure 14. Triaxial and cell apparatus

For the purposes of this thesis, it was assumed that the fill was fully consolidated and PWP's were apparent when the slope failures occurred. Therefore, a consolidated undrained (CU) triaxial compression test was administered to determine the strength parameters of the fill material. Figure 14 shows an example of a triaxial apparatus and loading frame used for this test. The CU test was organized into four phases: preparation, saturation, consolidation, and shearing.

The triaxial apparatus was then assembled. Six membranes with diameter of 2.8 inches were cut, greased, and placed on the top and bottom platens. Earlier, the bottom platen was secured to the apparatus' bottom plate, and this connection was tested for leaks. Shear keys were then placed into each top and bottom platen to prevent the soil from moving laterally during axial shear. Filter disks were placed in the sides of both platens to allow water/air to filter out of the specimen into the rest of the cell.

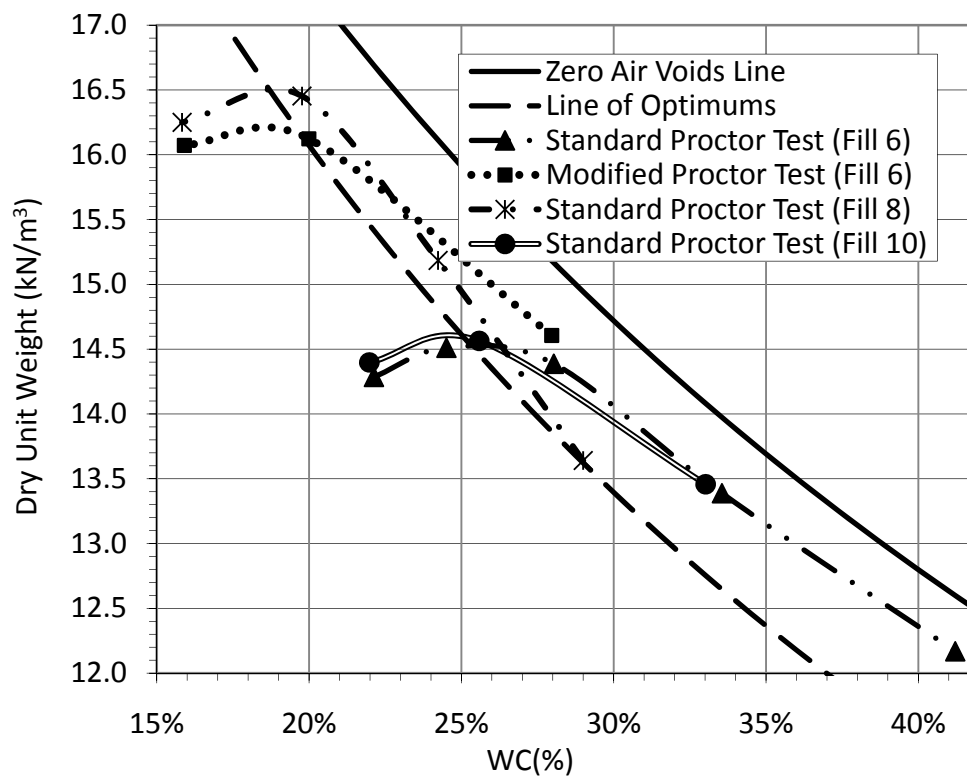
Figure 20. Standard and Modified Compaction Test Results

Note that the higher compactive effort produced by the modified compaction test allows the soil to be compacted at a lower water content and to a higher density. This, in turn, would lead to higher strength and a greater friction angle.

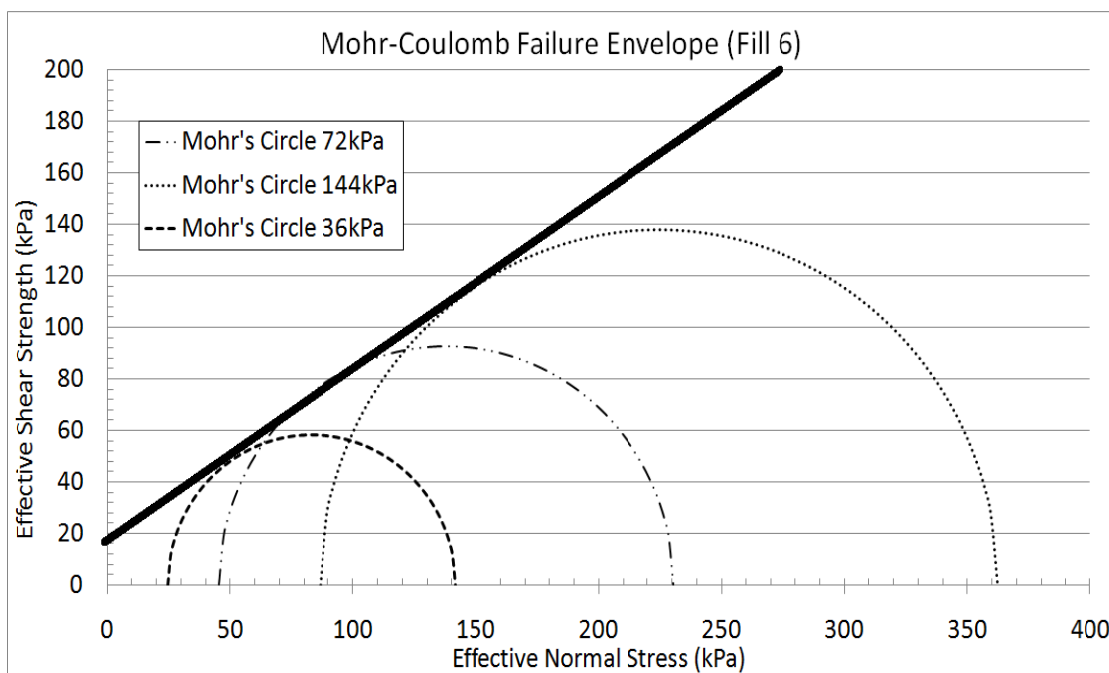
Figure 21. Approximate Mohr-Coulomb failure envelope from CU test (Fill 6)

(ϕ') and the effective cohesive strength (c'). The effective shear strength at zero effective shear stress is the effective cohesive strength. Graphically, this is represented by Figure 21. Using this equation and testing completed, the effective friction angle (ϕ') found was 33.7° with an effective cohesive strength (c') of 18 kPa. The total stress parameters found were a total friction angle (ϕ) of 29° and a total cohesion (c) of 22 kPa.

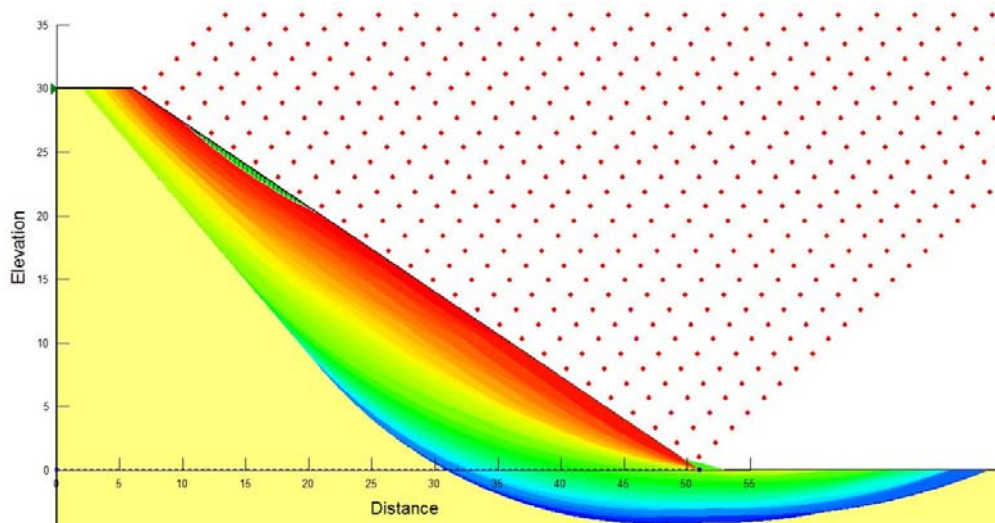
Figure 23. Factor of safety map against slope failure

which could very well influence where failure circles could occur on the slope. It was also noted that the factor of safety map at the top of the slope did not vary much with the straw wattle spacing scenarios. However, the bottom of the slope showed a slight decrease in factor of safety against global slope failure with no straw wattles.

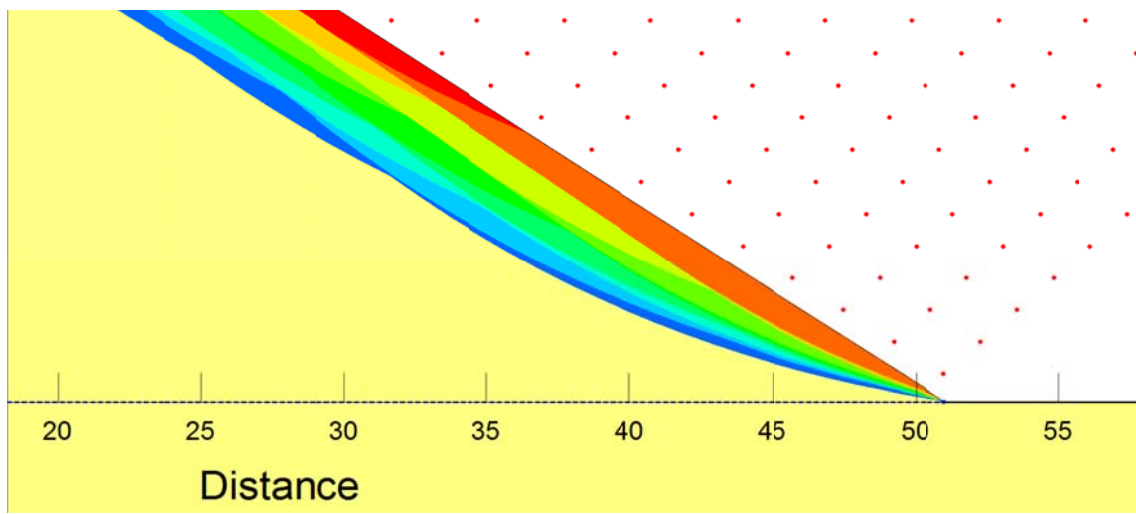
The majority of these critical slip circles (86) occurred on the upper half of the slope. However, investigation of the factor of safety map showed a slight decrease in global stability at the bottom of the slope with 25 foot straw wattles as shown in Figure 24 and Figure 25. In both figures, the highest factor of safety against slope failure is toward the bottom of the model while the lowest factor of safety is shown at the slope's surface. The slight decrease in factor of safety, discussed earlier, is shown by a lack of the darker shade toward the bottom of the model in Figure 25. However, overall, the factor of safety against global failure was greater than 1 for all critical slip circles therefore slope failures at deeper depths are not possible with the variables considered.

Figure 24. Factor of safety map for scenario with no straw wattles. Shades toward the surface represent decreased stability; shades toward the bottom represent increased stability.

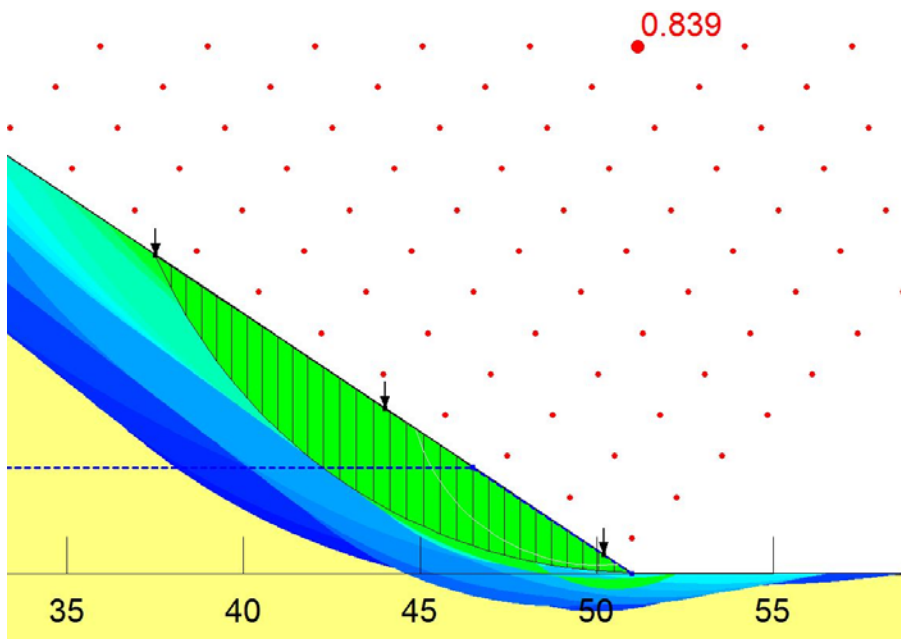
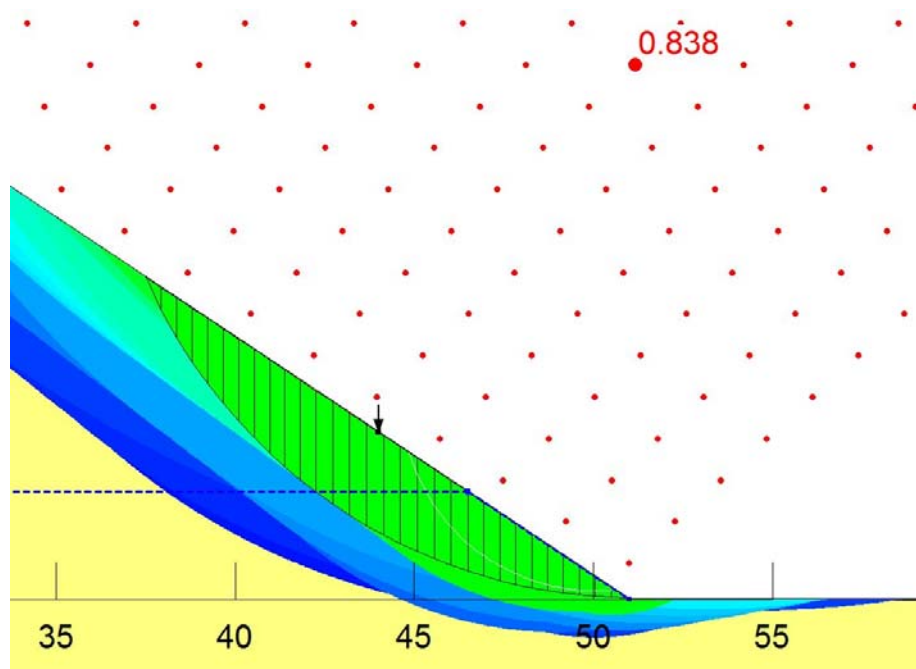
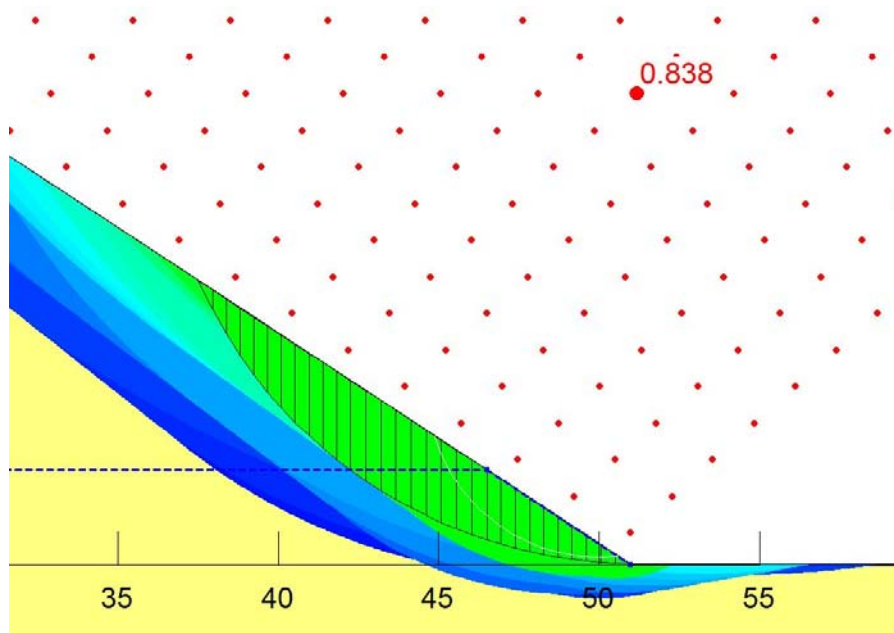
Figure 26. Failure circle with 25ft straw wattle spacing, 3m high water table

Figure 27. Failure circle with 75 ft straw wattle spacing, 3 m high water table

Figure 28. Failure circle with no straw wattles, 3m high water table

Overall stability modeling using $\phi' = 33.7^\circ$ and $c' = 18\text{kPa}$ (full cohesion) show that deep failures are unlikely, with or without straw wattles, unless there is a significant rise in groundwater.

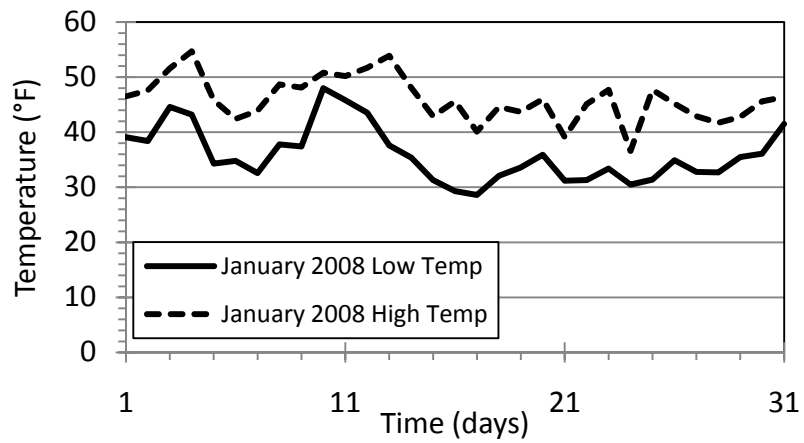
Preliminary modeling suggests there is a significant change in factor of safety with rainfall and possibly temperature as seen in Figures 29-31. A dramatic increase in factor of safety at day 12 (Figure 30) is observed following the initial rainfall. The subsequent rainfall appears to have minimal effect on the factor of safety, until 2 inches of rainfall is seen on day 28. This may, perhaps, indicate that the rainfall below a threshold of 1 in. per day is required to lower the factor of safety. Further research is needed to verify this and additional impacts of rainfall, temperature and other environmental factors on slope stability.
