Title: An Archaeological Analysis of the Architectural Artifacts and Features at the Robert Newell Homestead Site (35MA41).

An Archaeological Analysis of the Architectural Artifacts and Features at the Robert
Newell Homestead Site (35MA41)

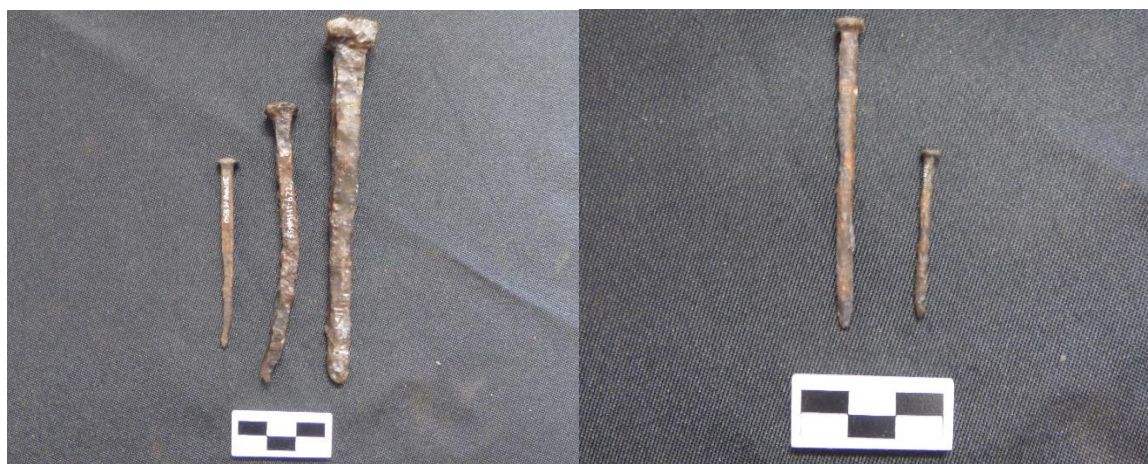
Figure 4.2 Handwrought nails (left); wire nails (right)

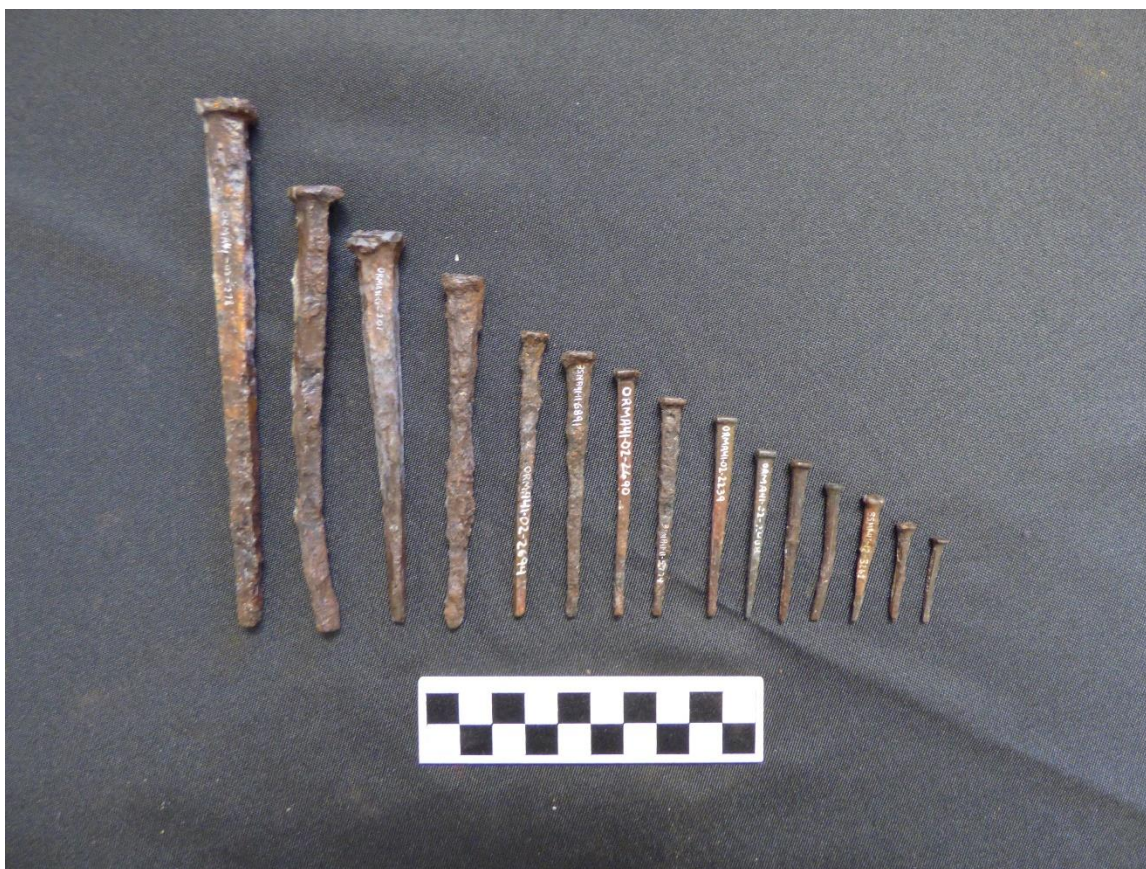
Figure 4.3 Machine cut square nails from site, left to right 60d, 40d, 30d, 20d, 16d, 12d, 10d, 9d, 8d, 7d, 6d, 5d, 4d, 3d, 2d

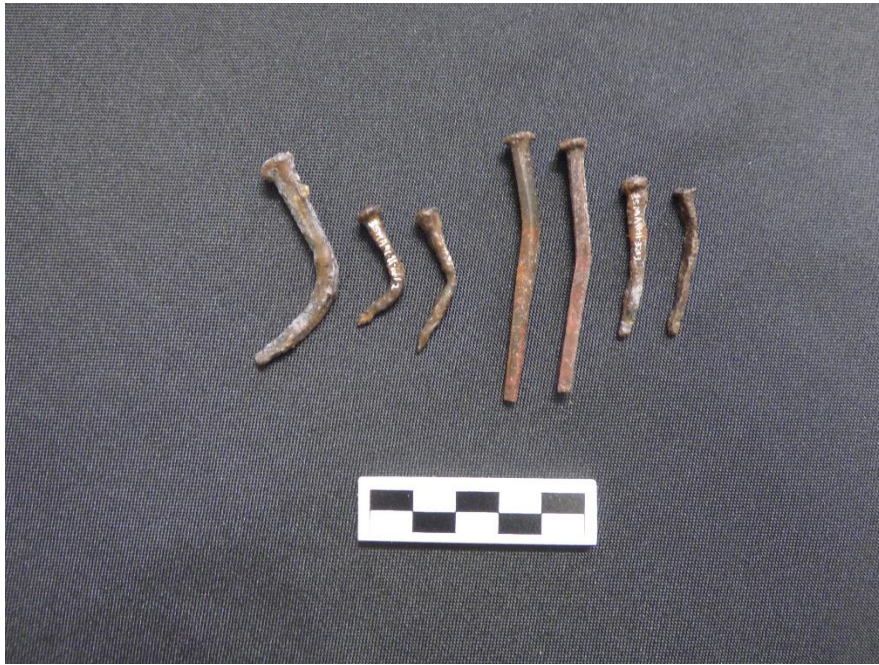
Figure 4.4 Clinched (left) and pulled (right) nails

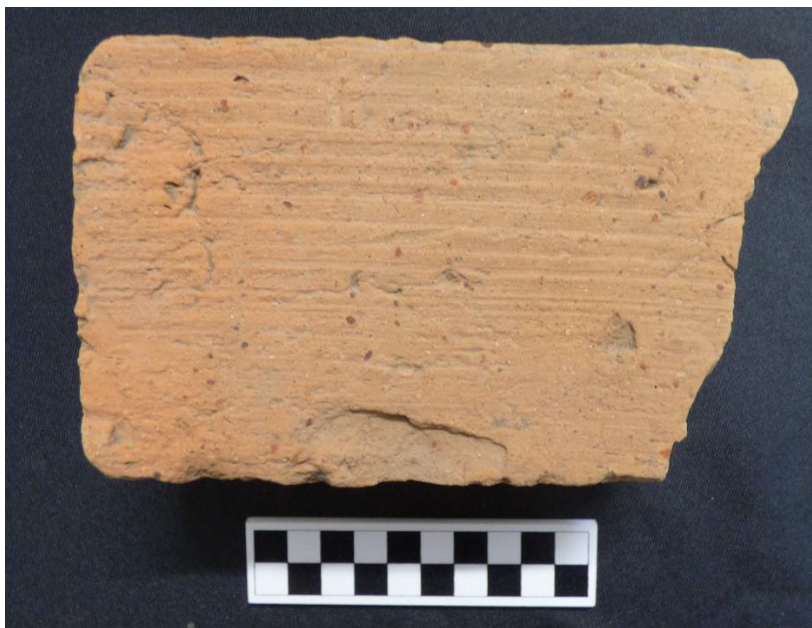
Figure 4.7 Top of Brick showing striations created during striking

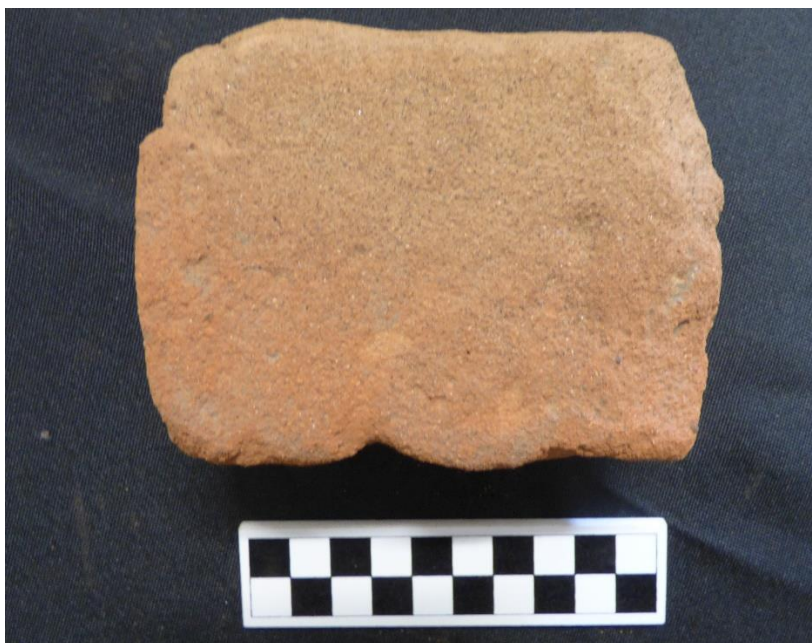
Figure 4.8 Bottom of brick showing remnants of the sand used during striking

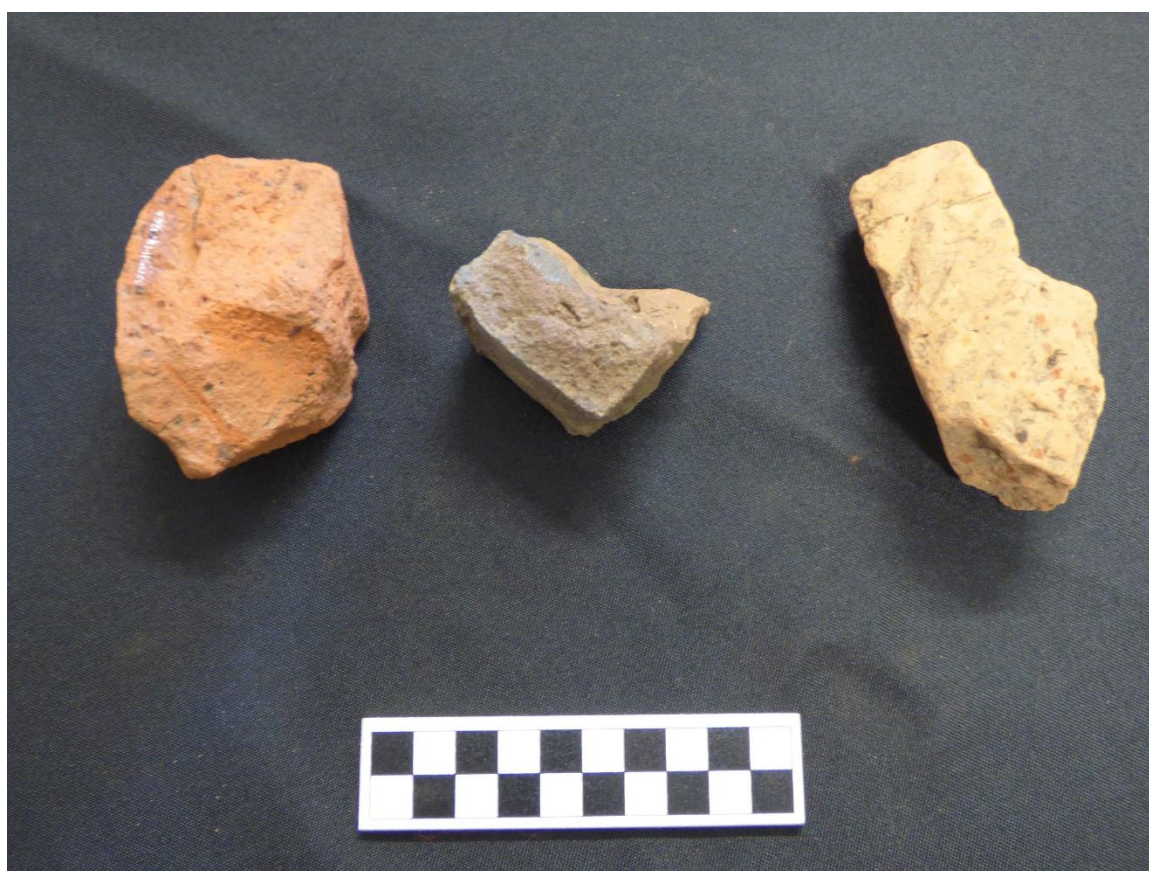
Figure 4.9 Fragments of brick showing variation in color found in the site caused by inconsistent kiln temperatures, common with temporary kilns

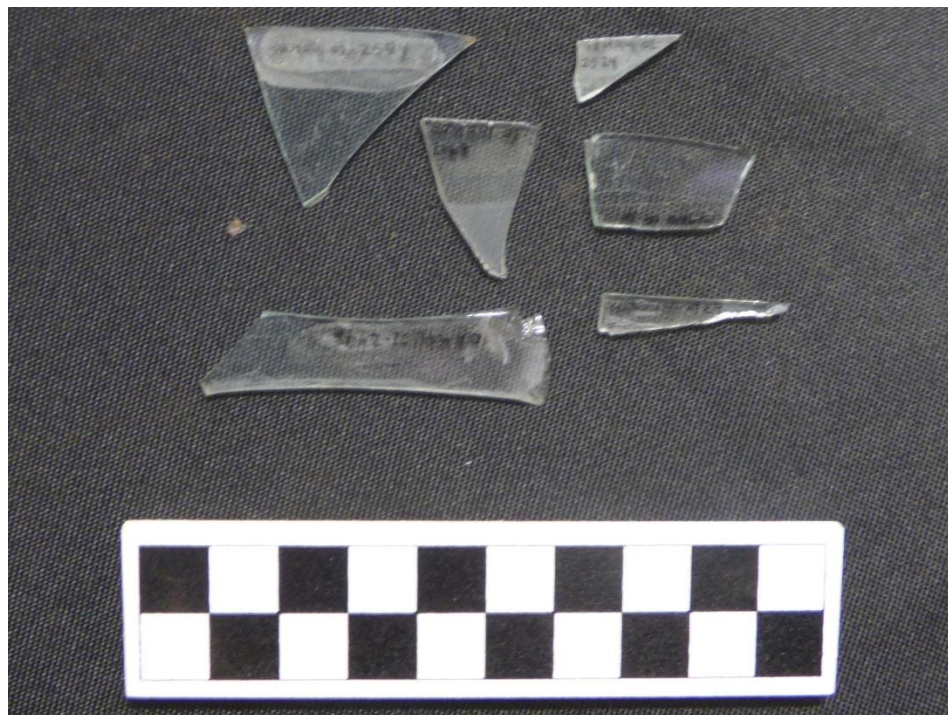
Figure 4.10 Photo showing the general size of window glass fragments at the site

In the last half a century, several methods have been developed to provide dates for window glass found at archaeological sites. These dates are based on the thickness of the glass as window glass gradually became thicker throughout the 19th century (Weiland, 2009:29; Roenke, 1978:35). Two types of methods were developed to evaluate the thickness of the glass, “Modal methods utilize a histogram compiled by assigning each sample to a mode determined by a range of thicknesses; each mode then correlates with a range of dates. The mean methods insert the mean value of all viable samples into a regression formula and produce a number that represents a relative date for site construction” (Weiland, 2009:30). These methods could then be further divided by

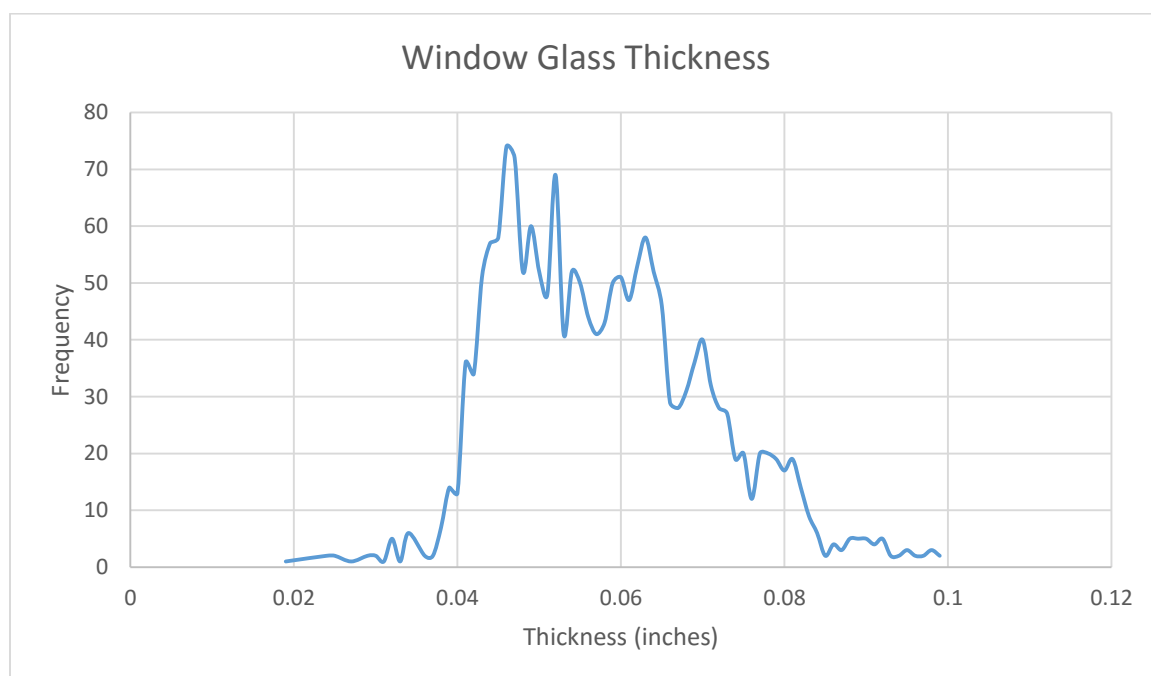
Figure 4.11 Frequency of window glass thickness at the Newell site

we see that these three thicknesses fall between the 1830-1840 .045 inch thickness and the 1840-1850 .065 inch thickness. This age range only eliminates one occupant, Donald Manson, from purchasing the window glass and gives a 20 year period for when the window glass was purchased. However, these dates do support the theory that both Johnson, as early as 1837, and Newell as late as the 1850s purchased window glass for the home. Mapping the glass in a distribution map may provide more information regarding dates and the placement of the windows.

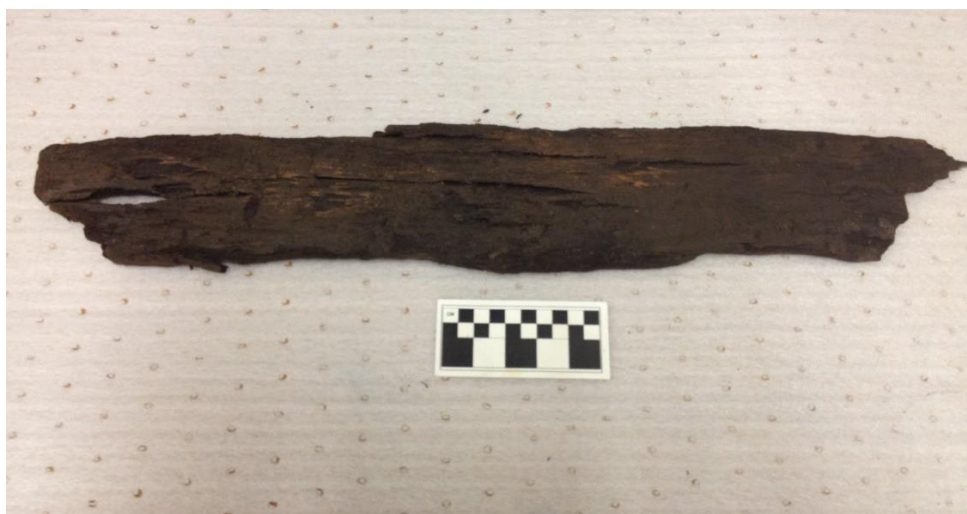
Figure 4.14 Example of wood plank found in well feature

Four different wood samples from the Newell site have been researched by the Oregon Wood Innovation Center (OWIC) located at Oregon State University. These samples included one post which was looked at by the center in the early 2000s, and three samples from the well, two which looked to be structural and one unique piece, which were looked at in Fall of 2014. Dr. Scott Leavengood, the director of OWIC offered to look at the three well samples for free as a fellow Oregon State researcher and identify what species of wood each of the samples were. This work is completed by looking at a

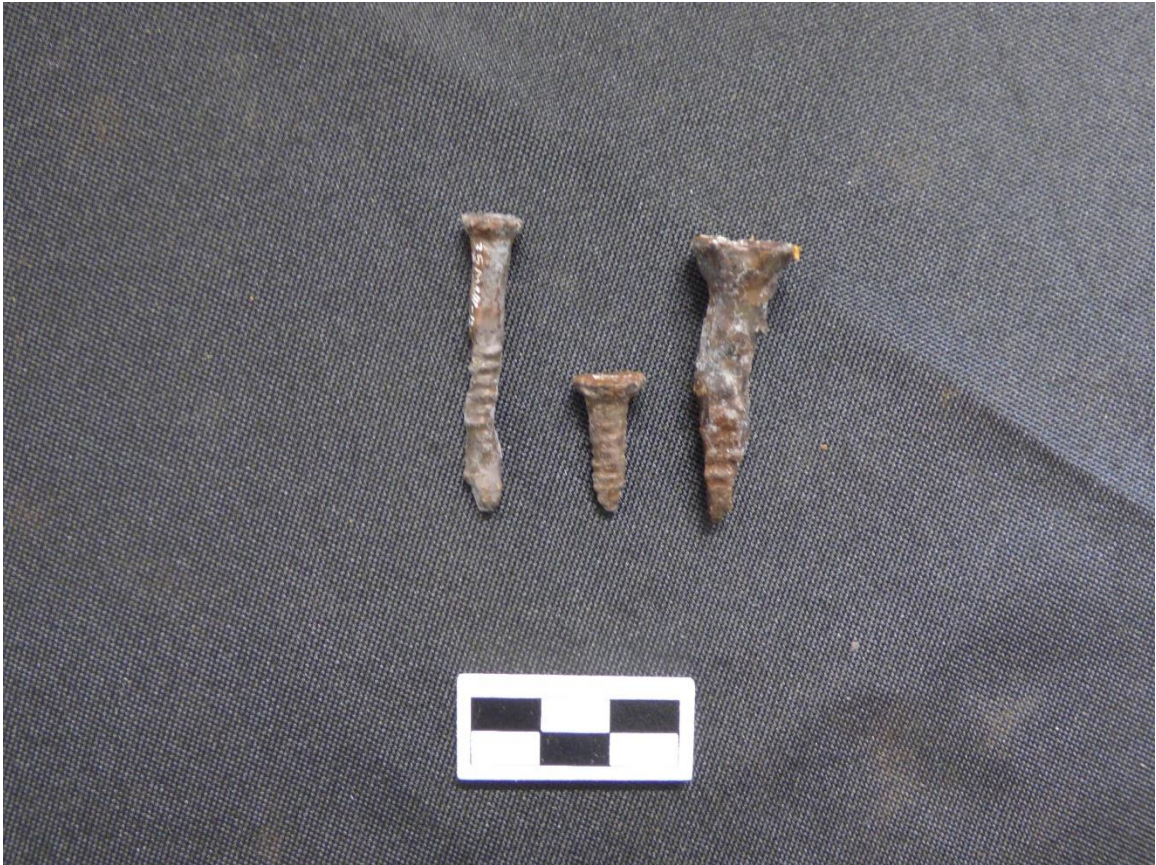
Figure 4.15 Example of types of screws found at site

until 1936 that the cruciform shape was added to the socket head by Henry F. Phillips (Rybczynski, 2000:83). These changes give us temporal markers which we can use to date the relative manufacture of the screws. However, it is likely that most of the screws were never structural and were instead incorporated into such things as furniture.

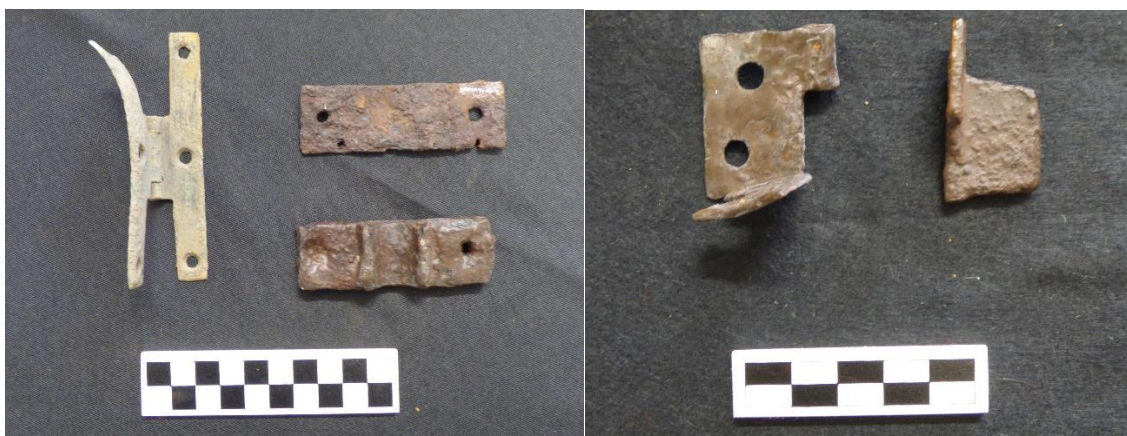
Figure 4.16 (left) A brass hinge, iron bracket for hinge, and iron door latch (right) a cast iron hinge fragment and a cast iron bracket fragment

Four separate hinges are found in the collection, one of which is complete while the other three only represent part of a hinge. The one complete hinge is a brass hinge which measures 4” (10.16 cm) in height and 2.5” (6.35 cm) wide when completely open. This hinge, because it is of a ferrous metal, was likely used on the interior of the home and though it may have been attached to a door, was more likely attached to a piece of furniture. The second hinge is the only part of the bracket which would have been used to attach the hinge to the door. It is made of iron and measures 3 1/8” (8cm) in height and 1” (2.5 cm) wide. The third hinges is also made of cast iron while the fourth is part of a bracket that may have been associated to a hinge system. These were not measured as the dimensions would be meaningless. These 4 hinges represent only part of this artifact class as hinges were not only part of doors but cabinets and furniture of which there were likely many, though only a few of the larger and stronger hinges would represent doors or an architectural purpose.

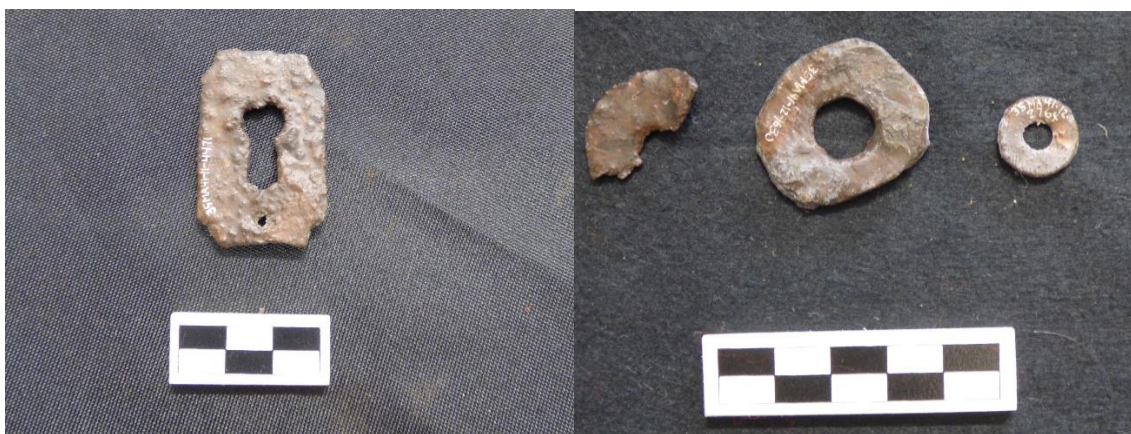
Figure 4.17 (left) escutcheon, (right) Washers

The escutcheon, or the keyhole, may have represented the other side of the lock on the front door. This cast iron key hole is a very simple design which indicated where the key was to be placed in order to lock or unlock the door. It was common for these escutcheon’s to be decorative, sometimes very ornate, to add a decorative element to the home. The one found at the site though is very simple and utilitarian. It measure 1.5” (4.5cm) in height and 1.2” (3cm) wide.

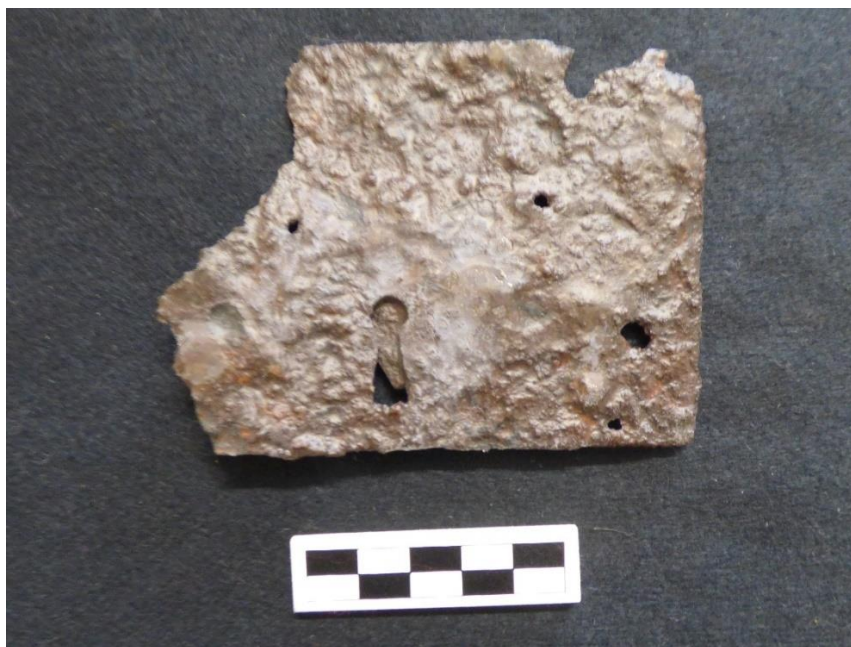
Figure 4.18 Lockplate

One iron lockplate was found near the brick path and likely where the front door of the home would have been. This lockplate would have performed the function of keyhole and lock for the front door. The artifact is cast iron and measures 3" (8 cm) in height and 3.5" (9 cm) wide though the lockplate is incomplete. If the keyhole is assumed the middle of the lockplate, then it would measure 4.5" wide whole. This lockplate is typical of an early lock used on the front door of the home. It is possible that other lockplates were used but they would only be found on exterior doors typically and while it is likely that the front door changed position on at least one occasion, the lockplate

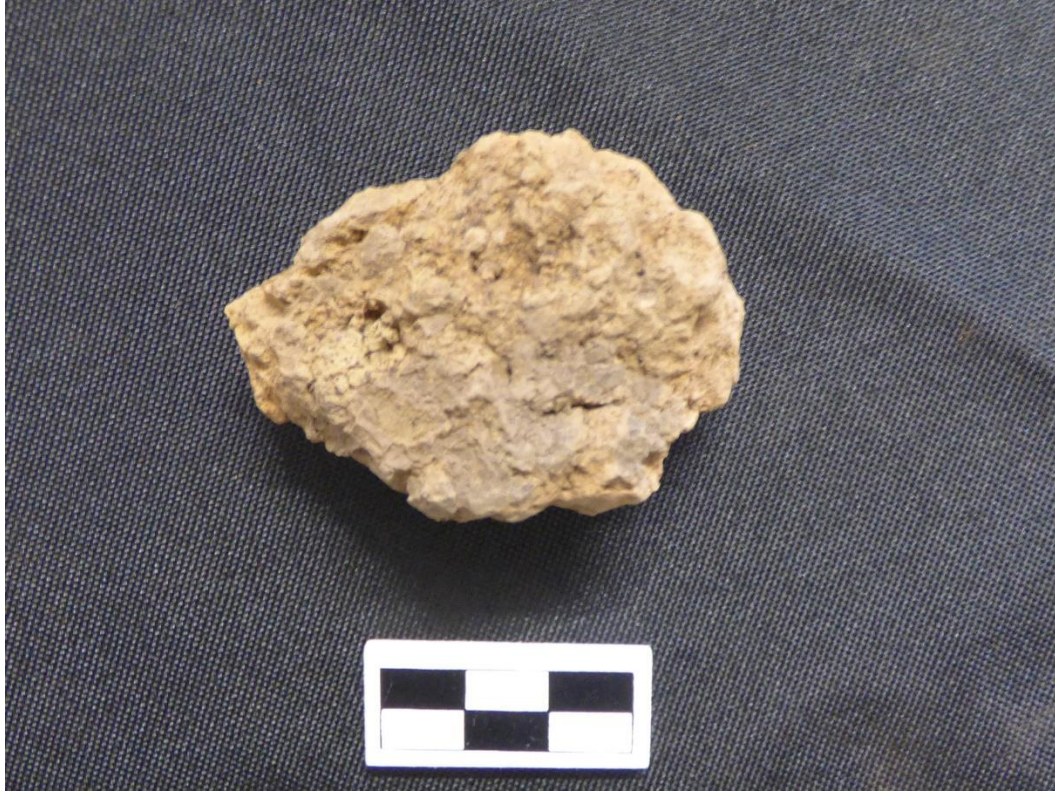
The artifact collection includes one example of wattle and daub which was found in association to the firebox. This artifact type, and the placement to the firebox indicates that this artifact was once part of a wattle and daub fireplace. Wattle and daub is simply a concoction of clay, sticks, and twigs which is packed between support beams to create the walls of a fireplace or chimney. The clay is then baked into a hard mass with the repeated firing and heating of the fireplace. Unfortunately, the original wattle and daub fireplace does not still exist at the site and the organic material, once reintroduced into the earth, would slowly decay leaving little evidence for what once was. The

Figure 4.19 Wattle and Daub found at site

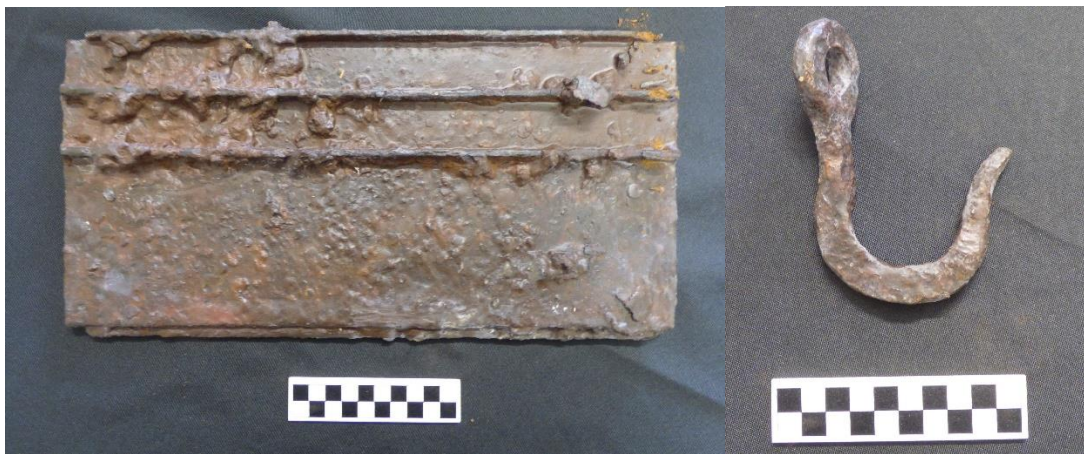
Figure 4.20 (left) Cast Iron oven door, (right) Cast iron hook for cooking

One oven door was found in association with the brick hearth. Made of cast iron, this artifact reiterates the large scale of the firebox and provides more detail as to how the firebox was likely designed. The door measures 7" (17.8cm) in height and 14.5" (36.8cm) wide.

One large cast iron hook was found, also in association with the hearth. This hook would have been used in association with a fireplace crane which pots could be hung on. The crane would then be pushed in and out of the firebox, over the fire, in order to cook. This too gives us a clearer picture of the design of the fireplace.

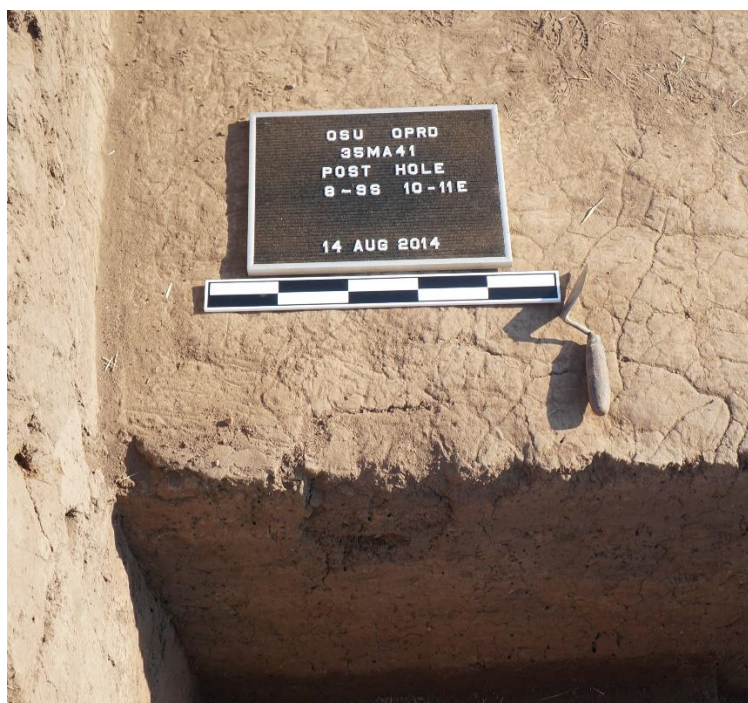
Figure 5.4 Excavated Post Mold

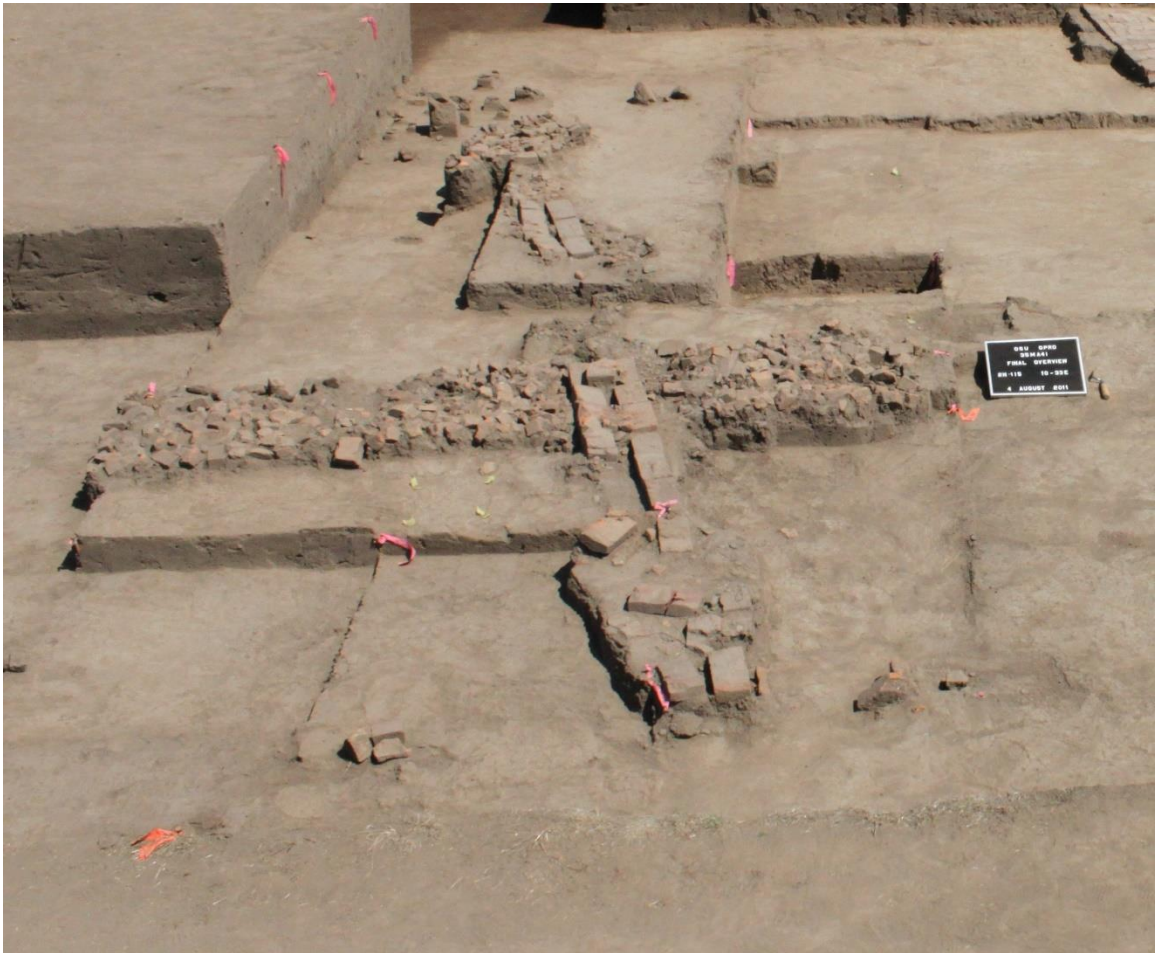
Figure 5.6 Brick foundation overlaying brick rubble path

Along with the brick foundation was found a brick rubble path. This path is made of broken and fragmented bricks which seem to represent a path from the original front door and into the yard of the homestead. The path leaves the house from the southwest corner of the home and leads to the west measuring approximately 50cm across and 3m long (Manion, 2014:106). This path would have minimized the amount of mud and grime brought into the house by the family as they accessed resources outside. The path consists of broken and fragmented bricks which seem to represent an earlier period than those bricks used for the foundation and potentially the firebox. Along this path were found a lock plate which would have been attached to the front door and artifacts which predated the Newell occupation. The path would only have been used with the original structure and maybe for a short period after the first addition represented by the brick foundation.

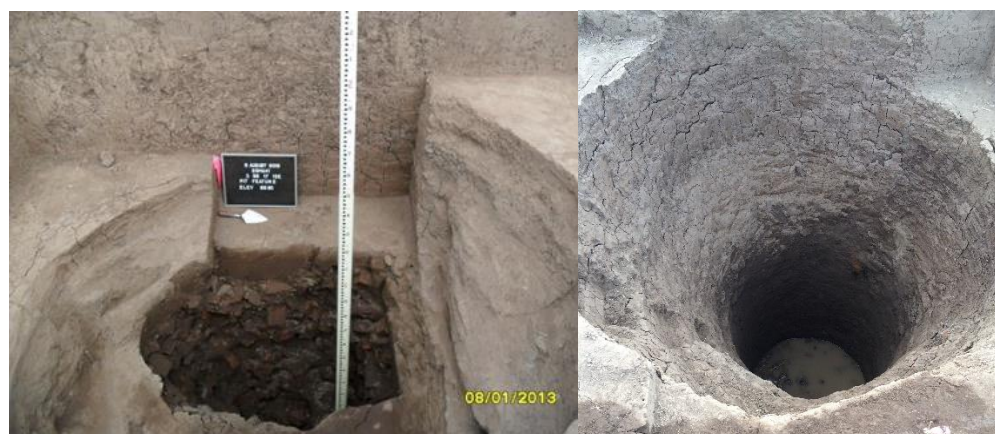
Figure 5.7 (Left) Well strata showing Brick layer (Manion, 2014:126); (Right) Extent of final Well excavation

well was filled with the bricks from the fireplace and chimney when the area was leveled for agriculture. Ultimately, it was concluded that the Newell well didn't need any help beyond the natural clay sediment to maintain its shape. This same clay made it easy to demarcate the walls of the well during excavation.

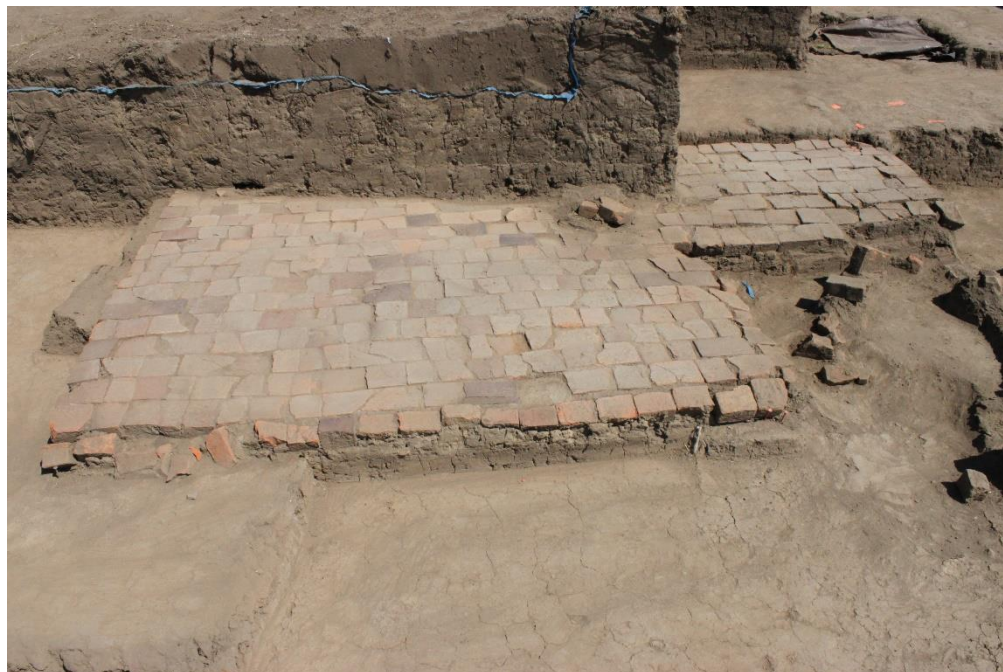
Figure 5.9 View of the Brick hearth facing North

were used to build the firebox and chimney, as they would have created a more sound structure, whereas the bricks for the hearth were supported by the floor and did not need the same structural integrity (Manion, 2006:57).

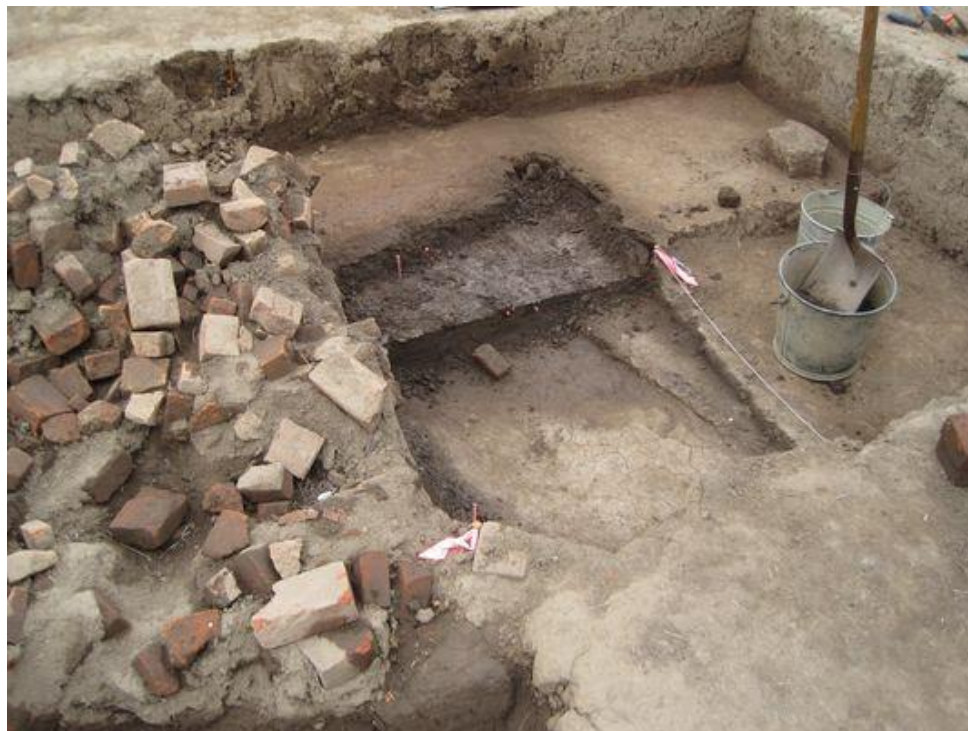
Figure 5.10 Cold Storage Pit with remnants of wood cribbing exposed (Miller, 2013)

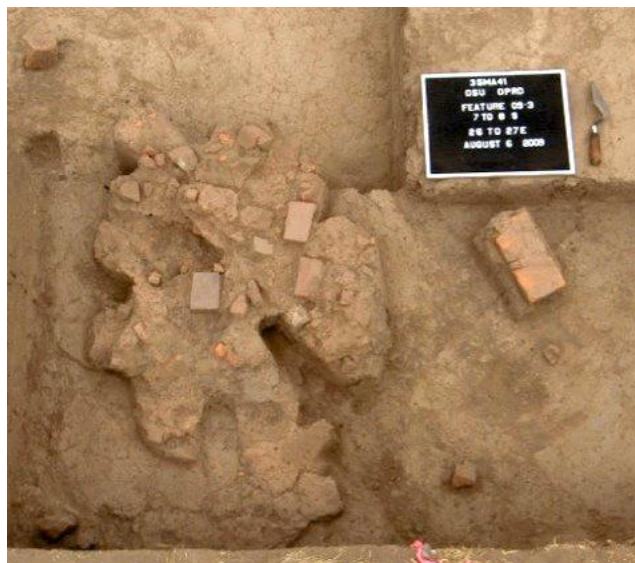
Figure 5.11 Burned Clay Anomaly (Manion, 2014:119)

Also in the 2009 field season, a burned clay anomaly was found along the southern façade of the house (Manion, 2014:119). It is unclear what exactly the feature represents but it includes both hardened clay and pieces of fragmented brick. This anomaly would not have formed without a heat source which would have baked the clay into its present form. It is possible that this feature represents a brick kiln which was used to form the bricks which we see in the sidewalk, thought to predate Newell. It is also possible that the feature represents an oven, like the French bread oven or *Le four a pain*, thought to be a necessity for every Frenchman's home, but this seems unlikely (Hebert, 2007:86). This type of oven, while likely appreciated by Ball's French Canadian neighbors, would not have been a priority for his home. Unfortunately, it is not possible to say exactly what this feature once was. If similar feature had been found around the façade of the home, maybe we could say it represented an architectural purpose such as a foundation, but it is unique in the site.

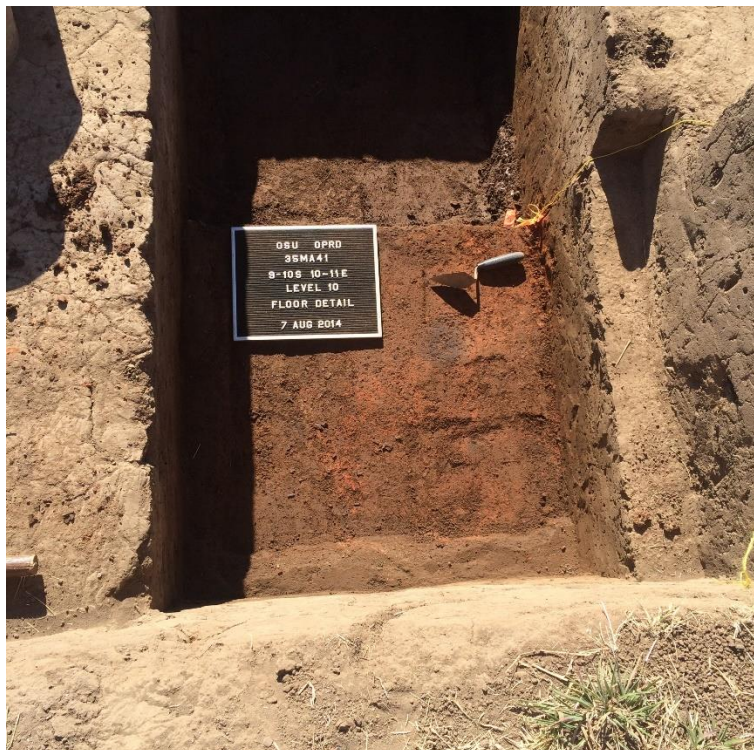
In 2014, in search of a possible privy, a burn feature measuring about one meter squared was found to the west of the original house structure. This feature was represented by sediment which had been exposed to repeated fire or heat, oxidizing the sediment and baking it into a hard red surface with some crystallization. What had originally led to the excavation of the area was the discovery of a post and rich artifact assemblage in previous years, thought to represent a possible structure like a privy. However, on the last day of excavations for the 2014 season, another post was located in the same vicinity as the original post and burn feature leading this researcher to believe that this area represented an addition to the original house rather than a separate structure and that the burn feature represented the location of a cast iron stove. The original front door to the home would then lead into this extension, a much needed space for the very large Newell family. The burn feature represents the sediment underneath the cast iron stove which would have been exposed to repeated heating and cooling and the rich

Figure 5.12 Burn feature

artifact assemblage represents the activities such as boiling water and such which would have occurred in association with the stove. This theory will be explored more in the section discussing the development of the house.
