Title: Historical Archaeology of Battery Freeman (ca. 1900-1940), Fort Stevens, Oregon.

**Historical Archaeology of Battery Freeman**

**(ca. 1900-1940), Fort Stevens, Oregon**

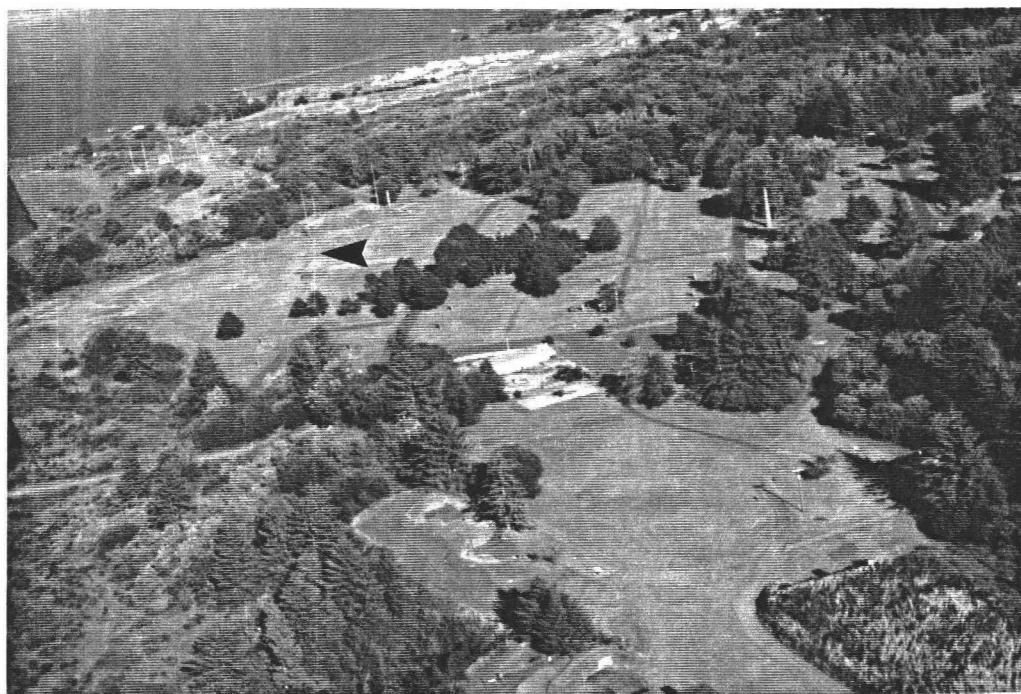
**FIGURE 2.3.** View looking east over area of Fort Stevens on Point Adams showing vegetation in 1989. Arrows point to area of former earthwork.

Vegetation (Figure 2.3) consists of deciduous trees such as red alder (*Alnus rubra*), weeping willow (*Salix babylonica*), Oregon crabapple (*Malus fusca*), cascara (*Rhamnus purshiana*), elderberry (*Sambucus canadensis*) and Sitka Spruce (*Picea sitchensis*). Salal (*Gaultheria shallon*), grasses, kinnikinnick (*Arctostaphylos uva-ursi*) and wild strawberry (*Fragaria virginiana*) are found along brushy areas.

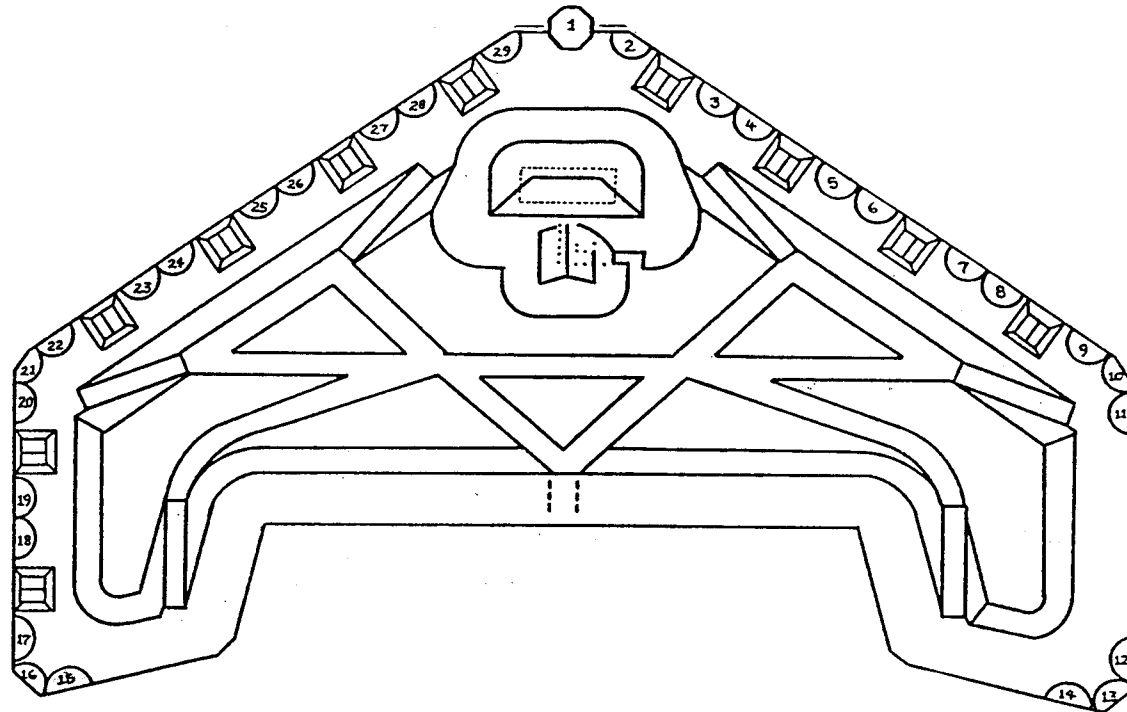
**FIGURE 3.1.** Nine-sided old earthwork structure, showing location of 26 gun emplacements (from Fort Stevens State Park brochure).

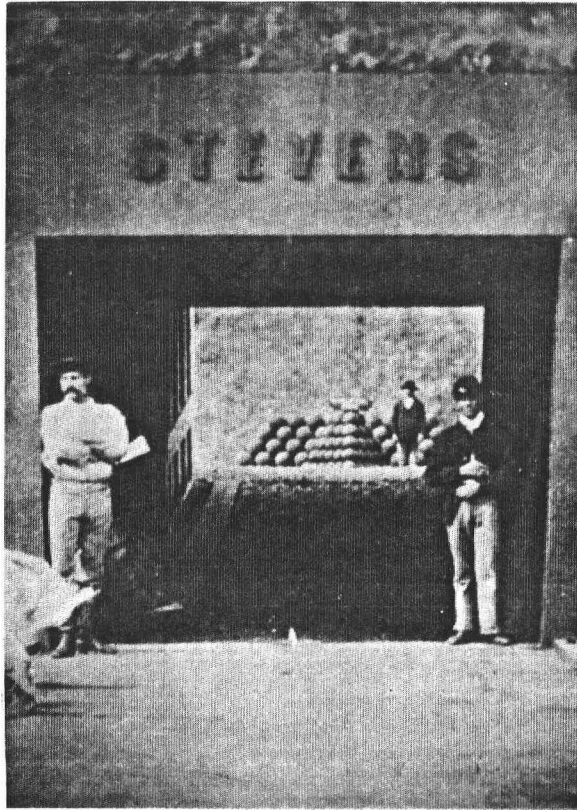
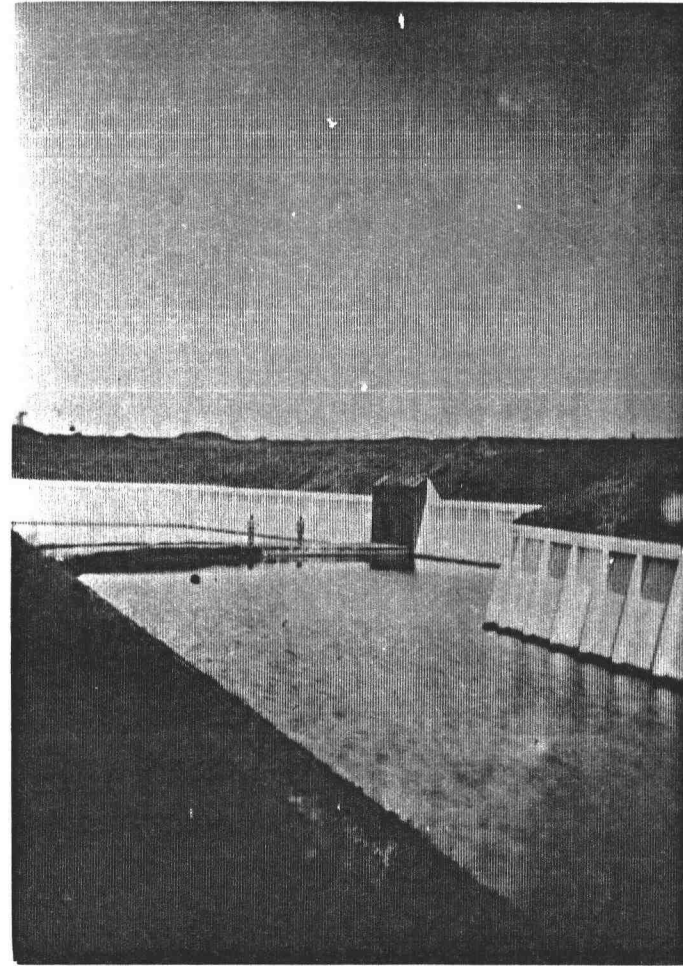
FIGURE 3.2. Photographs of sallyport entrance to interior of old earthwork structure (OHS photographs).

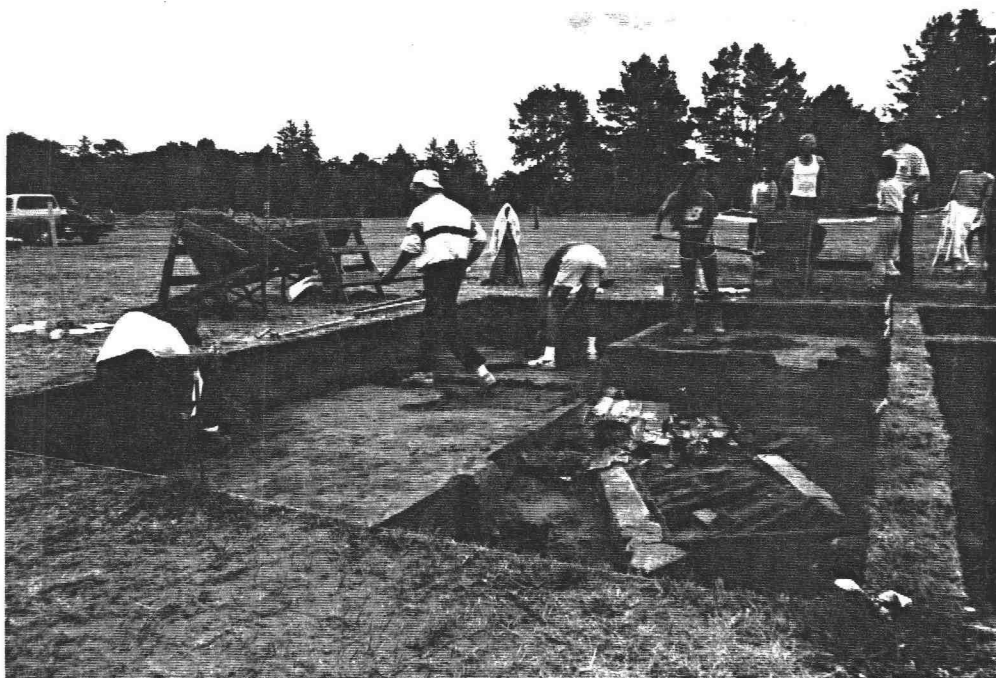
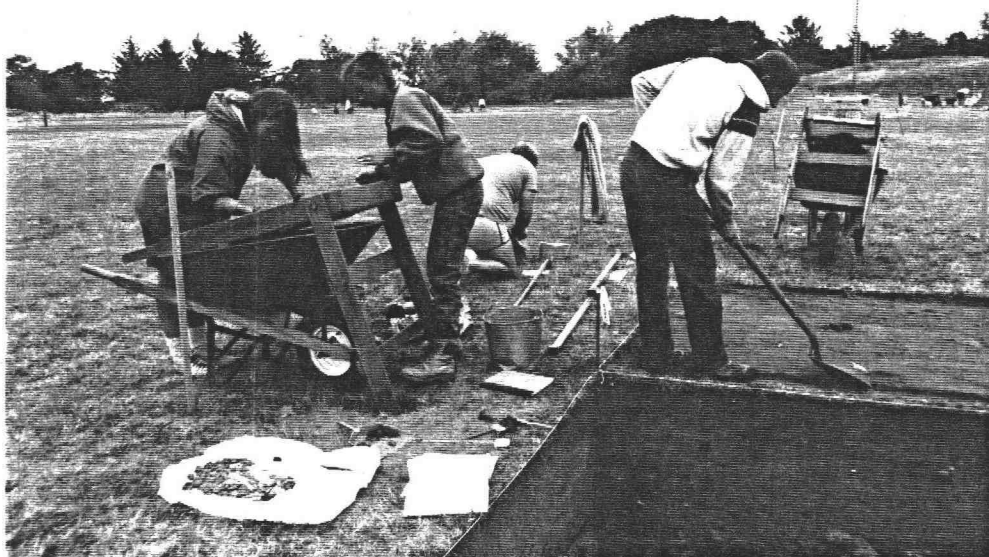
**FIGURE 4.3.** Photographs of 1989 excavation at Fort Stevens in progress.

to map all cultural materials *in situ*. However, we discovered that the upper 1 meter of sediment across the entire site was fill material resulting from the 1940 destruction and leveling of the earthwork. We then collected all cultural material in the fill unit by 1x1 meter quads within each 10 centimeter level per 2 meter test pit. Once we reached the well-defined Battery Freeman occupation surface below the fill unit, we again began to map the exact position of all cultural debris.

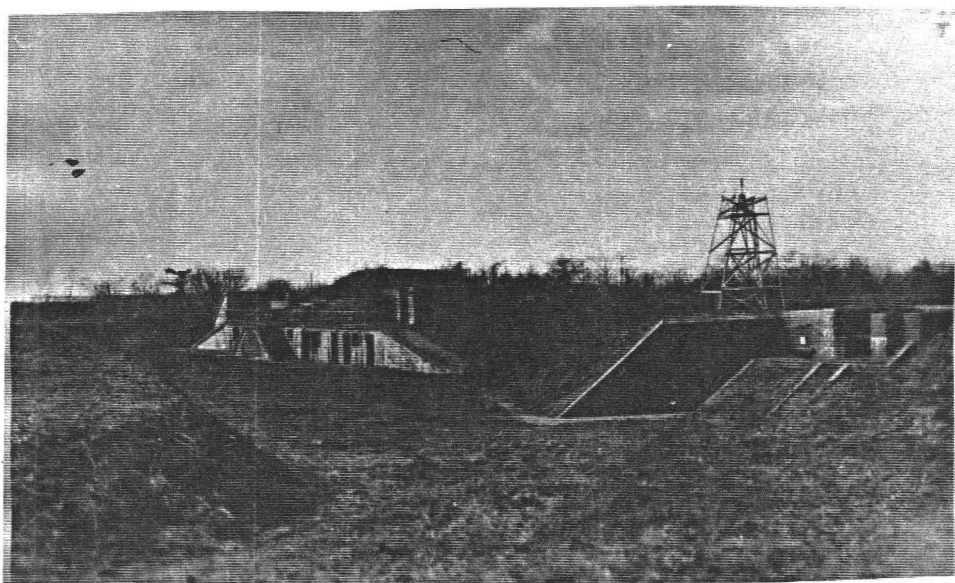
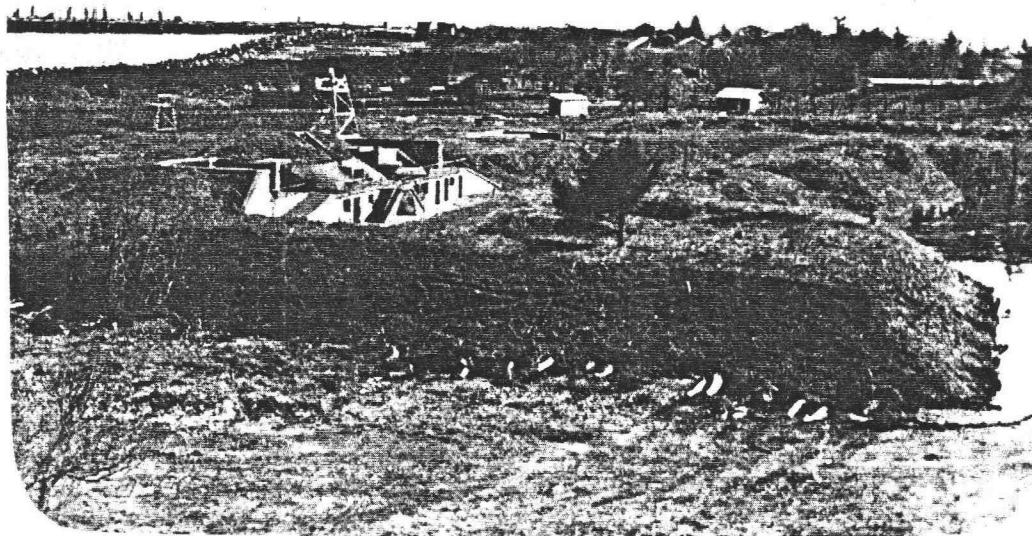
**FIGURE 5.2.** Photographs of the rear of Battery Freeman showing architectural features associated with its construction. (A) 1938 photograph looking northwest (from Fort Stevens Museum collection). (B) View looking toward northeast (from Hanft, 1980).

More general information on architectural design and function can be clearly identified in these photographs. They show that Battery Freeman was built on the left (west) side of the earthwork's interior to support two six-inch rifles on Barbette pedestal carriages (Figure 5.3) and one three-inch gun on a pedestal mount. The guns of the batteries were "on line with the 15 pounder-installation which was 190

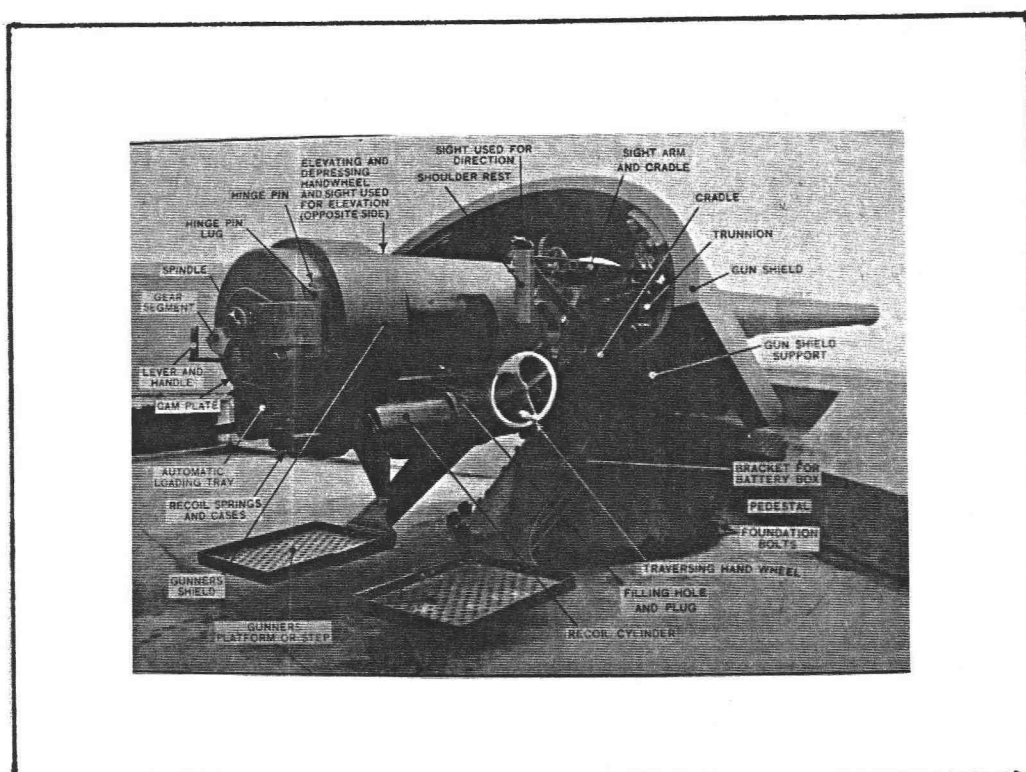
**FIGURE 5.3.** Example of a 6" gun mounted on a Barbette carriage (from Hines and Ward, 1910).

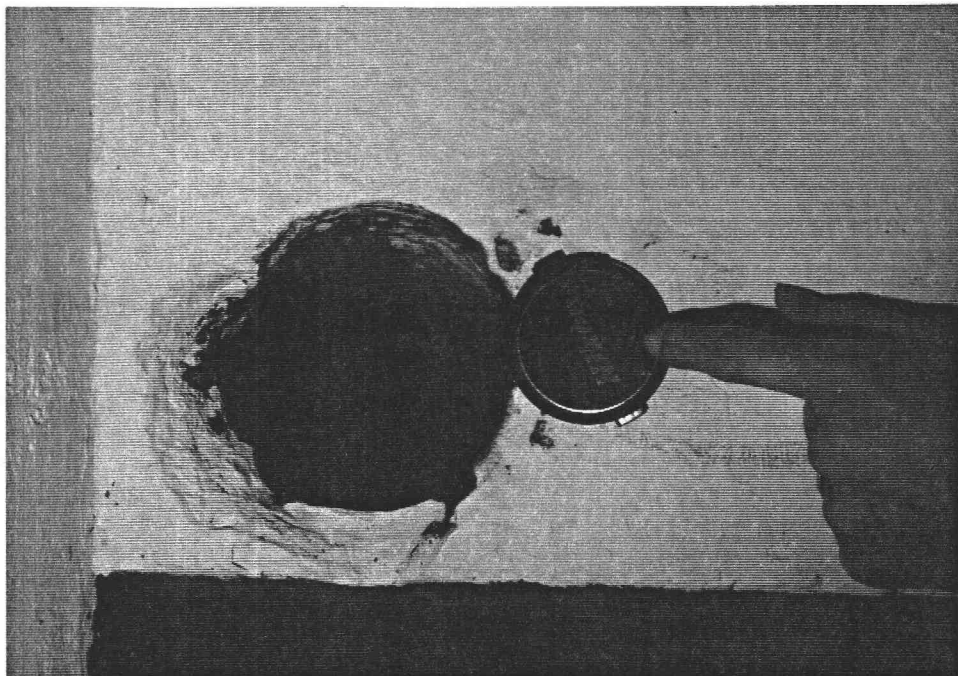
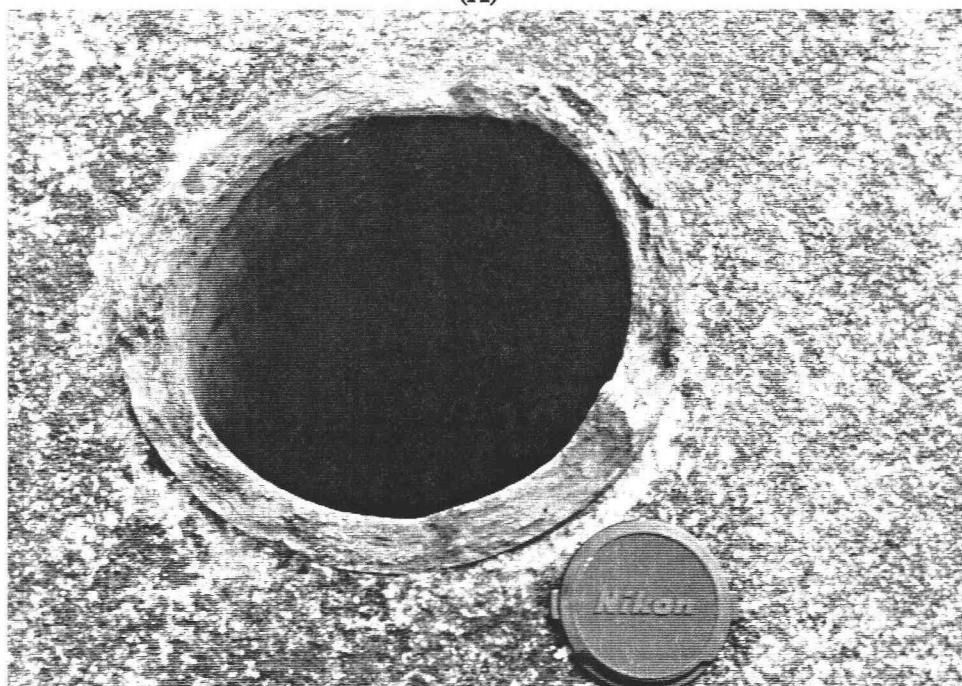
**Figure 5.5.** (A) Six inch ceramic pipe in Battery Pratt that was used for ventilation of shellrooms, guardroom, and latrines, as well as for access for electric wiring. (B) Eight inch ceramic pipe arising at top of Battery Pratt used for ventilation of magazines.

Observations of Battery Pratt provided significant information as to the function of some of the larger artifacts such as I-beams and metal doors that were recovered from the ditch. By examining the ceramic pipes that run through Battery Pratt, for example, we can say that the glazed tile fragments that were unearthed from Battery Freeman were not for drains but instead were used for air ventilation or conduits for electrical wiring (Figure 5.5) (e.g., Hanft, 1980:215). Examples of other functions of artifacts from Battery Freeman inferred by functional comparison with Battery Pratt include: iron I-beams situated between floor joints mainly to support the upper level; iron curved beams used for ammunition trolleys (Figure 5.6); several types of metal fasteners used to keep electrical wiring fastened to the wall or ceiling (Figure 5.7); metal wire (0.5-1.0" diameter) ranging from five to nine feet with an "eye" at the end used for fasteners; wooden interior doors; iron bars around the windows; and metal exterior doors.

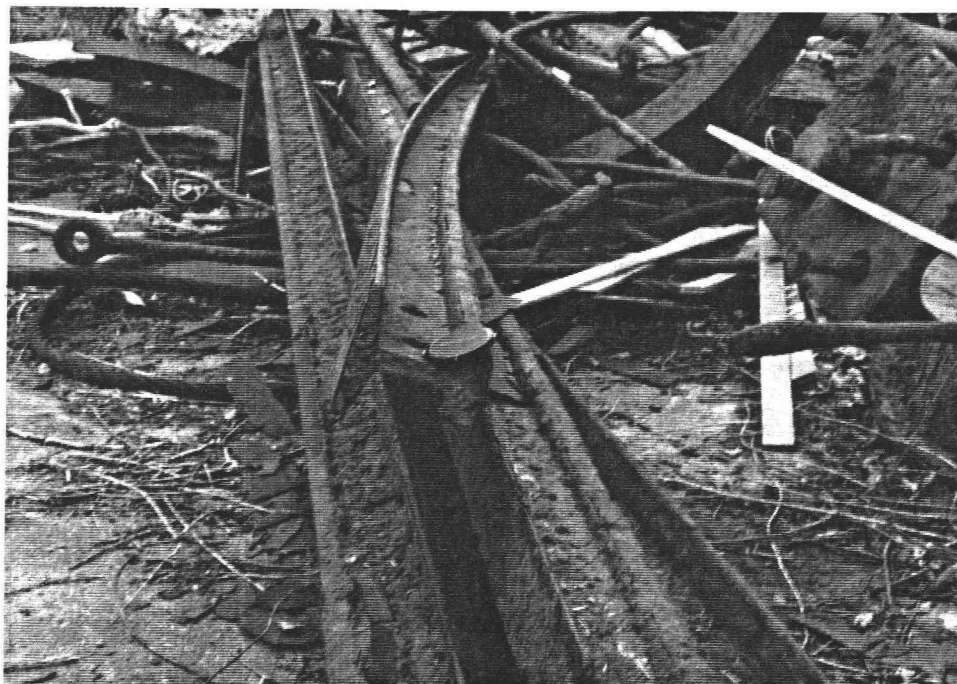
**FIGURE 5.6.** (A) Curved metal I-beam with one flange (left side) wider than the other and holes at the ends. Recovered from the ditch. (B) Curved metal I-beam from Battery Pratt with the same characteristics and dimensions as in (A). Their function was to support ammunition trolleys.

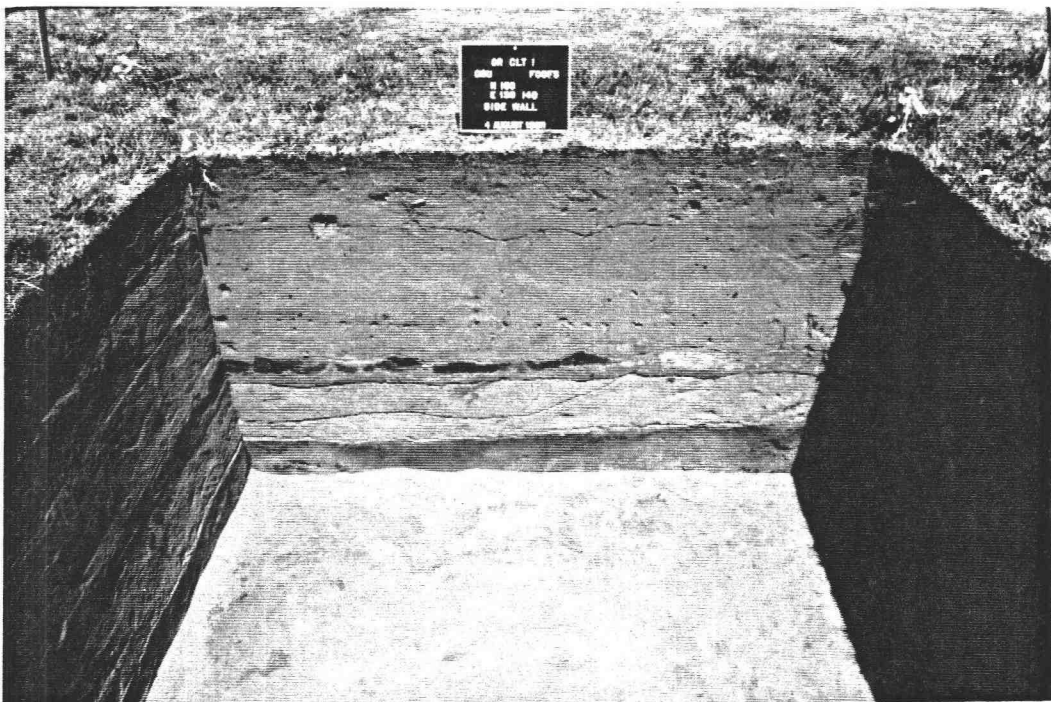
**FIGURE 5.8.** Photograph of typical fill unit sediments, exposed in unit 2.

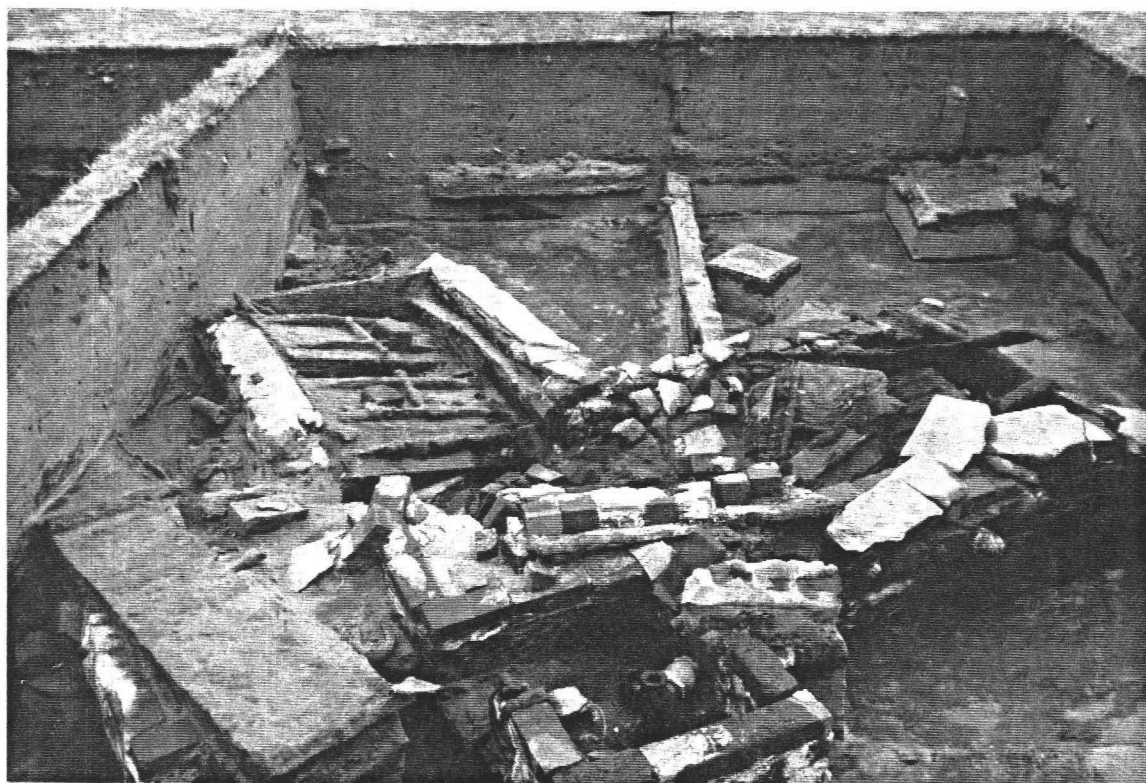
**FIGURE 5.9.** Photograph of the incinerator feature exposed in the 1989 excavation (unit 1).

Thus far, I have found no archival information on an incinerator used at Battery Freeman. Although the incinerator patent indicates a manufacturer's name and date, the patent only refers to the gas jets entering its fire box. Because of this, we know that this feature was gas operated.

Several indirect lines of evidence, however, offer conflicting functions for this feature. As described in a military dictionary, an incinerator is "a furnace designed to burn camp refuse" (Garber, 1936:163). If the feature was indeed an incinerator, it could possibly explain the "refuse" types of artifacts that were found in association with it (melted glass, metal miscellany etc., Table 5.3).

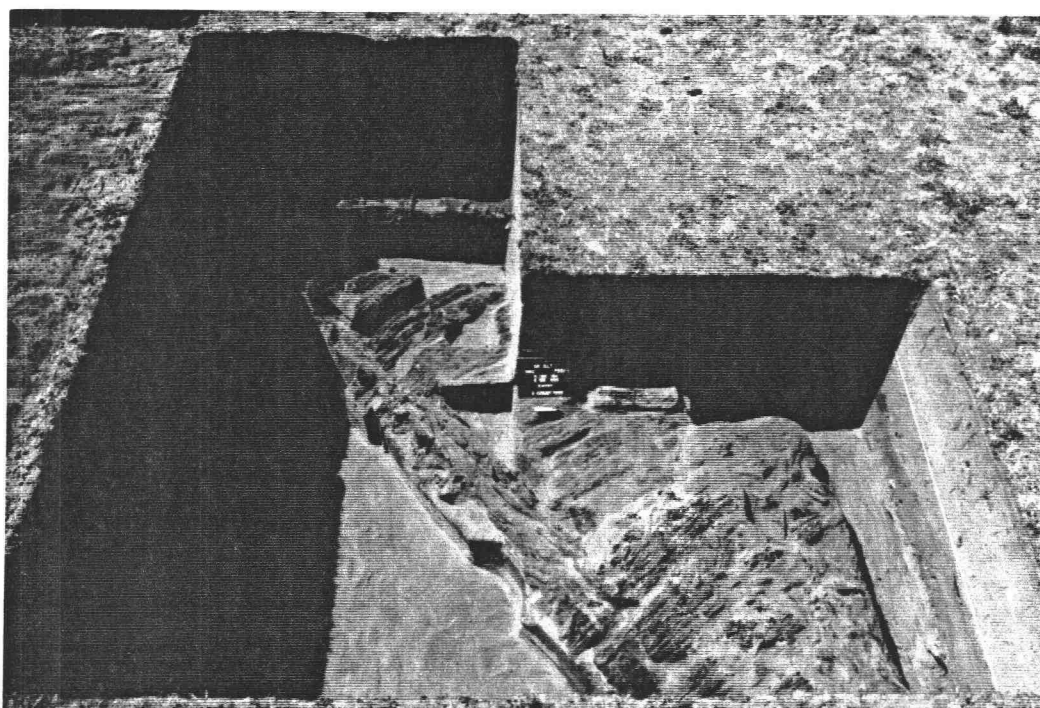
**FIGURE 5.12.** Photograph of the bulkhead wall feature exposed in the 1989 excavation (unit 9).

The artifacts associated with the bulkhead wall feature (Figures 5.11, 5.12) were primarily wood fragments, nails and spikes, with fewer numbers of glass and tile fragments than found in the other test units (Table 5.5).

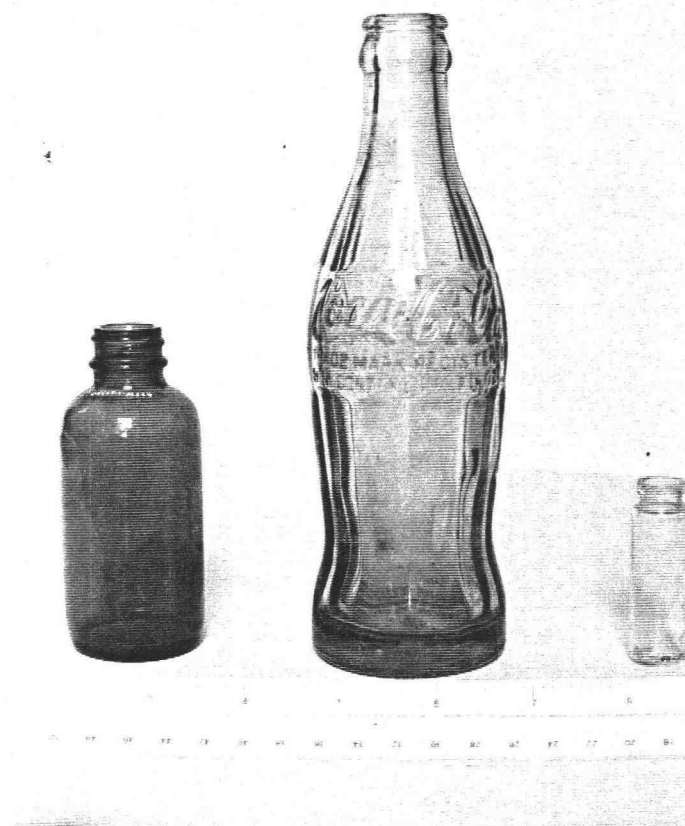
FIGURE A-3. Whole bottles. (3a) medicine (3b) soda and (3c) homeopathic.

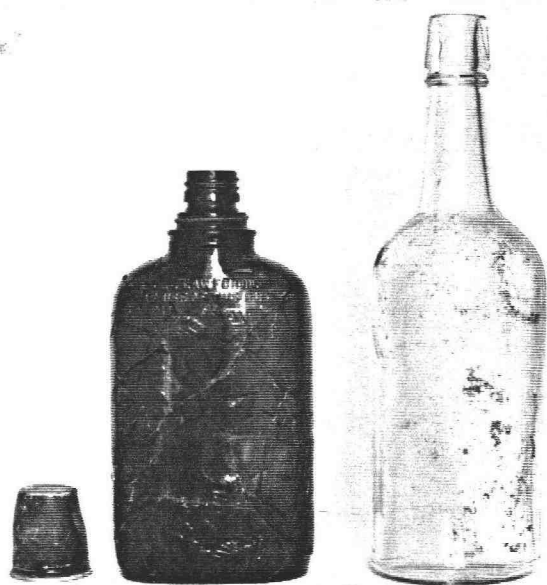
FIGURE A-4. Whole whiskey bottles (4a,4b).

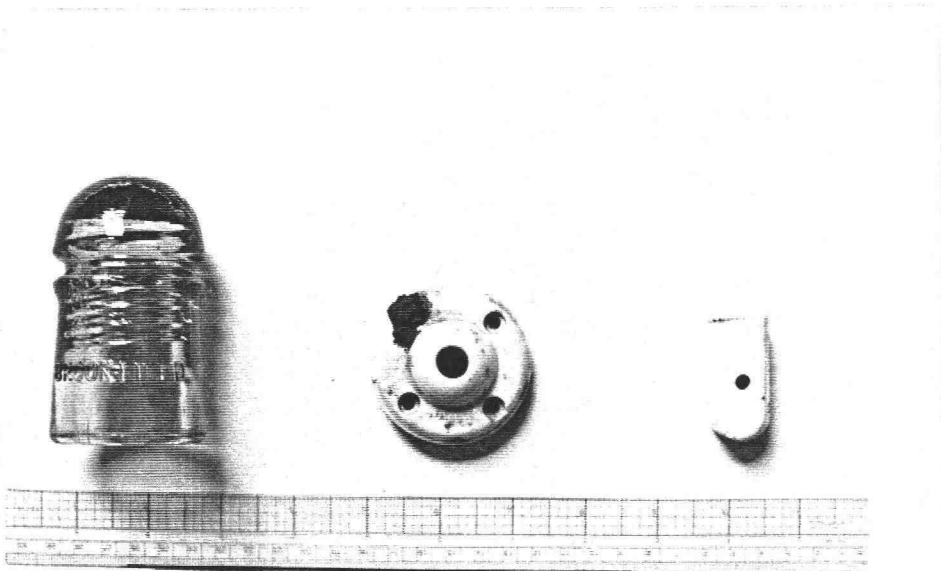
FIGURE A-20. Examples of insulators.

Insulators: Artifacts classified under porcelain insulators consist of three wire cleats, wire cleat fragments, split insulator fragments, a switch plate embossed with "BRYANT 2 AMP" diameter 56 mm, and unidentifiable fragments. The majority of these items were recovered from Unit 1, levels 3, 7 and 8 and functioned for electrical services. There was also one aqua glass insulator embossed "BROOKFIELD" that was recovered in ditch. Figure A-20 provides examples of insulators.

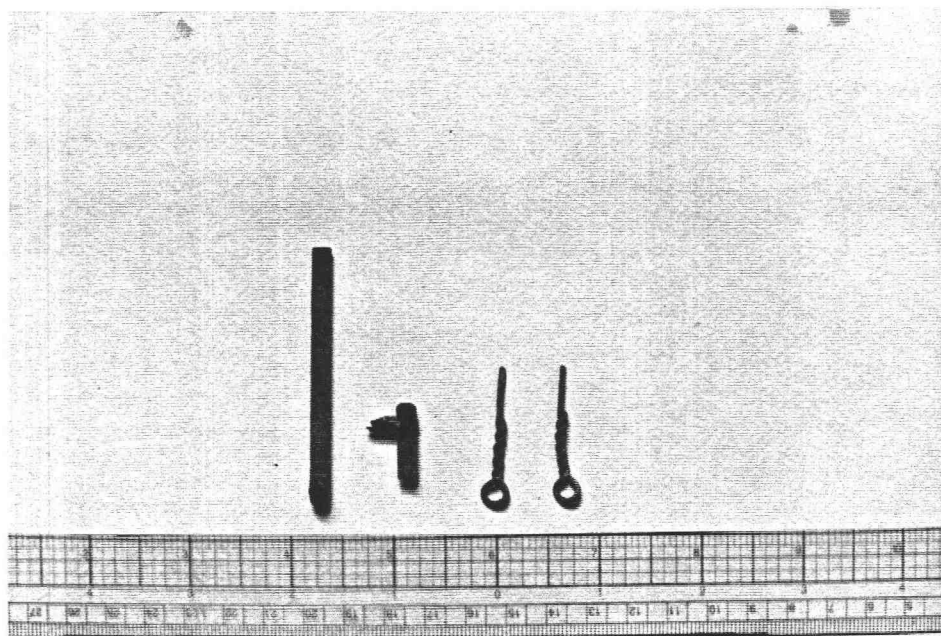
**FIGURE A-25.** Friction primers and pins.

Other artifacts that pre-date 1900 are friction primer pins. Friction primers were used to ignite powder charges in guns. A total of twenty-four cannon friction primer pins were recovered (most of which were found in Unit 9, bulkhead feature). There were also nine friction primer brass tubes, length 65 mm with a 5 mm diameter and; two complete friction primers (Figure A-25).
