**A Historical Reconstruction and Land Use History
of Six Tidal Wetlands in Oregon**

March 2005

By Jennifer Taylor Hennessey

Master's of Science Project
Marine Resource Management
College of Oceanic and Atmospheric Sciences
Oregon State University
Corvallis, Oregon

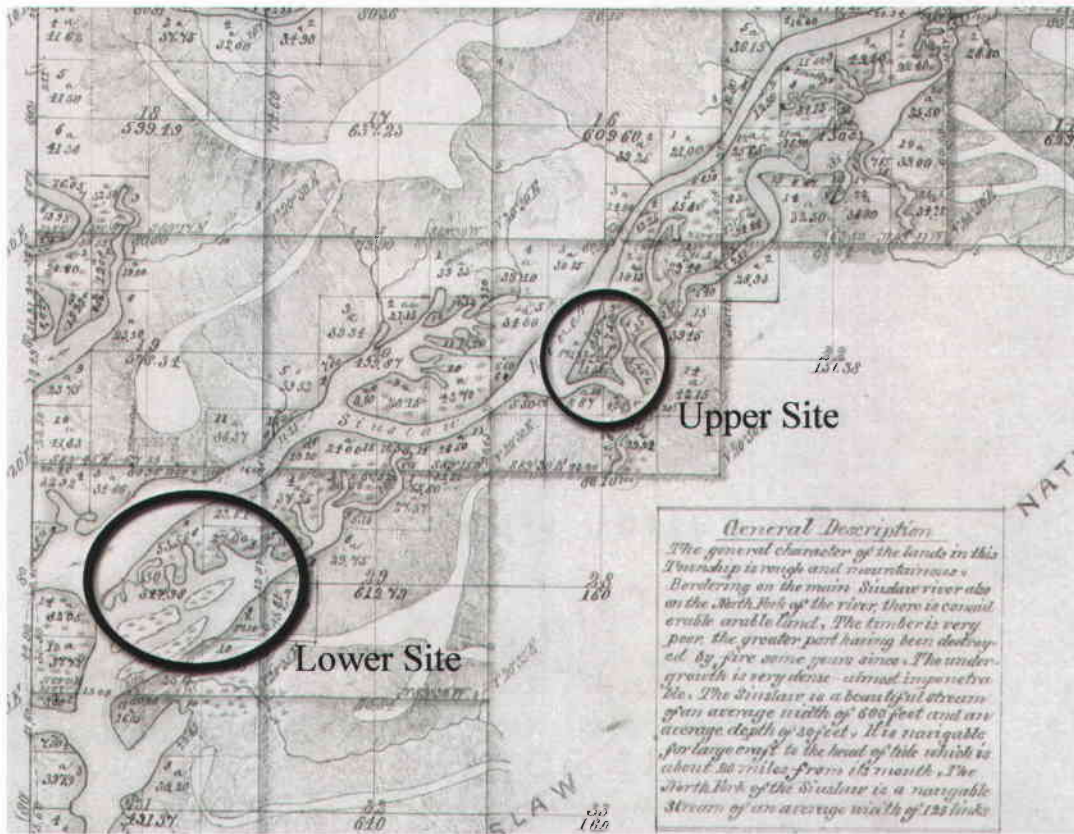
Figure 4. 1880 General Land Office Survey (circles and site text added).

¹⁶ These cadastral maps show a specific type of symbol to indicate marsh vegetation. This is similar to symbols used for marking marshes on maps today.

General Land Office Survey of 1880

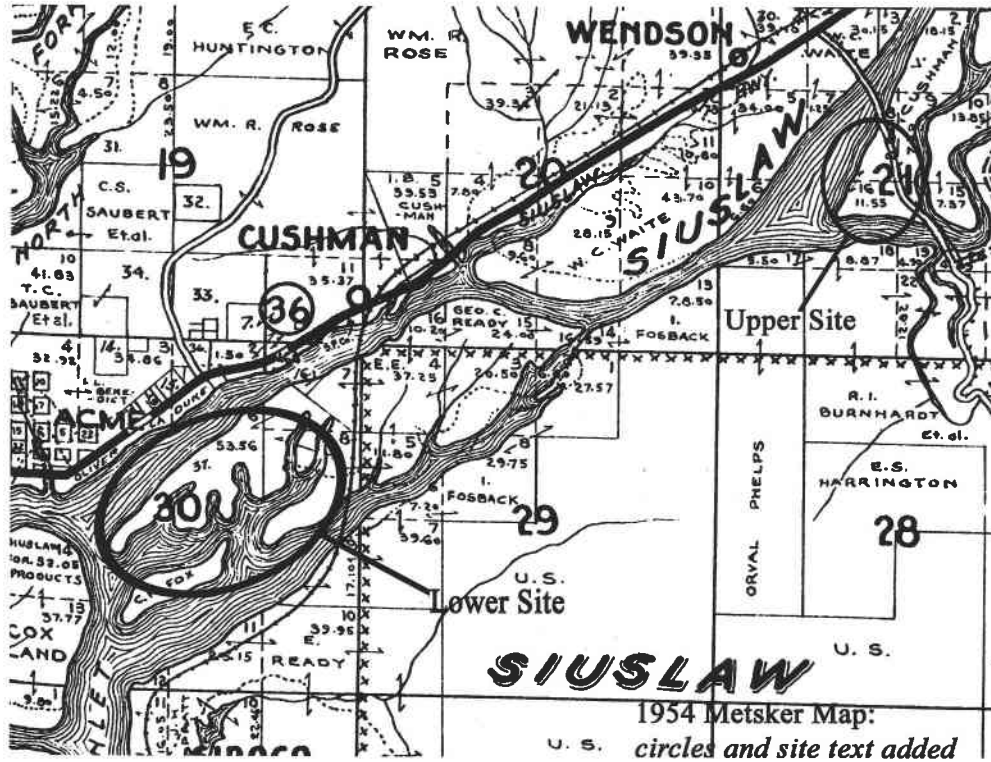
Figure 5. 1954 Metsker Atlas.

The Metsker Atlas of 1954 (Fig. 5) reveals some interesting changes in ownership and land use. The lower site now appears un-owned, while the upper portion of the area beyond the railroad, is owned by a private individual, Geo. C. Ready. Another portion of the island still remains in the Siuslaw National Forest. In 1954, a local timber company, Siuslaw Forest Products, now owns Cox Island. This indicates some use for timber extraction or processing. Likely this was due to the proximity of the railroad in Cushman. This was an important area for transporting logs and timber companies routinely floated logs down the river. Thus, Cox Island was an ideal place to locate for capturing and loading logs. Even more revealing is the upper site, still owned by V. Cushman, but across which an "unimproved" road appears that extends from one side of the river, across the marsh and to the other side. If a road did indeed cross this site, its

development and use would have greatly impacted the landscape. However, aerial photos from the early and late 1950s fail to confirm the road's existence. Lane County survey records show no record of the road either. It is unlikely a road that crossed such a major portion of the river would exist without a survey and financial backing of the county. Thus, as was common mapmaking practice at the time, this is probably an errant road put in by the mapmaker in order to mark it as the mapmaker's own work.

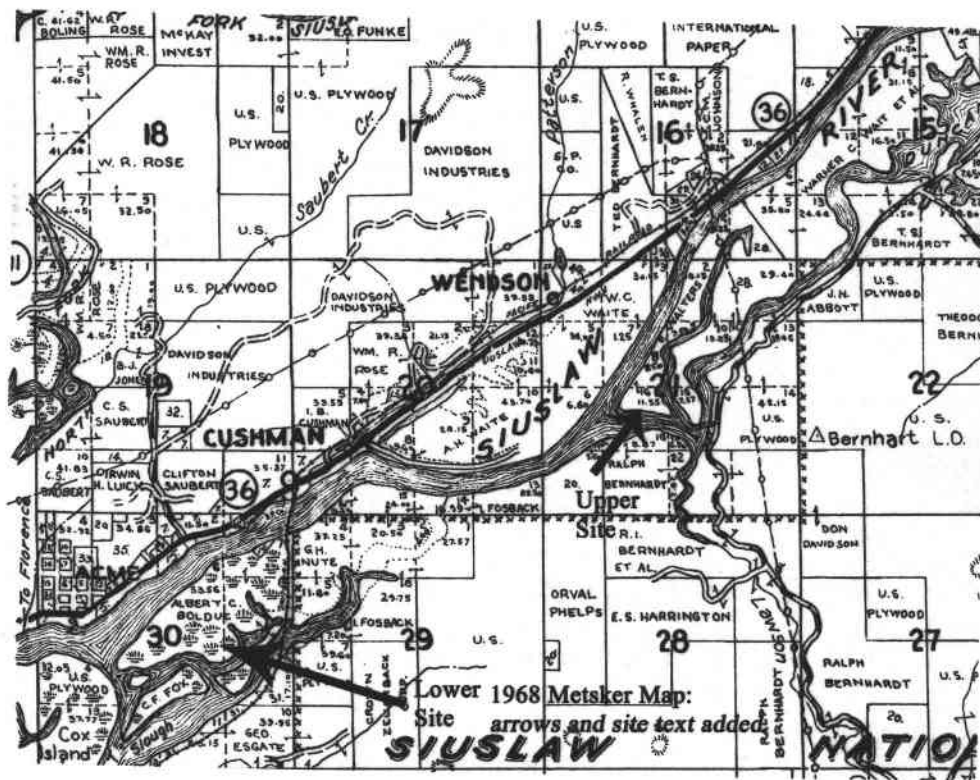
Figure 6. 1968 Metsker Atlas.

The Metsker Atlas of 1968 (Fig. 6) provides even more recent evidence of the changes to the landscape. The lower site appears to have accreted sediment, with a wider land mass; it was owned by Albert C. Boldue and marked for the first time in the Metsker Atlases with marsh symbols. Cox Island, along with many other properties in the area, is still held by timber interests, but has transferred ownership to U.S. Plywood. The upper site changed ownership as well, to E. Walters. The road from 1954 is absent in the 1968 map. Also absent are any symbols

marking marsh vegetation in the area. This reveals the possibility that agriculture or other vegetation was present; something other than what was traditionally considered tidal marsh. However, this is unlikely given the evidence from the historical aerial photos of this period that appear to indicate at least some marsh vegetation. Further up Duncan Island, a line of electrical transformers crosses the island.

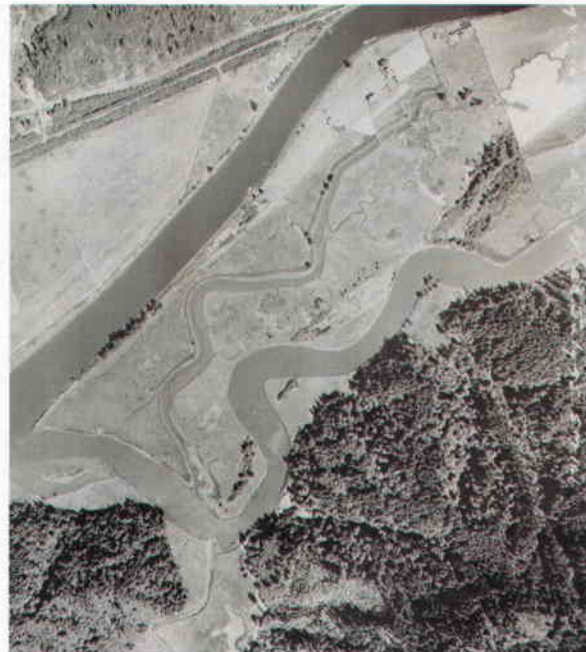
Figure 8. 1945 Historical Aerial Photo. Source: University of Oregon, Map Library.

By 1945 (Fig. 8), this channel appears unblocked, but bridged by several logs. These may have been stranded mid-channel or possibly placed by the landowner in order to easily access the other side of the marsh. There are other indications of increased land use including the

appearance of what looks like a straight ditch. The main vegetation still appears to be marsh vegetation, since the typically uniform crop look is not present on the site. However, the vegetation does appear somewhat disturbed likely from mowing or pasture use. Like the lower site, logs appear to be stranded on the marsh surface, but in much lower numbers. The dwelling with the pier is still apparent.

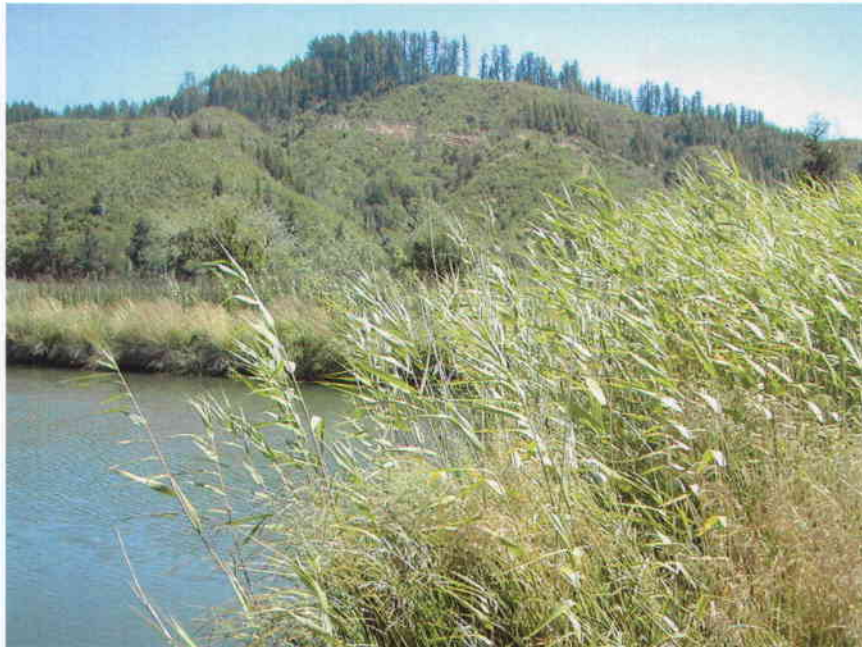
Figure 9. Reed canarygrass on upper site. Photo by Paul Adamus, 2003.

(Weinmann 1984). Most importantly reed canarygrass is an indication of disturbed land, especially past use as pasture and/or crops (Brophy 1999, Weinmann 1984). In fact, a caption from a newspaper article in 1956 shows Warner Waite, a nearby farmer, with tussock, or *Dechampsia caespitosa*, and planting reed canarygrass. The caption reads “Tussock – the common clump of reed-grass that torments coastal farmers – can be controlled by canary grass, says W.B Parker, extension agent in agriculture” (*Siuslaw Oar*, 4/20/1956).

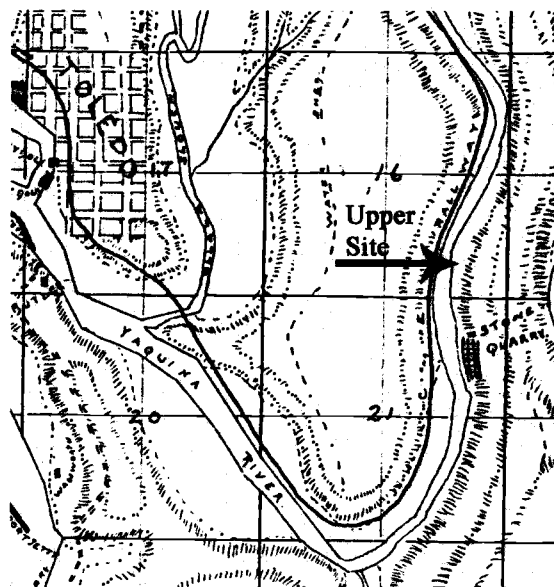
Figure 17. 1906 Topographic Map

A 1906 Topographic Map (see Fig. 17 or Appendix C - Yaquina, Folder: Deed Data, SubFolder: 1906 Topographic Map) for Yaquina River did not include land ownership data but revealed scattered houses, a few mills, and stone quarries (Map Files, Lincoln County Historical Society 1906). The main routes of transportation appear to be the railway, wagon roads, and the river. The lower site is indicated by the name Montgomery Point, and the nearest house owned by “Hansen” is just across from the railway track. Also nearby is a “Port Jetty”, likely what today is called a “wing dike,” to enhance navigation and deepen channels. Just south of the upper site is a Stone Quarry. Many quarries in the area provided rock for the main jetties, as well as for constructing local roads. This particular quarry is along the river, and no roads or trails are apparent. Thus, the quarry rock was likely shipped by river for further distribution rather than used for adjacent projects. The U.S. government owned this quarry in a deed dating back to 1889.
