# Ni-les'tun Tidal Wetland Restoration Effectiveness Monitoring: Baseline (2010-2011)

## June 2012

Laura Brophy	Green Point Consulting Estuary Technical Group, Institute for Applied Ecology, Corvallis, Oregon
Stan van de Wetering	Confederated Tribes of Siletz Indians, Siletz, Oregon

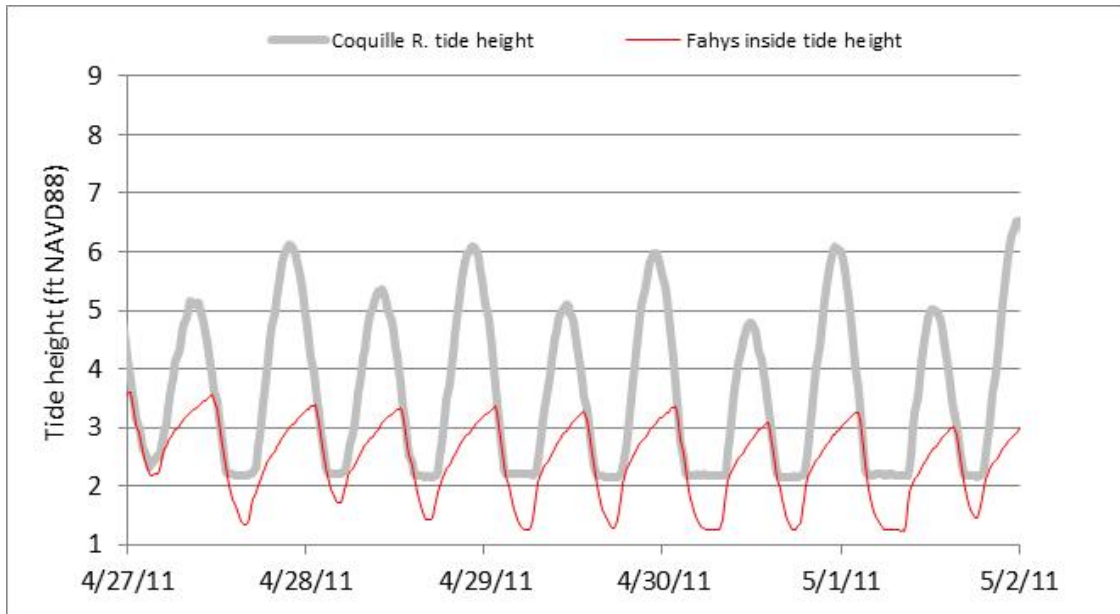
Figure 1. Pre-restoration tide heights in lower Fahys Creek (behind tide gates) and in the adjacent Coquille River, April 27-May 1, 2011. Fahys Creek and Coquille River gauges are labeled “NL TG inside” and “NL TG outside” respectively, in Figure A2, Appendix A.

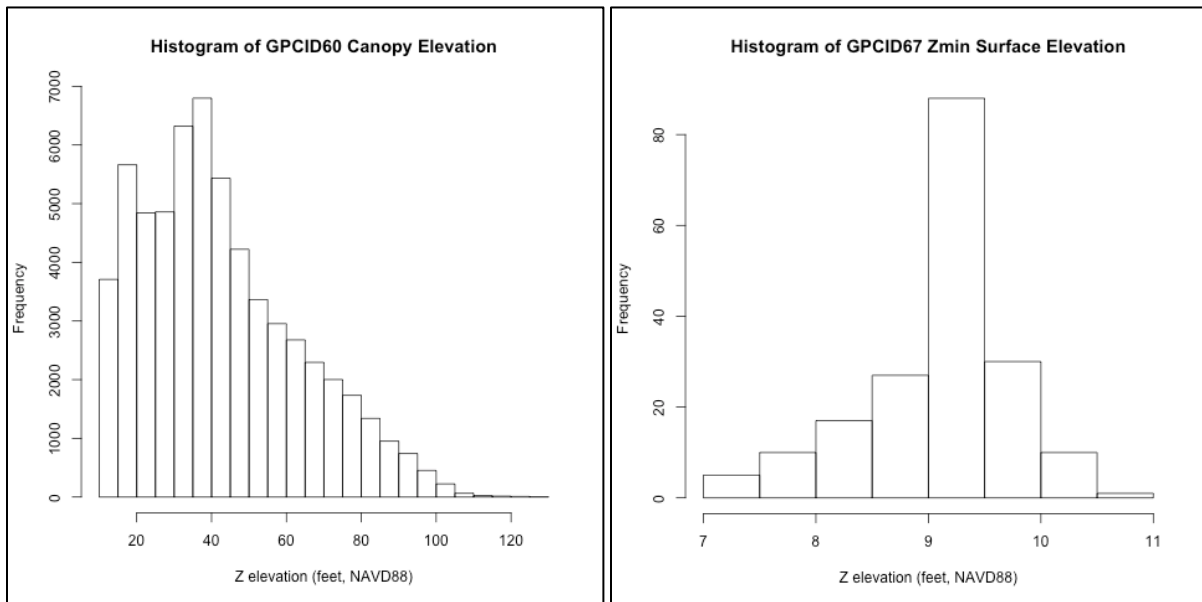
Figure 6. Examples of canopy height histograms created from FUSION canopy model.

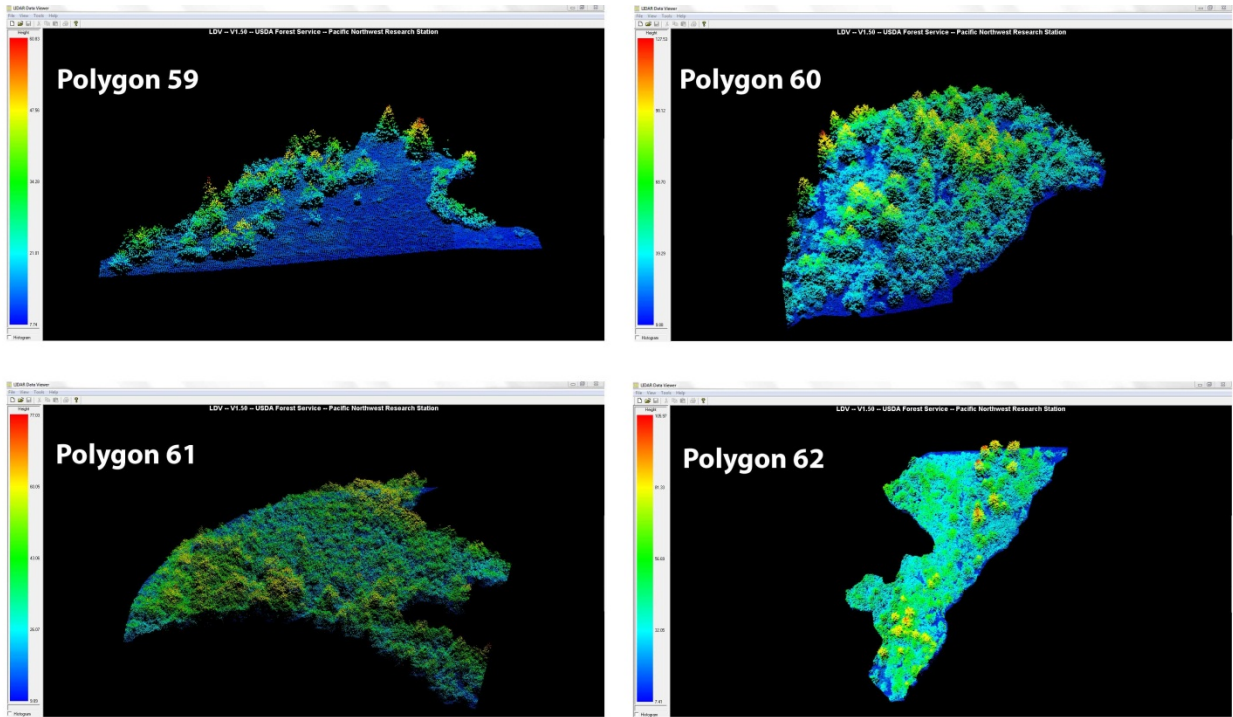
Figure 7. Canopy visualization images from FUSION output (polygons 59-62 of Figure 5).

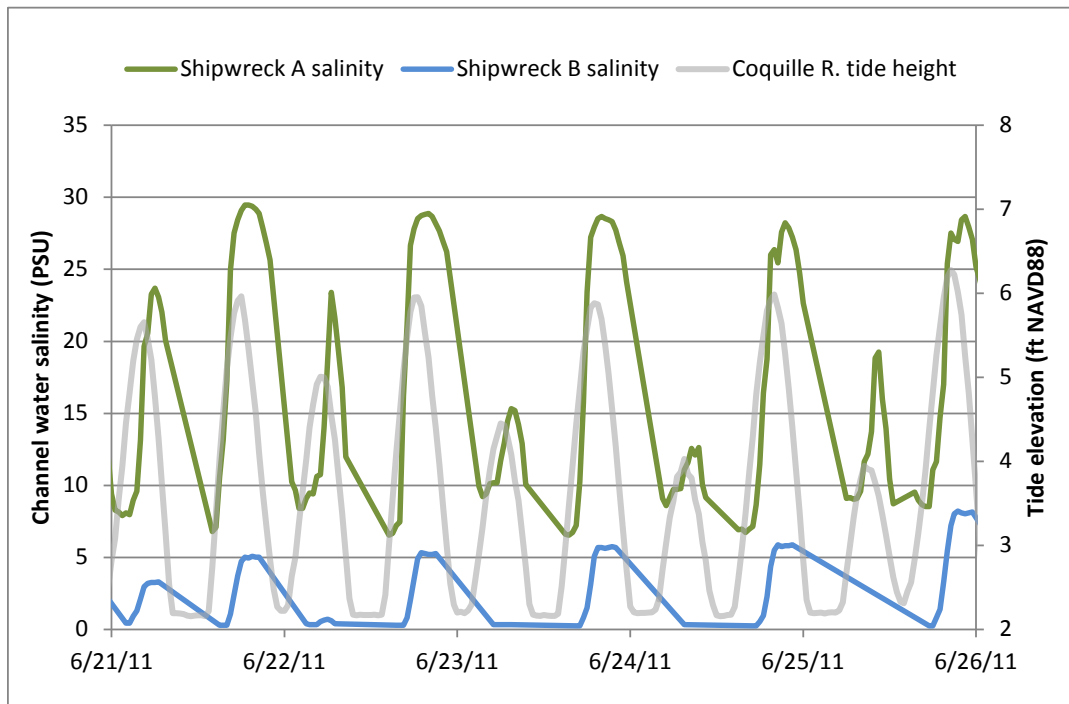
Figure 15. Bandon Marsh Unit: Salinities at Shipwreck A and B, June 2011. Sample locations are labeled "Shpwrk A 8238" and "Shpwrk B 8229" in Figure A3, Appendix A.

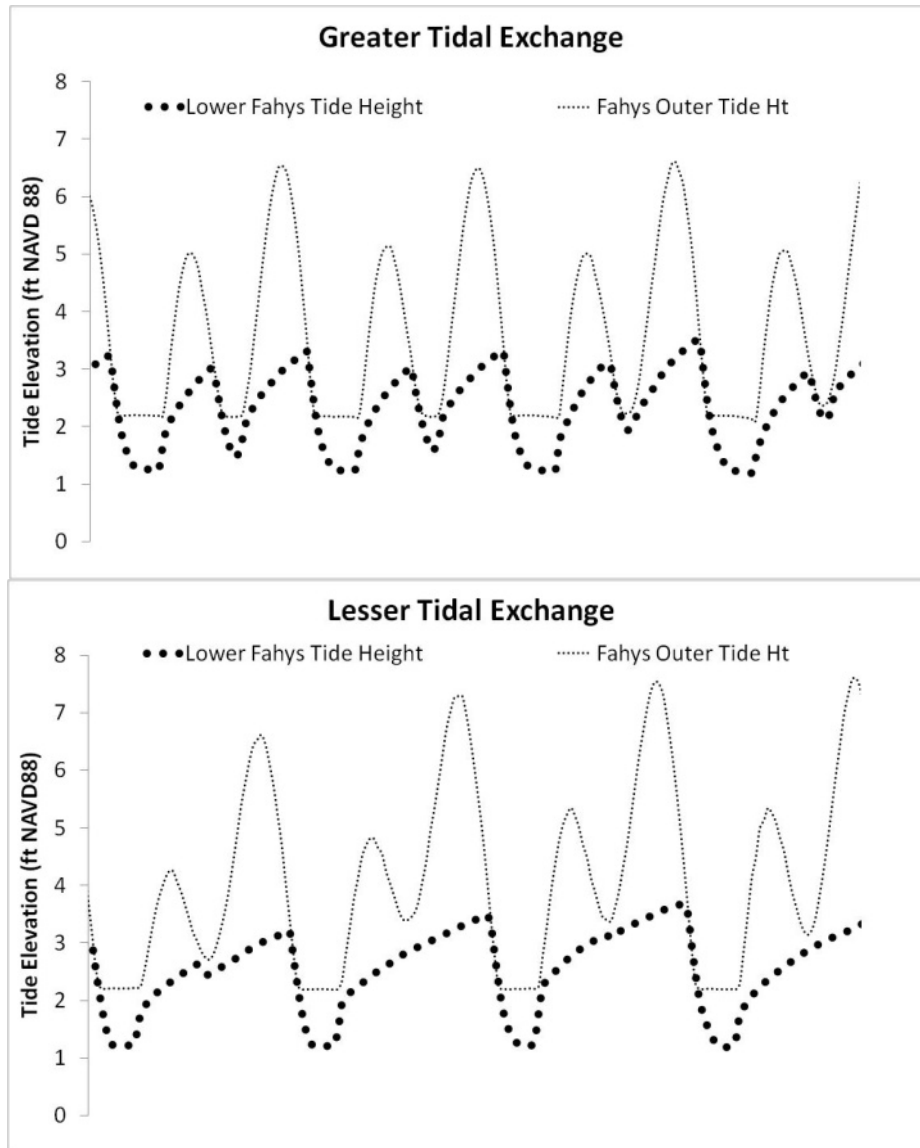
Figure 17. Observed tidal elevations prior to restoration at the Lower Fahys tide gauge (inside dike) and in the mainstem river (outside dike) during a spring period of greater and lesser tidal exchange. Gauges are marked “NL TG inside” and “NL TG outside” in Fig. A1 of Appendix 1.

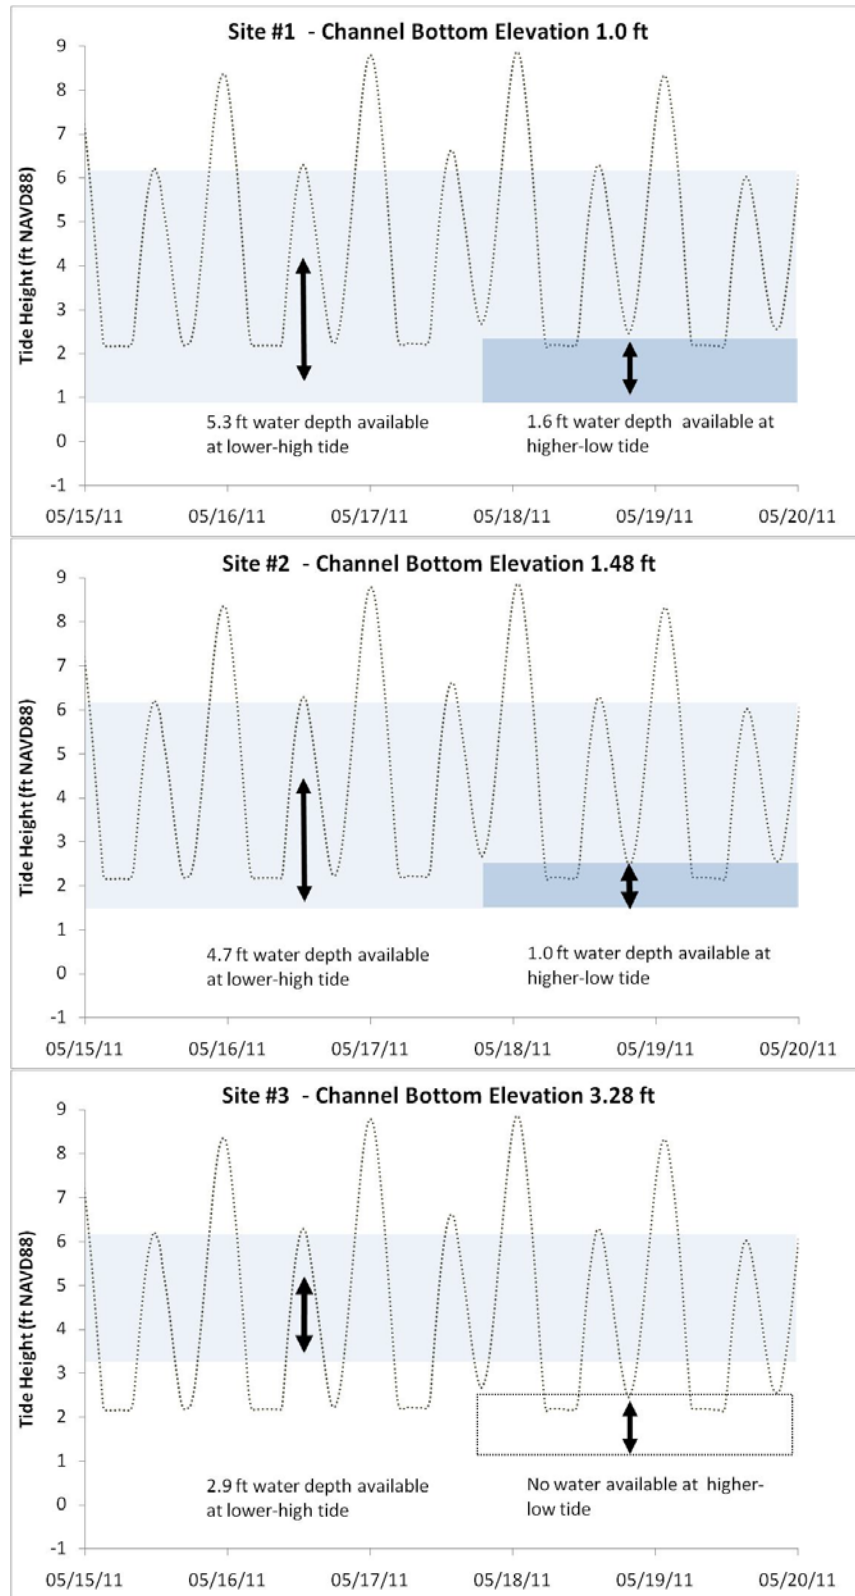
Figure 19. Predicted post-restoration channel water depths for example sites 1, 2 and 3 during a May tidal series.

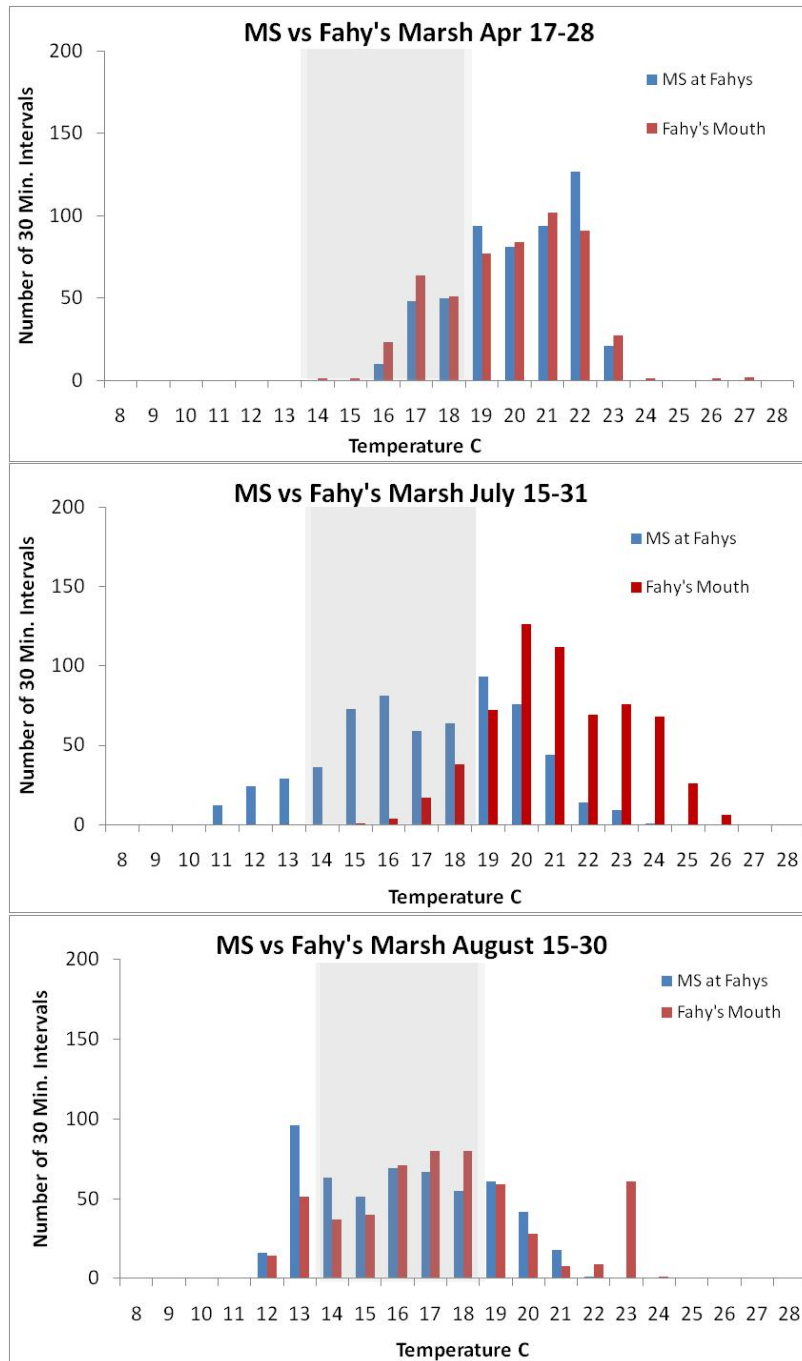
Figure 20. April, July and August 2011 stream temperatures for the mainstem Coquille River just upstream of Fahys Creek mouth (“MS at Fahys” above; “Coq Fahy T 8234” in Figure A2, Appendix A) and Lower Fahys Creek (“Fahys Mouth” = “Fahy Mth 8239” in Figure A2, App. A). Gray block shows temperatures suitable for migration and rearing of juvenile salmonids (Oregon DEQ 1996).

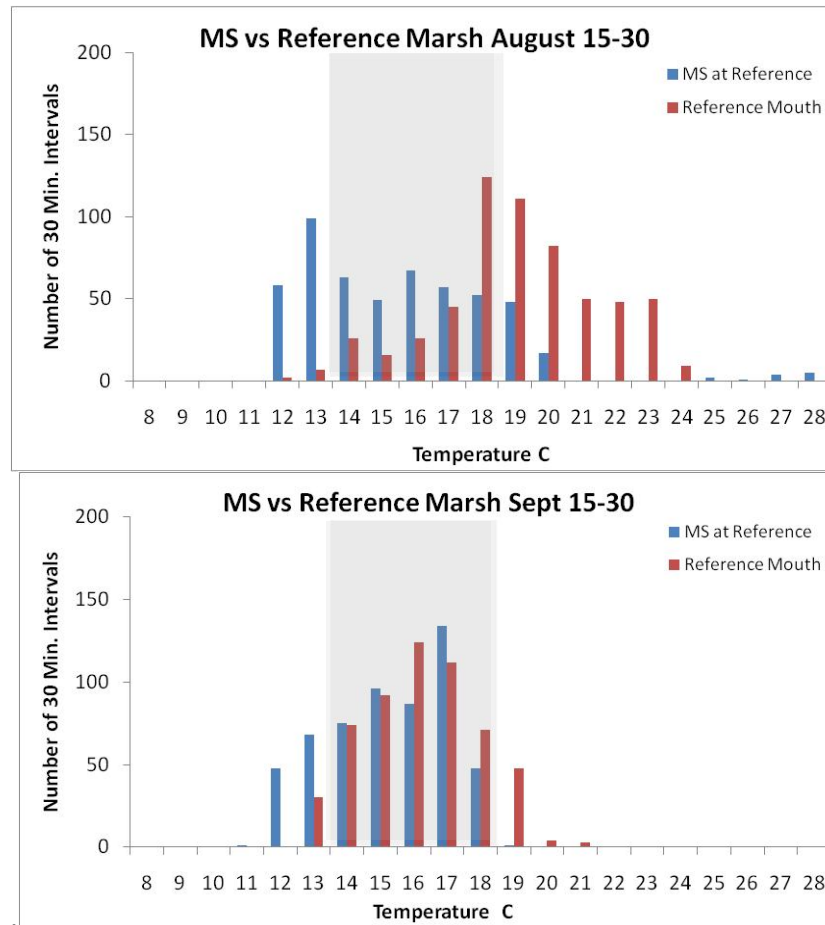
Figure 21. August and September 2011 stream temperatures for the mainstem (“MS at Reference” above; “Ramp T 8228” in Figure A3, Appendix A) and the reference marsh channel itself (“Reference Mouth” above, “Shipwreck A 8238” in Figure A3, Appendix A). Gray block shows temperatures suitable for migration and rearing of juvenile salmonids (Oregon DEQ 1996).

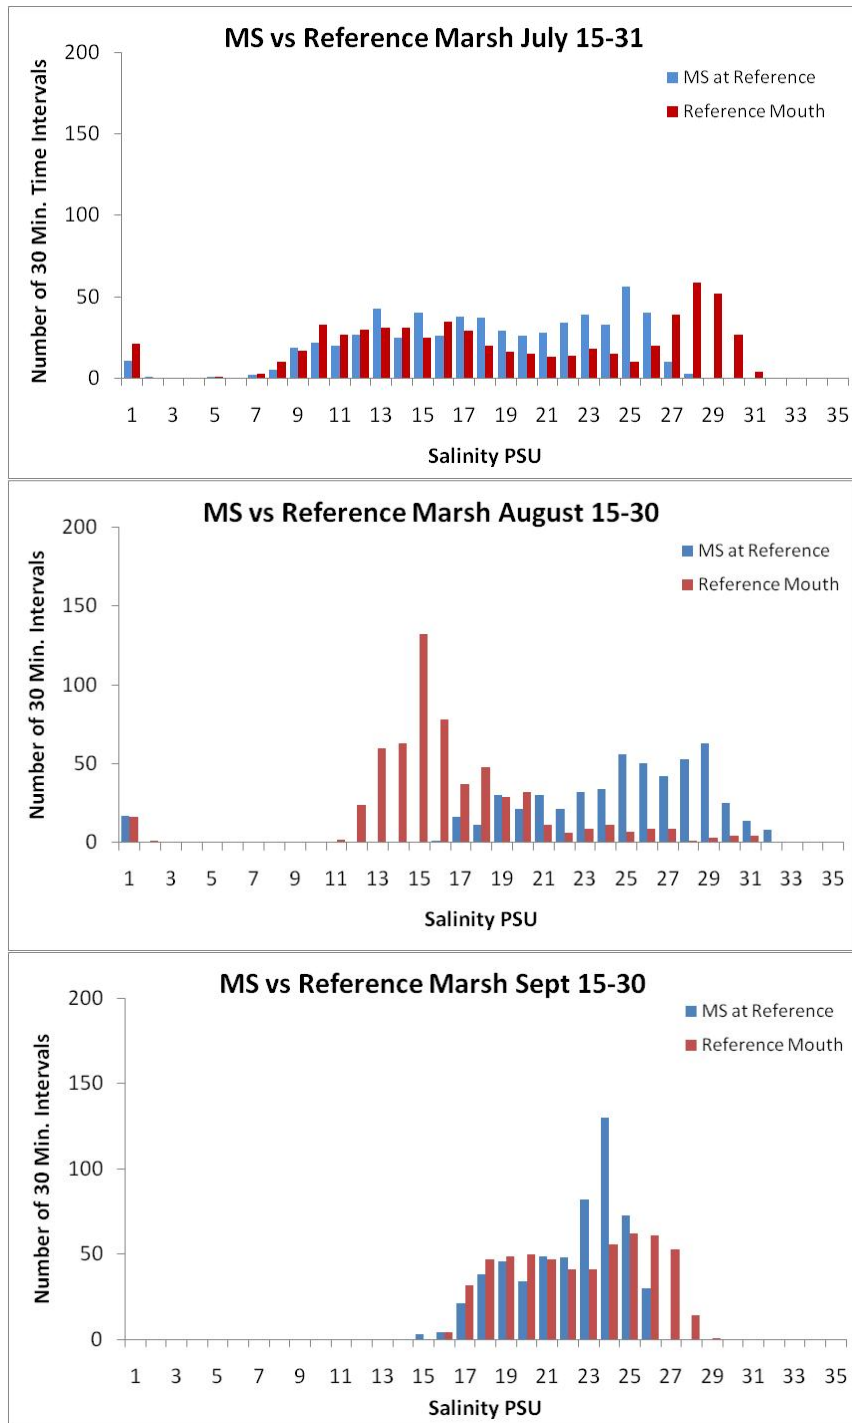
Figure 23. July, August and September 2011 stream salinities for the mainstem (“MS at Reference” above; “Ramp T 8228” in Figure A3, Appendix A) and the reference marsh channel itself (“Reference Mouth” above; “Shipwreck A 8238” in Figure A3, Appendix A).

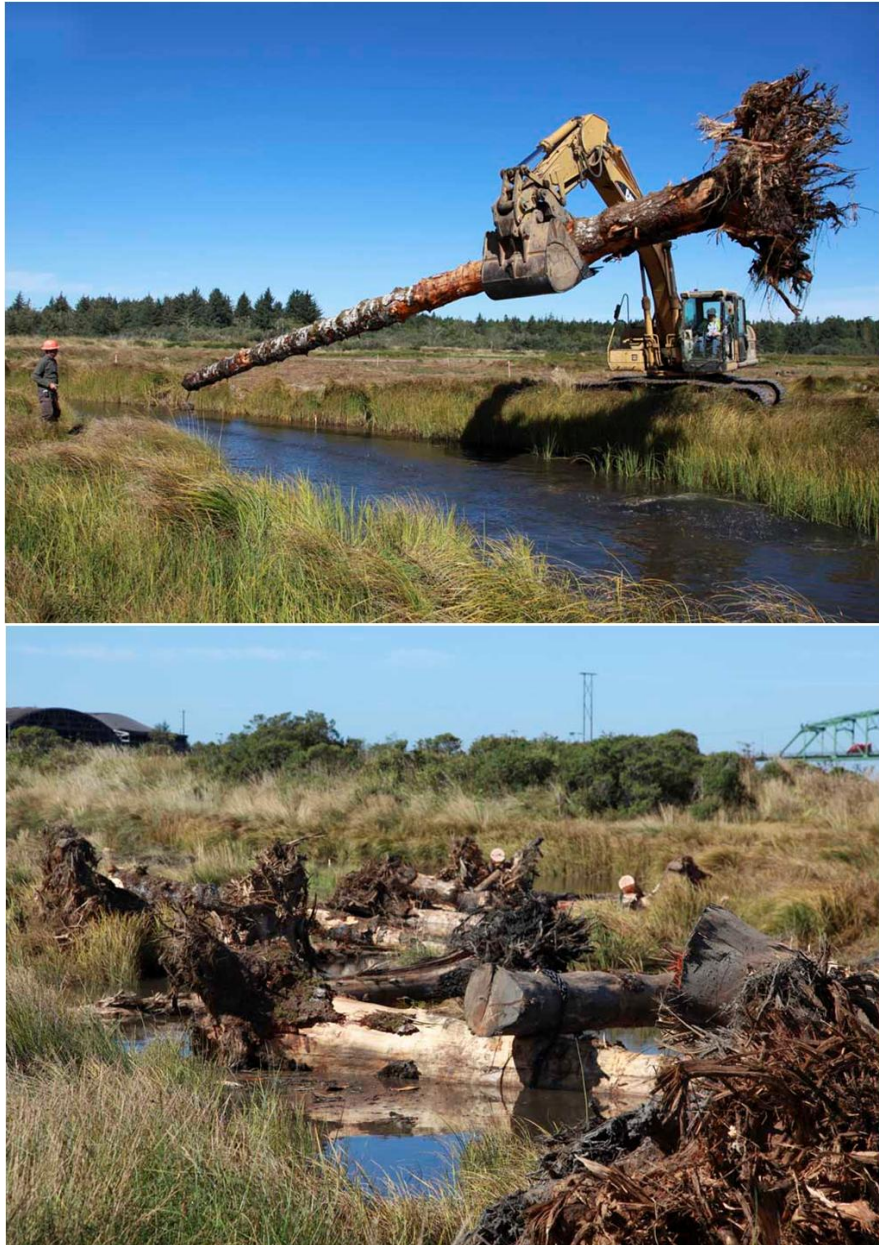
Figure 24. Ground view of restored in-stream wood habitats.

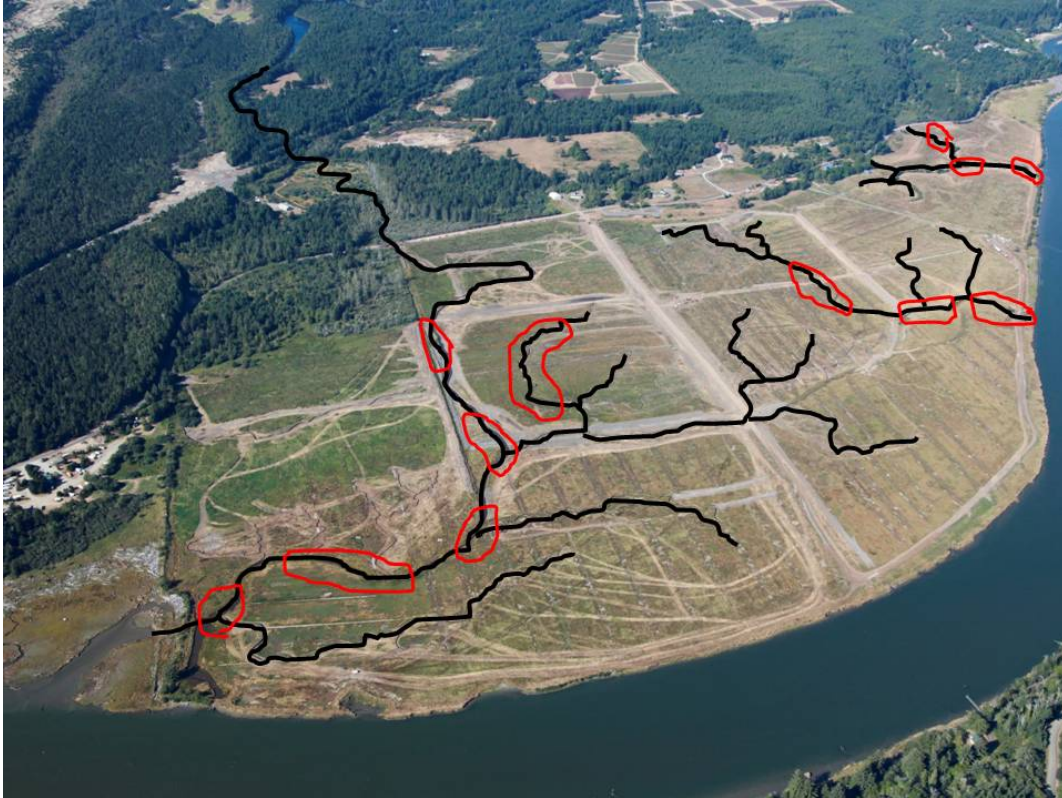
Figure 25. Locations of in-stream large wood monitoring reaches (red polygons).

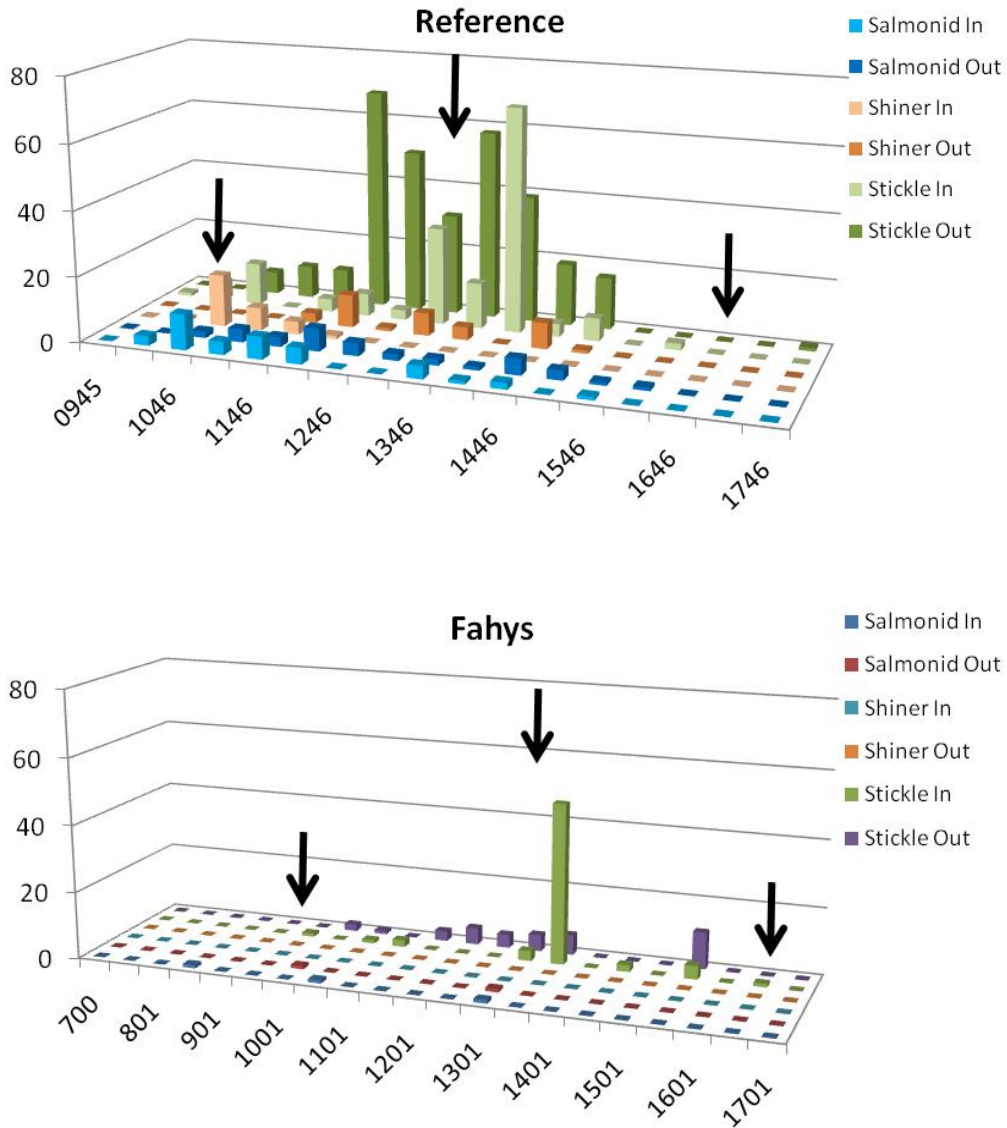
Figure 33. Early June 2010 tidal migration patterns for the mouths of the Reference (Shipwreck) channel and Fahys Creeks. Bars represent unexpanded into marsh and out of marsh migration (raw camera counts) at 30 minute intervals. Arrows denote morning low, afternoon high and afternoon low tides.

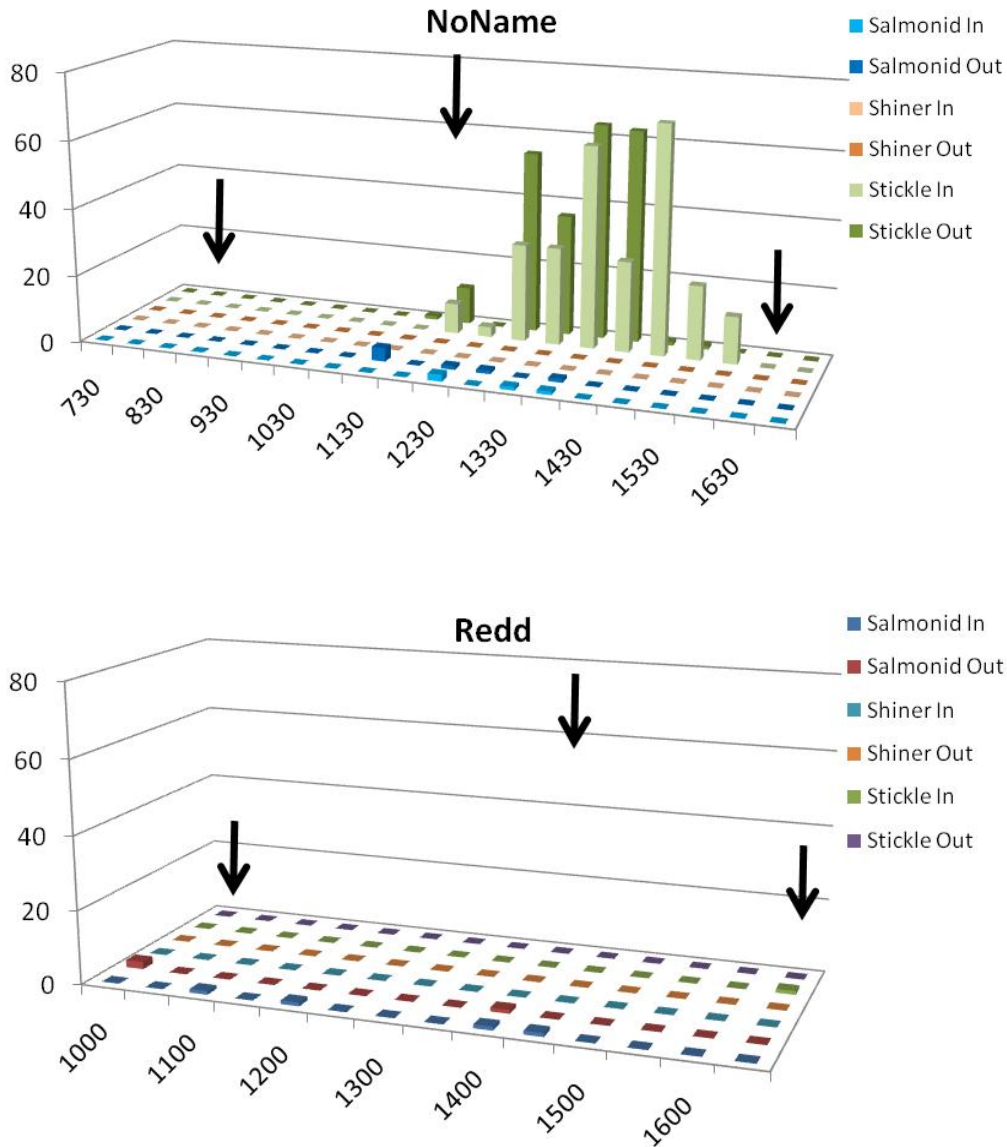
Figure 34. Early June 2010 tidal migration patterns for the mouths of NoName and Redd Creeks. Bars represent unexpanded into marsh and out of marsh migration (raw camera counts) at 30 minute intervals. Arrows denote morning low, afternoon high and afternoon low tides.

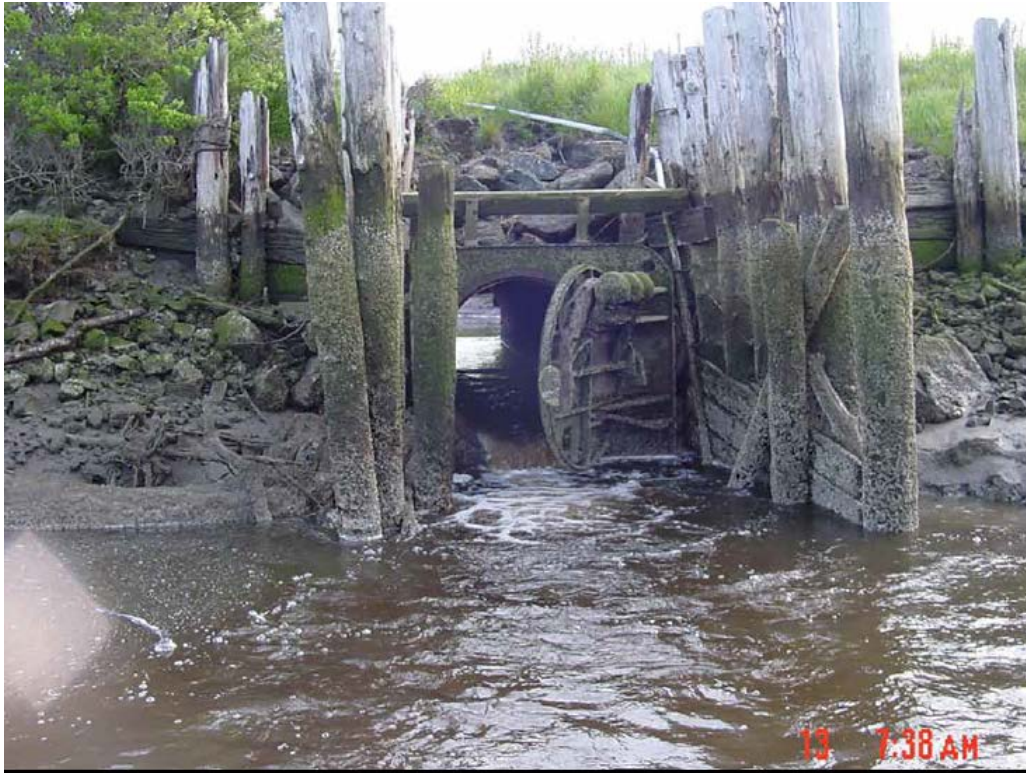
Figure 35. Fahys tide gate during mid-ebb tide in late spring. Note the elevation drop from the pipe to the pool level downstream.

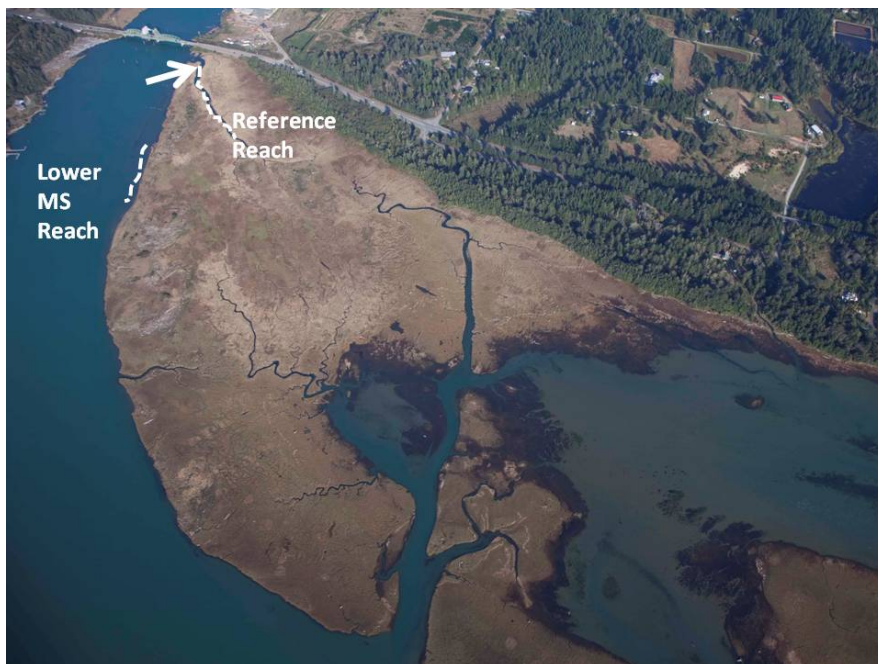
Figure A4. 2010-2011 fish sampling locations. Black lines (top image) represent restored tidal channels. Low tide seine sampling sites are represented by white dotted and solid lines. Arrows represent videography sample sites. Top: Restoration site. Bottom: Reference site.

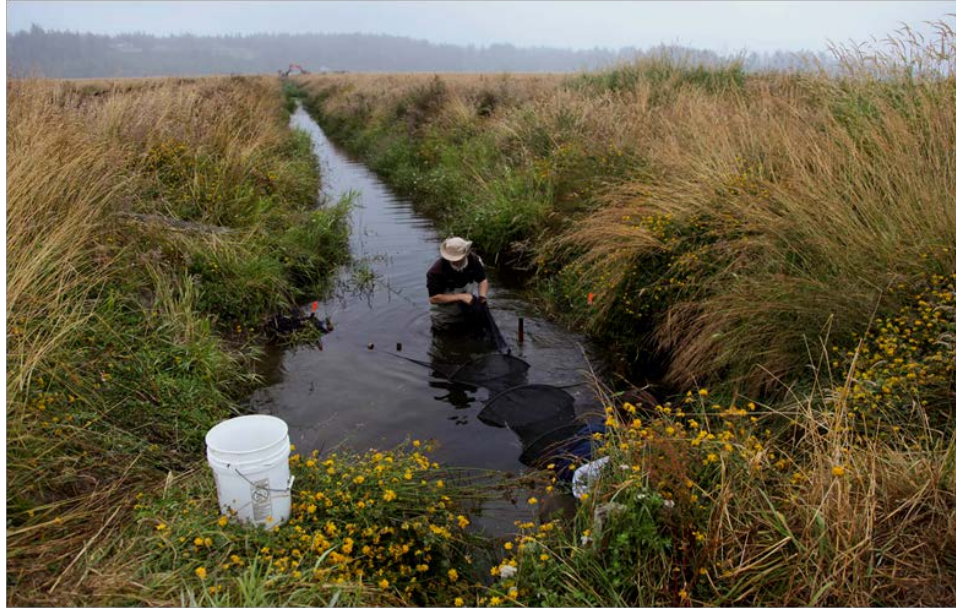
Figure A18. One of the larger ditches that was cleaned of aquatic macrophytes and fine sediments one year prior to fish rescue and the restoration fill actions.

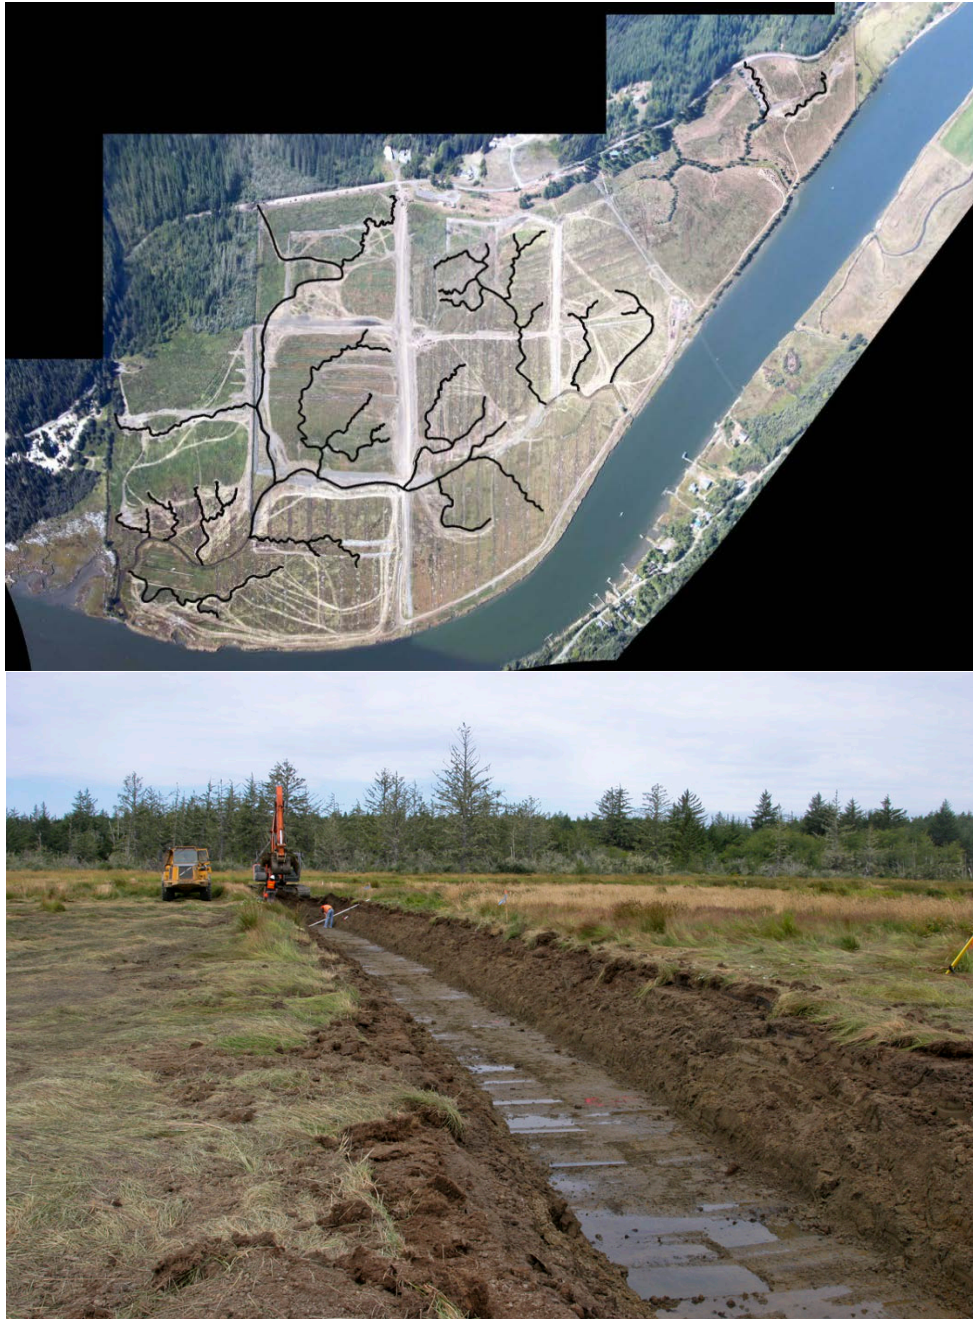
Figure A20. Top: Restored (excavated) marsh channels (black lines). Background is August 2010 aerial by Roy Lowe. Bottom: Newly dug channel form.

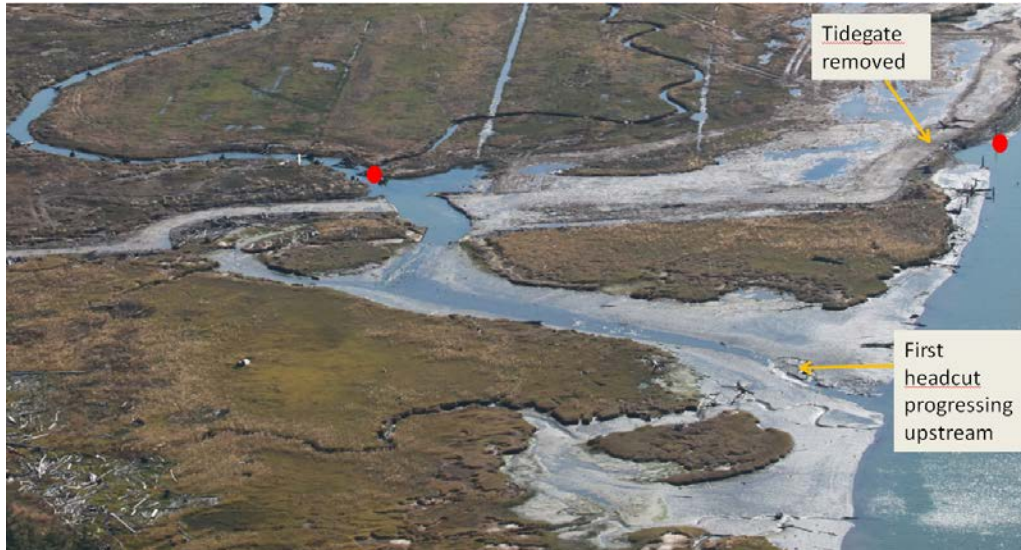
Photo C1. Lower Fahys Creek on September 2, 2011, showing location of inside and outside tide gauges (red dots). Former mouth of Fahys Creek is at upper right (“tidegate removed”). Photo by Bill Bridgeland, USFWS.

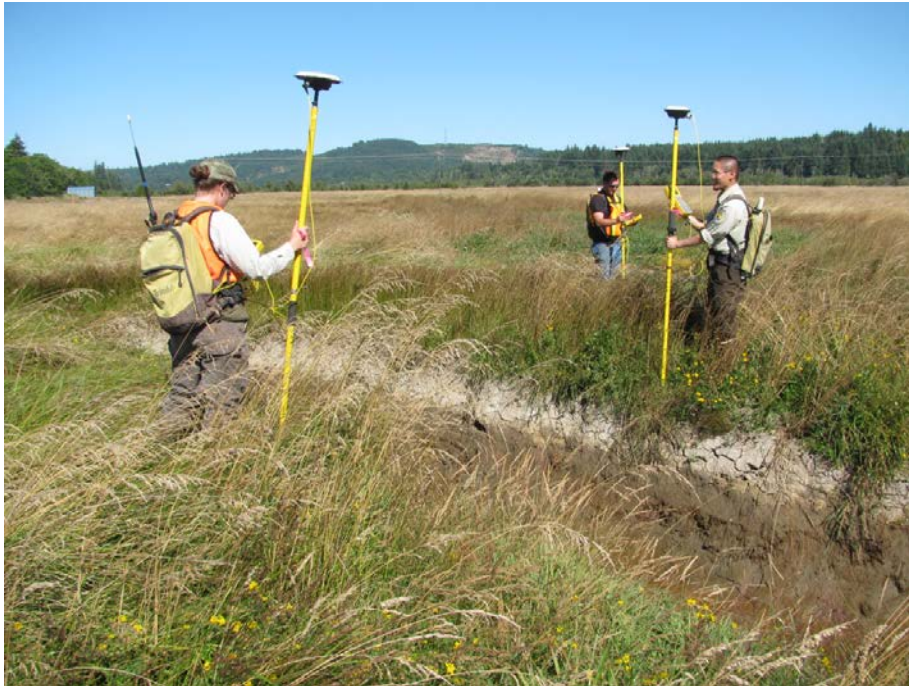
Photo C3. Monitoring channel morphology: RTK-GPS survey of constructed channels. L to R: Oregon State University graduate student Megan MacClellan, Americorps volunteer Curt Beyer, Khemarith So of USFWS. Photo by Laura Brophy.
