The cascading failure of check dam systems during the 28 July 2022 Emamzadeh Davood flood in Iran

Keywords Flood · Check dam · Emamzadeh Davood

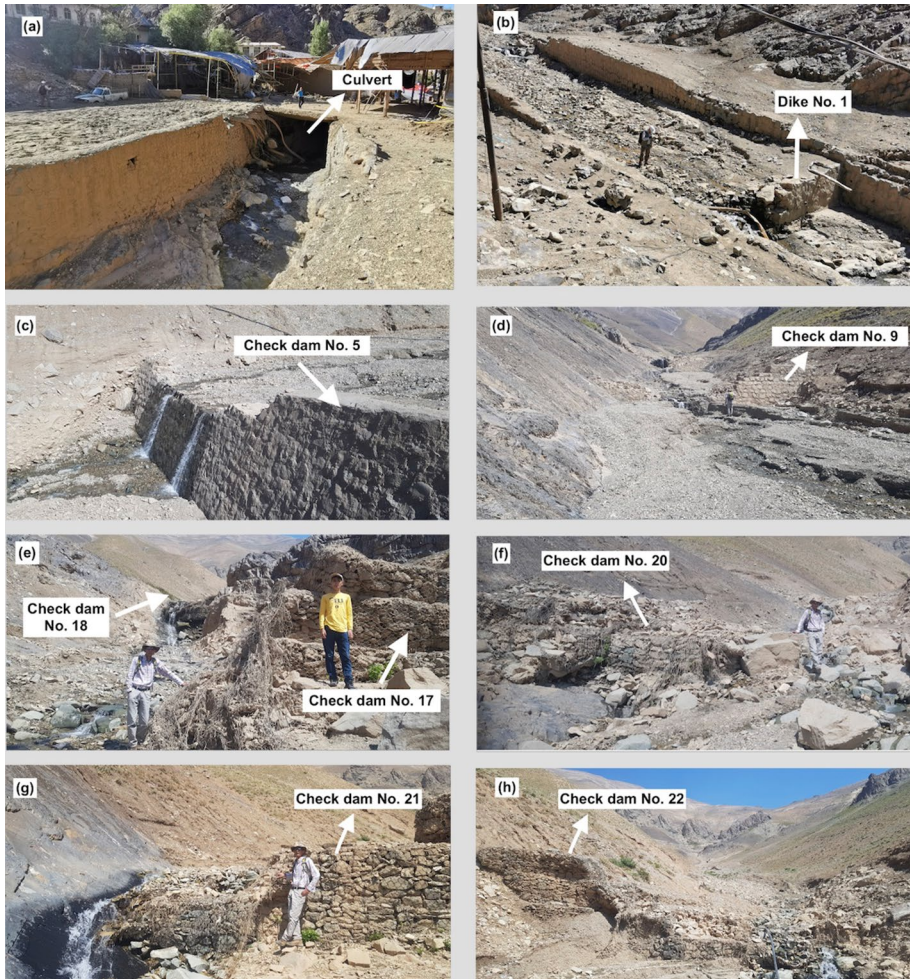
Fig. 3 a–h Exemplary ground photos of check dams and other construction. Photos taken on August 18, 2022. For the location of objects please refer to Fig. 2a (Photos credit H. Akhani)

For the 2022 flood event, analysis suggests that there were anthropogenic interventions in the main stream channel in region. The most significant one was a culvert constructed just in the northern entrance of the village to allow water to pass below the village (Fig. 3a). The culvert was reportedly blocked during the event by a falling car and debris brought by the flash flood, causing unexpected flow diversion out of the normal stream channel into the village. More than 45 check dams were already constructed by authorities as flood-control structures in the region (Fig. 2a). Inspection of the main flooded waterways after the event clearly revealed a cascading failure of check dam systems in the study area; except for a few ones (blue circles in Fig. 2a), most of the check dams in the main stream (red circles in Fig. 2a) were completely destroyed in the 2022 flood (See Fig. 3 for exemplary ground photos). Analysis of satellite data using Google Earth images also showed evidence of the destruction of 4 check dams in the upper part

In our field surveys, we also documented intensive erosion of upstream slopes due to over-grazing in a geologically degradable shale and tuff substrate (Fig. 4a). There were also several dikes and retaining walls in the river bed. The dike marked as No. 1 in Fig. 2 is located approximately 40 m before the main culvert. It was already filled with sediments before the 2022 flood so that the river bed was raised almost to the level of its surrounding (< 40 cm difference in height compared to its surrounding, see Fig. 3b). This paved the way for the lateral debris transfer of the 2022 event to both sides of the main stream channel, which then entered into the built-up areas, causing considerable damage to property and loss of life (Fig. 4).

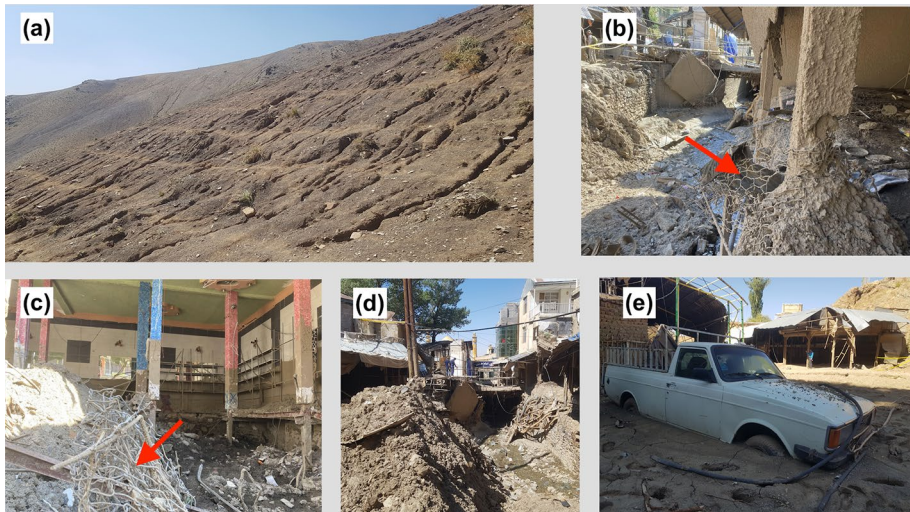
Fig. 4 **a** Degraded vegetation and intensive slope erosion in an altitude of 2900 m of Emamzadeh Davood upstream. **b–e** Examples of destruction to infrastructure in Emamzadeh Davood due to the 2022 flood. The remaining of metal nets from gabion check dams around columns of destroyed buildings has been marked with a red arrow in **(b)** and **(c)** (Photos credit H. Akhani)

of the main stream channel already in 2021 (yellow circles in Fig. 2a). Own documentation and many photos taken by independent journalists illustrated remnant of metal nets of destroyed check dams in destroyed buildings of the village (Fig. 4b–c). Topography analysis along a longitudinal profile using a 12-m TanDEM-X digital elevation model (DEM) shows a relation between channel gradient and the extent and pattern of the damage to check dams. As shown in Fig. 2b, check dams Nos. 9–22 which are located in the higher gradient segment of the channel (slope ~ 19°) were all destroyed either in the 2022 flood or previous floods. Here, two types of check dams were constructed; Nos. 9–11 are masonry check dams while Nos. 12–22 are gabion check dams. Check dams Nos. 1–8 which are located in the lower gradient part (slope ~ 15°) are all masonry; with
