TESTING OF CLOSE-RANGE PHOTOGRAMMETRY AND LASER SCANNING FOR EASY DOCUMENTATION OF HISTORICAL OBJECTS AND BUILDINGS PARTS

Almedina Rapuca and Eva Matoušková

*Czech Technical University in Prague, Faculty of Civil Engineering, Department of Geomatics, 16629 Prague 6, Thakurova 7, Czech Republic;
almedinarapuca@gmail.com, eva.matouskova@fsv.cvut.cz*

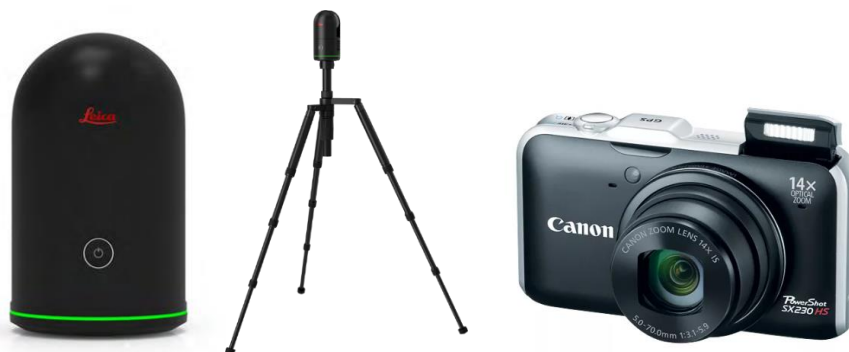
Fig. 1 – Laser scanner BLK360 (left) and Canon PowerShot SX230 HS (right)

For measurements and point cloud generation, different instruments were chosen. In the first case study, a scanner Leica BLK360 and a common digital camera Canon PowerShot SX230HS were used [10, 11].

Leica BLK360 is a compact laser scanner. It is small and light (around 1kg) easy to transport and use only for one person in site. The scanner is equipped with a camera for point cloud coloring and a thermal sensor; it accomplishes a comprehensive 360-degree panoramic image capture and finishes a full-dome scan in less than 30 seconds (with smallest resolution without images) till 6 minutes (full resolution with HDR images), where the vertical field of view is 300° and the horizontal field of view is 360° [10]. Based on testing and technical parameters, the accuracy of a measured spatial point is 4mm on 10m distance. The BLK360 includes an app called BLK Live, allowing us to control the laser scanner's images and quickly assess the on-site data for feedback, quality assurance, and quality control using a tablet. After measurements, the Leica Cyclone REGISTER 360 software helps with quickly setting up and organizing the collected data in the field. Canon PowerShot SX230 HS is a common low-cost compact digital camera that was used to capture photos of the buildings inside. It is equipped with a 12.1-megapixel CMOS sensor, 14x optical zoom lens (from 5mm to 70mm), allowing you to capture distant subjects with remarkable clarity and precision. Additionally, it incorporates built-in GPS functionality, enabling geotagging and location tracking for photos [11]. An older Surphaser 25 HS laser scanner was used to document the sculptures in 2018. It is one of the most accurate scanners with an accuracy of 0.6 mm at 10 meters, which is exceptional and very suitable especially for sculptures [12]. The scanner does not have a camera, but the declared accuracy is excellent; other laser scanners are not very suitable for documenting sculptures, as they have worse accuracy and the sculptures do not have proper detail. This is already lost at an accuracy of a few millimetres. Therefore, nowadays it is better to use photogrammetry, which gives an accuracy of up to 0.1 millimetres without any problems if done correctly, and the camera is several orders of magnitude cheaper than a laser scanner. In 2018, a professional 51Mpix Pentax 645 camera was used to document the sculpture for comparison with the laser scanner (Figures 1 and 2), [13].

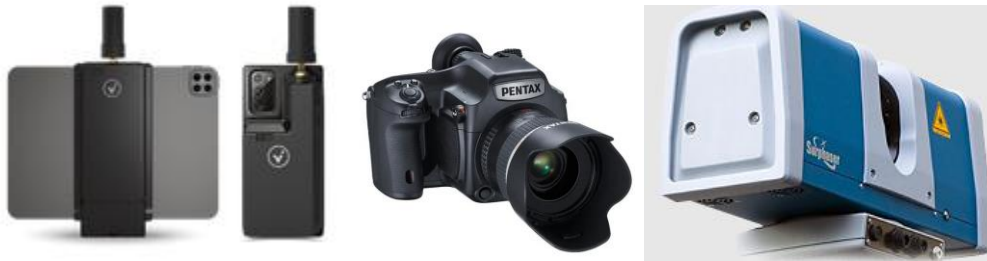
Fig. 2 – ViDOC (left), Pentax 645 and laser scanner Surphaser 25 HS (right)

The second case study used a BLK360 scanner, a Canon 450 camera and a new low-cost ViDoc device from Pix4D. The project was complemented by the analysis of older measurements of the same object with a Surphaser 25 HS laser scanner and a Pentax 645 camera.

ViDoc is a simple device that includes ViDoc RTK rover device, phone case (for iPad Pro or iPhone 12 Pro and higher with lidar sensor) and GNSS antenna.

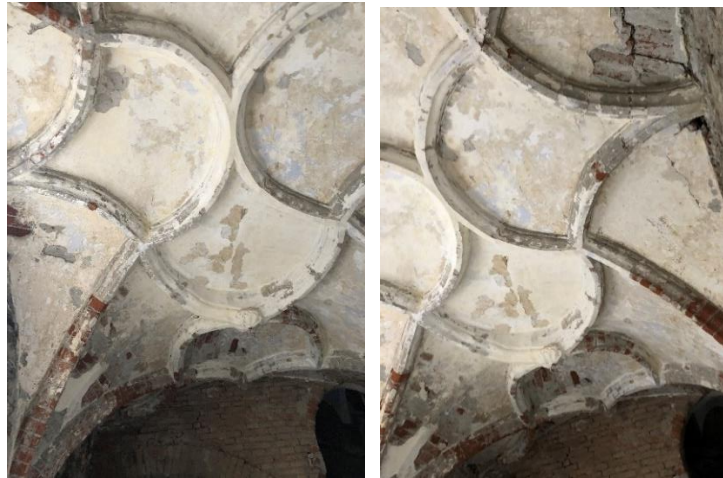
Fig.3 – Inside the house No.12, Jáchymov, year 2021. Gothic ribbed circular vault.

Many historic buildings have not been maintained for a long time. The landscape, population and employment opportunities have changed fundamentally, and these changes are still visible. The house no. 12 on the Republic Square in Jáchymov dates mostly from the turn of the Gothic and Renaissance periods. It was originally a noble house of a rich owner. The original parts of the structure from the time of the building's construction have been preserved (the cross vaults on the ground floor, the staircase to the first floor with a stone handrail and, in particular, the beautiful ribbed circular vault in the upper hall). Some details of the interior, the historic plasterwork on the first floor and the second-floor hall, and the exterior are also of considerable historical value. The entrance portal and the Renaissance lining of the window openings are original. The building was in a poor but habitable condition in the 1980s, but the rear wing and the support buildings behind the house were already in a state of desolation. Poorly executed anti-radon protection was also a factor, and the building degraded rapidly in the post-revolutionary period (after 1989). The great boom in property purchases during the Covid 19 pandemic caused a change of owner who decided to save the building. The pandemic and the high cost of construction work and materials in the post-Covid era delayed the work. Today, however, the building is in use again and has been well restored thanks to the efforts of the new owner (Figures 3 and 4).

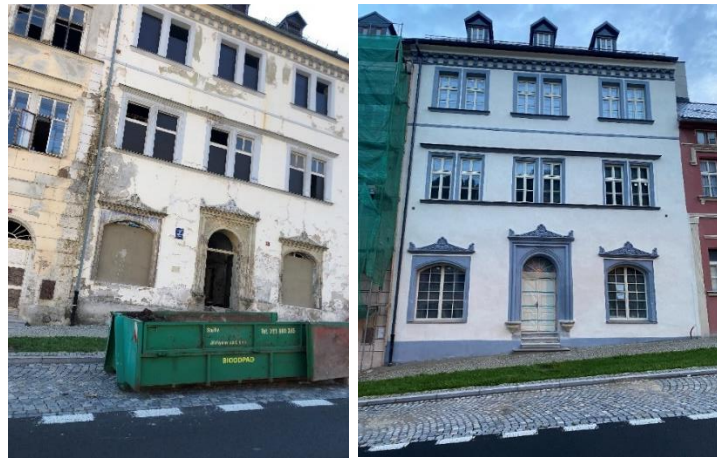
Fig.4 – The house No. 12 in Jáchymov before (left) and after reconstruction (right) in 2023.

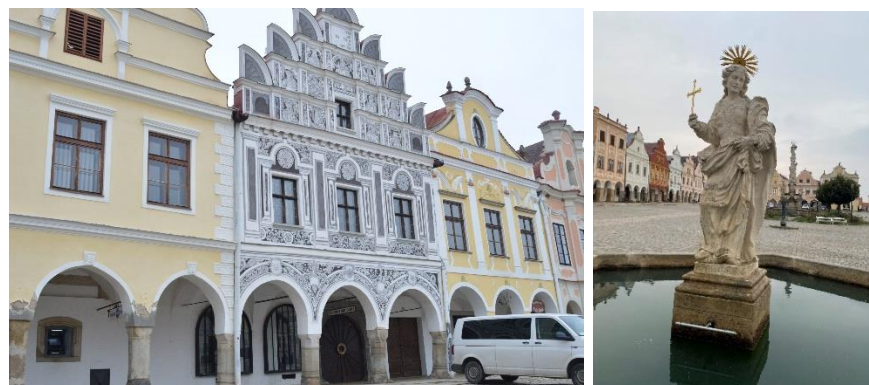
Fig.5 – Two selected historical objects on Zachariáš of Hradec Square in Telč city

The second part of the work was focused on the possibilities of low-cost documentation of monuments in the town of Telč. This historical town center has been a UNESCO World Heritage Site since 1992 [15]. The aim of the research was to compare data from the BLK360 laser scanner and the new low-cost ViDoc device. The first part was focused on the comparison of scanning time and accuracy in terms of the smaller historical house documentation on the square in Telč. The house No. 61 on Zachariáš of Hradec Square was selected; it is a single-story house with an archway. The originally late Gothic house was preserved during the Renaissance renovation. Further changes took place before the mid-16th century (under the ownership of the baker Michael). The reconstruction is dated on the sgraffito of the facade L.P. 1555. The imposing Renaissance façade with a Venetian-type gable with pilasters and cornices dominates the square. The façade is decorated with sgraffito with vegetative motifs¹.

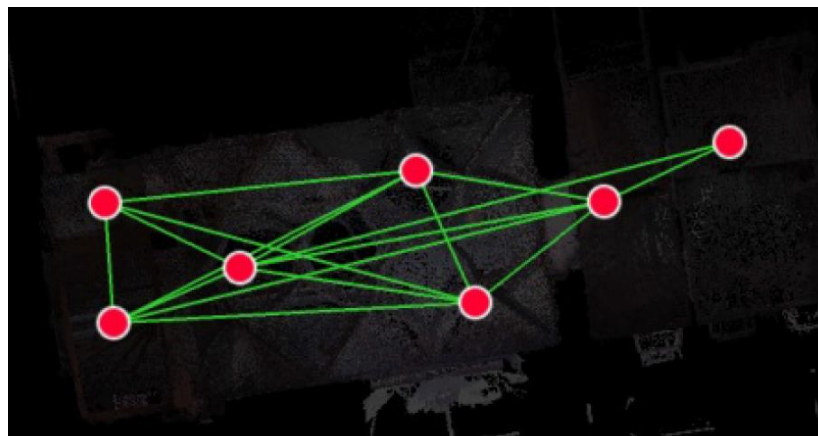
Fig. 6 – View of all merging scans in SiteMap

The first measurements were done by laser scanner. 7 scans of the building interior buildings were done (Figure 6). After that, the measurement data can be transferred with Wi-Fi and open in software Leica Cyclone REGISTER 360.

The next step after data import was the registration. This step involves aligning and merging multiple scan positions to create a unified point cloud dataset. This can be done automatically, where the program will match points in different scans, where the user can edit one by one. Following this, quality control can be performed, checking for alignment errors, outliers, and other issues to ensure the data's accuracy. After removing any unnecessary parts from the point cloud, we can visualize the 3D scan using various software tools. Through these processing steps, we achieved a successful result: 16 lines with a 50% overlap and an overall Bundle Error of 0.004 meters. The measurement takes 40 minutes, the semi-automatic data processing takes 30 minutes on a common HP workstation (processor I-7, 32 GB RAM) to a colored joined point cloud. Together 30 million spatial object points were saved.

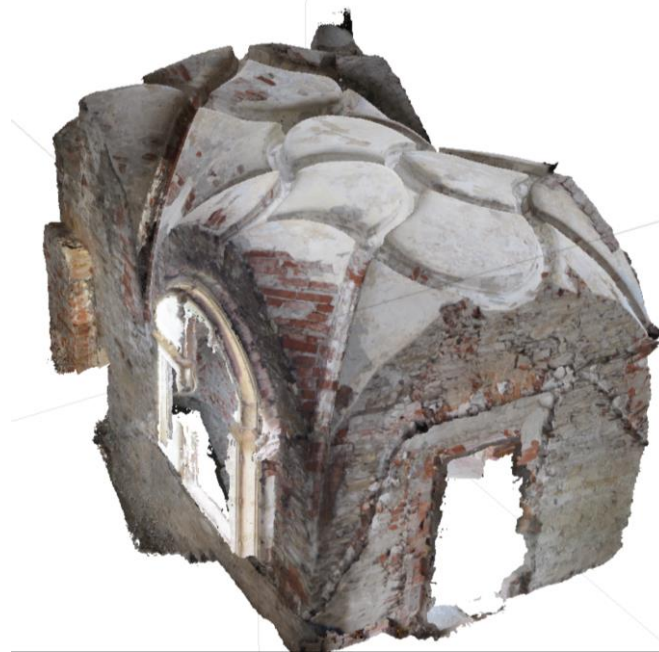
Fig. 9 – Textured 3D model of the object

At the end the Tiled Model or Textured 3D was generated with high quality. Build Texture allows adding the photos taken to the shape of the pre-created 3D Mesh object (Figure 9).

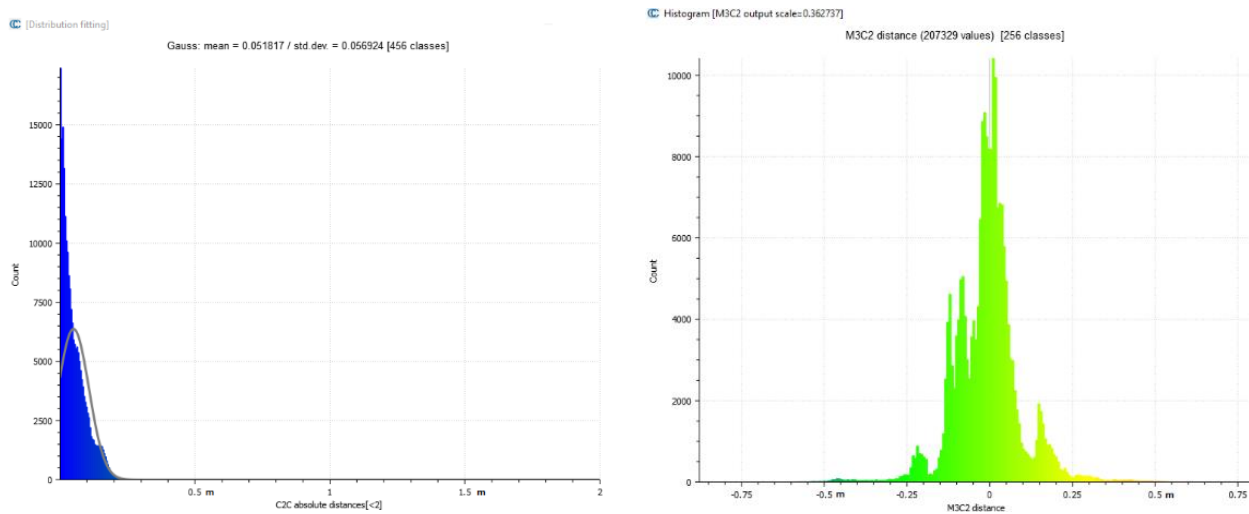
Fig. 11 – C2C absolute distance

The default way to compute distances between two-point cloud is the 'nearest neighbor distance' for each point of the compared cloud, CloudCompare searches the nearest point in the reference cloud and computes their (Euclidean) distance. If the reference point cloud is dense enough, approximating the distance from the compared cloud to the underlying surface represented by the reference cloud is acceptable [16].

reason, we relied on CloudCompare for the comparative analysis of metrics between two sets of point clouds. It is essential to note that measurements obtained through the BLK360 laser scanner proved significantly more accurate compared to those obtained with the Canon digital camera, therefore we used like the reference the point cloud of the laser scanner (Figure 10-11).

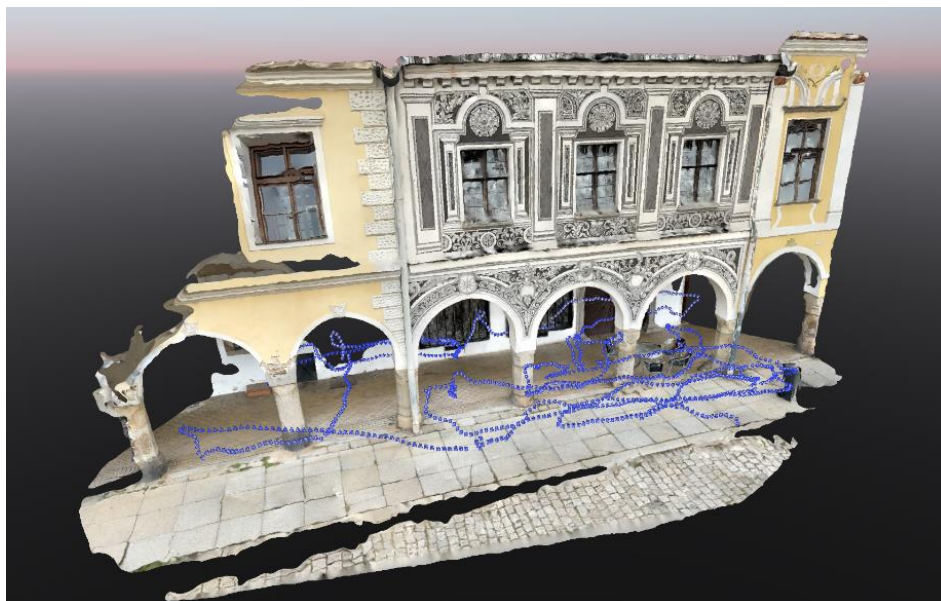
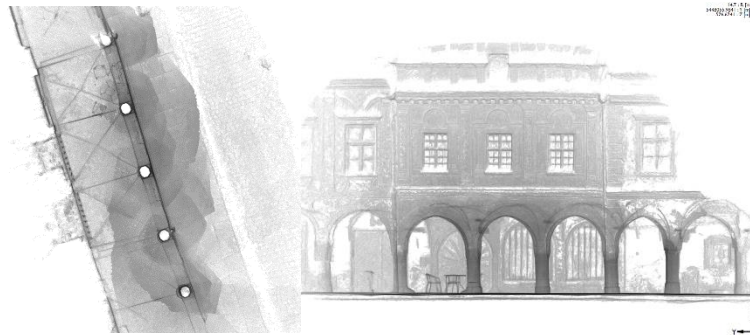
Fig.14 – View of the object and position of the moving device, plan view and side view created by projection of the point cloud from the ViDOC device.

The differences in documentation of historic house occurred due to range of devices. The BLK360 laser scanner has a range of 30 meters, and the photogrammetric measurement has a practically similar range. The difference is mainly in the use of ViDOC equipment, which has a realistic range of just over 5 meters and is not well suited for buildings. However, low objects and sculptures can be documented very easily, quickly, and accurately with ViDOC (Figures 12 to 14).

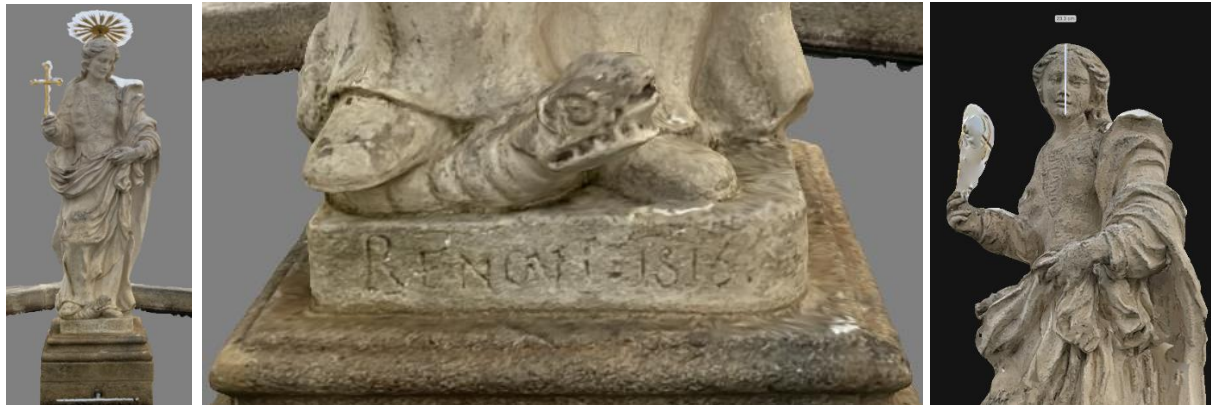
Fig.16 – The textured 3D mesh from iPhone 11 (left) and a detail from this model (from about 3 meters). Right – 3D model from the ViDOC instrument. Based on the lidar sensor and RTK GNSS, the model is scaled, and it is possible to measure real distances on the model.

Sculpture documentation is problematic. It depends on its size and especially the spatial complexity of the sculptures, on the material, on the devices used and its accuracy, and mobility in terms of covered and small spaces. Various devices were used here, mobile ViDOC, an expensive and high-quality digital camera Pentax 645, a very accurate laser scanner Surphaser 25 HS, and data from the camera of the iPhone 11 smartphone (Figure 16 to 17).

The difference in both models was mainly in the area of the head of the statue (it was not possible and allowed to scan) and reached a maximum of 2cm. Typically around 0.5-1 cm.
