Evaluation of Mangroves Effectiveness in Strengthening Coastal Bund Using Geophysical Method (Non-Destructive Testing) at Tanjong Laboh, Batu Pahat, Johor

Keywords: Mangroves, geo-physical method, coastal bund, Johor

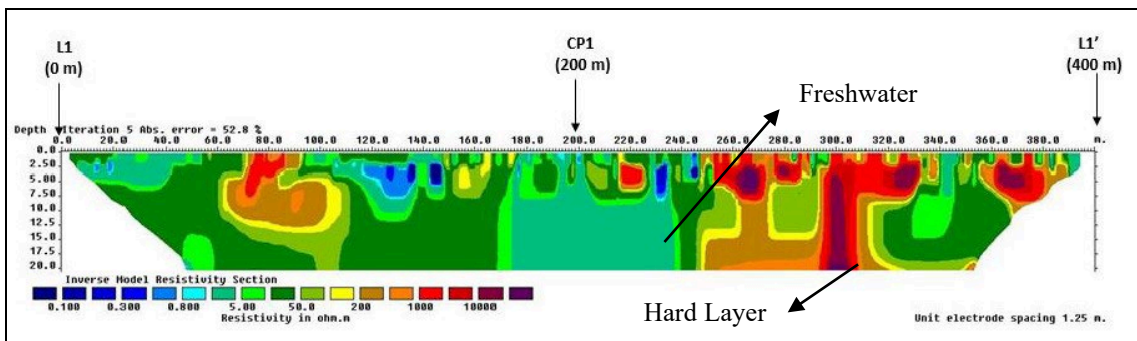
The result from the ERI survey obtained for survey line L1 to L1’ shows the resistivity values between 1 and 1000 ohm.m which indicates the presence of quaternary alluvial deposits and bund systems that are not intruded by seawater intrusion along with the presence of granite hard-rock. A high resistivity value represents that seawater was not dominantly found in the subsurface profile as shown in Fig. 5. The saline water was more dominant in the subsurface with low resistivity and well-made construction of engineered bund can prevent SI in surface soil. In addition, the

yellow to red colour represents the presence of hard layers such as the rock. Meanwhile, the turquoise to green colour indicates the presence of freshwater and the seawater can be seen a dark blue colour.

Fig. 5 - Subsurface profile image for survey line L1 to L1'

From the obtained results, the saltwater intrusion was more prominent in survey line L2 to L2' where there is mangrove bund meanwhile, there is no SI presence on survey line L1 to L1', which is located on engineered bund and rock outcrop areas. Mangrove forest has the ability to reduce SI, however, the studies also concluded that the SI might occur due to the reduced quantity of freshwater supply resulting in seawater completely entering the coastal area. This indicates that other than the presence of mangroves or not, there are other factors were considered as source of SI in the study area.
