Fatigue Behavior of a Cross-Ply Metal Matrix Composite at Elevated Temperature under Strain Controlled Mode

THESIS

Leon B. Dennis, Captain, USAF

AFIT/GAE/ENY/94D-7

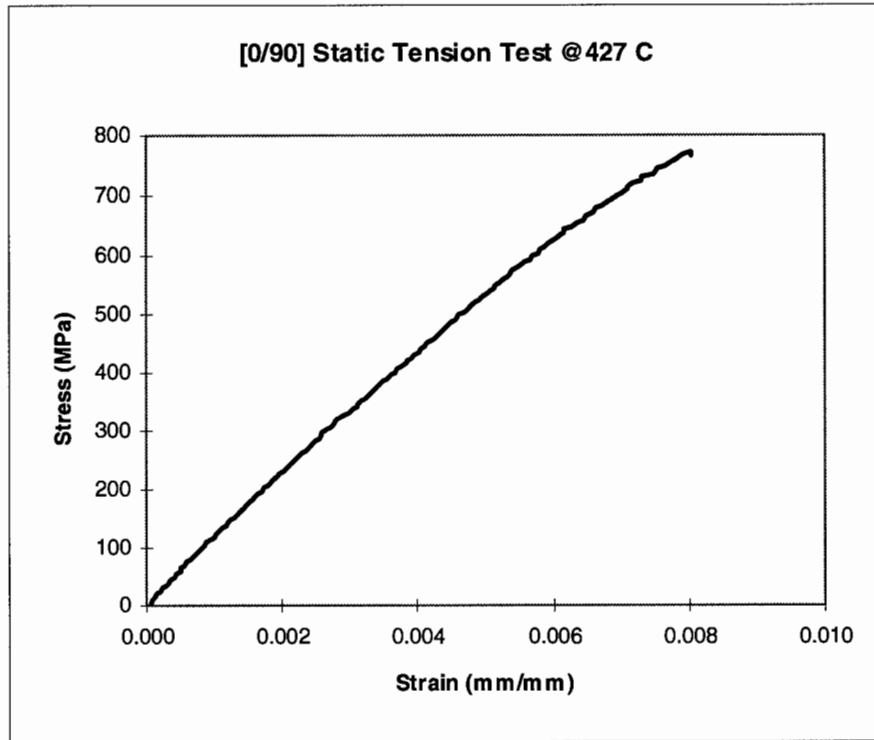
Figure 4.1 shows the monotonic tension stress-strain response of the $[0/90]_{2s}$ composite when tested under strain controlled mode, at a strain rate of 0.2%/sec. This test was performed at 427° C up to tensile failure, providing the maximum strain limit of the material. The curve shows the three stage stress strain response characteristic of crossply laminates. In the first stage, the linear-elastic response region extends to the first knee at approximately 0.06% strain (80 MPa). Boyum [3] reported a knee at the same load level and temperature. This stage is characteristic of undamaged material (no cracks or debonds). At the 0.06% knee, 90° fiber debonding initiates[23].

Figure 4.1: Monotonic Tension Test (0.2%/sec Strain Rate)

This debonding decreases the stiffness of the material, illustrated by slight decrease in slope of the stress-strain response, from 126.4 GPa to 103.5 GPa. After the debonding, the response is fairly linear until 0.55% strain, where a slight nonlinear response initiates. At this point, Sanders[23] reported that, for unidirectional Ti-15-3 composite, plastic deformation of the matrix initiates. This suggests matrix plasticity initiates at this strain.

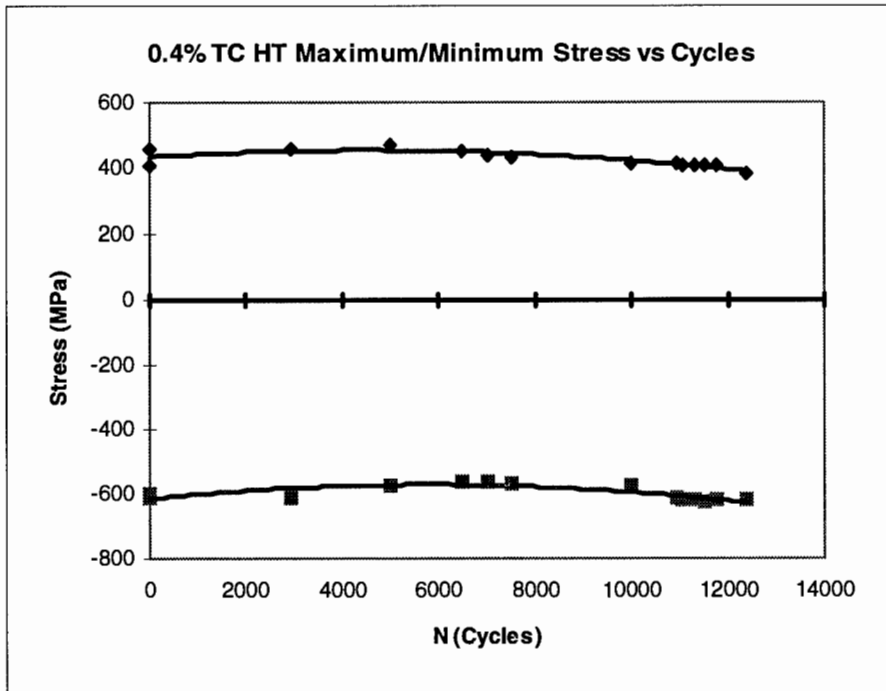
Figure 4.11 shows the typical histories of the maximum stress and minimum stress for the same test, with the dominant failure mode of matrix cracking. The maximum and

Figure 4.11: Maximum/Minimum Stress History, 0.4%

minimum stress history plots demonstrate an overall trend of decreasing maximum stress level over the latter half of the specimen life. This trend supports the theory that matrix cracking was the dominant mode of failure, since damage was slowly accumulating and thus the material deformed to a given strain with less stress at higher fatigue cycles.

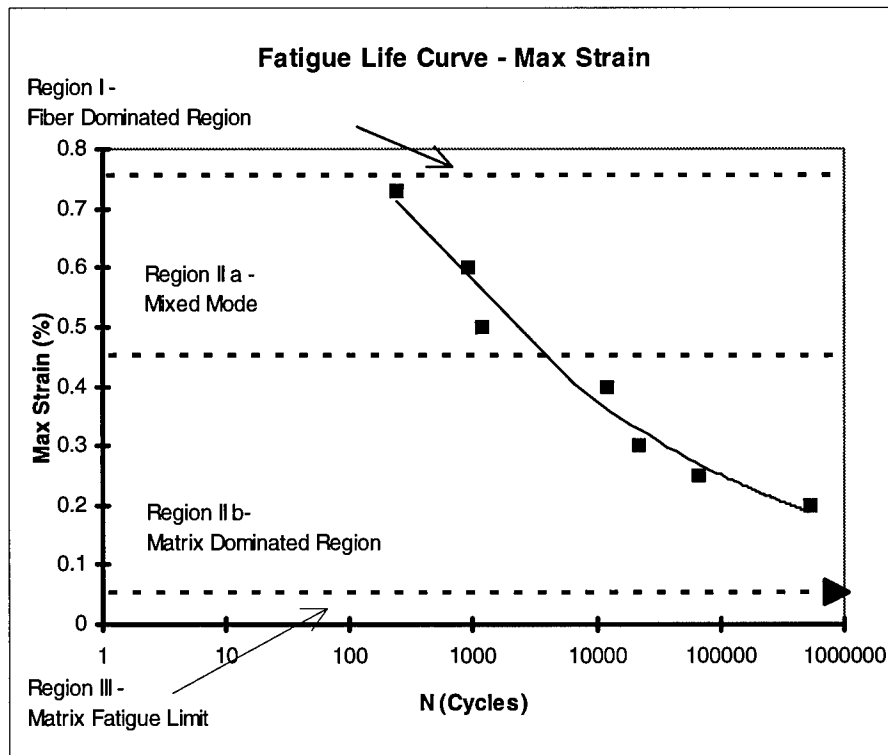
dominant failure modes. The divisions were determined both by macroscopic response and by microscopic evidence. The previously stated criteria of dominant failure modes was applied. The Region III matrix fatigue limit was estimated because all current specimens failed. Sanders [23] estimated the maximum strain of Region III for the unidirectional 90° layup to be 0.05%. This appears to be a reasonable and conservative estimate because the crossply composite has the relatively stronger 0° layers present.

Figure 5.5: Partitioned Maximum Strain Fatigue Curve

Region II was further divided into Regions IIa and IIb. Region IIa is a region where longitudinal fiber breakage and matrix cracking were both observed, thus implying that the failure mode was mixed since both modes were present. Region IIb, where fiber bridging was observed, is the matrix dominated failure region. No broken longitudinal fibers were present, and matrix cracking had increased substantially. The number and length of matrix cracks in this region had increased from the Region IIa tests, as can be observed from Figures 4.26 and 4.28.

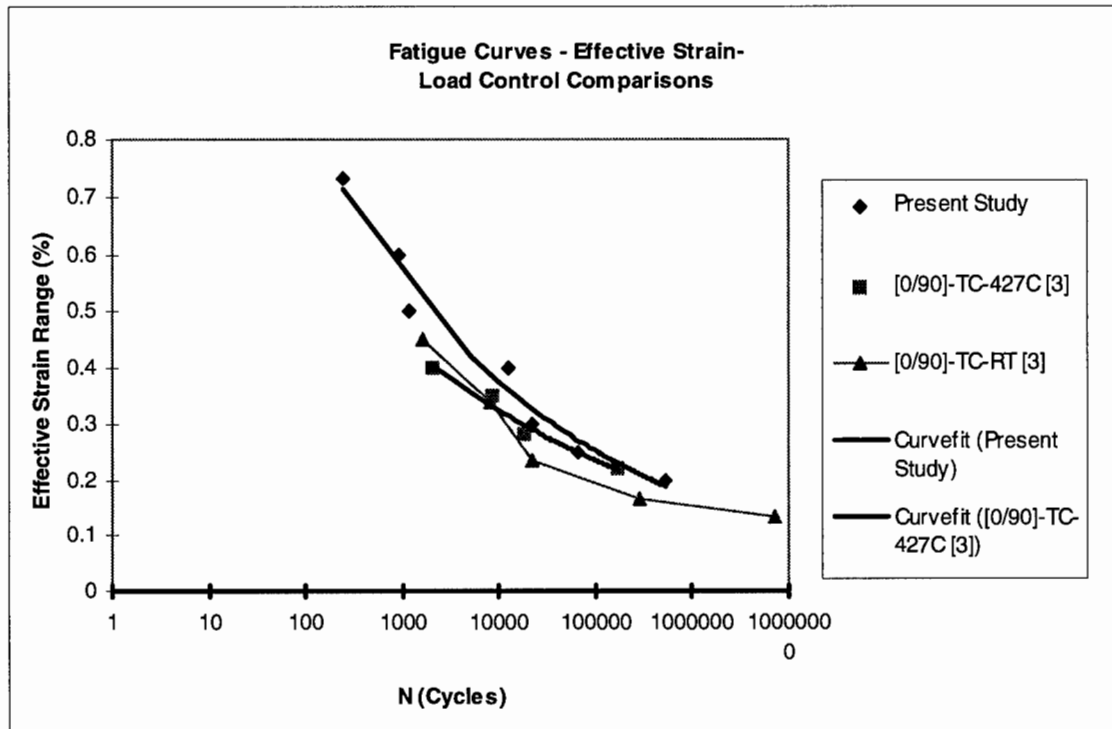
Fig 5.7, but using the new basis. Again the current data has a well correlated trend. However the data that was scattered in the last comparison is now well correlated and follows the same general trend as the current test data. Therefore, the effective strain range basis method appears to be a good method for comparing fully reversed strain controlled results with fully reversed load controlled results, all other variables being constant.

Figure 5.8: Effective Strain Range Fatigue Curve - Strain versus Load Control Comparison

Figure 5.10 presents the data of Figures 5.8 and 5.9 on the same plot in order to compare the two control modes. This allows all the data sets presented thus far to be observed on a single plot. An overall observation from Figure 5.10 is that both the matrix alloy and 0° specimens had longer fatigue lives than the cross ply composites. However, an exception was noted with the high temperature matrix alloy data. As discussed earlier, the trend fell with increasing fatigue. But of note is the fact that the failure criteria for the matrix was a 75% reduction in stress, as opposed to the typical failure definition of the specimen coming apart[23]. In another comparison, both the unidirectional 90° data and the high temperature matrix alloy data show a convergence for higher fatigue lives. This observation suggests that for lower loadings, the off-axis composite approaches the matrix alloy fatigue limit. Thus the presence of off-axis fibers for these cases impacts the higher loading fatigue lives more than lower loadings.

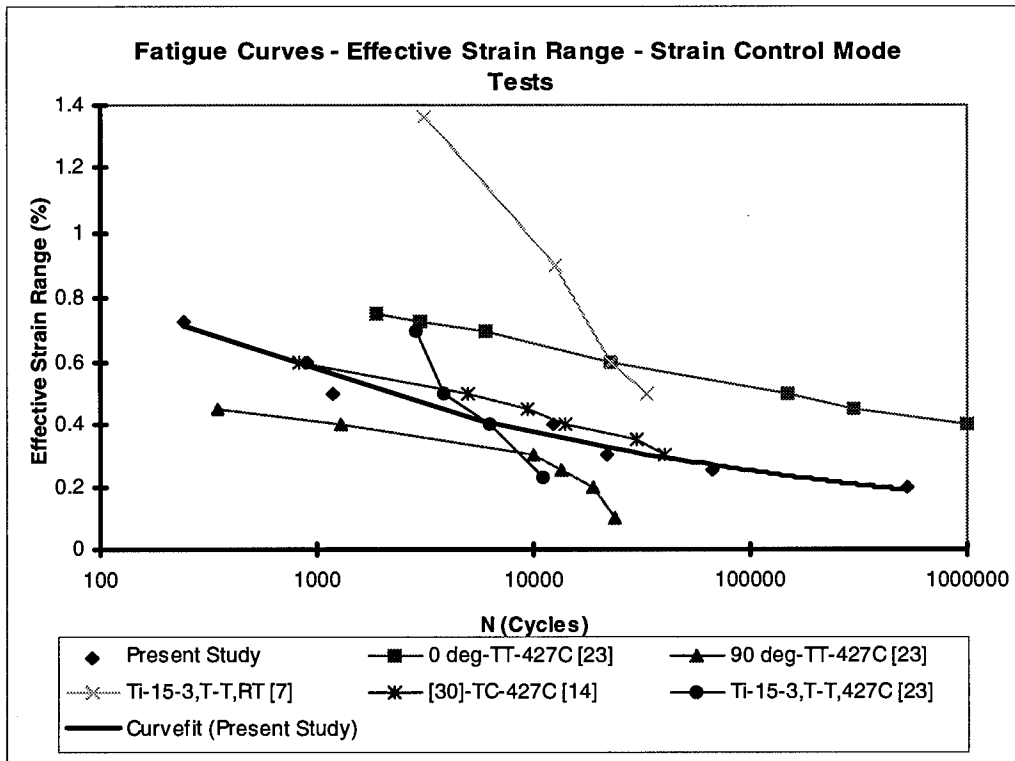
Figure 5.9: Effective Strain Range Fatigue Curve - Strain Control Comparison
