Investigation of Tension-Compression Fatigue Behavior of a Unidirectional Metal Matrix Composite at Elevated Temperature

THESIS

AFIT/GAE/ENY/94D-6

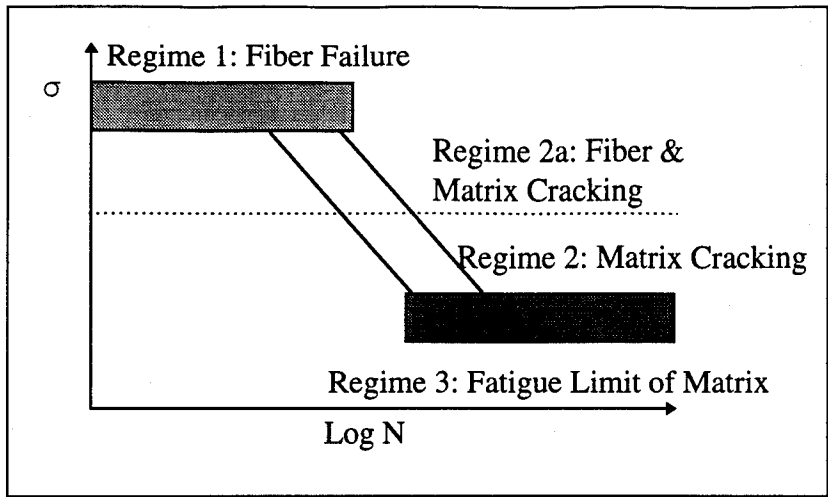
Figure 3. Boyum's Model for Regimes of Cross-Ply Laminate S-N Curve

For composite materials, fatigue life diagrams are often broken into regimes consisting of varying failure mechanisms. Following Taljera's approach (38), many researchers have broken the fatigue life of a MMC into three distinct regimes: Regime 1, 2 and 3. Specifically, Majumdar and Lerch have separated the S-N curve for the unidirectional SCS-6/Ti-15-3 laminate, tested in tension-tension at an R-ratio of 0.1, into Regime 1, which is dominated by fiber failure, Regime 2, which is dominated by matrix failure, and Regime 3, which consists of specimens that did not fail and fall below the fatigue limit of the material (21). Between these regimes, the authors found the failure modes to be complex, consisting of combinations of failure modes. Boyum, who tested a cross-ply laminate under tension-compression conditions, elaborated upon Taljera's approach by breaking Regime 2 into two separate qualitative regimes, Regime 2a and Regime 2 (4). In Regime 2a, the higher range of applied stress, failure was caused by a combination of fiber and matrix cracking while Regime 2 consisted solely of matrix cracking. Boyum's regimes are shown in Figure 3.

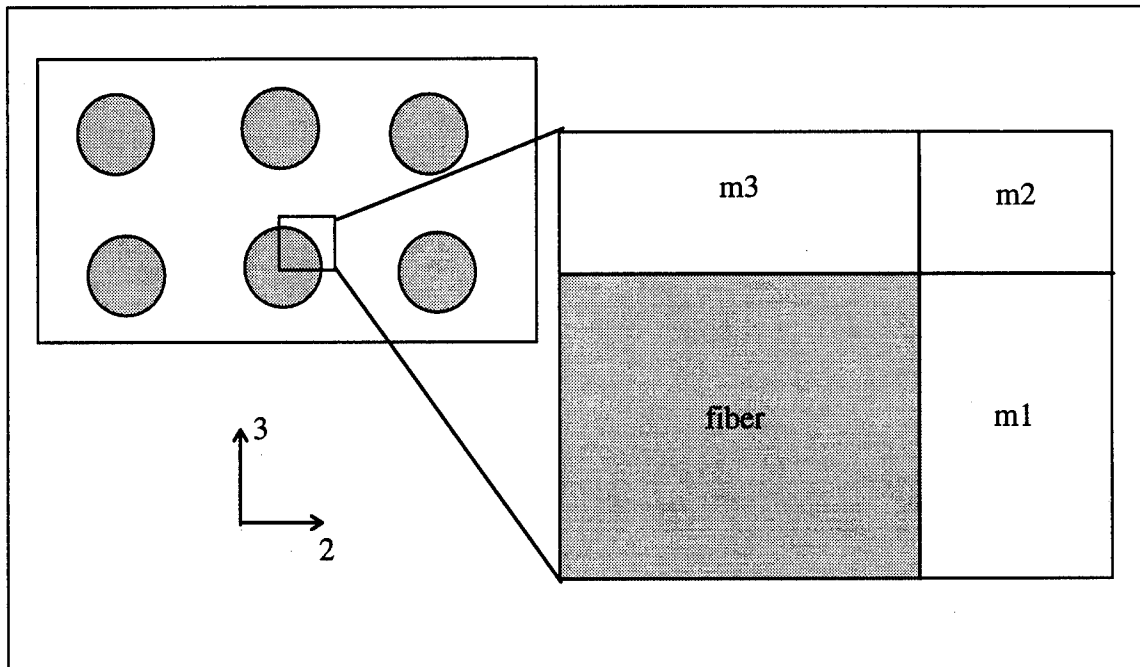
Figure 6. Representative Unit Cell

tenet that classical laminated plate (CLP) theory assumptions on the strain variation apply to the non-linear laminate formulation. It also incorporates a unified viscoplastic theory for the inelastic matrix behavior. This theory is based on combining plastic and viscoplastic strain into a single term. The advantages of this model over others is that it more closely models laminates containing off-axis plies. All calculations are made using the unit cell as illustrated in Figure 6. This cell models one quarter of the fiber and surrounding matrix, employing symmetry and equivalent boundary conditions.

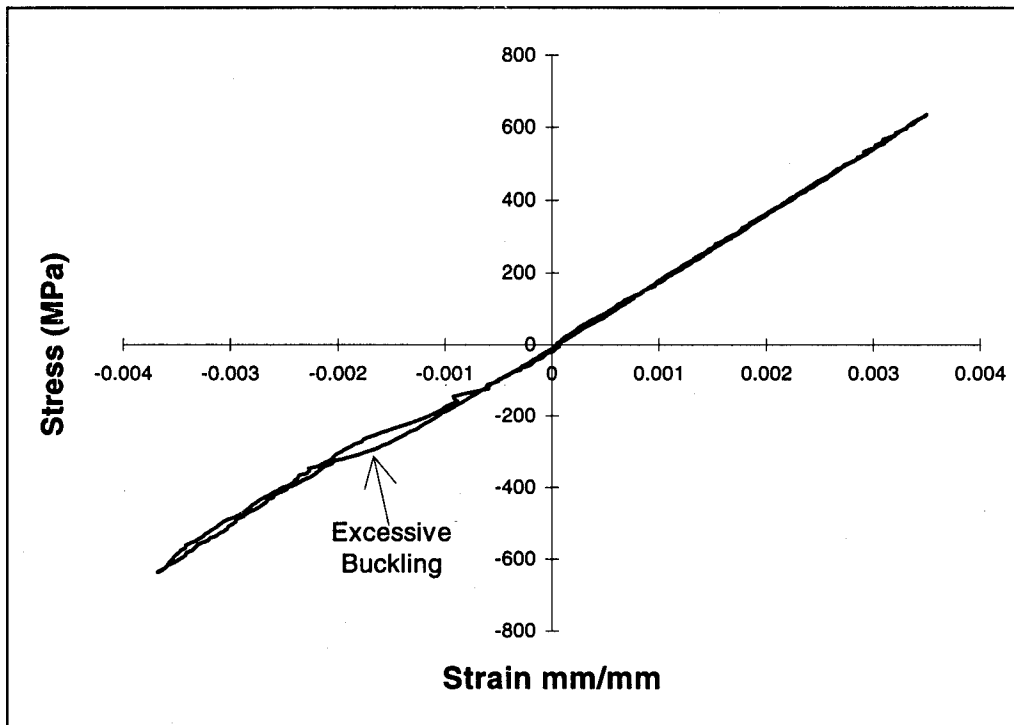
Figure 11. Excessive Buckling

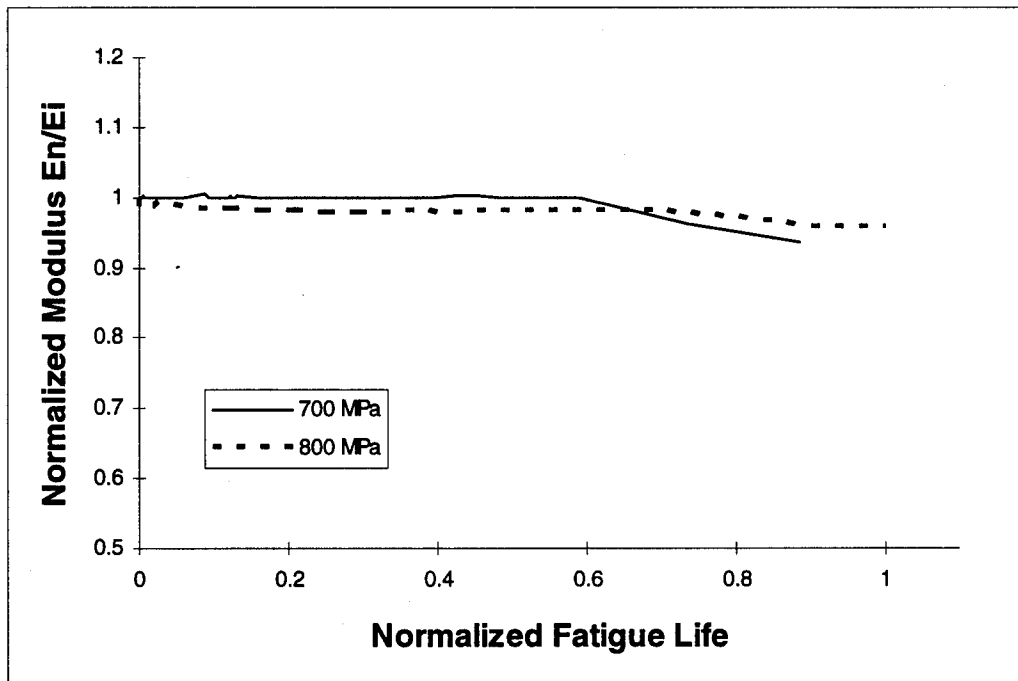
Figure 14. Group 1 Normalized Modulus Trends

Trends in the modulus during cycling are extremely helpful in determining the initiation of damage and the rate of damage progression throughout the fatigue life of the specimen. Generally, any degradation in the modulus indicates damage. Figure 14 shows the trends in the normalized modulus for all tests in Group 1. The normalized modulus is calculated by dividing the current modulus by the initial modulus. Likewise, the normalized fatigue life is calculated by dividing the current cycle by the number of cycles at failure.

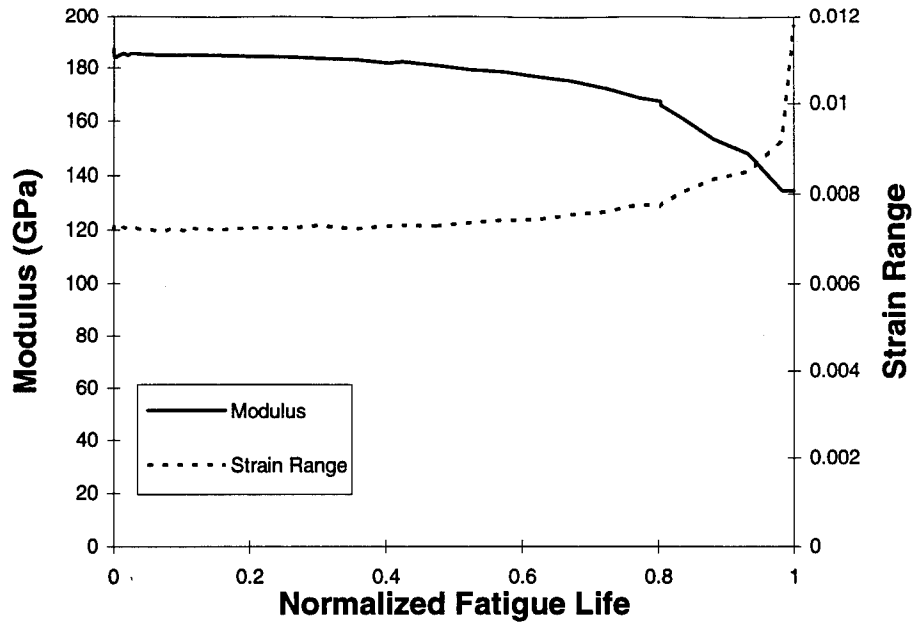
Figure 19. Modulus, Strain Range Data for 625 MPa, T=427 ° C

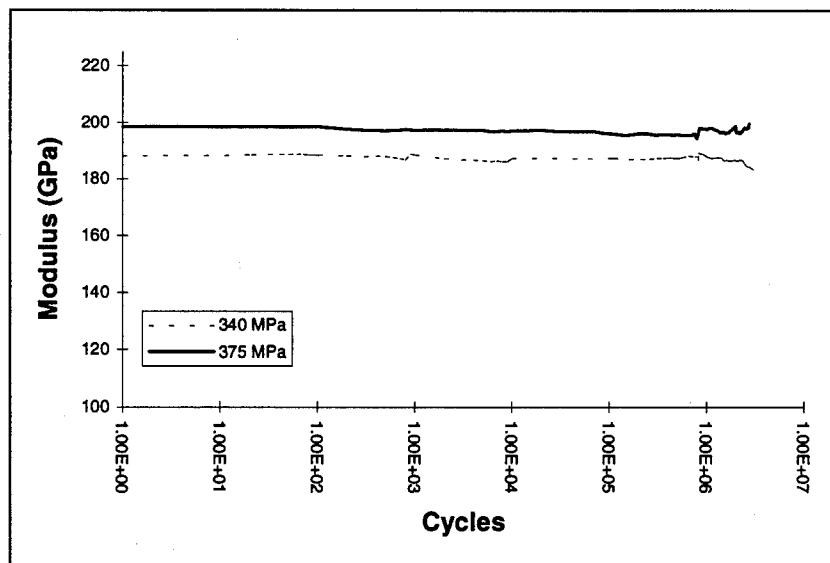
Figure 21. Modulus vs Fatigue Life for Group 3 Tests

Figure 21 shows the modulus trends for specimens in Group 3. The modulus remained constant throughout the test showing no indication of damage. Edge replicas showed some fiber cracking after 100,000 cycles and their number did not increase with subsequent cycles, but as mentioned before, this is not indicative of the rest of the specimen. Edge replicas also showed that some matrix cracking developed from the debonding between the fibers and the matrix where the fibers had already cracked. Also, once matrix cracks were detected in edge replicas, they did not increase in number or size. Analysis of the modulus trends indicates that the existing matrix cracks had no effect on the material stiffness and probably did not progress throughout the laminate.

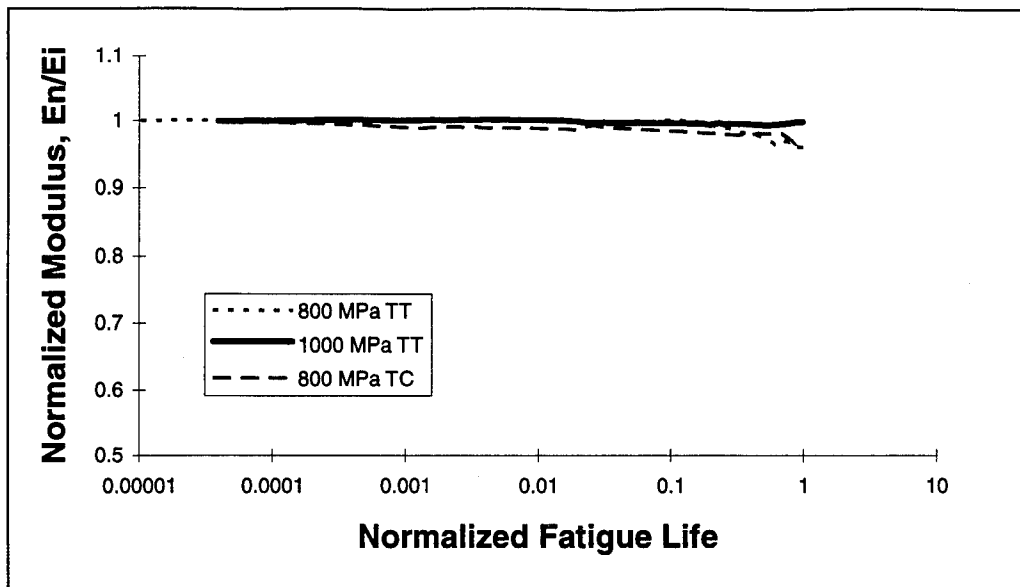
Figure 23. Normalized Modulus vs Fatigue Life

Also shown in Figure 23 is the modulus trend for the fully-reversed specimen cycled at 800 MPa. Modulus degradation under tension-tension fatigue occurred over a small number of cycles, spanning only over the end of the fatigue life, while tension-compression fatigue produced damage much earlier in the fatigue life. Once again, the percentage of fatigue life where damage initiates should not be confused with actual cycle number. Strain trends will show that damage initiated at approximately the same cycle count for both loading conditions but progressed at greatly different rates through the composite.

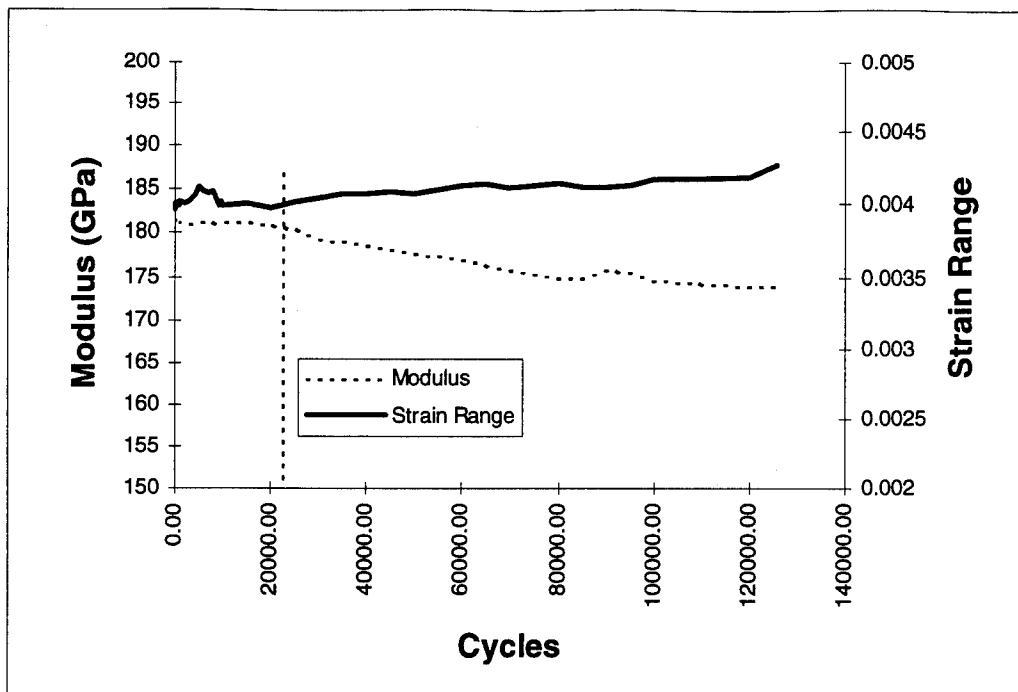
Figure 26. Modulus and Strain Range, 800 MPa, TT HT

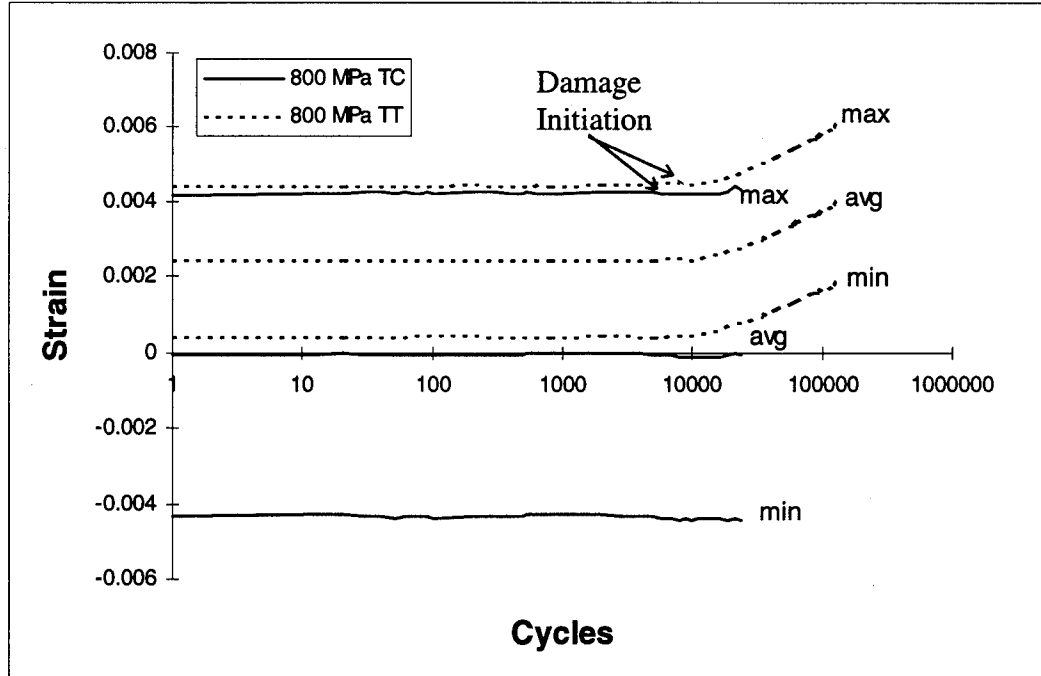
Figure 27. TT vs. TC Strain Trends, 427 ° C

Figure 27 plots the maximum strains for fatigue tests conducted at 800 MPa in both tension-tension and tension-compression loading conditions. Although damage initiated at approximately the same cycle count, the number of cycles to failure is much greater under tension-tension fatigue. Thus, once damage occurred under tension-compression fatigue, it progressed faster through the composite than under tension-tension fatigue.

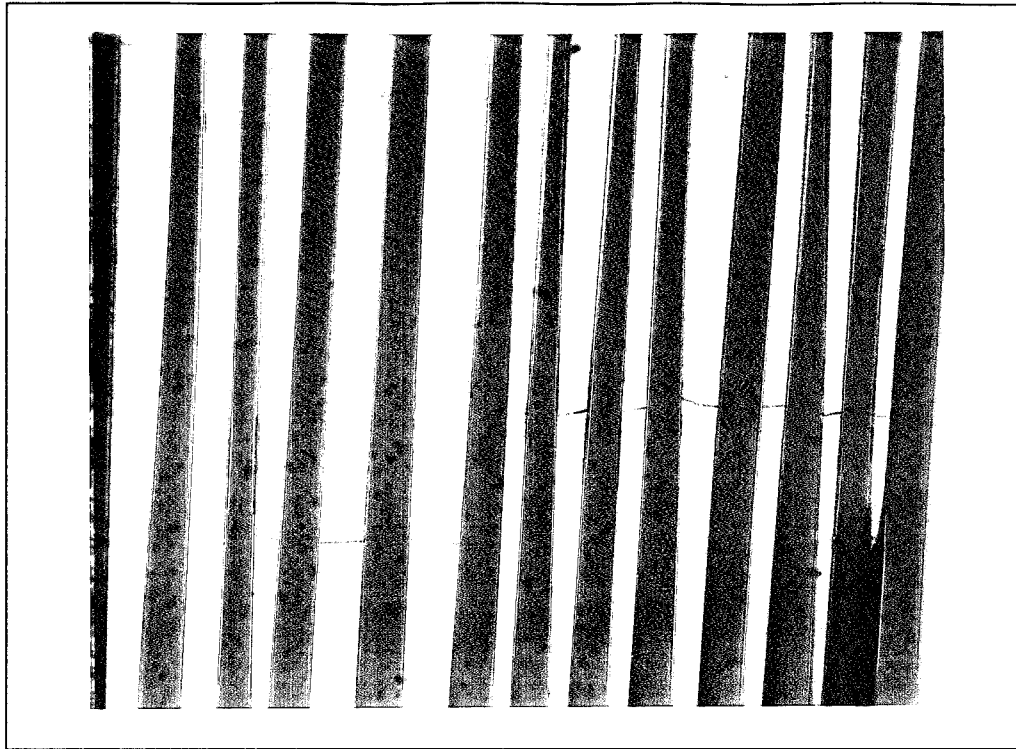
Figure 39. 500 MPa Fiber Bridging, TC HT

The damage observed in Group 2 consists of matrix cracking and extensive fiber bridging. As shown in Figures 38-40, the matrix cracks all grow across many lines of fibers without causing fiber failure. This phenomenon, called fiber bridging, was also noted by Sanders in matrix dominated failure modes (33). As cracks grow, they encounter fibers which are much stronger than the matrix in which the cracks are growing. The fiber-matrix interface is relatively weak and rather than progress through the fibers, the cracks progress around them, often causing fiber-matrix debonding. Also seen in Figure 40 are molyweave. Since the molyweave act like precipitates in an alloy, they are strong crack initiation sites. In this specimen, however, cracks did not originate from the molyweave.

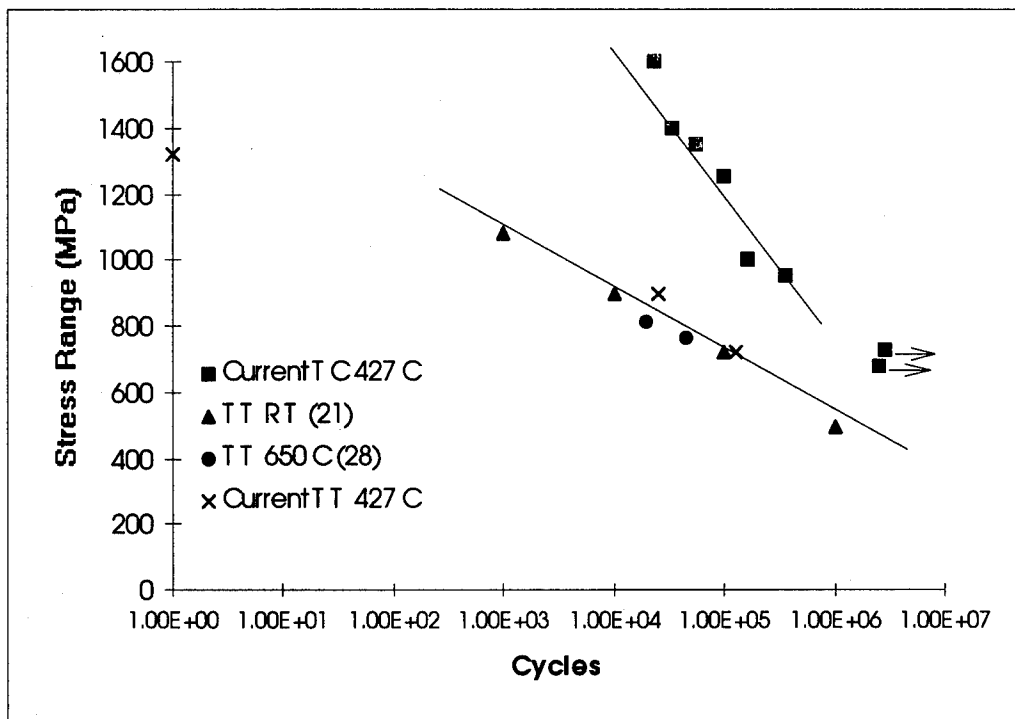
Figure 51. Stress Range Fatigue Life Curve

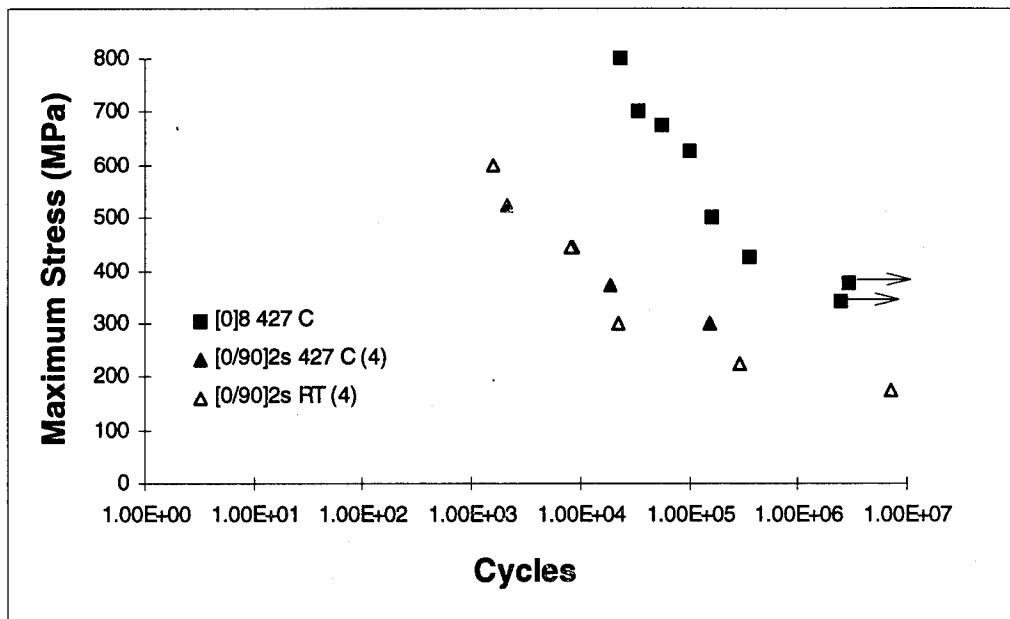
Figure 53. [0]₈ vs. [0/90]_{2s} Fatigue Life Comparison

longer fatigue life. Such behavior has been documented previously for tension-tension fatigue in previous studies (15, 20, 26, 29). In these studies, fatigue life became shorter as the percentage of 0° fibers in the laminate decreased. Thus, the fatigue life trend observed under tension-tension fatigue also occurs under tension-compression fatigue. The following sections describe the methods to collapse all of the data onto a single master curve for design purposes.
