Fatigue Behavior of a Cross-Ply Ceramic Matrix Composite at Elevated Temperature under Tension-Tension Loading

THESIS

Craig D. Steiner
Captain, USAF
AFIT/GAE/ENY/94D

AIR FORCE INSTITUTE OF TECHNOLOGY

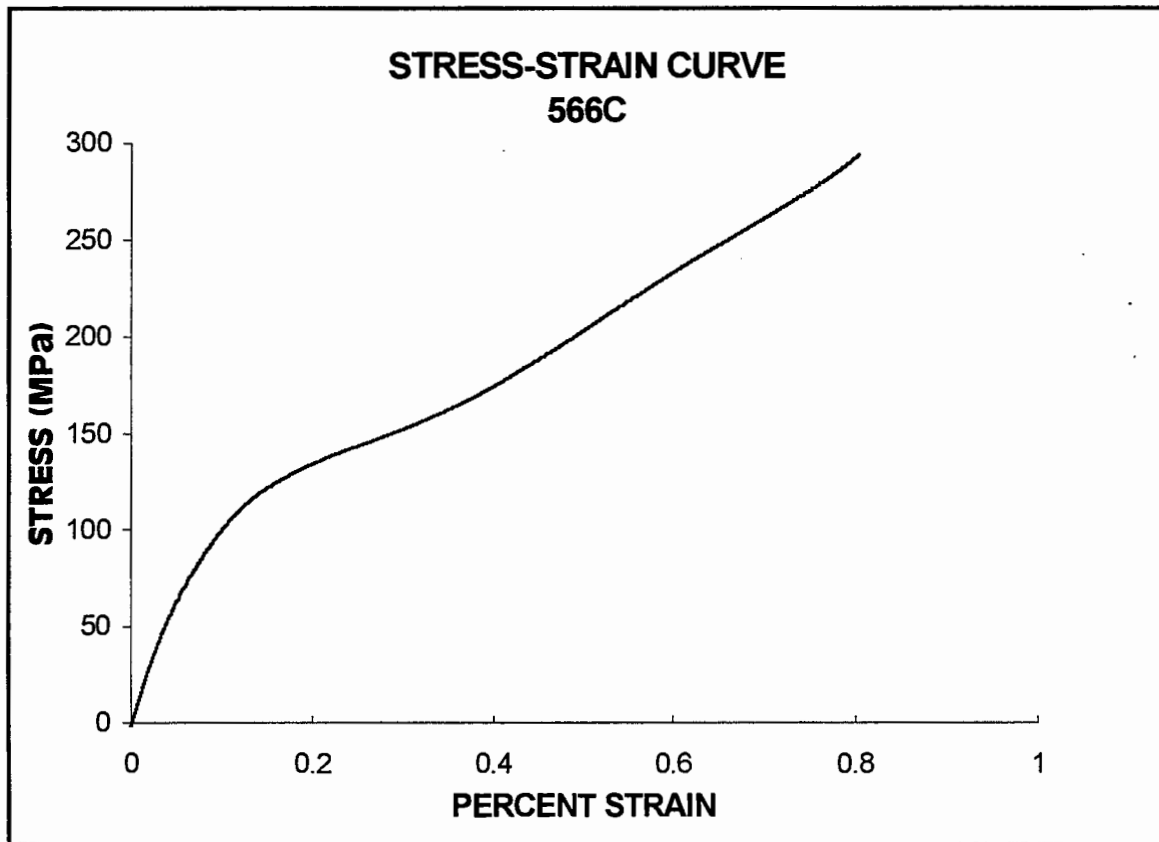
A.1. Monotonic Test 566°C. Figure 1 shows the stress strain response of the monotonic tensile test at 566°C. This figure shows that the material exhibits a knee at 50 MPa at this temperature. This knee is indicative of the proportional limit of the material where permanent damage of the 90° plies occurs. The material then displays a linear response up to a stress of 280 MPa, at which point the stress-strain response is nonlinear up to failure. The ultimate strength of the material at 566°C is 292.41 MPa and the

Figure 1. Stress Strain Curve for 566°C

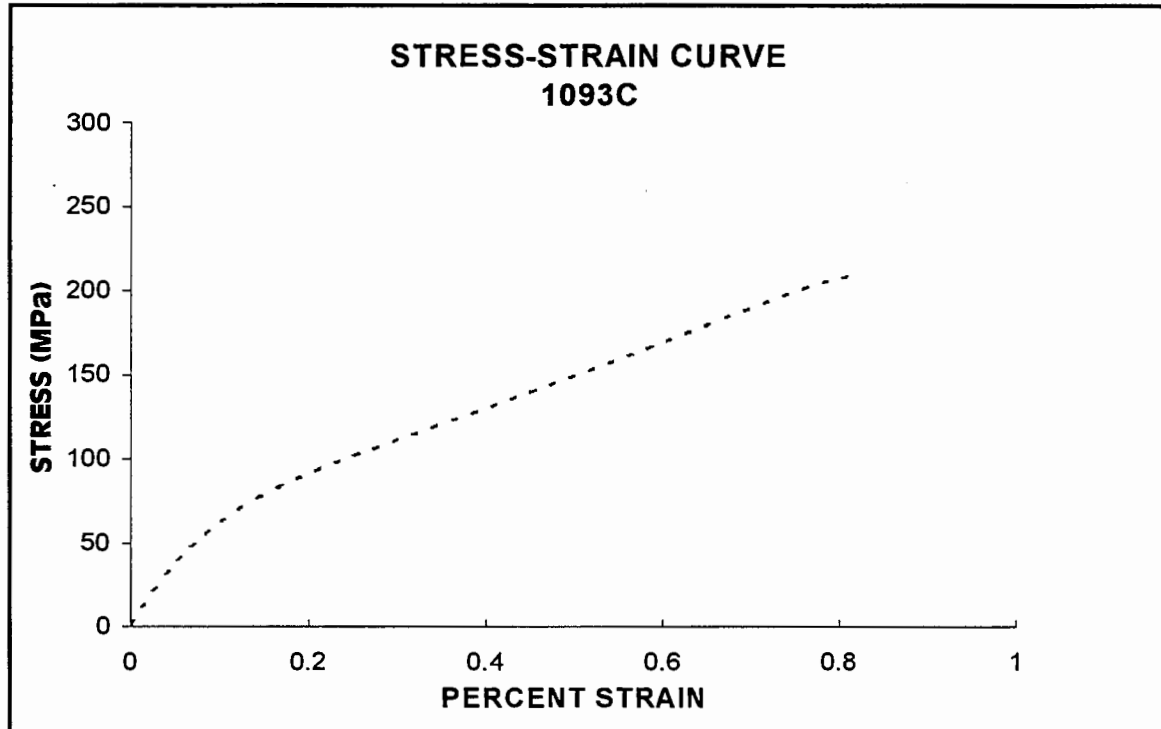
A.2. Monotonic Test 1093°C. Figure 2 shows the stress strain response of the monotonic tensile test at 1093°C. This figure shows that the material exhibits a knee at 30 MPa at this temperature. This is similar to previous work done by Larsen which shows a knee at 34 MPa. [7] The material then displays a linear response up to a stress of 195 MPa, at which time the stress-strain response is nonlinear up to failure. The ultimate

Figure 2. Stress Strain Curve for 1093°C

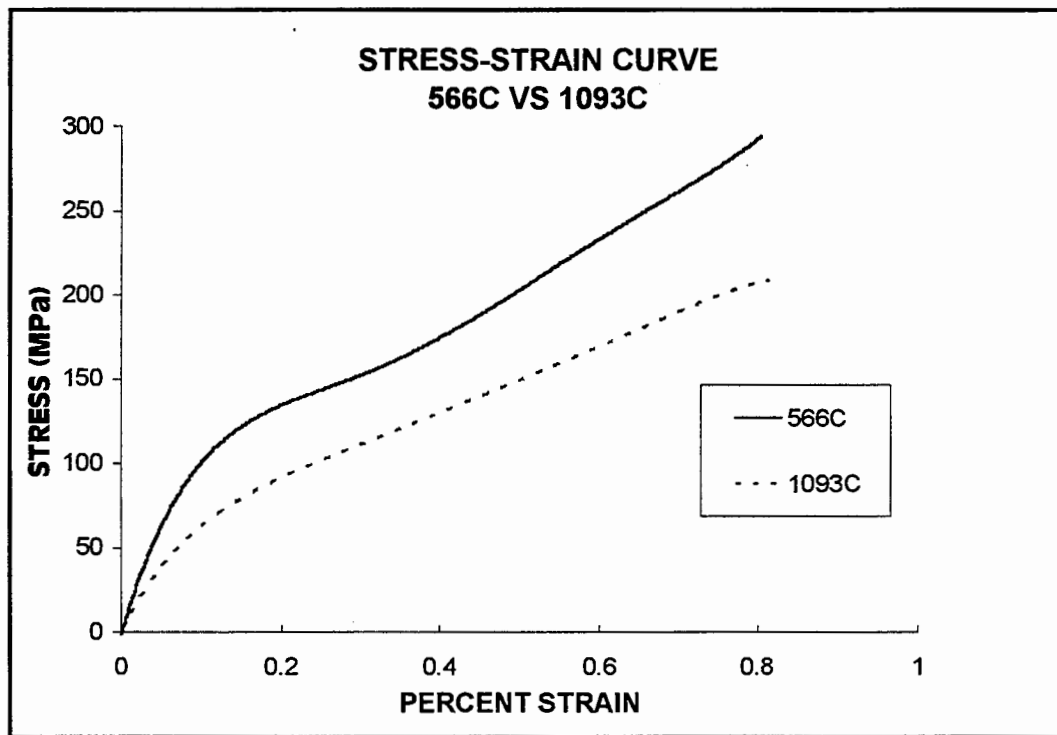
A.3. Monotonic Test Comparison 566°C vs 1093 °C. Figure 3 shows a comparison of the stress-strain curves at two temperatures, 566°C and 1093°C. It can be seen from this figure that the two curves are similar in shape. The material stress-strain response remains linear up to a higher stress level at 566°C than it does at 1093°C. The

Figure 3. Stress Strain Curve Comparison 566°C vs 1093°C

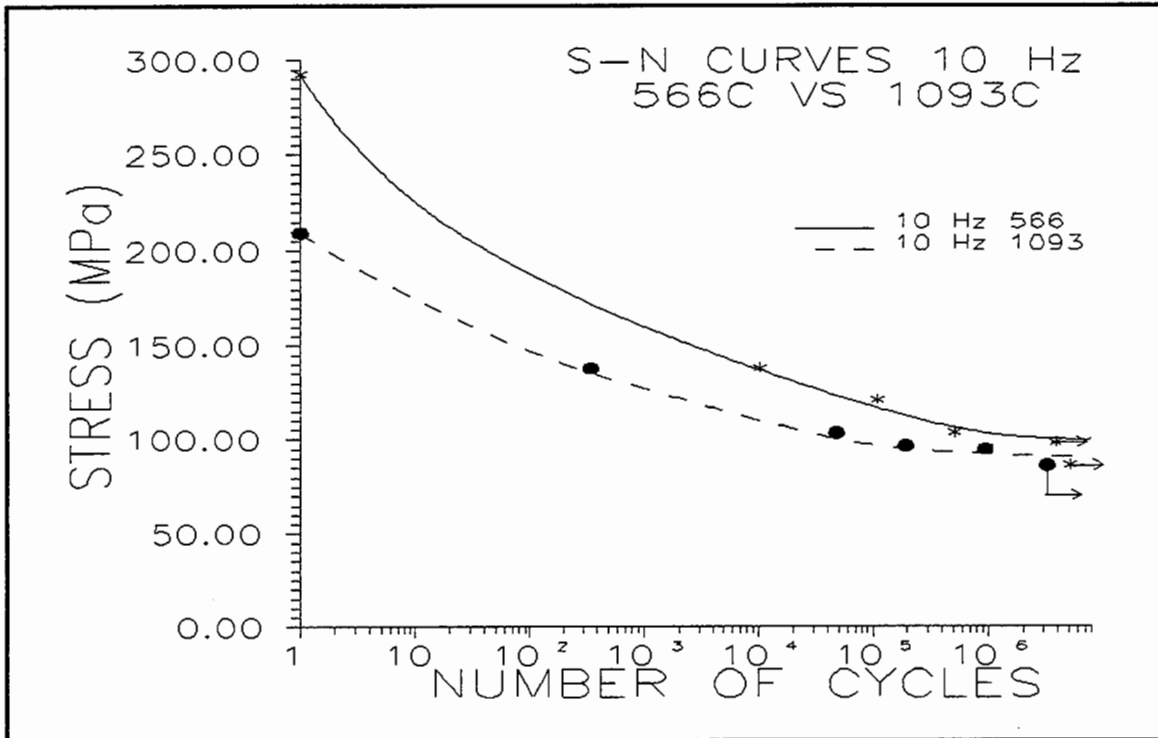
B.1. Fatigue Tests 10 Hz. Figure 4 uses the monotonic tensile and fatigue test data to show fatigue- life curves for the SiC/MAS material at 566°C/1050°F and 1093°C/2000°F for the cycling frequency of 10 Hz. These curves show that the ultimate

Figure 4. Fatigue Life Curves 10 Hz 566°C vs 1093°C

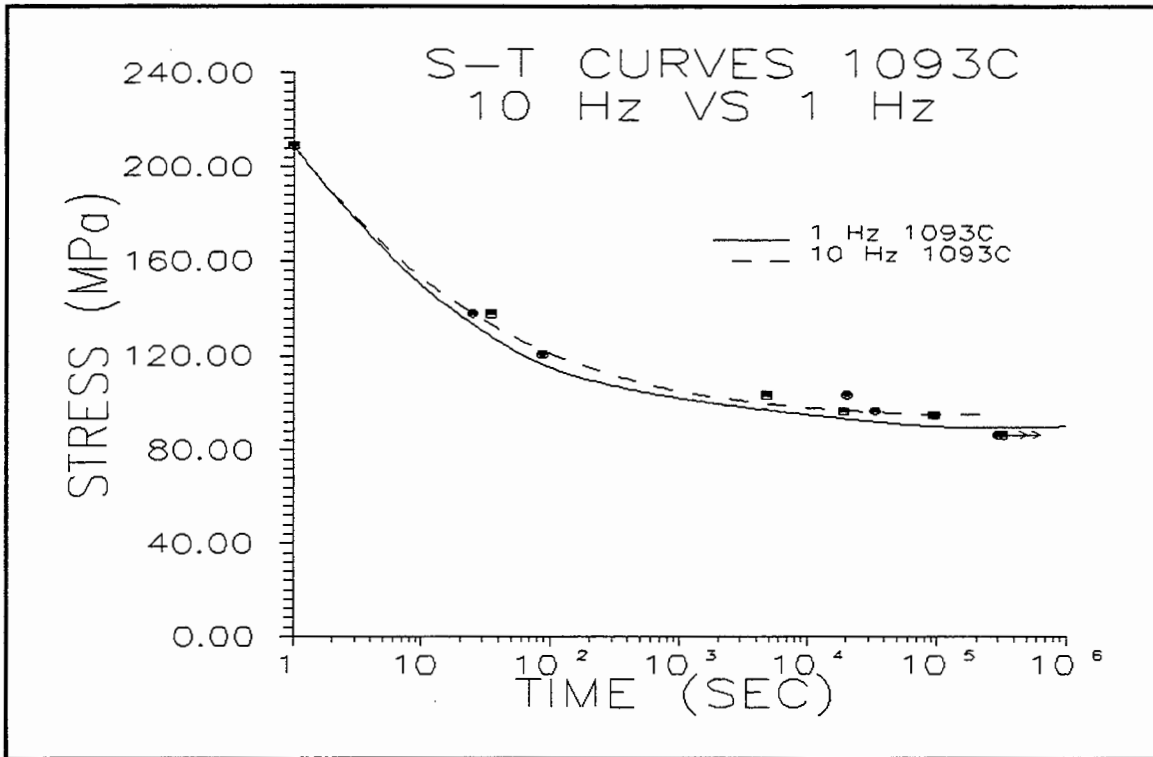
Figure 16. Fatigue Life Curves 1093°C 1 Hz vs 10 Hz

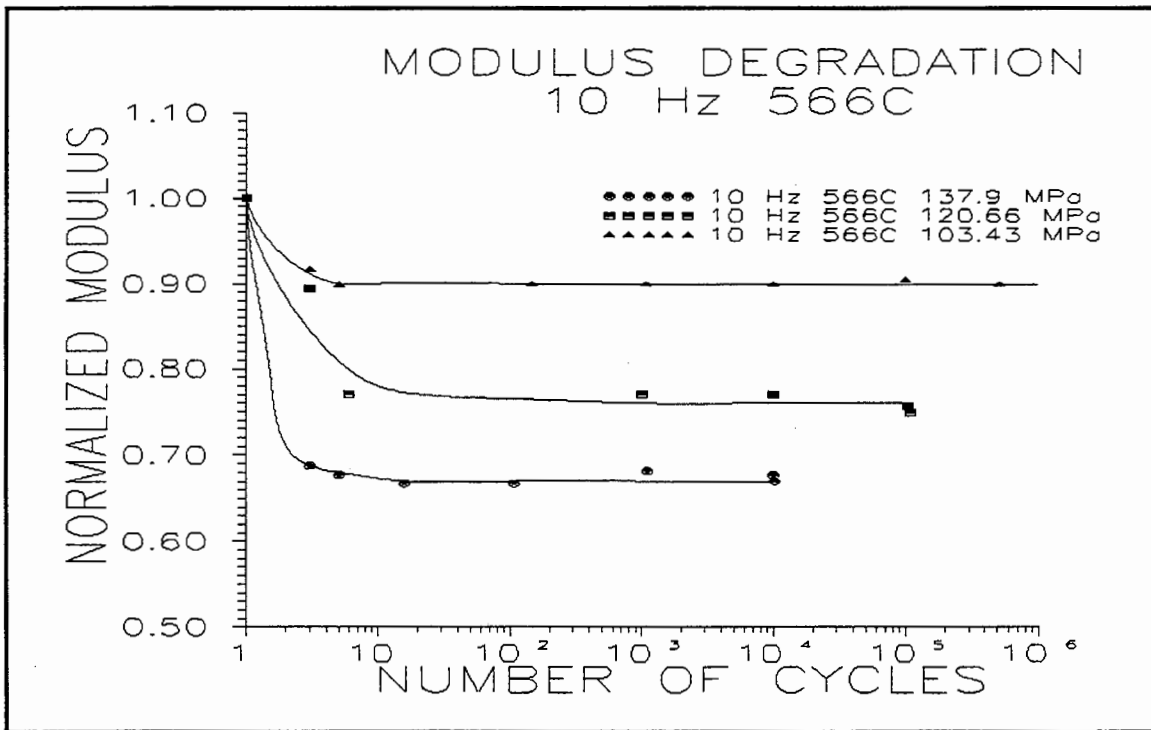
C.1. Modulus Degradation 566°C. Figure 18 shows the modulus degradation of the tests conducted at 566°C/1050°F with a frequency of 10 Hz. This figure shows that,

Figure 18. Modulus Degradation 566°C 10 Hz

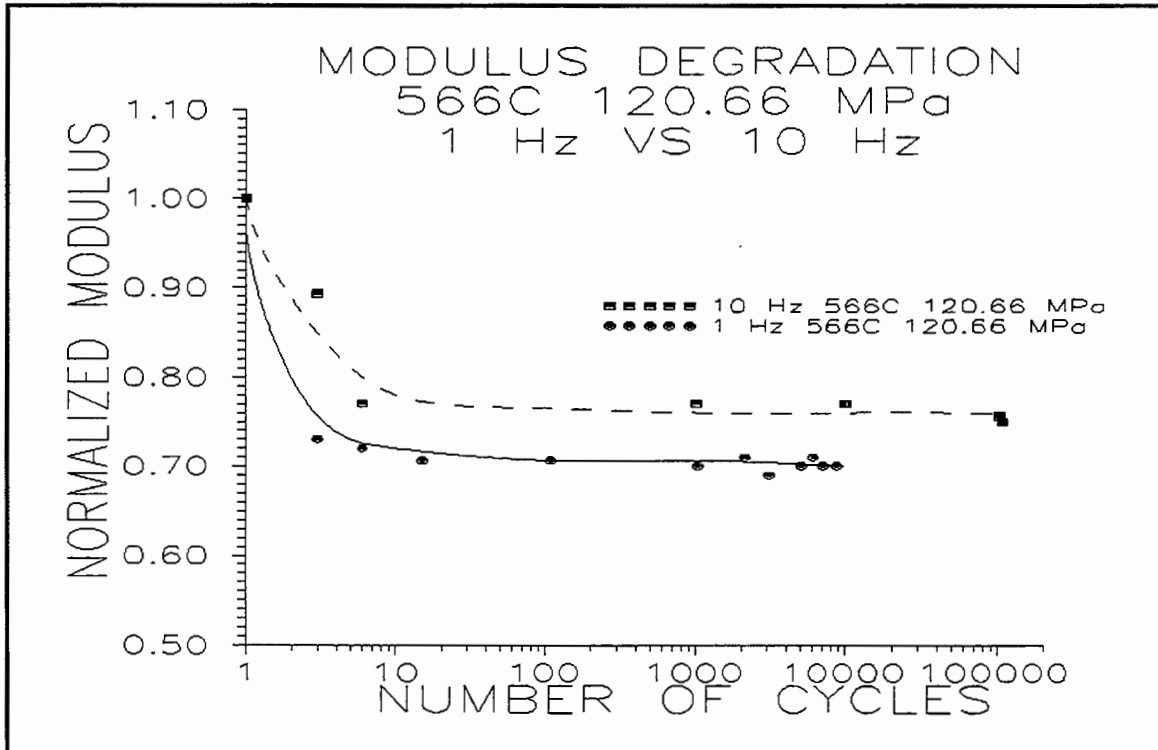
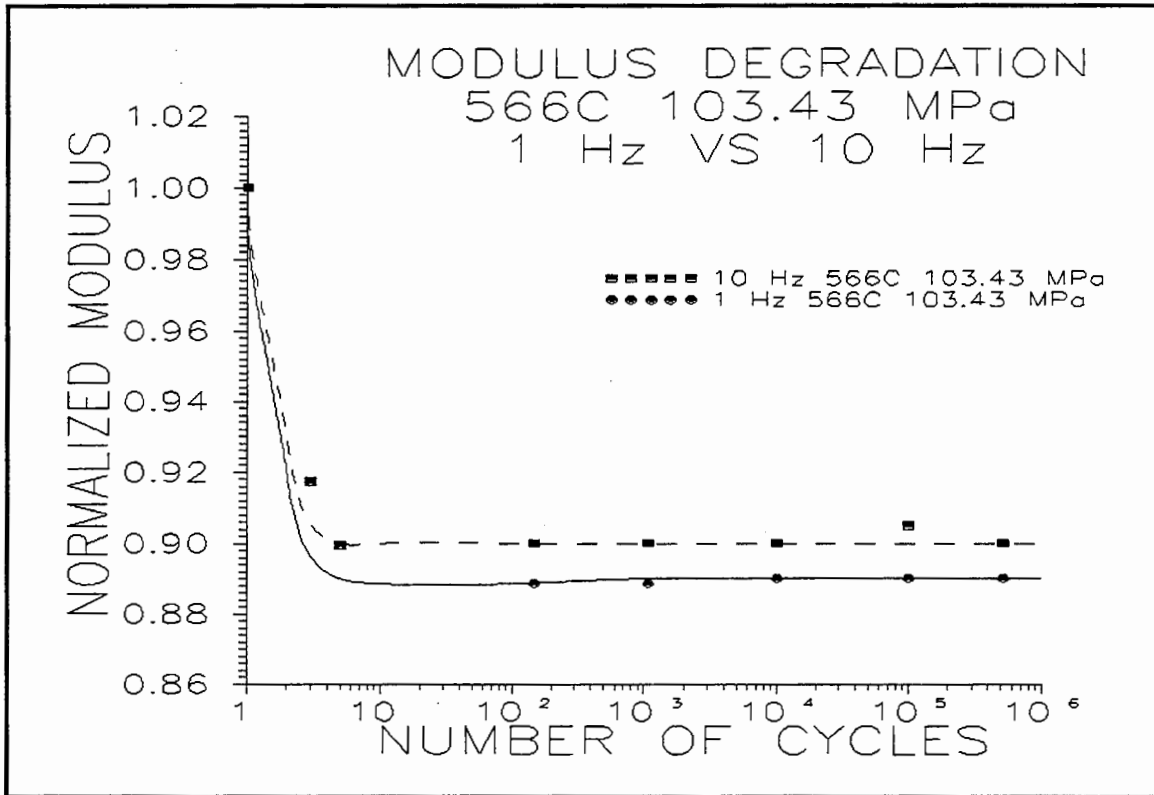
Figures 20, 21, and 22 show that, for maximum stress levels of 137.9 MPa, 120.66 MPa, and 103.43 MPa at a temperature of 566°C/1050°F, specimens tested at a 1 Hz frequency exhibit about 5 percent more degradation in modulus than the those that were tested at the 10 Hz frequency. This indicates that, at this temperature, the rate at which the specimen was cycled will have a small effect on the amount of modulus degradation. This can be attributed to the greater amount of time spent at the highest load levels during the first ten cycles for the specimens tested at 1 Hz than for those tested at 10 Hz. This additional time corresponds to more environmentally assisted crack growth due to more exposure to the environment.

Figure 20. Modulus Degradation 566°C 137.9 MPa

Figure 21. Modulus Degradation 566°C 120.66 MPa

Figure 22. Modulus Degradation 566°C 103.43 MPa

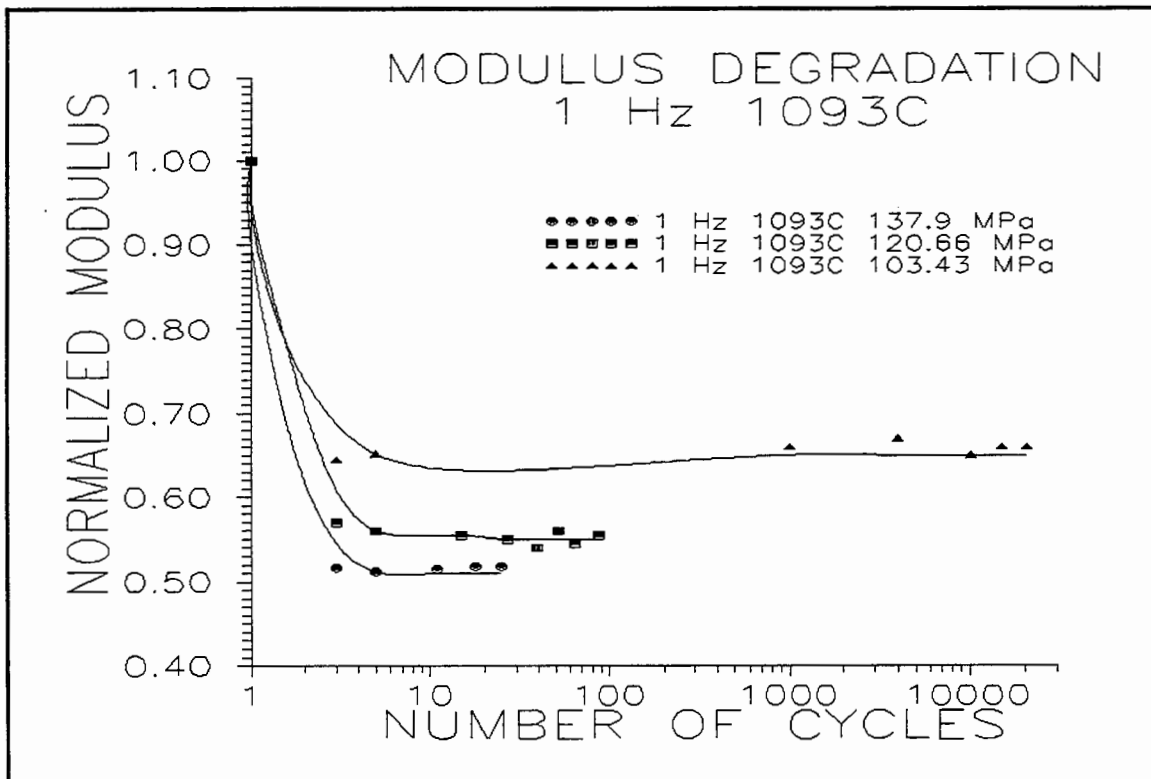
Figure 24. Modulus Degradation 1093°C 1 Hz

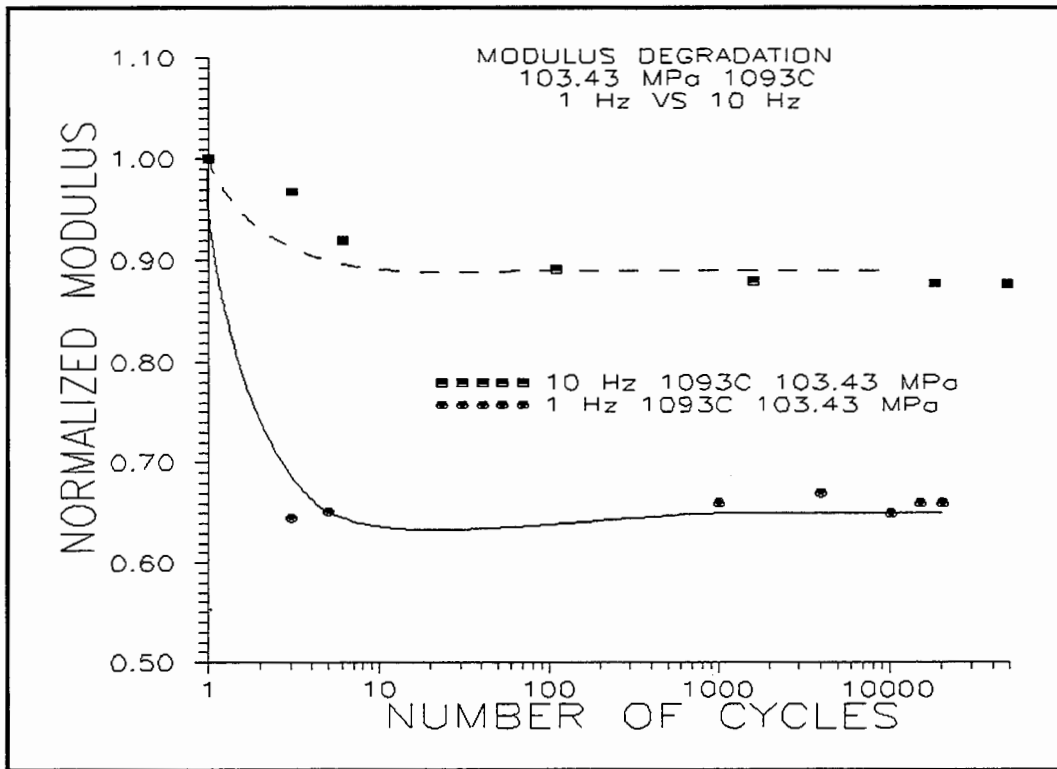
Figure 26. Modulus Degradation 1093°C 103.43 MPa 10 Hz vs 1 Hz

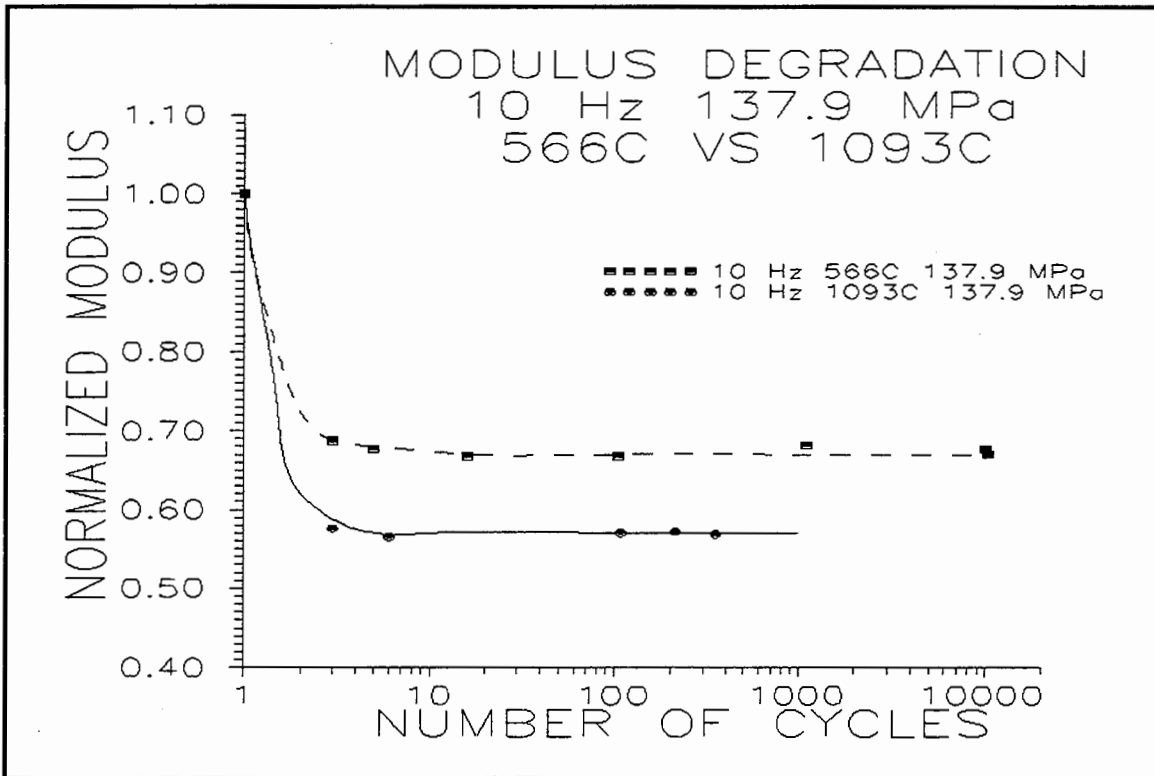
In Figure 27 it can be seen that for the tests conducted at a frequency of 10 Hz and with a maximum stress of 137.9 MPa, the modulus reduction at a temperature of 1093°C is greater than the reduction at 566°C. In Figure 28 it can be seen that the same trend holds true for the tests conducted with a maximum stress level of 103.43 Mpa.

Figure 27. Modulus Degradation 10 Hz 137.9 MPa 1093°C vs 566°C

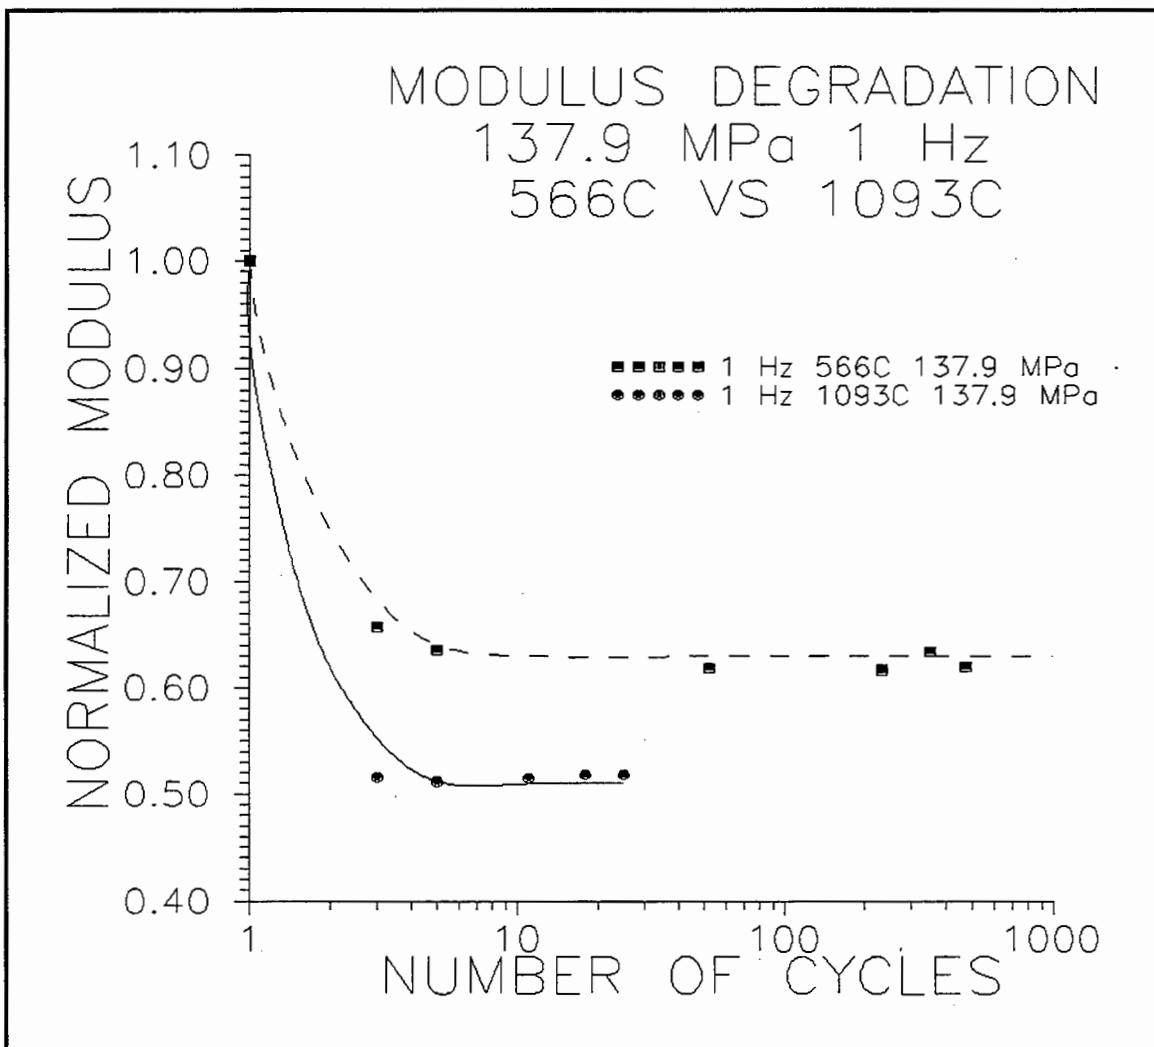
C.4. Modulus Degradation 1 Hz. It can also be shown that the same trends seen at 10 Hz are seen at 1 Hz. In Figure 29 it can be seen that, for the specimens tested at a frequency of 1 Hz and a maximum stress level of 137.9 MPa, the modulus reduction at a temperature of 1093°C is greater than the reduction at 566°C. In Figure 30 it can be seen that the same trend holds true for the tests conducted with a maximum stress level of 103.43 MPa.

Figure 29. Modulus Degradation 1 Hz 137.9 MPa 1093°C vs 566°C

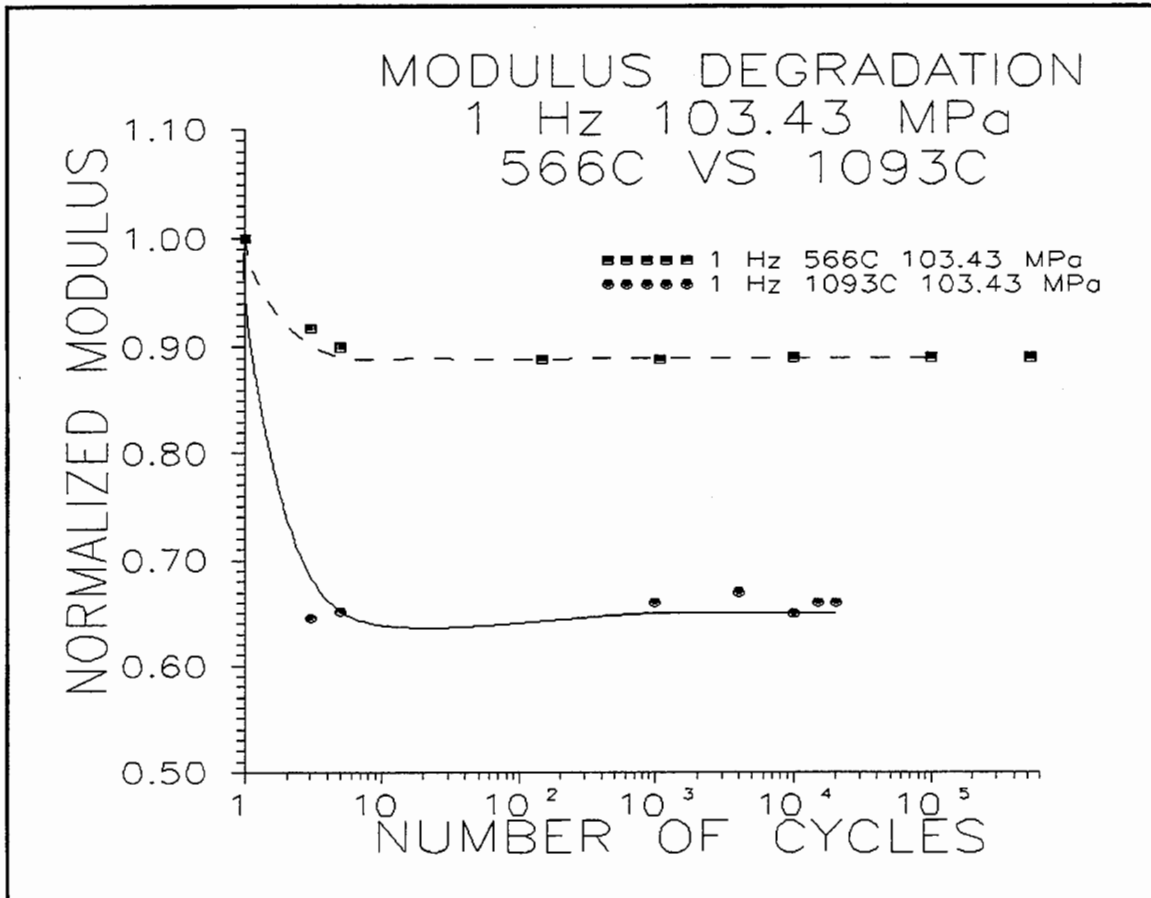
Figure 30. Modulus Degradation 1 Hz 103.43 MPa 1093°C vs 566°C

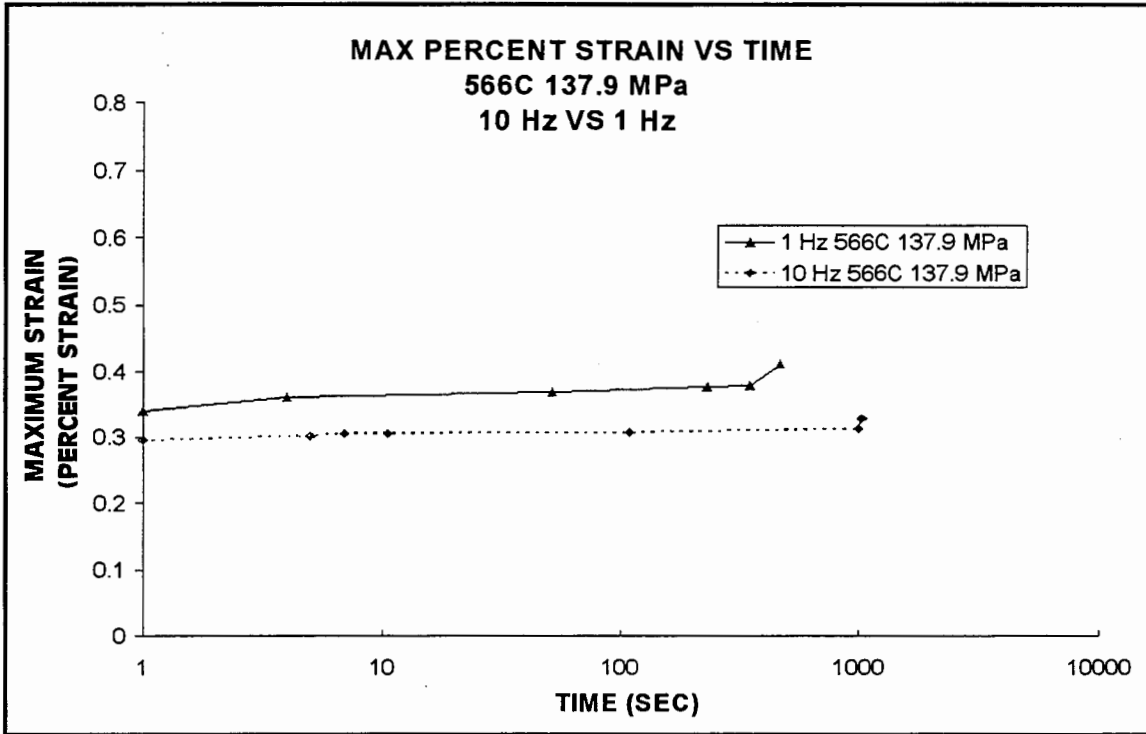
D.3. Strain Data 10 Hz vs 1 Hz at 566°C. Figures 37 through 41 compare the cycle and time history of the maximum strain and the strain difference for tests conducted at frequencies of 1 Hz and 10 Hz at a temperature of 566°C. Figure 37 compares the maximum strains for the tests conducted at 137.9 MPa. It can be seen that the test conducted at 1 Hz has a greater maximum strain from the initial cycle of the fatigue loading until failure. The lower frequency test allows for more environmentally assisted crack growth to occur because it causes the specimen to be at the highest stress level for the greatest amount of time. It can also be seen that the test conducted at 1 Hz exhibits a notably higher rate of increase of maximum strain than the test conducted at 10 Hz. In Figure 38 it can be seen that the difference between the maximum and minimum strain for each of the tests is constant but that the difference is greater for the 1 Hz test than for the

Figure 37. Maximum Strain 566°C 137.9 MPa 10 Hz vs 1 Hz

Figure 38. Strain Difference 566°C 137.9 MPa 10 Hz vs 1 Hz

10 Hz test. This would again indicate that the main phenomenon in both tests is creep-like, time dependent, environmentally assisted crack growth but that the amount of creep is greater at the lower frequency. The same trends are exhibited in Figures 40 and 41 for a maximum stress of 103.43 MPa. In addition, when the maximum strain is plotted against the time to failure, it can be seen that the frequency of the loading is not a factor in the life of the specimen. This is demonstrated in Figure 39 for the tests conducted at 566°C and a maximum stress of 137.9 Mpa.

Figure 39. Maximum Strain vs Time 566°C 137.9 MPa 10 Hz vs 1 Hz

Figure 41. Strain Difference 566°C 103.43 MPa 10 Hz vs 1 Hz

It has also been seen that the tests conducted at a lower frequency induced a higher strain. This can be seen in Figures 37 through 41 and Figures 48 through 51. This can be attributed to the greater amount of time spent at the highest stress levels for the specimens tested at the lower frequencies. An illustration of this can be seen in Figure 53.

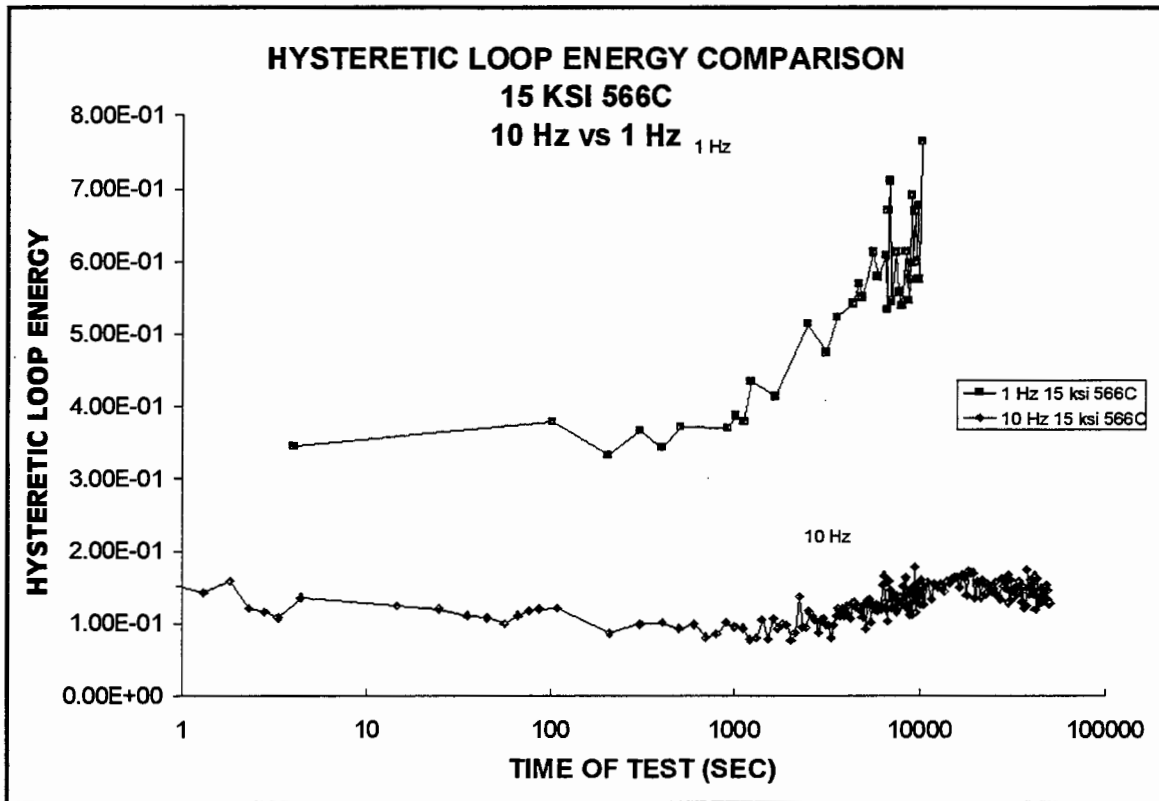
illustrated in Figure 66, which compares the two tests run at 566°C/1050°F and a maximum stress of 103.43 MPa. The similarity of the curves in these two charts support the idea that the fatigue behavior is the same for 1 Hz and 10 Hz.

Figure 66. Hysteretic Energy 566°C 103.43 MPa 1 Hz vs 10 Hz

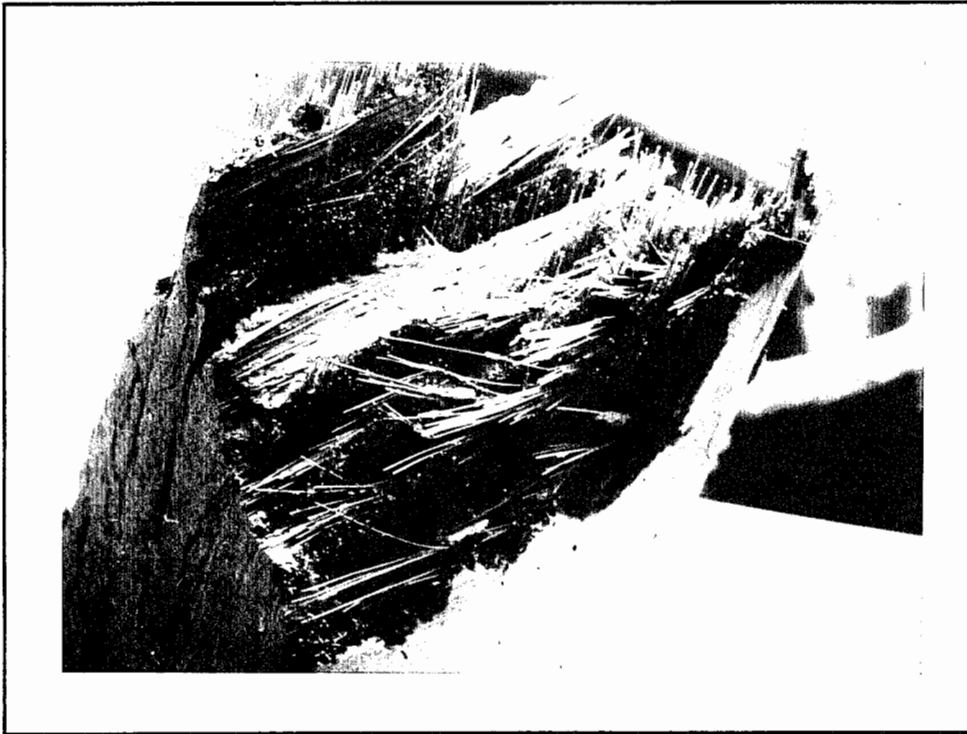
Figure 74. Fracture Surface, Monotonic Tensile, 566°C, 15.2X

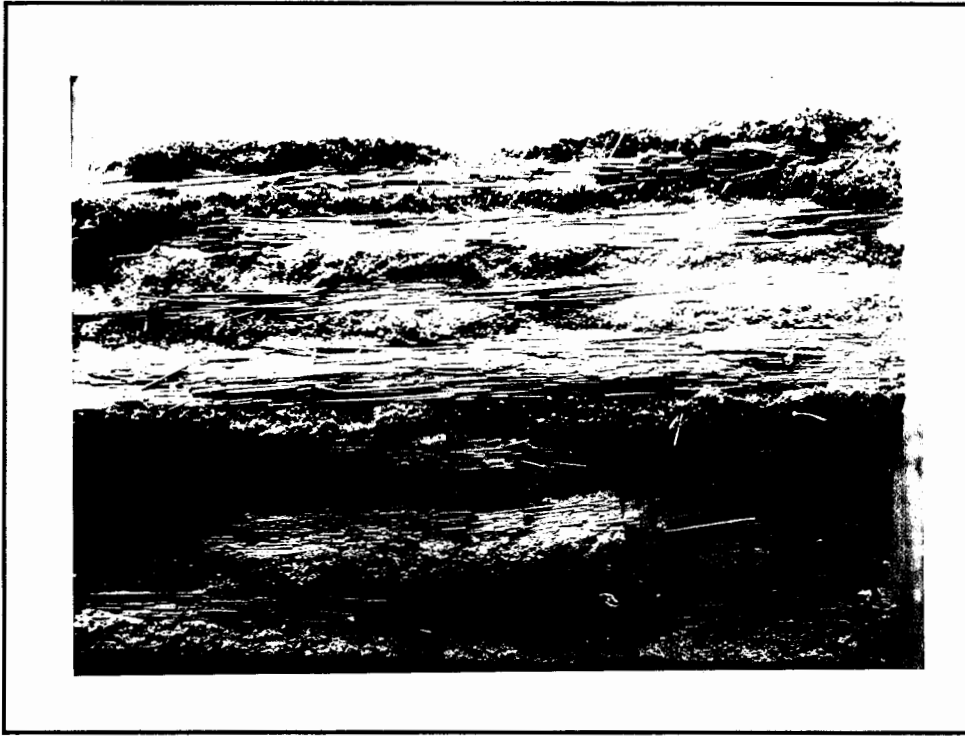
Figure 78. Fracture Surface, 10 Hz, 566°C, 103.43 MPa, 26.2X

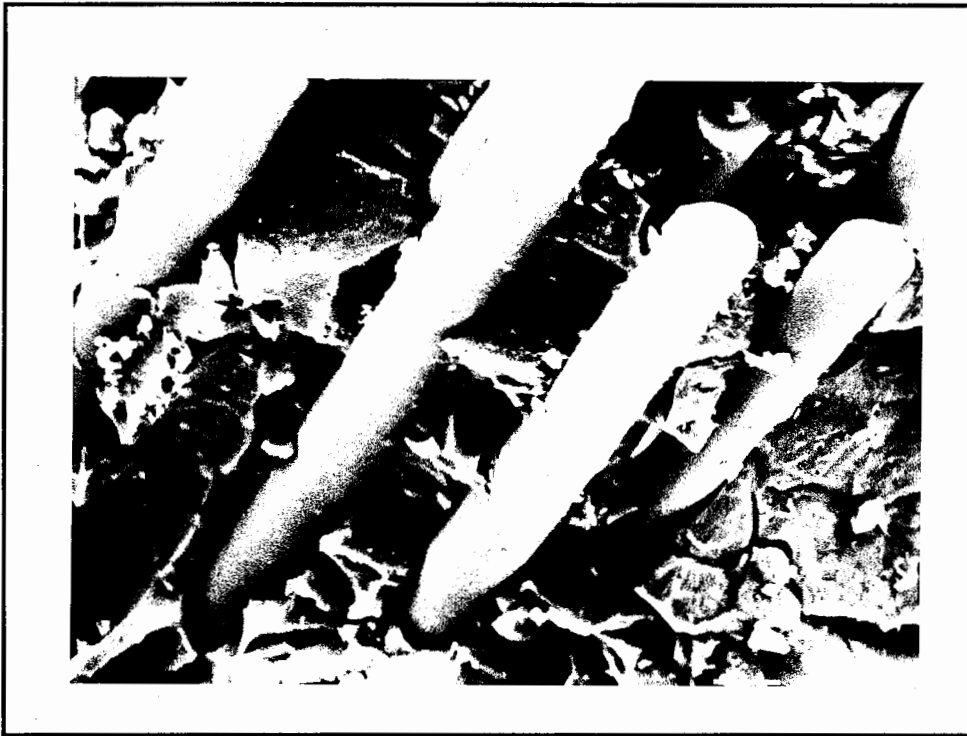
Figure 79. Fiber Surface, 10 Hz, 566°C, 137.9 MPa, 685X

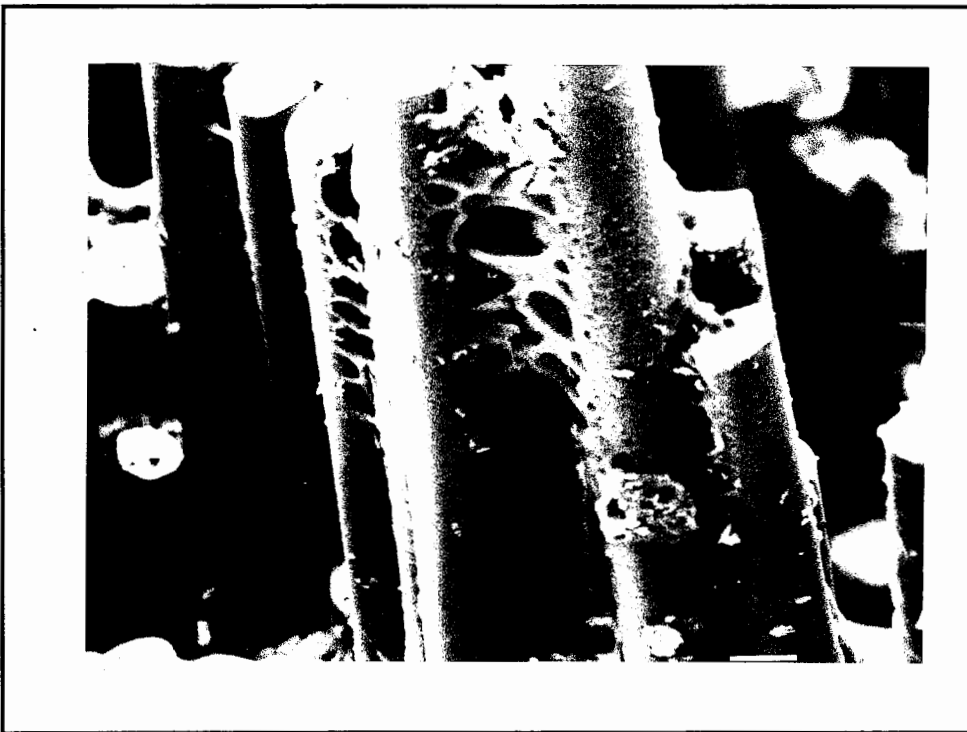
Figure 80. Fiber Surface, 10 Hz, 566°C, 103.43 MPa, 470X

penetrating along the debonded interface, as opposed to the oxidation of the fiber matrix interface which causes a strengthening and embrittlement of the interface allowing for a planar crack growth. A comparison of Figures 79 and 80 shows that the longer times of the tests that result from the lower stress levels will allow more exposure to the atmosphere and more oxidative attack of the debonded fiber-matrix interface.

The difference in the amount of oxidation penetrating along the fiber-matrix interface can be seen by comparing Figure 79, the fiber surface of a test conducted 10 Hz and 566 °C, to Figure 80, the fiber surface of a test conducted at 10 Hz and 566°C. The longer test showed more oxidation of the debonded interface than the shorter test.

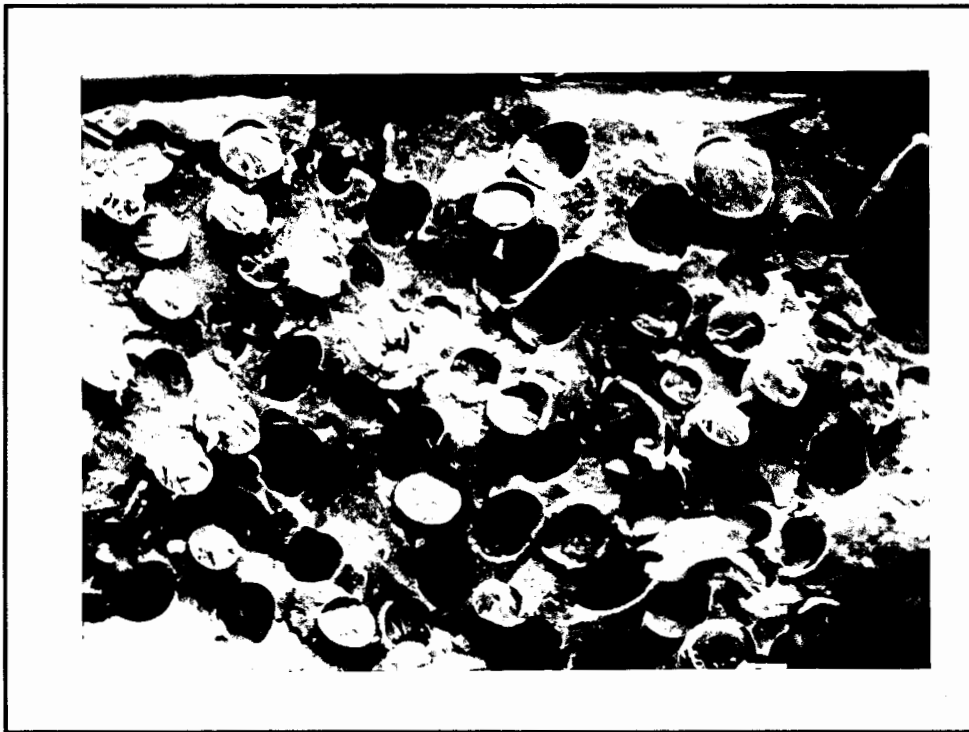
Figure 81 is an SEM microphotograph of a representative area of the fracture surface away from an area of fiber pullout. The fracture surface in this area is generally smooth and flat in appearance, indicating that the specimen failed due to an environmentally assisted crack growth, similar to that observed by Grant [5]. Figure 81 also illustrates the combination of mechanisms occurring in these tests. There is some

Figure 81. Fracture Surface, 10 Hz, 120.66 MPa, 566°C, 560X

evidence of debonding indicated by the few short lengths of fiber pullout on some of the fibers and there is also evidence of the environmentally assisted crack growth through the strengthened interfacial bonds, resulting in a flat planar surface.

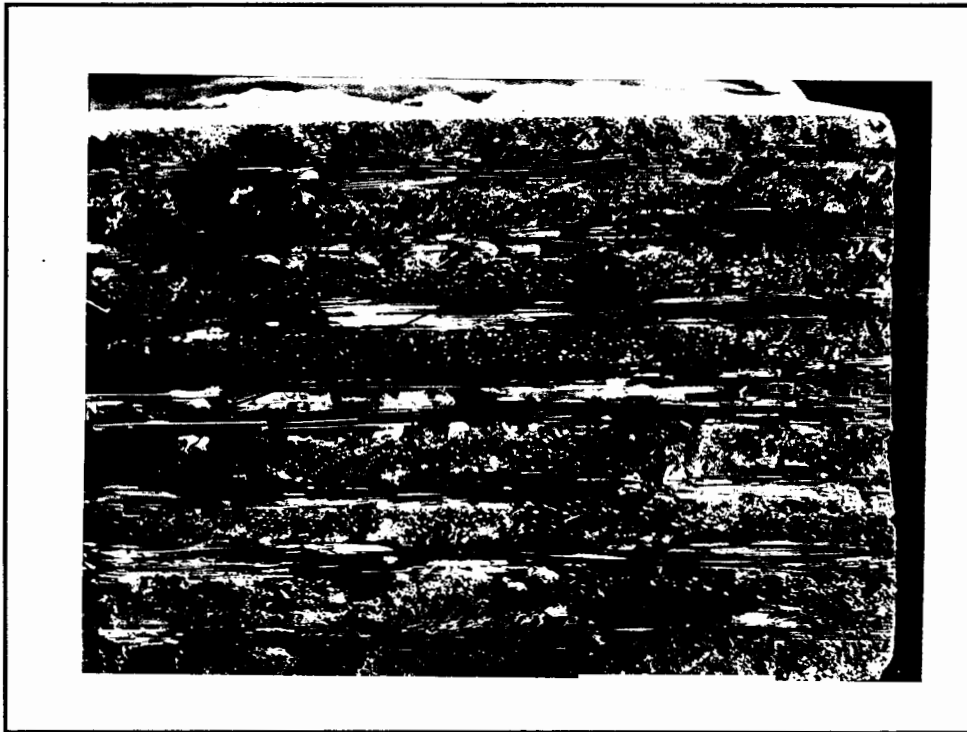
Inspection of the fracture surfaces of the specimens from this series of tests, using scanning electron microscopy, revealed that the surfaces all exhibited short fiber pullout over a portion of the fracture surface. This is the same observation as was made for the tests conducted at a frequency of 10 Hz at this temperature. Figure 84 is an SEM microphotograph of the fracture surface of the specimen tested at 137.9 MPa (high stress) exhibiting short fiber pullout over a portion of the fracture surface. This fiber pullout can be attributed to the effect of the cyclic loading causing a debonding of the fibers from the matrix along the weak fiber-matrix interface.

Figure 84. Fracture Surface, 1 Hz, 566°C, 137.9 MPa, 20.8X

Figure 85 is an SEM microphotograph of the fracture surface of the specimen tested at 103.43 MPa (low stress) which exhibits a smaller area of fiber pullout than the specimen depicted in Figure 84. This is the same trend as was seen in the specimens tested at a frequency of 10 Hz at this temperature. The longer tests showed a smaller area of fiber pullout and a correspondingly larger area of planar, brittle fracture surface. The smaller area of pullout, and correspondingly larger area of planar fracture surface, again indicates that the progression of oxidation of the fiber matrix interface through the cross section of the specimen is a function of the length of time of the test. The longer test will allow the oxidation and strengthening of the fiber-matrix interface to progress over a larger area of the specimen cross section. This is the same effect as was seen in the tests by Grant [5] and Larsen [7].

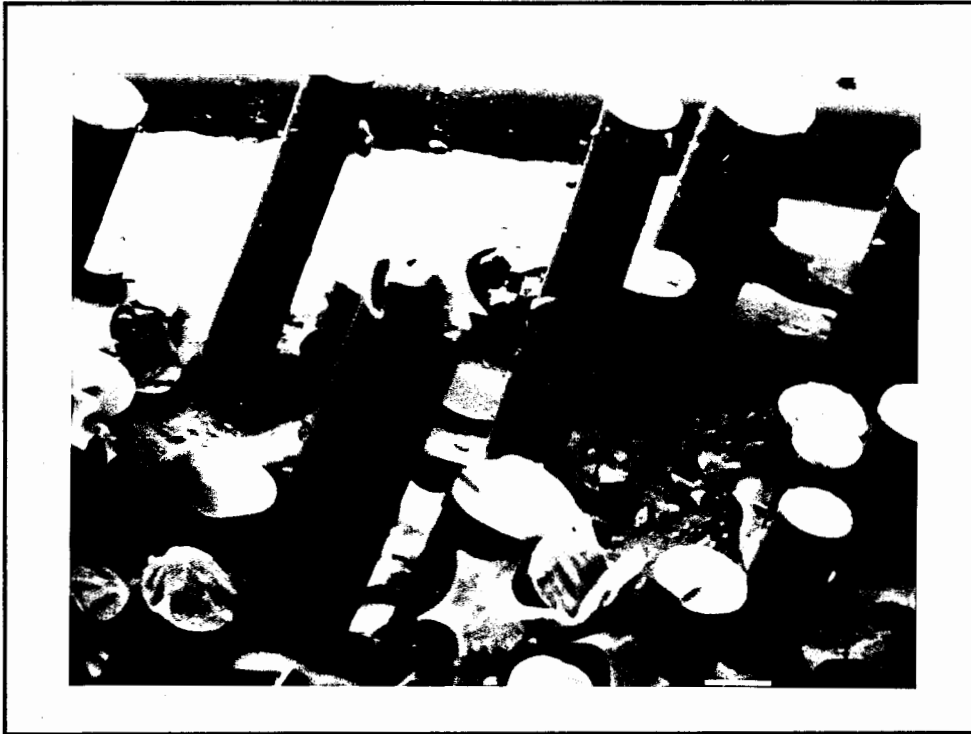
Figure 87. Fiber Surface, 1 Hz, 566°C, 120.66 MPa, 525X

debonded interface, as would be expected for a test of longer duration. A comparison of Figures 86 and 87 shows that the longer times of the tests that result from the lower stress levels will allow more exposure to the atmosphere and more penetration of the oxidative attack of the debonded fiber-matrix interface.

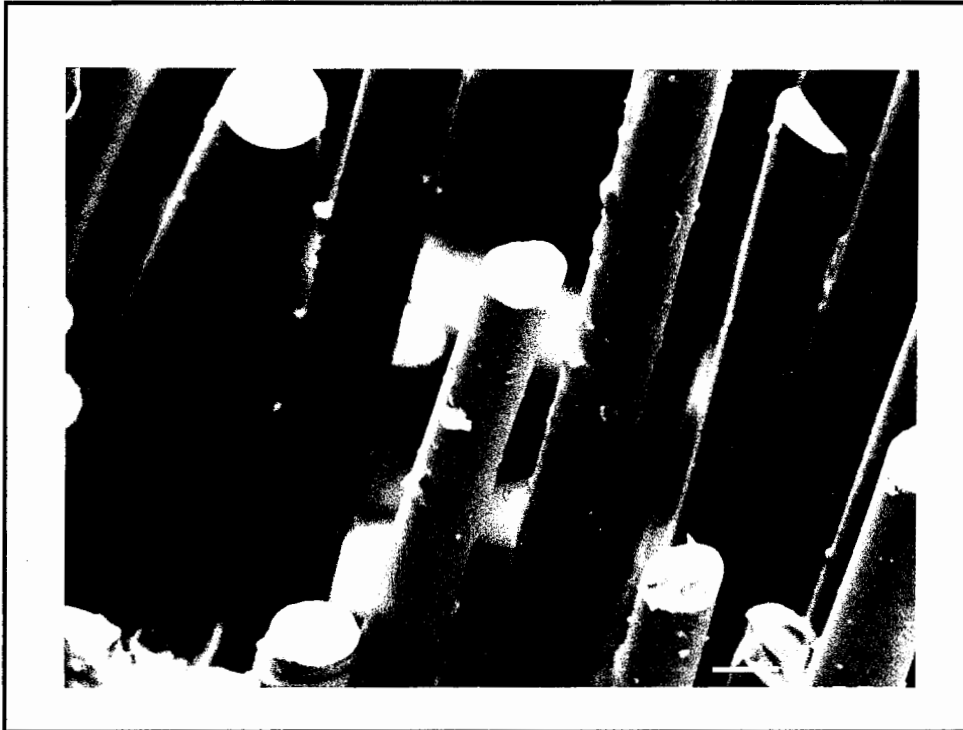
Figure 94 is an SEM microphotograph of some of the fibers that had debonded during the test conducted at 96.53 MPa (low stress) at a frequency of 10 Hz and a temperature of 1093 °C. These fibers show evidence of a lot of fiber damage along the debonded interface due to oxidation, as would be expected for a test of long duration and high temperature. A comparison of Figures 93 and 94 shows that the longer times of the tests that result from the lower stress levels will allow more exposure to the atmosphere

and more oxidative attack of the debonded fiber-matrix interface. This is consistent with the observations made for both the series of tests conducted at 566°C.

Figure 94. Fiber Surface, 10 Hz, 1093°C, 96.53 MPa, 855X
