Fatigue Behavior of a Cross-Ply Ceramic Matrix Composite at Elevated Temperature under Tension-Tension Loading

THESIS

Craig D. Steiner
Captain, USAF
AFIT/GAE/ENY/94D

AIR FORCE INSTITUTE OF TECHNOLOGY

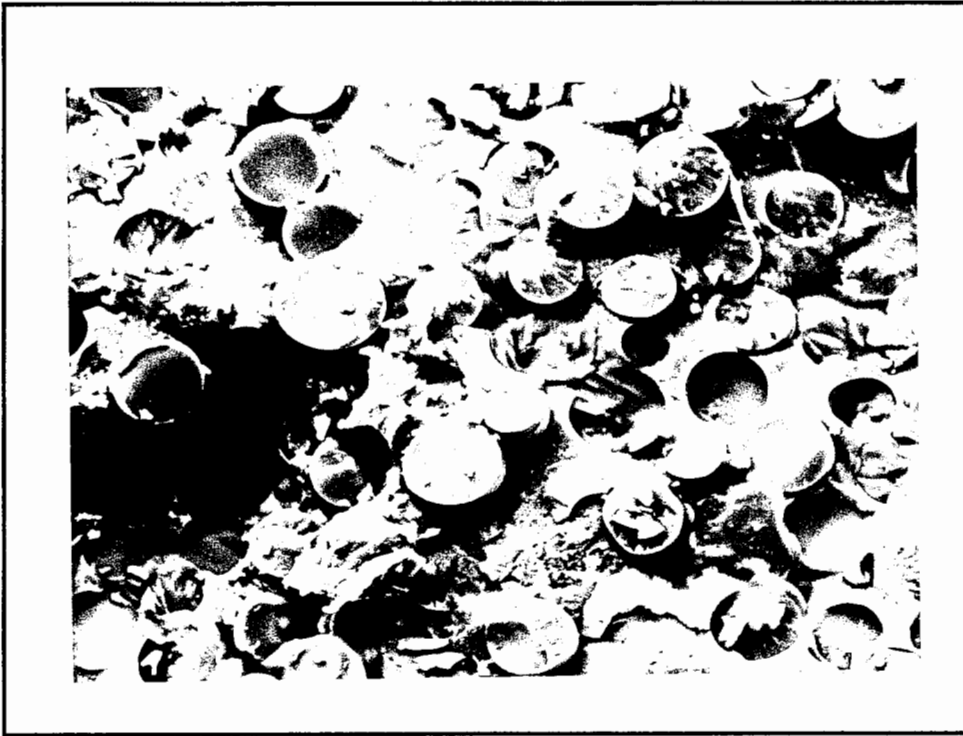
Figure 95 is an SEM microphotograph of a representative area of the fracture surface away from an area of fiber pullout. The fracture surface in this area is generally smooth and flat in appearance, indicating that the specimen failed due to an environmentally assisted crack growth, similar to that observed by Grant [5]. Figure 95 also illustrates the combination of mechanisms occurring in these tests. There is some evidence of debonding indicated by the few short lengths of fiber pullout and there is also evidence of the environmentally assisted crack growth through the strengthened interfacial bonds, resulting in a flat planar surface.

Figure 95. Fracture Surface, 10 Hz, 1093°C, 720X

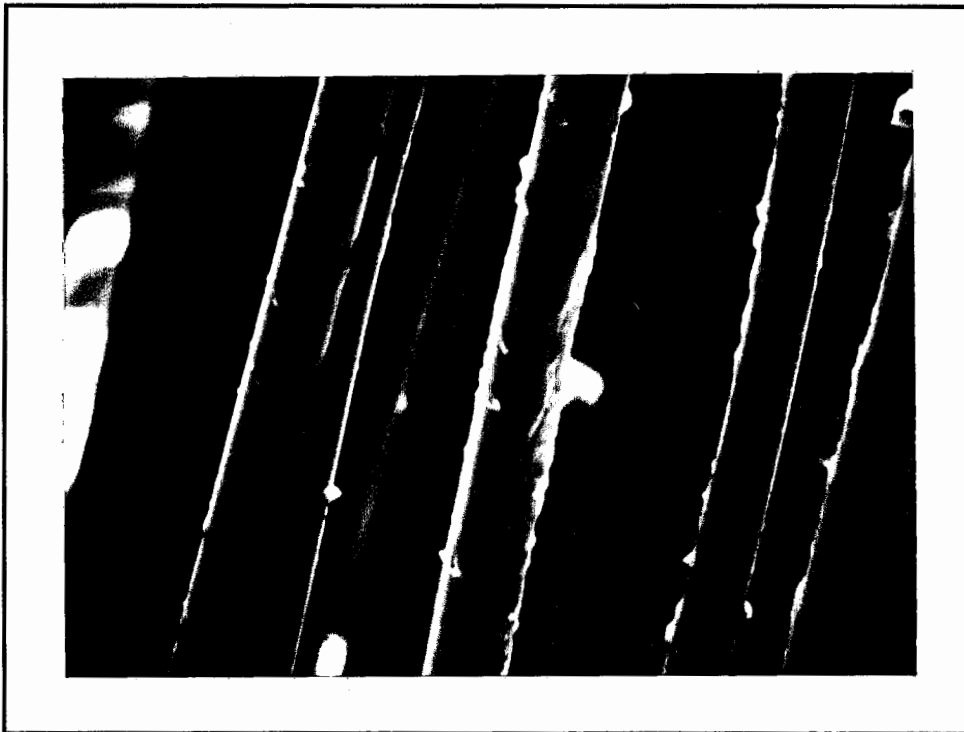
The next step of the inspection of the fracture surface was to determine the condition of the surface of the debonded fibers that had pulled out. Figure 100 is an SEM microphotograph of some of the fibers that had debonded during the test conducted at 137.9 MPa (high stress) at a frequency of 1 Hz and a temperature of 1093 °C. These fibers show a lot of evidence of damage due to oxidation of the debonded interface between the fiber and the matrix. Figure 101 is an SEM microphotograph of some of the fibers that had debonded during the test conducted at 96.53 MPa (low stress) at a

Figure 100. Fiber Surface, 1 Hz, 1093°C, 137.9 MPa, 625X

frequency of 1 Hz and a temperature of 1093 °C. These fibers show evidence of a lot of interfacial oxidation as would be expected for a test of long duration at a high temperature. A comparison of Figures 100 and 101 shows that the longer times of the tests that result from the lower stress levels will allow more exposure to the atmosphere and more oxidative attack of the debonded fiber-matrix interface. This is consistent with the observations from the series of tests conducted at 10 Hz at this temperature.

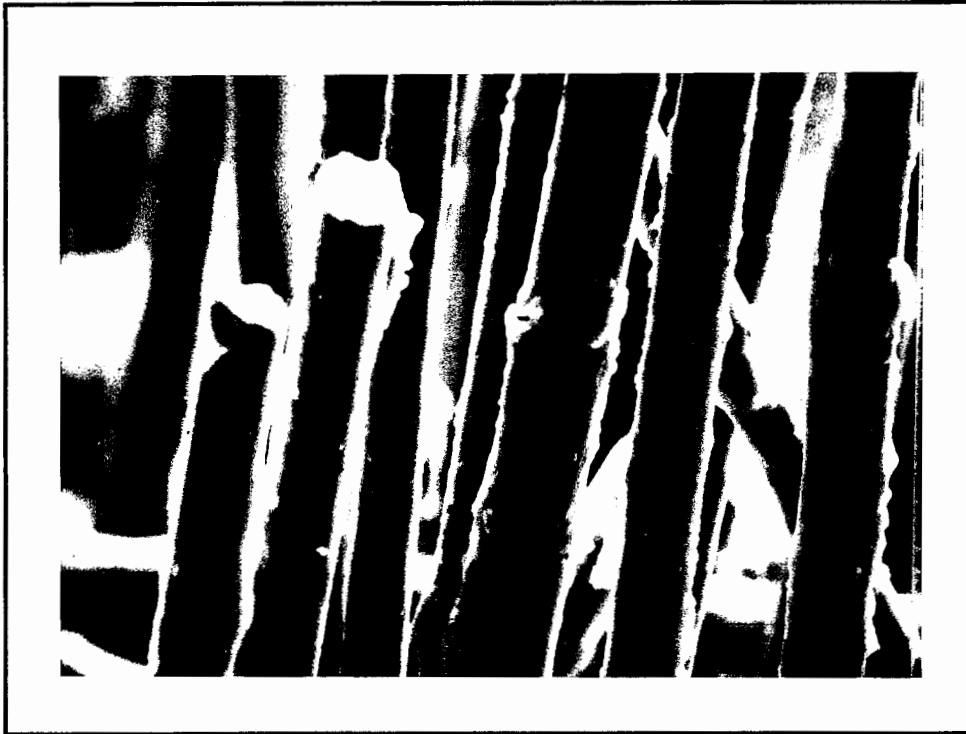
Figure 101. Fiber Surface, 1 Hz, 1093°C, 96.53 MPa, 575X

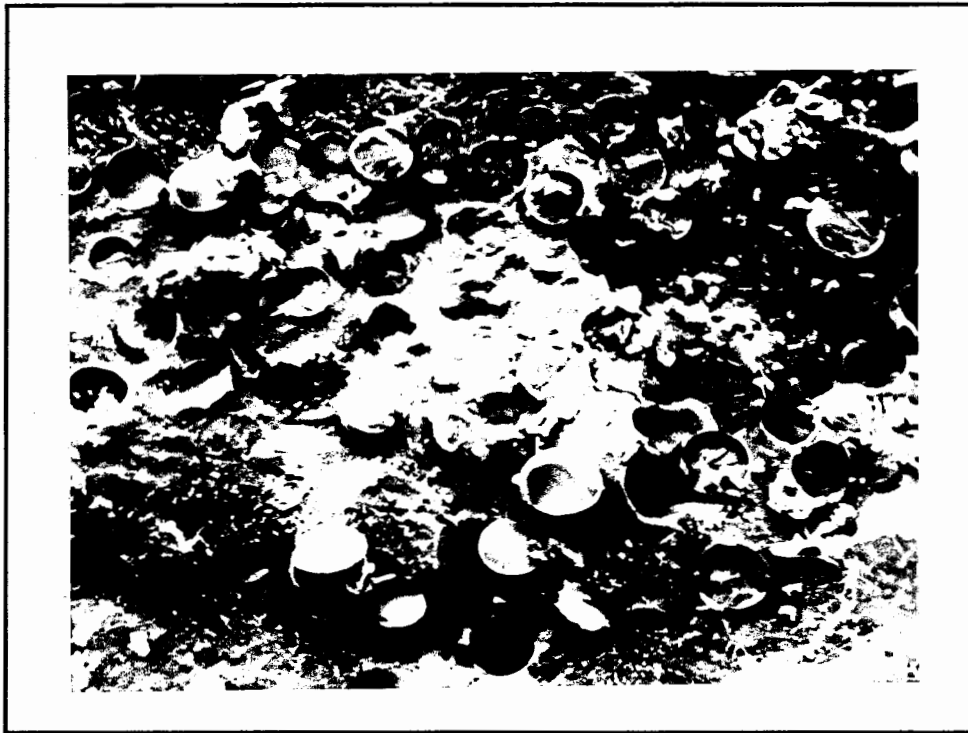
Figure 102 is an SEM microphotograph of a representative area of the fracture surface away from an area of pullout. The fracture surface in this area is generally smooth and flat in appearance, indicating that the specimen failed due to an environmentally assisted crack growth, similar to that observed by Grant [5]. Figure 102 also illustrates

the combination of damage mechanisms occurring in these tests. There is some evidence of debonding indicated by the few short lengths of fiber pullout and there is also evidence of the environmentally assisted crack growth through the strengthened interfacial bonds resulting in a flat planar surface.

Figure 102. Fracture Surface, 1 Hz, 137.9 MPa, 1093°C, 655X
