HIGH FREQUENCY LONGITUDINAL AND SHEAR WAVE  
INSPECTION OF GAS TURBINE CERAMICS

Thomas Derkacs  
Thompson-Ramo-Wooldridge  
Cleveland, Ohio 44117

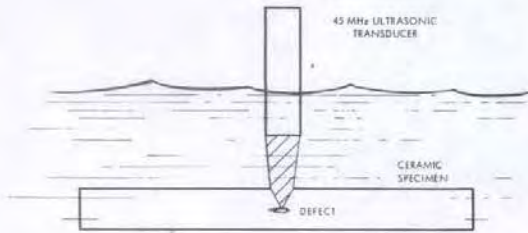
LONGITUDINAL WAVE INSPECTION

Figure 1. Pulse-echo longitudinal wave inspection is performed at 25 to 45 MHz using a focused ultrasonic transducer immersed in water. C-scan recordings are made of the results. This technique is more sensitive to defects oriented parallel to the surface that is normal to the transducer.

The basic technique developed employs an ultrasonic system operating in the pulse-echo mode at 25 to 45 MHz with a focused ultrasonic transducer. Figure 1 shows the arrangement for longitudinal wave inspection. The specimen and transducer are immersed in water with the transducer normal to the specimen surface. The transducer is scanned across the specimen and a C-scan recording is made of the results. We have found that for a 6.4 mm (0.25 inch) thick billet, scans are required at three focal planes to provide complete coverage. Because of the beam orientation, the strongest response is from a defect oriented parallel to the specimen surfaces. This, of course, is not usually the defect orientation of greatest interest. Figure 2 shows the arrangement for shear wave inspection. The same equipment is used, but the transducer is tilted at an angle (11° for hot pressed silicon nitride) in the direction of the scan. This results in a shorter ultrasonic wavelength for a given frequency and pro-

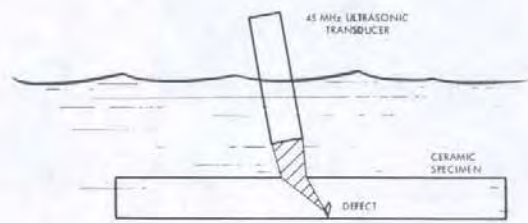
SHEAR WAVE INSPECTION

Figure 2. Pulse-echo shear wave inspection is performed using the same equipment, but with the transducer tilted at an angle of about 11° to the surface. This technique is more sensitive to defects oriented normal to the surface.

vides a beam in the specimen at about a 45 degree angle to the surface. This technique is more sensitive than the longitudinal wave technique and is better applicable to detecting defects which are oriented perpendicular to the specimen surfaces.

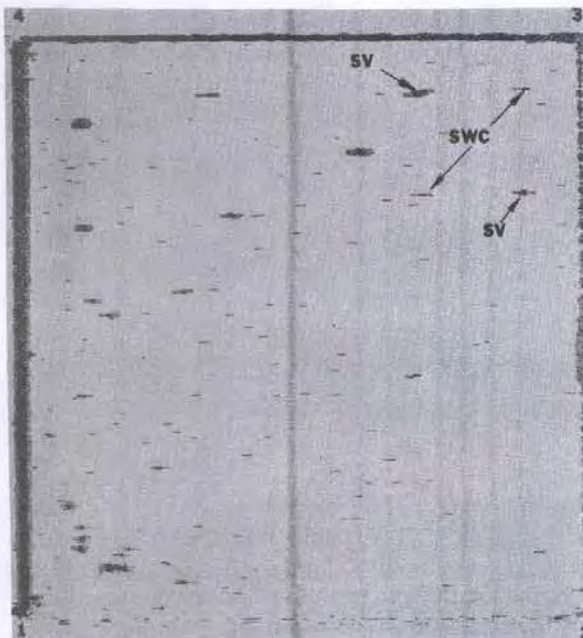
Figure 3. Typical C-scan recording of inspection results for a billet of Cerralloy 147A hot pressed silicon nitride showing seeded low density (SV) and high density (SWC) 125 μm (0.005 inch) defects as well as numerous natural defects.

The following figures illustrate some of the capabilities of these techniques. The first group of six illustrate some of the work done on the NAVAIR sponsored program. Figure 3 shows a typical C-scan recording of a billet of Ceralloy 147A, hot pressed silicon nitride. This billet contained four seeded defects forming a 25 mm (1 inch) square near corner No. 3. Two of these defects, located on one diagonal, were 125  $\mu\text{m}$  (0.005 inch) diameter simulated voids (SV) consisting of aluminum oxide inclusions. The other two were 125  $\mu\text{m}$  (0.005 inch) diameter tungsten carbide inclusions (SWC). In addition to these seeded defects, a number of natural defects were detected in the billet. Figure 4 is a composite sketch showing each defect detected in the billet as a dot. The layout of four-point bend specimens is shown with specimen numbers on the outside of each specimen and the height of the ultrasonic pulse from the defect in cm on the inside. The pulse heights were obtained with the beam focused on the defect and are referenced to 4.0 cm for the reference simulated void. Figure 5 shows how each specimen was cut from the billet in order to place the defect near the tensile surface during testing. The 6.4 x 3.2 x 31.8 mm (1/4 x 1-1/4 inch) specimens were cut with the billet thickness as the 6.4 mm (1/4 inch) dimension and with the defect 380  $\mu\text{m}$  (0.015 inches) below the tensile surface.

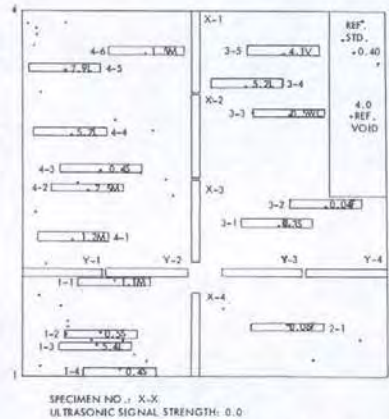
Figure 4. Sketch showing the defects detected in the billet of Cerralloy 147A, the four-point-bend specimens cut from the billet, and the ultrasonic signal strength of the defects located in the specimens.

Figures 6, 7 and 8 show fracture surfaces for specimens that initiated fracture at the ultrasonically detected defects. Figure 6 shows a 25  $\mu\text{m}$  (0.005 inch) tungsten carbide inclusion. The size and material of both these seeded defects were verified by electron microprobe analysis. The portion of the billet containing the other two seeded defects was saved for use as a reference standard as shown in Fig. 4.

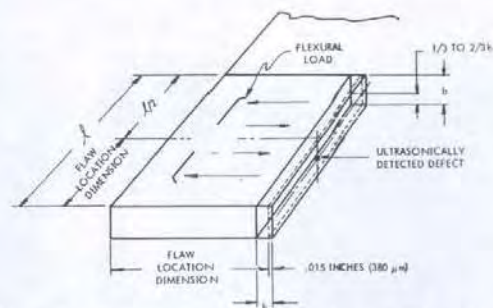
Figure 5. Sketch showing the method by which four-point-bend specimens were cut from the billet of Cerralloy 147A with ultrasonically detected defect located near the tensile surface.

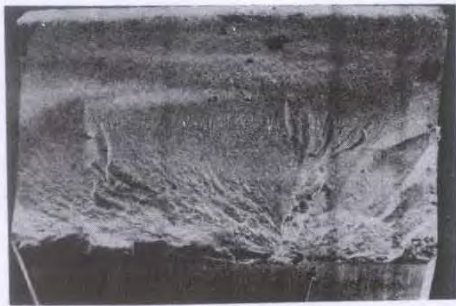
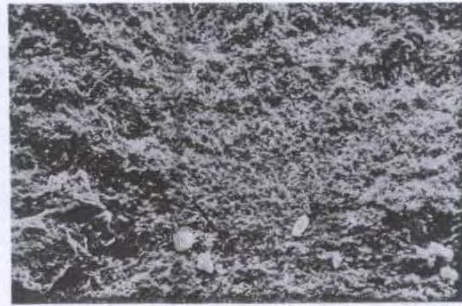
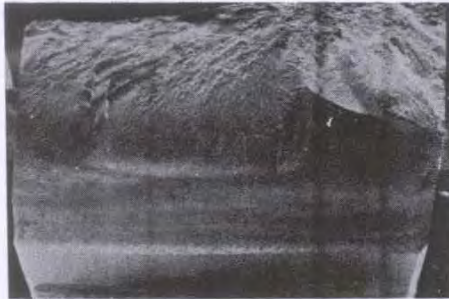
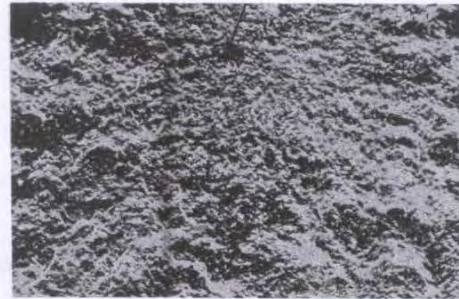
Figure 6. Fracture surfaces of specimen 1-4, showing fracture origin at ultrasonically detected 25  $\mu\text{m}$  (0.001 inch) void.

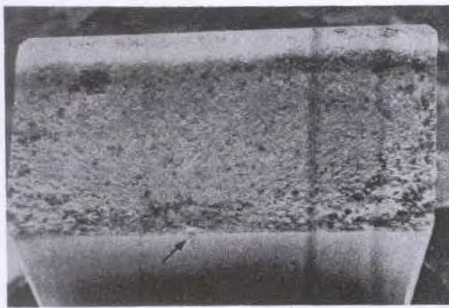
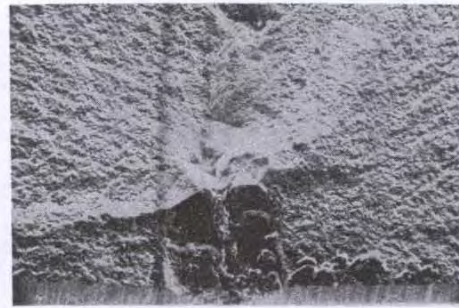
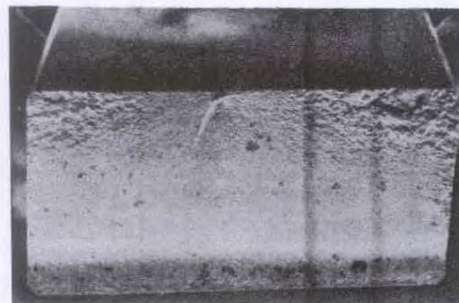
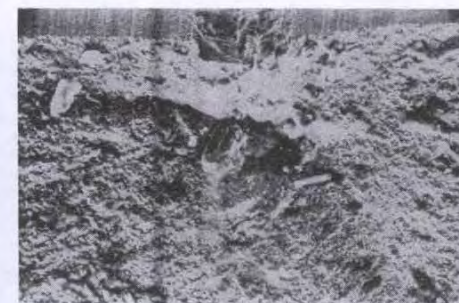
Figure 7. Fracture surfaces of specimen 3-5, showing fracture origin at seeded 125  $\mu\text{m}$  (0.005 inch) simulated void (aluminum oxide inclusion).

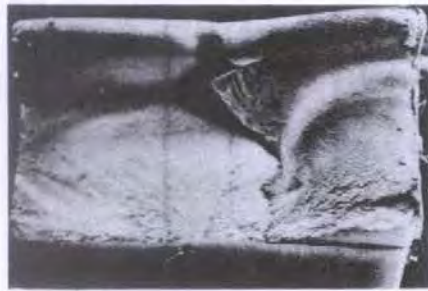
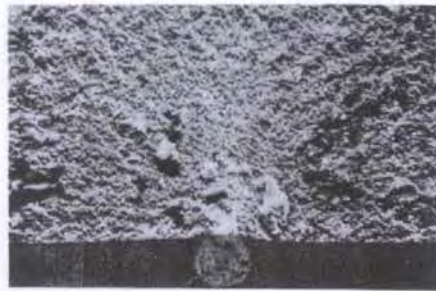
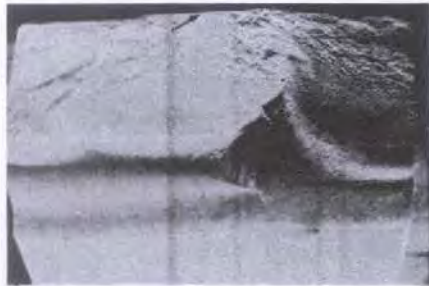
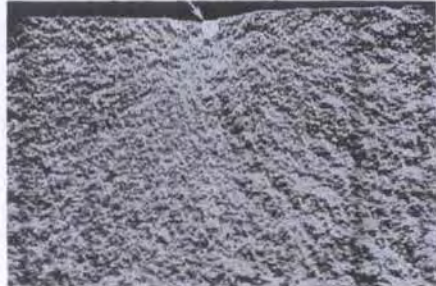
Figure 8. Fracture surfaces of specimen 3-3, showing fracture origin at seeded 125  $\mu\text{m}$  (0.005 inch) high density (tungsten carbide) inclusion.

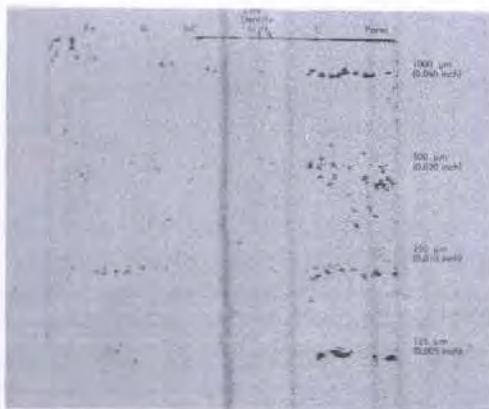
Figure 9. C-scan recording of 45 MHz longitudinal wave inspection results for Airesearch seeded billet of NC-350 reaction bonded silicon nitride.

Item 1 is almost complete and items 2 and 3 are in progress. Figures 9 through 12 show some of the results for item 1. Figure 9 shows the C-scan recording of the 45 MHz longitudinal wave inspection of a billet of NC-350, reaction bonded silicon nitride. The billet was seeded with Fe, Si, SiC, low density  $\text{Si}_3\text{N}_4$ , C and pores in sizes ranging from 125 to 1000  $\mu\text{m}$  (0.005 to 0.040 inches) as shown in the margins. Figure 10 shows the corresponding shear wave inspection results. Not only are the defect indications larger in Fig. 10, but there are a number of defect indications in Fig. 10 which do not appear in Fig. 9. This shows the superior sensitivity of the shear wave techniques. Although there are some blank areas where seeded defects are supposed to be, particularly for the low density  $\text{Si}_3\text{N}_4$  and the smallest size of Si and SiC, there is no way of knowing whether the defects are actually present until the billet is cut up.

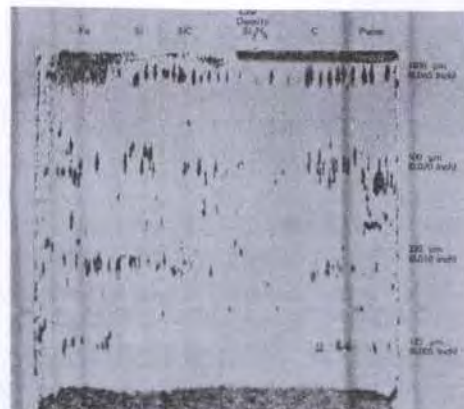
Figure 10. C-scan recording of 45 MHz shear wave inspection results for Airesearch seeded billet of NC-350, showing superior sensitivity of shear wave technique.

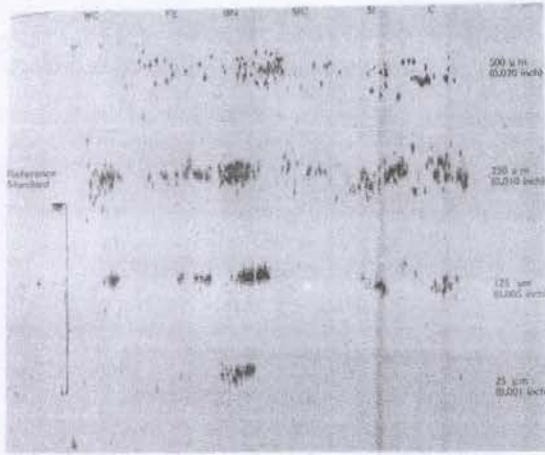
Figure 11. C-scan recording of 45 MHz longitudinal wave inspection results for Airesearch seeded billet of NC-132 hot pressed nitride.

Figures 11 and 12 show C-scans of 45 MHz longitudinal and shear wave inspections of a seeded billet of NC-132, hot pressed silicon nitride. In this case the seeded defects are WC, Fe, BN, SiC, Si and C in sizes ranging from 25 to 500  $\mu\text{m}$  (0.001 to 0.020 inches). Once again the shear wave inspection shows more defects than the longitudinal wave inspection. Although the actual defect sizes have yet to be verified by metallurgical evaluation, Fig. 12 offers additional evidence of the ability of high frequency ultrasonics to detect defects at least down to 25  $\mu\text{m}$  (0.001 inches) in size in hot pressed silicon nitride.

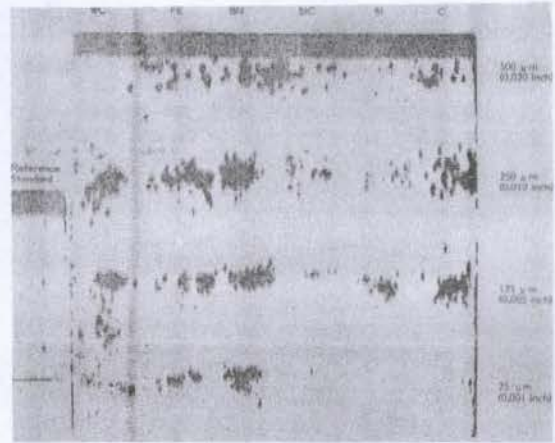
Figure 12. C-scan recording of 45 MHz shear wave inspection results for Airesearch seeded billet of NC-132, showing superior sensitivity of shear wave technique.
