Masonry Barn Design and Construction

BY HENRY GIESE, H. J. BARBE AND J. BROWNLEE DAVIDSON

AGRICULTURAL EXPERIMENT STATION
IOWA STATE COLLEGE OF AGRICULTURE
AND MECHANIC ARTS

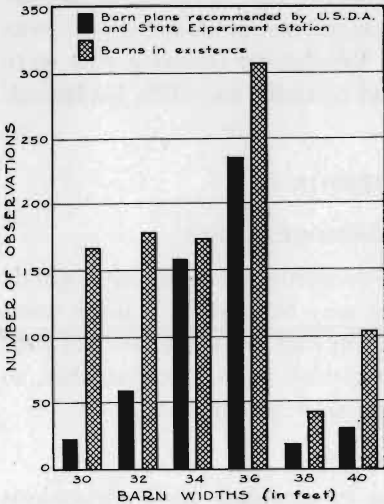
Fig. 1. Number of barns by widths.

Observations of barns and plans by common widths are shown in fig. 1. These show that 34 and 36-foot widths are generally recommended for dairy and general purpose barns and that there is in existence a large number of barns of widths narrower than those generally recommended. The average of the 30, 32, 34, and 36-foot widths is 34.3 ft., while the average of all barns included in the plans is 33.9 ft. A barn of 34 ft. gives ample work space and conforms well to present practice.

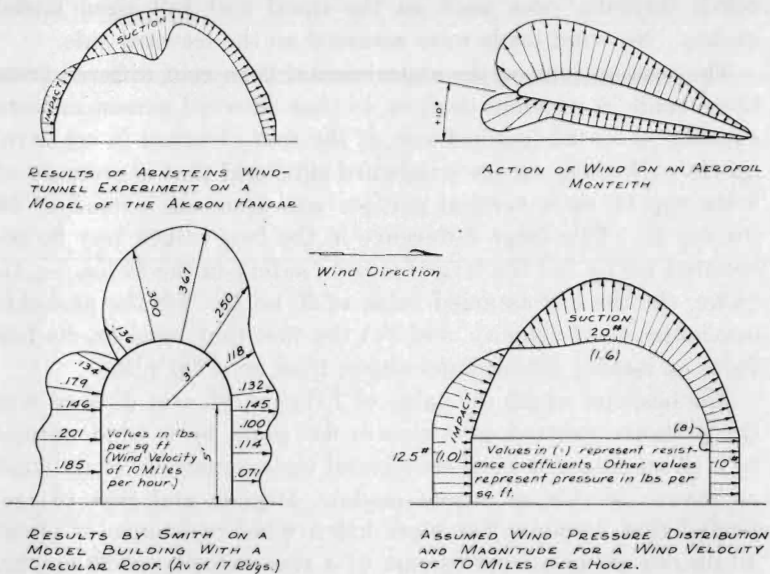
Fig. 4. Wind pressure distribution on models of buildings and the distribution and magnitude of wind pressures on the barn roof.

with a roof semi-circular in section. The results are shown graphically in fig. 4. The positive or impact pressure constituted a very small part of the total wind load.

Similar results were obtained in Carl Arnstein's (19) wind tunnel experiments on the model of the large airship hangar at Akron, Ohio. (See fig. 4.) The positive or impact pressure constituted a very small part of the total wind load.

Experiments on aerofoils in aerodynamics indicate that 60 to 70 percent of the total lifting force is due to a reduced pressure on the upper side (fig. 4).

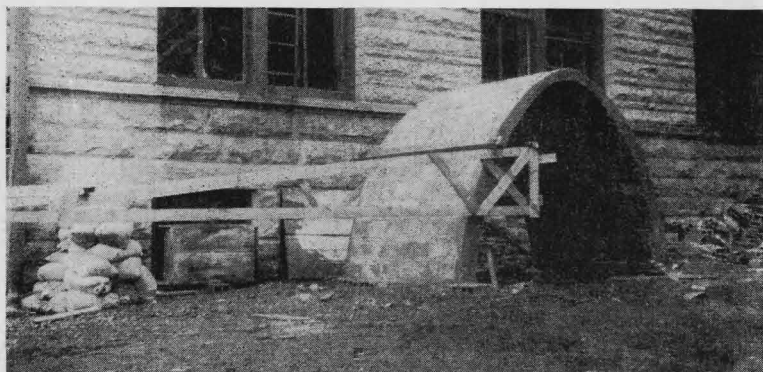
Fig. 9. Apparatus for larger load application.

To obtain a larger load application, a system of levers was used, since it was difficult to add sacks of sand (fig. 9). Under a concentrated load of 2,200 lbs., the steel on the inside of the rib split away from the concrete. This shows the importance

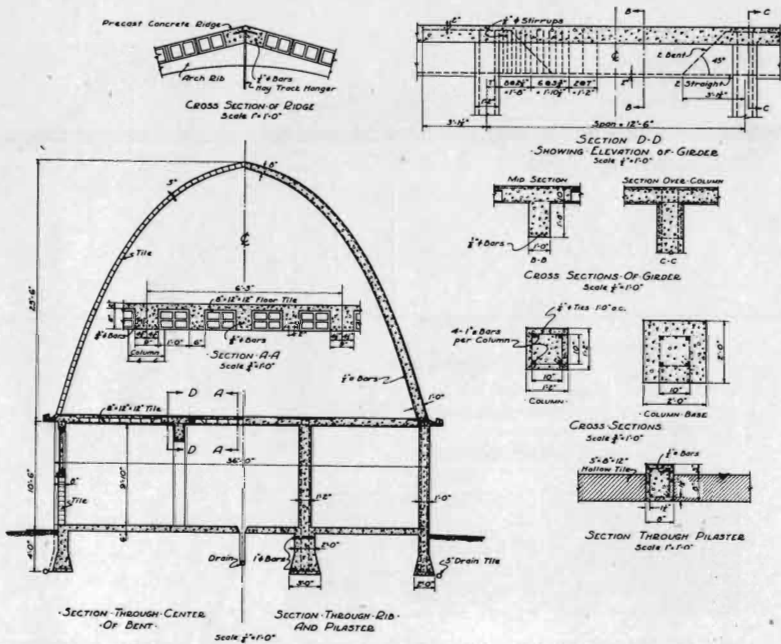
Fig. 18. Cross section and typical details of the experimental barn.

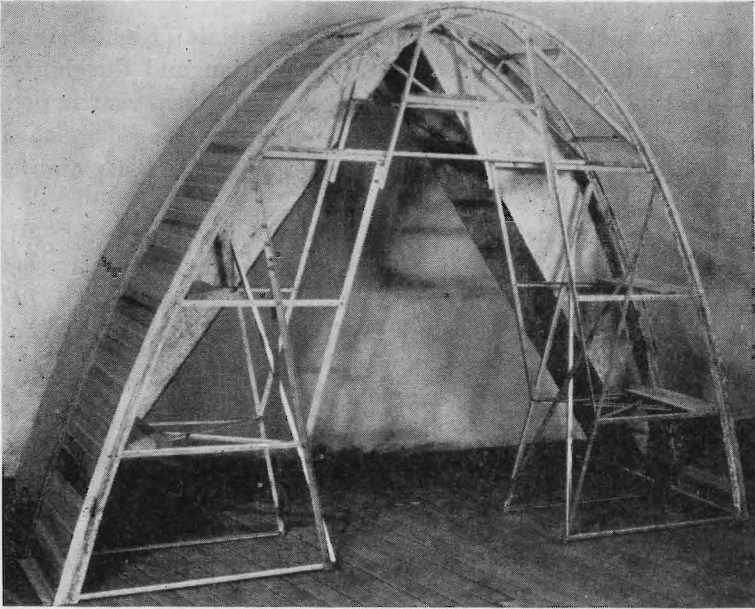
Fig. 20. The closed and open type of roof forms.

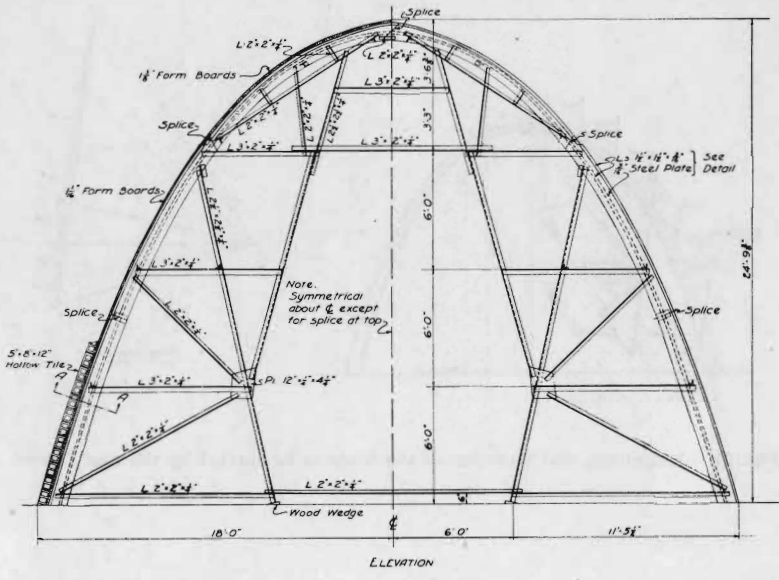
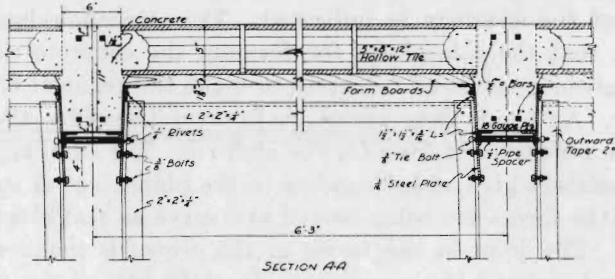
Fig. 22. Details of steel roof forms.

Figure 22 gives a detailed elevation of the forms with the sizes of the members as indicated. The accompanying detail shows that the side plates for forming the concrete rib have been given a batter of 2 degrees to make the removal of forms easier. Although these plates are in several sections, they constitute a continuous form for the arch rib. The auxiliary framing members give added rigidity to the plates, act as supports when the forms are being moved and serve as scaffolding supports. The joint in the forms at the crown is inclined sufficiently to permit the clearing of the right half of the form as it is being removed.

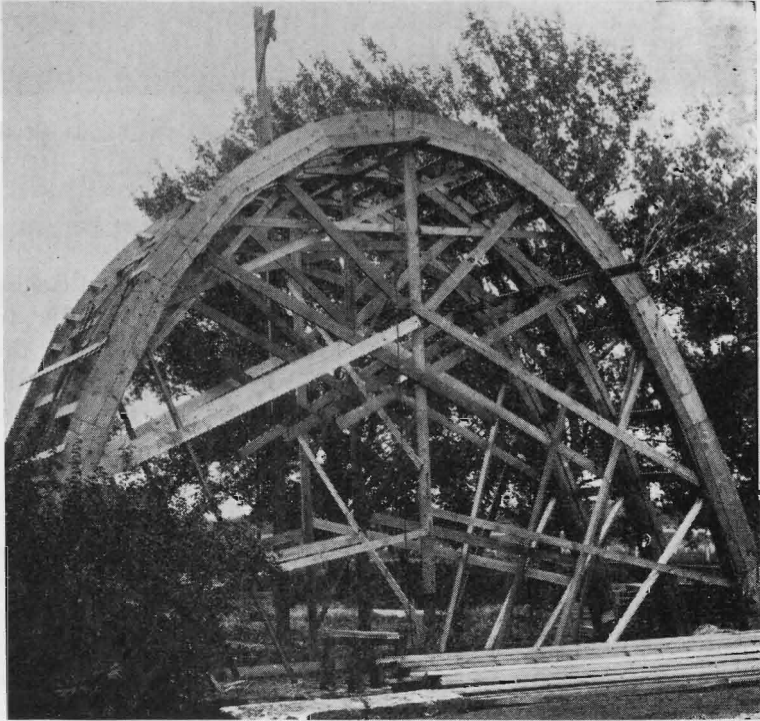
Fig. 24. Wood forms for the construction of the full sized arch.

The forms for the construction of the full sized arch were quite complicated, and the necessary lumber cost over \$100. An attempt was made to build them in such a manner as to permit easy manipulation when erecting and disassembling, and to

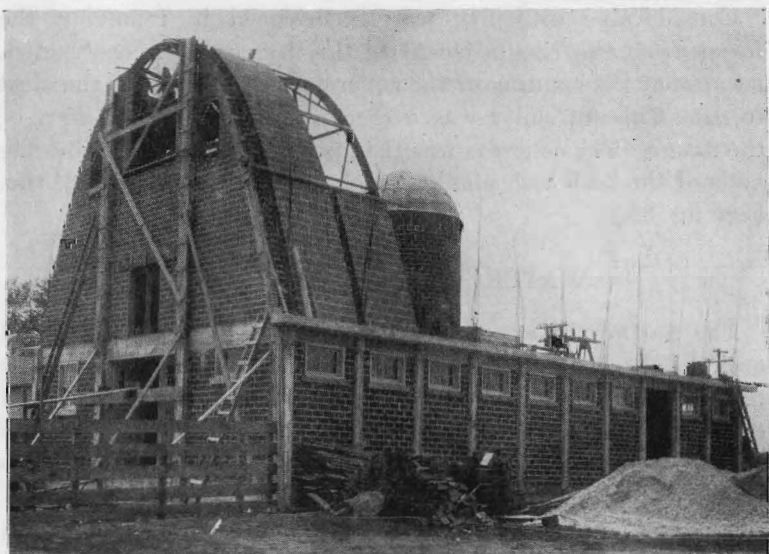
Fig. 30. Beginning of the construction of the roof.

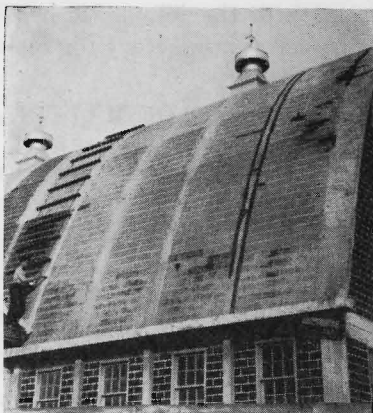
Fig. 34. Treating of the leaky areas with fibered asphalt and aluminum paint.

In furthering the attempts to seal the cracks and otherwise make the roof watertight, a heavier and fibered asphalt was used in treating the leaky areas (fig. 34). Its consistency was such as to permit application with a brush. The leaky areas which had been noted and other visible cracks were treated with one coat of this material. A coat of aluminum paint was applied after sufficient drying.

The condition of the fibered asphalt was fairly good after a year's exposure. In a few places it had become firm and dry and had partially cracked, exposing former cracks.
