Seismic Vulnerability of Essential Facilities in the West Tennessee Region

A Thesis

Major: Civil Engineering

The University of Memphis

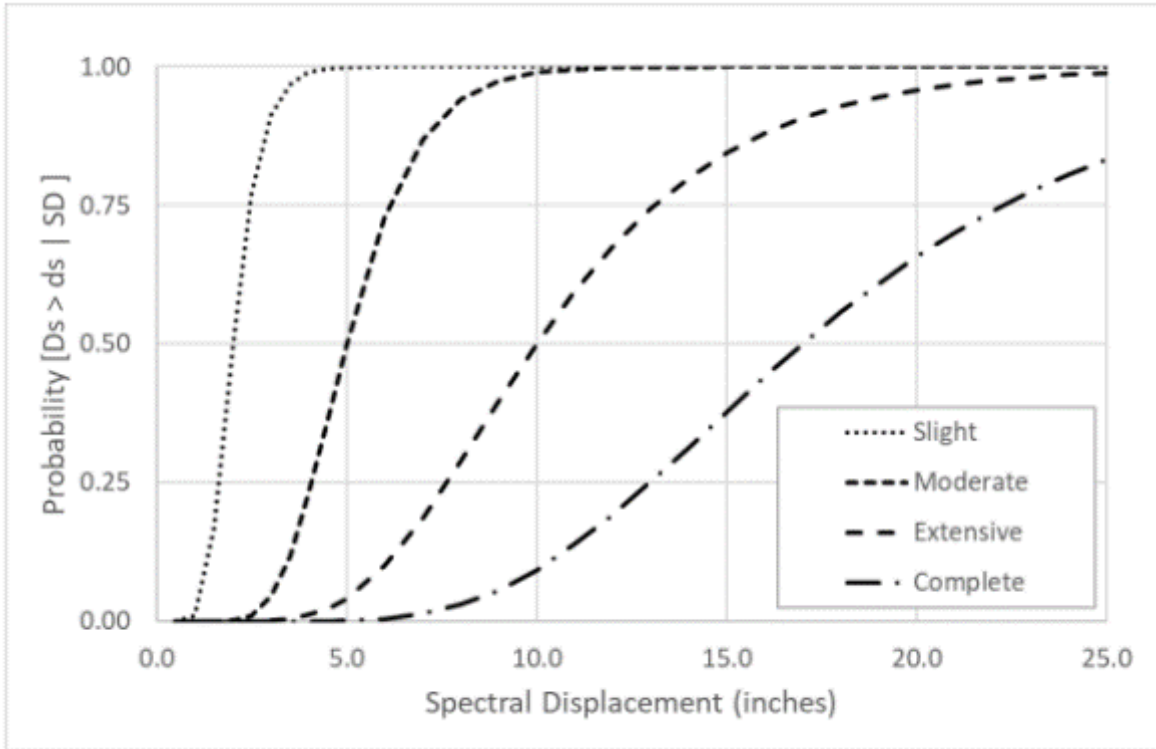
Figure 3.1 Example Fragility Curves for Essential Facilities (FEMA, 2022)

Fragility curves are defined by a median and a lognormal standard deviation (β). Fragility curves show the probability of a structure falling into a damaged state given a spectral displacement. Spectral displacement is for both structural and nonstructural damage for drift-sensitive components of a structure, whereas spectral acceleration is just nonstructural damage for acceleration-sensitive components of a structure. The probability of being in or exceeding a damaged state given a spectral displacement for structural damage can be calculated using Equation 1. Example figures of fragility curves with various β values and final fragility curves can be found in Assessment of the Seismic Vulnerability of West Tennessee School Buildings (Assadollahi C. M., 2019).

Ultimately the fragility curves are completed for each building type and for each category of damage: slight, moderate, extensive, and damage. Hazus develops fragility curves for each structure based on the building type and seismic design level. A general example of the fragility curves produced in the Hazus software can be seen in Figure 3.1.

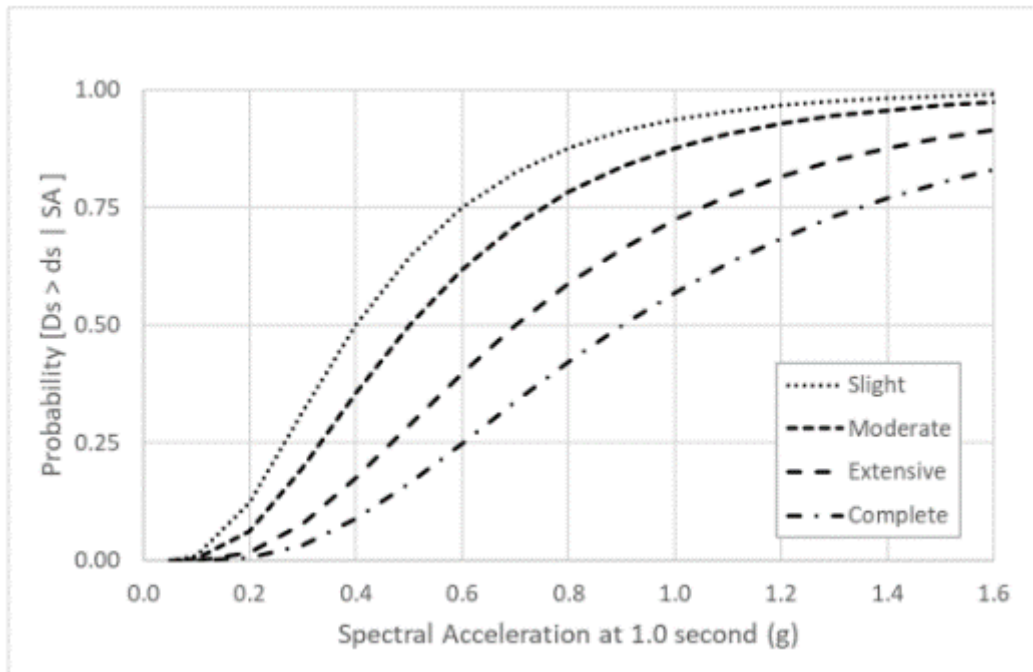
Figure 3.2 Fragility Curves for Conventionally Designed HWB1 (FEMA, 2022)

Bridges damage states and fragility curves are calculated using multiple equations and factors dependent on different aspect of each bridge. Each bridge had modification factors applied, and there are three types of modification factors that are applied. The first modification factor is due to bridge skewness, and the second is a shape factor based on the spectral accelerations at 0.3s and 1s. The Hazus technical manual further states, “The Kshape factor is the modifier that converts cases for short periods to an equivalent spectral amplitude at T=1.0 second. When $I_{shape} = 0$, the Kshape factor does not apply. When $I_{shape} = 1$, the Kshape factor applies” (FEMA, 2022). Note I_{shape} is defined for each bridge, which are provided in Table B.3 Hazus Bridge Classification (FEMA, 2020a). The third modification factor is referred to as the K_{3D} factor; there are a total of 7 different possible equation for the K_{3D} factor based on the bridge type. The Hazus technical manual mentions that the K_{3D} factor is to convert the bridges piers’ 2D

capacity for 3D arch action in the deck. Further explanations and example calculations done within the Hazus software can be found in Chapter 7.1.6 in Hazus Technical Manual 5.1. Examples of fragility curves for bridges can be seen in Figure 3.2 and Figure 3.3, and when the two figure are compared there is a notable difference in the probability of damage for a the same bridge type when it is conventionally designed versus when it is seismically designed. The determination of whether a bridge is seismically designed or not is determined by when the bridge was built/remodeled.

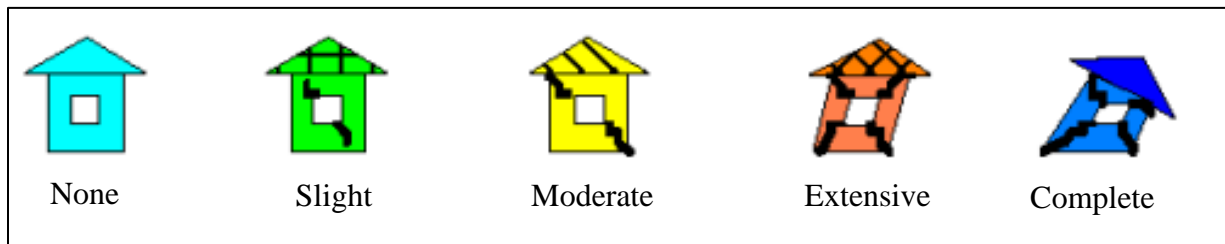
Figure 3.4 Essential Facility Damage States (FEMA, 2022)

For both bridges and essential facilities there are a total of 5 damage states, but only four damage states impact economic loss, functionality, and casualties. For essential facilities slight damage means small cracks at openings, like doors and windows, will occur. Moderate damage is large cracks in nonstructural components and small cracks in structural components. Extensive damage is associated with large cracks across structural components and permanent lateral movement in the structure. Complete damage is where the structure is collapse or near collapse, and all these damage states are illustrated in Figure 3.4. When the AEBM module is used the probability of damage states are separated into structural, nonstructural due to acceleration, and nonstructural due to drift. For bridges, slight damage is minor spalling and cracks, and moderate damage is when moderate cracks occur, approach settlement, or rocker bearing failure. Extensive damage is when the structure is unsafe but not collapse whereas complete damage is a collapsed bridge. Examples of the damage states for bridges can be seen in Figure 3.5. After the software

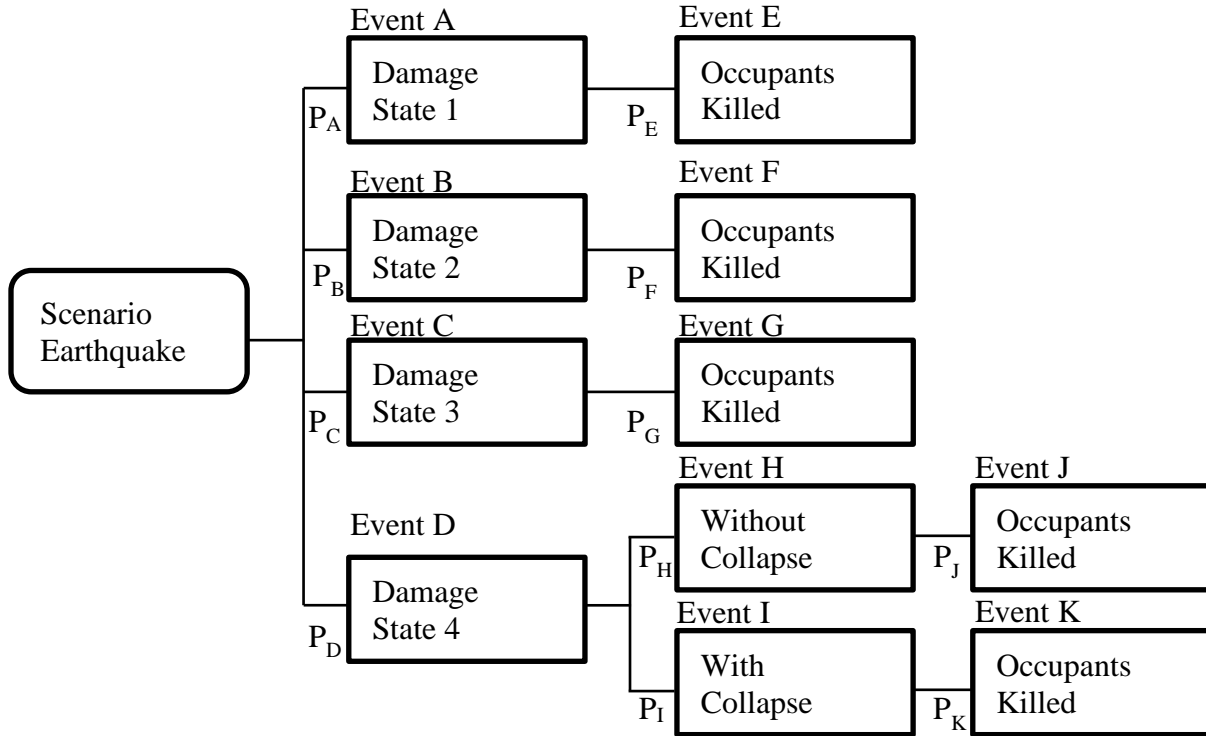
Figure 3.6 Casualty Tree for Fatalities (FEMA, 2022)

After probability of damage states are determined, then casualties due to essential facilities can be calculated within the software. There is a total of four different type of casualties levels:

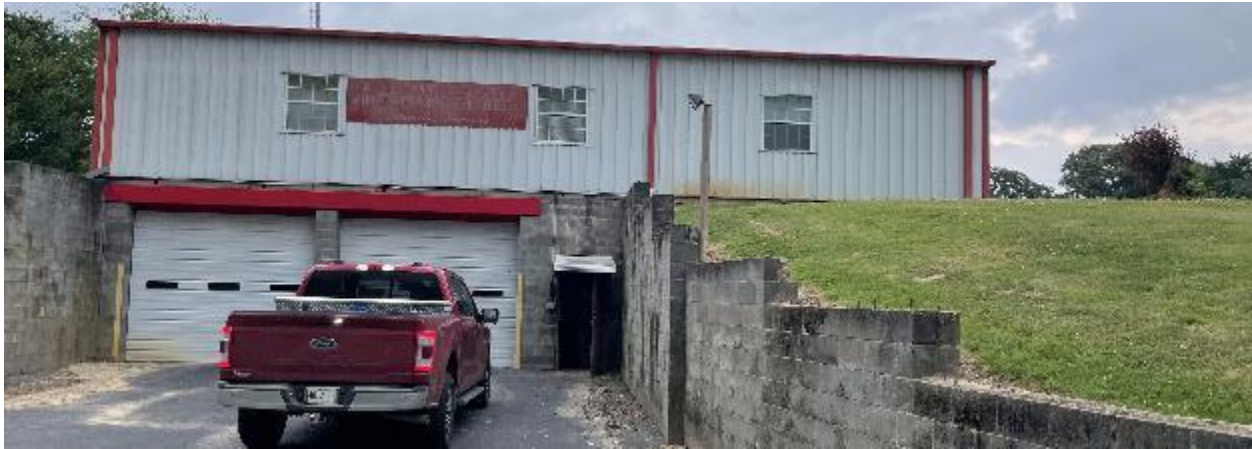
setback, short column/pier, and split levels. An example of soft story encountered in one of the site visits conducted can be seen in Figure 3.21, and an example of out-of-plane setback encountered can be seen in Figure 3.22.

Figure 3.21 Soft Story Vertical Irregularity from Site Visit

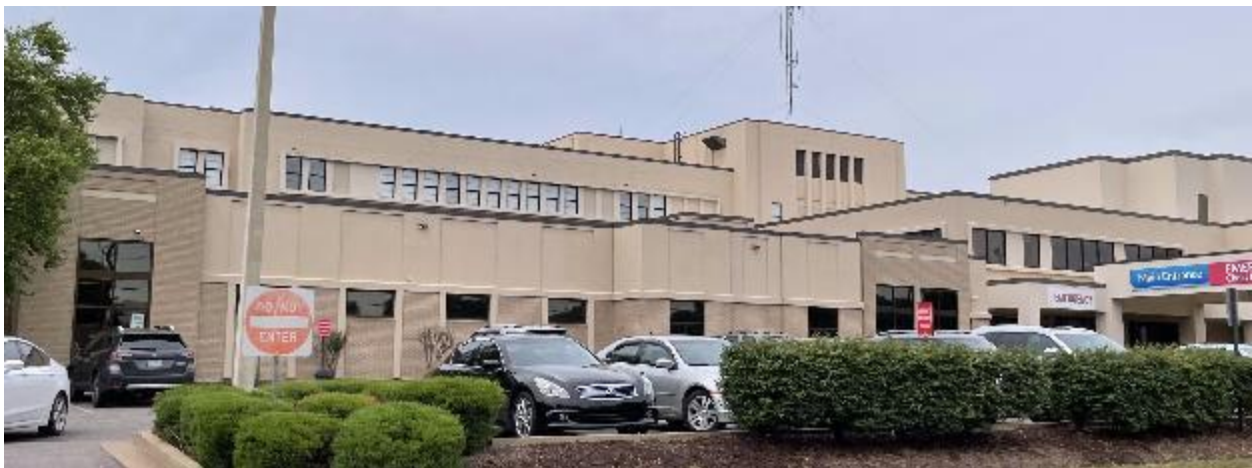
Figure 3.22 Out-of-Plane Setback Vertical Irregularity from Site Visit

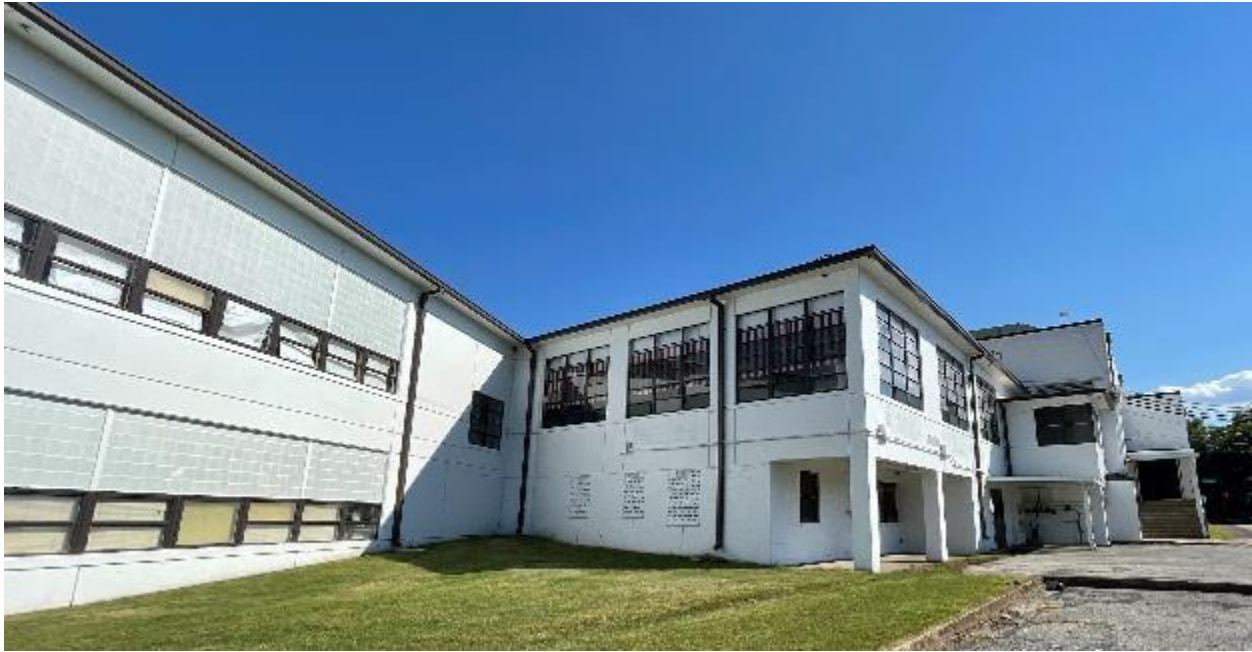
FEMA P-154 further explains these categories in Chapter 3 and what could distinguish the irregularity as severe rather than moderate. Plan irregularity is defined into five categories: torsion, non-parallel systems, reentrant corners, diaphragm openings, and beams that do not align with columns. An example of plan irregularity encountered in one of the site visits conducted can

Figure 3.23 Plan Irregularity from Site Visit

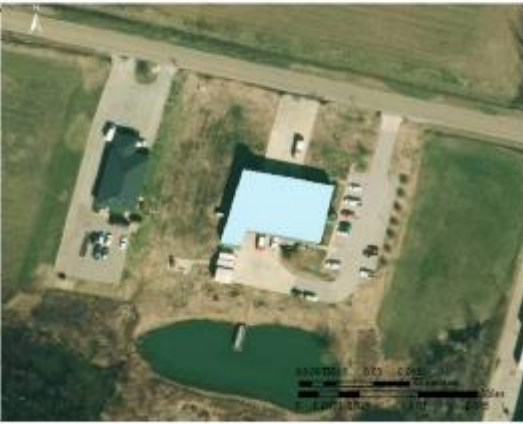
Address: 101 JLNNESSER AVENUE Zip: 38079
 Other Identifiers: FNR0450
 Building Name: COVINGTON FIRE DEPARTMENT - NORTH STA...
 Use: Fire Station
 Latitude: 35.580001 Longitude: 89.645894
 S: 1.241 S: 0.476
 Screener(s): Abdulmutab Abdulhadi Date/Time:
 No. Stories: Above Grade: Below Grade: Year Built: 1963 est
 Total Floor Area (sq. ft.): 9190 Code Year: 1991
 Additions: None Yes, Year(s) Built:
 Occupancy: Assembly Commercial **Other Services** Historic Shelter
 Industrial Office School Government
 Utility Warehouse Residential, # Units:
 Soil Type: A B C D E F DNK
 Hard Avg Dense Stiff Soft Poor #DNK, assume Type D
 Rock Rock Soil Soil Soil
 Geologic Hazards: Liquefaction: Yes/No/DNK Landslide: Yes/No/DNK Surf. Rupt: Yes/No/DNK
 Adjacency: Pounding Falling Hazards from Taller Adjacent Building
 Irregularities: Vertical (type/severity) Plan (type)
 Exterior Falling Hazards: Unbraced Chimneys Heavy Cladding or Heavy Veneer

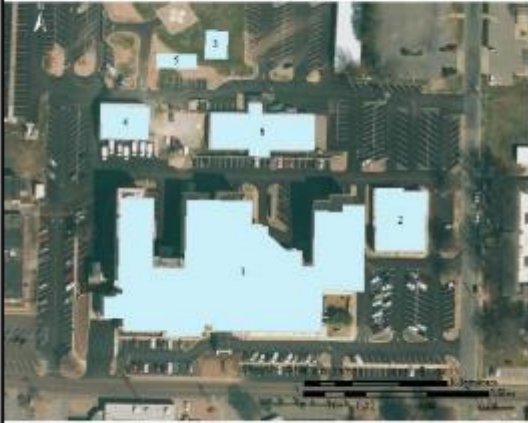
<p style="text-align: center;">SKETCH</p>	<p>Address: 400 TICKET ST Zip: 38024</p> <p>Other Identifiers: TN000306</p> <p>Building Name: TENNIVA HEALTHCARE - DYERSBURG REGIONAL</p> <p>Use: Hospital</p> <p>Latitude: 36.043186 Longitude: -89.579914</p> <p>S₁: 2.359 S₂: 0.645</p> <p>Screener(s): Abdulrhman Abdalrhadi Date/Time:</p> <p>No. Stories: Above Grade: _____ Below Grade: _____ Year Built: 2006 <input type="checkbox"/> est</p> <p>Total Floor Area (sq. ft.): 5955 Code Year: 1991</p> <p>Additions: <input type="checkbox"/> None <input type="checkbox"/> Yes, Year(s) Built: _____</p> <p>Occupancy: Assembly <input type="checkbox"/> Commercial <input checked="" type="checkbox"/> Emer. Services <input type="checkbox"/> Historic <input type="checkbox"/> Shelter Industrial <input type="checkbox"/> Office <input type="checkbox"/> School <input type="checkbox"/> Government Utility <input type="checkbox"/> Warehouse <input type="checkbox"/> Residential, # Units: _____</p> <p>Soil Type: <input type="checkbox"/> A <input type="checkbox"/> B <input checked="" type="checkbox"/> C <input type="checkbox"/> D <input type="checkbox"/> E <input type="checkbox"/> F <input type="checkbox"/> DNK Hard Avg. Dense Stiff Soft Poor #DNK, assume Type D Rock Rock Soil Soil Soil Soil</p> <p>Geologic Hazards: Liquefaction: Yes/No/DNK Landslide: Yes/No/DNK Surf. Rupt.: Yes/No/DNK</p> <p>Adjacency: <input type="checkbox"/> Founding <input type="checkbox"/> Falling Hazards from Taller Adjacent Building</p> <p>Irregularities: <input type="checkbox"/> Vertical (type/severity) _____ <input type="checkbox"/> Plan (type) _____</p> <p>Exterior Falling Hazards: <input type="checkbox"/> Unbraced Chimneys <input type="checkbox"/> Heavy Cladding or Heavy Veneer <input type="checkbox"/> Parapets <input type="checkbox"/> Appendages <input type="checkbox"/> Other: _____</p> <p>COMMENTS:</p> <p><input type="checkbox"/> Additional sketches or comments on separate page</p>																																																																																																																																																																																																																
	<p>BASIC SCORE, MODIFIERS, AND FINAL LEVEL 1 SCORE, S_{L1}</p>

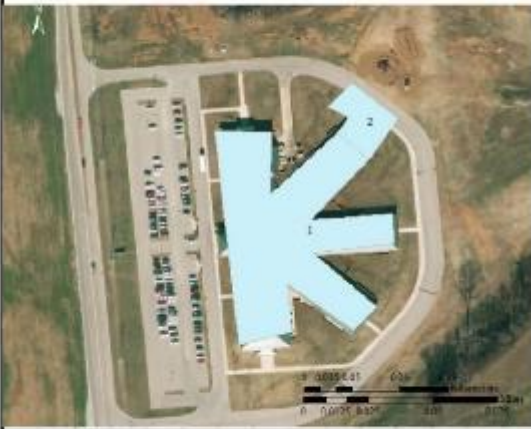
<p style="text-align: center;">SKETCH</p>	<p>Address: 800 ROSEMARE RD Zip: 38054</p> <p>Other Identifiers: F000151</p> <p>Building Name: ATOKA ELEMENTARY SCHOOL</p> <p>Use: Schools</p> <p>Latitude: 35.422167 Longitude: 89.767439</p> <p>Sr: J.121 Sr: 0.184</p> <p>Screeners(s): Abdulmutau Abdulhadi Date/Time:</p>
	<p>No. Stories: Above Grade: _____ Below Grade: _____ Year Built: 2007 <input type="checkbox"/> est</p> <p>Total Floor Area (sq. ft.): 89404 Code Year: 1991</p> <p>Additions: <input type="checkbox"/> None <input type="checkbox"/> Yes, Year(s) Built: _____</p> <p>Occupancy: Assembly <input type="checkbox"/> Commercial <input type="checkbox"/> Enter, Specify <input type="checkbox"/> Historic <input type="checkbox"/> Shelter Industrial <input type="checkbox"/> Office <input checked="" type="checkbox"/> School <input type="checkbox"/> Government Utility <input type="checkbox"/> Warehouse <input type="checkbox"/> Residential, # Units: _____</p> <p>Soil Type: <input type="checkbox"/> A <input type="checkbox"/> B <input type="checkbox"/> C <input checked="" type="checkbox"/> D <input type="checkbox"/> E <input type="checkbox"/> F <input type="checkbox"/> DNK <small>Hard Avg Dense Stiff Soft Poor #DNK, assume Type D Rock Rock Soil Soil Soil Soil</small></p> <p>Geologic Hazards: Liquefaction: Yes/No/DNK Landslide: Yes/No/DNK Surf. Rupt: Yes/No/DNK</p> <p>Adjacency: <input type="checkbox"/> Pounding <input type="checkbox"/> Falling Hazards from Taller Adjacent Building</p> <p>Irregularities: <input checked="" type="checkbox"/> Vertical (type/severity) _____ <input checked="" type="checkbox"/> Plan (type) _____</p> <p>Exterior Falling Hazards: <input type="checkbox"/> Unbraced Chimneys <input type="checkbox"/> Heavy Cladding or Heavy Veneer <input type="checkbox"/> Parapets <input type="checkbox"/> Appendages <input type="checkbox"/> Other: _____</p> <p>COMMENTS:</p> <p style="text-align: right;"><input type="checkbox"/> Additional sketches or comments on separate page</p>

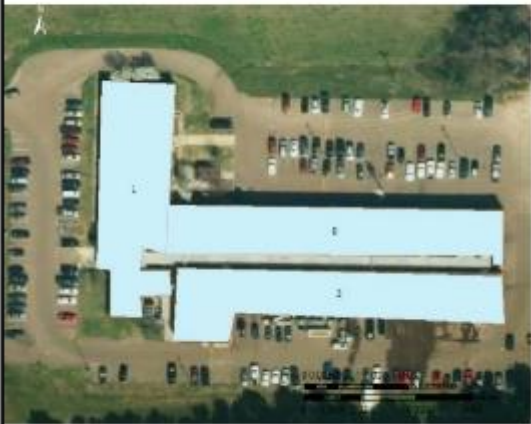
<p>Address: 1600 EDWY SL SOUTH Zip: 38079</p> <p>Other Identifiers: TN019250</p> <p>Building Name: TENNESSEE COLLEGE OF APPLIED TECHNOLOGY</p> <p>Use: Schools</p> <p>Latitude: 35.545225 Longitude: 89.659976</p> <p>Sr: 1.2 Sr: 0.412</p> <p>Screeners(s): Abdulrahman Abdulhadi Date/Time: _____</p>
	<p>No. Stories: Above Grade: _____ Below Grade: _____ Year Built: 1963 <input type="checkbox"/> est</p> <p>Total Floor Area (sq. ft.): 28416.66602 Code Year: 1991</p> <p>Additions: <input type="checkbox"/> None <input type="checkbox"/> Yes, Year(s) Built: _____</p> <p>Occupancy: Assembly <input type="checkbox"/> Commercial <input type="checkbox"/> Enter Specifics <input type="checkbox"/> Historic <input type="checkbox"/> Shelter Industrial <input type="checkbox"/> Office <input checked="" type="checkbox"/> School <input type="checkbox"/> Government Utility <input type="checkbox"/> Warehouse <input type="checkbox"/> Residential, # Units: _____</p> <p>Soil Type: <input type="checkbox"/> A <input type="checkbox"/> B <input type="checkbox"/> C <input checked="" type="checkbox"/> D <input type="checkbox"/> E <input type="checkbox"/> F <input type="checkbox"/> DNK Hard Avg Dense Stiff Soft Poor #DNK, assume Type D Rock Rock Soil Soil Soil Soil</p> <p>Geologic Hazards: Liquefaction: Yes/No/DNK Landslide: Yes/No/DNK Surf. Rupt: Yes/No/DNK</p> <p>Adjacency: <input type="checkbox"/> Pounding <input type="checkbox"/> Falling Hazards from Taller Adjacent Building</p> <p>Irregularities: <input type="checkbox"/> Vertical (type/severity) _____ <input checked="" type="checkbox"/> Plan (type) _____</p> <p>Exterior Falling Hazards: <input type="checkbox"/> Unbraced Chimneys <input type="checkbox"/> Heavy Cladding or Heavy Veneer <input type="checkbox"/> Parapets <input type="checkbox"/> Appendages <input type="checkbox"/> Other: _____</p> <p>COMMENTS:</p> <p><input type="checkbox"/> Additional sketches or comments on separate page</p>

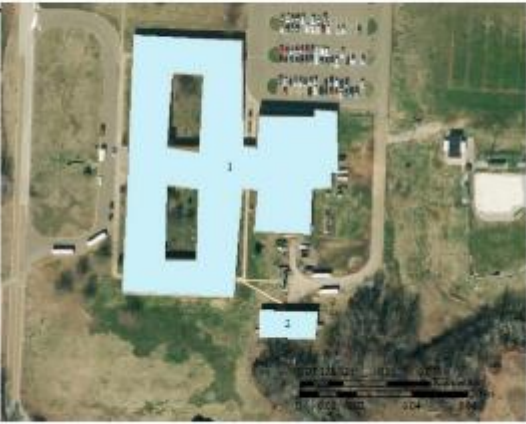
PHOTOGRAPH	Address: 100 EDUCATION AV Zip: 38058
	Other Identifiers: FNR0651
SKETCH	Building Name: MUNFORD ELEMENTARY
	Use: Schools

Latitude: 35.459614 Longitude: 89.802624
	Sr: 1.222 St: 0.118
Screener(s): Abdulmutau Abdulhadi Date/Time: _____	
No. Stories: Above Grade: _____ Below Grade: _____ Year Built: 1992 <input type="checkbox"/> est	
Total Floor Area (sq. ft.): 112000 Code Year: 1991	
Additions: <input type="checkbox"/> None <input type="checkbox"/> Yes, Year(s) Built: _____	
Occupancy: Assembly <input type="checkbox"/> Commercial <input type="checkbox"/> <u>Elementary School</u> <input type="checkbox"/> Historic <input type="checkbox"/> Shelter Industrial <input type="checkbox"/> Office <input type="checkbox"/> <u>School</u> <input type="checkbox"/> Government Utility <input type="checkbox"/> Warehouse <input type="checkbox"/> Residential, # Units: _____	
Soil Type: <input type="checkbox"/> A <input type="checkbox"/> B <input type="checkbox"/> C <input checked="" type="checkbox"/> D <input type="checkbox"/> E <input type="checkbox"/> F <input type="checkbox"/> DNK Hard Avg Dense Stiff Soft Poor #DNK, assume Type D Rock Rock Soil Soil Soil Soil

Geologic Hazards: Liquefaction: Yes/No/DNK Landslide: Yes/No/DNK Surf. Rupt: Yes/No/DNK	
Adjacency: <input type="checkbox"/> Pounding <input type="checkbox"/> Falling Hazards from Taller Adjacent Building	
Irregularities: <input checked="" type="checkbox"/> Vertical (type/severity) _____ <input checked="" type="checkbox"/> Plan (type) _____	
Exterior Falling Hazards: <input type="checkbox"/> Unbraced Chimneys <input type="checkbox"/> Heavy Cladding or Heavy Veneer <input type="checkbox"/> Parapets <input type="checkbox"/> Appendages <input type="checkbox"/> Other: _____	
COMMENTS: _____	
<input type="checkbox"/> Additional sketches or comments on separate page

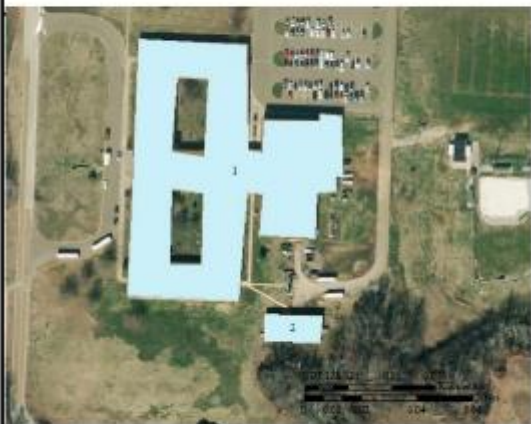
PHOTOGRAPH	Address: 100 EDUCATION AV Zip: 38058
	Other Identifiers: FNU0652
SKETCH	Building Name: MUNFORD MIDDLE SCHOOL (BRAND)
	Use: Schools

Latitude: 35.459614 Longitude: 89.802624
	Sr: 1.222 Sr: 0.118
	Screener(s): Abdulmutau Abdulhadi Date/Time:
	No. Stories: Above Grade: Below Grade: Year Built: 1992 <input type="checkbox"/> est
	Total Floor Area (sq. ft.): 5000 Code Year: 1991
	Additions: <input type="checkbox"/> None <input type="checkbox"/> Yes, Year(s) Built:
	Occupancy: Assembly <input type="checkbox"/> Commercial <input type="checkbox"/> <u>Elementary School</u> <input type="checkbox"/> Historic <input type="checkbox"/> Shelter Industrial <input type="checkbox"/> Office <input type="checkbox"/> <u>School</u> <input type="checkbox"/> Government Utility <input type="checkbox"/> Warehouse <input type="checkbox"/> Residential, # Units:
	Soil Type: <input type="checkbox"/> A <input type="checkbox"/> B <input type="checkbox"/> C <input checked="" type="checkbox"/> D <input type="checkbox"/> E <input type="checkbox"/> F <input type="checkbox"/> DNK Hard Avg Dense Stiff Soft Poor #DNK, assume Type D Rock Rock Soil Soil Soil Soil

Geologic Hazards: Liquefaction: Yes/No/DNK Landslide: Yes/No/DNK Surf. Rupt: Yes/No/DNK
	Adjacency: <input type="checkbox"/> Pounding <input type="checkbox"/> Falling Hazards from Taller Adjacent Building
	Irregularities: <input type="checkbox"/> Vertical (type/severity): <input type="checkbox"/> Plan (type)
	Exterior Falling Hazards: <input type="checkbox"/> Unbraced Chimneys <input type="checkbox"/> Heavy Cladding or Heavy Veneer <input type="checkbox"/> Parapets <input type="checkbox"/> Appendages <input type="checkbox"/> Other:
	COMMENTS:
	<input type="checkbox"/> Additional sketches or comments on separate page
