## VACUUM SYSTEM OF KLYSTRON REPAIR FACILITY FOR ELECTRON ACCELERATORS

KIU-12AM “AVRORA” klystron has been the main source of rf power for the accelerators for decades. Large accumulations of malfunctioning klystrons made it possible to recycle them using the donor parts, which are well preserved and still functional. Klystron repair process comprises of few stages and part of these stages requires maintaining the high vacuum inside the klystron and adjacent systems.

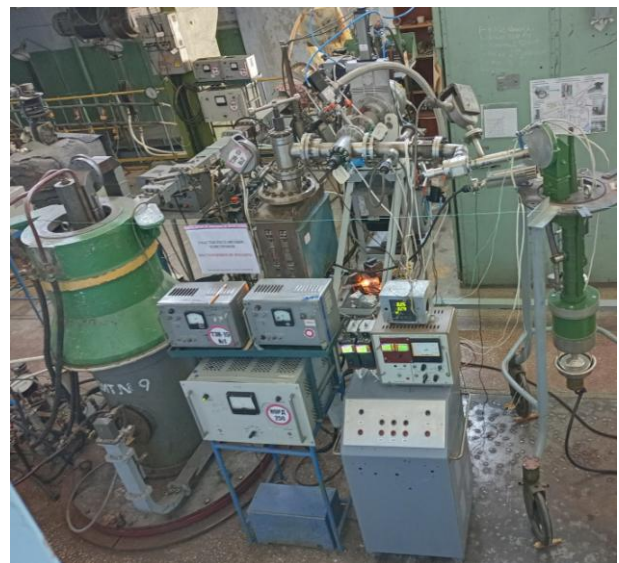
Fig. 3. Configuration of modernized vacuum system during klystron baking and cathode activation

During all previous restorations total time of baking and cathode activation lasted relatively long time (approx. 150 h) which was not acceptable in terms of cost and operational schedule. In order to reduce the total duration we decided to improve the system. The main part of vacuum system improvement is adding of the turbo molecular pump Turbo-V 750 Twis Torr with pumping speed 700 l/s. Turbo molecular pump is backed by Dry Scroll Pump TriScroll300 with pumping speed 210 l/s. Few additional valves and vacuum gauges were installed too. Vacuum system schematically presented in Fig. 2 and new appearance of it is shown in Fig. 3. Newly added elements of vacuum system are visible on the Fig. 2 above the horizontal dashed line.

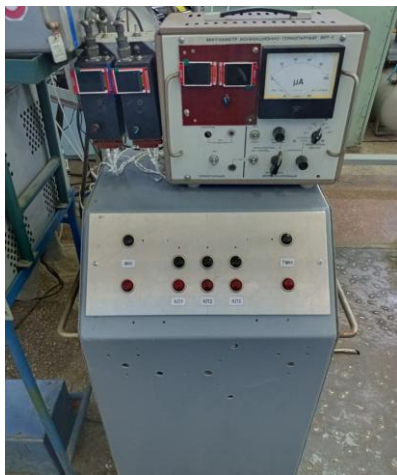
Fig. 5. Controlling unit of vacuum system

Safe operation of newly added equipment required presence of controlling unit that performs all necessary commutation and safety interlocks. Such controlling unit has been designed and manufactured. Safety interlocks have been incorporated for isolation of turbo molecular pump in case of accidental depressurization of vacuum system or power failure. Electric diagram of controlling unit and overall appearance of it are shown in Figs. 4 and 5.

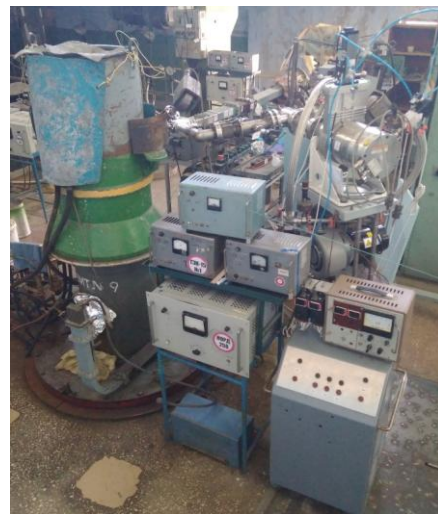
Fig. 6. Configuration of vacuum system during HV and RF training of klystron

Configuration of the system during HV and RF training of klystron is shown in Fig. 6.
