The 'Deluge' of 25 October 1822 in Genoa, Italy

Pietro Piana¹ and
Francesco Faccini^{2,*}

Floods in Genoa

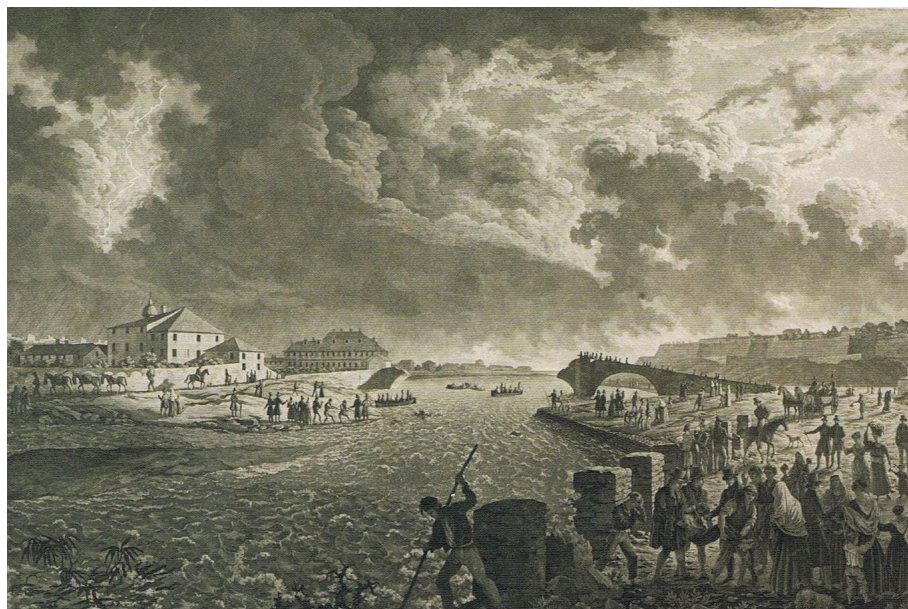
Figure 2. View of the Pila bridge over the Bisagno river near the walls of Genoa shortly after it was ruined by the great flood of October 26th, 1822, by Luigi Garibbo (*Veduta del ponte della Pila sul Bisagno presso alle mura di Genova poco dopo il suo diroccamento per la gran piena del 26 Ottobre del 1822*, Centro DocSAI, Collezione Topografica del Comune di Genova).

The first view is an aquatint that depicts the furious waters of the Bisagno and the collapsed Pila bridge in background with the church of Santa Zita on the left during the flood event (Figure 2). Children, women and men of all social classes are gathering along the right bank of the river where a body was just recovered from the water. On the right background of the image the walls of Genoa and the ancient gate of Porta Pila, which also gave its name to the bridge depicted. A second view shows the Bisagno from the same viewpoint as the flood is beginning to subside. Just like the previous view, some boats are crossing the muddy waters of the Bisagno but a provisional wooden bridge is already operational and communications between Genoa and the Eastern Riviera are restored (Figure 6.1). Evidence of the damage of the 1822 flood is also detectable from contemporary cartography, particularly

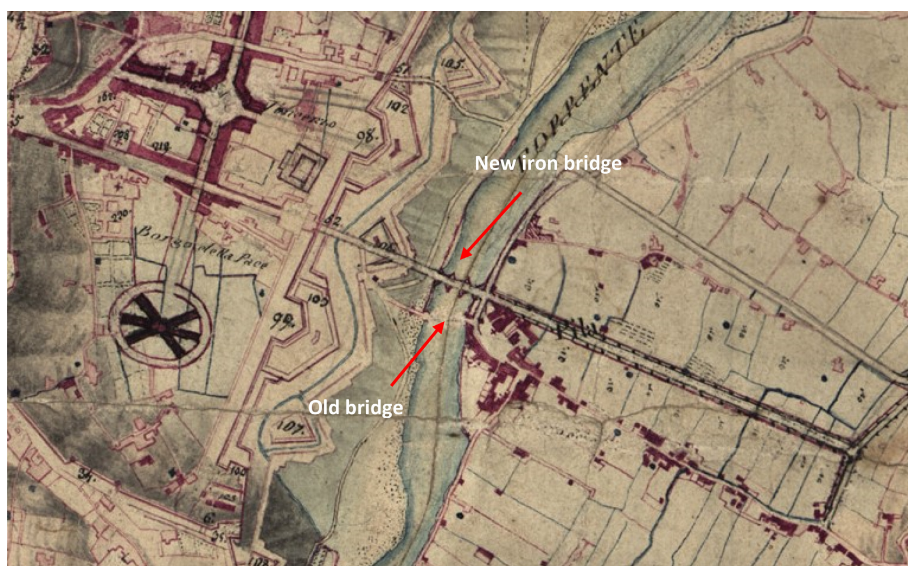
Figure 3. Stretch of the Bisagno Valley showing the new iron bridge and the erased collapsed bridge of Santa Zita, Archivio Storico Istituto Geografico Militare (*Riviera di Levante alla quarta della scala di Savoia ossia di 1:9450 eseguita negli anni 1816, 1822, 23, 24, 25, 1826 e 1827, foglio 78*).

from a topographical map produced by the Sardinian Kingdom where a detail of this stretch of the valley shows that the old bridge destroyed in 1822 was erased by the cartographer (Figure 3). After its collapse, Santa Zita bridge was replaced by a new iron bridge designed by the engineer Luigi Barbavara, which opened in 1835 (Podestà, 1878).

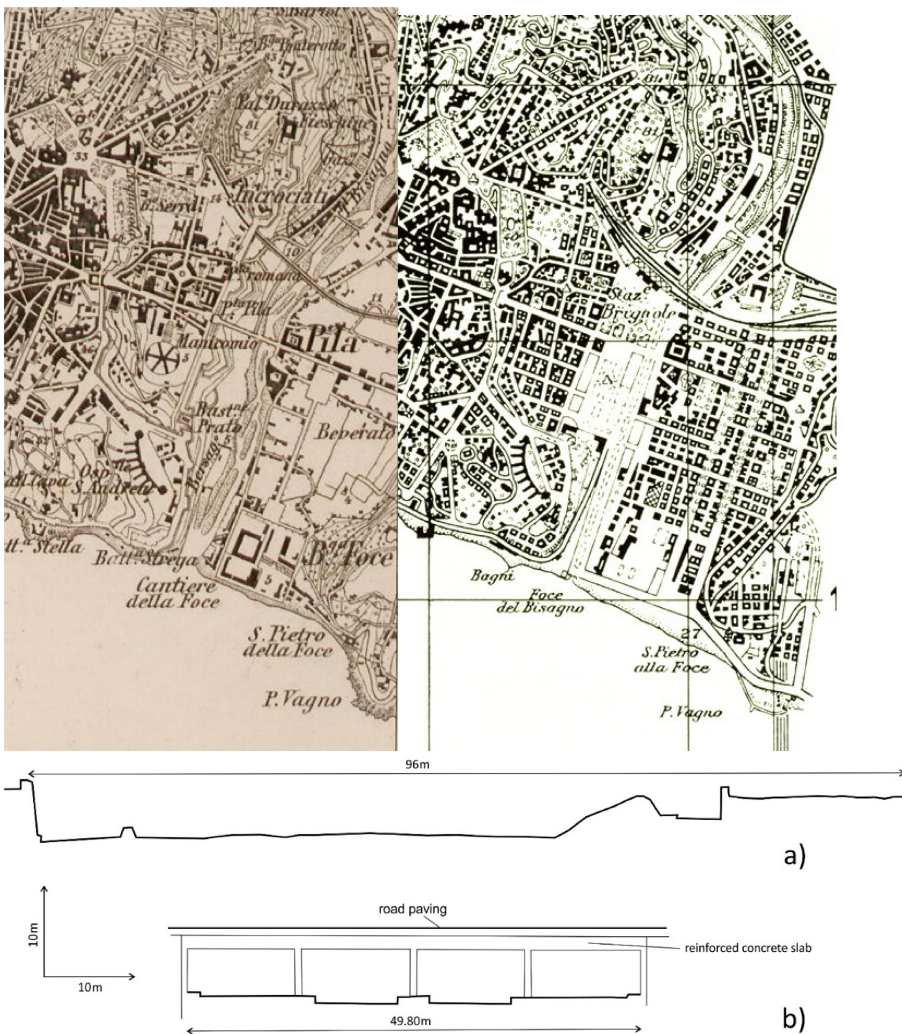
Figure 5. Historical map comparison (from Italian Military Geographical Institute maps, 1:25 000 scale, ed. 1878 and 1939) and corresponding stream cross-section at the mouth. (Modified from Inglese et al., 1909.)

This natural floodplain smoothed out the peak flow in the terminal section, which, as shown by historical maps, was characterized by historical settlements, gardens and a dense network of water channels for agriculture. With the gradual and often irrational urbanisation of the slopes, which also involved floodplain sealing, the main and minor river networks were narrowed, channelized and locally culverted, including the terminal stretch of the Bisagno, as shown in Figure 5.

At the beginning of the twentieth century, a team of hydraulic engineers was commissioned to design the culvert of the terminal section of the Bisagno. The hydro-meteorological data noted by Pagano, the surface effects described by the various iconographic and written sources were not considered significant, and a rectangular area suitable for disposing of an expected flood of $500\text{m}^3\text{s}^{-1}$ was designed (Figure 5; Inglese et al., 1909). Channelisation work on the first section began in 1928 and was completed in 1933; in 1934 the second overlay project was approved up to the mouth, which was carried out in 1936. The image comparison of Figure 6 shows the view of Garibbo and two present-day images from the same viewpoint and from an elevated position, providing evidence of the significant landscape changes the area went through in the last century.

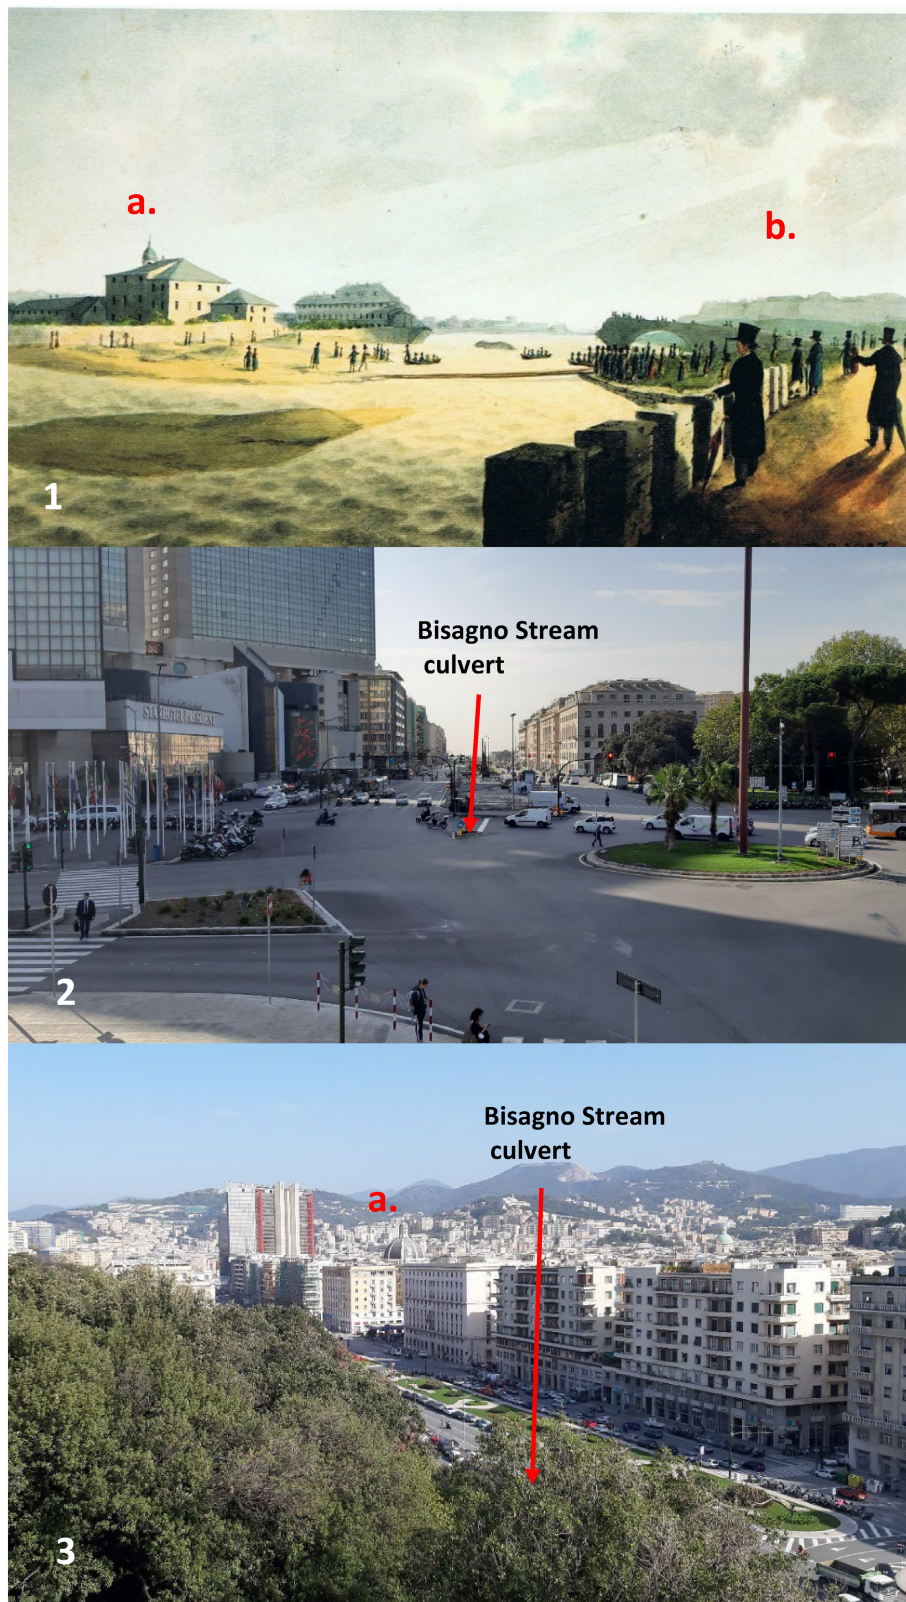
Figure 6. Landscape changes in the terminal stretch of the Bisagno between 1822 and today. (1) Luigi Garibbo, *Il Ponte Pila rotto dal Bisagno*, Centro DocSAI, Collezione Topografica del Comune di Genova (a. Church of Santa Zita; b. Santa Chiara walls); (2) current view from Garibbo's viewpoint; (3) current view from (b).
