XIX ANIDIS Conference, Seismic Engineering in Italy

## Push ‘o ver: in situ pushover tests on as built and strengthened existing brickwork constructions

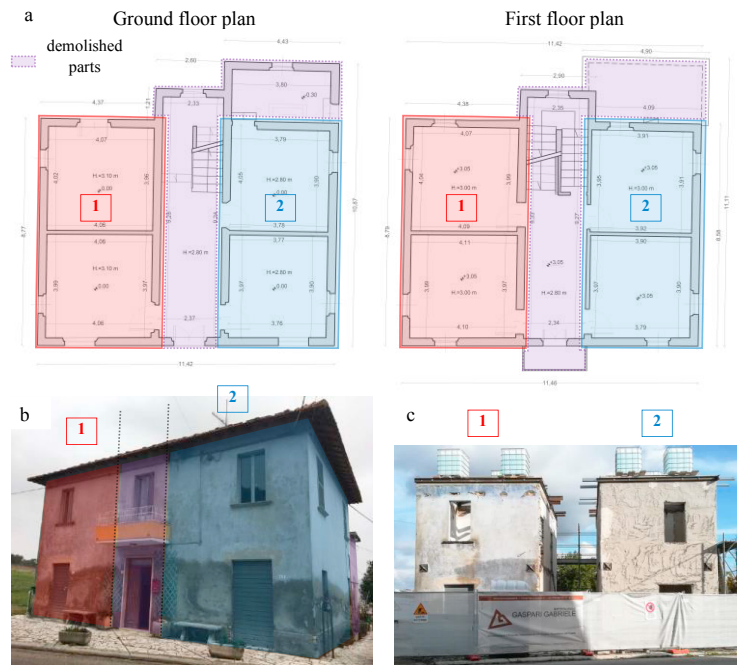
Fig. 1. (a) Ground and first floors plant of the building; (b) image of the original building; (c) derived buildings subjected to test.

The original building, used to derive the two structures investigated (Boccamazzo et al. 2022), is an area hit by the 2016 Central Italy earthquakes. It was built in the first half of the Nineteenth Century, and it was in a bad state of conservation, with diffuse cracking patterns due to the overmentioned seismic events. The building is a two-storey clay-brick masonry structure, with an almost square shape of 11.42 m x 10.87 m, and inter-storey height of 2.80 m (ground floor) and 3.00 m (first floor). Fig. 1a, shows the ground and first storey plans of the original structure, while Fig. 1b shows a picture of the main façade of the building before the interventions and the tests. The masonry structure is made with 2-headed bricks linked by a poor mortar with an overall thickness of 0.25 m. The left part of the first floor of the building is constituted by a jack arch supported by I-beams, while the right side was realized by joists with concrete reinforced precast "I" beams. The roof is built with wood elements, while the shallow foundation is masonry. The plan distributions of the walls, identify two seismic-resistant wall cells separated by a staircase that connects the ground level with the first floor. Once demolished the central staircase and the back annexe, such structural configuration allowed to divide the building into two similar portions, called building 1 and building 2, characterized by the same dimensions and resistance with respect to the horizontal forces (Fig. 1).

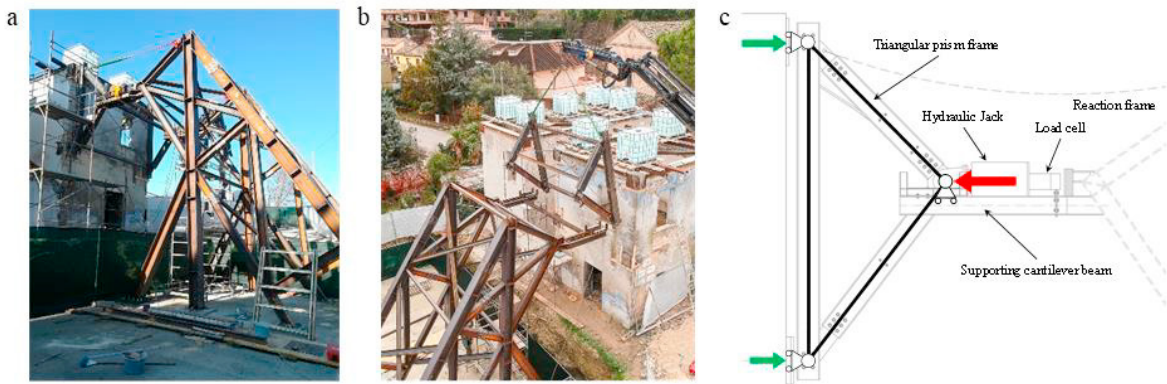
Fig. 3. (a) Pushing system during the test; (b) Assembly of the triangular steel frame; (c) Static scheme of the triangular steel frame.

In situ testing requires a strong reaction frame while imposing lateral loads by means of hydraulic actuators. For this purpose, a braced steel frame was built behind the test buildings. The pushing device, similar in concept to the one used in Mazzolani et al. (2004), was made of two portions: a reaction steel frame and a sliding triangular-prism frame, as shown in Fig.2a. Two hydraulic jacks with 5000kN capacity each and equipped with load cells, were adopted to apply the pushing force. A new foundation was built specifically for the test, and it is composed of a concrete slab supported by 8 drilled piles of 800 mm diameter. The pushing device was designed to allow its assembly/disassembly and shifting in the case of other buildings that might be subjected to this same test or other similar. An horizontal

cantilever beam fixed on the edge of the reaction frame supports the triangular frame (as shown in Fig. 3b,c) through a Teflon surface to minimize the friction force during the pushing phase. The ratio between the position of the contact points on the building and the height of hydraulic jacks defines the distribution of the forces applied. In this test the ratio between upper and lower forces is 1.28, to reproduce an inverse triangular pushing profile.

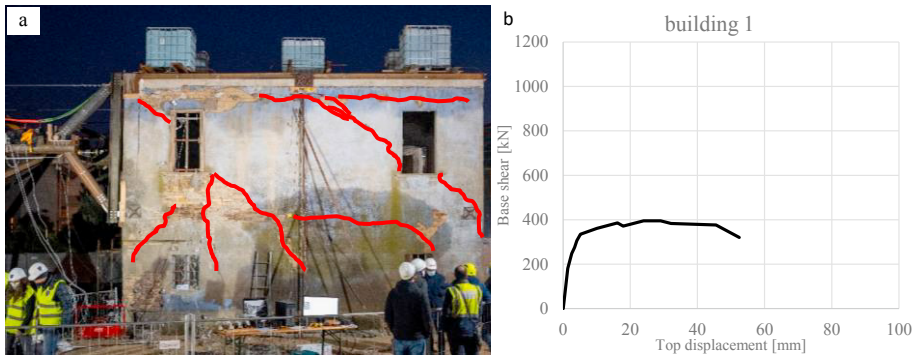
Fig. 5. Building 1: (a) cracks pattern at the end of the test; (b) pushover curve.

Fig. 5a and b report the cracks pattern, which characterizes building 1 at the end of the pushing tests (Fig. 5a) and the related pushover curve (Fig. 5b). The maximum level of force sustained by the building is 396 kN, while the maximum displacement is 53.5 mm. The cracks, underlined by red solid lines in Fig. 5a, are located to both horizontal spandrels and vertical masonry piers. Such cracks highlight the portion of masonry subjected to compression forces, which is mainly the masonry pier located between the openings, but also the sliding due to shear experienced by the concrete beam, located at the roof level. By focusing on the pushover curve, it is possible to observe a quite stiff initial elastic behaviour, up to a lateral force 335 kN with a displacement of nearly 5 mm, while the post-elastic one is characterized by a displacement of 47 mm. The maximum value of the inter-storey drift recorded during the test is close to 1.1% of the storey height, at the upper floor. Such value can be associated to the chord rotation experienced by the vertical pier. It is worth to observe that the Italian Standard NTC 2018 associates the ultimate displacement for a seismic action having a 5% of exceedance probability within 50 years, to a chord rotation that ranges between 0.5% and 1% for masonry piers subjected, respectively to sliding shear and to axial force plus bending moment in its plane. The drift shown by building 1, together with the cracks pattern showed, underlines the coherence of the building performance when subjected to lateral loads, with the code prescription for the safety assessments towards the Collapse prevention Limit State (CLS). The tests were stopped once it was recorded a significant reduction of the force resisted by the building, avoiding possible detachments of masonry.
