ECHOES OF DECLASSIFIED INTELLIGENCE SATELLITE PHOTOGRAPHS: THEIR ROLE AND APPLICATION IN THE RESEARCH AND PRESERVATION OF CHINA'S BUILT VERNACULAR HERITAGE

KEY WORDS: DISP (Declassified Intelligence Satellite Photographs), Vernacular Architecture, Heritage, Restoration, History Research, China.

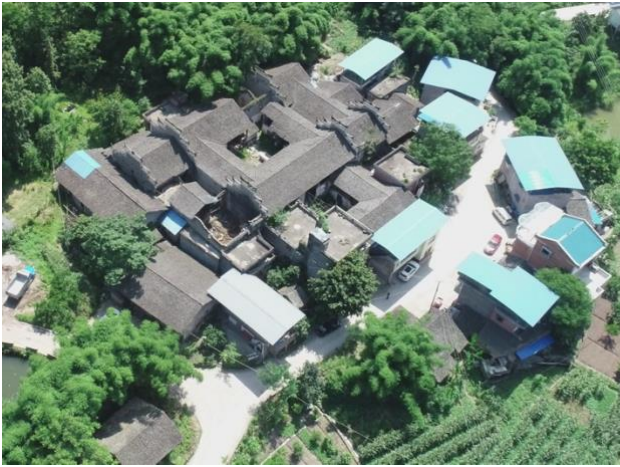
Figure 1. The Guo House in Yunyang is a result of the part remains, demolish, modification, and additions, © the author 2019.

Therefore, many cases, although survived these overwhelming social reforms, had already been subject to considerable change by the time they were listed as preservation targets (Figure 1). According to the criteria for declaring *Traditional Villages*, once the number of traditional architectures constitutes 1/3 of the total number, the village is qualified to be listed (Ministry of Housing and Urban-Rural Development et al., 2012).

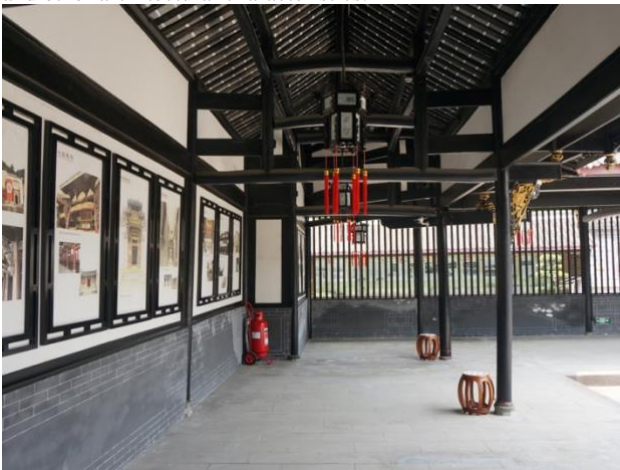
Figure 2. Chen House in Wenjiang was renovated as a museum © the author 2019.

For example, the Chen House in Wenjiang, Sichuan Province was restored in 2005 and opened to the public as a museum to display the traditional architecture and living culture of a previous gentry family (Figure 2). After the restoration, the house turns out to be an integral and exquisite architectural artwork and is appreciated a lot by tourists. It was listed as a monument at the national level in 2013. This house has been cited a lot, as an example of a gentry's house in the Qing Dynasty (1636-1911), by researchers in art/architecture history who conduct a lot of analysis on its layout, decoration, craft, and other architectural characteristics.

It was until we read an investigation report on this building which was compiled by Z. Liu and based on his investigation in the 1940s that we started to know how naive it is to take it for granted that the restored work is authentic remains of traditional architecture. In Liu's report, there used to be a *Baoting*¹, in front

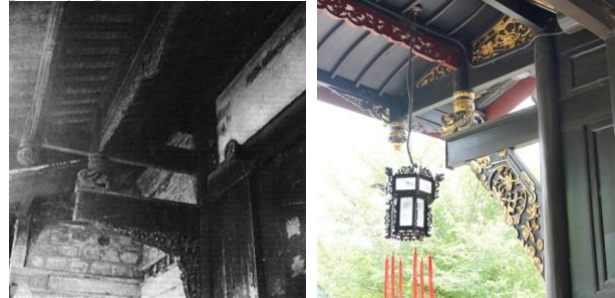
Figure 3. The difference in tectonic under the eave of the Chen House: before and after the restoration, left © Z. Liu 2000, right © the author 2019.

of the main hall and two *Wugongjia*² in the slender courtyard between the main hall and the back hall (Liu, 2000). But these two structures which were very typical in the traditional construction of Sichuan totally disappear in today's Chen House after the restoration. Besides, there are many inconsistencies in the decoration and tectonics between the restored works and the photographs taken by Liu in the 1940s (Figure 3).

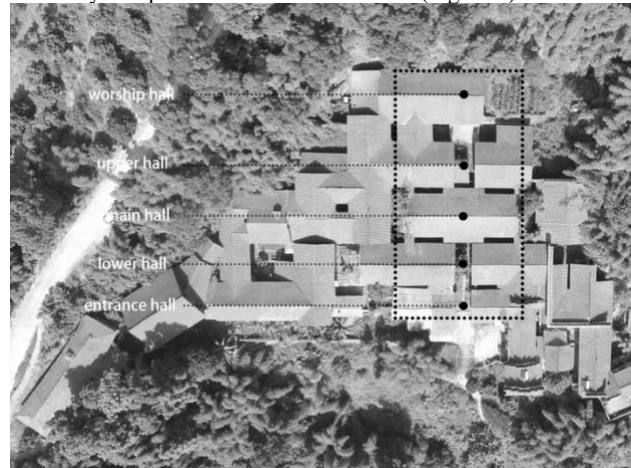
Figure 5. The remains of the Chen House in Jiangjin © the author 2019.

Here is a case, the Chen House in Jiangjin, Chongqing used to be the house of a local gentry surnamed Chen. In the *Land Reform* movement, this house was confiscated and allocated to over 20 peasant families, so it has been modified a lot by each family according to their own demands, with many demolitions and additions. With more people moving to the city in recent decades, the house was gradually abandoned and now occupied by only three families, in a worse situation. It was until 2014 this house was listed as a provincial monument because of the relatively complete architectural survivals (Figure 5).

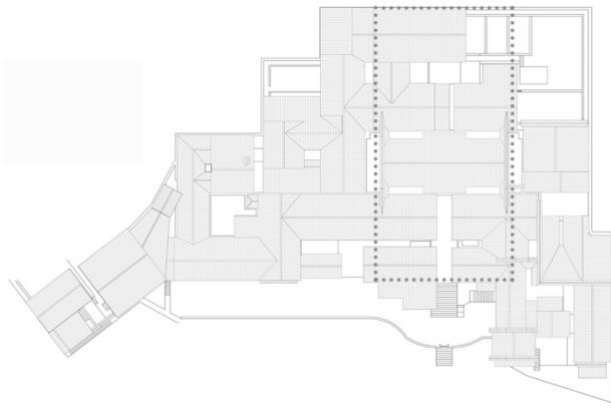
Figure 6-1. The current roof plan © CTDI 2014.

Based on the construction traces and interviews with left residents, we could know that the roofs of the entrance hall, lower hall, and upper hall, as well as the four *Baoting* above the small courtyards between those halls along the main axis, were removed in the last century (Figure 6-1).

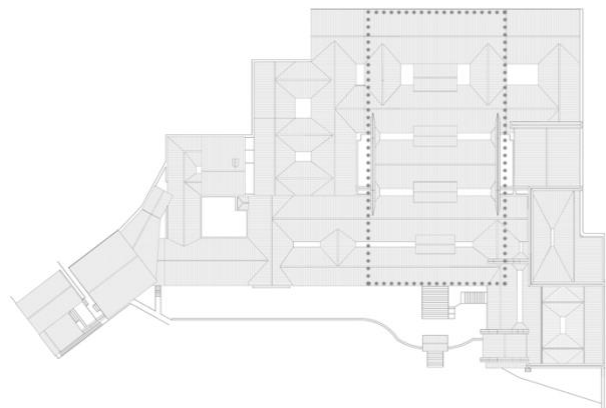
Figure 6-2. The hypothesized recovery design of the roof plan proposed by © the author 2021.

Based on the interviews and using other vernacular buildings in the surrounding area as a reference, we propose that the eaves of *Baoting* are higher than the eaves of the halls that they connect and formulate the hypothesized recovery design of the roof (Figure 6-2)

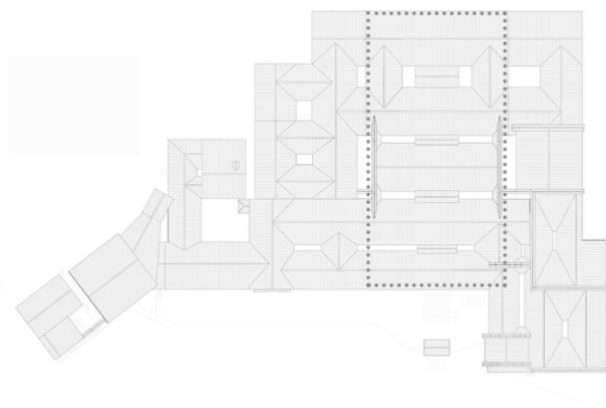
Figure 6-3. The hypothesized recovery design of the roof plan proposed by © CTDI 2014.

However, this design is different from the one shown in the official conservation plan for this house, proposed by Chongqing Tianyi Design Institute (CTDI) and approved by Cultural Heritage Administration in 2014. In this plan, the eaves of *Baoting* are of equal height with and directly connected to the eaves of the halls they connect (Figure 6-3).

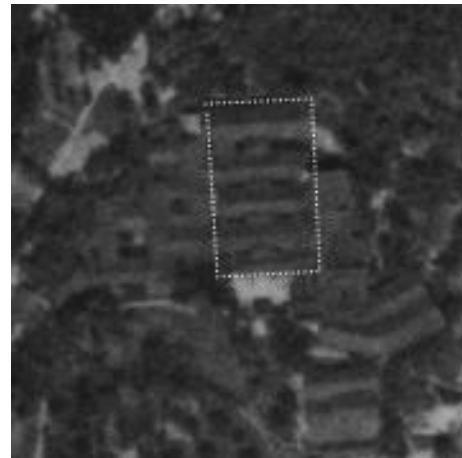
Figure 7. The satellite photograph of Chen House © USGS image database 1972.

We are lucky to find the satellite photograph of the Chen House which was taken on 17 July 1972 in the USGS image database. As we can see, *Baoting's* roofs partially overlap with the roofs of the halls they connect (Figure 7). This implies that the eaves of the former were higher than those of the latter. Thus, it can serve as strong proof that the hypothesized recovery design of *Baoting* in the conservation plan is wrong.

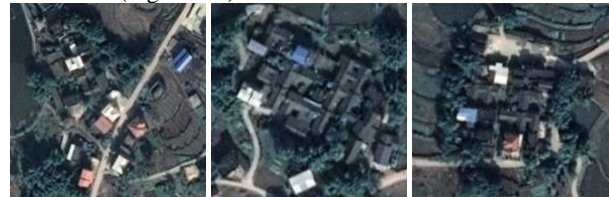
Figure 8-1. Current situation of several vernacular houses in Luxian © Google Earth 2023.

This is a small case to show the role of DISPs in providing reference to the restoration of some architecture. It reminds us of the existence of these photographs which we can refer to when there is difficulty in finding a reliable basis for restoration. Many cases face similar situations. In the Shipaifang village of Luxian, Sichuan, many vernacular houses have experienced big changes as different families who own different parts of the house have different adaptations and additions to suit their needs (Figure 8-1). The DISPs taken in 1979 provide a possible route to track their historical condition if there is a need for restoration (Figure 8-2).

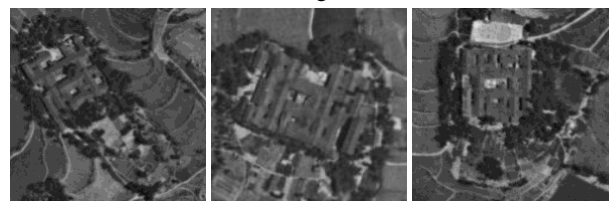
Figure 8-2. Historical satellite photographs of several vernacular houses in Luxian © USGS image database 1979.

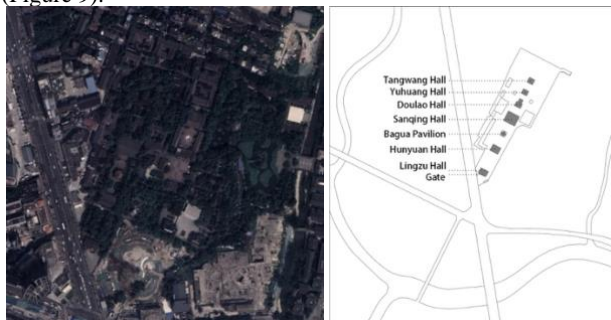
Figure 9. The current layout of Qingyang Temple, left © Google Earth 2023, right © the author 2023.

In the contemporary remains, along the axis lies the main gate with Lingzu Hall behind, Hunyuan Hall, Bagua Pavilion, Sanqing Hall, Doulao Hall, Yuhuang Hall, and Tangwang Hall (Figure 9).

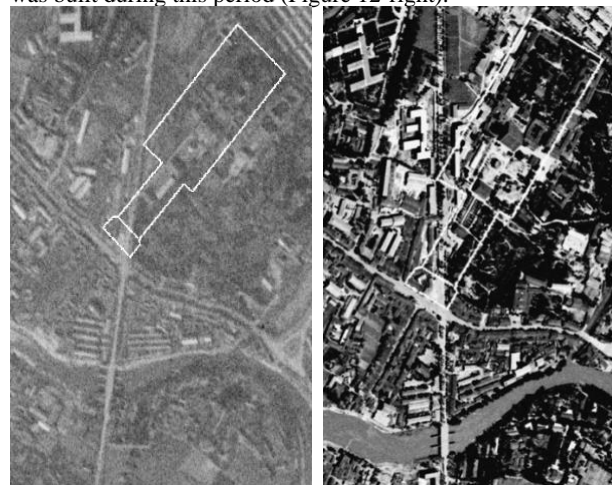
Figure 12. The historical maps of Qingyang Temple © USGS image database 1968, 1974.

Through a historical satellite photograph taken in 1974, we could find the clue. First, a new north-south road was built crossing the front part of the temple and it resulted in the removal of the original main gate and attached courtyard, with only a small part of the entrance square remaining (Figure 12-left). Second, the last hall depicted in the 1903 map is actually two adjoining halls which were simplified into one in the drawing. Third, the current gate was newly built, attached in front of Lingzu Hall. Since there was still no new gate in the 1974 satellite photograph but it had appeared in an investigation report published in 1992, we could speculate that the new gate was built during this period (Figure 12-right).
