Western and Central Asia. Satellite Imagery for the Study of Conservation and Restoration of Earthen Architecture. Research Carried Out between July and September 2022

Satellite Imagery for the Study of Conservation and Restoration of Earthen Architecture

Research carried out between July and September 2022

by Luca Volpi

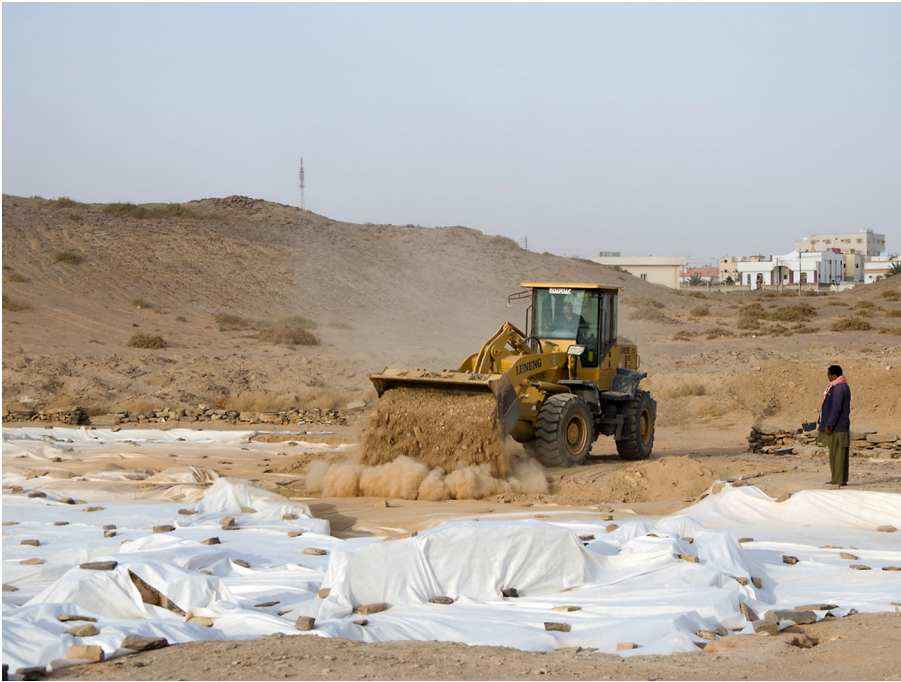
2 Examples of conservation and restoration techniques. Backfilling: Tayma, Saudi Arabia. (Photo: Hausleiter 2018, fig. 8)

- 4 Archaeologists working in Western and Central Asia have a major responsibility for the management of archaeological remains. Once excavated, the remains of earthen walls are re-exposed to decay agents. How to preserve these remains? Should they be made accessible to the public? Or is the alternative to backfill (Fig. 2) or even let them decay?

10 The first two approaches consist of indirect, passive interventions that do not directly impact the earthen structure. Backfilling is a preservative method consisting of re-covering the excavated archaeological structure with soil, and it is commonly used in ongoing excavation for protecting the structures from one campaign to another. However, it has its disadvantages in terms of the fruition of the archaeological property. The construction of temporary or permanent protective shelters is another passive, preservative method that does not directly impact the earthen structures but helps in their preservation, especially against weathering. Disadvantages are the following: impact on the landscape from both a structural and a visual point of view; the choice and availability of materials that should be (by preference) local, low-cost, of low impact, and durable; the decay of materials in time; the construction works that can seriously affect and endanger the archaeological structure; the placement of posts that should not affect the archaeological structure or even the underlying stratigraphy.

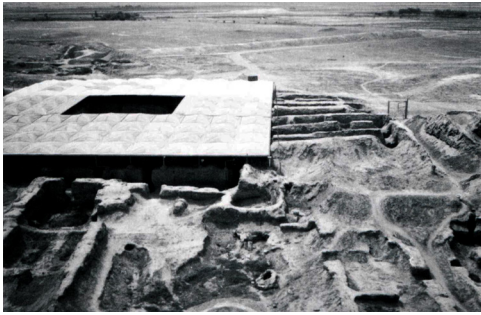
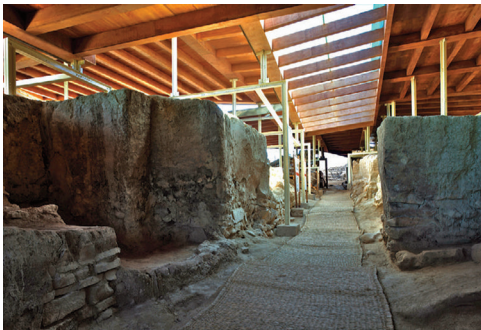
3 Examples of conservation and restoration techniques. Protective shelters: a. Mari, Syria; b. Arslantepe, Türkiye. (Photo a: Bendakir u. a. 2003, fig. 1; Photo b: Frangipane 2022, fig. 19)

1. Backfilling (see Fig 2).
2. The construction of temporary or permanent protective shelters (Fig. 3a. b).
3. Limited interventions on the structures without using stabilising materials (e.g. encapsulation, capping, filling voids and cracks with mortar, and covering the mudbricks with a plaster made of a lime-clay-straw mixture, Fig. 4a. b).
4. Interventions on the structures using stabilising materials as a hardener against weathering and other decay agents (Fig. 5).

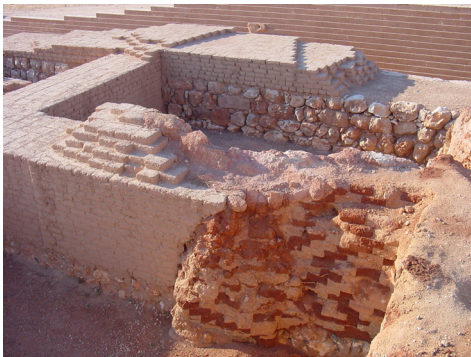
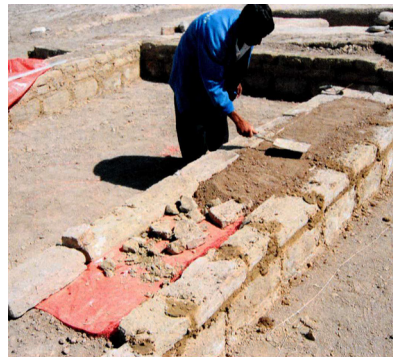
4 Examples of conservation and restoration techniques. Interventions without the use of stabilising materials: a. Konar Sandal, Iran; b. Ebla, Syria – Area Q of the Western Palace. (Photo a: Dehkordi u. a. 2011, fig. 6; Photo b: Nadali 2023, fig. 8)

11 The last two approaches consist of direct interventions on the structure. The most widely used procedure to date is the one based on limited interventions without the use of stabilising materials. It is carried out by using local earthen materials, and the new mudbricks are manufactured from the same clay found in the vicinity of the site to be preserved. These interventions appear useful and cost-effective. Maintenance is essential because they require continuous interventions to be effective, i.e. against weathering. These techniques also have the disadvantage of not being applicable when access to the site in question is no longer possible due to external factors. As for the use of stabilising materials, there is debate about the appropriateness of the use of chemical components in earthen architecture. On the one hand, their use as a hardener can be beneficial against weathering and other decay agents; on the other hand, their usage fosters change in the structural composition and stability of the architecture and poses issues related to sustainability and reversibility of interventions. Moreover, chemical components have the risk of being high-cost, hard to find locally, and environmentally unfriendly.

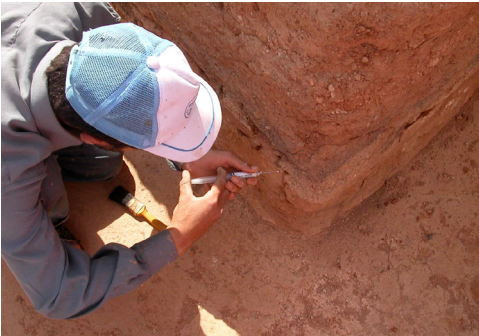
5 Examples of conservation and restoration techniques. Interventions with the use of stabilising materials: Ebla, Syria – Area Q of the Western Palace. (Photo: Nadali 2023, fig. 6)

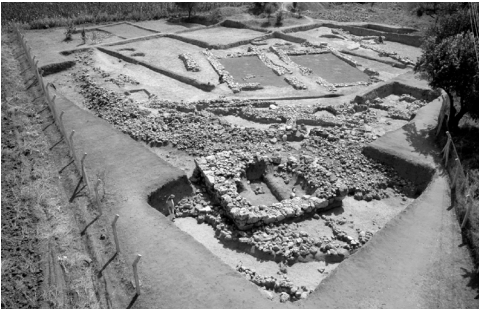
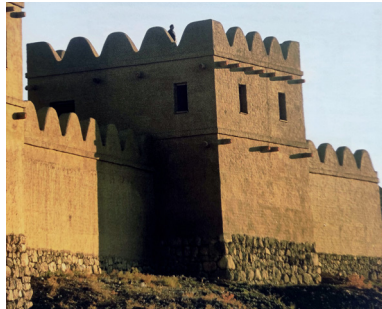
6 Examples of conservation and restoration techniques. Integrative reconstruction: a. Kanlıgeçit, Türkiye; b. Hattuša, Türkiye. (Photo a: Özdoğan 2016, fig. 2; Photo b: Seeher – Schachner 2014, fig. 10)

12 There are also two other possibilities, more restricted in terms of use and with several disadvantages, consisting of integrative reconstructions after backfilling (Fig. 6a. b) and encapsulation and capping interventions made with the use of backed bricks (Fig. 7).

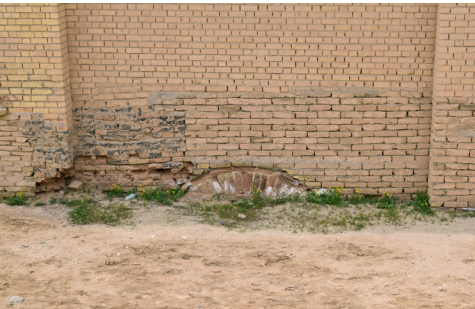
7 Examples of conservation and restoration techniques. Encapsulation and capping with backed bricks: Babylon, Iraq. (Photo: Luca Volpi)

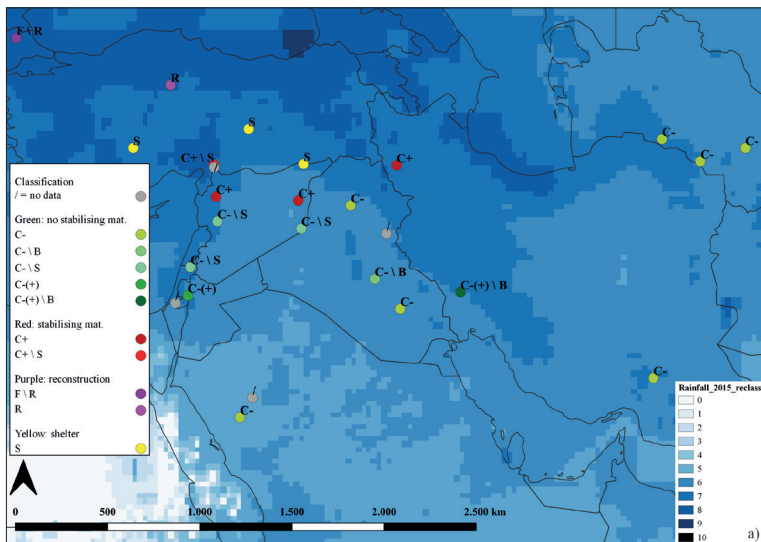
8 Reclassified rainfall map with site classification. (Data: https://neo.gsfc.nasa.gov/view.php?datasetId=TRMM_3B43M&year=2015 ⁷, Reclassified map: Luca Volpi)

Space Administration (NASA). In particular, **Moderate Resolution Imaging Spectroradiometer (MODIS) data** ⁷ have been used as a case study. MODIS is a satellite-based sensor used for earth and climate measurements. The program was launched in 2002 and furnishes images with daily and monthly data. **Rainfall** ⁷ and **snow and ice cover images** ⁷ have been used for weathering; Average Land Surface Temperature, for **the day** ⁷ and **night images** ⁷ have been used for wet-dry cycle. One year (as a case study) has been selected for each set of images. Twelve images (each for a single month) have been downloaded; they have been analysed using the open-source software QGIS; they have been merged together, and the value of each cell has been reclassified according to a specific range of values (algorithm GRASS r.reclass) [2]. The analysis has produced four reclassified images that are useful for evaluating the conservation and restoration procedures performed based on the environmental parameters taken into consideration (Fig. 8. 9. 10. 11).

15 Water erosion is one of the most dangerous for earthen structures. The amount and frequency of rainfall during a year is one of the main climatic parameters to be considered (Fig. 8). The selected sites are included in four classes (classes 5–8). The conservation and restoration procedures performed have considered this parameter, considering that where rainfall precipitation is more abundant, various approaches have been used to protect earthen architectures, from backfilling with reconstruction in **Kanlıgeçit** ⁷ (KLG) to the use of shelters in **Arslantepe** ⁷ (ARS), **Çatalhöyük** ⁷ (ÇAT), and Tell Mozan (MOZ), and to the use of stabilising materials, as for example at **Hasanlu** ⁷ (HAS), **Tilmen Höyük** ⁷ (TLH), and **Ebla** ⁷ (EBL). Sites where rainfall precipitation is less frequent, there is a more widespread use of the conservation technique without the use of stabilising materials, as we can see, e.g., in **Mari** ⁷ (MAR) and **Uruk** ⁷ (URK).

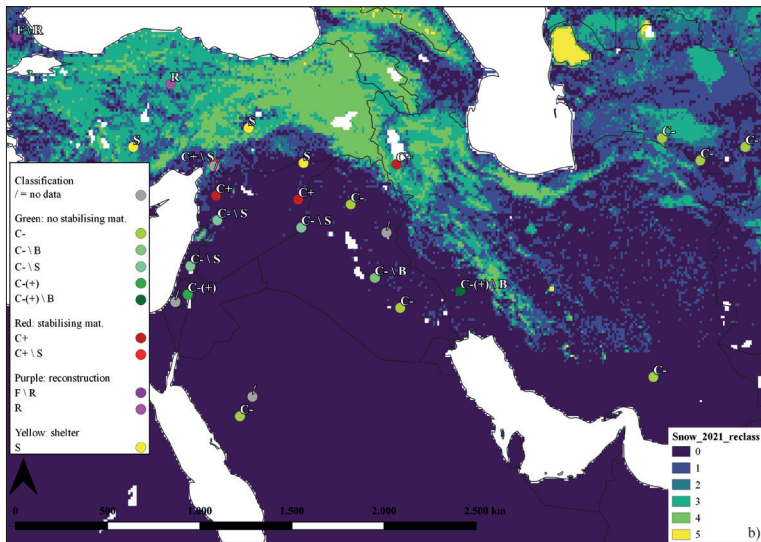
9 Reclassified snow-ice map with site classification. (Data: https://neo.gsfc.nasa.gov/view.php?datasetId=MOD10C1_M_SNOW&year=2021 ⁷, Reclassified map: Luca Volpi)

16 Snow is another important parameter among weathering agents (Fig. 9). In most of the selected sites in Western and Central Asia, snow is never attested. However, in the sites where snow is present for one or more months of the year (classes 3 and 2), its presence is dangerous for earthen
