**Ecosystem-based Approaches for Developing Resilience to Landslide Risk  
in Japan and Nepal**

A Thesis submitted to  
The Division of Sciences for Bioproduction and Environment  
Graduate School of Bioresources and Environmental Sciences  
and the committee on graduate studies of Ishikawa Prefectural University, Japan  
In Partial fulfillment of the requirements for the degree of Doctor of Philosophy.

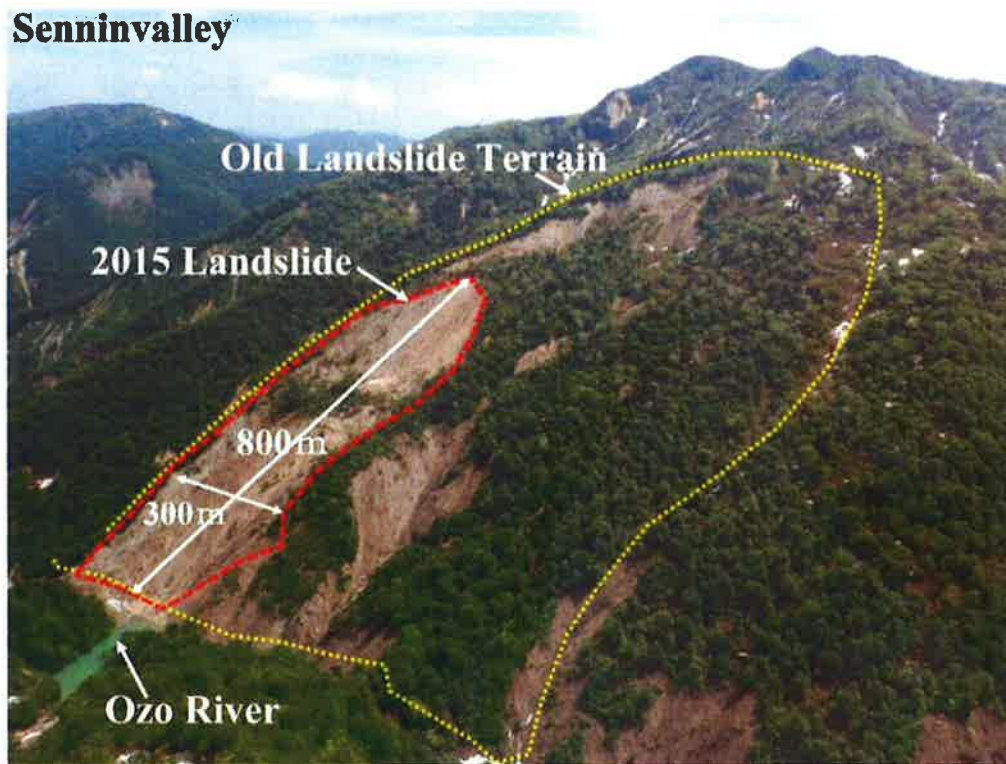
Figure 2 : 2015 Landslide overview showing the maximum horizontal length and width of the landslide (photo credit: Ishikawa Forest Management Office, 2016).

The 2015 Landslide has a maximum length of 800 m and a width of 300 m (Fig. 2). The elevation of the crown of the landslide is approximately 1560 m and the lowest depositional area (Ozo River) has an elevation of 1200 m. The maximum elevational difference observed was approximately 400 m. Fig. 2 depicts the Sennindani Landslide, the adjoining landslide topography (potentially old landslide terrain), and the Ozo River located at the bottom of the slope.

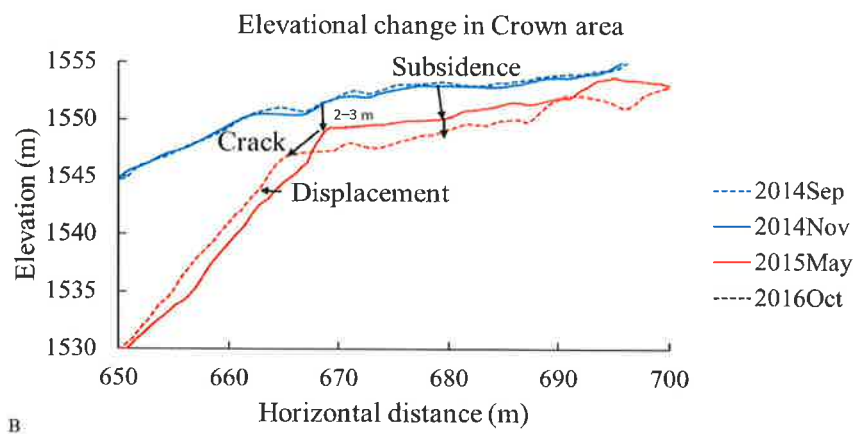
Figure 6 : Temporal longitudinal profiles derived from four periods from LiDAR-derived DEMs: (A) longitudinal profile of 2015 Landslide from crown to bottom toe areas (X–X’); (B) enlarged profile near the crown area (smaller rectangle B).

The geomorphic changes that occurred between November 2014 and May 2015 are presented in Figure 5B, which reveals the occurrence of the 2015 Landslide. In Figure 5B, the bluish color indicates that a large-scale landslide (ca. 1.3 million m<sup>3</sup>) occurred and deposited (reddish color) near the toe scar areas and valley floor of the Ozo River between November 2014 and May 2015. This 2015 Landslide occurred within just six months of the small landslide at the bottom. The slide occurred close to the crown-section (1560–1400 m) altitude and deposited at the bottom slope around the 1200–1400 m section of the landslide terrain. From the available LiDAR-derived DEM analysis, we estimated the longitudinal profile for four periods. Fig. 9A presents the longitudinal profile (X–X') from the crown to the bottom of the 2015 Landslide for four different periods. When longitudinal sections along the crown to the toe of the landslide were assessed, it was evident that approximately 350 m of the crown part slipped and was transported along the lower landscape (450 m horizontal length) to accumulate the produced debris along the 500 m section of the Ozo River. The 2015 Landslide significantly changed the upslope morphology and a concave slope formed after the occurrence of the landslide (Figure 6A).

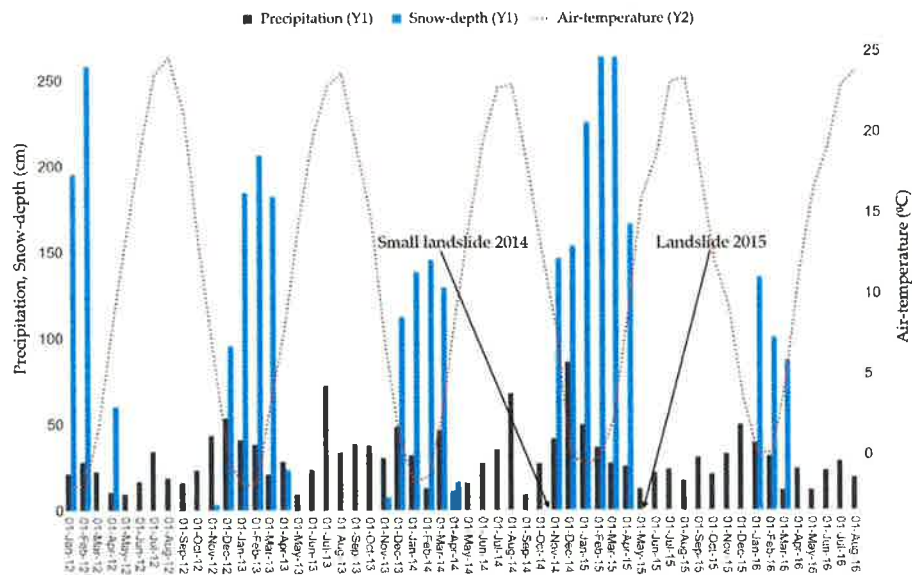
Figure 7 : Monthly precipitation, air-temperature, and maximum snow-depth levels in 2012–2016.

The temporal variations in the meteorological factors, including precipitation, temperature, and snow depth, which were analyzed to determine the relationship between water availability and landslide occurrence (January 2012–August 2016), are presented in Fig. 7. In this period, the peak daily precipitation reached 85.6 cm in the month of December 2014 and the maximum snow depth recorded was 263 cm in February and March 2015, which is the highest reading for the 2012–2016 study period. In the year 2015, the temperature started gradually increasing from the month of February, and from April onwards snow melting was observed.

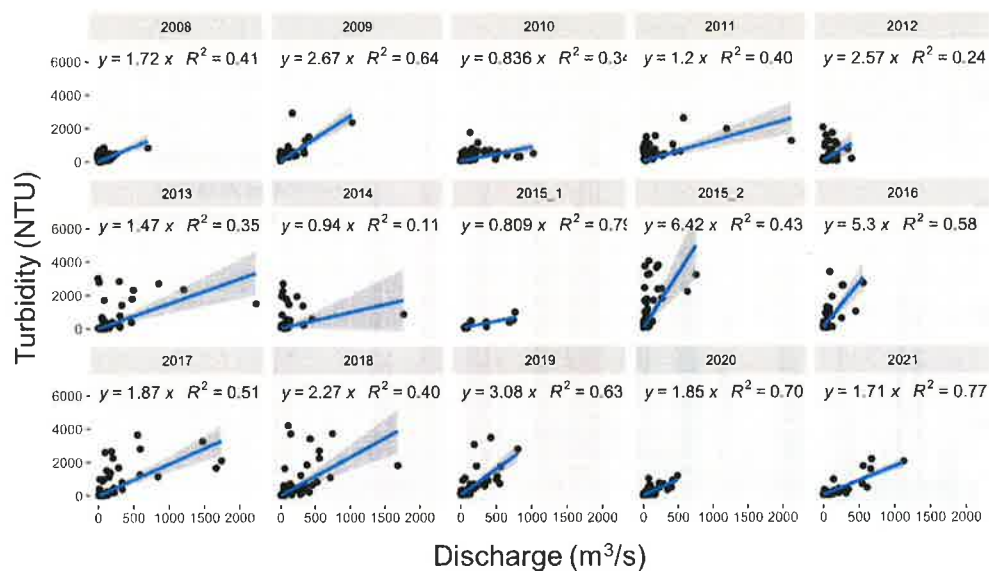
Figure 4. Changes in the relationship between discharge and turbidity for each fiscal year from 2008–2021. Sub figures for 2015 (before (2015\_1) and after (2015\_2) the landslide in May) are separately presented.

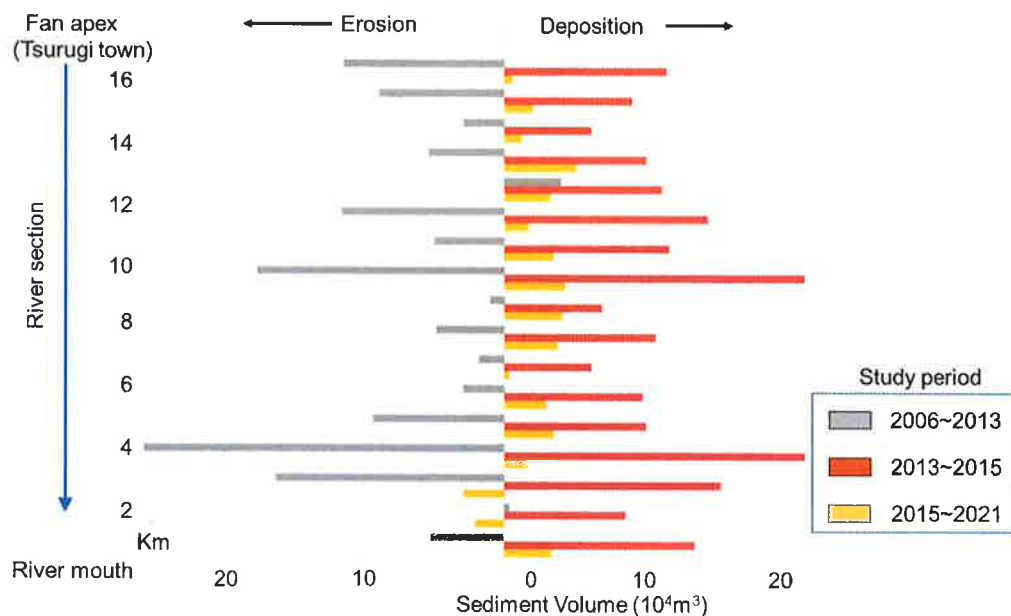
Figure 5. Erosion/sedimentation volume changes in 17 sections (each with 1 km length shown in Figure 1B) of the Tedori River for the three periods between 2006–2021.

The erosion and sediment deposition volumes for 17 sections of the Tedoru River (alluvial fan) were calculated from the LiDAR data for three time periods (2006–2013, 2013–2015, and 2015–2021), as shown in Figure 5. Of the 17 sections studied between 2006 and 2013, all showed a negative erosion trend before the landslide, except for section 2 near the river mouth and section 13 upstream, which exhibited a positive trend. In particular, sections 3, 4, and 10 were remarkably eroded, exceeding  $200,000 \text{ m}^3$ . Between 2013 and 2015, positive sedimentation (i.e., sediment accumulation) occurred in all 17 sections. During this period, sections 4 and 10 exceeded a sediment volume of  $200,000 \text{ m}^3$ , and a few other sections exceeded  $100,000 \text{ m}^3$ . Finally, between 2015 and 2021, a mostly positive trend was observed in sedimentation, although the sediment quantity ranged from  $20,000$  to  $50,000 \text{ m}^3$ . In addition, downstream sections 2 and 3 demonstrated negative sedimentation values.

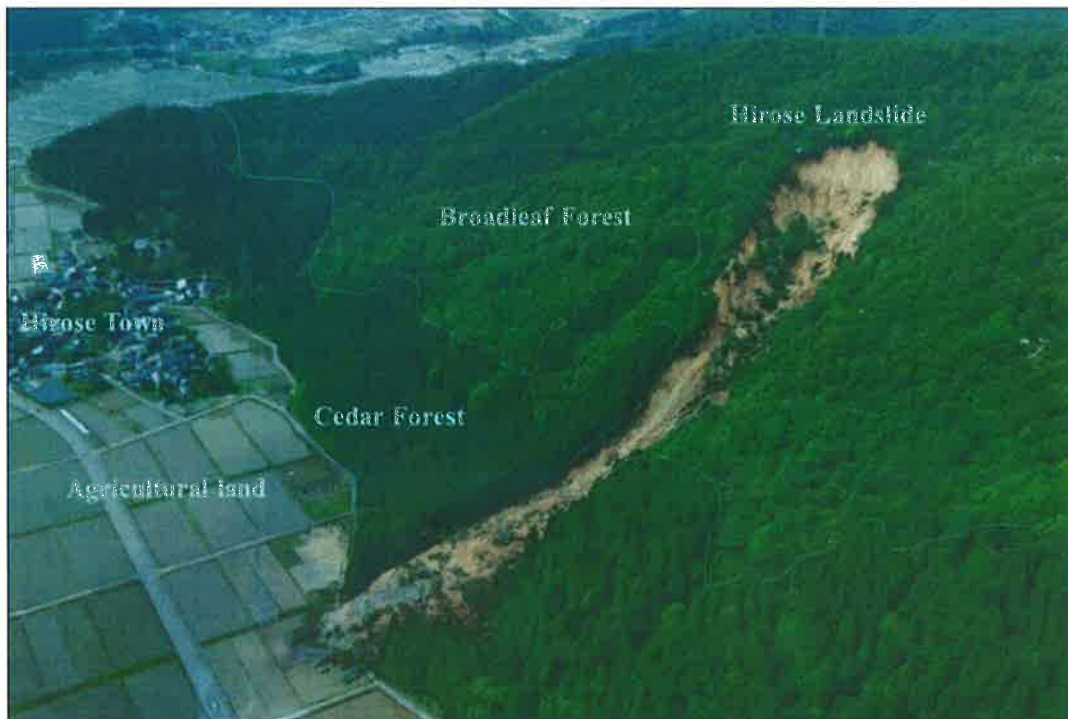
Figure 2: Panoramic view of the collapsed area taken from the helicopter (Source: Seiji Yanai, 2021)

It has an elevation range of 125m-385m with the land surface generally inclining from east to west. The area is located near a Hirose town settled on a river terraces on the left bank of Tedori river, which is 72km long perennial river that originates from Mt. Hakusan (2702m) and conflues in the Sea of Japan. The nearest settlement has 34 households (Figure 2) living around and cultivating the alluvial fan for vegetables and paddies production.

In this area, distinct river terraces are formed along the Tedoru River. River terraces have a specific height less than 10 m having a clear flat surface along the middle to lower reaches of the Tedoru River (Ishikawa Prefecture, 1987). In the Hirose Landslide area, the terraces form a flat surface with a horizontal distance of about 500 m from the Tedoru River, and mostly used as paddies production land. On the left bank of the Tedoru River, where the landslide occurred in 2021, a hill range with an elevation of 300-400m has developed continuously for 4-5km parallel to the river, and the mountain slope is steep with an average gradient of 30°. Furthermore, a distinct alluvial cone topography, with a width of 100 meters and a 15-degree slope, is continuously formed along the boundary between the river terrace and the hill slope. The tip of this cone overhangs the river terraces, forming a fan shape (Figures 1 and 2). The upper part of the slope has a steep valley-like topography.

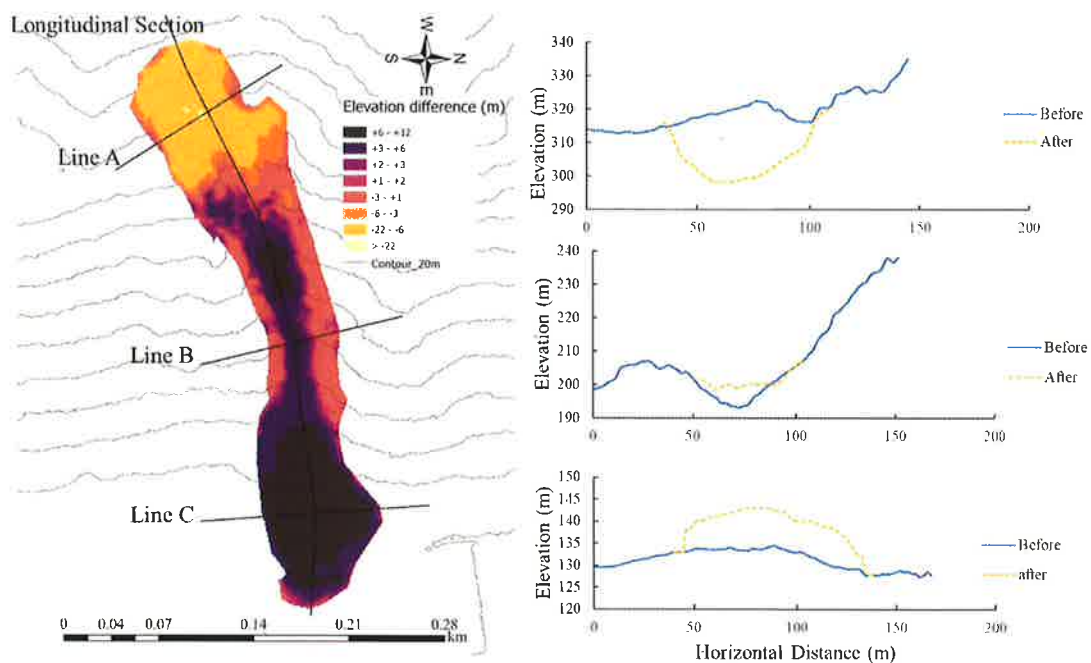
Figure 5: Topographic surface changes before and after collapse in three sections: Initiation section-Line A, Transport section-Line B, and deposition area-Line C.

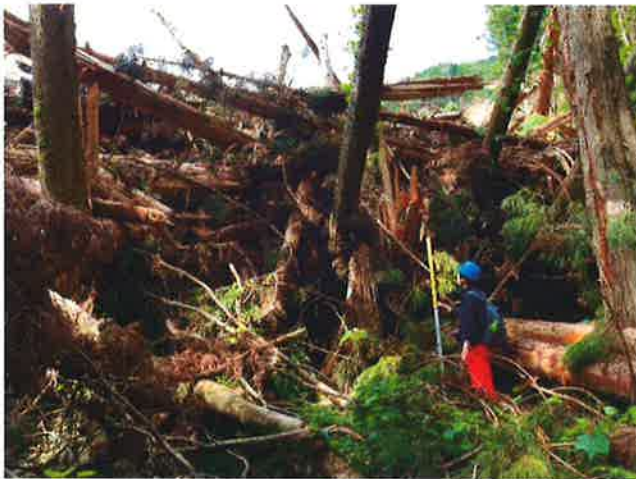
Figure 9: Sediment accumulation by “retentiondam” like structure of driftwood observed in the sedimentation area.

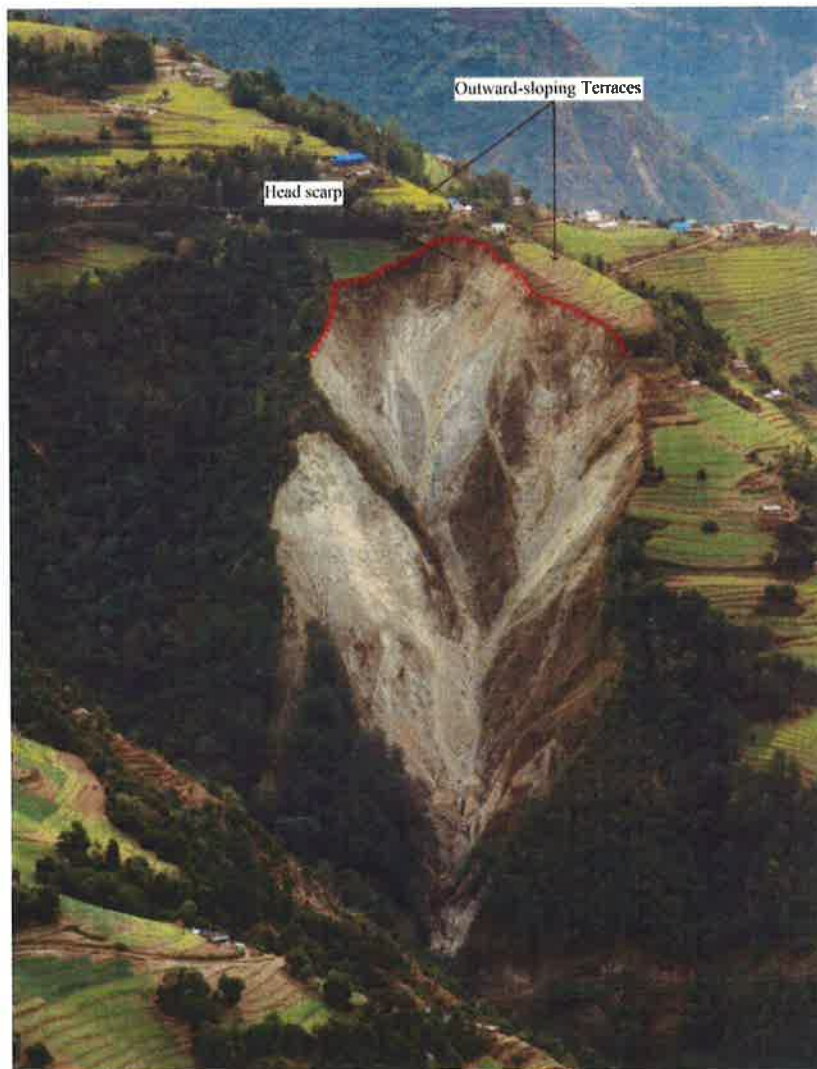
Figure 8. Overview of the Methum landslide; looking from north to south: outward-sloping terraces farming practiced around the Methum landslide.

inhabitants had been farming on the outward-sloping terraces for multiple generations, producing rice, wheat, mustard, and vegetables. For agricultural crops, such as rice and wheat, local farmers plow and hoe the sloping terraces to loosen the soil, as shown in Figure 8. Most of the landslide region has a slope of more than 50%, which is more susceptible to erosion.

On such steep slopes, practicing outward-sloping terrace farming increases the susceptibility of the surface to erosion following plowing and hoeing activities. The Asian monsoon rainfall then erodes these soil surfaces, forming gullies.

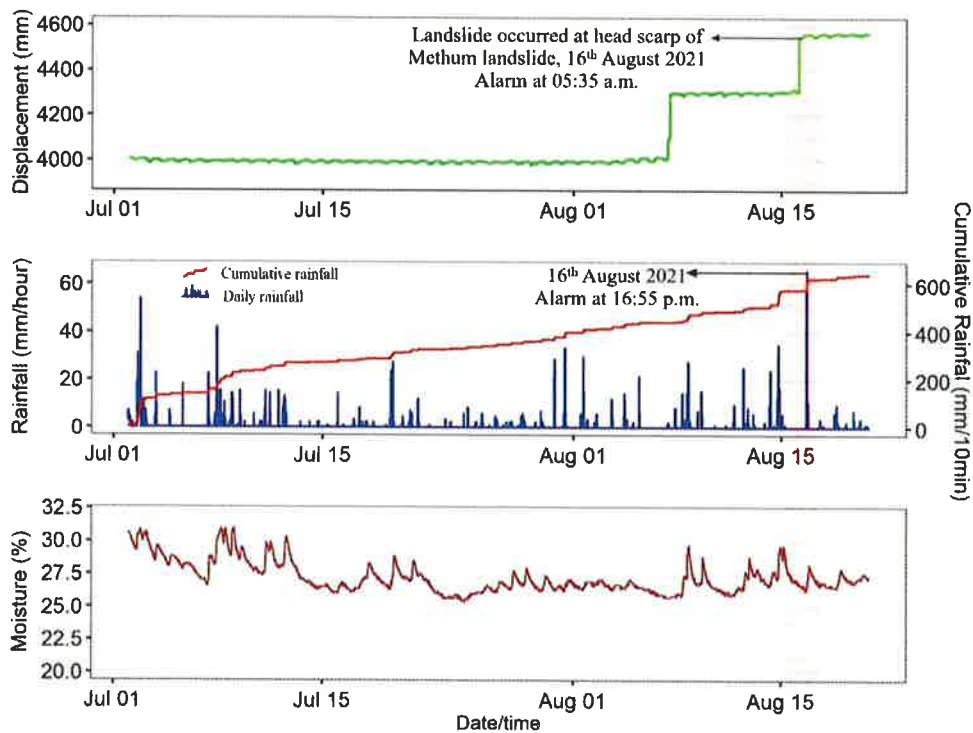
Figure 9. Displacement, rainfall, and moisture measured by LEWS for the Methum landslide.

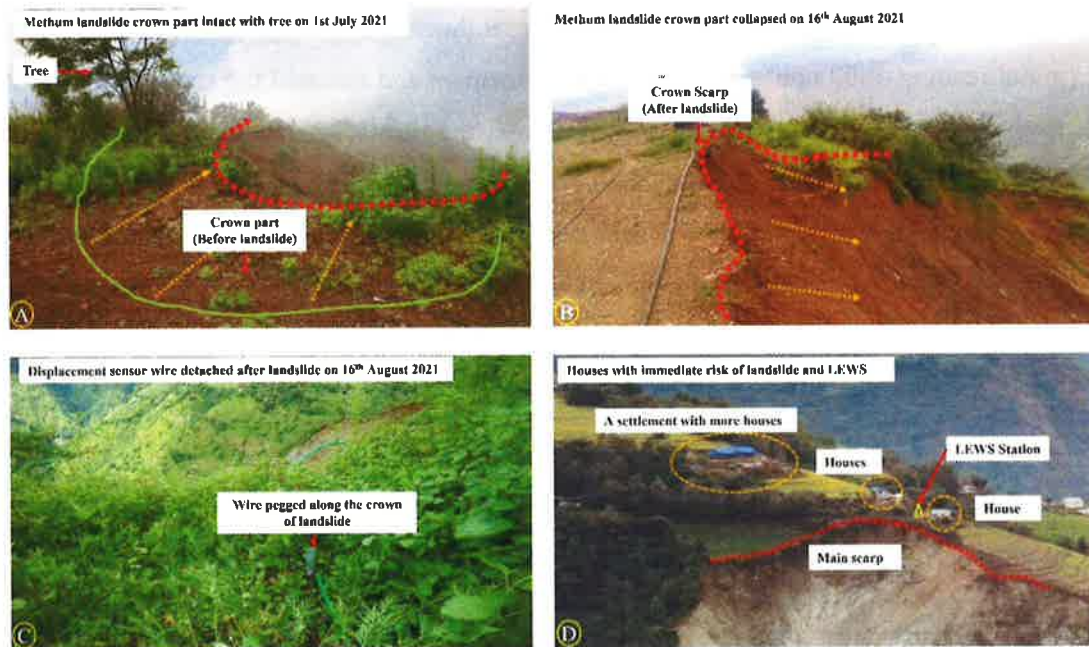
Figure 10. Methum landslide crown failure and vulnerable households: (A) head scarp of the Methum landslide as of July 1, 2021; (B) the scarp following the collapse on August 16, 2021; (C) detached wire from the displacement sensor on August 16, 2021; (D) houses and settlement above the landslide's main scarp.

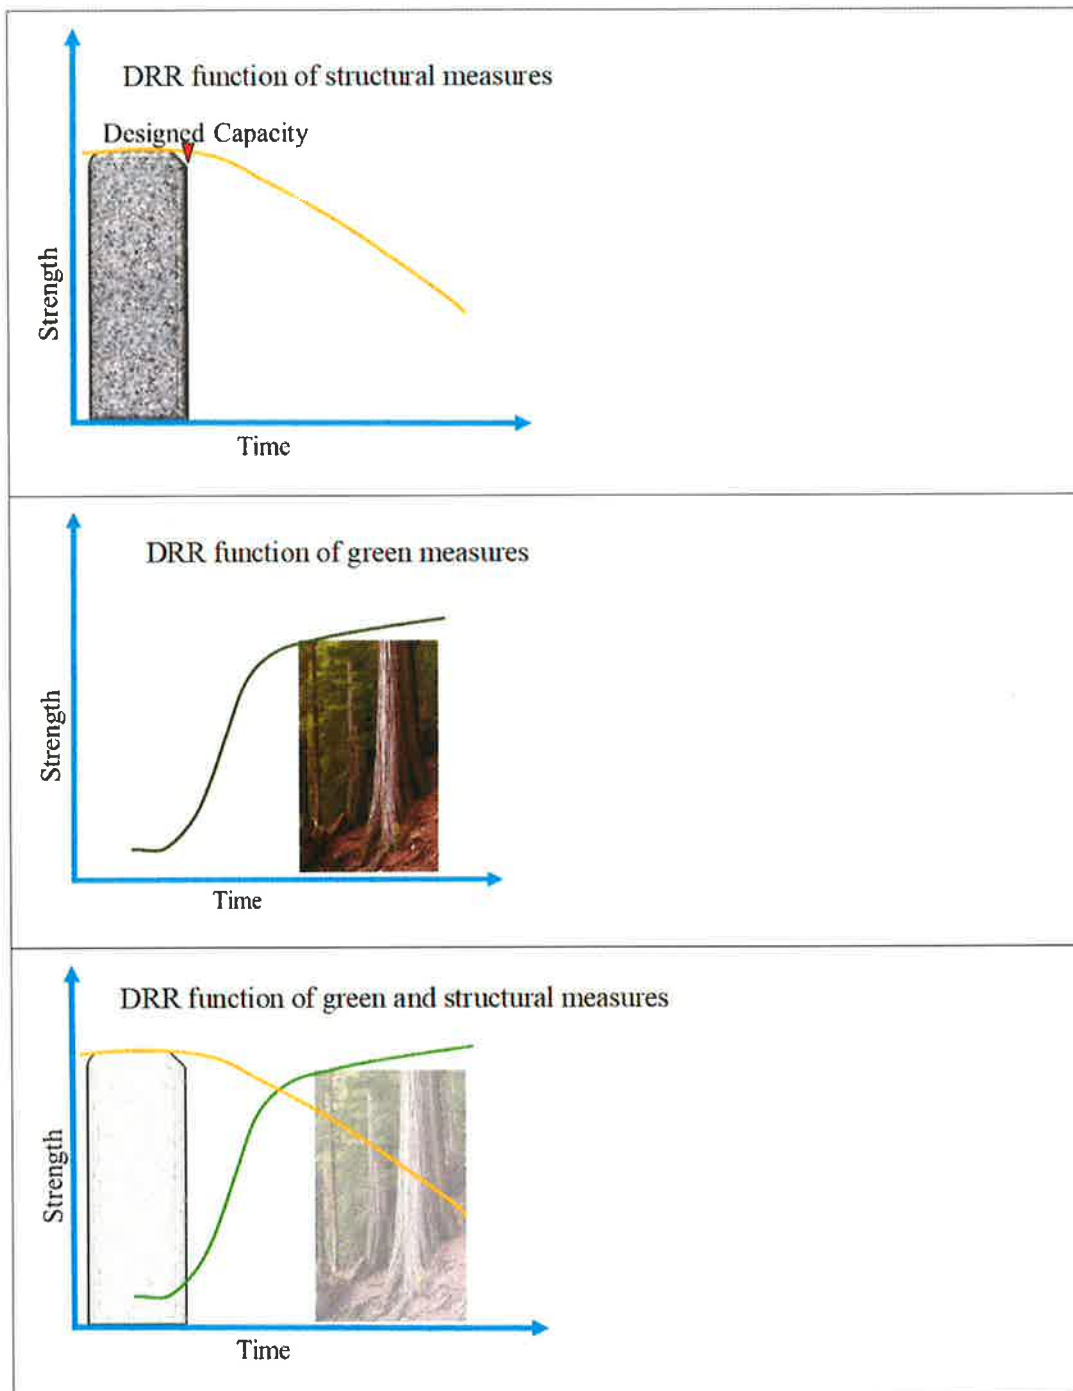
Figure 2: Lifetime of vegetative and civil engineering structures in normal condition (Adopted and modified from Natural Resource Management Handbook by Marongiu & Cencetti, 2013)

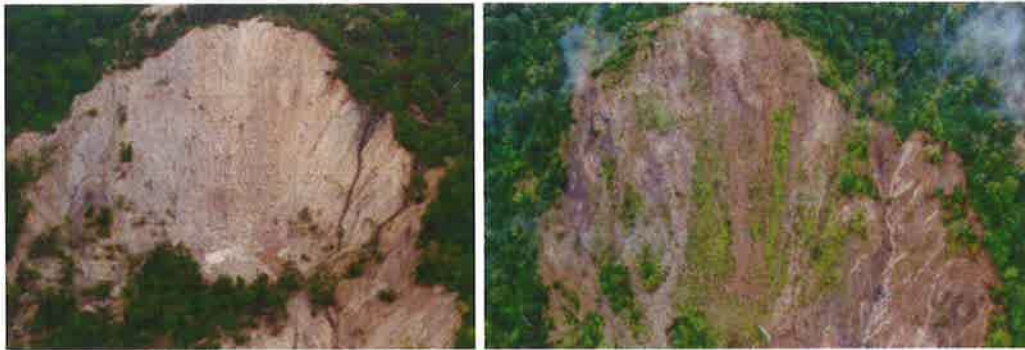
Figure 3: Photographs of the Sennindani landslide in 2015 (left) and 2022 (right) (Source: Forest Management Bureau, Chugoku Forestry Agency)

fertilizer and willow cuttings were broadcasted from 2017 to 2021, and organic erosion inhibitors were reapplied in 2020 and 2021. By 2022, green patches of planted grasses and trees had developed on the upper slope of the landslide. Hirose landslide occurred in 2021 in Hirose-town, Hakusan City, in Japan. Cedar trees were found to be effective in minimizing debris flow of this landslide. Cedar trees planted across the lower belt of the landslide acted as a barrier to stop debris flow and mitigate sediment spreading. The Methum landslide in Nepal posed a threat to settlements and agricultural lands, and a Landslide Early Warning System (LEWS) was used to monitor the landslide movement. The LEWS system monitored rainfall, land displacement, and soil moisture. This LEWS proved effective in some incidences of Methum landslide reactivation by providing alarms when the set thresholds were exceeded.

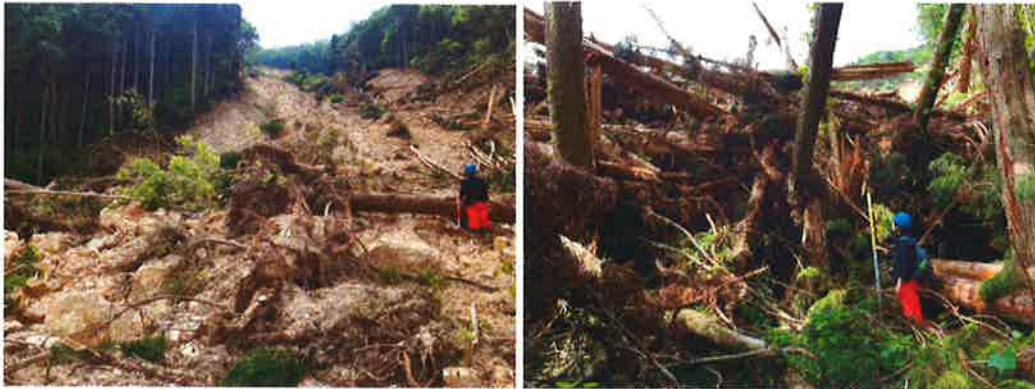
Figure 4: Photographs of the Hirose landslide: trees fallen due to debris flow (left) and retention dam-like structure at the bottom (right) (Photo source: Yanai, S., 2021)
