## Earthquake Tests on Midbroken Scale 1:5 Reinforced Concrete Frames

# INSTITUTTET FOR BYGNINGSTEKNIK

FRACTURE & DYNAMICS  
PAPER NO. 99

MAY 1997

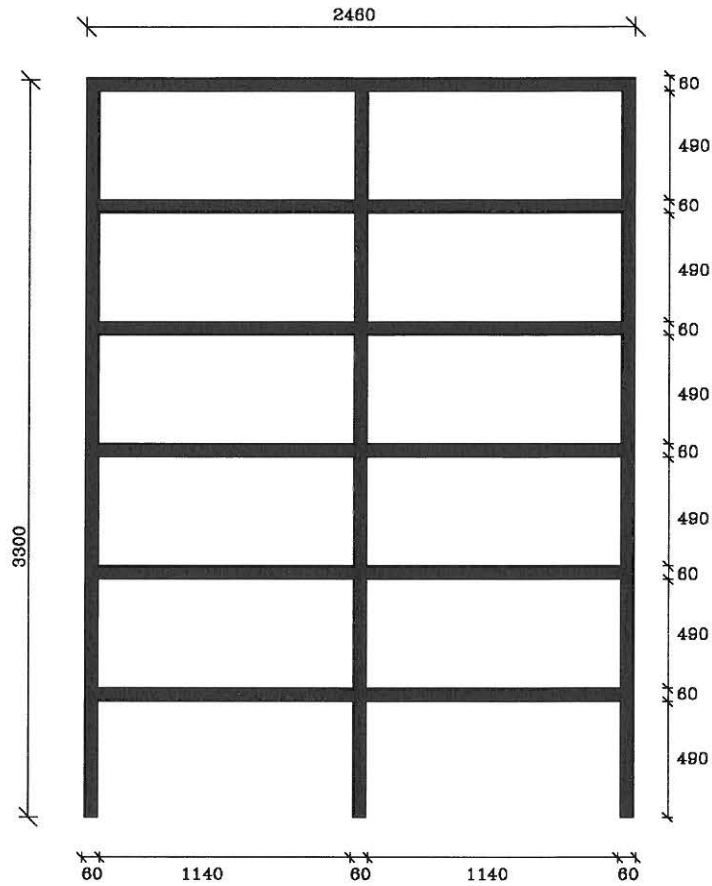
Figure 2.1: Plane view of test frames.

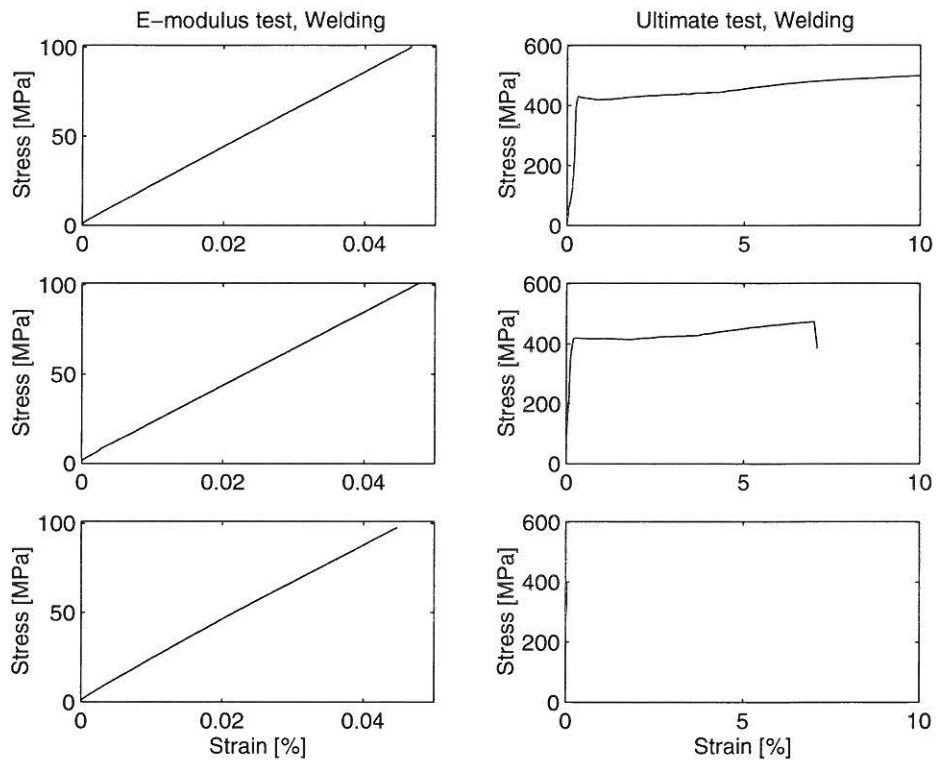
Figure 2.4: Stress-strain curves obtained from the three reference specimens of the welded connection between KS550 and St37.

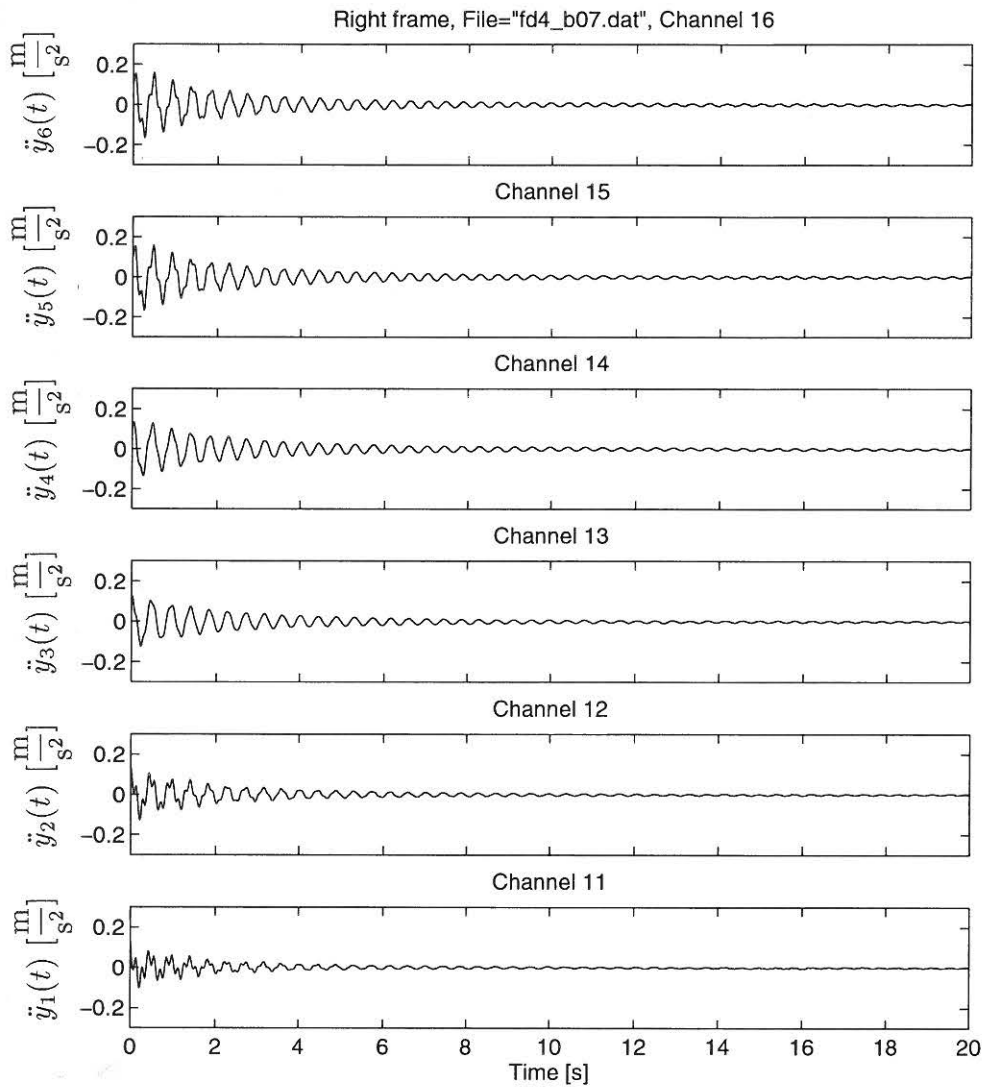
Figure 4.2: Measured accelerations from pull-out test of frame AAUW after EQ1. Pull-out force of 0.5 kN.

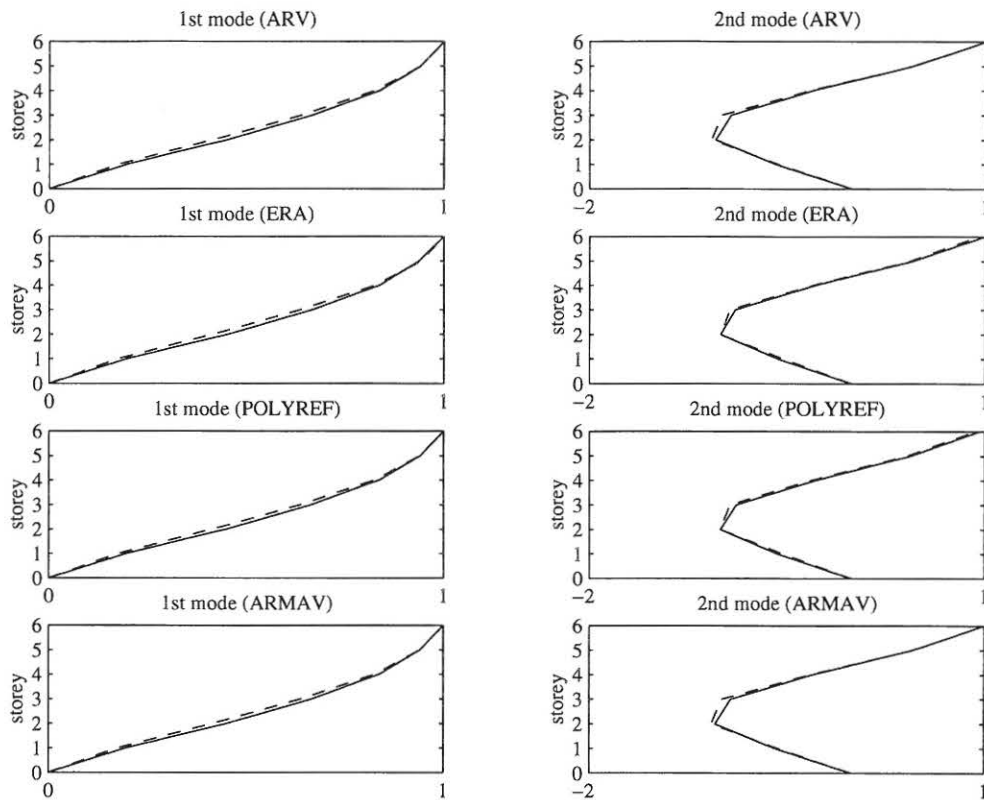
Figure 4.9: Estimated mode shapes of frame AAUW after EQ1. Pull-out force 0.50 kN. [—]: Virgin structure. [— —]: Damaged structure.

From figures 4.6-4.16 is concluded that generally only small changes in the mode shapes occurs during the damage process. Hence these seems of little use for application in damage localization and quantification procedures.

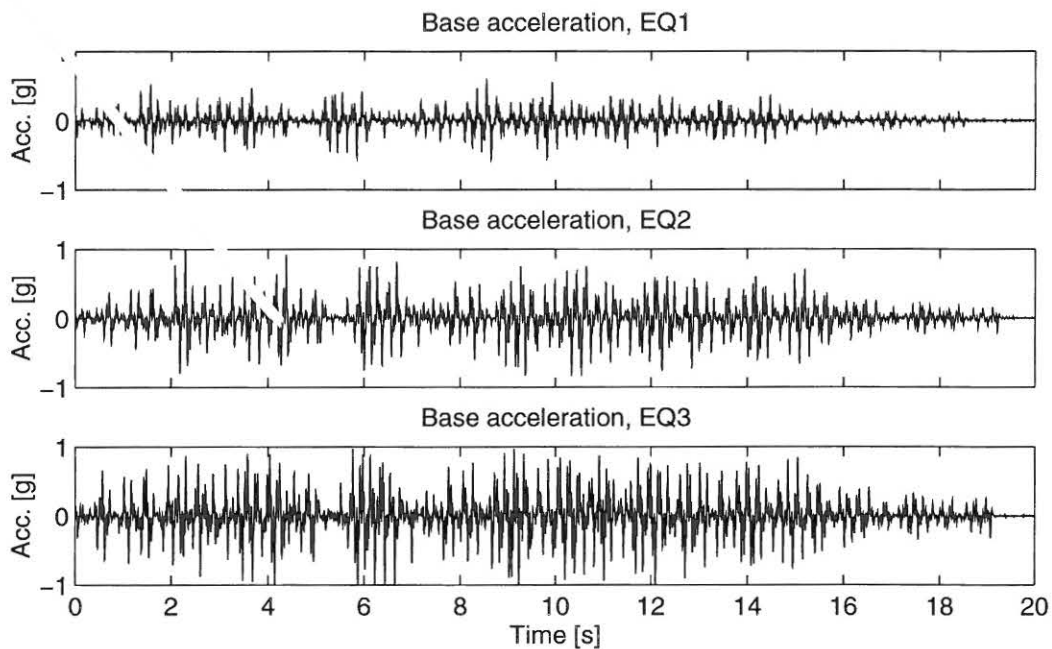
Figure 5.1: The three applied earthquakes in units of g.

In this chapter data sampled during and after strong motions are presented. In the destructive testing the frame AAUW is exposed to three sequential earthquakes of increasing magnitude called EQ1, EQ2 and EQ3. These are shown in figure 5.1.

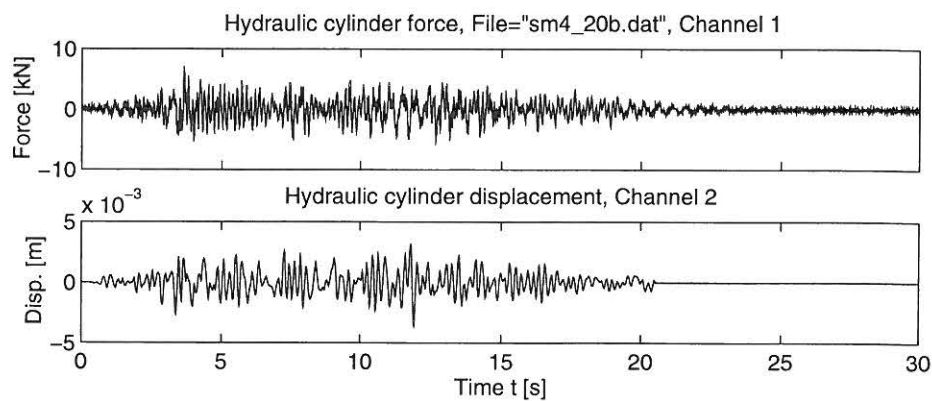
Figure 5.3: Measured shaking table displacement and cylinder force during EQ1 for frame AAUW.

In figures 5.3, 5.5 and 5.7 the applied cylinder force and displacements are shown during the three runs, respectively.

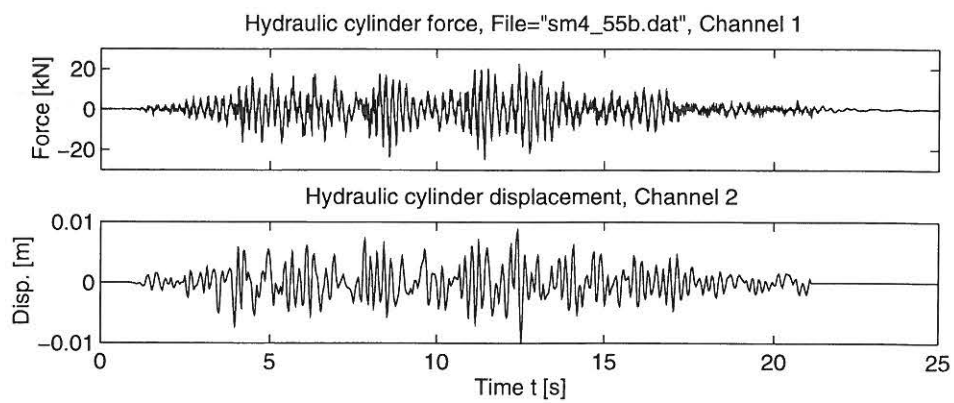
Figure 5.7: Measured shaking table displacement and cylinder force during EQ3 for frame AAUW.

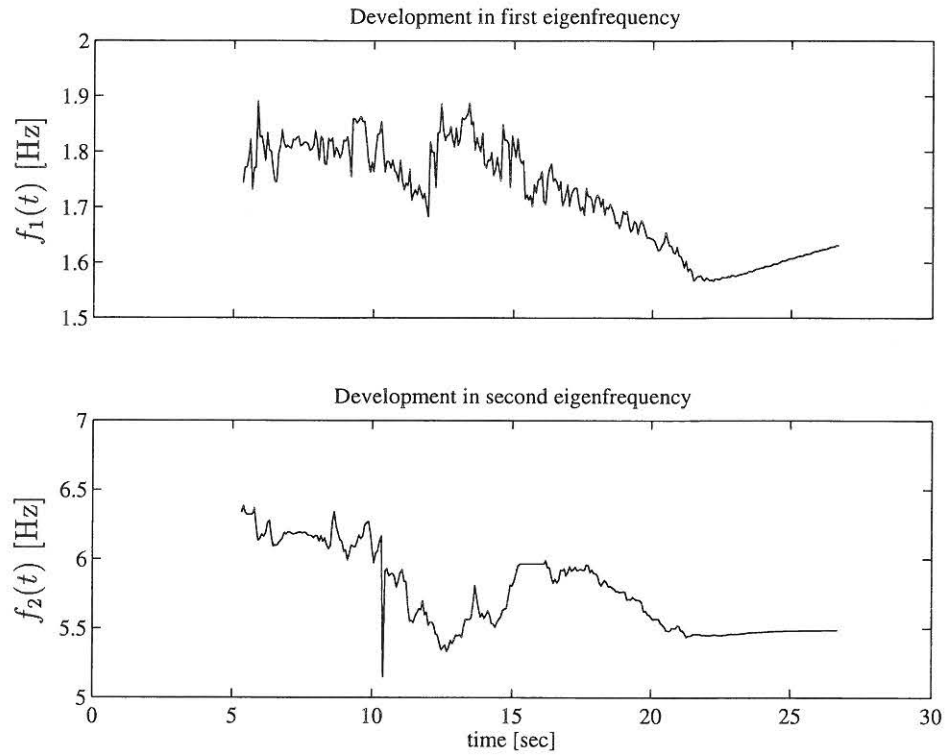
Figure 5.13: Development of eigenfrequencies in first and second mode during EQ2.

In order to evaluate the development of the natural frequencies of the structure during the earthquakes a recursive implemented ARMAV model have been fitted to the measured acceleration time series, see Kirkegaard et al. [15]. The evaluated development in the two lowest eigenfrequencies are shown in figures 5.12-5.14 for the three earthquakes, respectively.

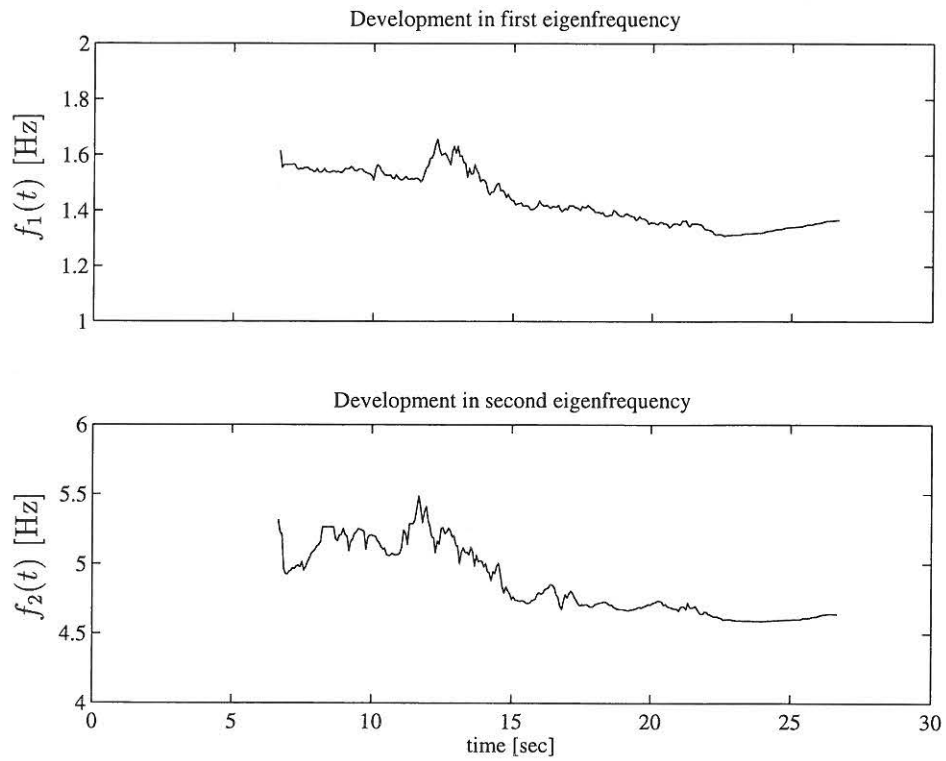
Figure 5.14: Development of eigenfrequencies in first and second mode during EQ3.

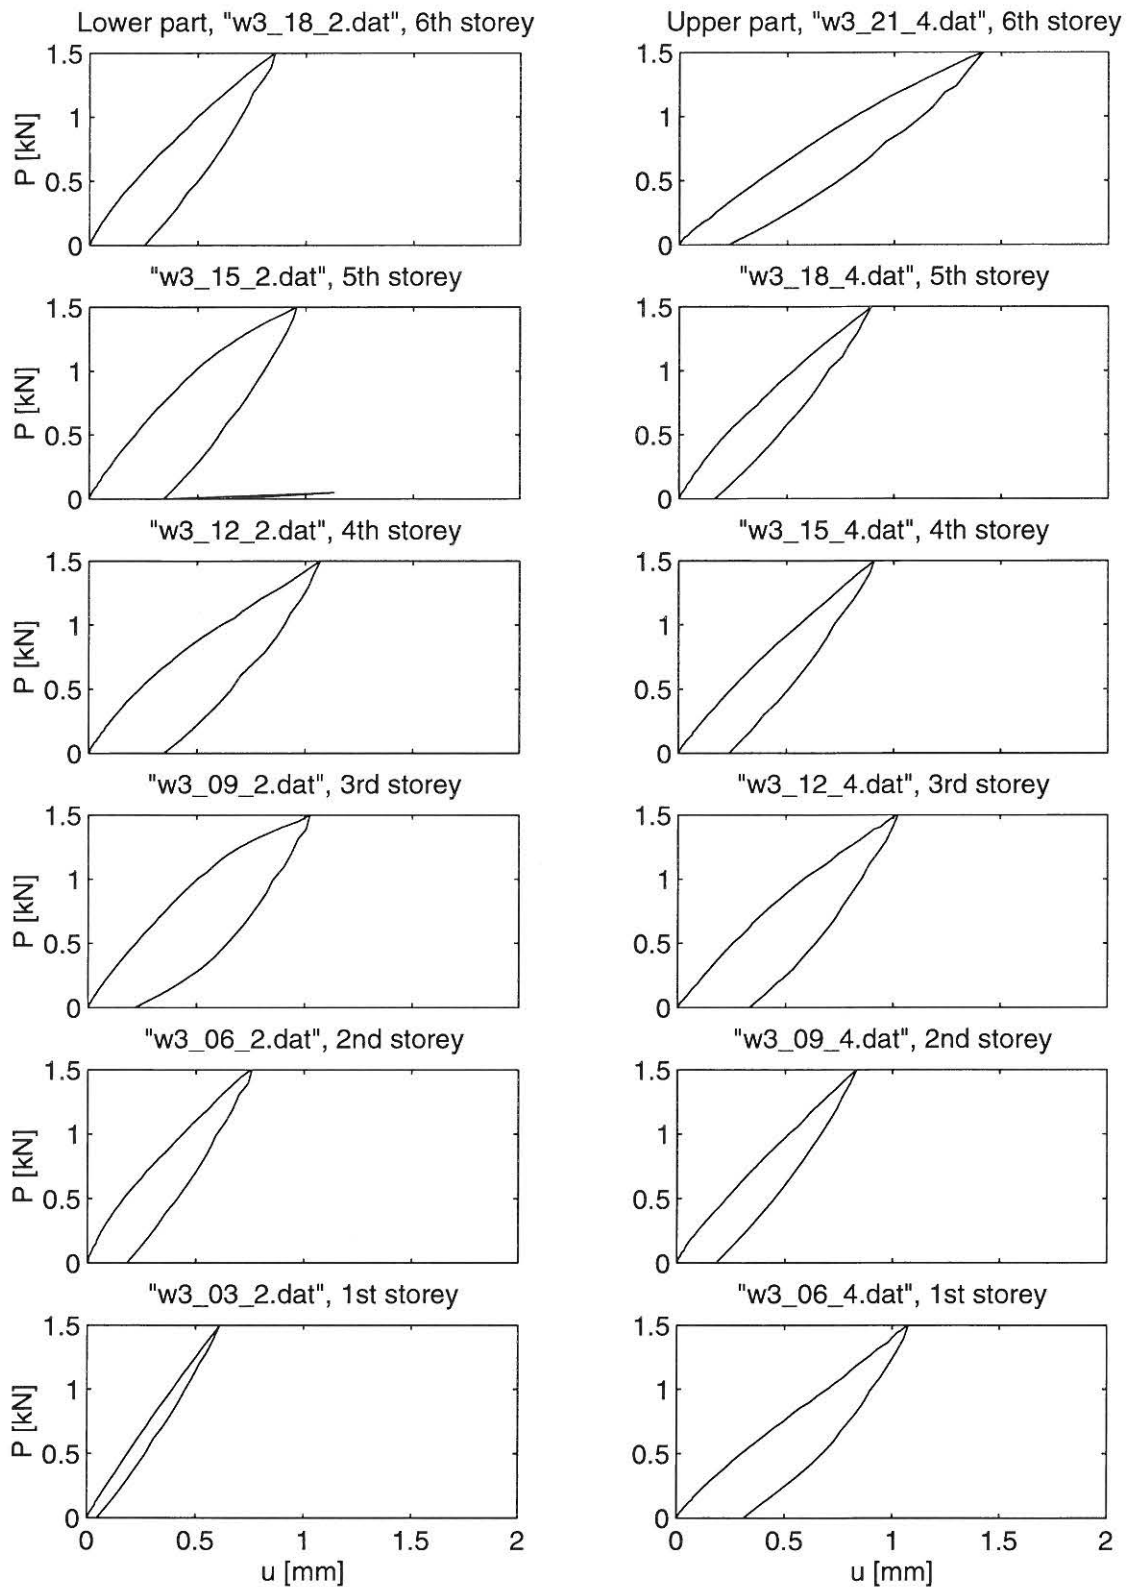
Figure 6.7: Force-deformation curves for the outer columns obtained from the static tests. Undamaged frame AAUW3.

The force-deformation curve obtained for each of the half-beams and half-columns are shown in figures 6.6-6.11.

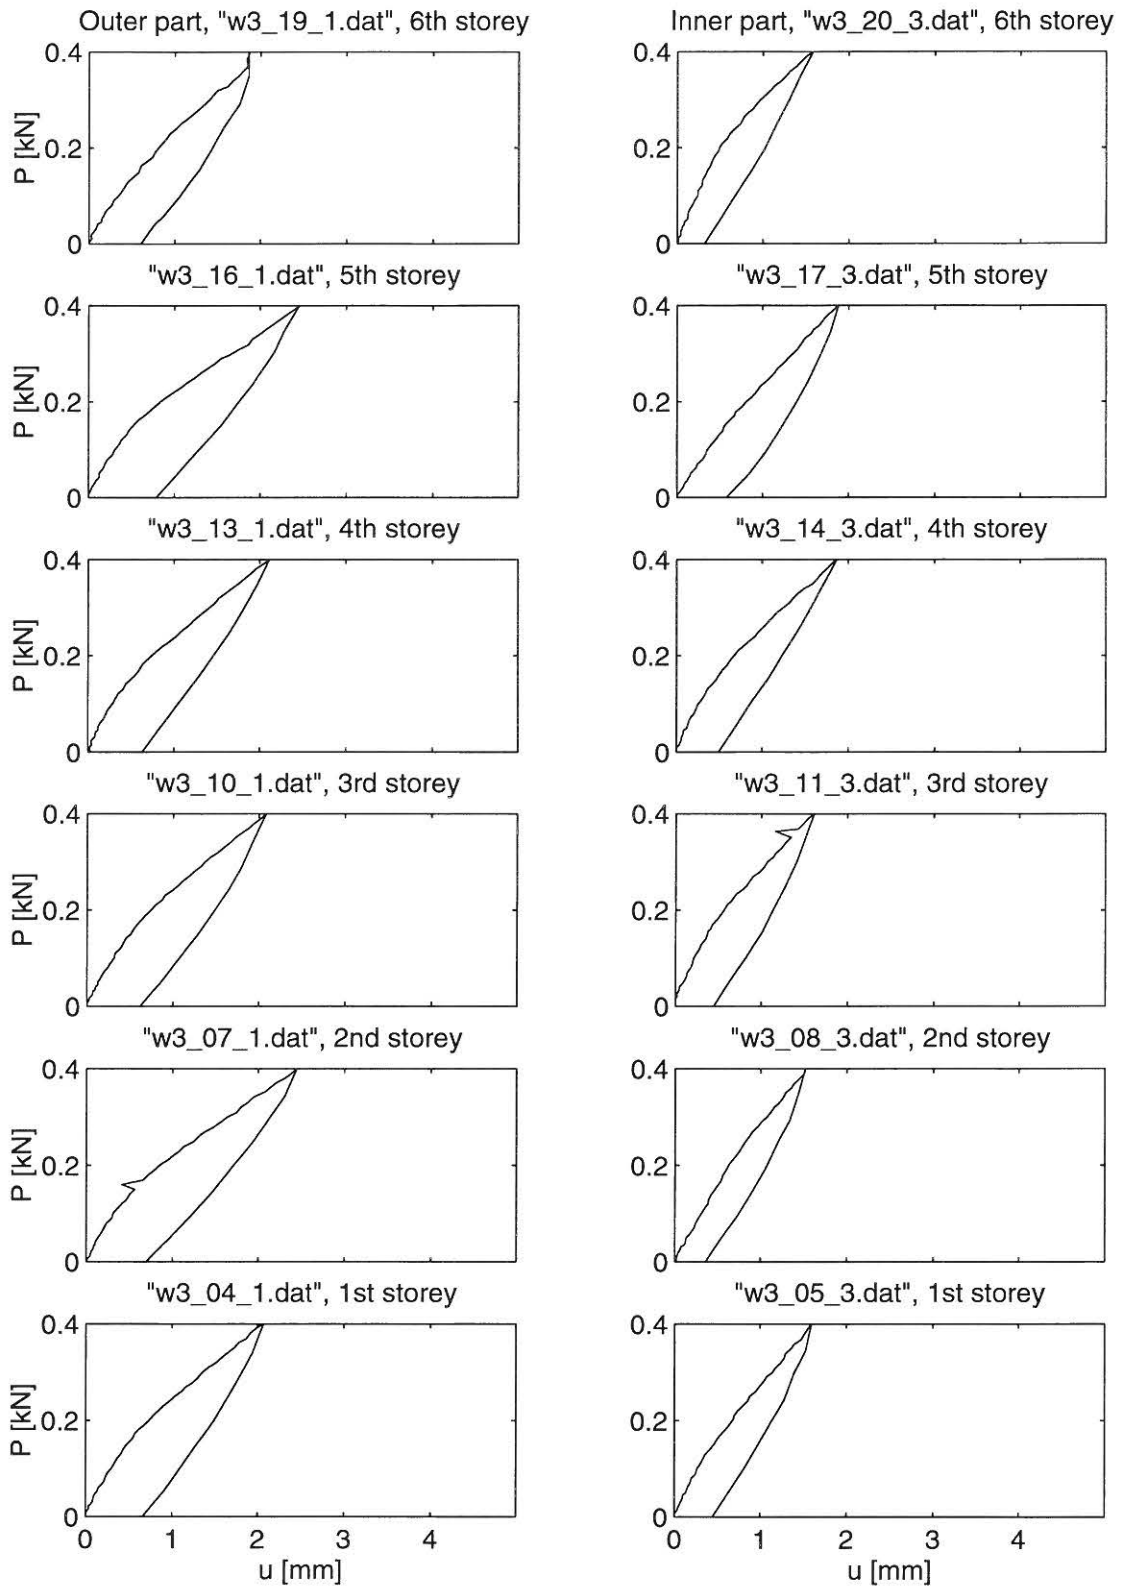
Figure 6.8: Force-deformation curves for the beams obtained from the static tests. Undamaged frame AAUW3.

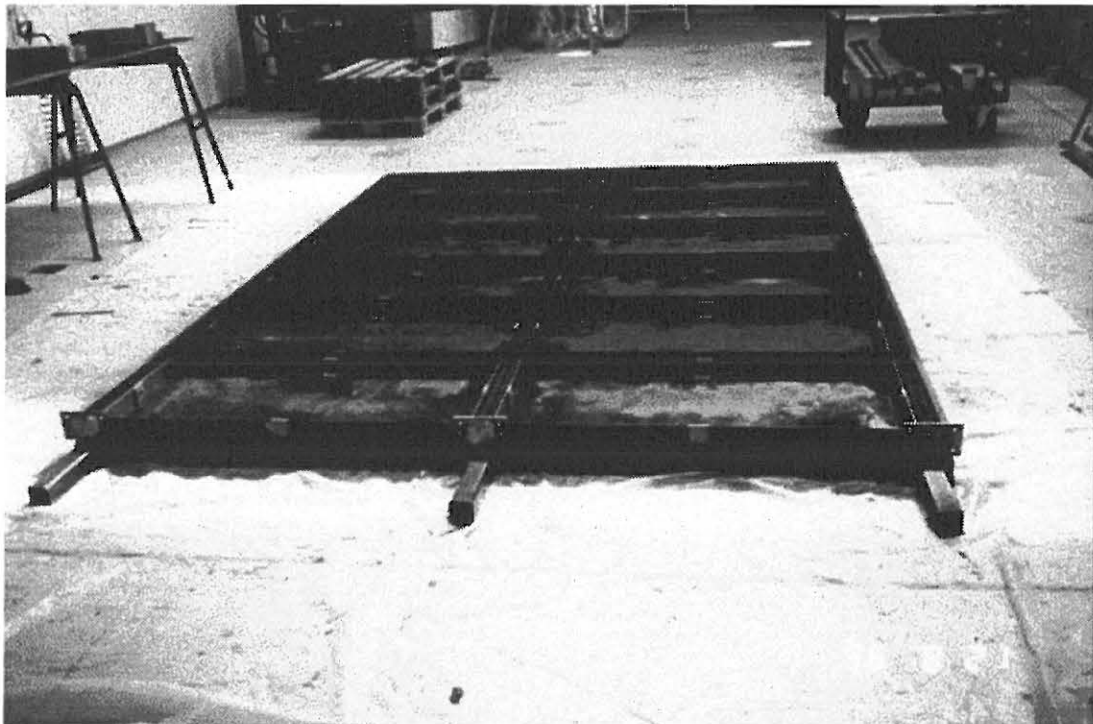
Figure A.1: The form used for construction of the frames.

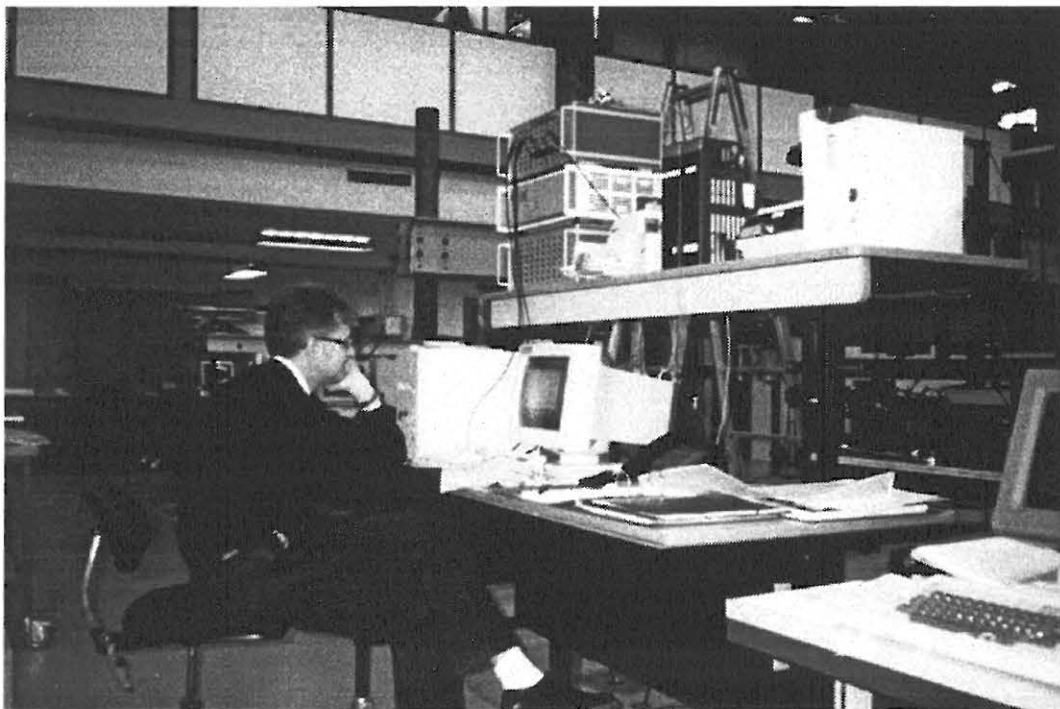
Figure A.5: Data acquisition system.

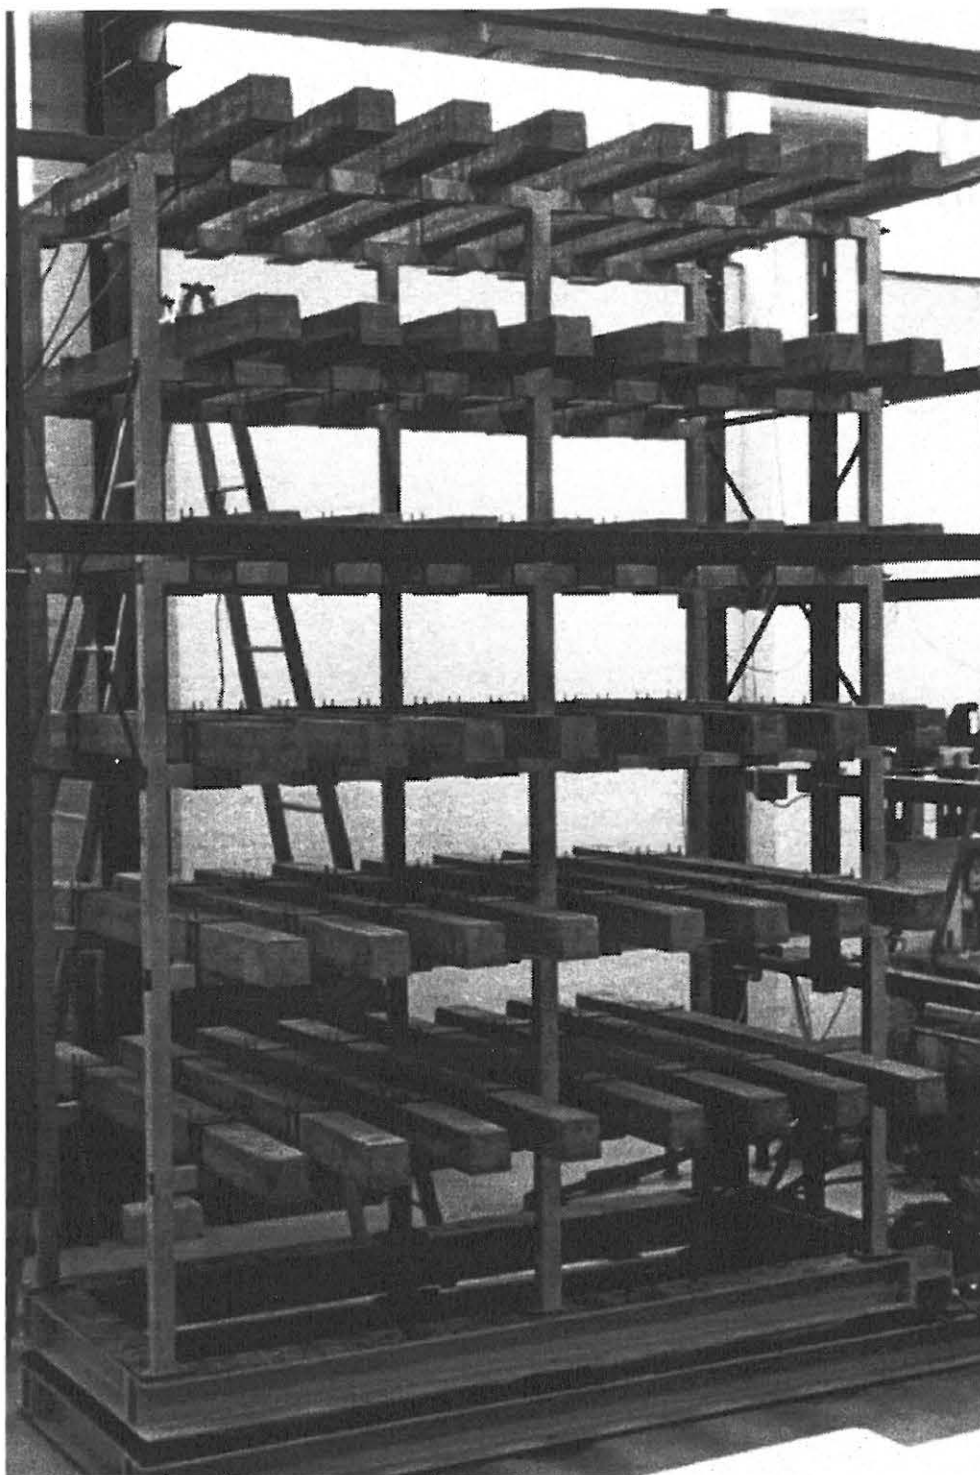
Figure A.6: Undamaged structure before testing.

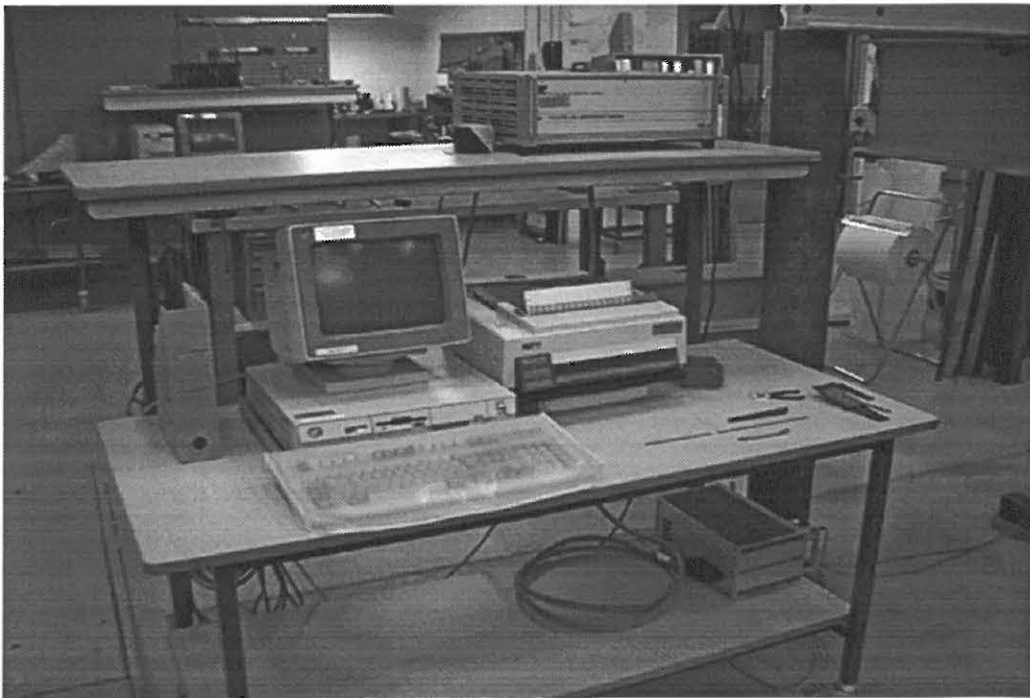
Figure A.9: Photo of the data acquisition system used for the static tests of parts of the structure.
