Scour and Scour Protection for Bucket Foundations

Hydraulics and Coastal Engineering No. 16

March 2005

By request from MBD Offshore Power A/S a test programme has been performed to determine the scour around a bucket foundation for an offshore windturbine. Furthermore the necessary scour protection has been investigated.

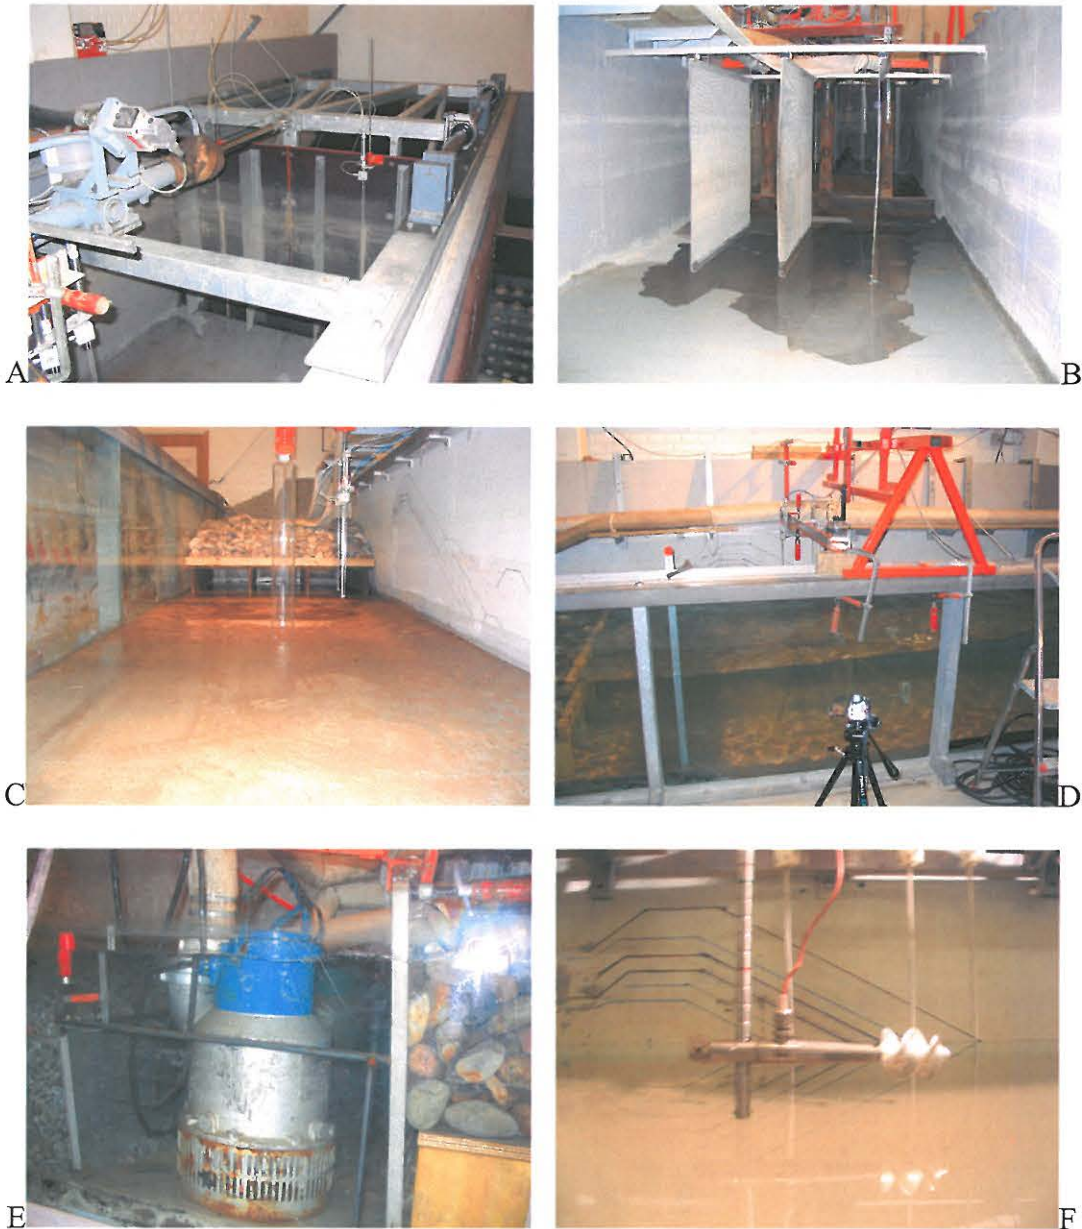
Figure 1.1. A: The paddle. B: Diffuser and guiding walls. C: Model in front of stone beach with a flow tunnel to increase the flow at the bottom. D: Side view with ruler to the left and a video camera in the front. The video footage on the movie DVD is shot through the glass. E: Pump. There are three pumps in all - standing next to each other. F: Propeller for measuring current velocity.

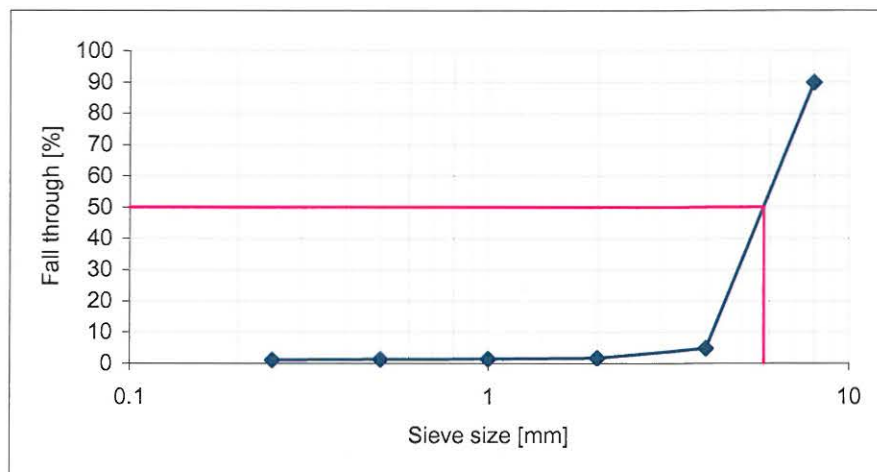
Table 4.4. Grain size distribution. D_{50} is 5.8 mm. In prototype scale D_{50} is 290 mm and W_{50} is 37.4 kg.

Figure 4.4. Grain size distribution curve.
