Scour and Scour Protection for Windturbine Foundations

Scour and Scour Protection for Windturbine Foundations for the London Array

Hydraulics and Coastal Engineering No. 17

Brian Juul Larsen & Peter Frigaard, Aalborg University

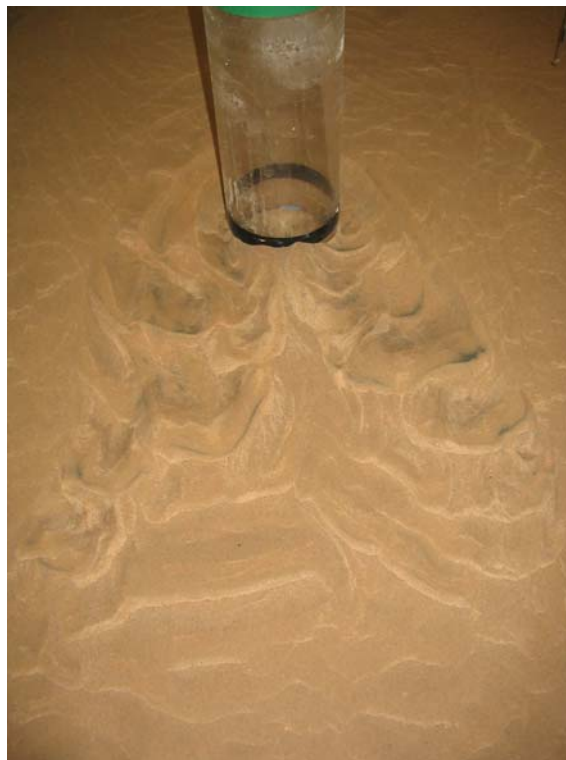
Figure 1.1. Scour hole at the end of 1.1.

Minutes	S [m]	R [m]
106	0.5	15
212	1.0	17.5
424	1.0	17.5

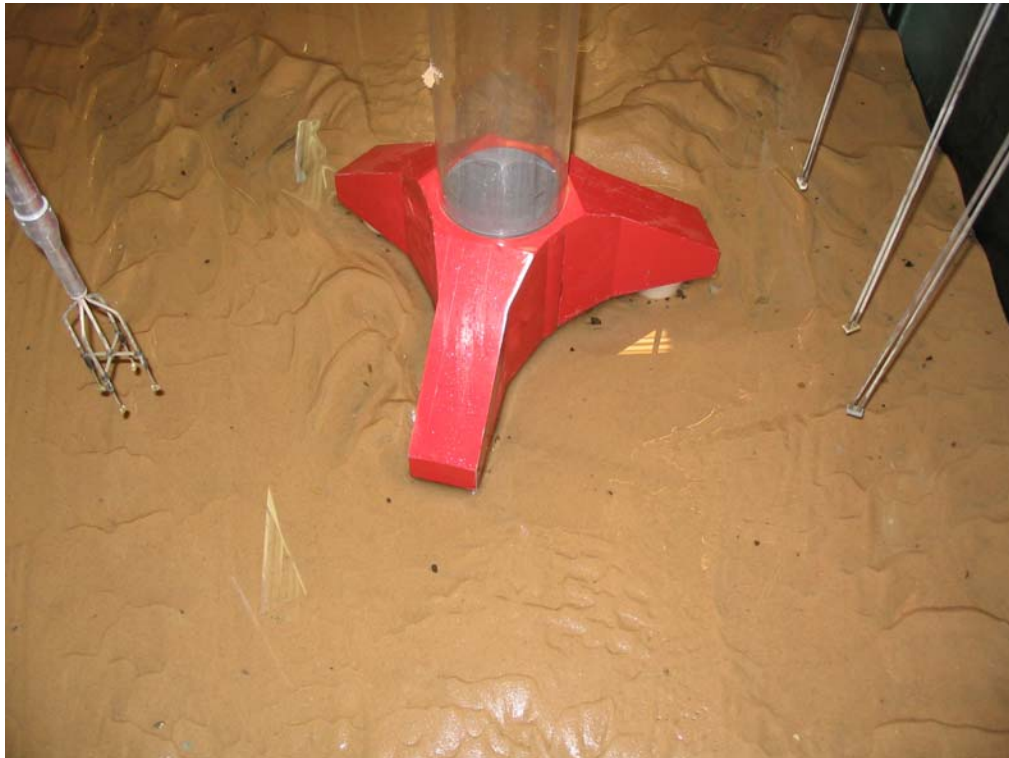
Figure 1.2. Scour hole at the end of 1.2.
The scour is occurring underneath the structure.

Minutes	S [m]	R [m]
106	1.5	2.5
212	2.0	3.5
424	2.5	5.0

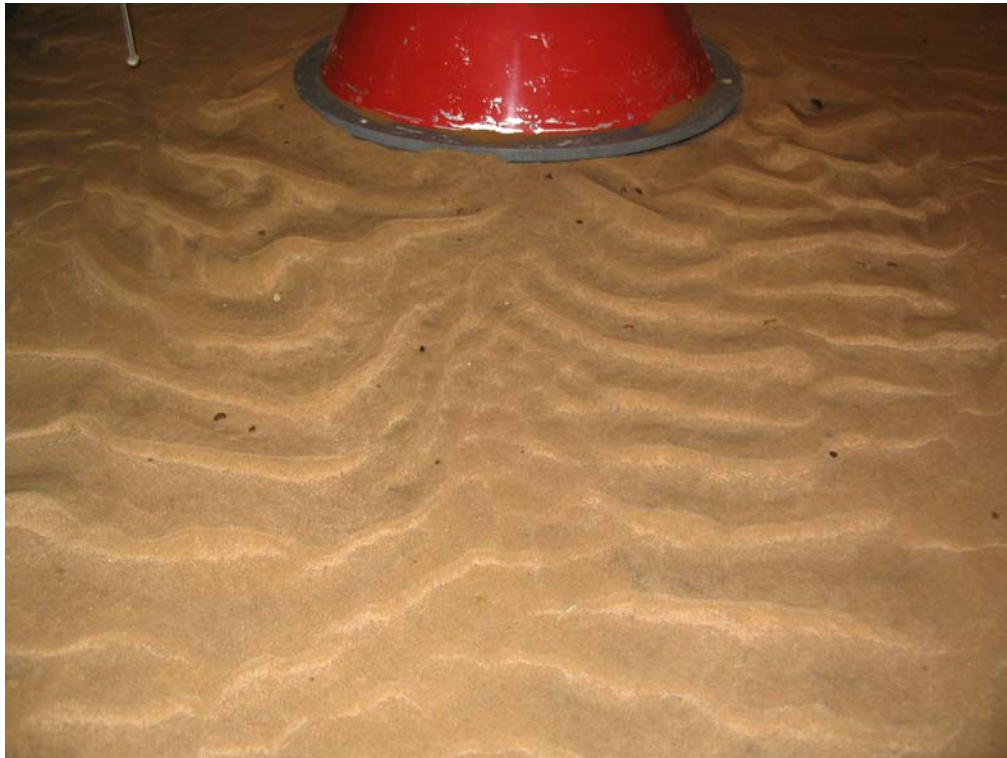
Figure 1.3. Scour hole at the end of 1.3.

Minutes	S [m]	R [m]
106	0	0
212	0.5	1.5
424	0.5	1.5

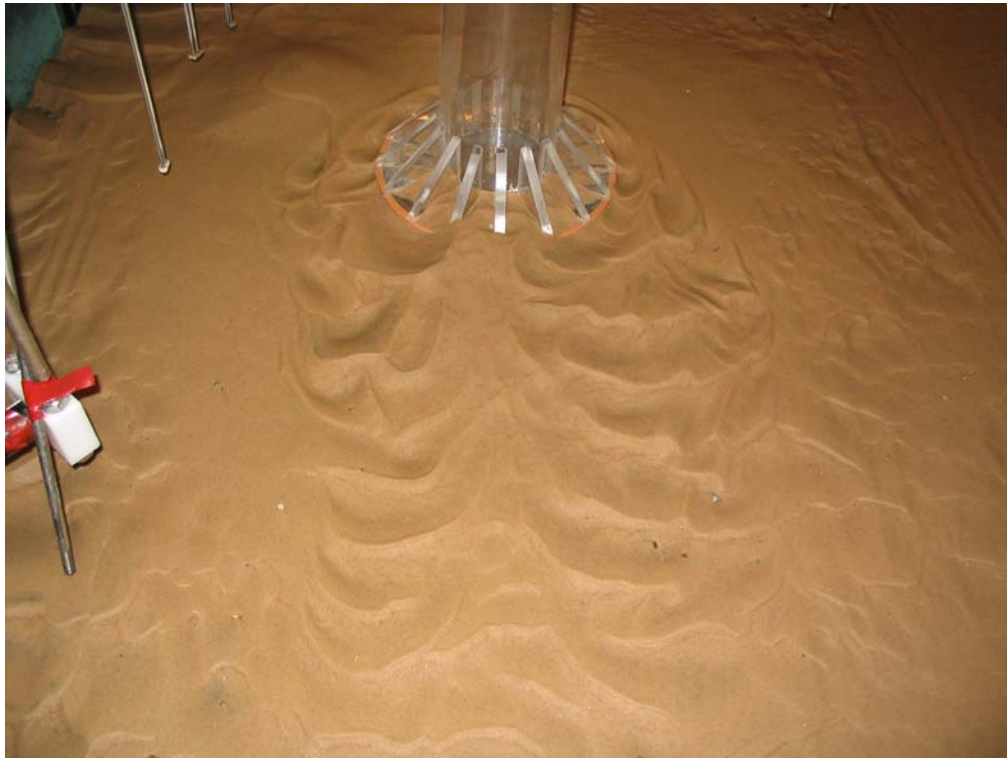
Figure 1.4. Scour hole at the end of 1.4.

Minutes	S [m]	R [m]
106	0.5	5.0
212	0.5	5.0
424	0.5	5.0

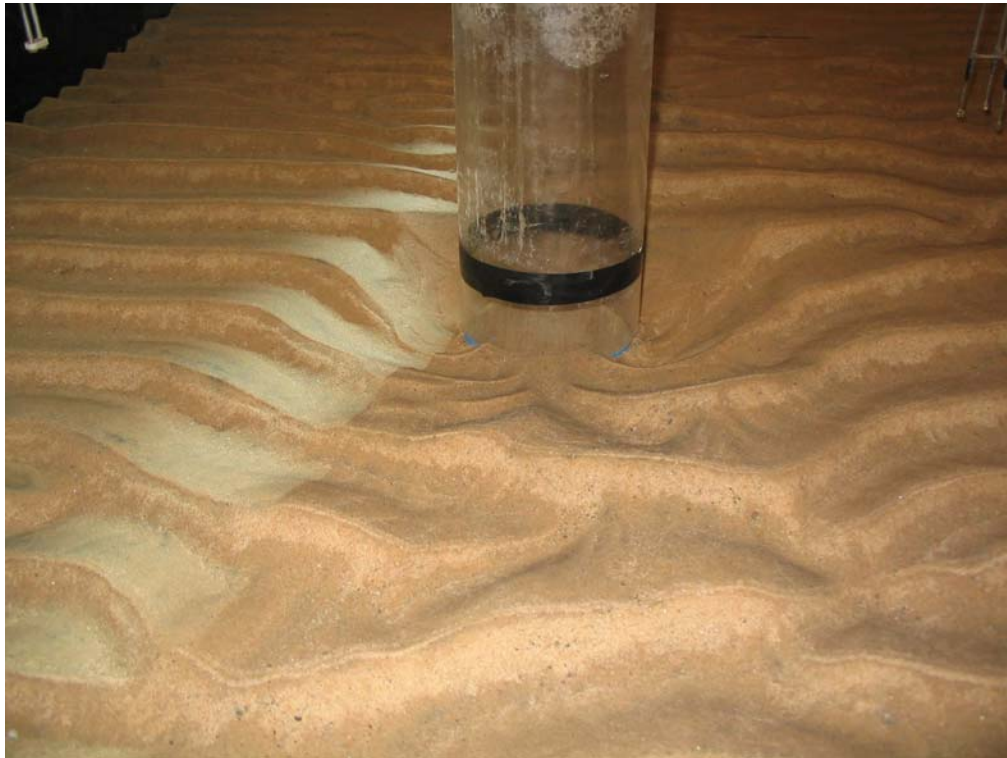
Figure 1.5. Scour hole at the end of 1.5.

Minutes	S [m]	R [m]
106	2.0	5.0
212	2.5	7.5

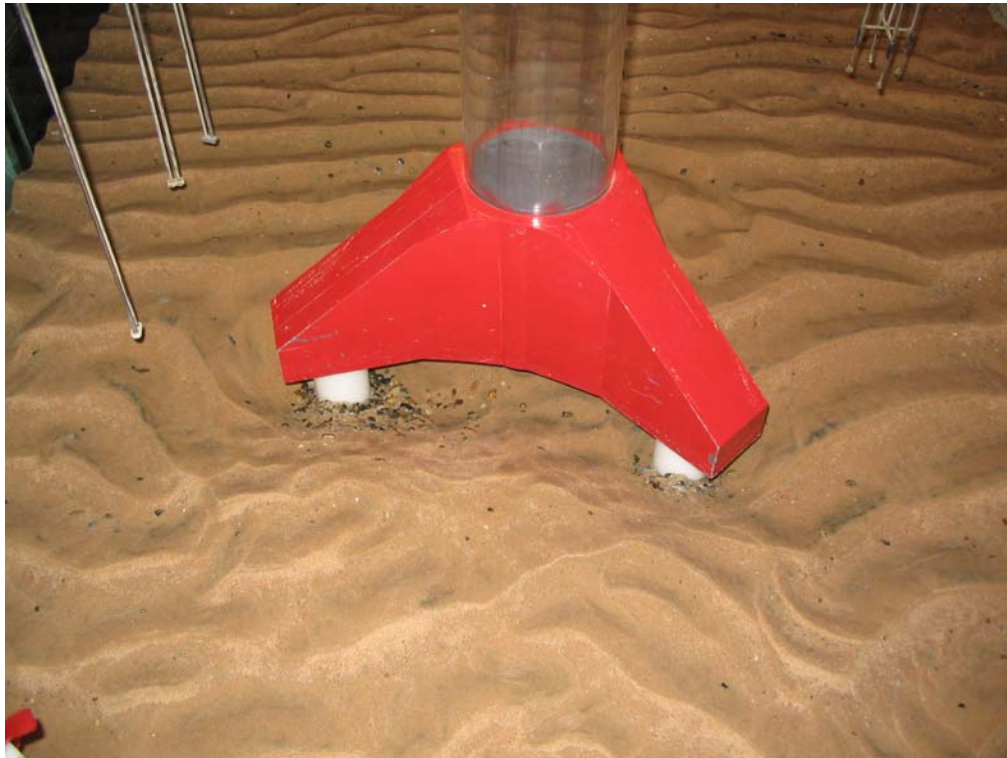
Figure 1.6. Scour hole at the end of 1.6.
The scour is occurring underneath the structure.

Minutes	S [m]	R [m]
106	2.5	5.0
212	3.0	6.5

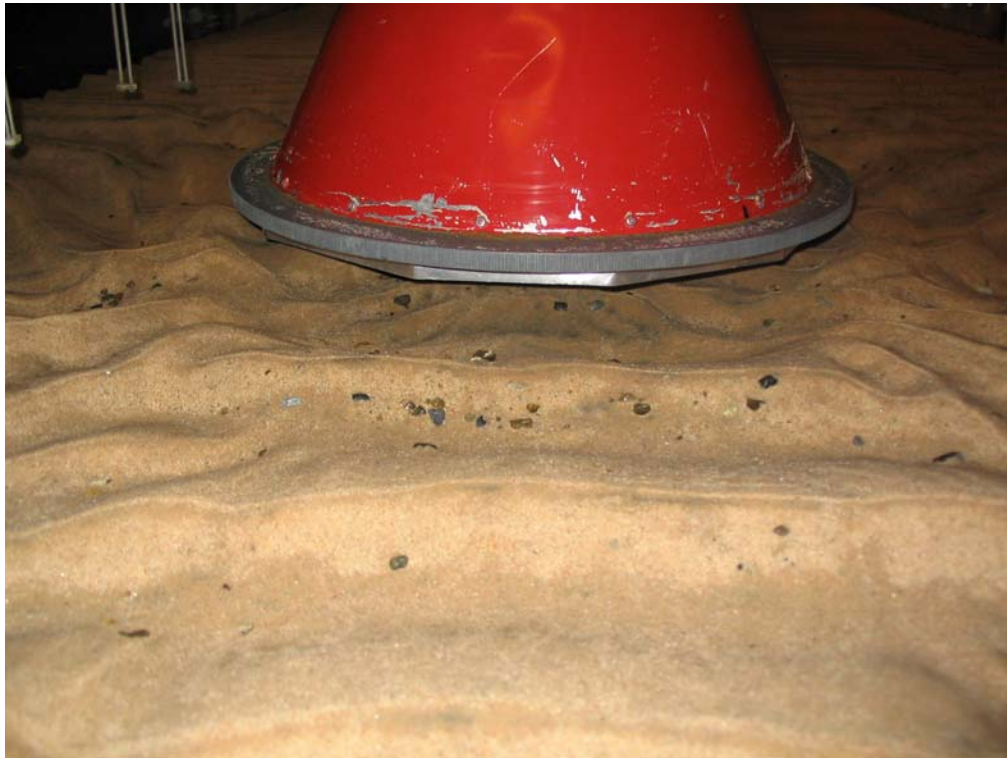
Figure 1.7. Scour hole at the end of 1.7.

Minutes	S [m]	R [m]
106	2	5.5
212	2	5.0

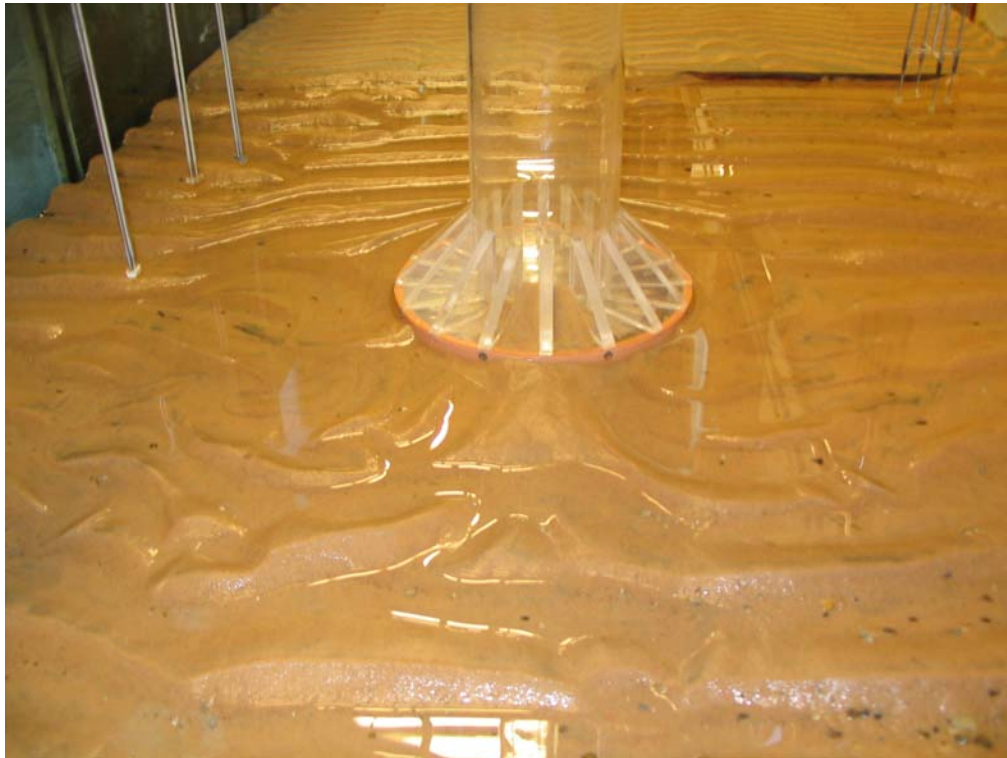
Figure 1.8. Scour hole at the end of 1.8.

Minutes	S [m]	R [m]
106	1.0	10.0
212	1.5	10.0

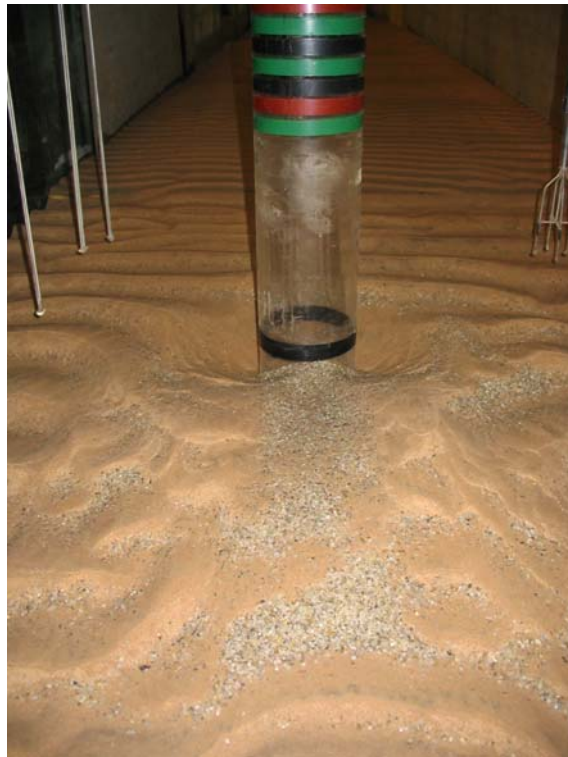
Figure 1.11. Shape of scour protection at the end of 2.2. Complete damage. 2.5 m scour depth.

In this test protection type number one was used. It has a D_{50} of 93 mm.

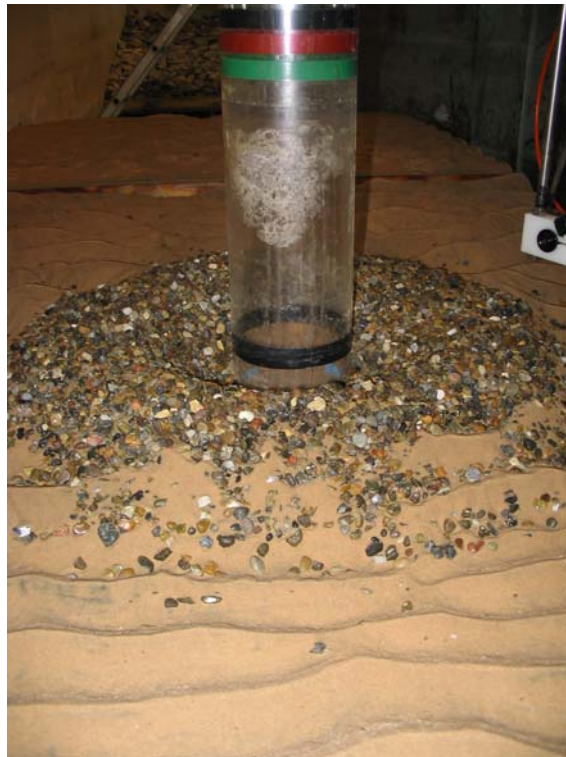
Figure 1.13. Shape of scour protection at the end of 2.3.
Severe damage. 1.5 m scour depth.

In this test protection type number two was used. It has a D_{50} of 258 mm.

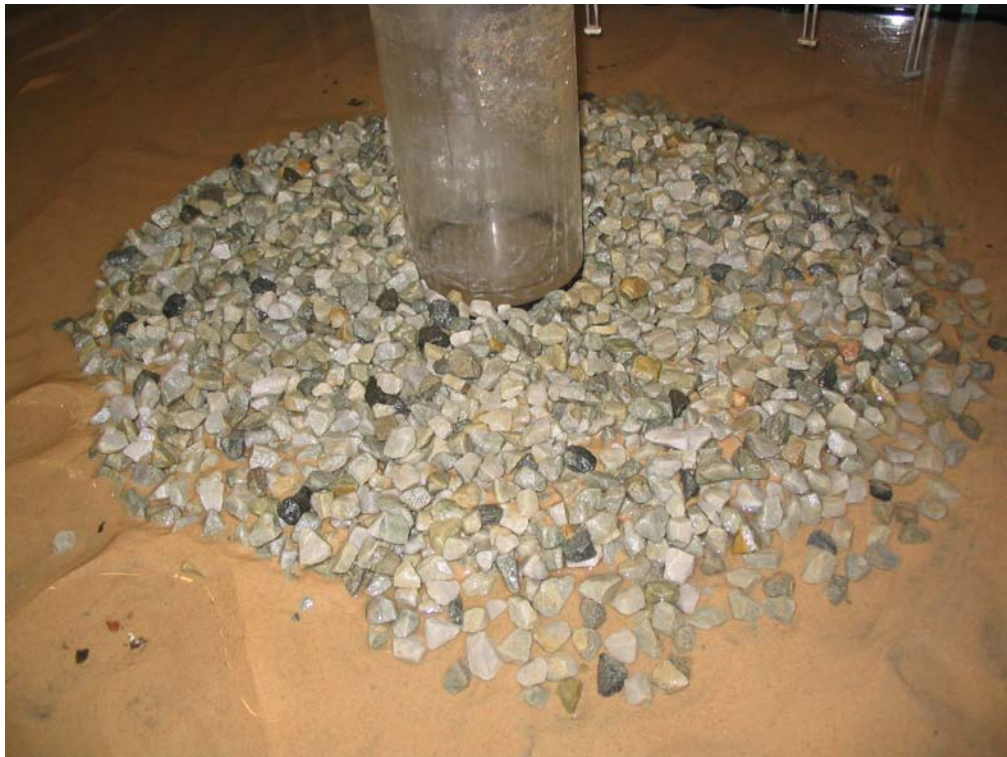
Figure 1.15. Shape of scour protection at the end of 2.4.
No damage occurred.

In this test protection type number three was used. It has a D_{50} of 585 mm.

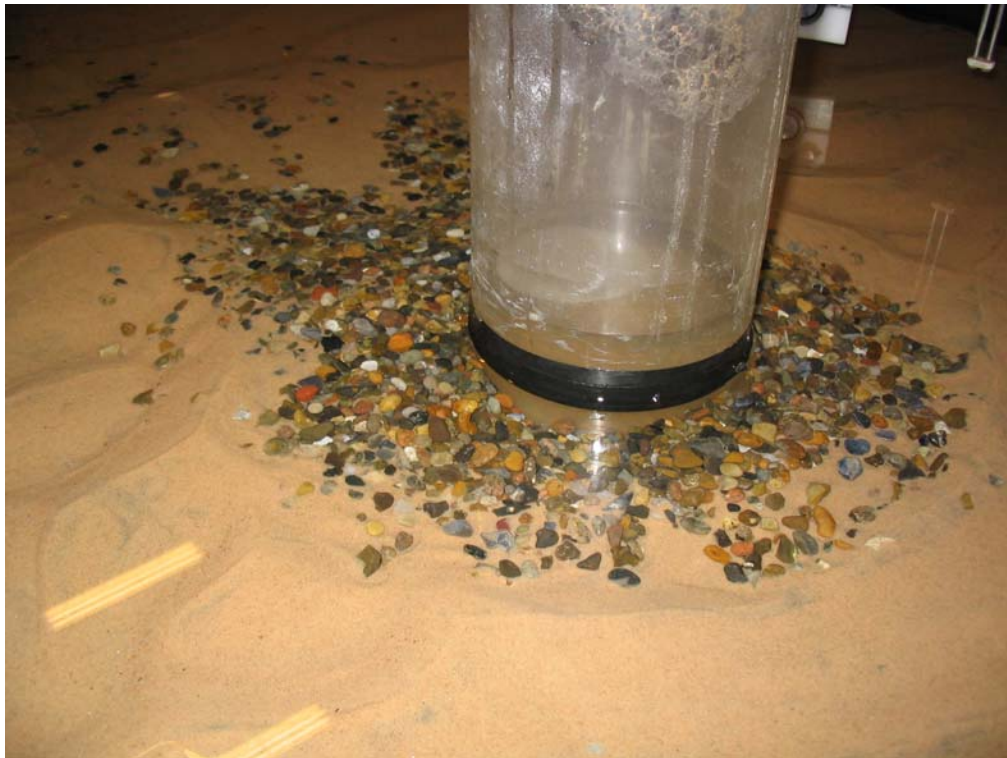
Figure 1.17. Shape of scour protection at the end of 2.5.
Severe damage. 1.5 m scour depth.

In this test protection type number two was used. It has a D_{50} of 258 mm

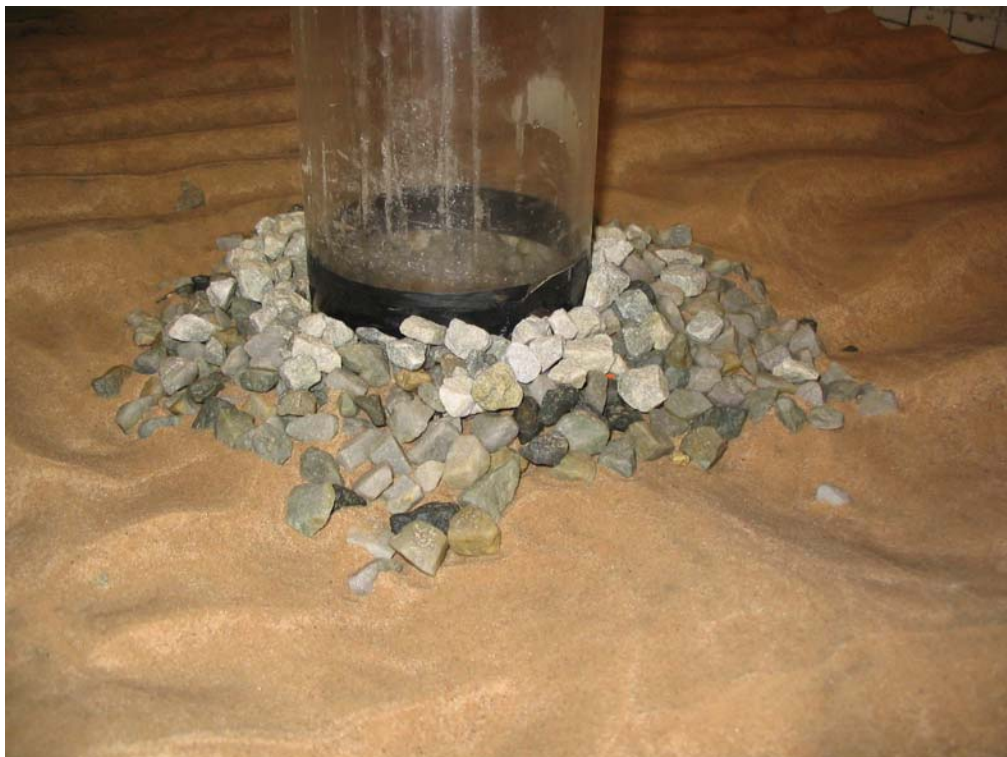
Figure 1.19. Shape of scour protection at the end of 2.6.
No damage occurred.

In this test protection type number three was used. It has a D_{50} of 585 mm.

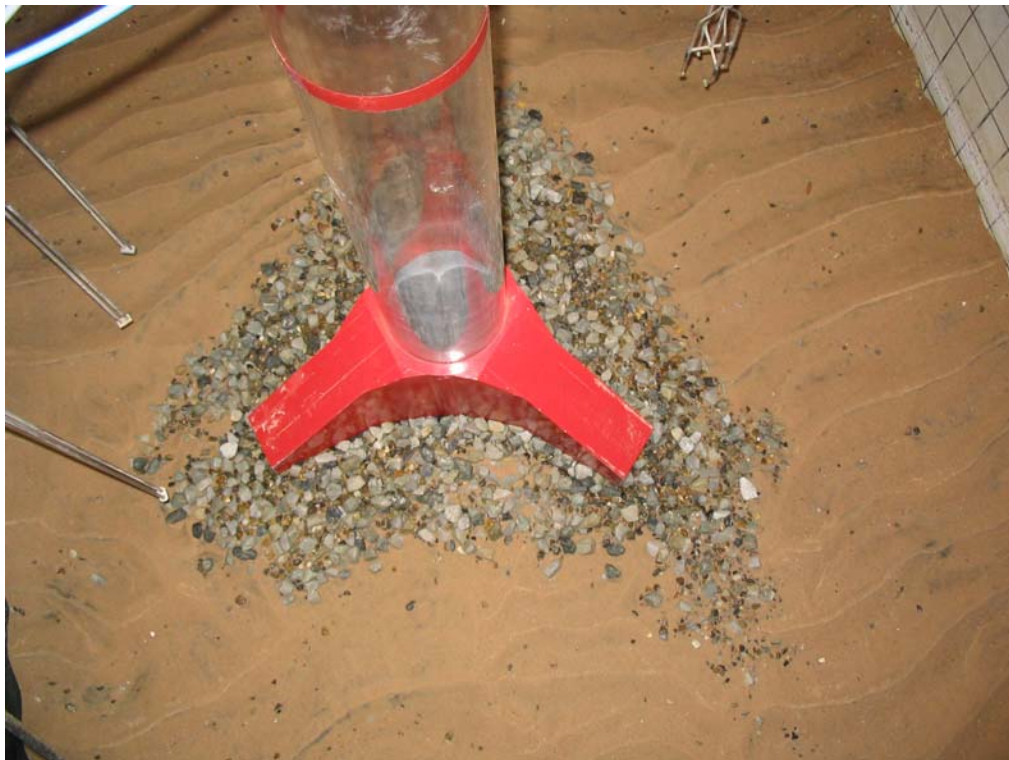
Figure 1.21. Shape of scour protection at the end of 2.7.
No severe damage.

In this test protection type number four was used. It has a D_{50} of 365 mm.

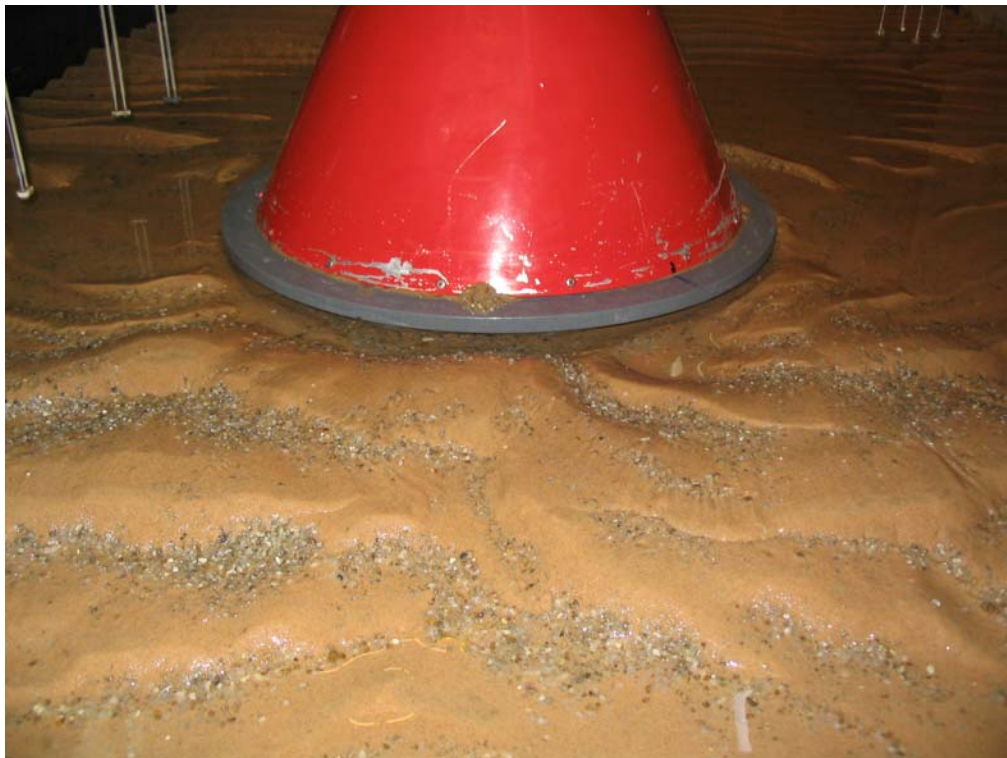
Figure 1.23. Shape of scour protection at the end of 2.8.
Complete damage. 1.0 m scour depth.

In this test protection type number one was used. It has a D_{50} of 93 mm.

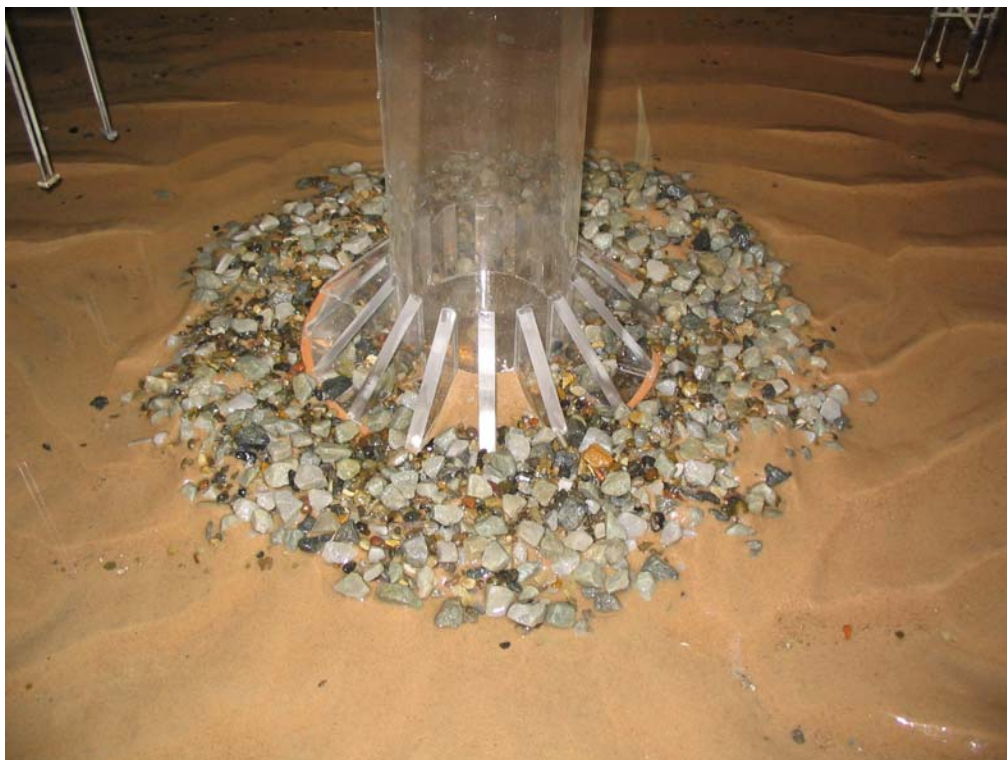
Figure 1.25. Shape of scour protection at the end of 2.9.
No severe damage.

In this test protection type number four was used. It has a D_{50} of 365 mm.

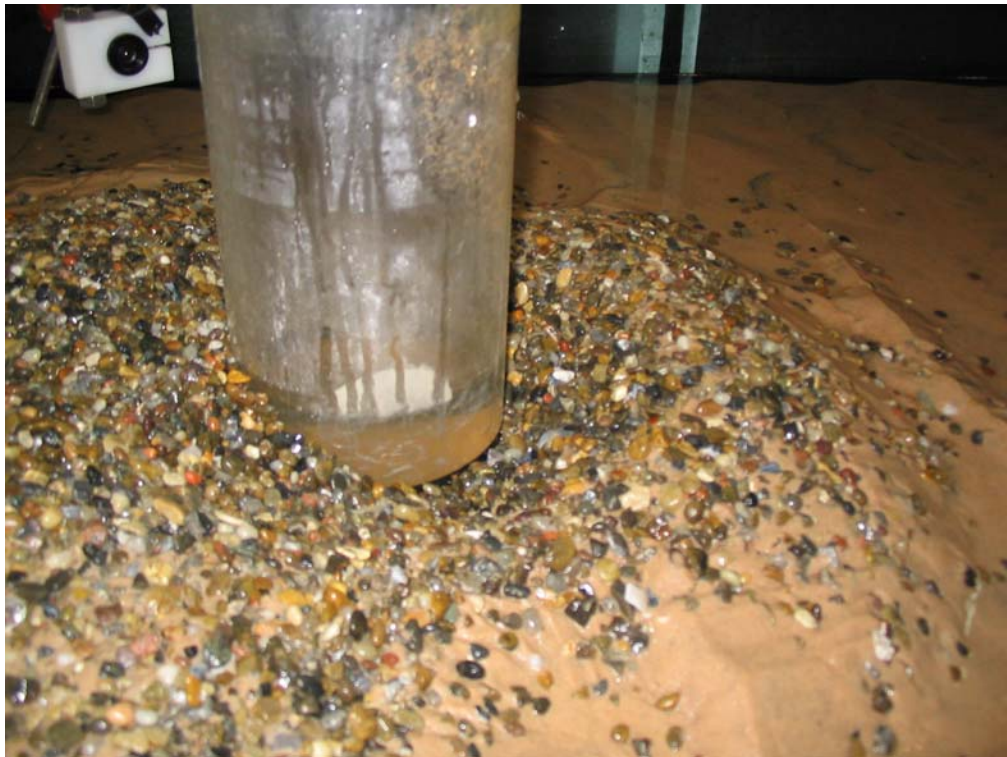
Figure 1.29. Shape of scour protection at the end of 3.2.
Some damage. 1.5 m scour depth.

In this test protection type number two was used. It has a D_{50} of 258 mm.

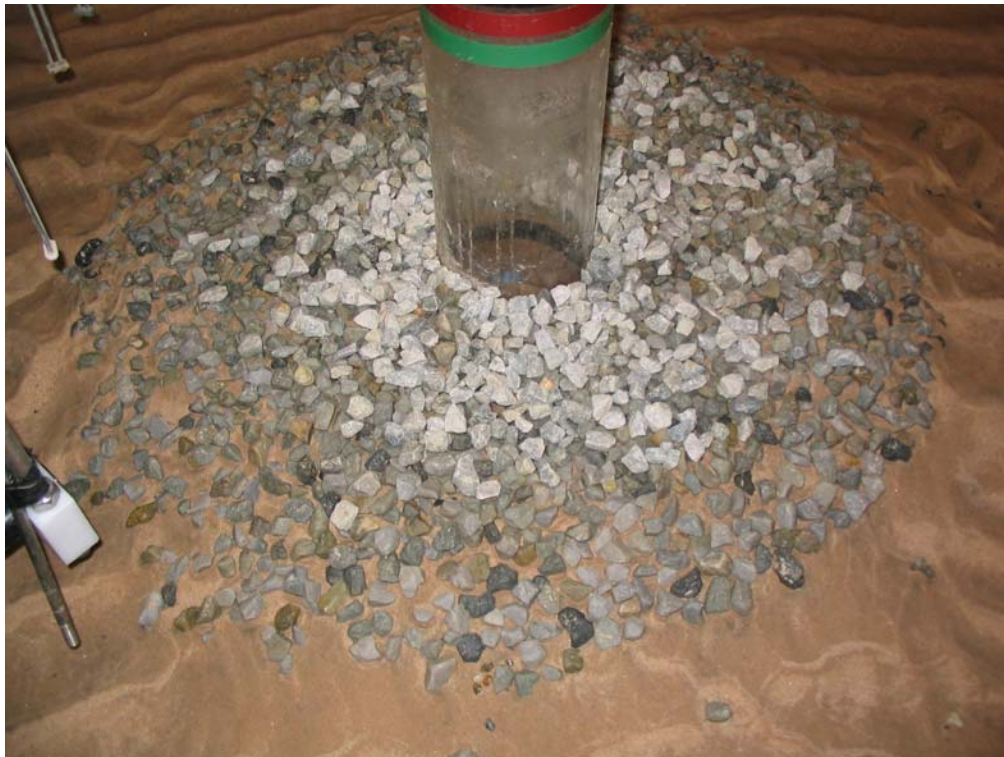
Figure 1.31. Shape of scour protection at the end of 3.3.
No damage occurred.

In this test protection type number three was used. It has a D_{50} of 585 mm.

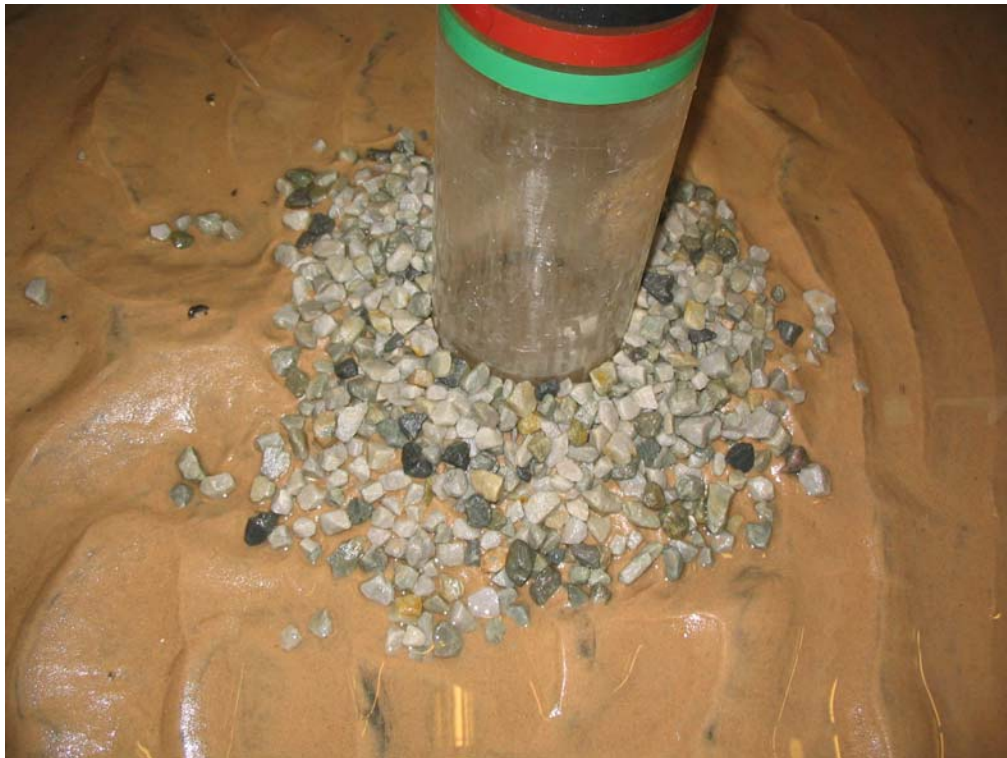
Figure 1.33. Shape of scour protection at the end of 3.4.
No severe damage.

In this test protection type number three was used. It has a D_{50} of 585 mm.

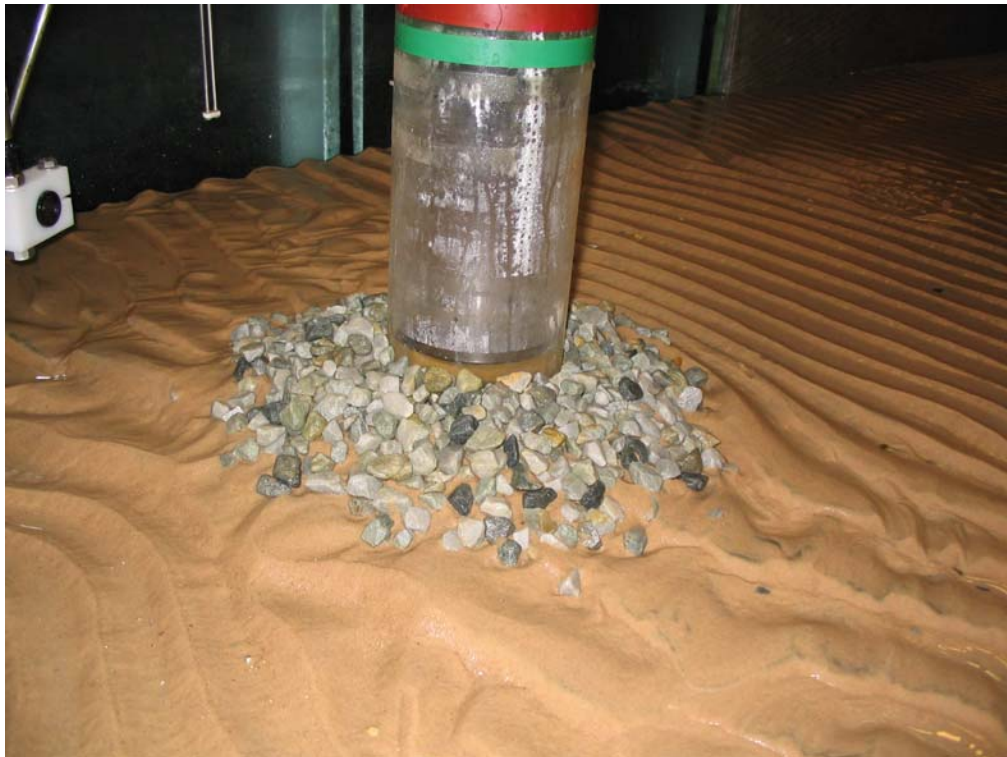
Figure 1.35. Shape of scour protection at the end of 3.5.
No severe damage.

In this test protection type number three was used. It has a D_{50} of 585 mm.

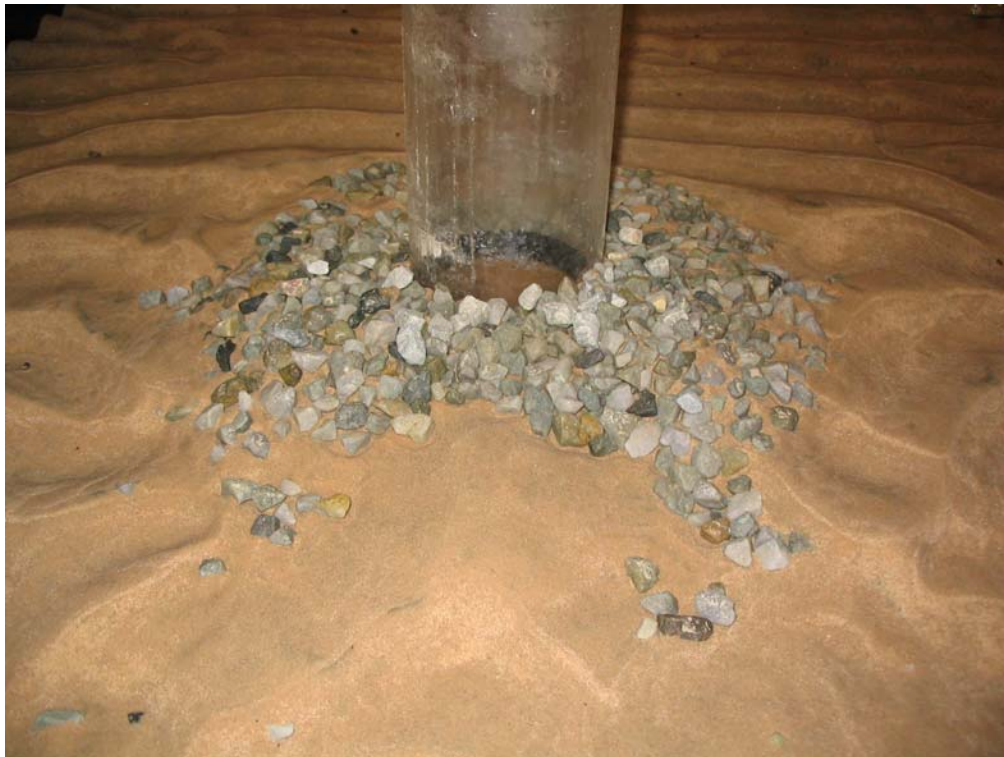
Figure 1.37. Shape of scour protection at the end of 3.6.
No severe damage.

In this test protection type number three was used. It has a D_{50} of 585 mm.

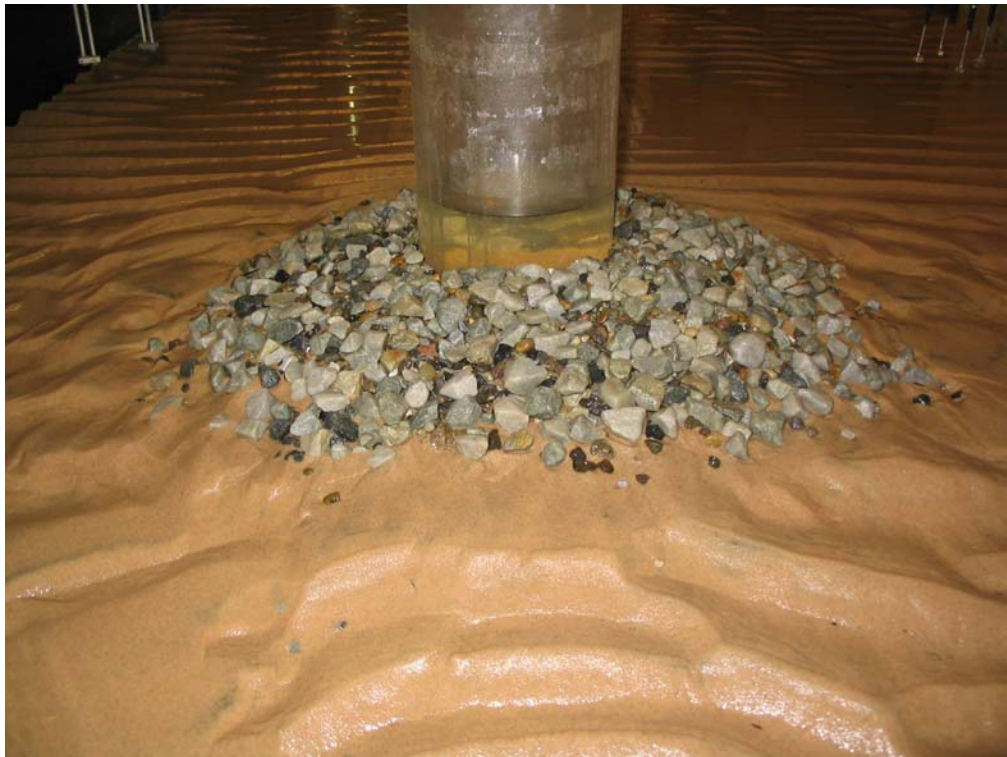
Figure 1.39. Shape of scour protection at the end of 3.7.
No damage occurred.

In this test protection type number four was used. It has a D_{50} of 365 mm.

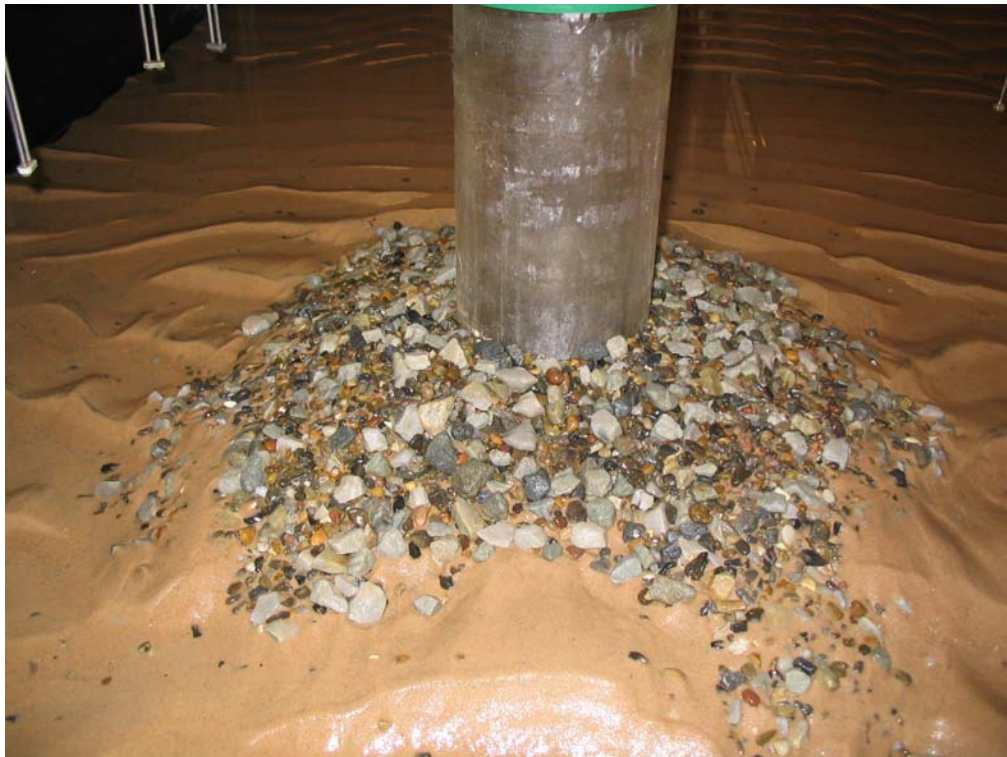
Figure 1.41. Shape of scour protection at the end of 3.8.
No severe damage.

In this test protection type number four was used. It has a D_{50} of 365 mm.

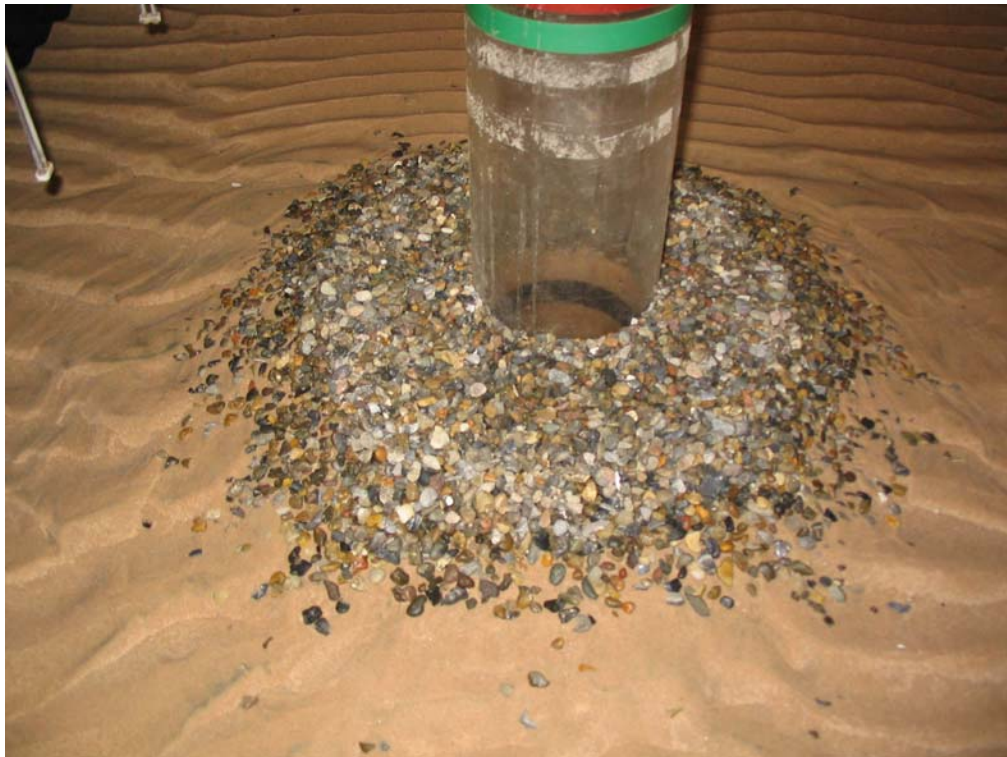
Figure 1.43. Shape of scour protection at the end of 3.9.
No damage occurred.

In this test protection type number two was used. It has a D_{50} of 258 mm.

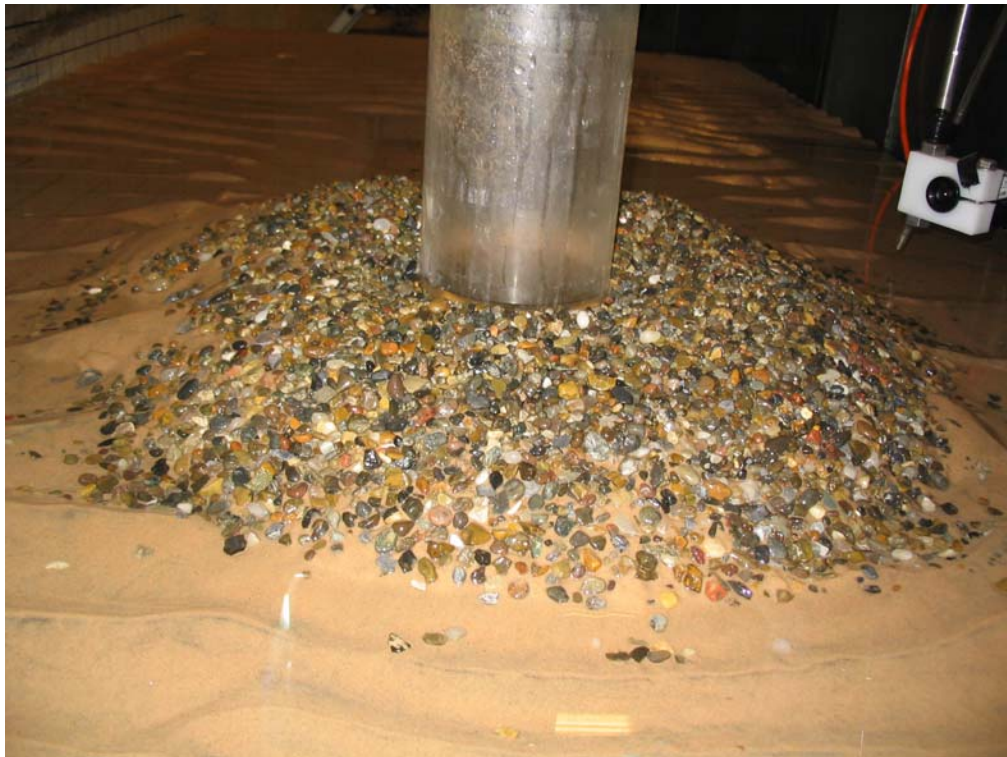
Figure 1.45. Shape of scour protection at the end of 3.10.
No severe damage.

In this test protection type number two was used. It has a D_{50} of 258 mm.

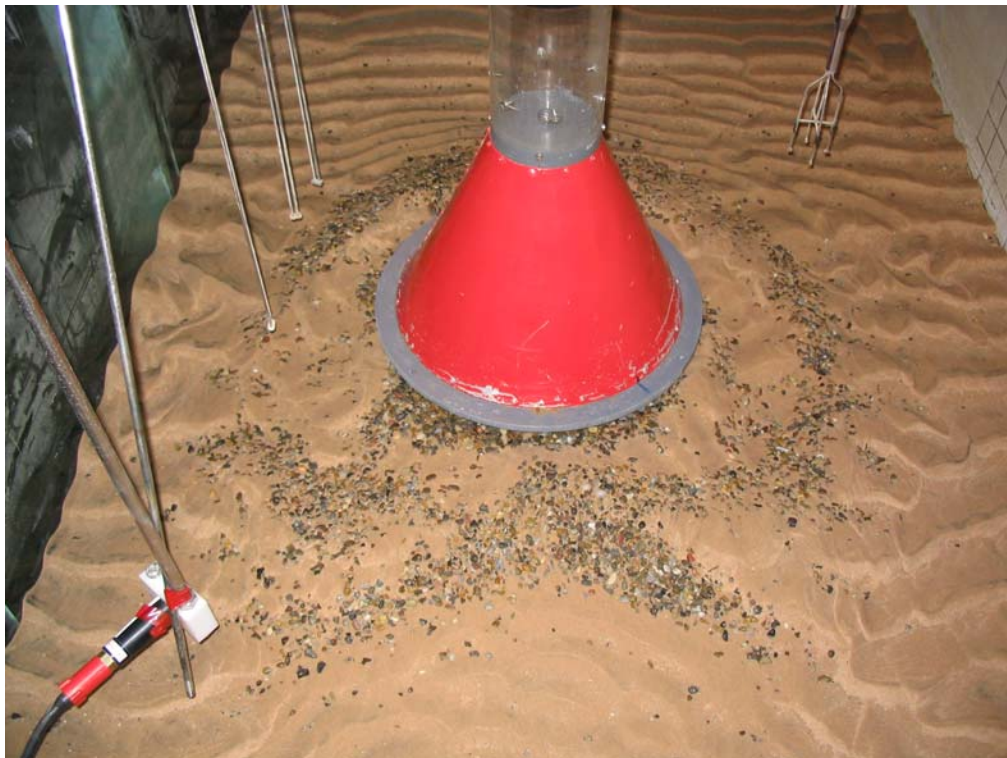
Figure 1.47. Shape of scour protection at the end of 3.11.
Complete damage. 1.0 m scour depth.

In this test protection type number two was used. It has a D_{50} of 258 mm.

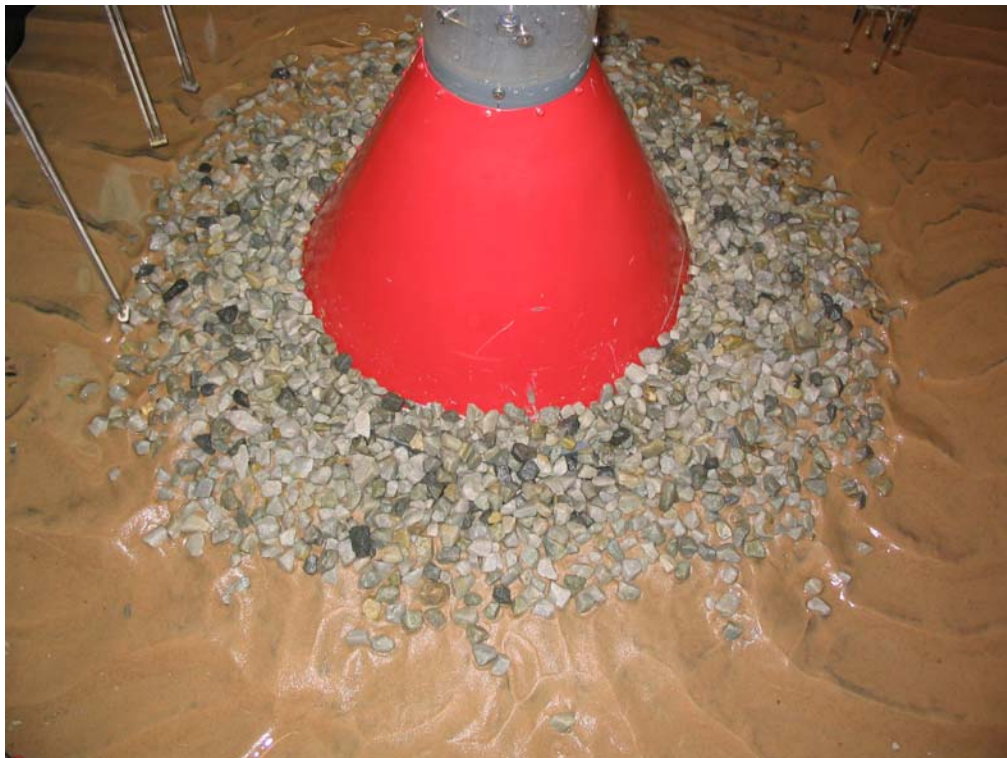
Figure 1.49. Shape of scour protection at the end of 3.12.
No damage occurred.

In this test protection type number three was used. It has a D_{50} of 585 mm.

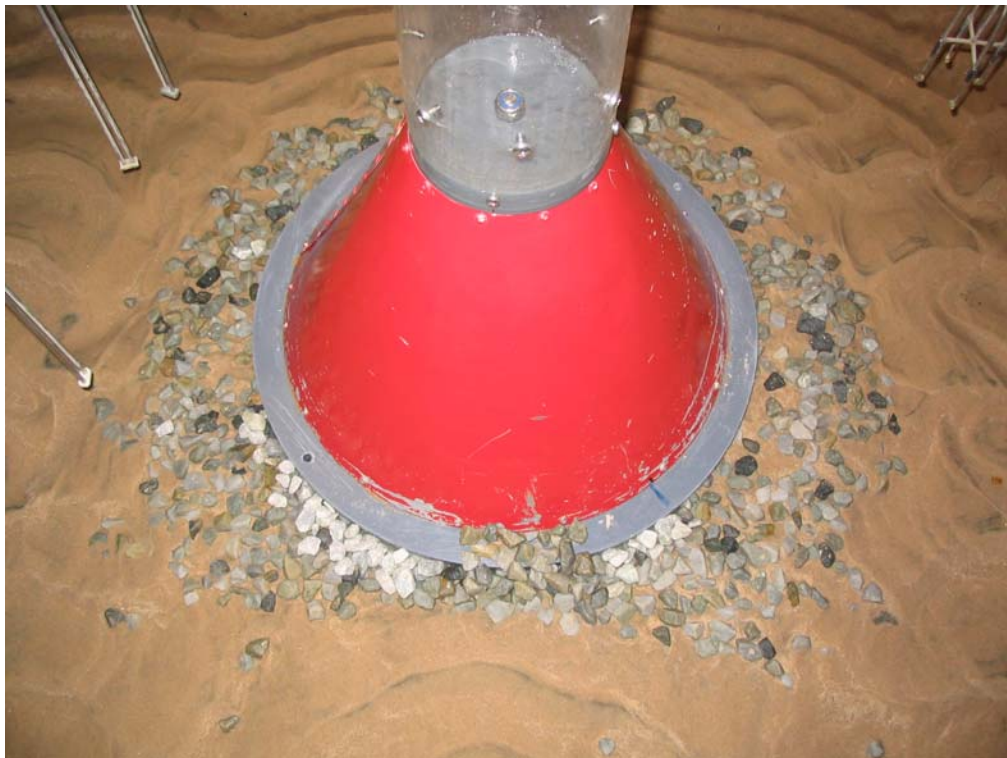
Figure 1.51. Shape of scour protection at the end of 3.13.
Some damage. 1.0 m scour depth.

In this test protection type number three was used. It has a D_{50} of 585 mm.

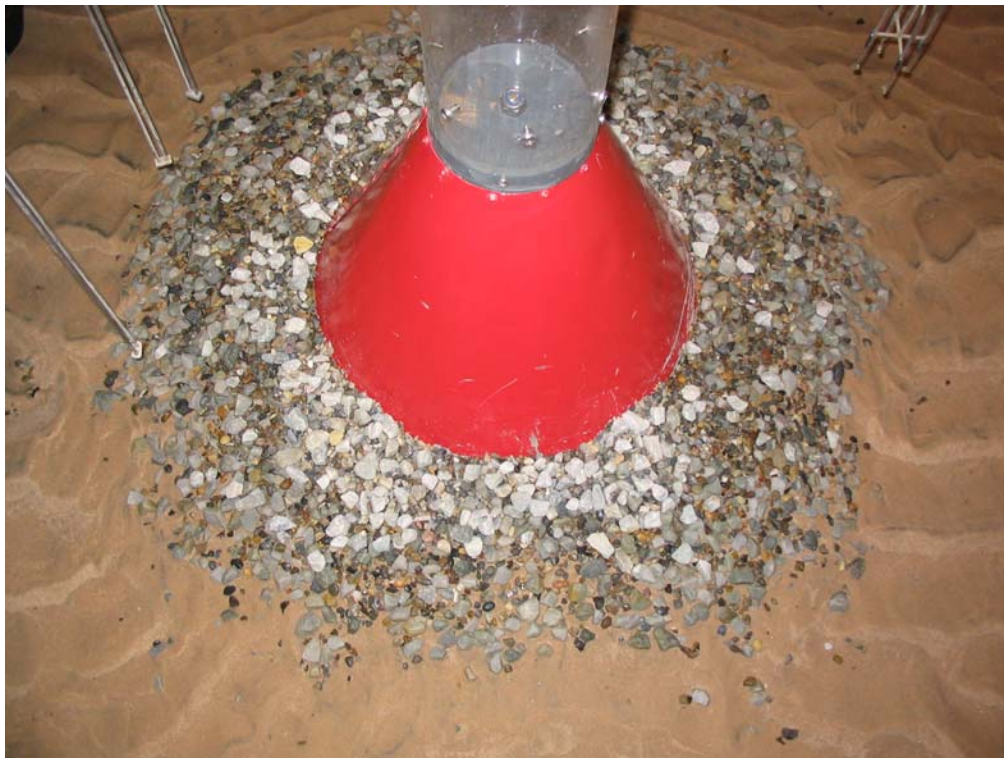
Figure 1.53. Shape of scour protection at the end of 3.14.
No damage occurred.

In this test protection type number four was used. It has a D_{50} of 365 mm.

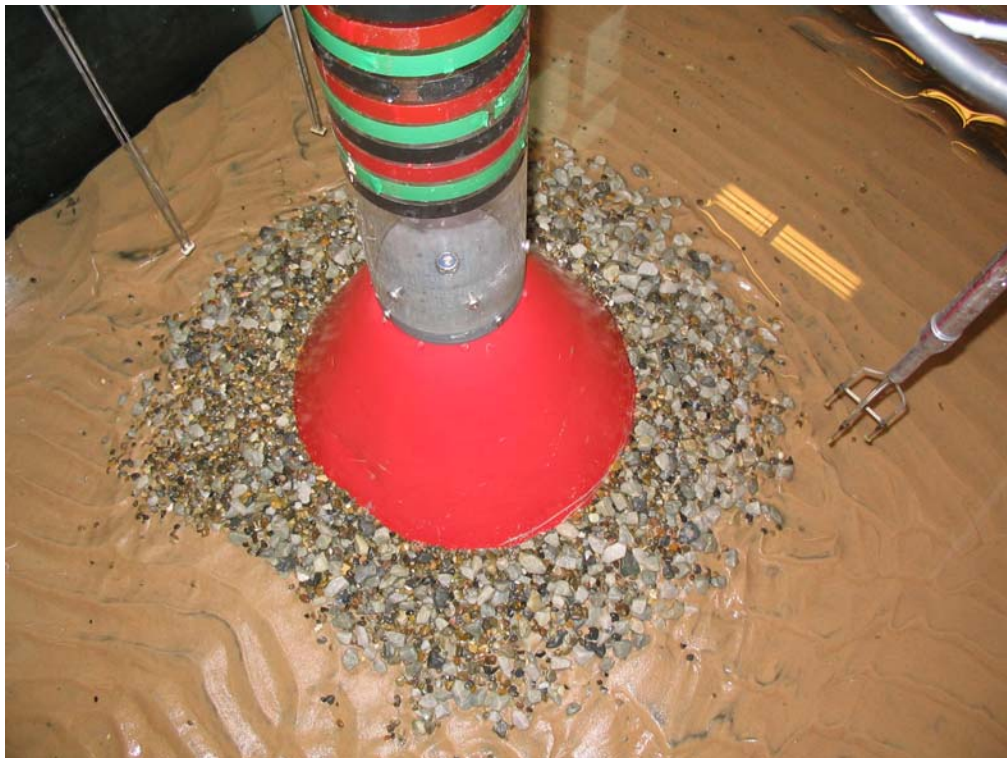
Figure 1.55. Shape of scour protection at the end of 3.15.
No damage occurred.

In this test protection type number four was used. It has a D_{50} of 365 mm.
