Scour and Scour Protection for Windturbine Foundations

Scour and Scour Protection for Windturbine Foundations for the London Array

Hydraulics and Coastal Engineering No. 17

Brian Juul Larsen & Peter Frigaard, Aalborg University

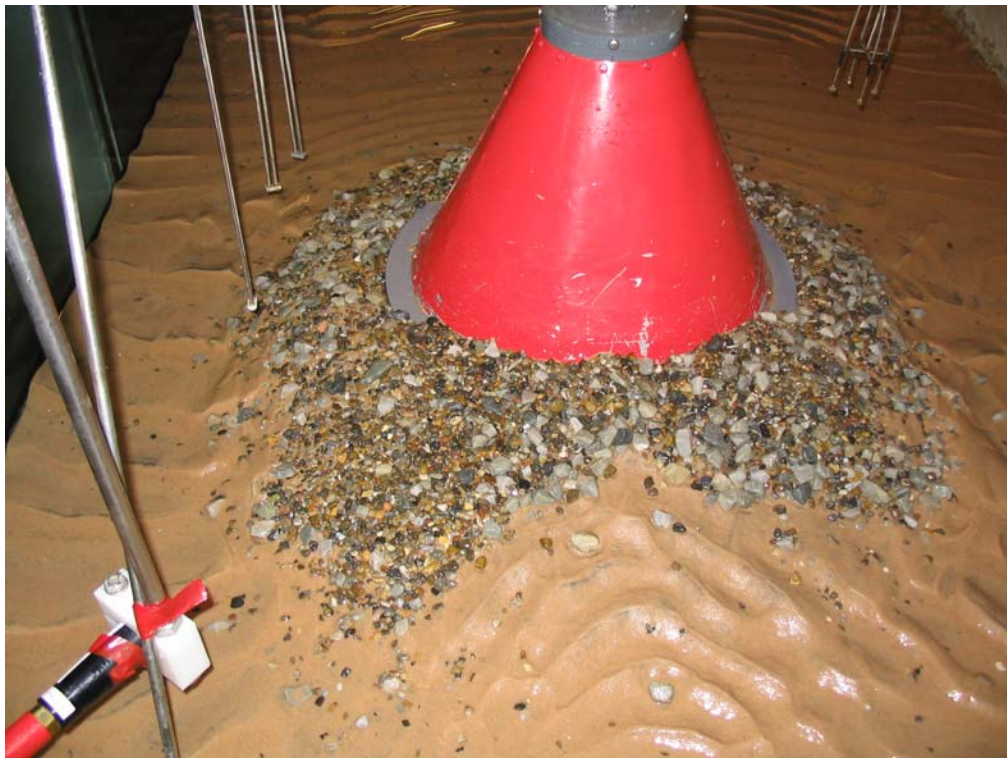
Figure 1.57. Shape of scour protection at the end of 3.16.
No damage occurred.

In this test protection type number four was used. It has a D_{50} of 365 mm.

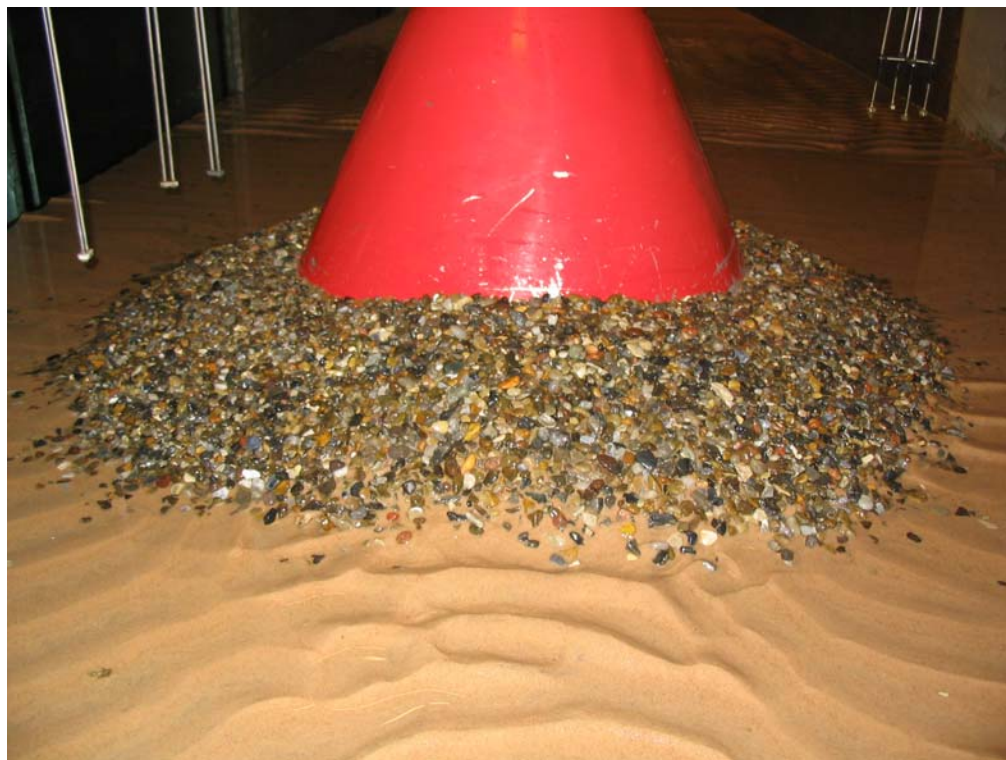
Figure 1.59. Shape of scour protection at the end of 3.17.
No damage occurred.

In this test protection type number two was used. It has a D_{50} of 258 mm.

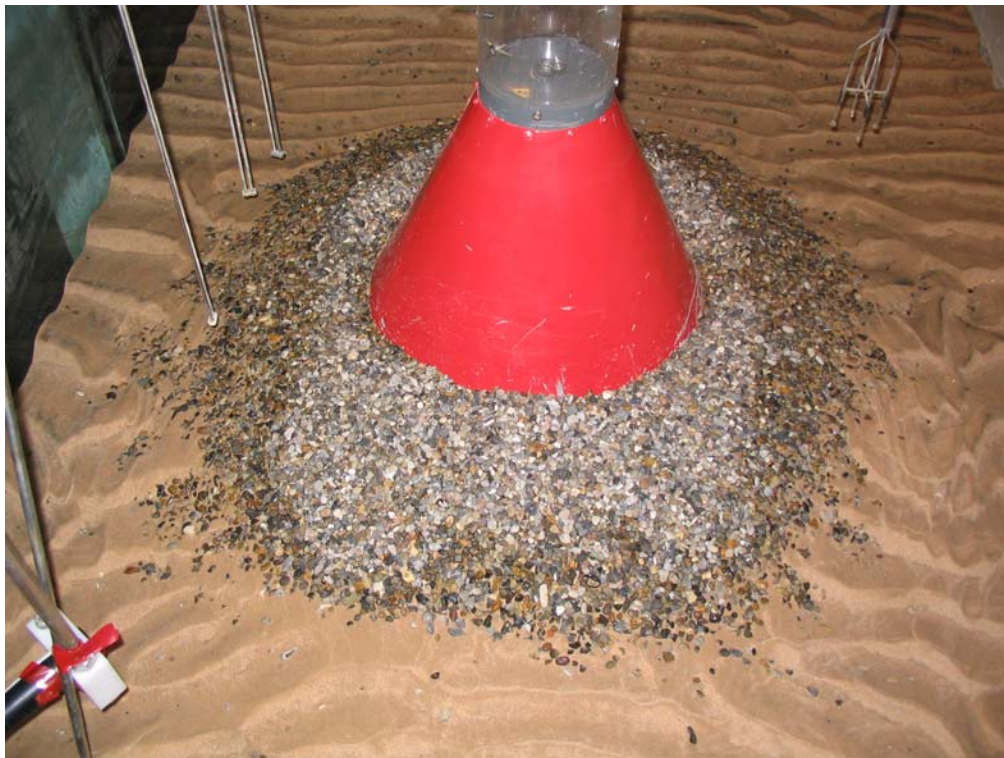
Figure 1.61. Shape of scour protection at the end of 3.18.
No damage occurred.

In this test protection type number two was used. It has a D_{50} of 258 mm.

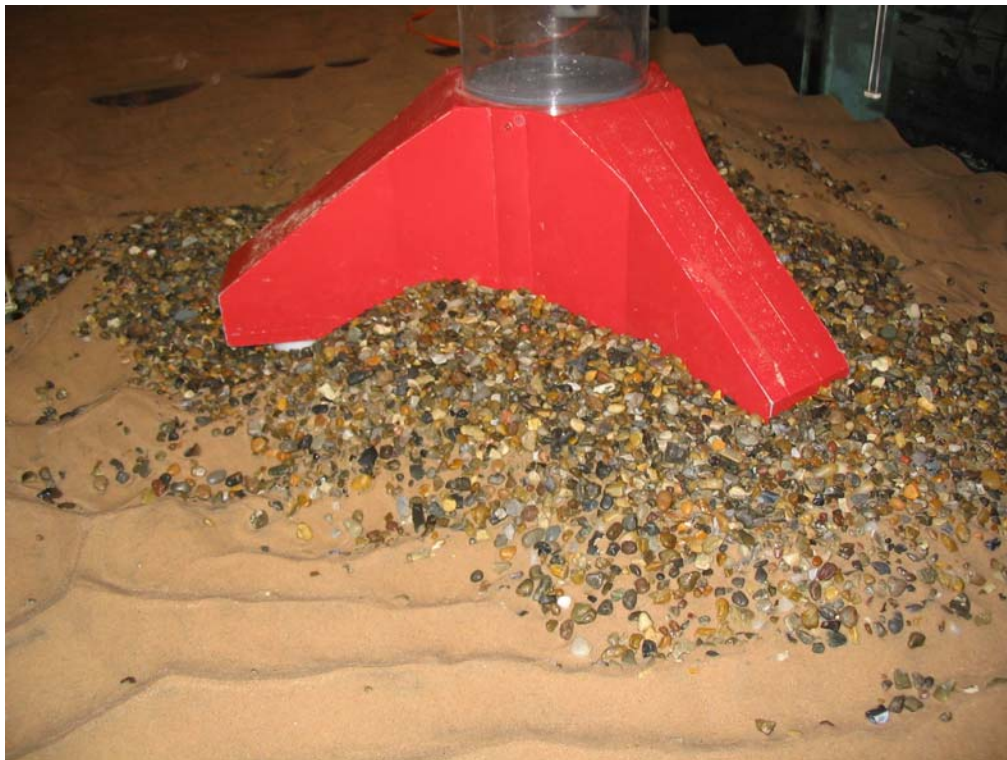
Figure 1.63. Shape of scour protection at the end of 3.19.
Some damage occurred.

In this test protection type number two was used. It has a D_{50} of 258 mm.
