BEACH AND VEGETATION-LINE CHANGES
AT GALVESTON ISLAND, TEXAS:
EROSION, DEPOSITION, AND RECOVERY
FROM HURRICANE ALICIA

Prepared for the
Texas Office of the Attorney General
Environmental Protection Division
under Contract No. IAC (84-85)-0930

Bureau of Economic Geology
The University of Texas at Austin
Austin, Texas 78713

November 1984

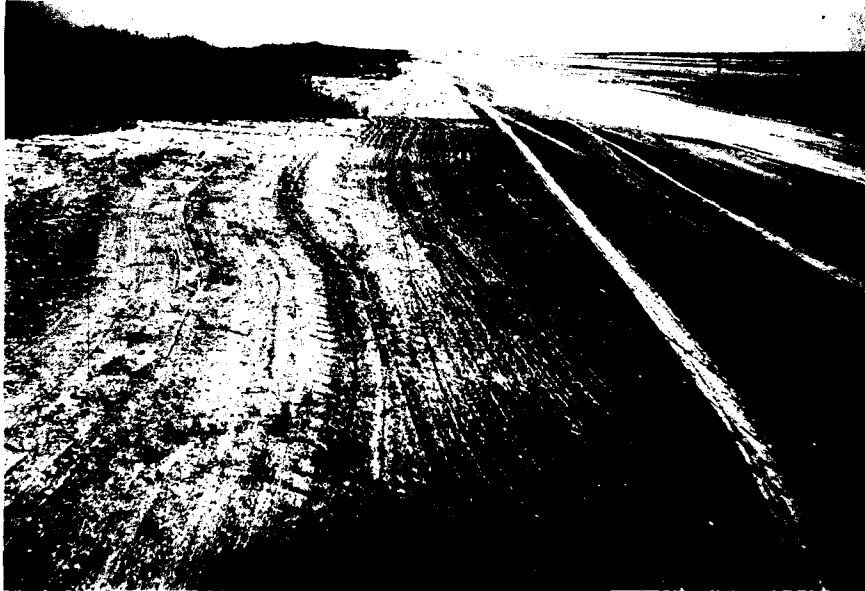
Figure 6a. Pre-Alicia vegetation line, West Beach.

Figure 6b. Post-Alicia erosional escarpment and vegetation line, West Beach. Shoreline to right of picture.

The greatest loss of sand occurred on the beach, lowering elevations considerably (fig. 5) and removing part of the vegetated zone (fig. 6a and b). The generally lower beaches allowed normal high tides to reach farther inland than they did before the storm. Indeed, many West

The boundary on or near the beach that is consistent regardless of the tide or season is the vegetation line (fig. 6a and b). Like the shoreline, it is also a dynamic boundary; however, it changes imperceptibly from day to day under normal conditions. Under extreme conditions, such as during a hurricane, it can move rapidly landward tens or hundreds of feet as a result of beach erosion. In the aftermath of a hurricane, several years may pass as coastal processes gradually increase backbeach elevation, allowing vegetation to encroach on the bare beach and move the vegetation line seaward.

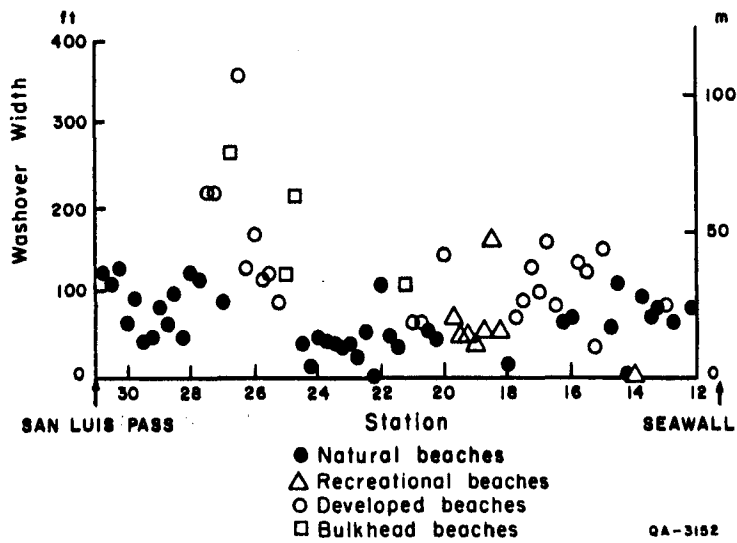
Figure 11. Inland extent of washover deposition from Hurricane Alicia, West Beach. Station locations shown in figure 3.

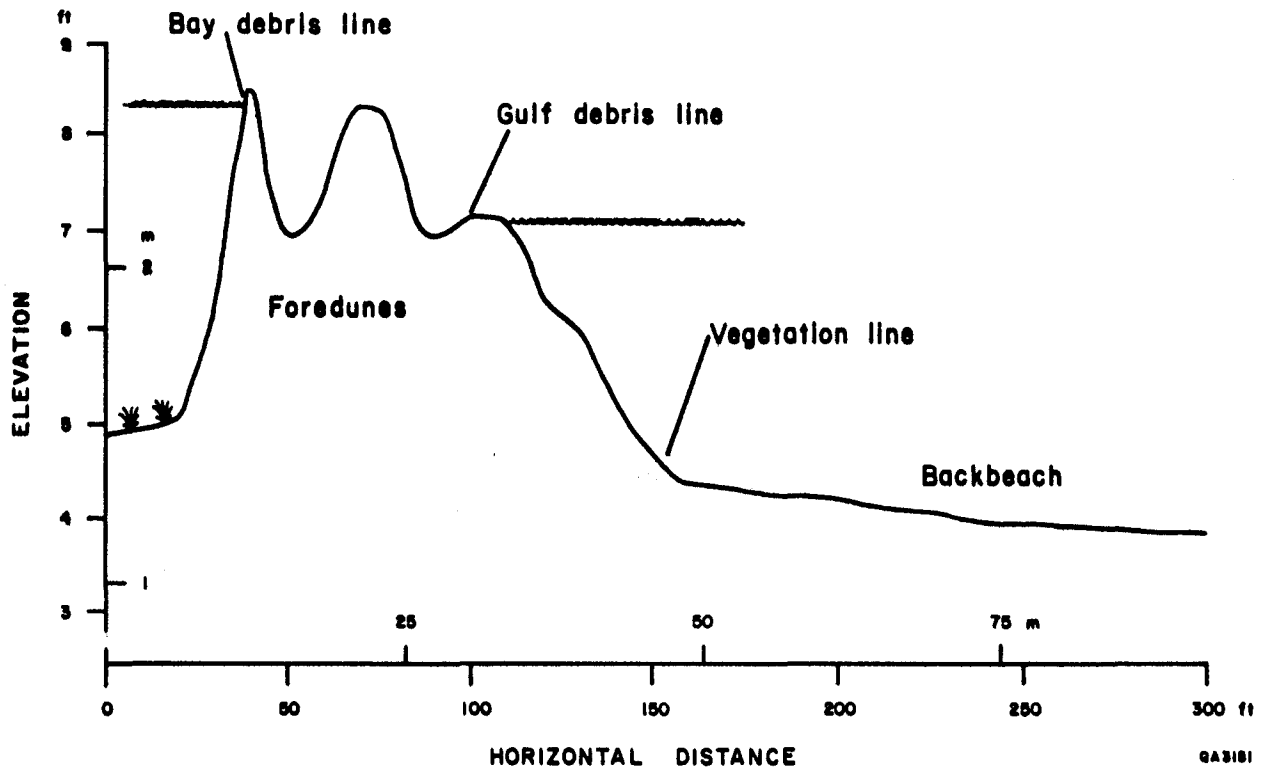
Figure 13. Profile of dune ridge on Follets Island (fig. 1) showing Gulf and bay debris-line elevations. Profile location is adjacent to a large storm-runoff drainage channel.

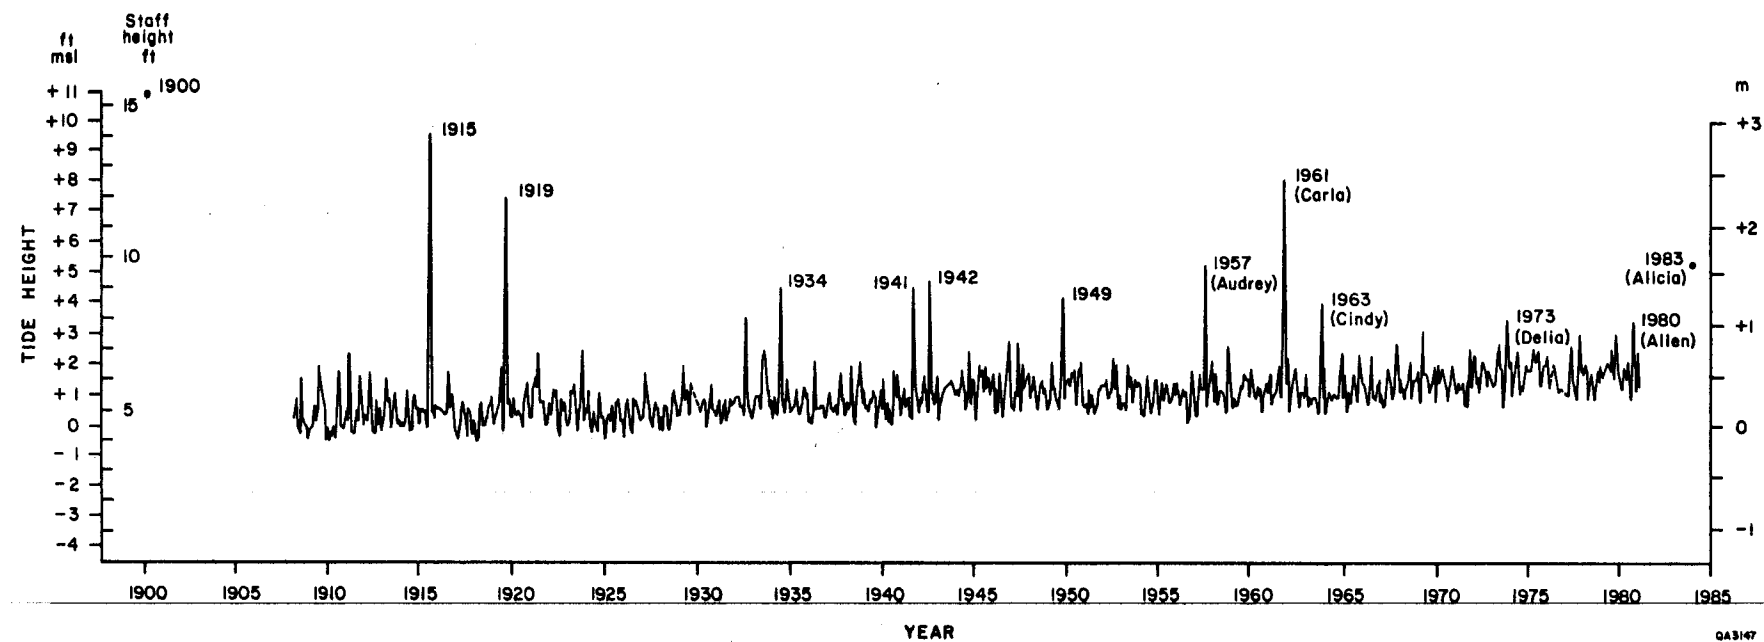
Figure 17. Highest monthly tides observed at Pier 21 on the bay side of Galveston Island, 1908 to 1983. Mean sea level (m.s.l.) calculated from 1960-1978 hourly tide heights. Modified from U.S. Army Corps of Engineers (1983b). Data from National Ocean Service.

The tide record goes back to 1908 at Pier 21 (on the bay side of Galveston Island), allowing comparison of all storms after 1908 at the same gauge. A summary of monthly high tides at this gauge (fig. 17) shows that several storms have caused tides higher than Alicia's 5.7 ft peak, including the storms of 1915 (10.5 ft), 1919 (8.4 ft), 1957 (5.9 ft), and 1961 (8.4 ft). The 1900 storm tide was estimated at 11.2 ft. Several other storms registered tides only slightly lower than Alicia, notably in 1932, 1934, 1941, 1942, 1949, 1963, 1973, and 1980. For comparison, highest monthly tides for non-hurricane months average about 2 ft (U.S. Army Corps of Engineers, 1983b).

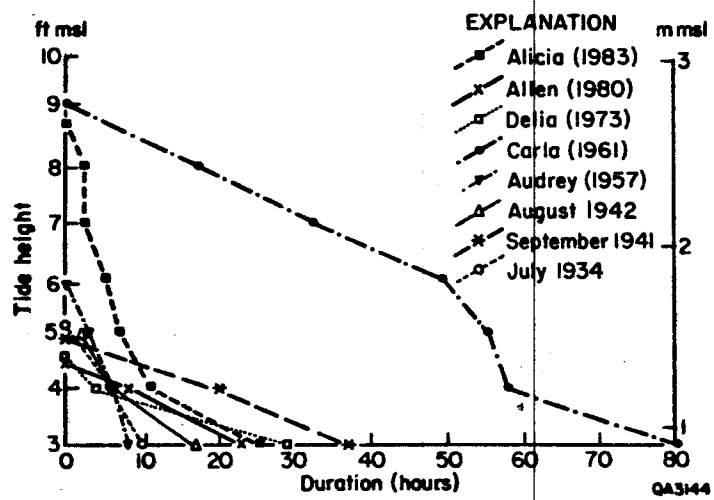
Figure 18. Storm surge height and duration, Galveston Island. Carla (1961) and later storms were recorded at Pleasure Pier (gulf gauge); earlier storms were recorded at Pier 21 (bay gauge). Data from National Ocean Service.

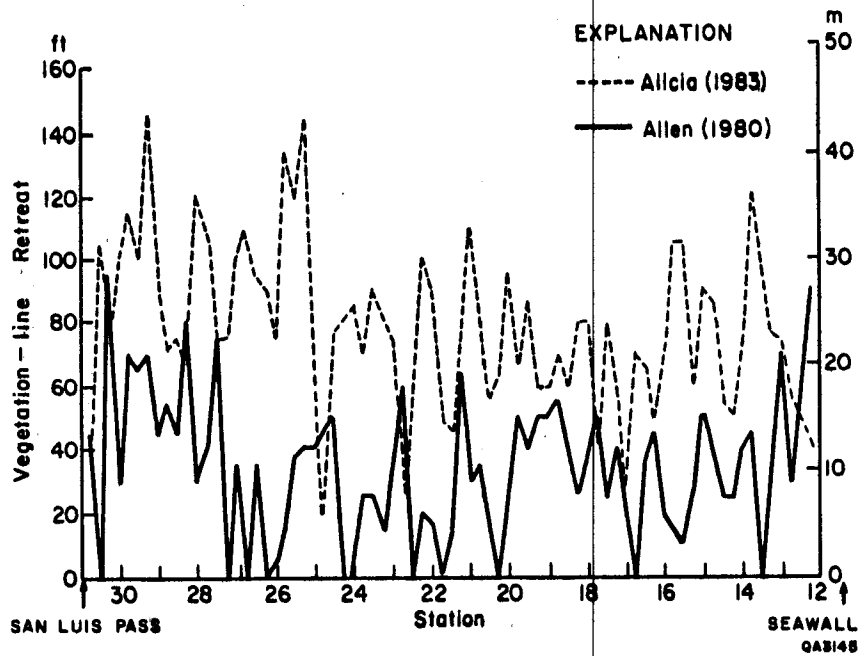
Figure 19. West Beach vegetation-line retreat caused by Hurricanes Allen and Alicia. Station locations shown in figure 3.

stations. A comparison of the average retreat observed along West Beach during Allen and Alicia indicates that Alicia eroded the vegetation line over twice as far landward as did Allen (78 ft versus 34 ft, table 5). Areal measurements made from pre- and post-storm photographs also indicate that over twice as much vegetated area was lost during Alicia (7,575,000 ft² to 3,570,000 ft²).
