Automated Deep Learning for Defect Detection in Carbon Fibre Reinforced Plastic Composites

July 2023

ASME
QNDE 2023
Quantitative Nondestructive Evaluation

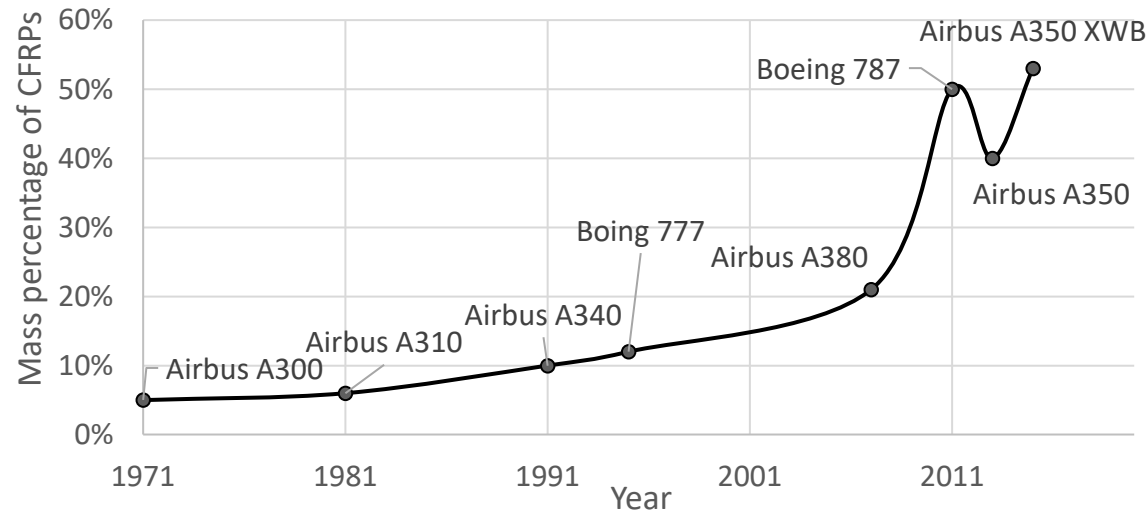
Structural percentage (mass) of composites in commercial aircraft [1,2]

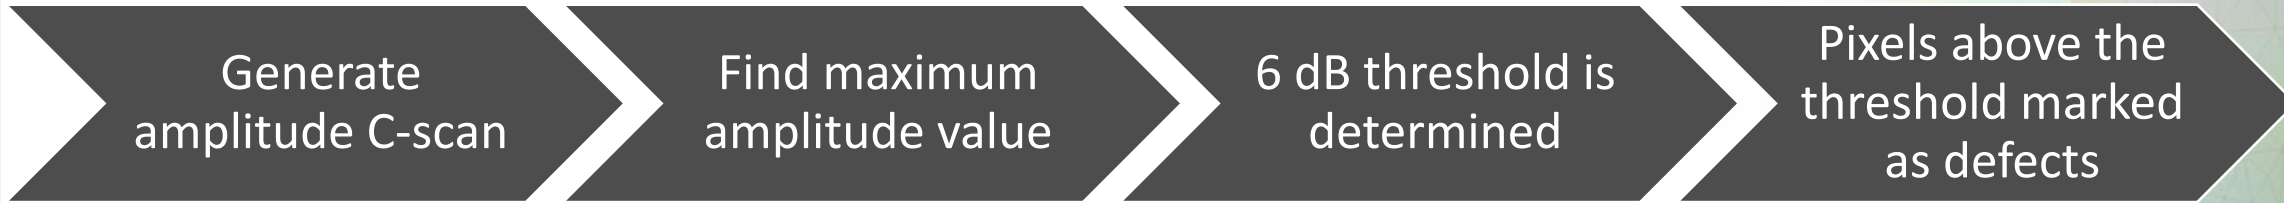
- Adaptation from 6 dB drop method used in defect sizing
- 6 dB drop physically refers to the decrease in the amplitude by half
- In generated C-scan, 6 dB drop is performed with respect to the maximum occurring amplitude

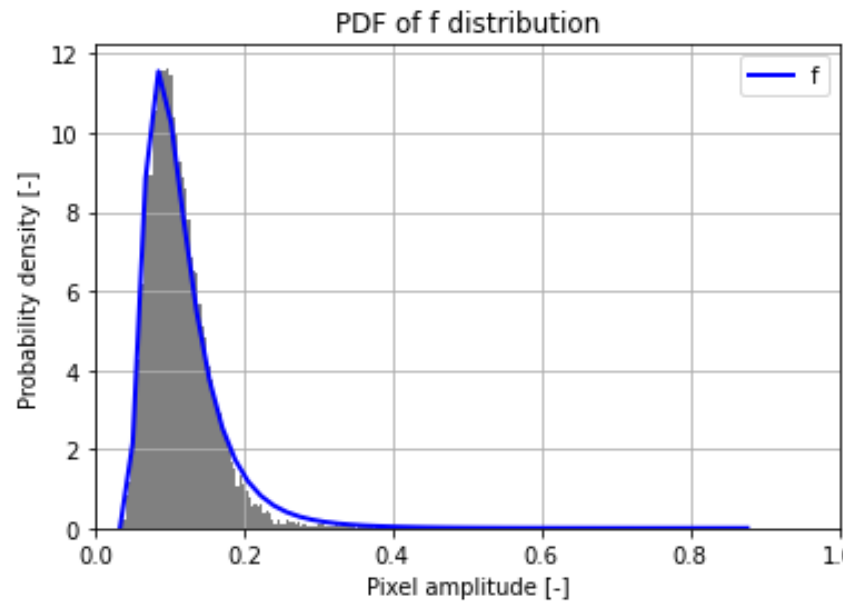
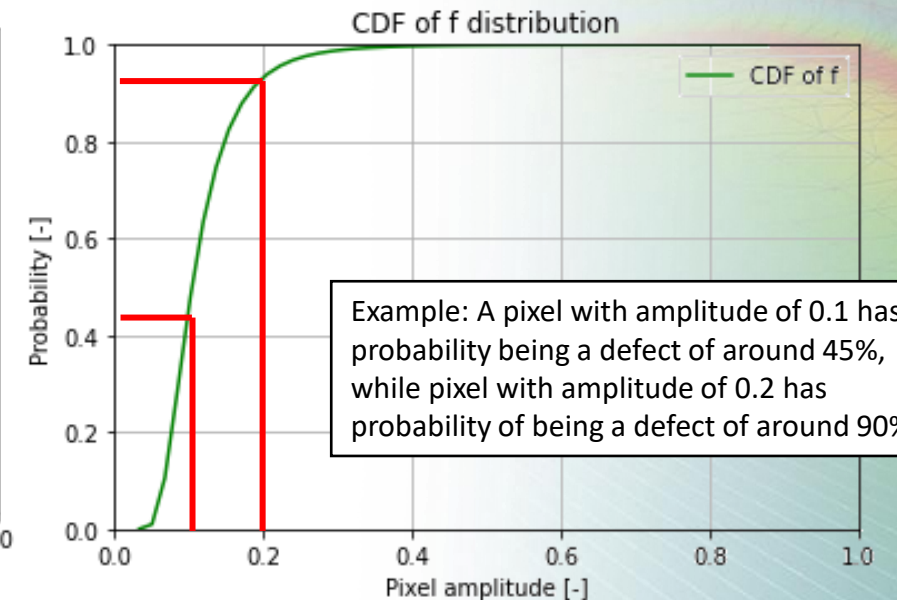
- Method based on work by Wilcox et al. [4] where no prior knowledge about defective areas is needed, if they are sufficiently different from background
- A healthy ultrasonic C-scan (or a section) is used to produce statistical distribution of pixel amplitudes

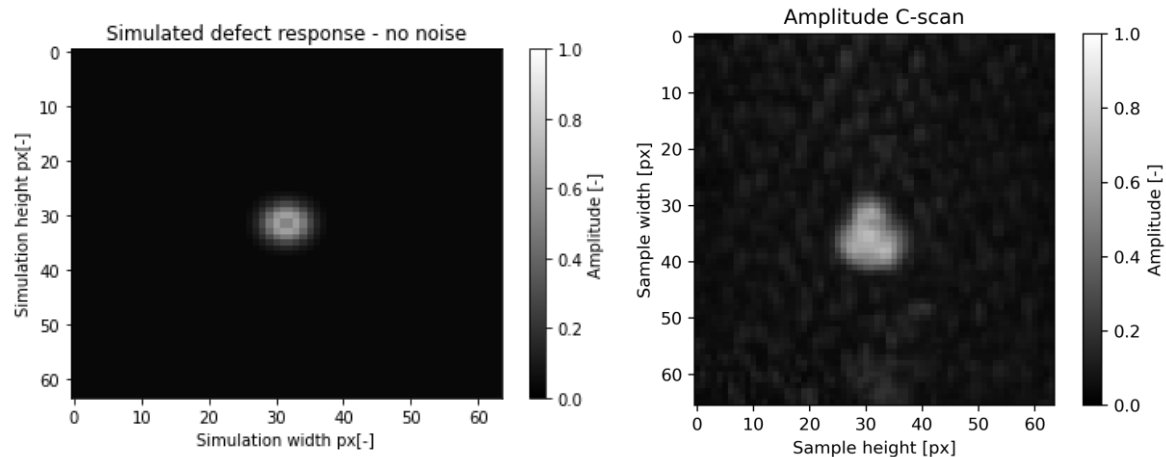
Example of CIVA generated data (left) and experimental data (right)

- ✓ Relatively fast generation of ultrasonic data
- ✓ Reasonably accurate representations
- ✗ Lacks finer detail in the response (noise)
- ✗ Shape of embedded defects is limited in geometry
